## **Wylfa Newydd Project**

**6.3.25 ES Volume C - Road traffic-related effects (project-wide) App C2-4 - DCO TA Appendix K - Road Safety Audits**

**Logistics Centre External Layout**

**Stage 1 Road Safety Audit**

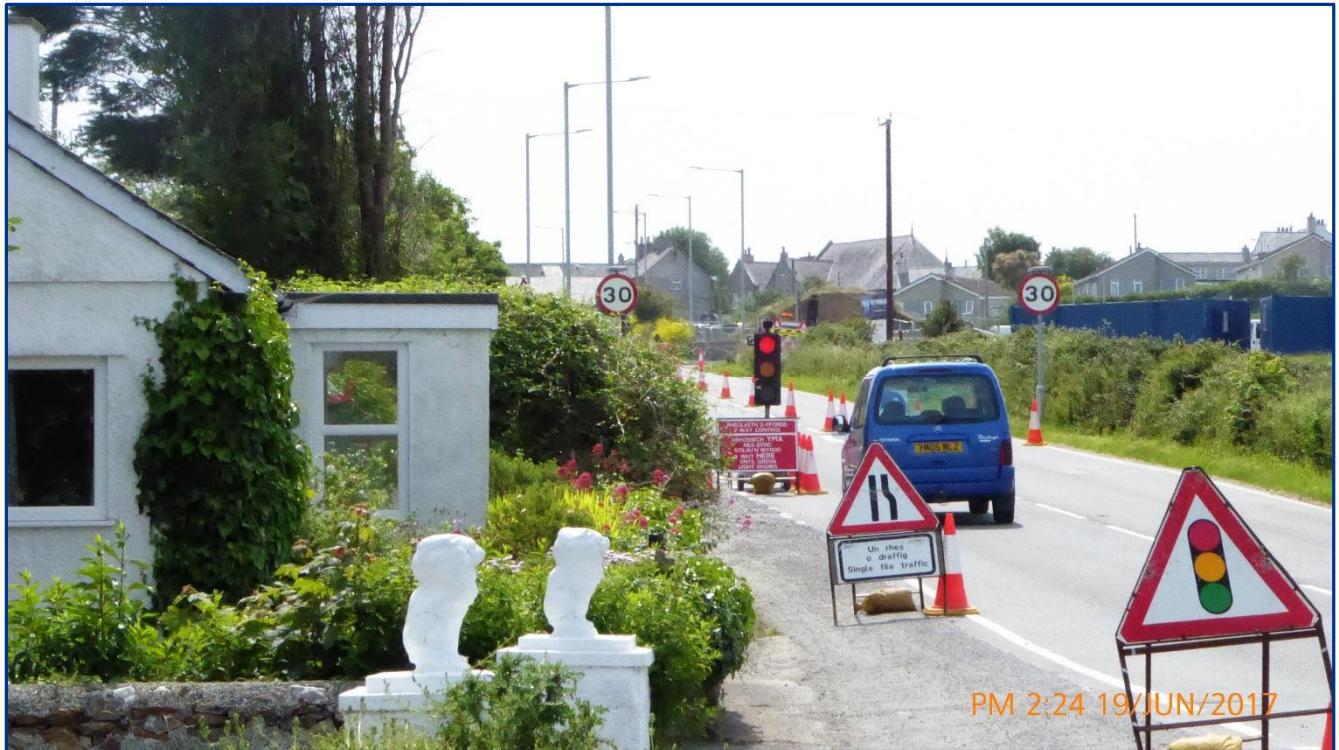
**Figure 3.1: Image showing the view to the south of the proposed access to the Off-site Power Station Facilities along with the recently installed 30mph signage.**

The junction visibility splays for both the north and south of the junction are obstructed by fence lines, existing buildings or neighbouring land boundaries. The 2.4m x 120m (appropriate for a 40mph road) visibility splay to the left passes through the neighbouring property. Whilst a visibility splay of 2.4m x 62m is achievable this is below the required standard. The 2.4m x 120m visibility splay to the right pass through the retaining wall/tubular fence. Inadequate visibility could result in drivers pulling out onto the A5025 with insufficient forward visibility when it is unsafe to do so, resulting in collisions with approaching traffic or drivers on the A5025 having to take evasive action to avoid a collision. It should be noted however, that a 30mph speed limit has recently been introduced to the south of the site following the construction of a new school (Ysgol Rhyd Y Llan): **See figure 3.1 below.**

If the scheme is implemented, it is recommended that the appropriate junction visibility splays should be implemented and safeguarded.

The visibility to the south is limited on the exiting arrangement. The proposed realignment of the A5025 and potential changes to the speed limits will further impact on the visibility. Figure 2.1 indicates the impact on the visibility. HNP/IACC to review.

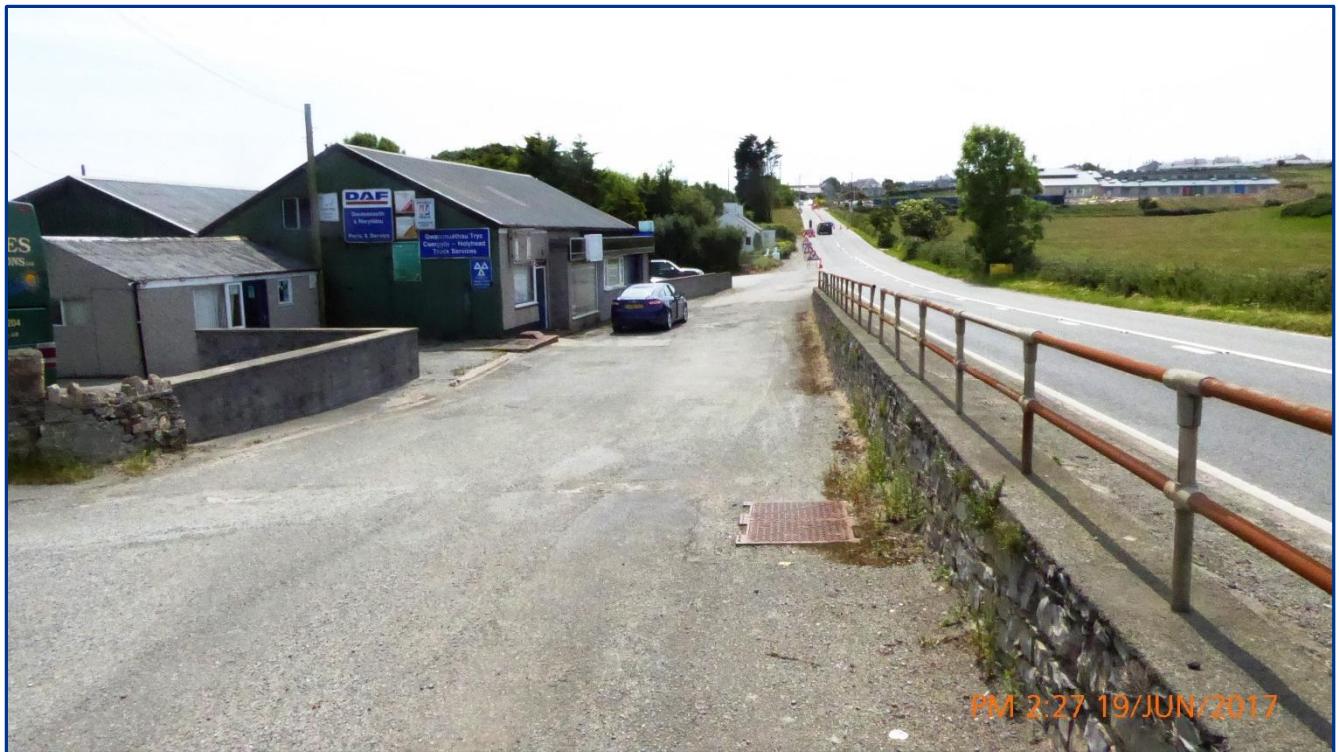
**Figure 3.2: Image showing the extent of the existing service road and the proposed Off-site Power Station Facilities access.**

If the scheme is implemented, it is recommended that the southern section of the service road is removed and a new access installed to the farm.

The service road is to be retained along with the access to the existing bus facility, which will become the access point to the new site. The access along the northern boundary to the property will be retained in its current location. Vehicles entering and leaving the new site will cross the service road to the A5025 directly opposite the entrance. Vehicles using the existing property access will be able to turn north or south on the service road to access the A5025. It is not considered that this will be a conflict.

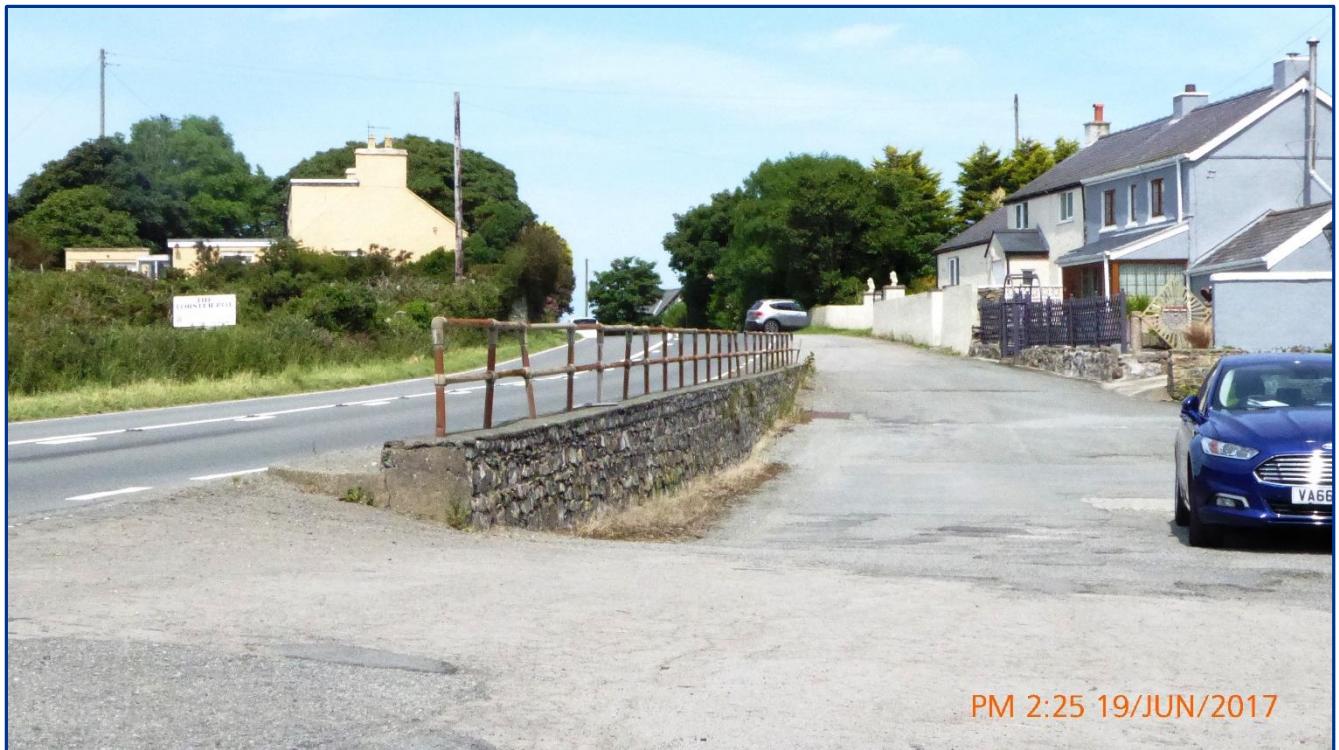
There is a retaining wall adjacent to the service road which is close to the proposed Off-site Power Station Facilities. This retaining wall results in a level difference of 0.83m between the service road and the main carriageway. There is section of rusty/damaged tubular fencing on top of this retaining wall which allows neither visibility nor an appropriate vehicular restraint system. Drivers turning out of the proposed access may fail to see a southbound vehicle and a collision could occur. This feature also falls within the 4.5 x 12m visibility splay: **See figure 3.3 below.**

**Figure 3.3: Image showing the location of the retaining wall adjacent to the existing coach depot.**

If the scheme is implemented, it is recommended that the requirement for this retaining wall/tubular fence should be removed by lifting the service road level to that of the existing carriageway in this location.

The retaining wall may be removed by the A5025 online works. This issue will be reviewed at the detailed design stage.

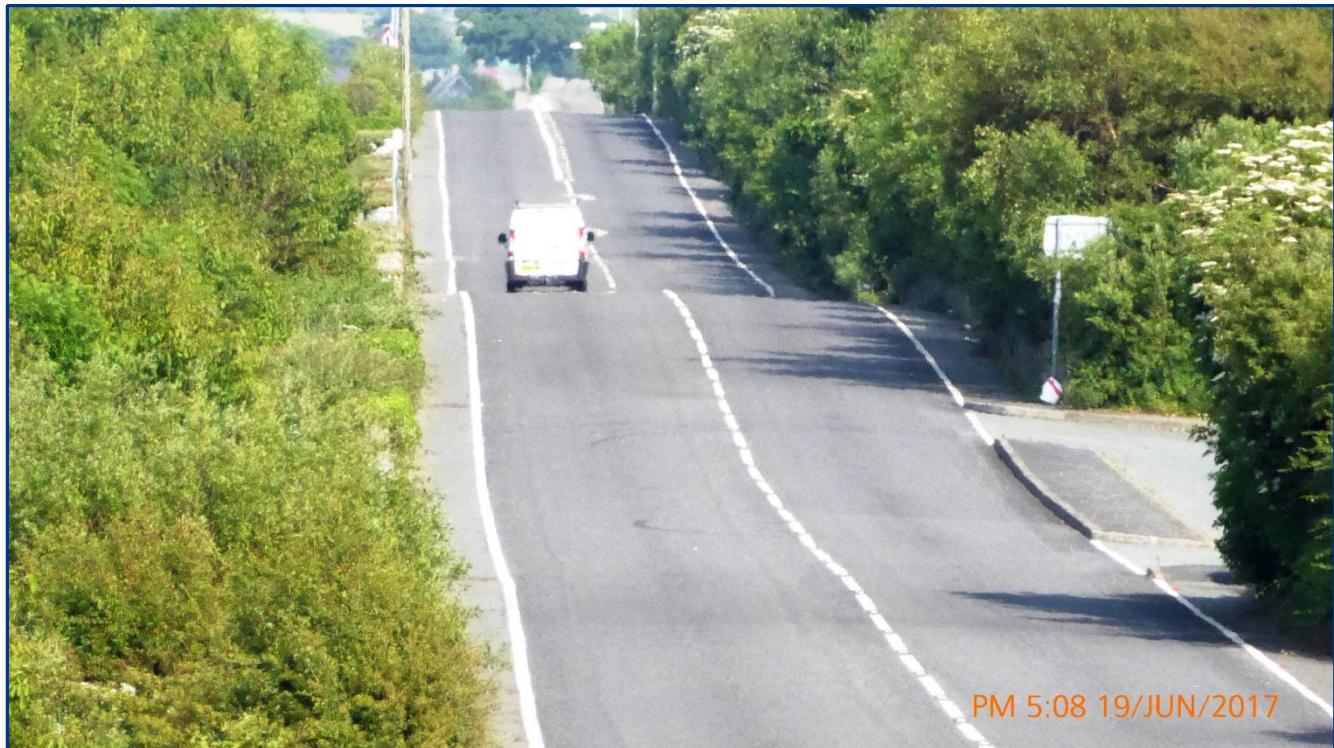
**Figure 3.1 - Image showing that there is a 'crest' in the carriageway (A5) on the westbound approach to the proposed traffic signals.**

We are not convinced that this is an issue. Figure 3.1 looks very misleading when you compare it to standing at the point where the junction will be located. Forward visibility exercise has been undertaken by Jacobs highways team. Further assessment can be undertaken to confirm if high-mast traffic poles are required.
