# SIGNIFICANT INCIDENT REPORT

Incident: 018965 - 15092020

Address: Orsted BESS, Carnegie Road, Liverpool, L137HY

Date of incident: 15<sup>th</sup> September 2020

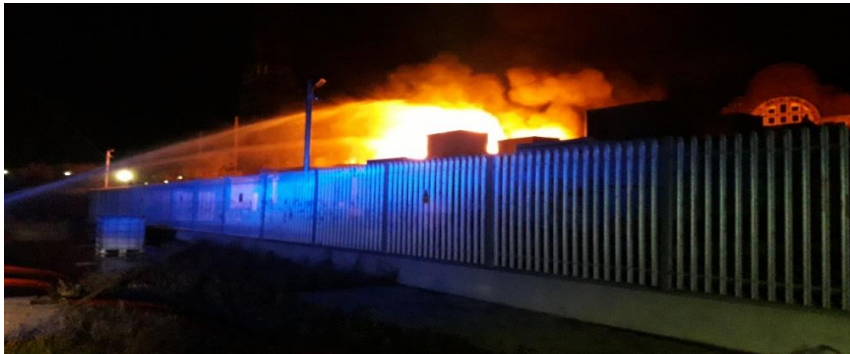
**Firefighting action  
from Sector 1.**

2 ground monitors at work.

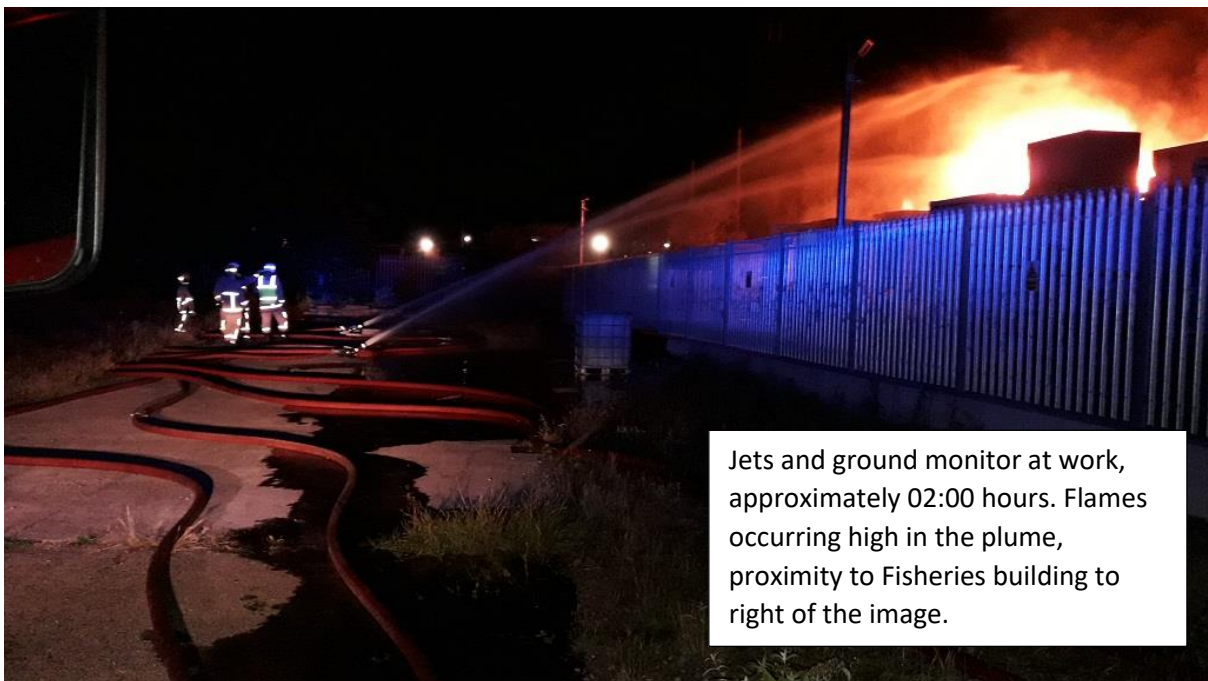
Jets and ground monitor at work, approximately 02:00 hours. Flames occurring high in the plume, proximity to Fisheries building to right of the image.

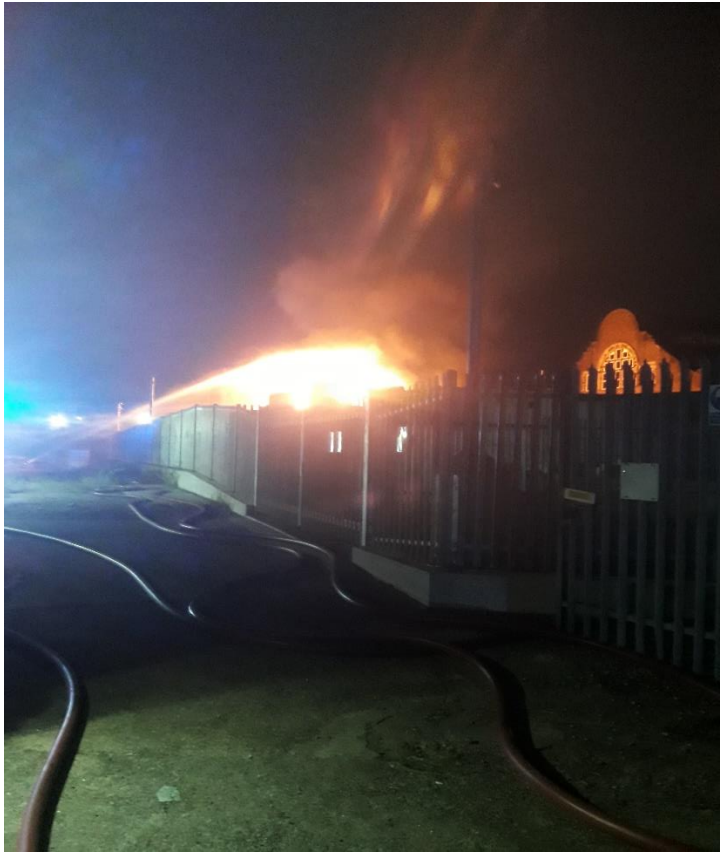
Ground monitors in use and personnel upwind of plume approximately 03:00 hours.

Information on plume toxicity gained at this point.

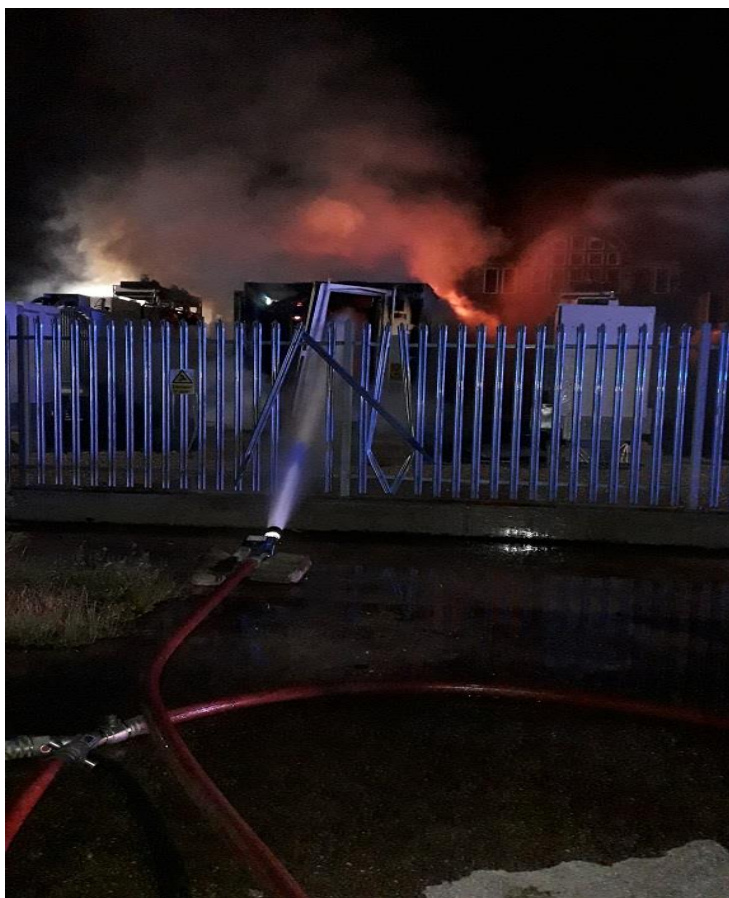
Ground monitor in use at approximately 05:15hrs.

Note sections of railings opened by MFRS to allow straight play of monitor jet.

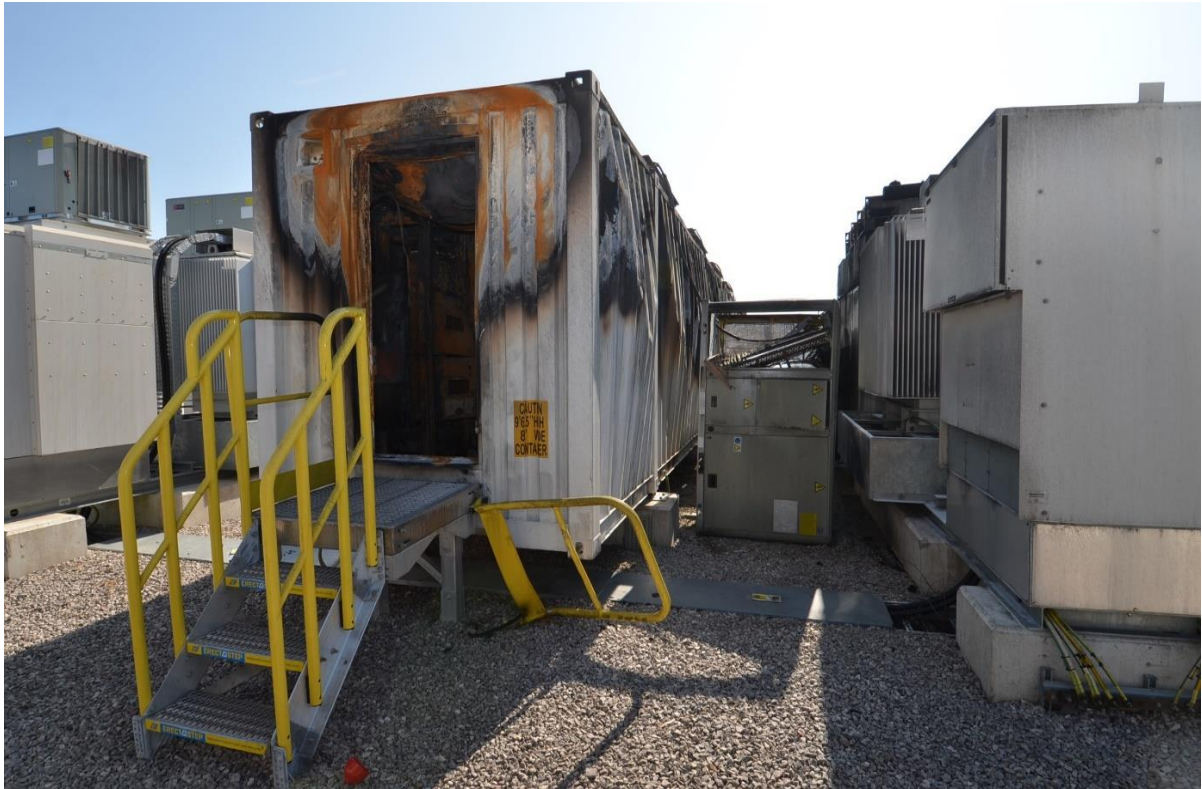
*'Accidental ignition caused by a lithium battery failure transitioning into thermal runaway'.*

Image above: Exterior of unit with pressure damage to side.

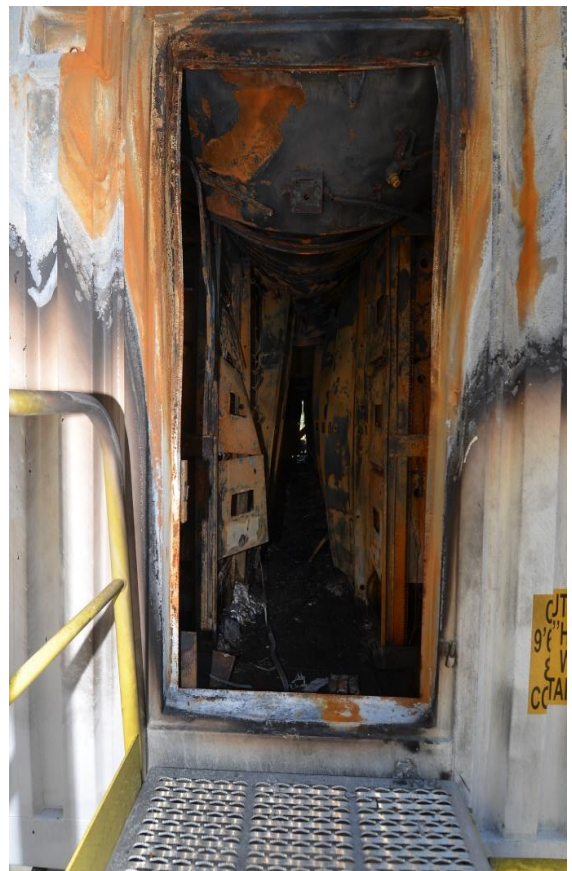
Image below right: Internal view of modules.
