CASSINGTON TORNADO 2021

Report by the Tornado and Storm Research Organisation (TORRO)

On 31st October 2021, a tornado went through the village of Cassington. This report covers the findings from a site investigation conducted by Sarah Horton (TORRO) over two days following the event

Author:
Sarah Horton (TORRO)

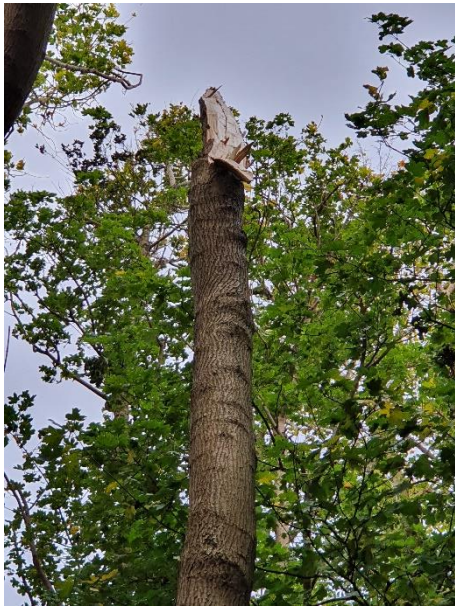
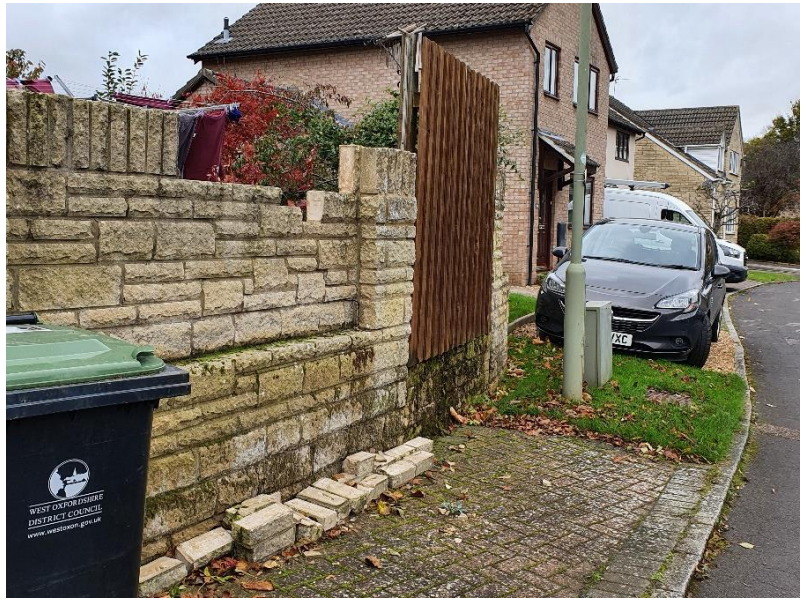
The most south-western point of damage found was close to Eynsham Primary school and consisted of large branches from a tree. These had been tidied into a pile and so direction of fall could not be ascertained.

There was some tile damage to houses close to the B4449. One garden wall had partially collapsed. Several large trees had lost branches or snapped high up.

Estimated strength at this point T1 Width 120m.

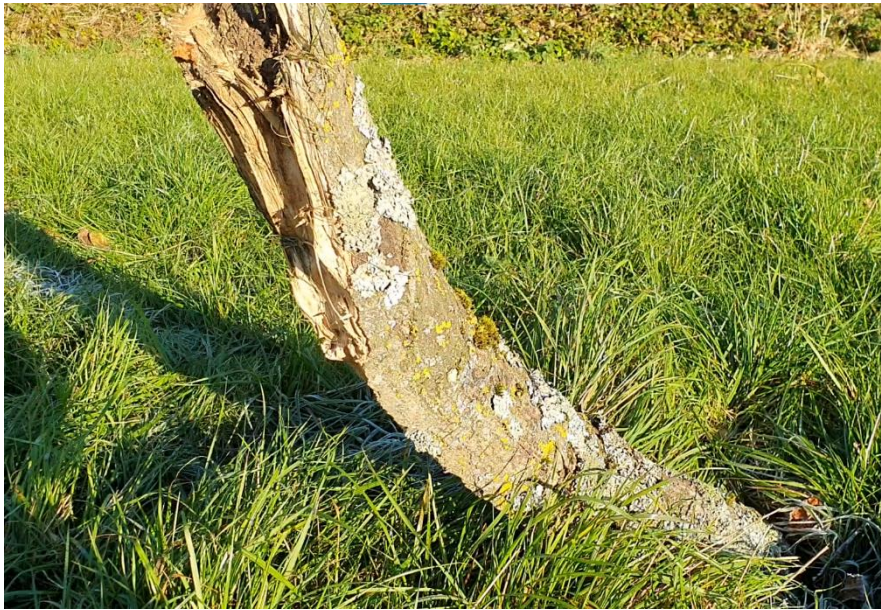
The purple marker shown on the map is where this branch impaled the ground. It was over 1m long and around 15cm in diameter. It was embedded around 20cm deep. It had travelled around 40m before becoming embedded. Other tree debris was scattered across the field.

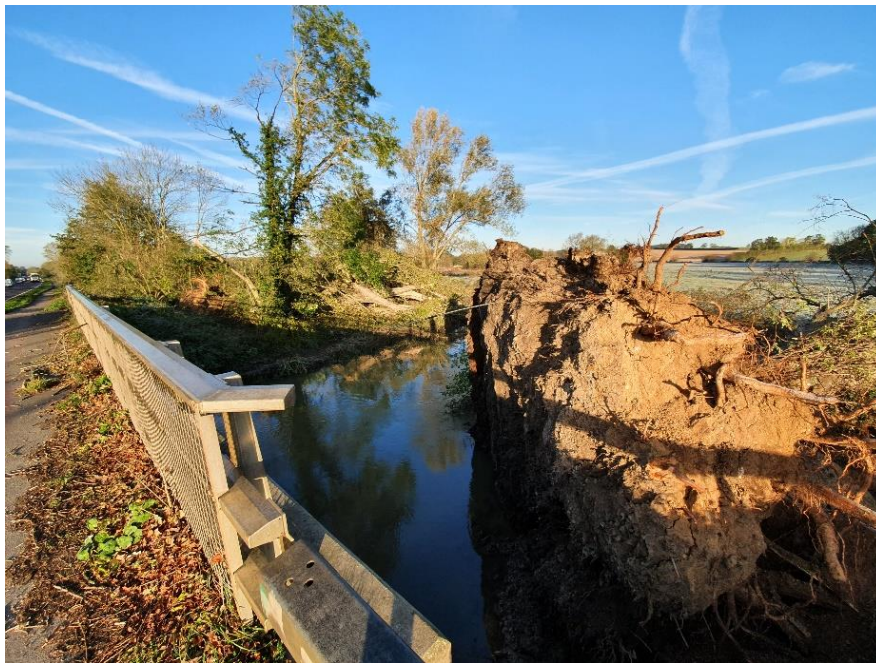
Two extremely large poplar trees had been completely uprooted alongside the River Evenlode. There was much evidence of twisting on broken branches. Debris had been scattered to the north.

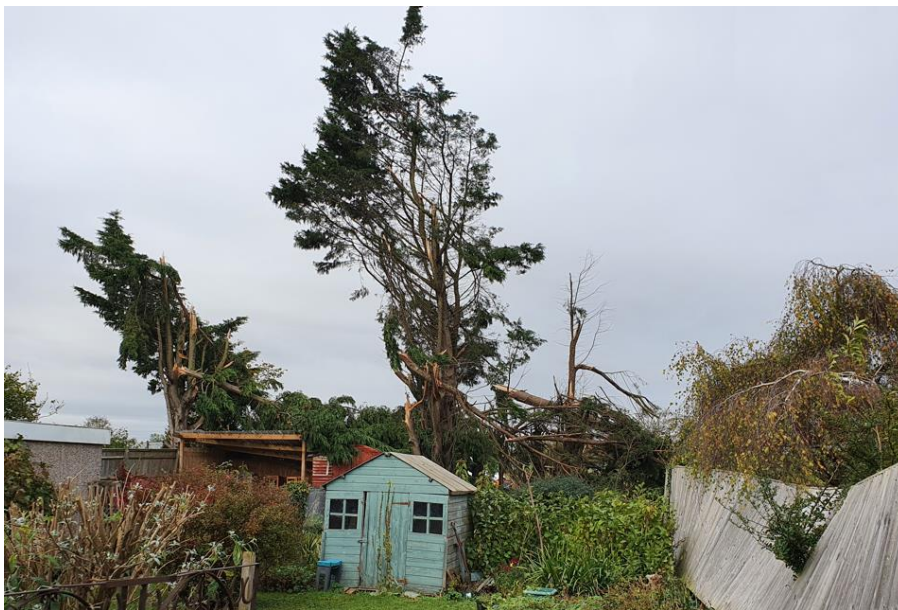
From the road some damage was evident to large trees and a fence.

In Hollow Furlong, one witness said that she saw branches and leaves swirling on the eastern side of the property. Afterwards leaves were plastered to the window. Tiles had come off from both sides of a garage.

In Williams Court, roof tiles travelled approximately 20-30m denting a car. Another car had its windscreen smashed from falling tiles.

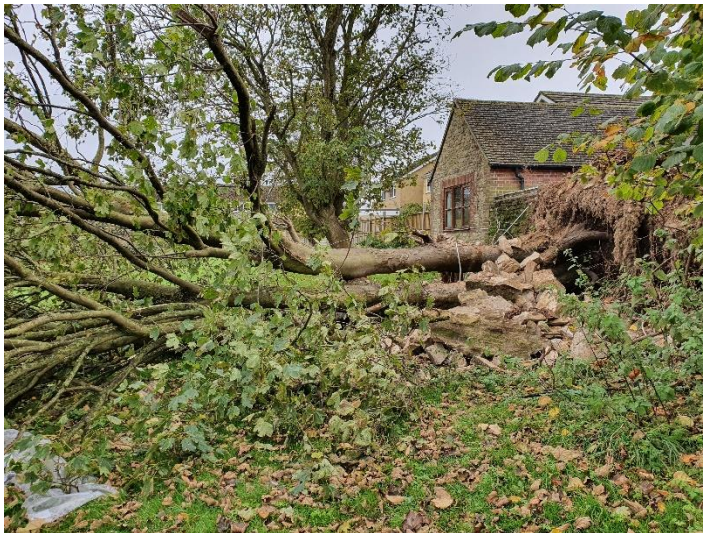
The damage in this area was similar to the damage at the A40 end of Cassington. Numerous large trees, including sycamores and oaks, were either felled, or badly damaged. In the field to the north east of the village there was damage along the periphery, in the centre and throughout the wooded area.

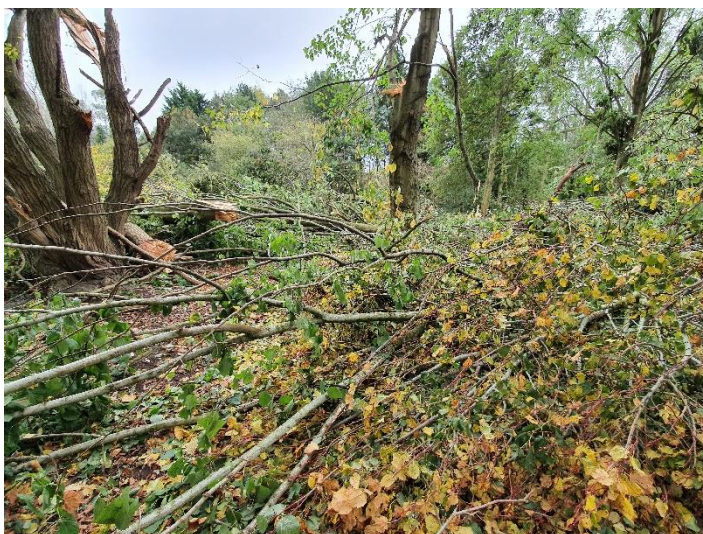
It was clear that the trees had been twisted by the winds. They lay generally in a north-easterly direction.

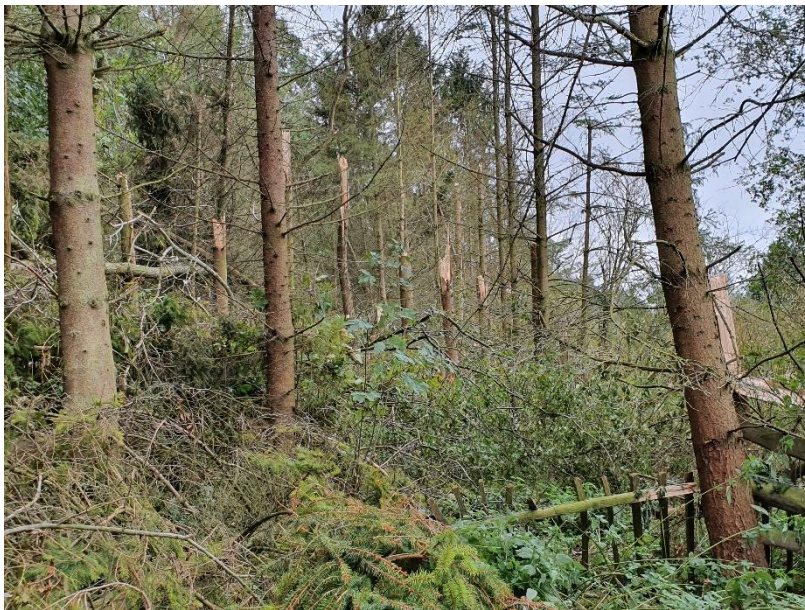
A footpath led to another tree boundary. Most of the damaged trees could not be accessed as they were on private land, but the front edge contained a number of snapped trees. On the back edge of this there were some trees that had clearly fallen to the north east.

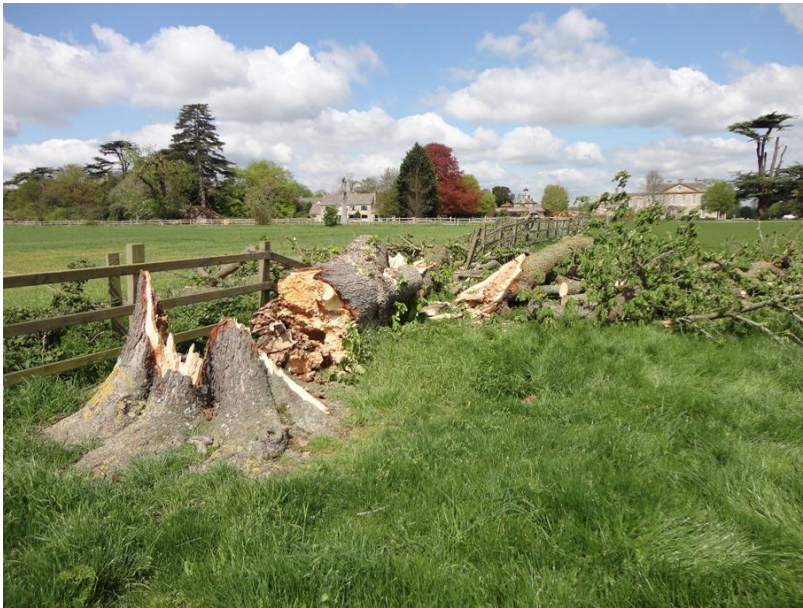
Cokethorpe School. This tree had snapped in two places.
