BURLEIGH WOOD TORNADO 2021

Report by the Tornado and Storm Research Organisation (TORRO) SI20211031_Burleigh Wood

On 31st October 2021, a tornado went through the Burleigh Wood. This report covers the findings from a site investigation conducted by Sarah Horton (TORRO) over two days following the event

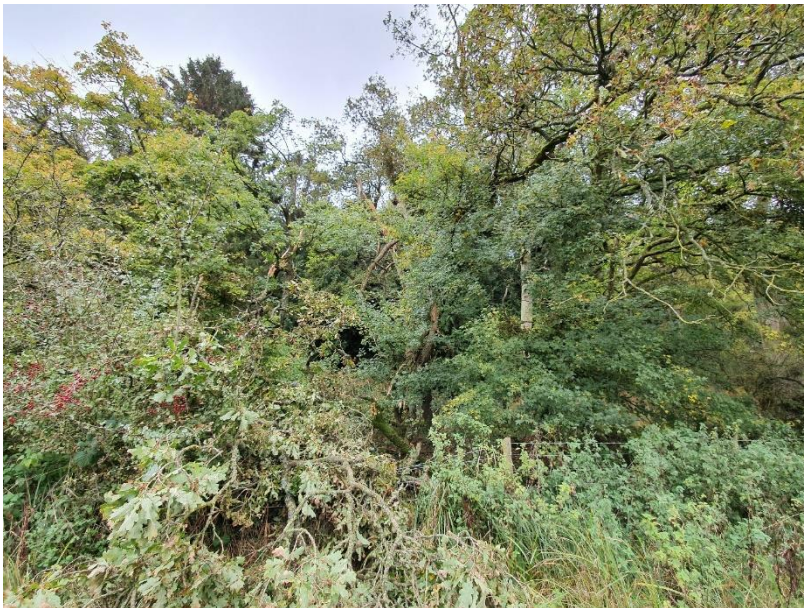
On the south western edge of Burleigh Wood lies some cottages. Some substantial tree damage was found on these grounds with one having been blown into the River Evenlode. A teak table had been destroyed. Pieces were scattered to the north west and some a substantial distance to the SE.

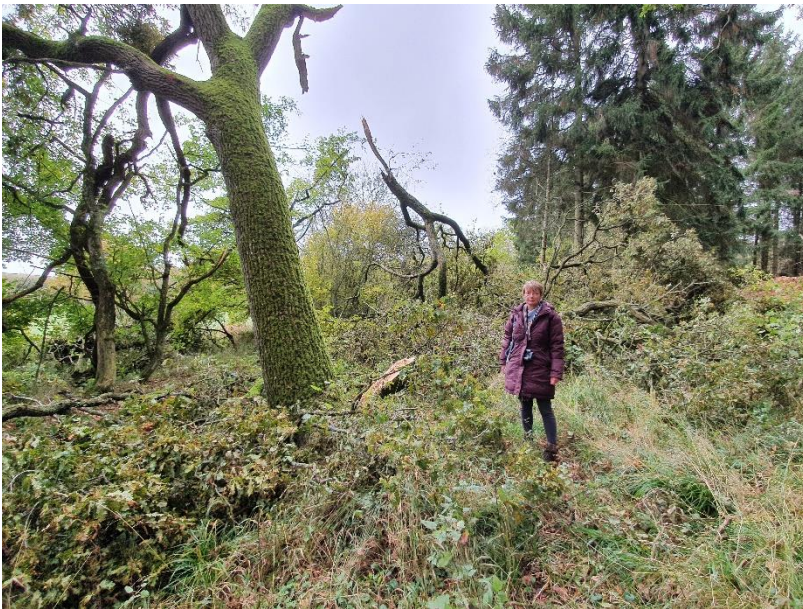
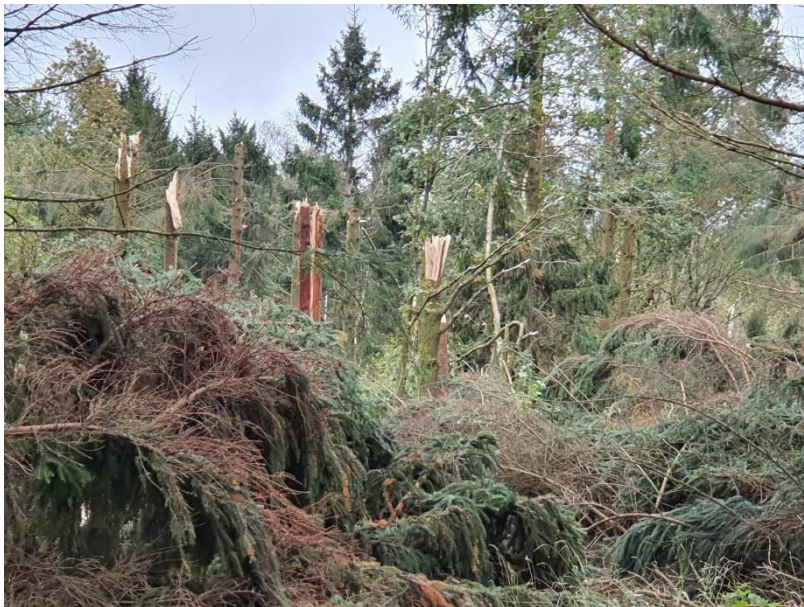
Across the river lies a railway line. A line of damaged trees 100m wide bounded the track on the south western side. On the north eastern side the same pattern was evident. Some trees had fallen. Large branches had been thrown approximately 30m away in a clearing.

On the edge of Burleigh Wood itself a 130m margin of fallen and damaged trees lined the clearing. Some of the trees had fallen SW.

Inside the woodland this oak had lost some large branches. The branch in the picture had been thrown in a north westerly direction. Other trees were also badly damaged.

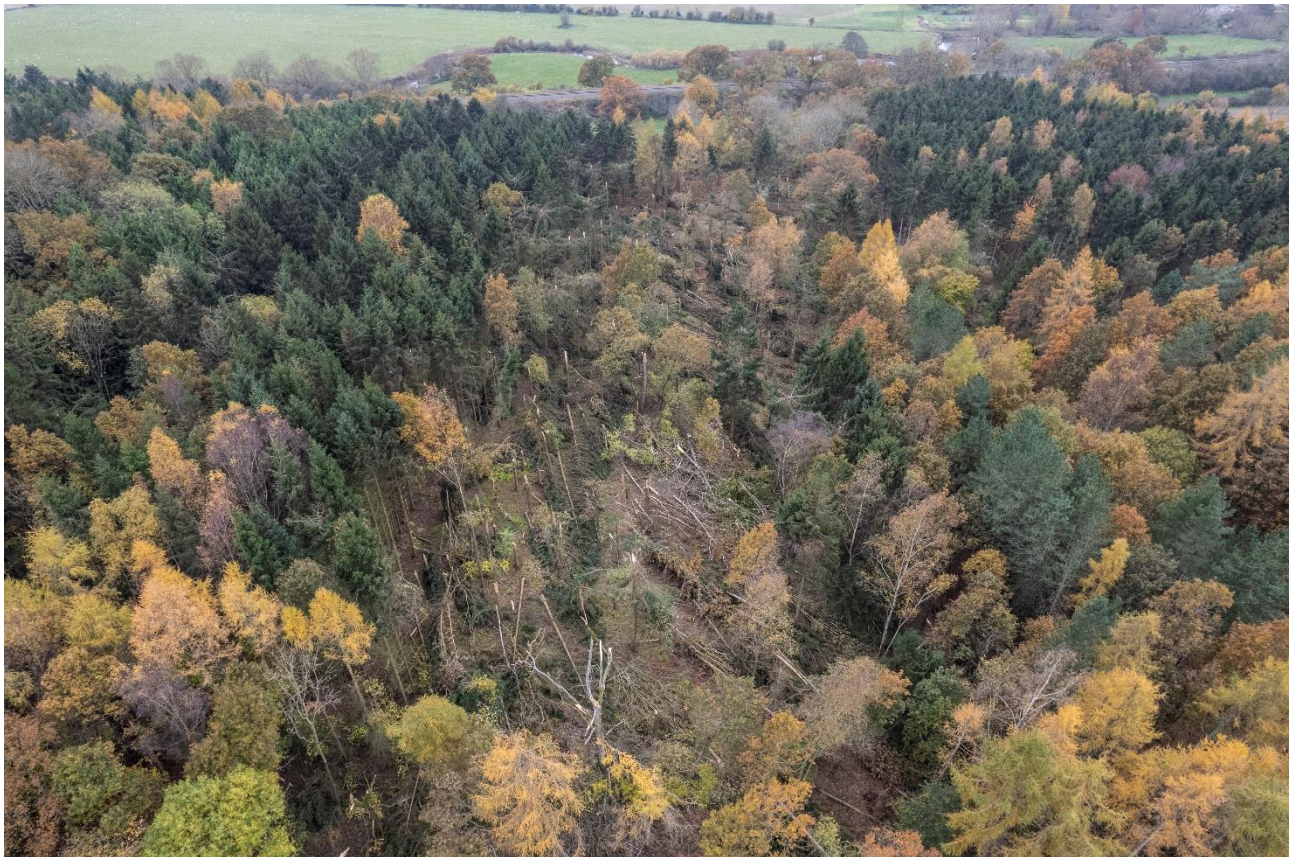
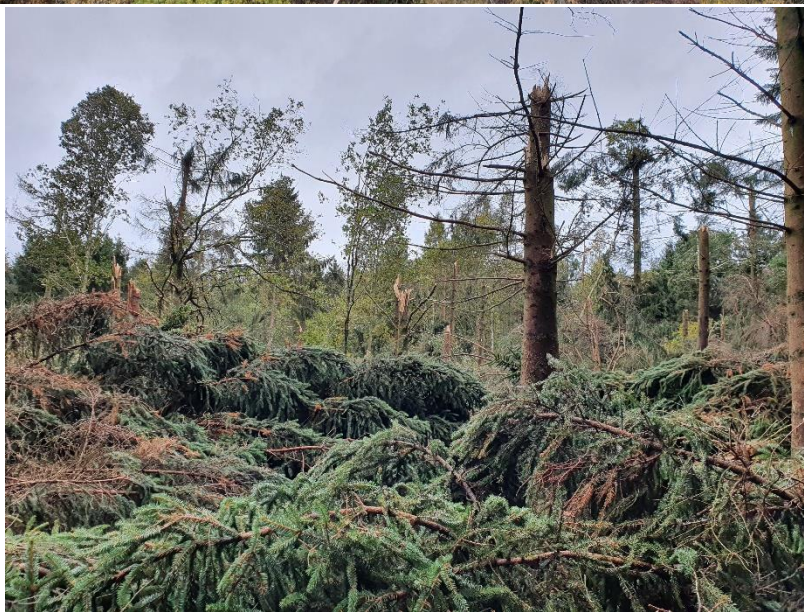
It became apparent that damage to the woodland was extremely substantial. A swath approximately 100-130m appeared to have largely been felled. These trees mostly consisted of larch.

it was difficult to see in which direction precisely these trees had been snapped off in as they lay in an impenetrable tangle. The predominant direction though was NNE-NE

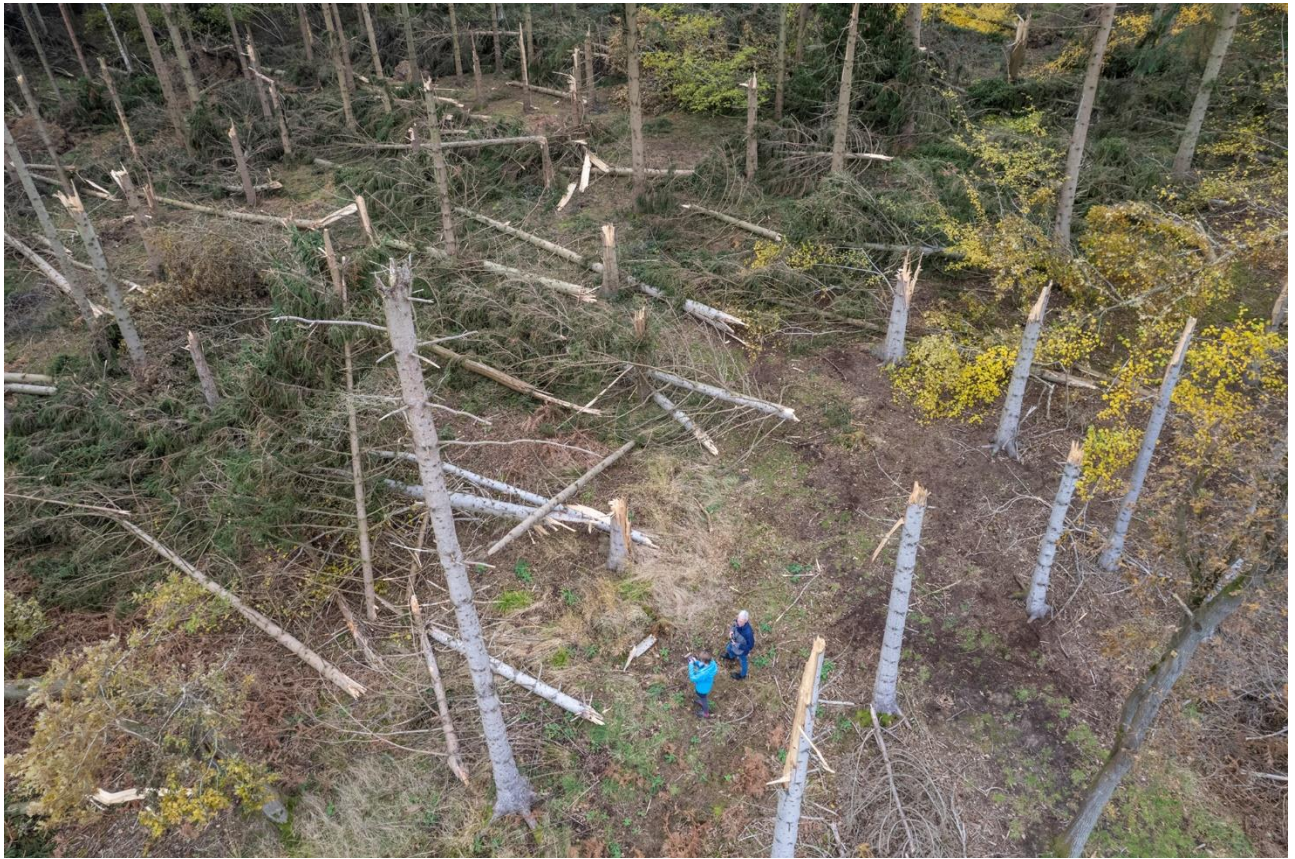
Access was easier to the more northern part of damage in the woodland. Trees had landed in multiple directions, ranging from northerly to easterly. Even within small areas, trees ended up in different directions.

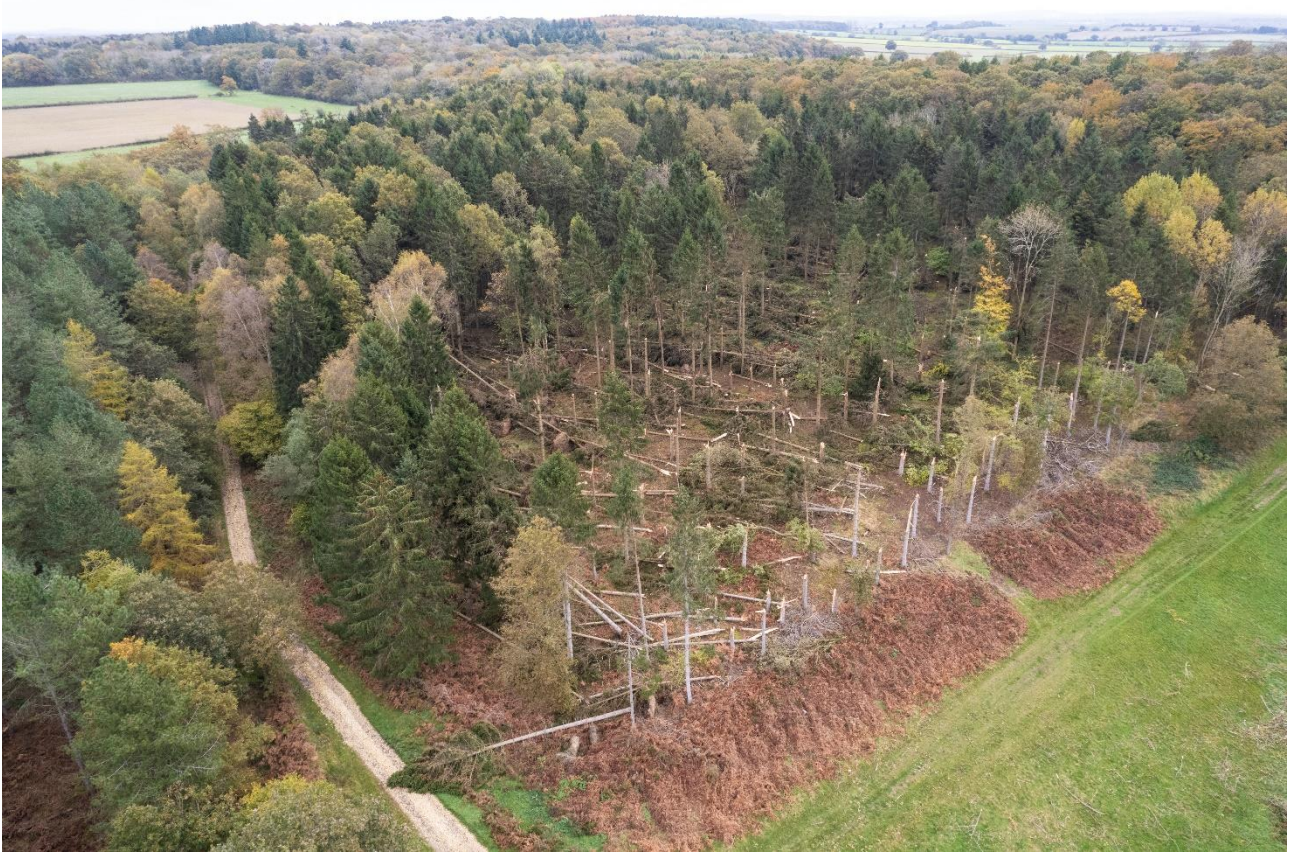
One noticeable aspect was that many trees had snapped more than once along their trunk, with trunks lying in separate directions from the main body of the tree.

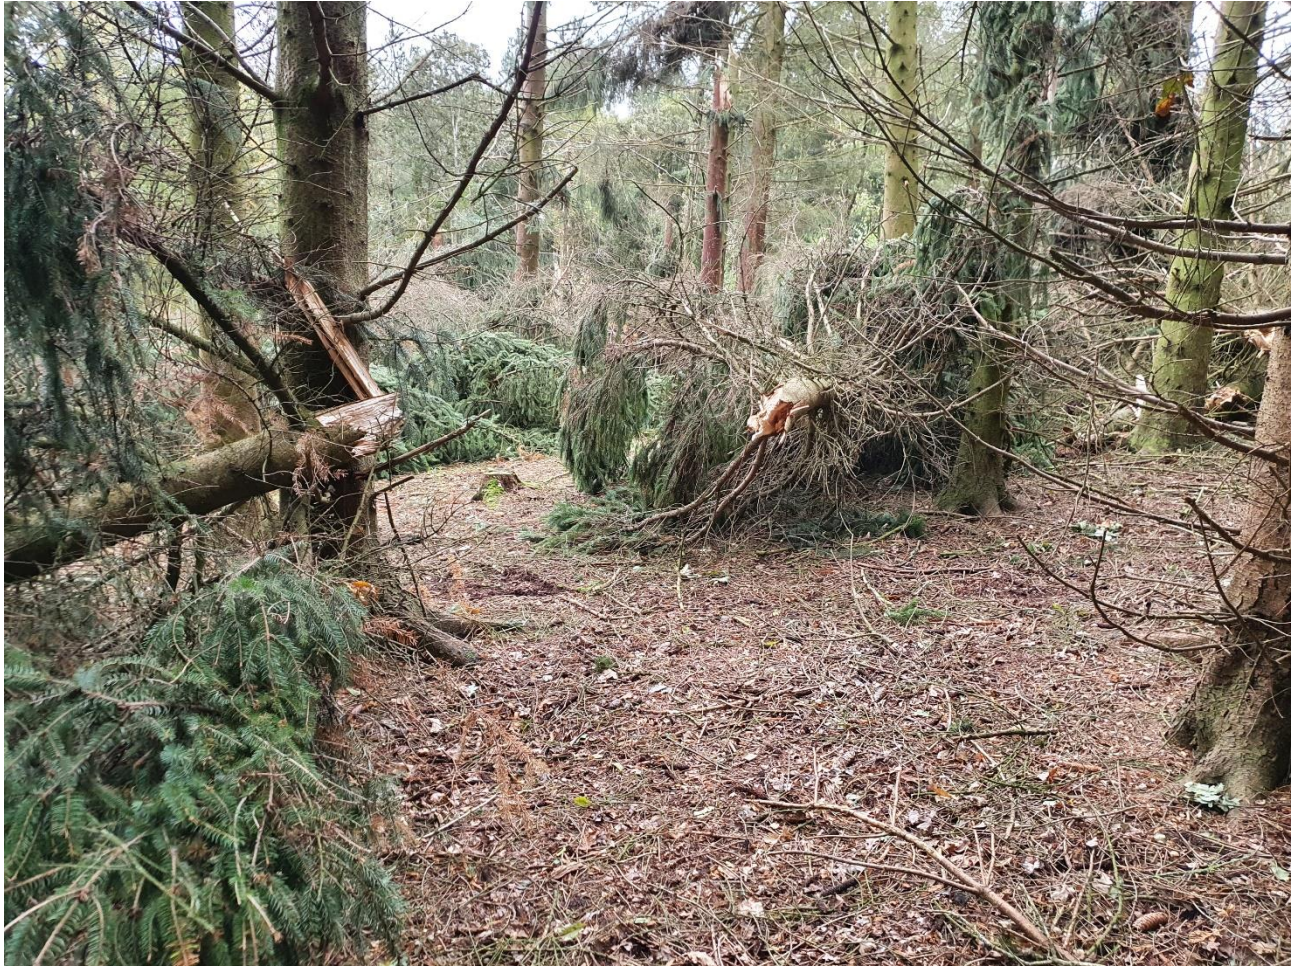
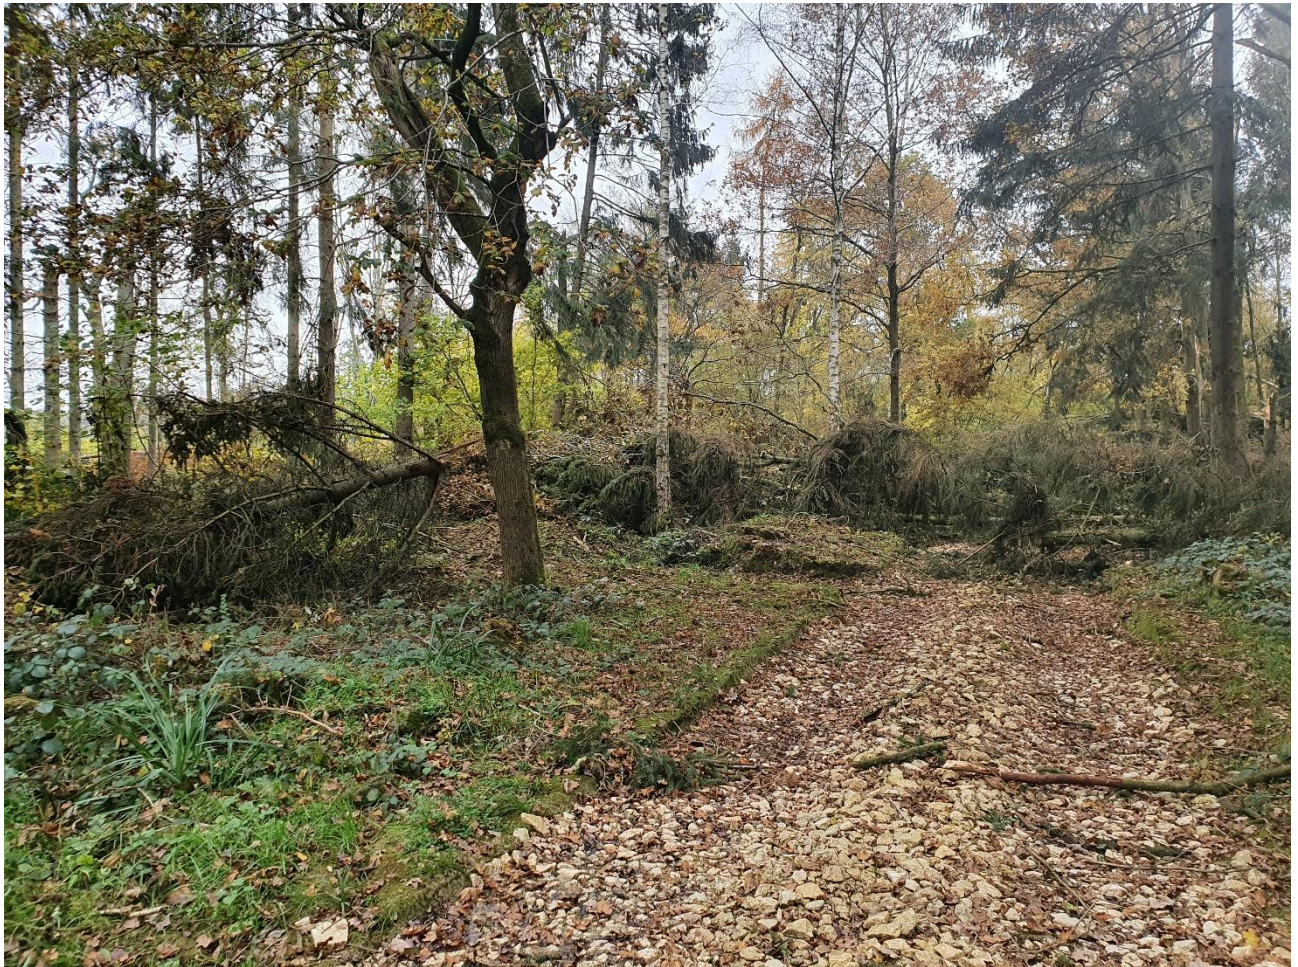
Looking at the drone photograph taken looking at the north eastern side of the woodland provides a deceptive picture. It looked like the tornado had ended abruptly. However, this photograph is deceptive.

Underneath the apparently intact tree canopy, there was still substantial damage. The tornado appeared to weaken here. This apparent weakening may appear to be exaggerated as the eastern boundary of the woodland became more of a deciduous mix. These trees appeared to be generally more resilient, although Blenheim Estate say that young oak trees were snapped and mature Oak and chestnut trees had their tops taken out.

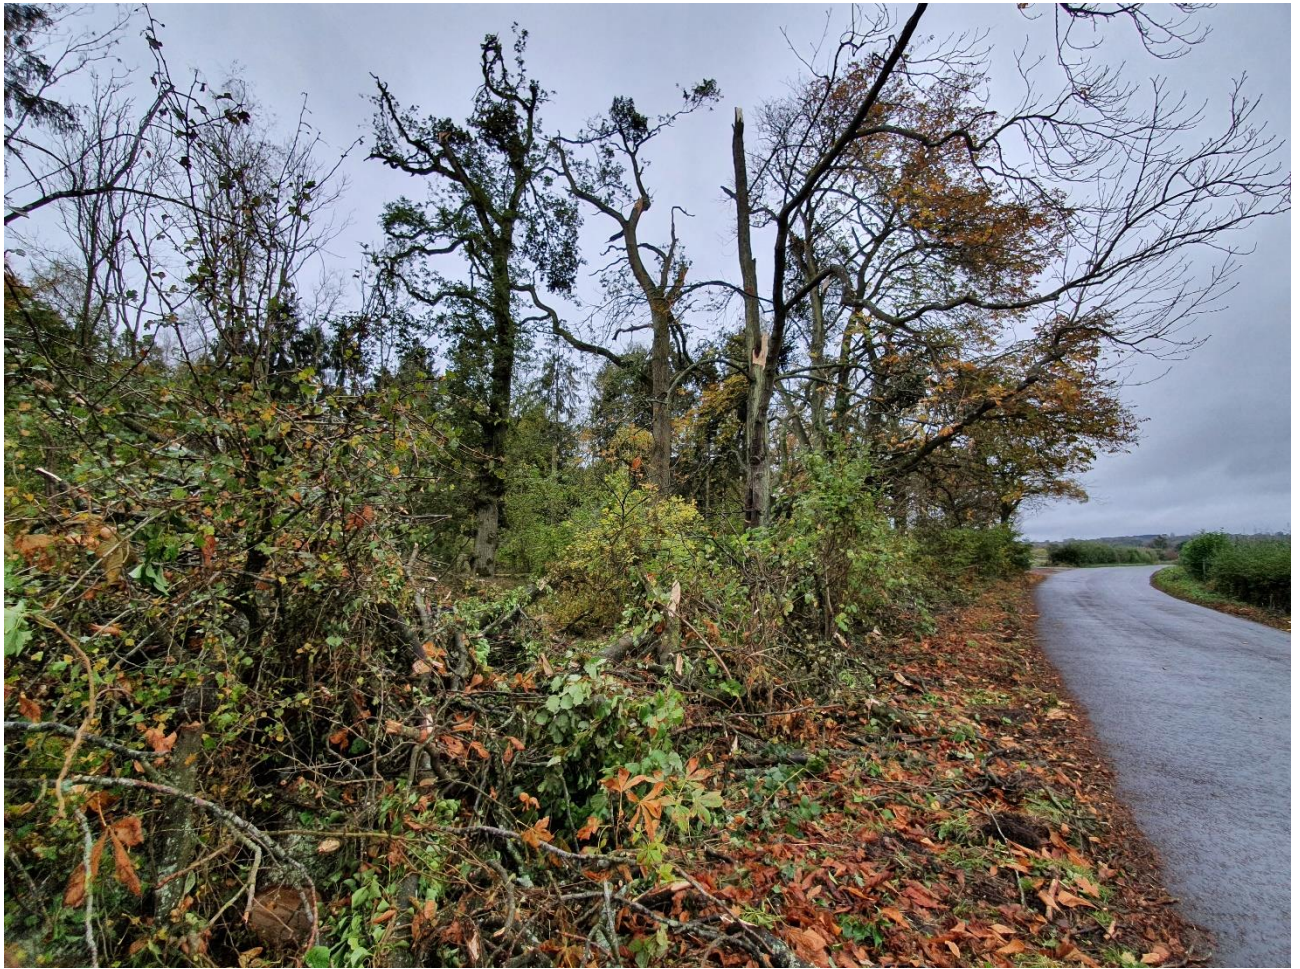
By the Cassington road oaks, chestnuts and other trees had been badly damaged or felled. The damage within Burleigh Wood was consistent with an intensity of T4.

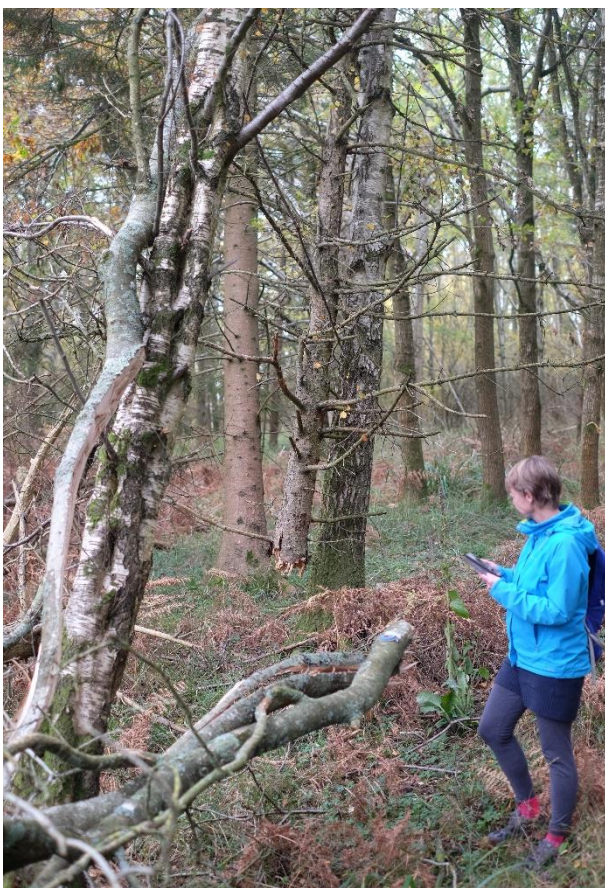
Drone photographs were taken from the north of Bladon Heath. Little damage could be seen. However, on foot, more extensive damage was found. On the western edges was consistent with T1/T2. There were some peculiarities, such as this tree in the background caught and suspended by another tree.

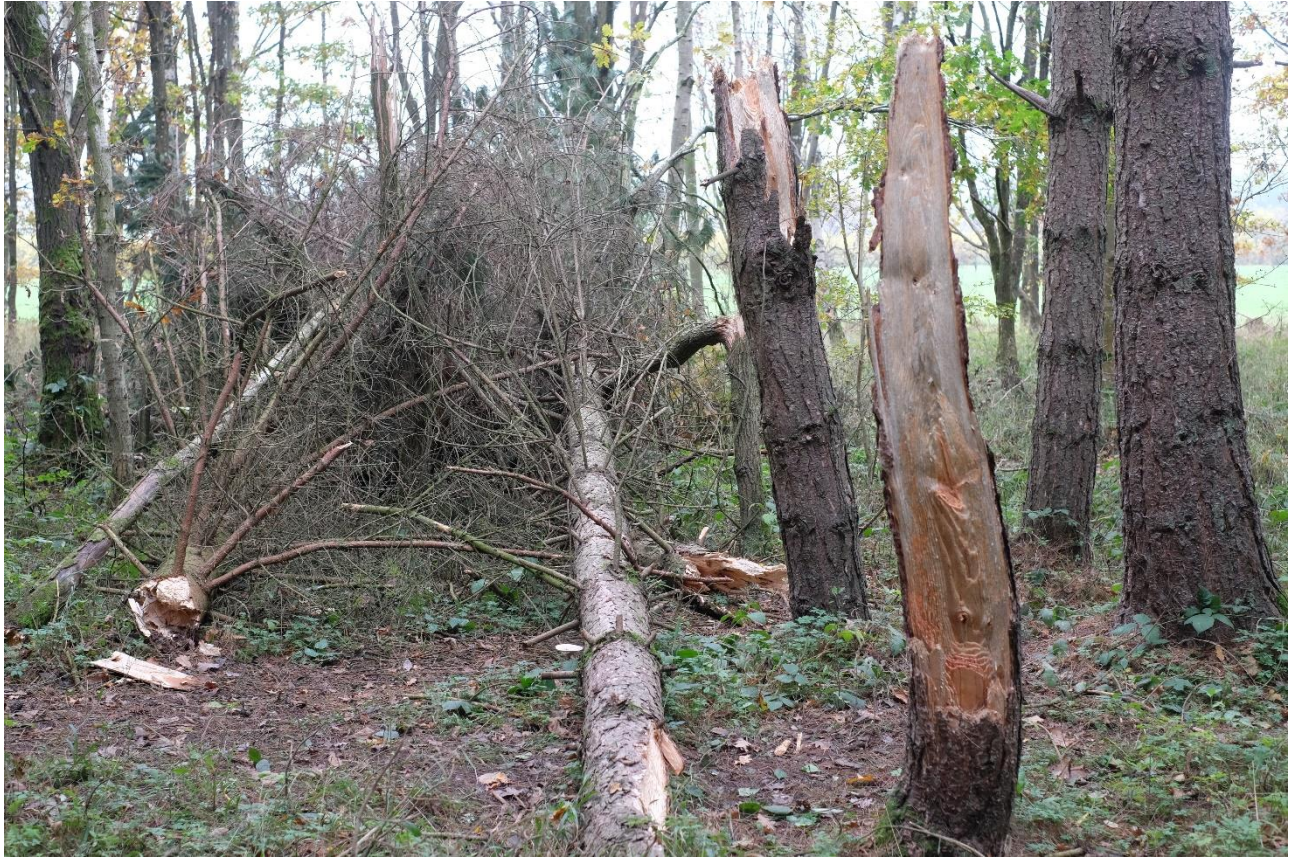
However, on the north eastern edge of the woodland, tree damage became more severe and consistent

with some elements of T3 levels of damage.
