BOTLEY WEST SOLAR FARM

Veteran & Ancient Tree Survey

Veteran Tree Survey –
Botley West
V5

June 2026

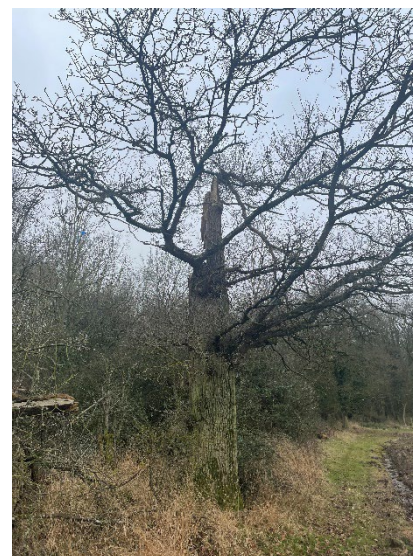
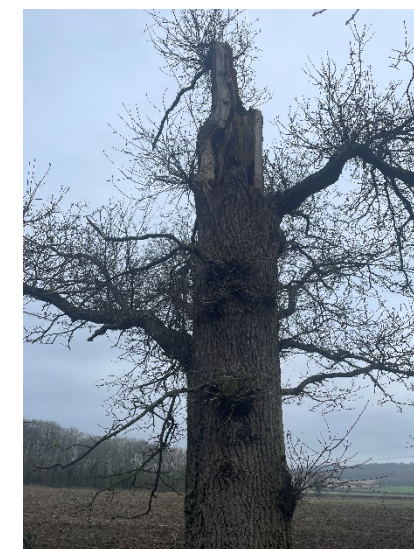
Species	Height (m)	Crown spread (m)				Stem dia. (mm) Including irregularities information	Stem no. at 1.5m	Height of crown clearance (m)	Dir/ height	Age class	Condition	Type	General observations Management recommendations	Estimated remaining contribution (years)	Tree Quality Category (BS5837)	Tree Typology
		N	E	S	W											
T1 <i>Quercus robur</i> - Pedunculate Oak	5.0	2.0	4.0	4.0	6.0	1100	1	2.00	N/A	V	Fair	Field border	Decay loss, whole stem. Evidence of hollow entirety. Complete leader loss at 5m. Brown rot core. Vigorous nonetheless	40+	A3	Field

Primary Tree Qualities						
Extensive Decay			Previous aged management	Senescence / Aged decline	Retrenchment / Canopy Reduction	
Brown rot	Exposed heartwood	Hollowing (by %)				
Yes	Yes	75%	Field	Major	90%

Secondary Tree Qualities											
Attached deadwood >150mm dia	Storm Damage	Roosts, nests, crevices	Aerial Roots	Bark flux / Sap	Wet pockets	Bark loss/decay	Fungi		Other epiphytic plants		
							Major	Minor	Lichens	Ferns	Other
None	None	Hollows	None	None	None	75%	None visible	None visible	None	None	-

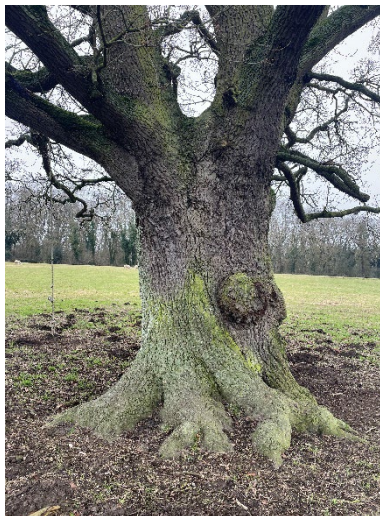
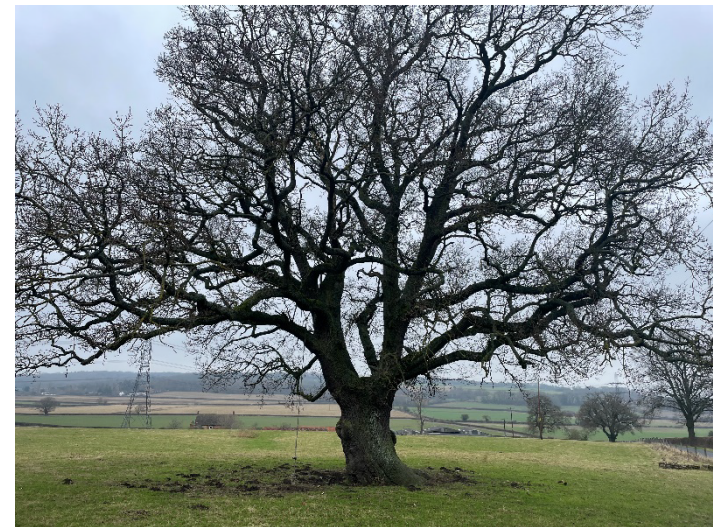
Species	Height (m)	Crown spread (m)				Stem dia. (mm) including irregularities information	Stem no. at 1.5m	Height of crown clearance (m)	Dir/height	Age class	Condition	Type	General observations Management recommendations	Estimated remaining contribution (years)	Tree Quality Category (BS5837)	Tree Typology	
		N	E	S	W												
T2	<i>Quercus robur</i> - Pedunculate Oak	14.0	9.0	10.0	12.0	12.0	1600	1	2.00	-	V	Good	Field	Fine, Open grown former pollard, curved stem to west. Bulged unions, minor pruning stubs rope swing.	60+	A2/3	Field

Primary Tree Qualities						
Extensive Decay			Previous aged management	Senescence / Aged decline	Retrenchment / Canopy Reduction	
Brown rot	Exposed heartwood	Hollowing (by %)				
None	None	X	Former Pollard	X		X

Secondary Tree Qualities											
Attached deadwood >150mm dia	Storm Damage	Roosts, nests, crevices	Aerial Roots	Bark flux / Sap	Wet pockets	Bark loss/decay	Fungi		Other epiphytic plants		
							Major	Minor	Lichens	Ferns	Other
0.2m	X	Dry nest in hollow, dry hollow at pollard union at 2.5m	Root flare at buttress	None	None	Bulged	None visible	Ganoderma root flare	None	None	-

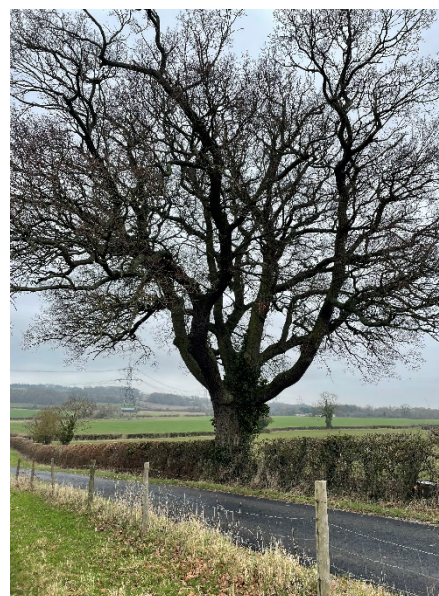
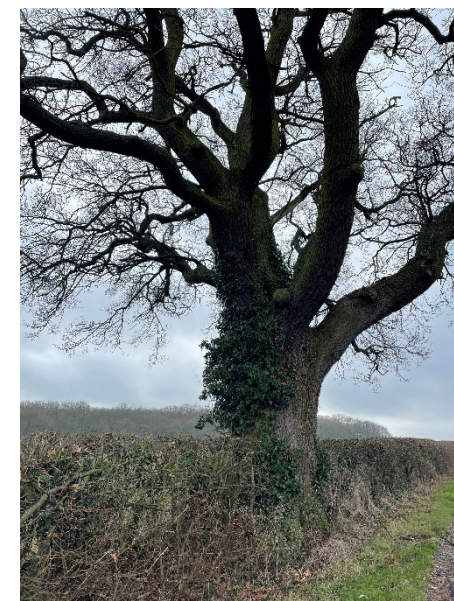
Species	Height (m)	Crown spread (m)				Stem dia. (mm) Including irregularities information	Stem no. at 1.5m	Height of crown clearance (m)	Dir/height	Age class	Condition	Type	General observations Management recommendations	Estimated remaining contribution (years)	Tree Quality Category (BS5837)	Tree Typology
		N	E	S	W											
T3 <i>Quercus robur</i> - Pedunculate Oak	16.0	12.0	12.0	10.0	10.0	1500	1	3.00	-	V	Good	Hedgerow	Fine hedgerow oak, former pollard, huge bole, ivy in places, attached deadwood – up to 20cm diameter. Various decay stubs.	40+	A2/3	Hedgerow

Primary Tree Qualities												
Extensive Decay						Previous aged management			Senescence / Aged decline		Retrenchment / Canopy Reduction	
Brown rot	Exposed heartwood		Hollowing (by %)									
None visible	On major bough, over road		None visible			Pollard			X		X

Secondary Tree Qualities												
Attached deadwood >150mm dia	Storm Damage	Roosts, nests, crevices	Aerial Roots	Bark flux / Sap	Wet pockets	Bark loss/decay	Fungi		Other epiphytic plants			
							Major	Minor	Lichens	Ferns	Other	
0.2m	-	Dry hollow at pollard	None	None	None	Yes	None visible	None visible	None	None	-

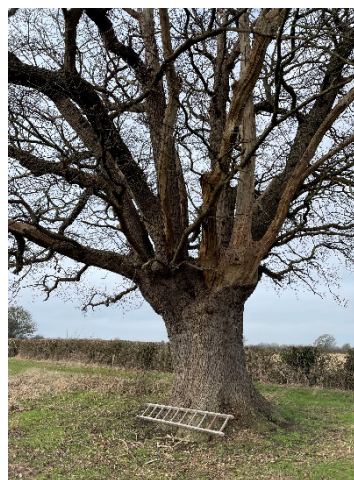
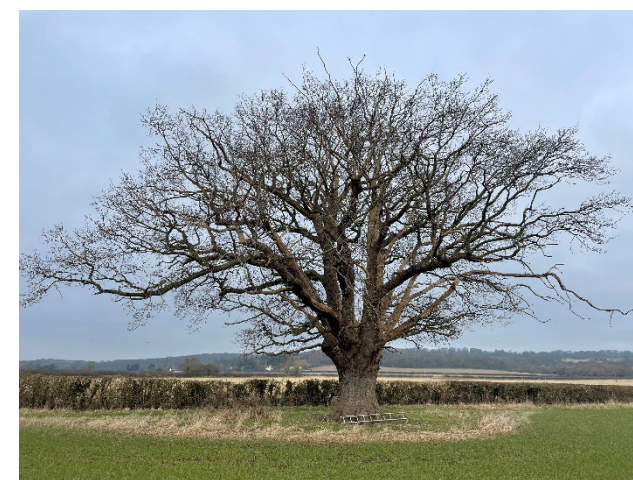
Species	Crown spread (m)					Stem dia. (mm) including irregularities information	Stem no. at 1.5m	Height of crown clearance (m)	Dir/height	Age class	Condition	Type	General observations Management recommendations	Estimated remaining contribution (years)	Tree Quality Category (BS5837)	Tree Typology
	Height (m)	N	E	S	W											
T4 <i>Quercus robur</i> - Pedunculata Oak	12.0	13.0	11.0	12.0	12.0	1700	1	2.00	-	V	Fair	Field	Superb, former pollard, major decline/decay. Decayed hollow pocket at roof flare. Attached and hung deadwood greater than 30cm diameter. Pollard head circa 3m diameter	30+	A2/3	Field

Primary Tree Qualities					
Extensive Decay			Previous aged management	Senescence / Aged decline	Retrenchment / Canopy Reduction
Brown rot	Exposed heartwood	Hollowing (by %)			
Yes	-	70% buttress cavity	Pollard	40-50% dead pollard head	40% major decline

Secondary Tree Qualities											
Attached deadwood >150mm dia	Storm Damage	Roosts, nests, crevices	Aerial Roots	Bark flux / Sap	Wet pockets	Bark loss/decay	Fungi		Other epiphytic plants		
							Major	Minor	Lichens	Ferns	Other
+10 30cm diameter	-	Major saddle at pollard head	Fluted buttress	x	Major saddle	Yes	None visible	None visible	None	None	-

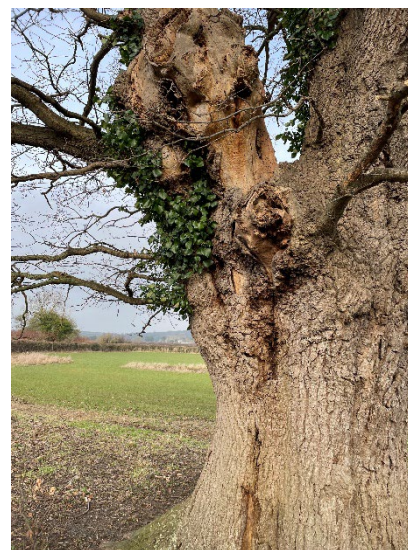
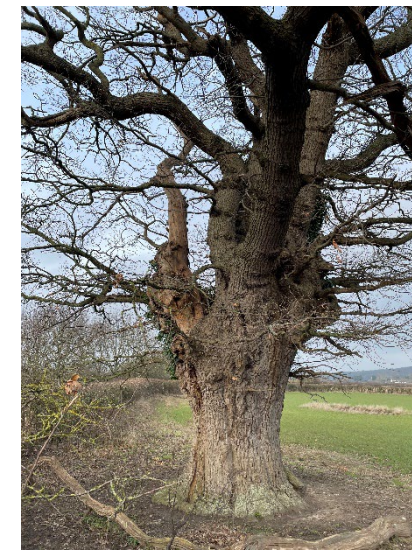
Species	Height (m)	Crown spread (m)				Stem dia. (mm) including irregularities information	Stem no. at 1.5m	Height of crown clearance (m)	Dir/height	Age class	Condition	Type	General observations Management recommendations	Estimated remaining contribution (years)	Tree Quality Category (BS5837)	Tree Typology	
		N	E	S	W												
T5	<i>Quercus robur</i> - Pedunculate Oak	13.0	8.0	10.0	9.0	9.0	1400	1	2.00	-	V	Fair/good	Field	Superb, former pollard. Pollard head circa 2.5m diameter. Major decay to west, evident to root flare. Dry saddle at pollard head, ivy and fluted buttress.	40+	A3	Field

Primary Tree Qualities					
Extensive Decay			Previous aged management	Senescence / Aged decline	Retrenchment / Canopy Reduction
Brown rot	Exposed heartwood	Hollowing (by %)			
Yes	Yes, saddle	Estimated 30-50%	Yes	Yes	25%

Secondary Tree Qualities											
Attached deadwood >150mm dia	Storm Damage	Roosts, nests, crevices	Aerial Roots	Bark flux / Sap	Wet pockets	Bark loss/decay	Fungi		Other epiphytic plants		
							Major	Minor	Lichens	Ferns	Other
0.4m	-	Insects and potentially bats	Fluted	-	-	Yes	None visible	None visible	None	None	-

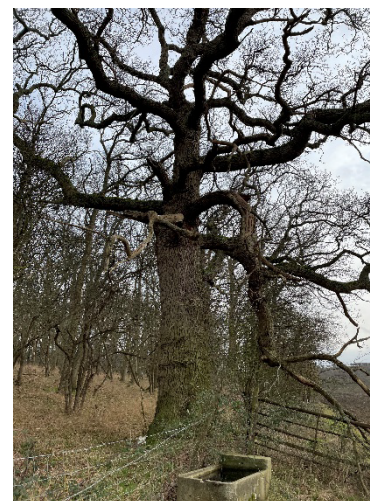
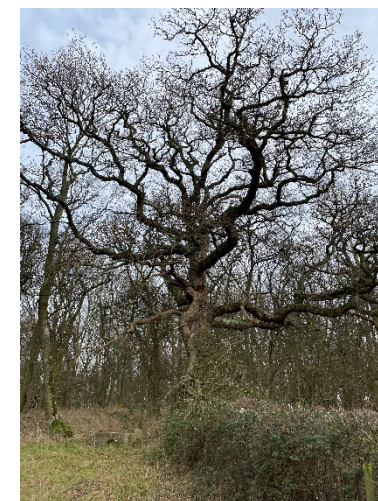
Species	Height (m)	Crown spread (m)				Stem dia. (mm) Including irregularities information	Stem no. at 1.5m	Height of crown clearance (m)	Dir/ height	Age class	Condition	Type	General observations Management recommendations	Estimated remaining contribution (years)	Tree Quality Category (BS5837)	Tree Typology	
		N	E	S	W												
T6	<i>Quercus robur</i> - Pedunculata Oak	-	12.0	12.0	14.0	10.0	1300	1	3.00	NW	V	Good	Woodland	Fine, maiden oak on edge of sloping copse. Huge main bole to 8m. Major snags and storm damage attached/ Various stubs and deadwood.	40+	A2/3	Woodland

Primary Tree Qualities						
Extensive Decay			Previous aged management	Senescence / Aged decline	Retrenchment / Canopy Reduction	
Brown rot	Exposed heartwood	Hollowing (by %)				
None	None	None	Maiden	None	25 None

Secondary Tree Qualities												
Attached deadwood >150mm dia	Storm Damage	Roosts, nests, crevices	Aerial Roots	Bark flux / Sap	Wet pockets	Bark loss/decay	Fungi		Other epiphytic plants			
							Major	Minor	Lichens	Ferns	Other	
0.4m	Yes	Bat roost potential, Woodpecker holes	Fluted buttress	-	-	Yes	None visible	None visible	Minor	None	-

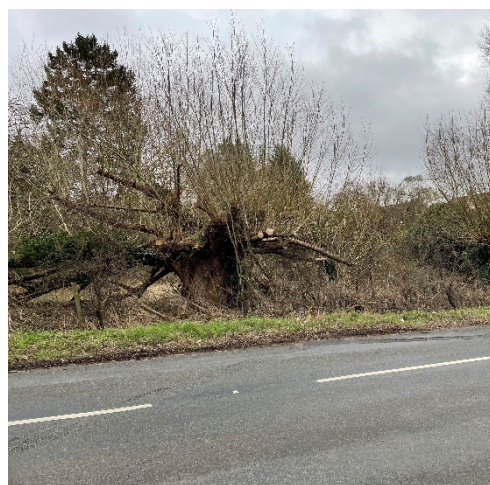
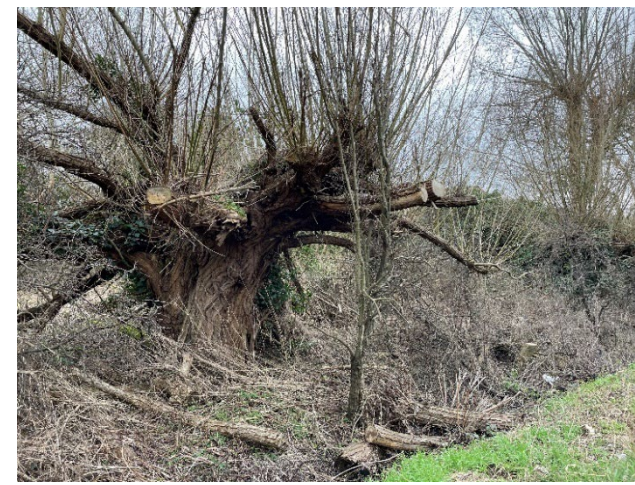
Species	Height (m)	Crown spread (m)				Stem dia. (mm) Including irregularities information	Stem no. at 1.5m	Height of crown clearance (m)	Dir/height	Age class	Condition	Type	General observations Management recommendations	Estimated remaining contribution (years)	Tree Quality Category (BS5837)	Tree Typology
		N	E	S	W											
T7 x2 <i>Salix x fragilis</i> – Crack Willow	5.0	8.0	3.0	3.0	3.0	1200	1	1.00	E	V	Fair/Poor	Specimen	Pair of close, low pollard. Major decay. Lapsed bough. Repollarded recently. Various hollows, decay forks, mosses, ivy and habitat features.	10+	A3	Specimen

Primary Tree Qualities							
Extensive Decay			Previous aged management		Senescence / Aged decline		Retrenchment / Canopy Reduction
Brown rot	Exposed heartwood	Hollowing (by %)					
-	Yes	25%	Pollard		Yes		X

Secondary Tree Qualities												
Attached deadwood >150mm dia	Storm Damage	Roots, nests, crevices	Aerial Roots	Bark flux / Sap	Wet pockets	Bark loss/decay	Fungi		Other epiphytic plants			
							Major	Minor	Lichens	Ferns	Other	
X	Bough lapsed	Possible	X	X	Yes	Yes	None visible	None visible	Minor	None	-

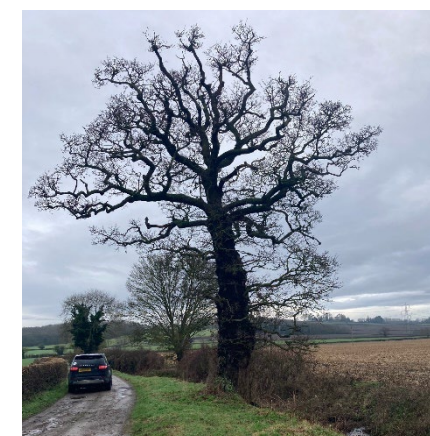
Species	Height (m)	Crown spread (m)				Stem dia. (mm) including irregularities information	Stem no. at 1.5m	Height of crown clearance (m)	Dir/height	Age class	Condition	Type	General observations Management recommendations	Estimated remaining contribution (years)	Tree Quality Category (BS5837)	Tree Typology	
		N	E	S	W												
T8	<i>Quercus robur</i> - Pedunculata Oak	10.0	5.0	7.0	5.0	5.0	1170	1	6.00	S/4m	V	Fair/Poor	Notable	Locally notable oak on the west side of Denman's Lane. Close to the junction with Eynsham Rd. Thinning by aprox. 50%	40+	B2	Field Boundary

Primary Tree Qualities						
Extensive Decay			Previous aged management	Senescence / Aged decline	Retrenchment / Canopy Reduction	
Brown rot	Exposed heartwood	Hollowing (by %)				
X	X	X	Maiden	Yes	Yes

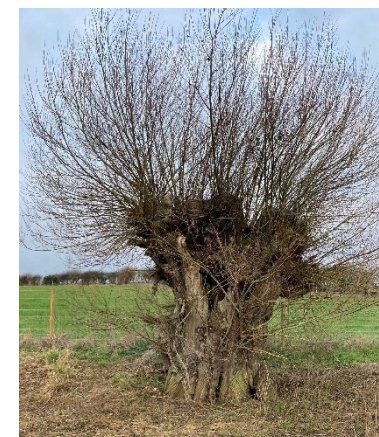
Species	Height (m)	Crown spread (m)				Stem dia. (mm) including irregularities information	Stem no. at 1.5m	Height of crown clearance (m)	Dir/height	Age class	Condition	Type	General observations Management recommendations	Estimated remaining contribution (years)	Tree Quality Category (BS5837)	Tree Typology	
		N	E	S	W												
T9	<i>Salix fragilis</i> – Crack Willow	5.0	3.0	3.0	3.0	3.0	1750	1	0.50	NA	V	Fair/Poor	-	Old willow pollard (at 3m) on field boundary. Recently cut-back with young, vigorous epicormic shoots.	20+	B3	Field Boundary

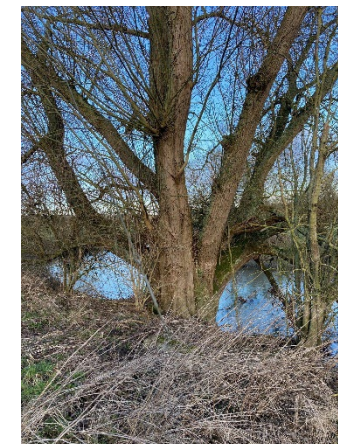
Species	Height (m)	Crown spread (m)				Stem dia. (mm) Including irregularities information	Stem no. at 1.5m	Height of crown clearance (m)	Dir/ height	Age class	Condition	Type	General observations Management recommendations	Estimated remaining contribution (years)	Tree Quality Category (BS5837)	Tree Typology	
		N	E	S	W												
T10	<i>Salix fragilis</i> – Crack Willow	12.0	8.0	10.0	6.0	7.0	3000	5	0.00	NA	M/V	Fair	-	Multi-stemmed willow on river bank of substantial girth. Multiple hazards, beams on north and east lateral branches	20+	B3	Riverside

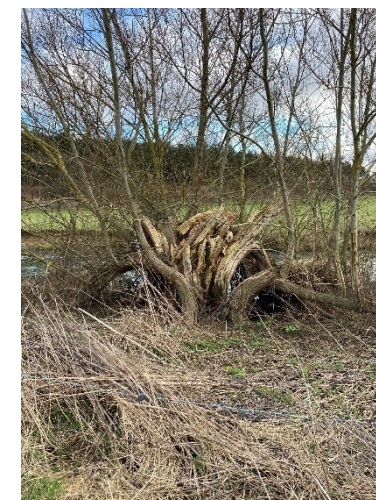
T11	Species	Height (m)	Crown spread (m)				Stem dia. (mm) Including irregularities information	Stem no. at 1.5m	Height of crown clearance (m)	Dir/height	Age class	Condition	Type	General observations Management recommendations	Estimated remaining contribution (years)	Tree Quality Category (BS5837)	Tree Typology
			N	E	S	W											
	<i>Salix fragilis</i> – Crack Willow	8.0	6.0	8.0	11.0	3.0	2000	1 collapse	0.00	NA	V	Poor	-	Collapsed willow pollard on the riverside.	20+	B3	Riverside

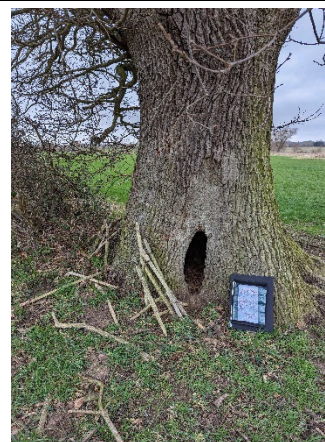
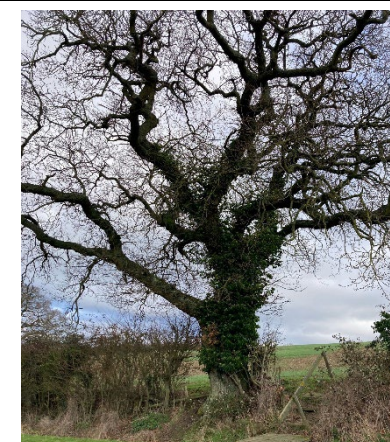
Species	Height (m)	Crown spread (m)				Stem dia. (mm) Including irregularities information	Stem no. at 1.5m	Height of crown clearance (m)	Dir/height	Age class	Condition	Type	General observations Management recommendations	Estimated remaining contribution (years)	Tree Quality Category (BS5837)	Tree Typology	
		N	E	S	W												
T12	<i>Quercus robur</i> - Pedunculate Oak	16.0	8.0	9.0	9.0	9.0	1210	1	2.00	E/3	V	Fair	Maiden/Field Boundary	Ivy on main stem Moderate deadwood in crown, epicormics on stem and crown. Stubs in crown.	40+	A3	Field Boundary

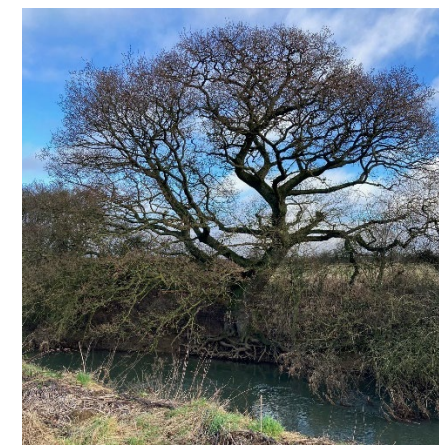
T13	Species	Height (m)	Crown spread (m)				Stem dia. (mm) including irregularities information	Stem no. at 1.5m	Height of crown clearance (m)	Dir/height	Age class	Condition	Type	General observations Management recommendations	Estimated remaining contribution (years)	Tree Quality Category (BS5837)	Tree Typology
			N	E	S	W											
	<i>Quercus robur</i> - Pedunculate Oak	12.0	8.0	5.0	7.0	8.0	900	2	0.50	N/1	V	Good	-	Notable local tree. Squat, wind-pruned riverbank oak. Northern surface roots exposed from river bank erosion. Notable landscape form	40+	A1	Riverside

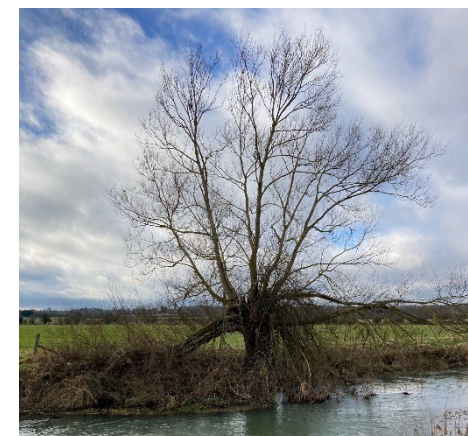
Species	Height (m)	Crown spread (m)				Stem dia. (mm) Including irregularities information	Stem no. at 1.5m	Height of crown clearance (m)	Dir/height	Age class	Condition	Type	General observations Management recommendations	Estimated remaining contribution (years)	Tree Quality Category (BS5837)	Tree Typology	
		N	E	S	W												
T14	<i>Salix fragilis</i> – Crack Willow	14.0	8.0	3.0	2.0	6.0	3500	1 collapsed	0.00	NA	OM/V	Poor	-	Collapsed willow pollard. Multiple branch failures. Eastern side of stem open with exposed heartwood. Pollarded at 2.5m.	20+	B3	Riverside

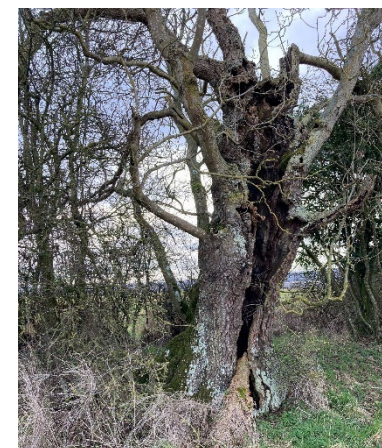
Species	Height (m)	Crown spread (m)				Stem dia. (mm) Including irregularities information	Stem no. at 1.5m	Height of crown clearance (m)	Dir/height	Age class	Condition	Type	General observations Management recommendations	Estimated remaining contribution (years)	Tree Quality Category (BS5837)	Tree Typology	
		N	E	S	W												
T15	<i>Quercus robur</i> - Pedunculate Oak	15.0	6.0	6.0	7.0	6.0	1290	1	-	N/4	V	Good	-	Large Ganoderma applanatum/australe bracket on northern buttress. Cavity openings on western side at 1m and 8m. Locally notable future veteran.	40+	A1	Field Boundary

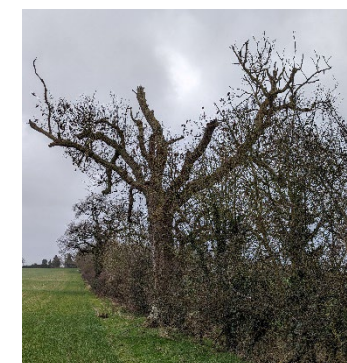
Species	Height (m)	Crown spread (m)				Stem dia. (mm) Including irregularities information	Stem no. at 1.5m	Height of crown clearance (m)	Dir/ height	Age class	Condition	Type	General observations Management recommendations	Estimated remaining contribution (years)	Tree Quality Category (BS5837)	Tree Typology	
		N	E	S	W												
T17	<i>Fraxinus excelsior</i> - Ash	11.0	8.0	8.0	6.0	6.0	1120	-	2	-	V	Good	-	Single stem. Formation of lower crown through established epicormic growth. Sap runs down south of stem. Branch socket cavities. Hollowing and brown rot around buttress roots. Major deadwood in crown from dieback of primary leaders. Water pockets and exposed heartwood from large tear wounds.	10+	A1	Field Boundary

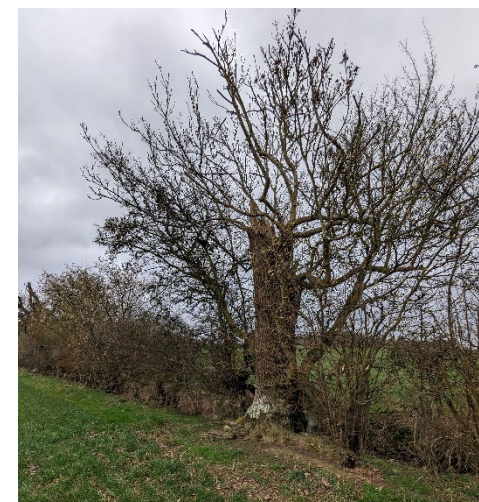
T28	Species	Height (m)	Crown spread (m)				Stem dia. (mm) Including irregularities information	Stem no. at 1.5m	Height of crown clearance (m)	Dir/height	Age class	Condition	Type	General observations Management recommendations	Estimated remaining contribution (years)	Tree Quality Category (BS5837)	Tree Typology
			N	E	S	W											
	<i>Fraxinus excelsior</i> - Ash	17.0	8.0	8.0	8.0	10.0	1210	1	2	W4	V	Poor	Maiden/Field Boundary	Major crown failures, Moderate deadwood, lvy on main stem, Epicormics on stem and crown, Decay in main stem	10+	C3	Field Boundary

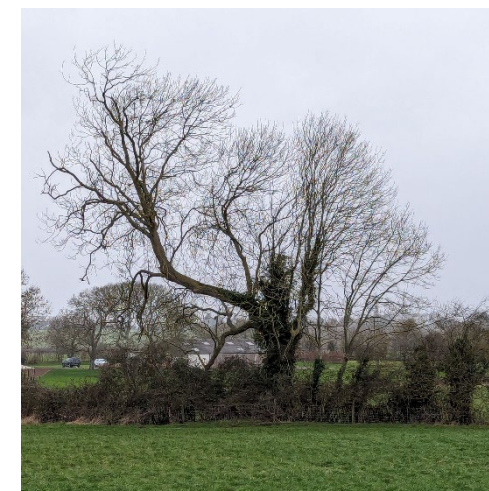
Species	Height (m)	Crown spread (m)				Stem dia. (mm) Including irregularities information	Stem no. at 1.5m	Height of crown clearance (m)	Dir/height	Age class	Condition	Type	General observations Management recommendations	Estimated remaining contribution (years)	Tree Quality Category (BS5837)	Tree Typology	
		N	E	S	W												
T29	<i>Quercus robur</i> - Pedunculate Oak	20.0	8.0	10.0	8.0	8.0	1080	1	2	E/2.5	V	Fair	Maiden/Field Boundary	Scars and tears to crown, Epicormics to stem and crown, Moderate deadwood in crown, Ivy on main stem.	40+	A3	Field Boundary

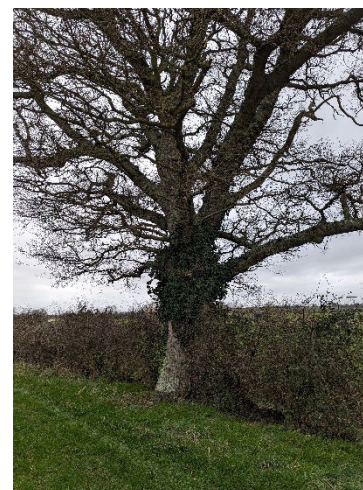
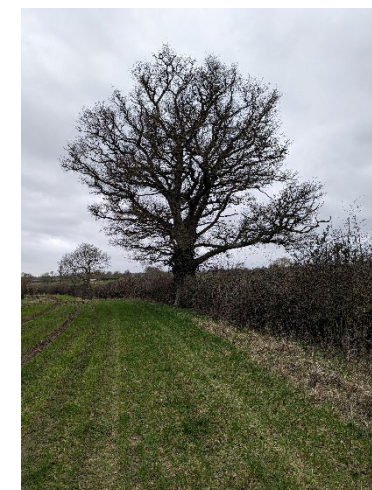
Species	Height (m)	Crown spread (m)				Stem dia. (mm) Including irregularities information	Stem no. at 1.5m	Height of crown clearance (m)	Dir/height	Age class	Condition	Type	General observations Management recommendations	Estimated remaining contribution (years)	Tree Quality Category (BS5837)	Tree Typology	
		N	E	S	W												
T30	<i>Quercus robur</i> - Pedunculate Oak	20.0	10.0	10.0	10.0	10.0	1380	1	1	W/2	V	Fair	Maiden/Field Boundary	Hollow, Cavity at base, Large pruning wounds to crown, Epicormics in crown and on stem, Moderate deadwood in crown	40+	A3	Field Boundary

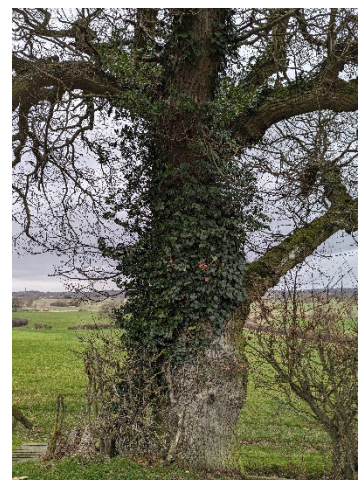
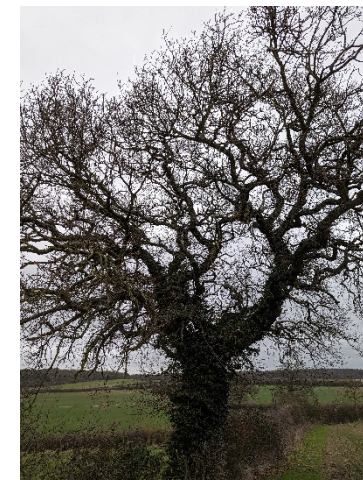
Species	Height (m)	Crown spread (m)				Stem dia. (mm) Including irregularities information	Stem no. at 1.5m	Height of crown clearance (m)	Dir/height	Age class	Condition	Type	General observations Management recommendations	Estimated remaining contribution (years)	Tree Quality Category (BS5837)	Tree Typology	
		N	E	S	W												
T31	<i>Quercus robur</i> - Pedunculate Oak	20.0	10.0	9.0	9.0	8.0	1080	1	2	W/3	V	Fair	Field Boundary	Epicormics to crown and stem, Moderate deadwood in the crown, Previous branch failures, Scars to crown	40+	A3	Field Boundary

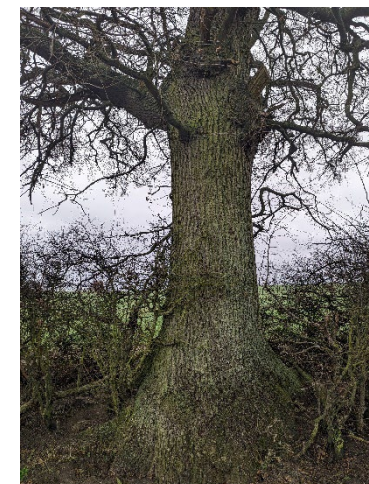
Species	Height (m)	Crown spread (m)				Stem dia. (mm) Including irregularities information	Stem no. at 1.5m	Height of crown clearance (m)	Dir/height	Age class	Condition	Type	General observations Management recommendations	Estimated remaining contribution (years)	Tree Quality Category (BS5837)	Tree Typology	
		N	E	S	W												
T32	<i>Quercus robur</i> - Pedunculata Oak	20.0	10.0	9.0	9.0	8.0	1080	1	2	W/3	V	Fair	Field Boundary	Epicormics to crown and stem, Moderate deadwood in the crown, Previous branch failures, Scars to crown	40+	A3	Field Boundary

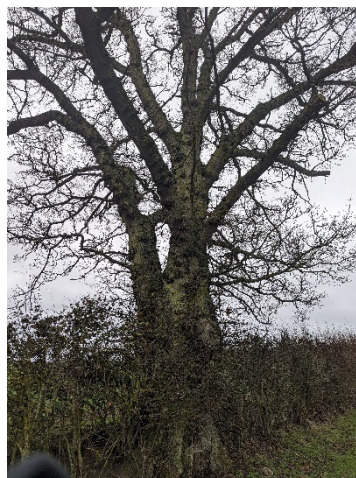
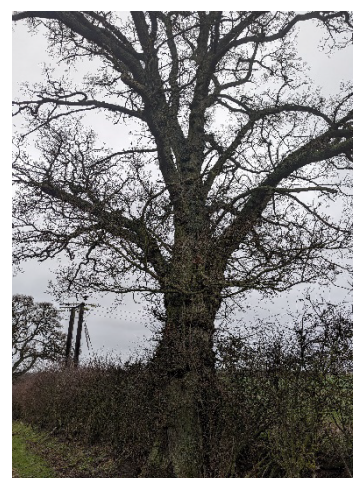
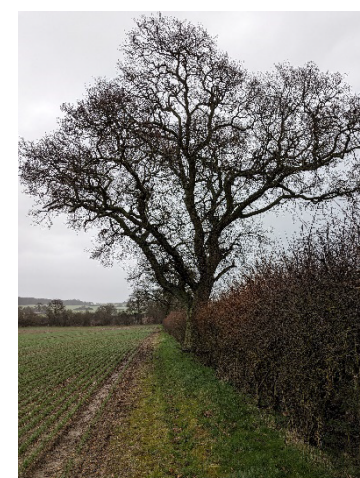
Species	Height (m)	Crown spread (m)				Stem dia. (mm) Including irregularities information	Stem no. at 1.5m	Height of crown clearance (m)	Dir/height	Age class	Condition	Type	General observations Management recommendations	Estimated remaining contribution (years)	Tree Quality Category (BS5837)	Tree Typology	
		N	E	S	W												
T33	<i>Quercus robur</i> - Pedunculate Oak	17.0	8.0	6.0	8.0	7.0	1110	1	3	N/3	V	Fair	Maiden/Field Boundary	Basal decay fungi present, Moderate deadwood in crown, Tears, stubs, Epicormics in crown	20+	B3	Field Boundary

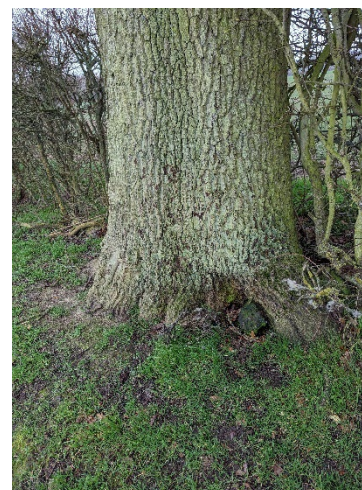
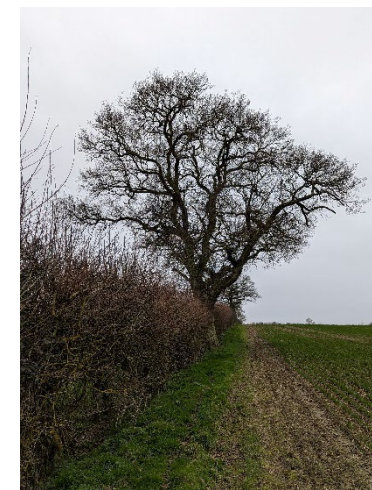
T34	Species	Height (m)	Crown spread (m)				Stem dia. (mm) Including irregularities information	Stem no. at 1.5m	Height of crown clearance (m)	Dir/height	Age class	Condition	Type	General observations Management recommendations	Estimated remaining contribution (years)	Tree Quality Category (BS5837)	Tree Typology
			N	E	S	W											
	<i>Fraxinus excelsior</i> - Ash	11.0	4.0	6.0	4.0	5.0	800	1	1	S/0	V	Poor	Maiden/Field Boundary	Major crown failure, Stubs from failures, Epicormics in crown and on stem, Moderate deadwood.	10	C3	Field Boundary

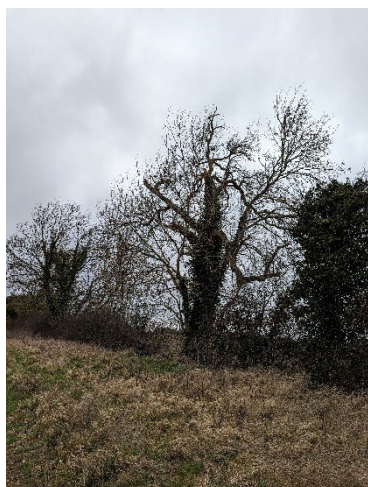
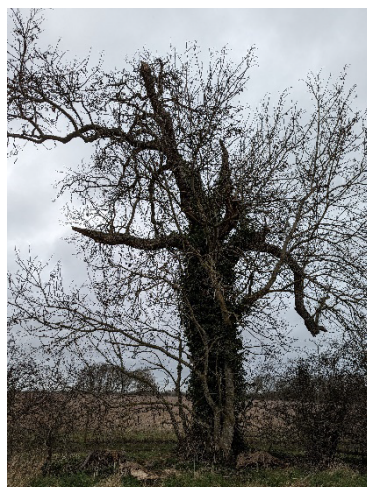
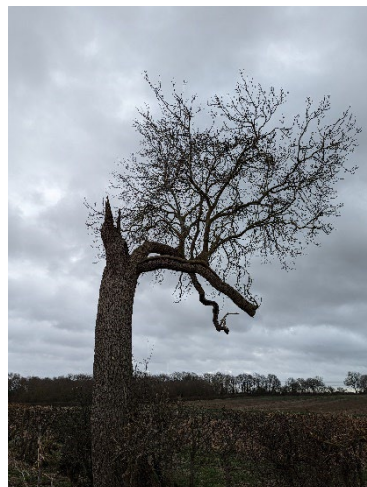
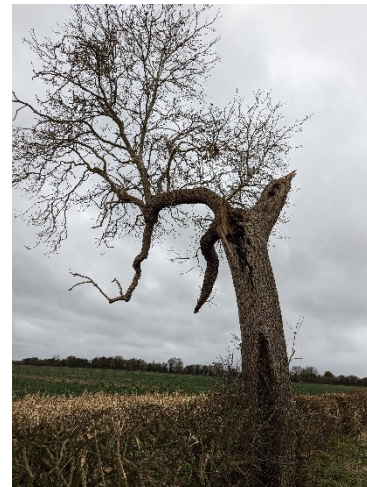
Species	Height (m)	Crown spread (m)				Stem dia. (mm) Including irregularities information	Stem no. at 1.5m	Height of crown clearance (m)	Dir/height	Age class	Condition	Type	General observations Management recommendations	Estimated remaining contribution (years)	Tree Quality Category (BS5837)	Tree Typology	
		N	E	S	W												
T35	<i>Fraxinus excelsior</i> - Ash	11.0	1.0	2.0	7.0	4.0	800	1	4	S/5	V	Poor	Maiden/Field Boundary	Major crown failure, Ash Dieback present, Scars and rips to crown. Hollow main stem.	<10	C3	Field Boundary

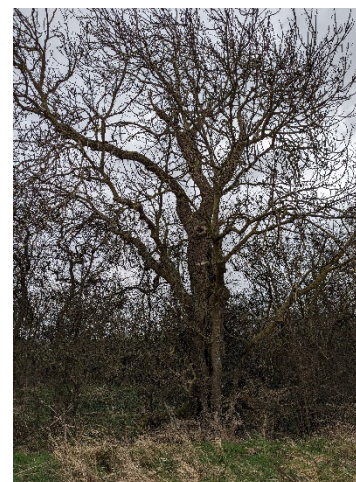
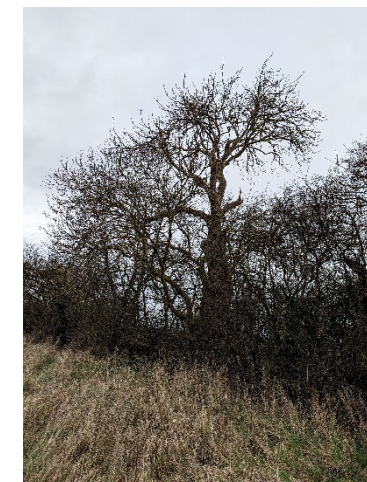
T36	Species	Height (m)	Crown spread (m)				Stem dia. (mm) Including irregularities information	Stem no. at 1.5m	Height of crown clearance (m)	Dir/height	Age class	Condition	Type	General observations Management recommendations	Estimated remaining contribution (years)	Tree Quality Category (BS5837)	Tree Typology
			N	E	S	W											
	<i>Fraxinus excelsior</i> - Ash	12.0	6.0	4.0	4.0	5.0	800	1	2	NE/2.5	V	Poor	Maiden/Field Boundary	Hollow main stem, various crown failures, Epicormic growth in crown, Moderate deadwood in crown	10+	C3	Field Boundary

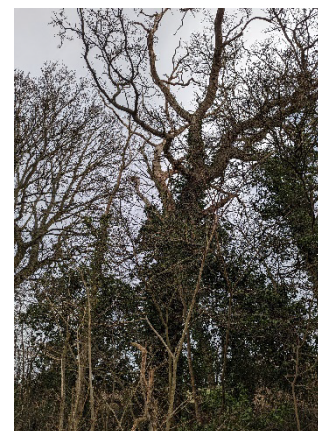
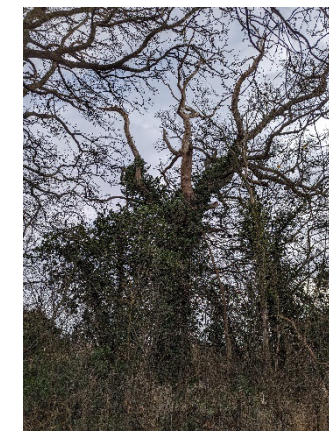
Species	Height (m)	Crown spread (m)				Stem dia. (mm) Including irregularities information	Stem no. at 1.5m	Height of crown clearance (m)	Dir/height	Age class	Condition	Type	General observations Management recommendations	Estimated remaining contribution (years)	Tree Quality Category (BS5837)	Tree Typology	
		N	E	S	W												
T37	<i>Populus canadensis</i> - Hybrid Black Poplar	20.0	7.0	4.0	6.0	8.0	1230	1	9	W/9	V	Poor	Maiden/Field Boundary	Major crown failure, Restricted inspection due to ivy on stem and crown, Stubs and tears in crown, Decay in stem, Sesia apiformis flight holes at base	10	C3	Field Boundary

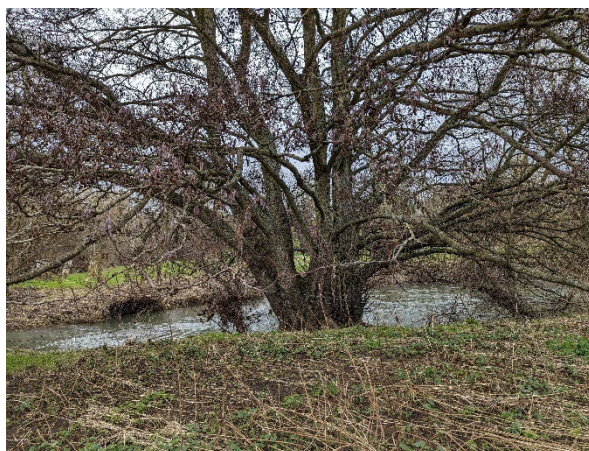
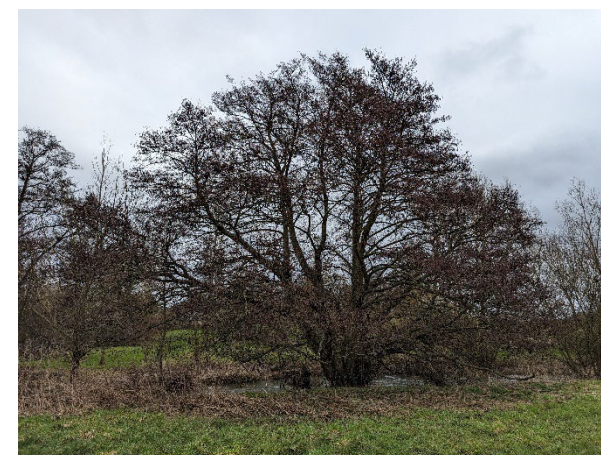
T39	Species	Height (m)	Crown spread (m)				Stem dia. (mm) including irregularities information	Stem no. at 1.5m	Height of crown clearance (m)	Dir/ height	Age class	Condition	Type	General observations Management recommendations	Estimated remaining contribution (years)	Tree Quality Category (BS5837)	Tree Typology
			N	E	S	W											
	<i>Alnus glutinosa</i> - Common Alder	11.0	7.0	7.0	7.0	7.0	840	6.00	0.30	-	V	Good	River edge	Epicormics base and crown, multi stemmed form, Minor deadwood in the crown	40+	A3	Riverside

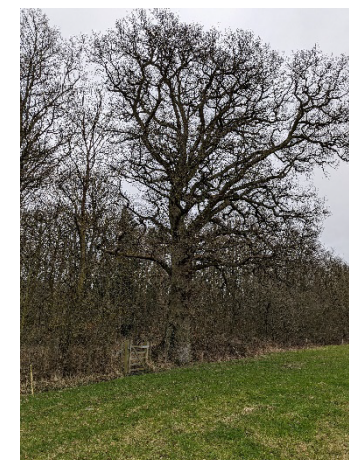
T40	Species	Height (m)	Crown spread (m)				Stem dia. (mm) Including irregularities information	Stem no. at 1.5m	Height of crown clearance (m)	Dir/ height	Age class	Condition	Type	General observations Management recommendations	Estimated remaining contribution (years)	Tree Quality Category (BS5837)	Tree Typology
			N	E	S	W											
	<i>Quercus robur</i> - Pedunculate Oak	18.0	8.0	7.0	10.0	9.0	1340	1.00	3.00	-	V	Fair	Woodland edge/Maiden	Epicormics Stem and crown, Previous branch failures, Scars, tears and rips. Moderate deadwood in crown.	40+	A3	Woodland

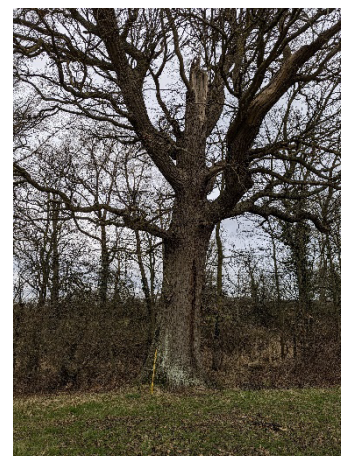
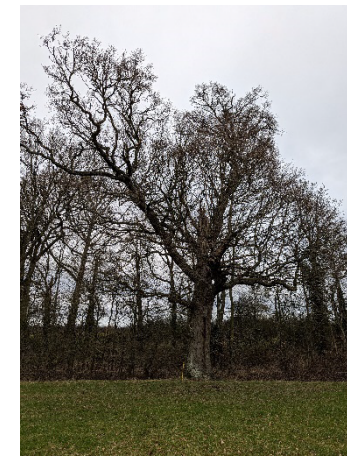
Species	Height (m)	Crown spread (m)				Stem dia. (mm) Including irregularities information	Stem no. at 1.5m	Height of crown clearance (m)	Dir/ height	Age class	Condition	Type	General observations Management recommendations	Estimated remaining contribution (years)	Tree Quality Category (BS5837)	Tree Typology	
		N	E	S	W												
T41	<i>Quercus robur</i> - Pedunculate Oak	17.0	8.0	6.0	7.0	6.0	1230	1.00	3.00	-	V	Fair	Woodland edge/Maiden	Previous branch failures, Stubs, tears and splits in crown, Moderate deadwood in crown, Main leader failure.	40+	A3	Woodland

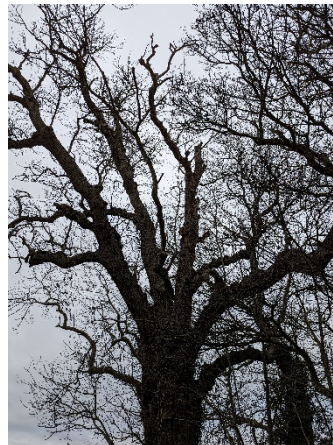
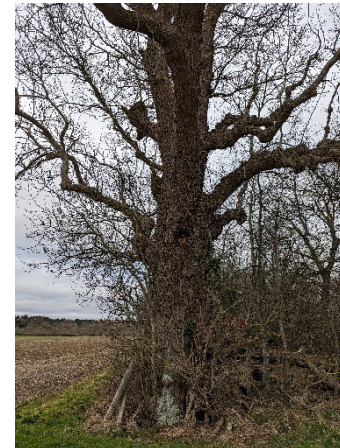
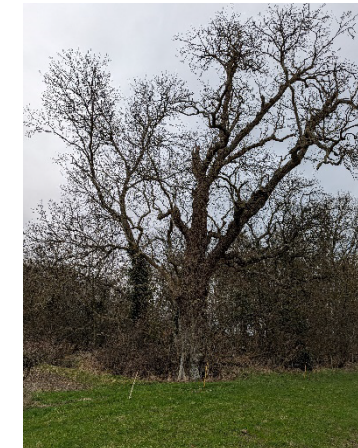
Species	Height (m)	Crown spread (m)				Stem dia. (mm) Including irregularities information	Stem no. at 1.5m	Height of crown clearance (m)	Dir/ height	Age class	Condition	Type	General observations Management recommendations	Estimated remaining contribution (years)	Tree Quality Category (BS5837)	Tree Typology	
		N	E	S	W												
T42	<i>Fraxinus excelsior</i> - Ash	20.0	4.0	9.0	8.0	5.0	1270	1.00	3.50	-	V	Poor	Woodland edge/Maiden	Multiple failures, Stubs, tears and splits, woodpeckers in cavities.	20+	C3	Woodland

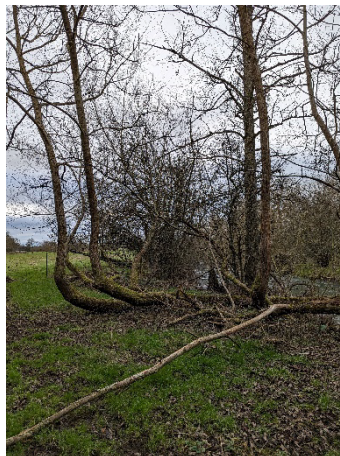
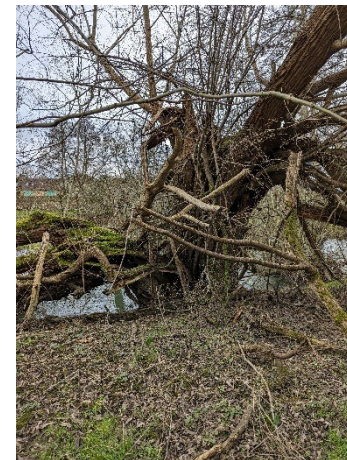
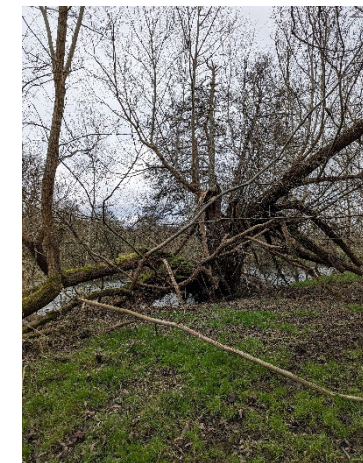
Species	Height (m)	Crown spread (m)					Stem dia. (mm) Including irregularities information	Stem no. at 1.5m	Height of crown clearance (m)	Dir/ height	Age class	Condition	Type	General observations Management recommendations	Estimated remaining contribution (years)	Tree Quality Category (BS5837)	Tree Typology
		N	E	S	W												
T43	Salix alba - White Willow	10.0	15.0	20.0	4.0	4.0	2000	2.00	0.00	-	V	Fair	River edge pollard	Collapsed crown, Layering with Pheonix growth, Multiple failures	20+	B3	Riverside

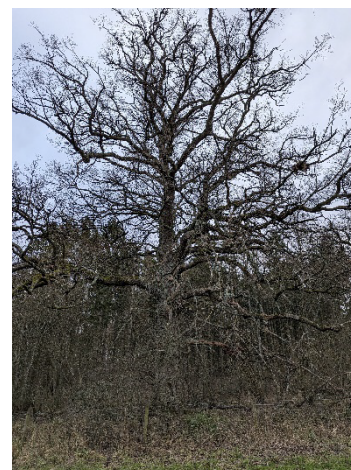
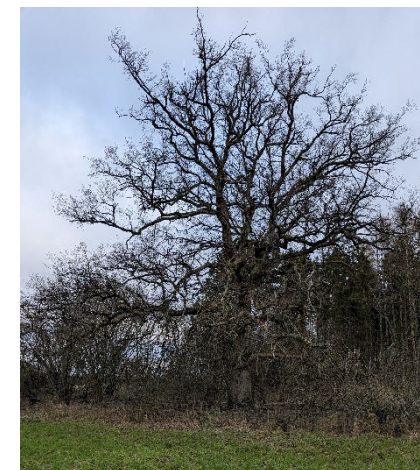
Species	Height (m)	Crown spread (m)				Stem dia. (mm) Including irregularities information	Stem no. at 1.5m	Height of crown clearance (m)	Dir/ height	Age class	Condition	Type	General observations Management recommendations	Estimated remaining contribution (years)	Tree Quality Category (BS5837)	Tree Typology	
		N	E	S	W												
T44	<i>Quercus robur</i> - Pedunculate Oak	25.0	8.0	9.0	8.0	9.0	1430	1.00	2.00	-	V	Good	Woodland	Moderate deadwood, Epicormics in crown, Splits tears, old nest in crown	40+	A3	Woodland

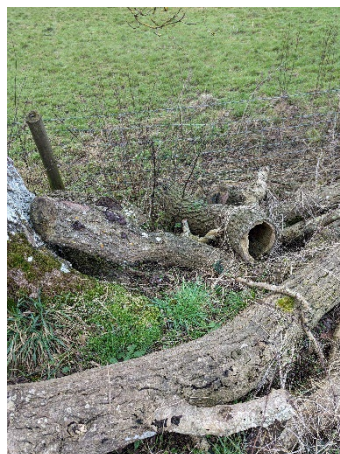
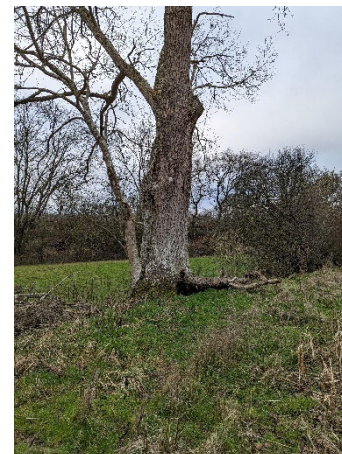
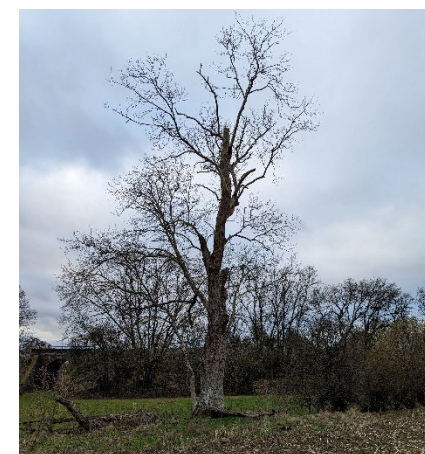
Species	Height (m)	Crown spread (m)				Stem dia. (mm) Including irregularities information	Stem no. at 1.5m	Height of crown clearance (m)	Dir/ height	Age class	Condition	Type	General observations Management recommendations	Estimated remaining contribution (years)	Tree Quality Category (BS5837)	Tree Typology	
		N	E	S	W												
T45	<i>Fraxinus excelsior</i> - Ash	18.0	4.0	3.0	6.0	6.0	1260	1.00	4.00	-	V	Poor	Field Boundary	Major crown failures, Hollow main stem, Limb stem fractures, Epicormics to stem and crown	10+	C3	Field Boundary

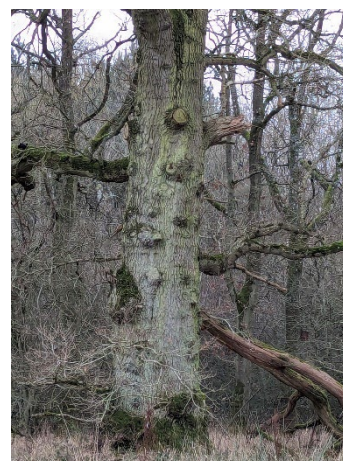
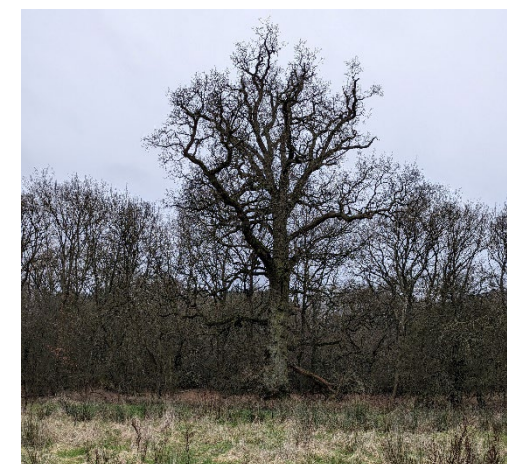
Species	Height (m)	Crown spread (m)				Stem dia. (mm) Including irregularities information	Stem no. at 1.5m	Height of crown clearance (m)	Dir/ height	Age class	Condition	Type	General observations Management recommendations	Estimated remaining contribution (years)	Tree Quality Category (BS5837)	Tree Typology	
		N	E	S	W												
T46	<i>Quercus robur</i> - Pedunculate Oak	20.0	8.0	8.0	8.0	8.0	1430	1.00	1.00	S/5	V	Fair	Woodland edge/Maiden	Epicormics on stem and crown, Moderate deadwood, Previous limb failures,	40+	A3	Woodland

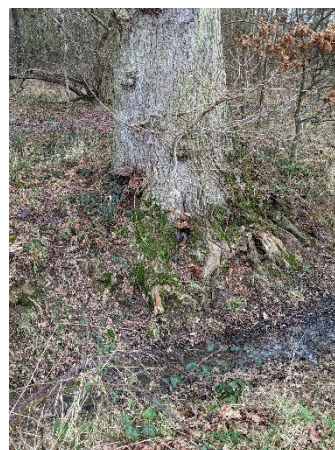
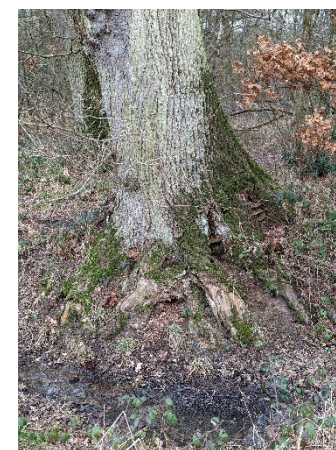
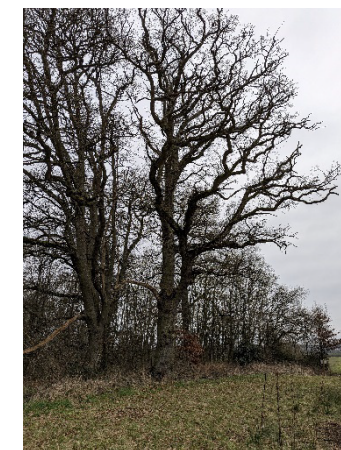
Species	Height (m)	Crown spread (m)				Stem dia. (mm) Including irregularities information	Stem no. at 1.5m	Height of crown clearance (m)	Dir/ height	Age class	Condition	Type	General observations Management recommendations	Estimated remaining contribution (years)	Tree Quality Category (BS5837)	Tree Typology	
		N	E	S	W												
T47	<i>Quercus robur</i> - Pedunculate Oak	27.0	9.0	12.0	8.0	6.0	1400	1.00	5.00	E/5	V	Poor	Woodland edge/Maiden	Fungi fruiting bodies at base, Epicormics stem and crown, Pruning wounds to crown and stem.	20+	B3	Woodland

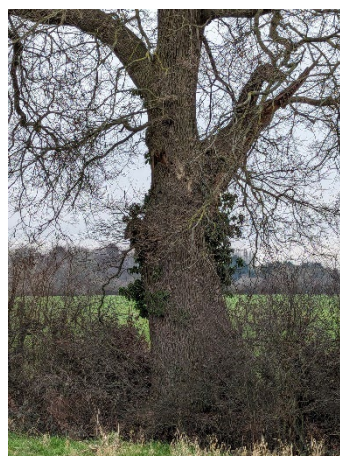
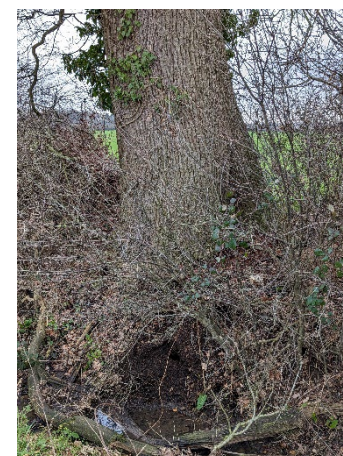
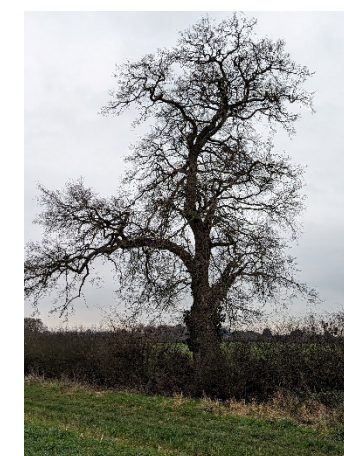
Species	Height (m)	Crown spread (m)				Stem dia. (mm) Including irregularities information	Stem no. at 1.5m	Height of crown clearance (m)	Dir/ height	Age class	Condition	Type	General observations Management recommendations	Estimated remaining contribution (years)	Tree Quality Category (BS5837)	Tree Typology	
		N	E	S	W												
T48	<i>Quercus robur</i> - Pedunculate Oak	20.0	8.0	5.0	5.0	5.0	1590	1.00	2.00	W/5	V	Fair	Field boundary	Hollow main stem, Major crown failures, Rips, splits and tears, Unbalanced crown	40+	A3	Field boundary

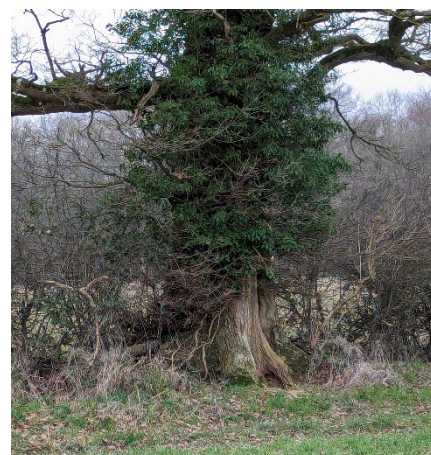
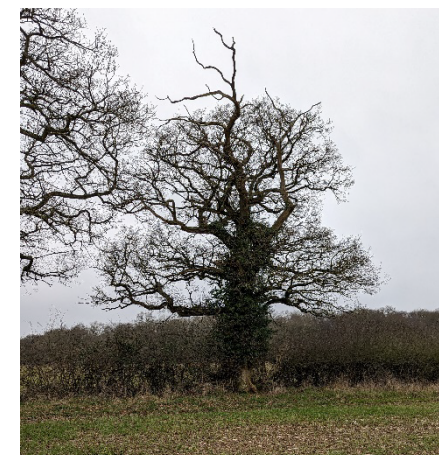
Species	Height (m)	Crown spread (m)				Stem dia. (mm) Including irregularities information	Stem no. at 1.5m	Height of crown clearance (m)	Dir/ height	Age class	Condition	Type	General observations Management recommendations	Estimated remaining contribution (years)	Tree Quality Category (BS5837)	Tree Typology
		N	E	S	W											
T49	<i>Quercus robur</i> - Pedunculate Oak	13.0	6.0	6.0	6.0	1200	1.00	2.50	E/5	V	Fair	Field boundary	Storm damage, Epicormics stem and crown, Splits, cracks, Large scar main stem,	40+	A3	Field boundary
