## Land Parcel C, Site Walkover Photographs

Site Walkover Questionnaire.

Date	30/11/2023
Project Name	Peartree solar farms
Project No.	323165
Site Name	Area D
GPS Location	53° 51' 51.965" N 0° 20' 28.8" W
Site Engineer	Matthew Fenton
Accompanied by	
Site Engineer Arrival Time	30/11/2023, 08:00
Site Engineer Departure Time	30/11/2023, 10:30
Other RSK Staff On Site	
Weather Conditions	<div><div><input type="checkbox"/> Heavy Rain</div><div><input type="checkbox"/> Rain</div><div><input type="checkbox"/> Drizzle</div><div><input type="checkbox"/> Overcast</div><div><input checked="" type="checkbox"/> Cloudy</div><div><input checked="" type="checkbox"/> Sunny Spells</div><div><input type="checkbox"/> Sunny</div><div><input type="checkbox"/> Fog</div><div><input type="checkbox"/> Snow</div><div><input type="checkbox"/> Thunder</div><div><input type="checkbox"/> Hail</div></div>

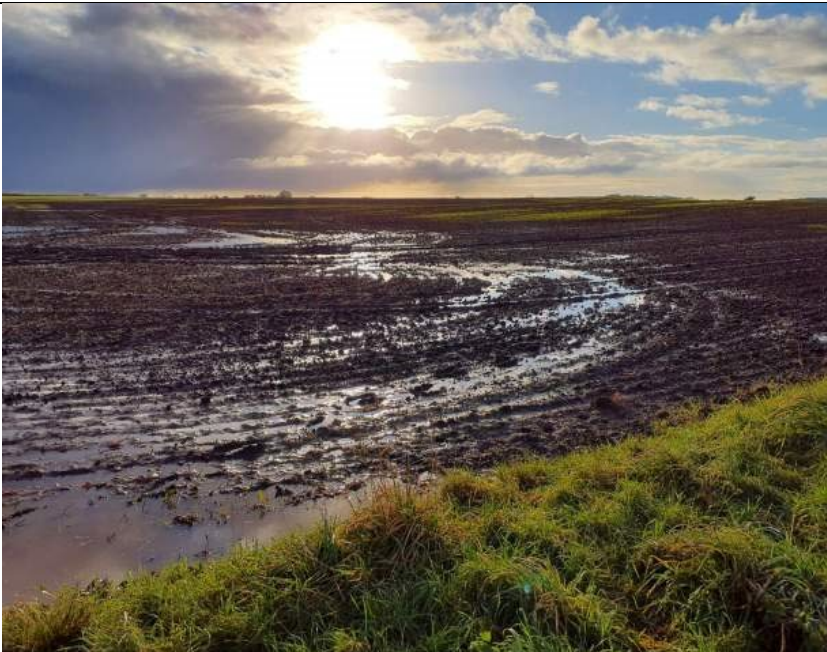
Photo no.	Details	Direction	
C1	C1 looking SW from NE corner. B8 is directly north of this photo (behind). Notice slight crest towards centre of field.	SW

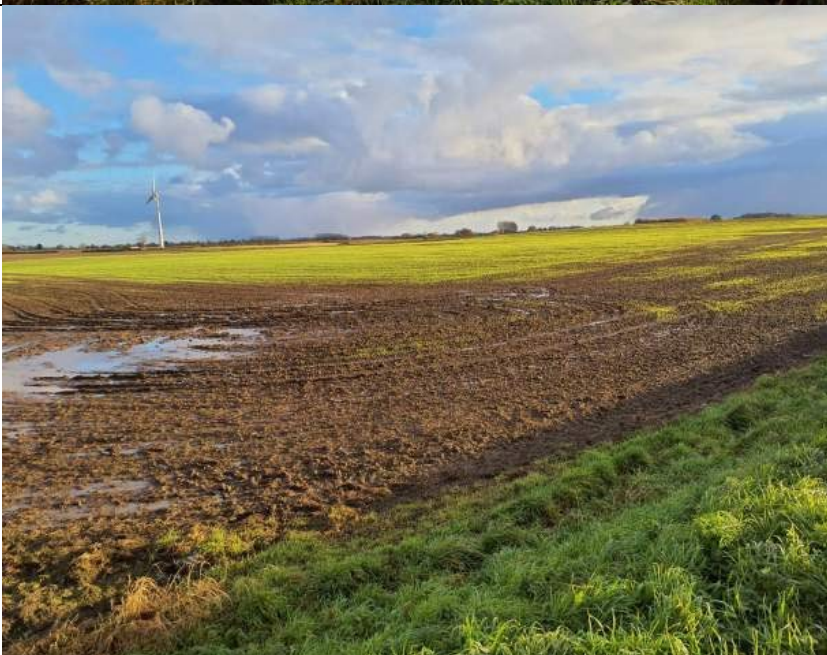
C2	C1 looking SE from NW corner by the Arnold West Carr Drain.	NW

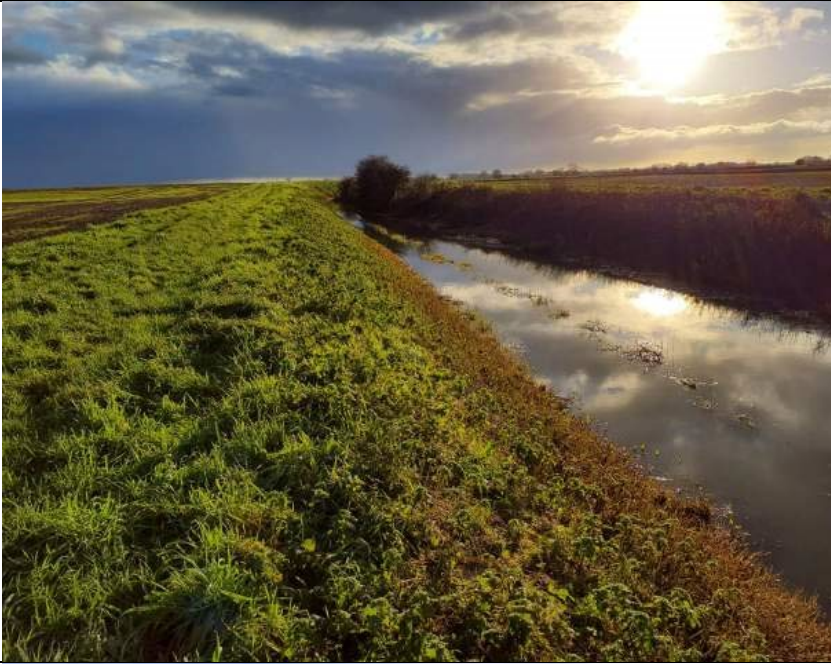
C3	Arnold West Carr Drain continuing south before moving west.	S

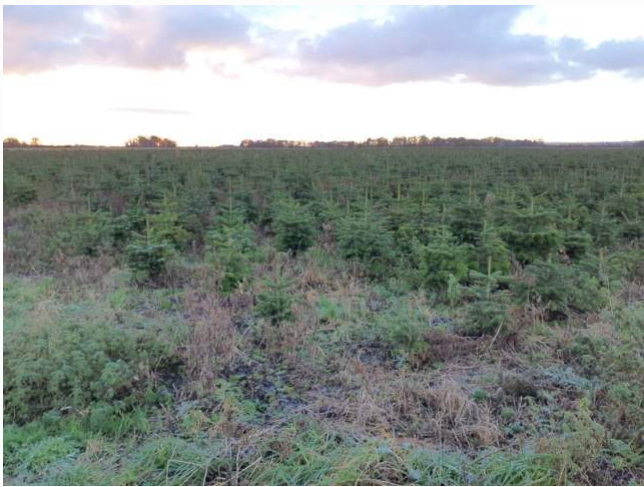
OTHER	NE corner of D3 looking SW. This field used differently to others in this parcel, looks to be growing trees as opposed to be for grazing on crops.	SW

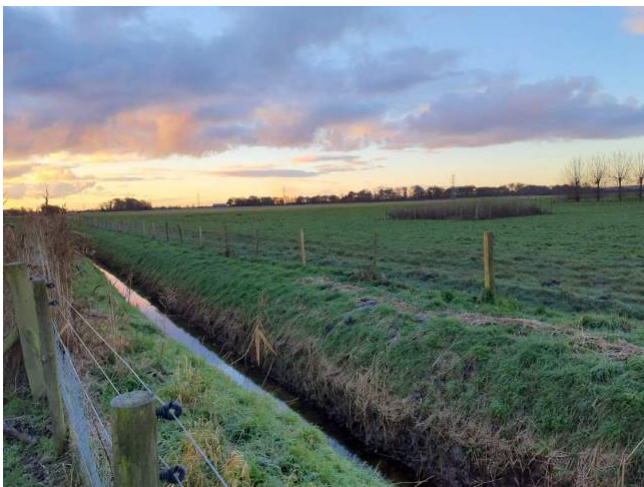
OTHER	NE corner of D1 looking SW. Ditch in foreground borders D1 and D3. Note pylons are not in area of D1.	SW

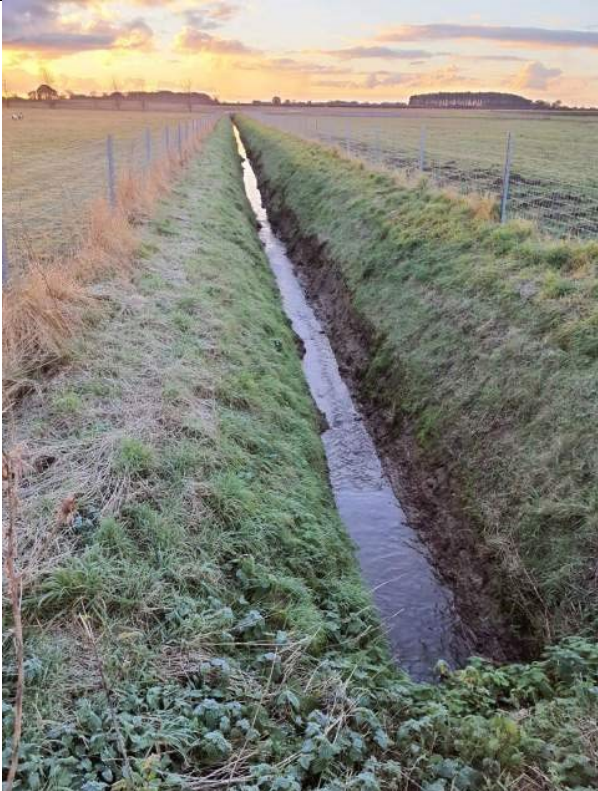
D2	Ditch on western border of D6 with outfall at foreground of image. D4 to the right	S

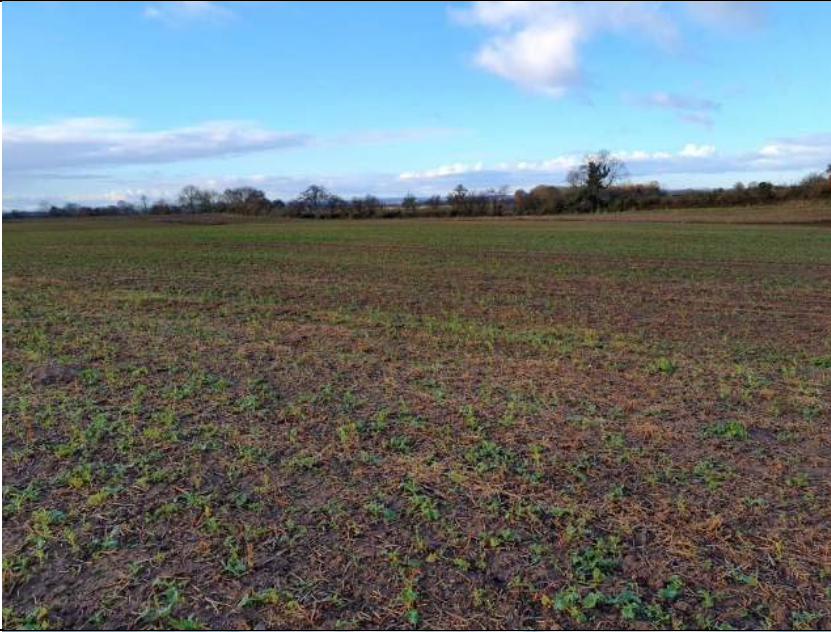
D25	Western edge of field of D8 looks boggy than rest of field, not worked and different vegetation.	W

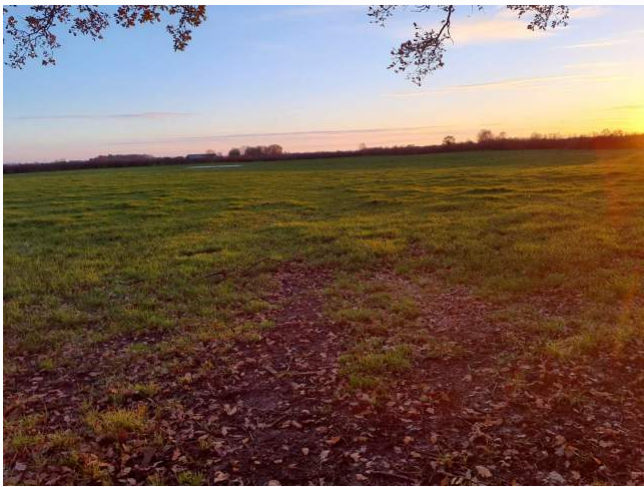
OTHER	View of E15 from northern corner (Carr Lane) looking south. Field is very boggy.	S

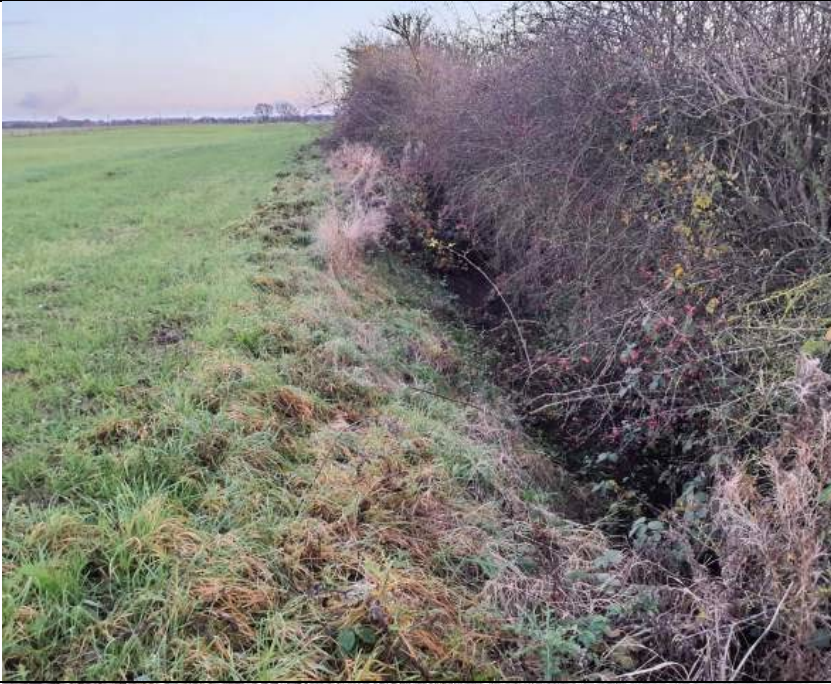
E39	Ditch between E16 and E17 looking south. Runs to border at both ends	S

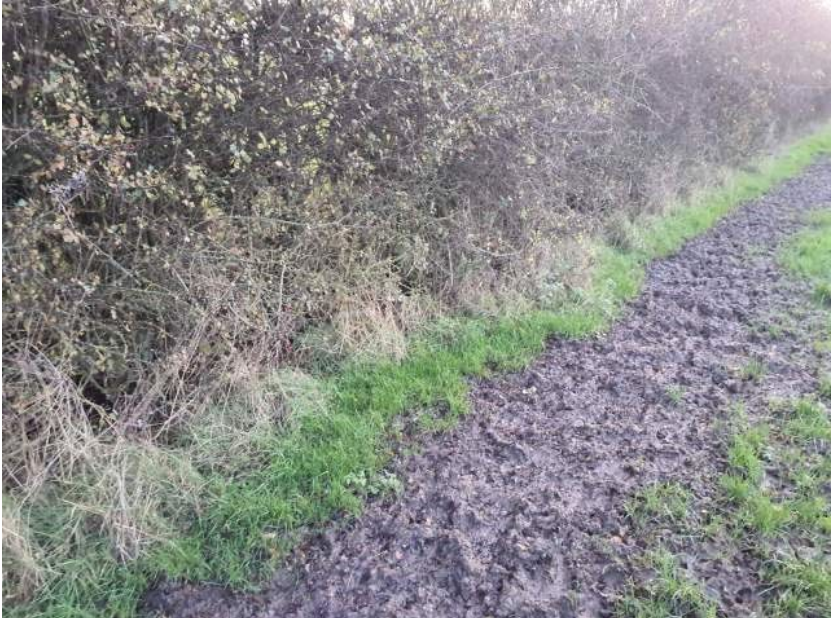
E40	Ditch between E15 and E16. Runs east to west.	E

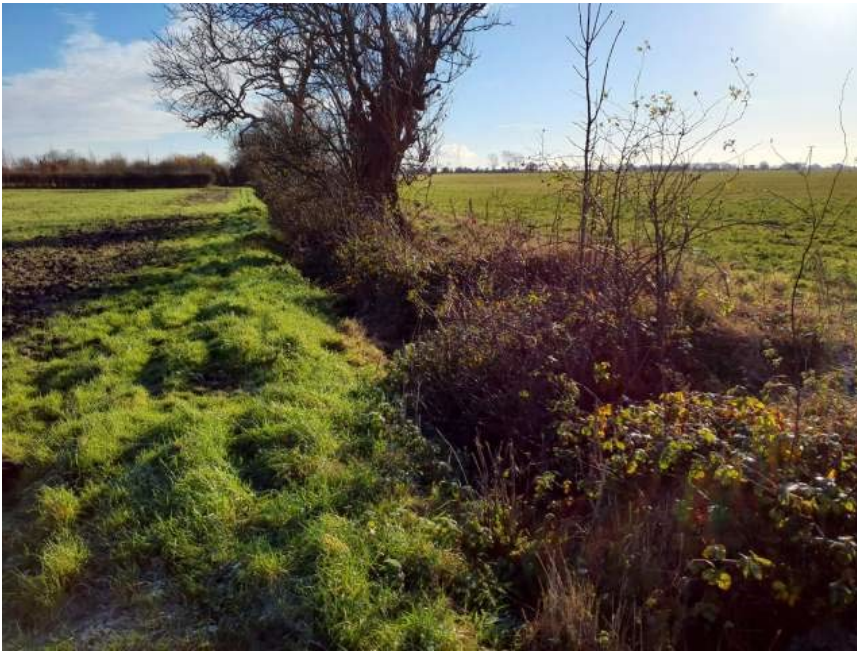
F16	Overgrown ditch by Western edge of F2.	S

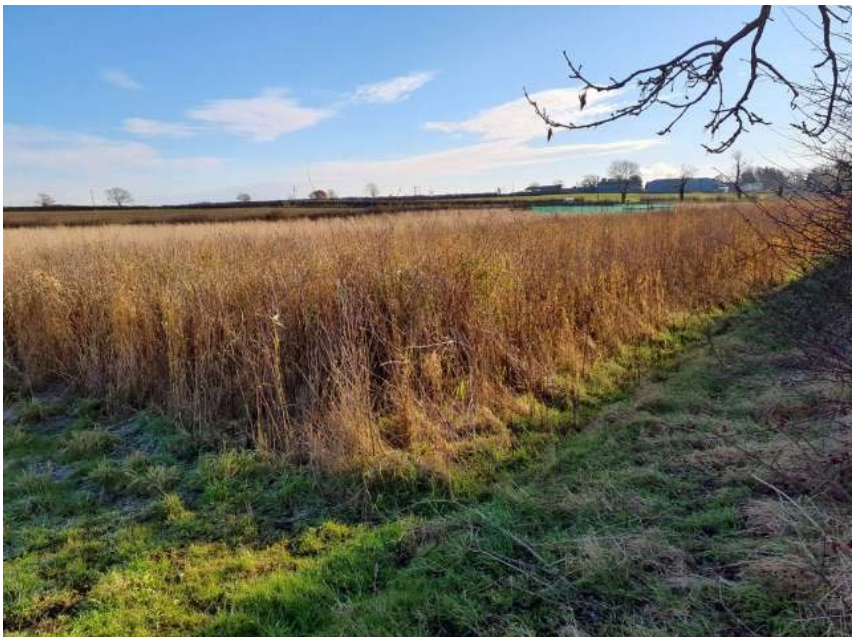
F27	From middle of Western edge looking north over F5. boggy/more unkempt vegetation.	N	 
F28	Same as above looking south over F5 showing another bird enclosure in boggy ground.	S

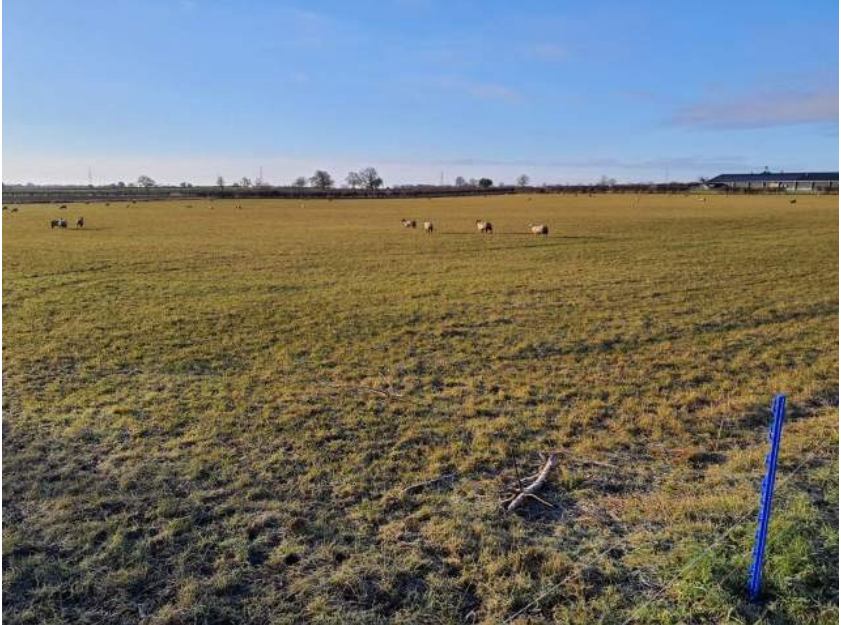
F49	Looking south from northern border of F12. Ground here is damp.	S
