Site Walkover Questionnaire.

Date	15/03/2024
Project Name	One earth solar
Project No.	323323
Site Name	Route 7: one earth solar
GPS Location	53° 14' 25.439" N 0° 47' 6.863" W
Site Engineer	Euan Gray-Stephens
Accompanied by	
Site Engineer Arrival Time	15/03/2024, 09:07
Site Engineer Departure Time	
Other RSK Staff On Site	
Weather Conditions	<div><input type="checkbox"/> Heavy Rain</div> <div><input type="checkbox"/> Rain</div> <div><input type="checkbox"/> Drizzle</div> <div><input type="checkbox"/> Overcast</div> <div><input checked="" type="checkbox"/> Cloudy</div> <div><input type="checkbox"/> Sunny Spells</div> <div><input type="checkbox"/> Sunny</div> <div><input type="checkbox"/> Fog</div> <div><input type="checkbox"/> Snow</div> <div><input type="checkbox"/> Thunder</div> <div><input type="checkbox"/> Hail</div>
Any Other Details	
Due Diligence report?	<div><input checked="" type="checkbox"/> No</div> <div><input type="checkbox"/> Yes</div>

1a. Main land use(s)	Field 35 green crop	N

APPENDIX F TECHNICAL BACKGROUND

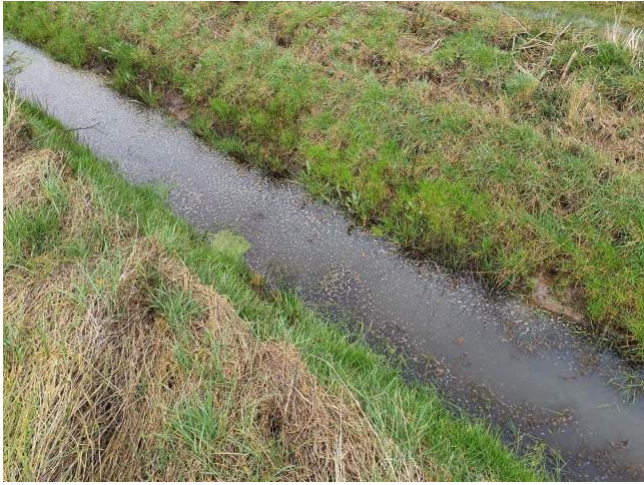
4f. Visual evidence of contamination of surface waters	Discolored water in ditches field 28 and 30 boundary	N

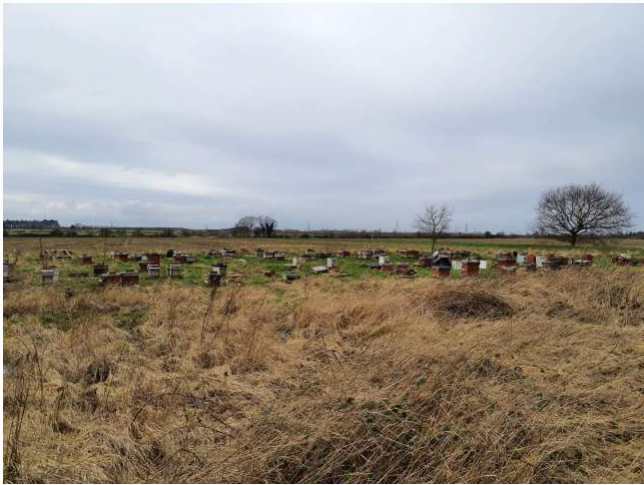
1a. Main land use(s)	Bee hives on field 30	W

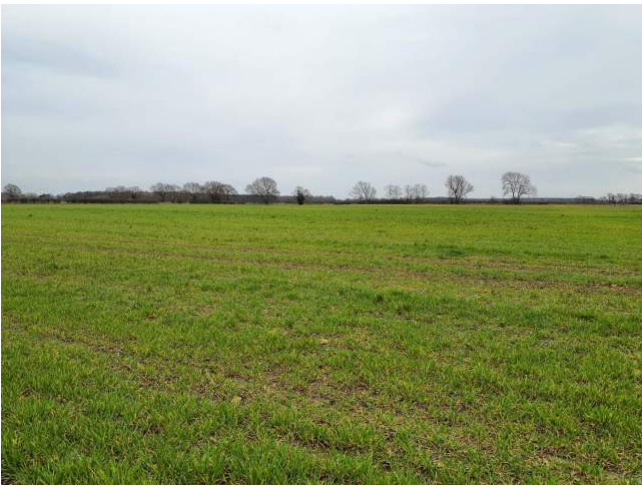
1a. Main land use(s)	Green crop u named centre field	SE

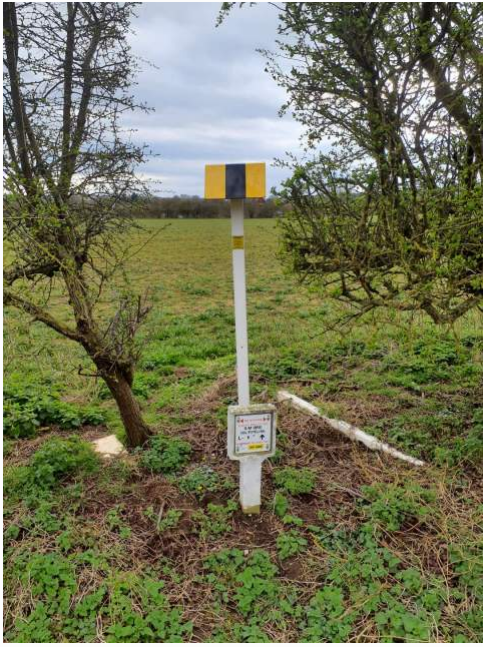
5c. Buried and overhead services	Oil pipeline into field 81	S

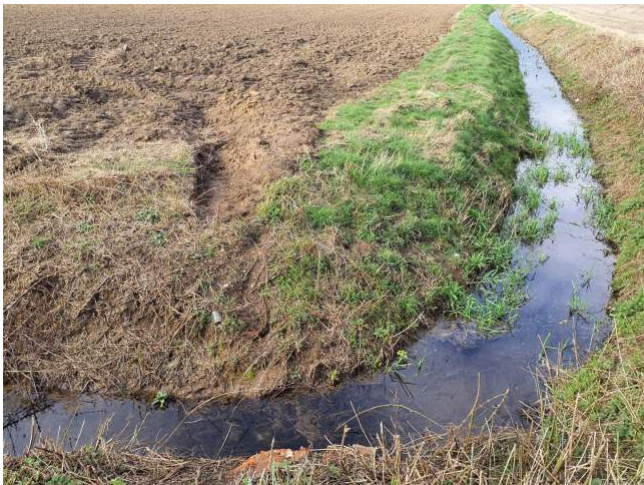
4d. Surface waters on site	Ditches drain with dark brown colour and build up beside field 92 and 90	N

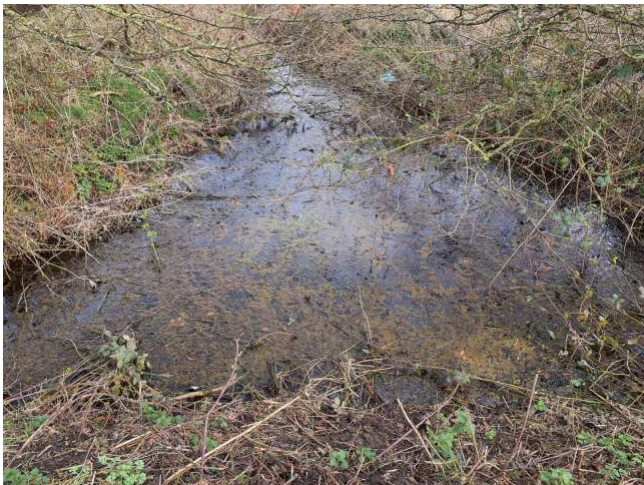
4f. Visual evidence of contamination of surface waters	Ditches foaming beside field 88	E

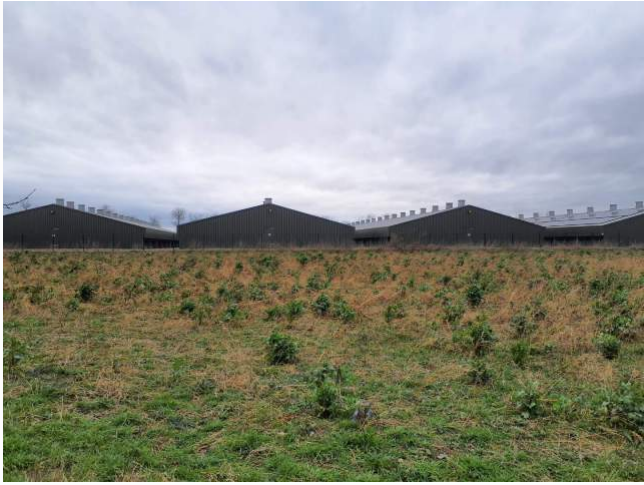
1c. Adjacent land use(s)	Poultry Houses, silos and gas tanks on site.	W

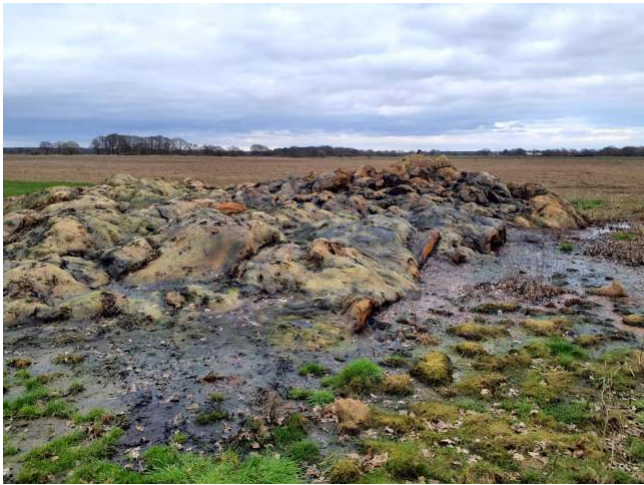
7f. Evidence of possible
land contamination on-site

Silage or hay bays
decaying in field 80

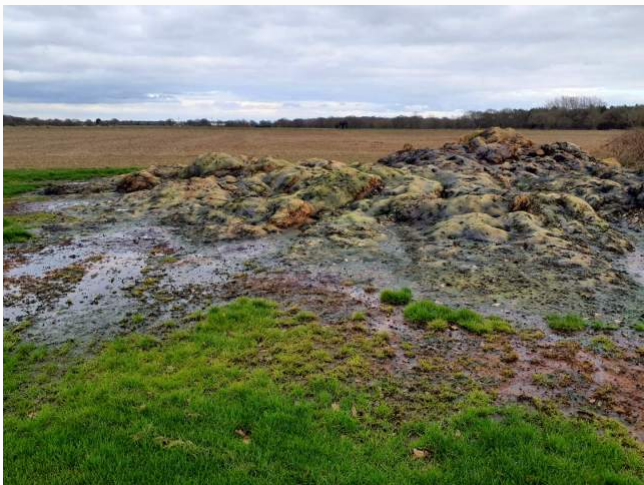
7f. Evidence of possible
land contamination on-site

Hay or silage bales
decaying in field 80

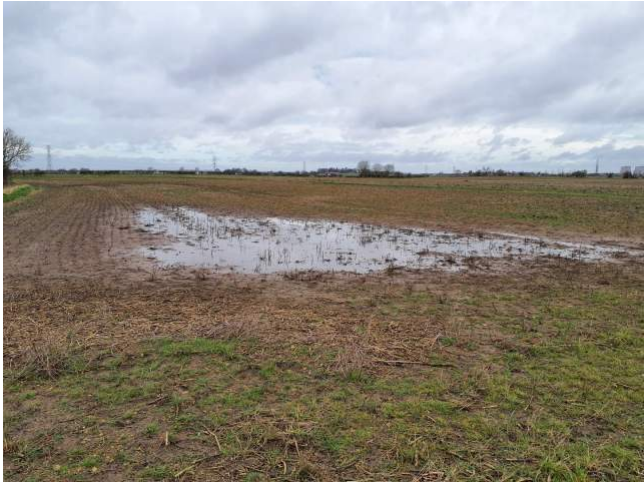
4i. Waterlogging or flooding	Local surface flooding	NW

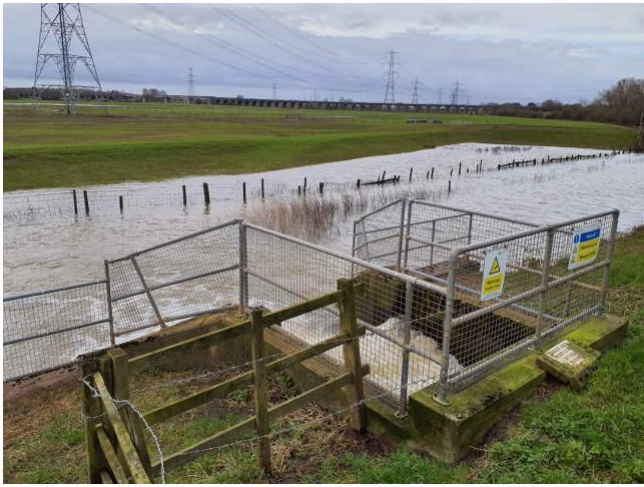
1c. Adjacent land use(s)	Pump in use and flooding east of site	E

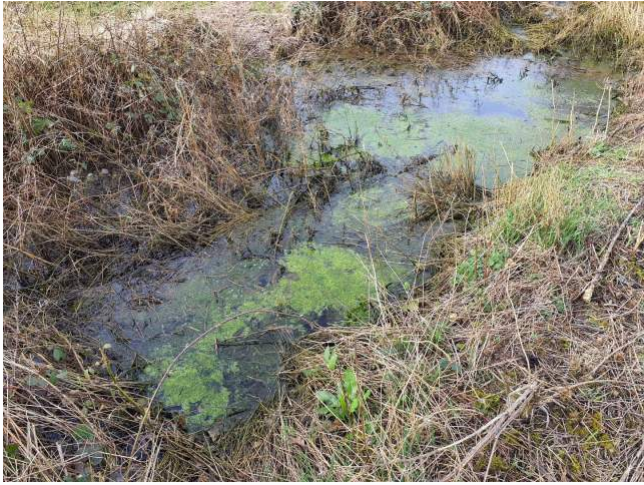
4e. Surface waters adjacent (within 250m)	Green algae in ditches	SW

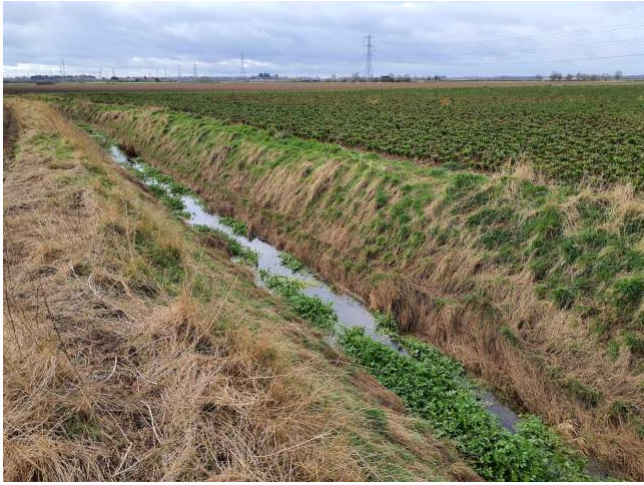
4d. Surface waters on site	Deep ditches throughout this sector, approx 2-3m at points	SW

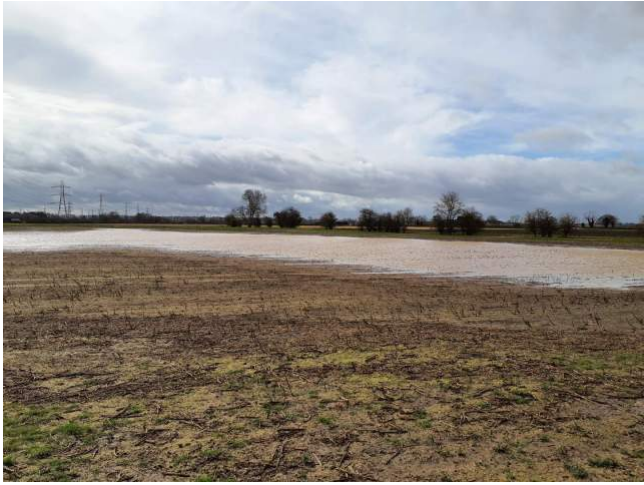
4i. Waterlogging or flooding	Field 33 nearly all flooded	S
