Response for Deadline 4 concerning the use of the Hoverport part 1

Planning Inspectorate ref: EN020026

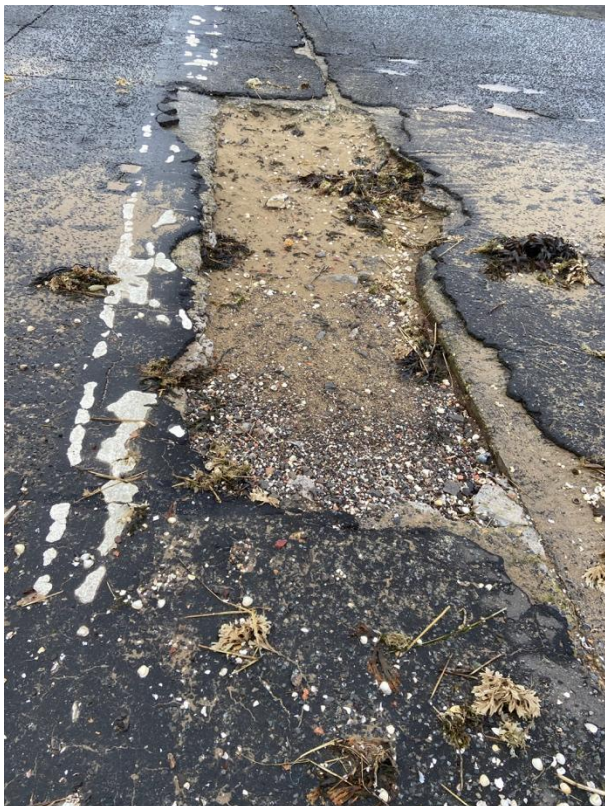
01

The photographs and their location clearly show that the deterioration is widespread over the area indicated by the Applicant as possible routes to the intertidal area. I reiterate my point previously made that 40 movements a day of very heavy machinery even with matting are likely to break up the surface increasing the risk of heavy metals, including Arsenic and Lead, leeching into the SSSI.
