M1 Junction 15
Northampton Rail Freight Interchange

Stage 1 Road Safety Audit

M1 Junction 15 Northampton Rail Freight Interchange Stage 1 Road Safety Audit

March 2018

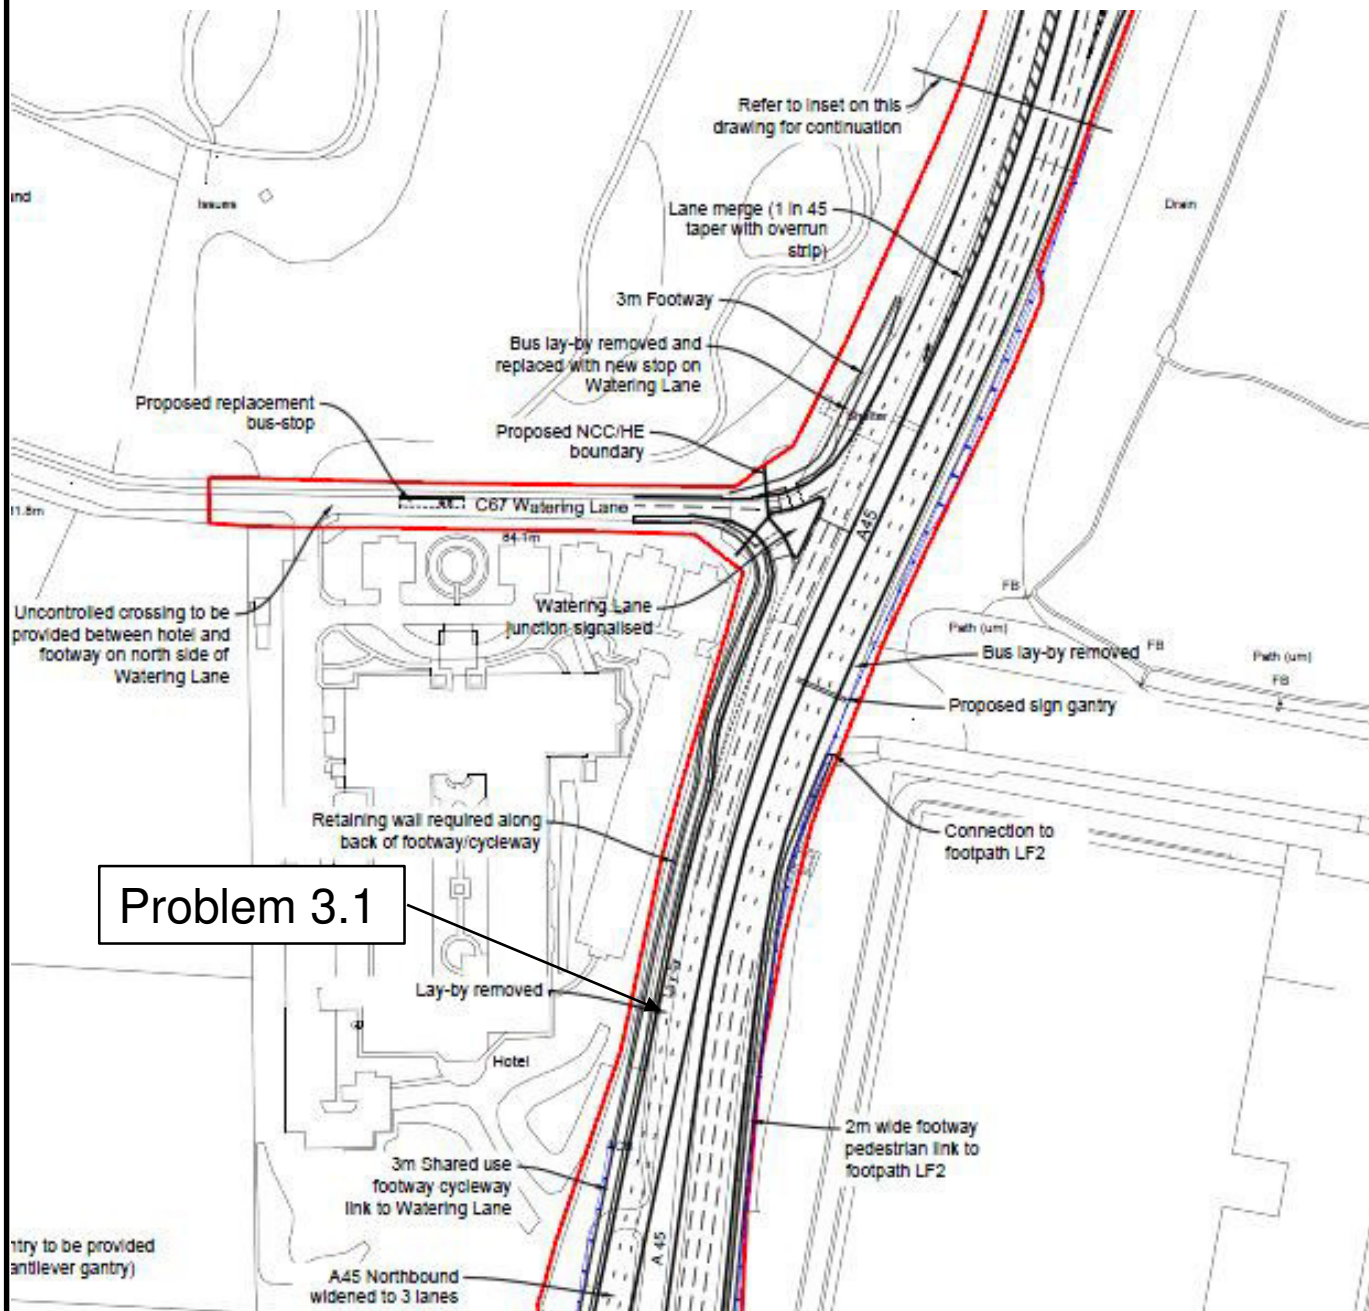
Figure 2 – Location of problems identified within this audit;
A45 north of M1 J15

Summary: The lay-by is heavily used by HGVs, hence it is unknown what would happen to the displaced demand.

The lay-by, which is proposed to be removed, is heavily used by HGV drivers as witnessed during the site visit. There is no reference to the facility being replaced, hence it is unknown where displaced vehicles would attempt to park. HGV drivers could be tempted to park on Saxon Avenue on the exit from the roundabout and surrounding roads for example, which could create conflict with passing vehicles.

Further information is required with regards to the removal of the lay-by, to determine if any alternative solutions have been considered to prevent any inappropriate HGV parking.

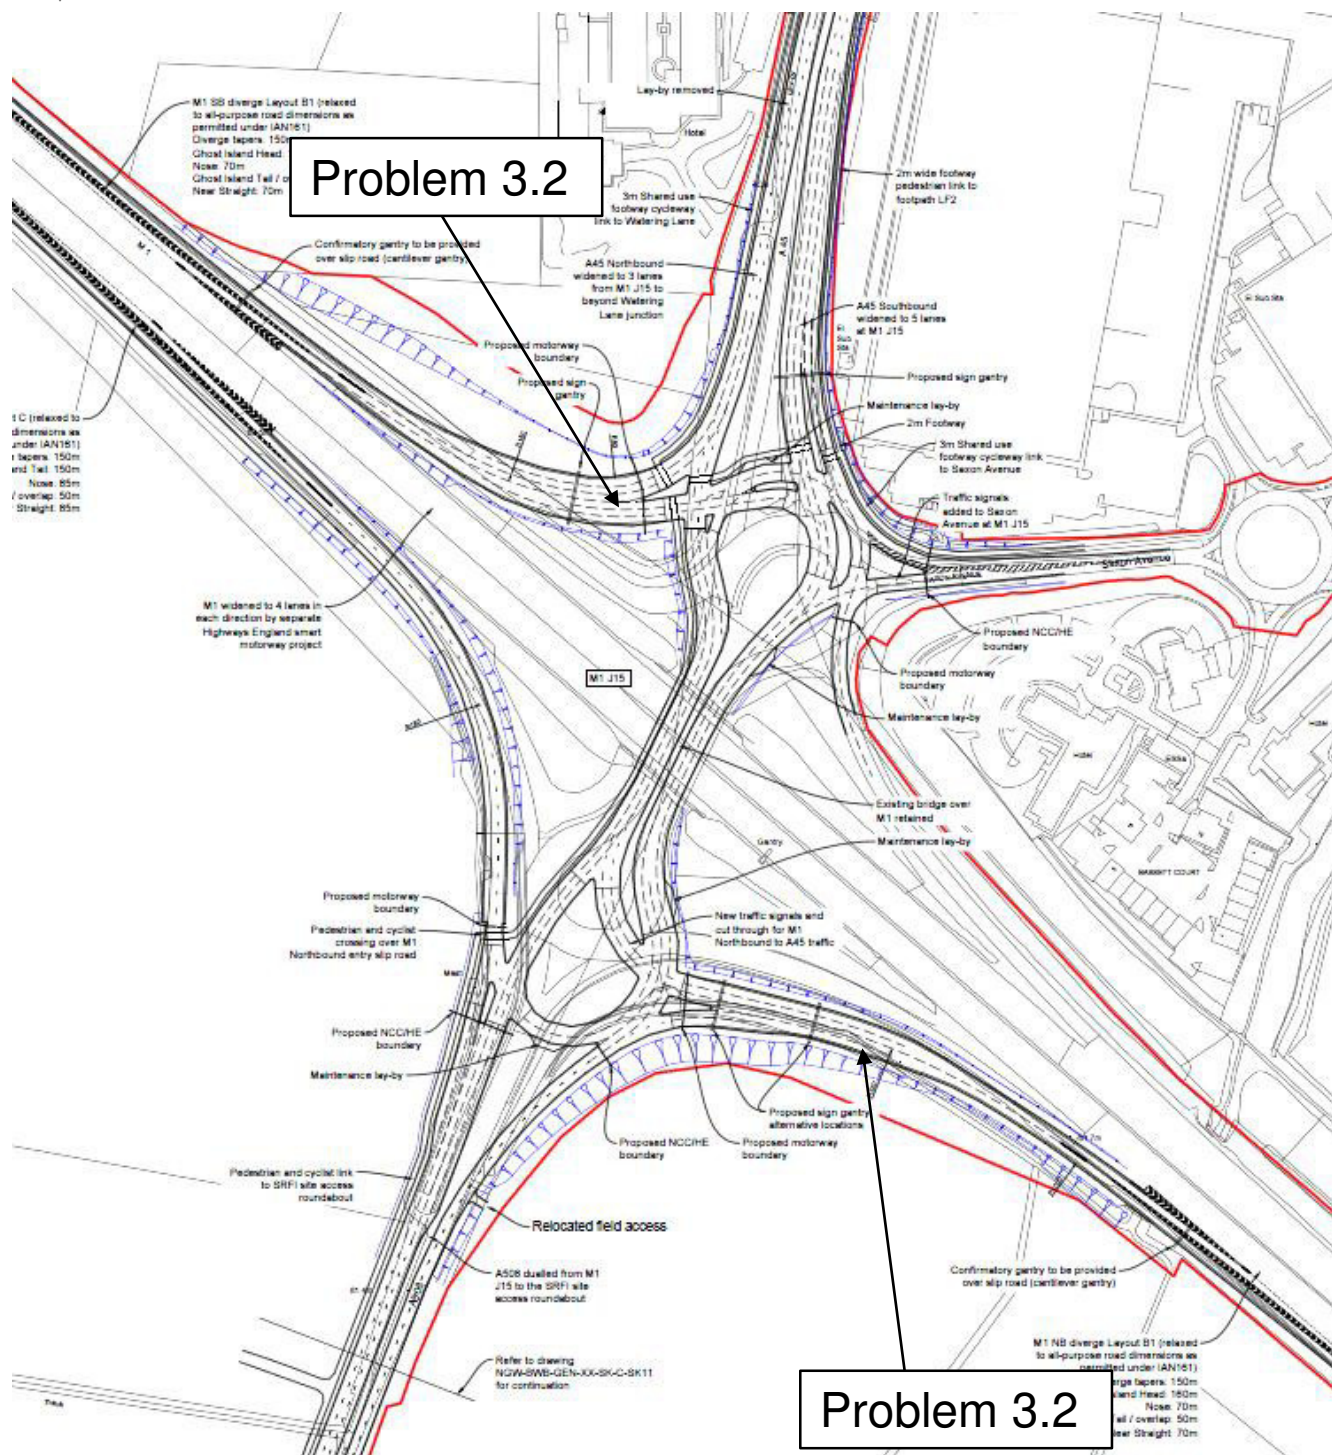
Summary: Potential weaving issues.

Early exiting drivers in the nearside lane of the southbound off-slip may want to travel south at Junction 15, towards the site. There is minimum weaving distance on the slip road for lane choice as drivers that were ready to leave the motorway early may not be able to get across to turn right at the junction, which could result in side swipe collisions. This issue is exacerbated by the fact that drivers using the later slip road lane are still able to travel north in the offside lane, which therefore results in vehicles crossing one another's path.

The same issue also arises at the northbound off-slip should drivers in the offside lane want to travel south at Junction 15, towards the site.

Ensure that suitable road markings and associated signage should be introduced to help drivers exit the M1 in the correct lane on the slip roads. It would also help if the two slip road lanes were allocated one direction of travel, for instance on the southbound off-slip the first slip road would provide access to the A45 and the second slip road provide access to Saxon Avenue and the A508. This would result in motorists only having to switch one lane if they found themselves on the wrong slip road.

Road markings and associated signage at the junction will have to be thoroughly examined in further detail as part of the Stage 2 RSA regardless, to ensure that the considerable changes to the junction are as clear as possible to drivers.

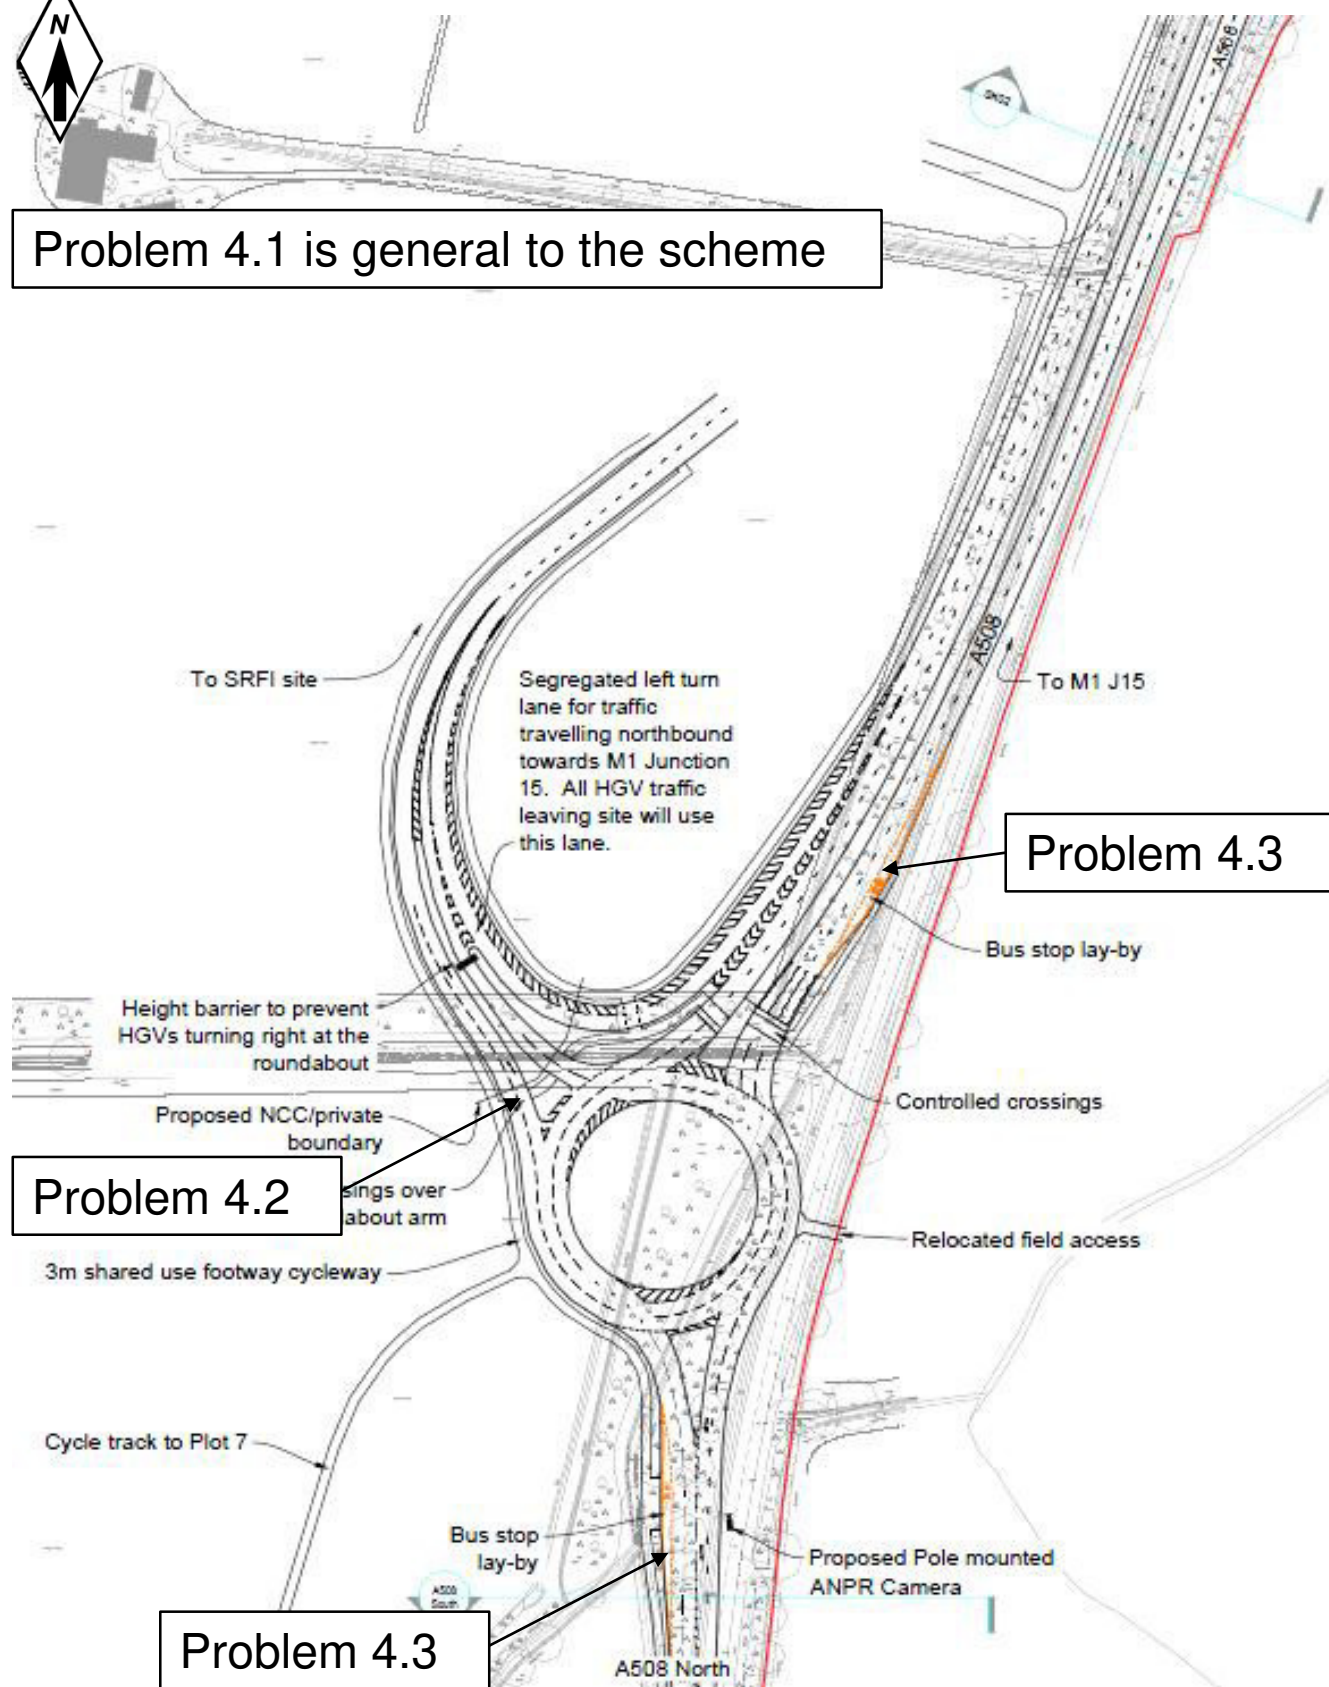
Summary: The road markings are not clear.

The road markings as currently proposed are not clear. For example, on the site access the centreline is not central. In addition, directional road markings as well as arrows will be required at the roundabout to make it clear as to what movement is permitted in each of the entry lanes. As a result, this could result in vehicles not taking the correct line of travel if they were guided by the road markings as currently proposed.

Summary: Uncontrolled crossings provided on potentially busy exit from roundabout.

The crossing facility provided over the site access arm is proposed as an uncontrolled crossing. However, the access will potentially be busy during peak times, and the exit from the roundabout is provided with two lanes merging to one within the site. This could make it difficult for pedestrians to cross the carriageway and predict vehicle movements exiting the roundabout. This is exacerbated by the provision of two lanes allowing access to the site around the roundabout.

Summary: Provision of bus stop close to the roundabout could create confusion.

The proposals include bus stops provided on both the northbound and the southbound A508 approaches to the roundabout. The northbound bus stop in particular is provided close to the roundabout and is also provided in addition to a flare from one lane to

two lanes. This results in a potentially confusing layout, as a bus pulling into the bus stop, could be followed by a car, expecting it to turn into the site, for it to suddenly stop. This could potentially lead to shunt type collisions.

Similarly, the southbound bus stop could restrict visibility to and from pedestrians using the pedestrian crossing.

Problem 4.1 is general to the scheme

Problem 4.2

Problem 4.3

Ensure that the road markings and signage strategy at the site access junction is completely clear for all users.

Assuming pedestrian movements across the site access arm would be low, it could be beneficial to provide a signal controlled facility on the basis that it should not prejudice the capacity of said junction.

The bus stops should be located at a suitable distance away from the roundabout to prevent any confusion for motorists at the roundabout.

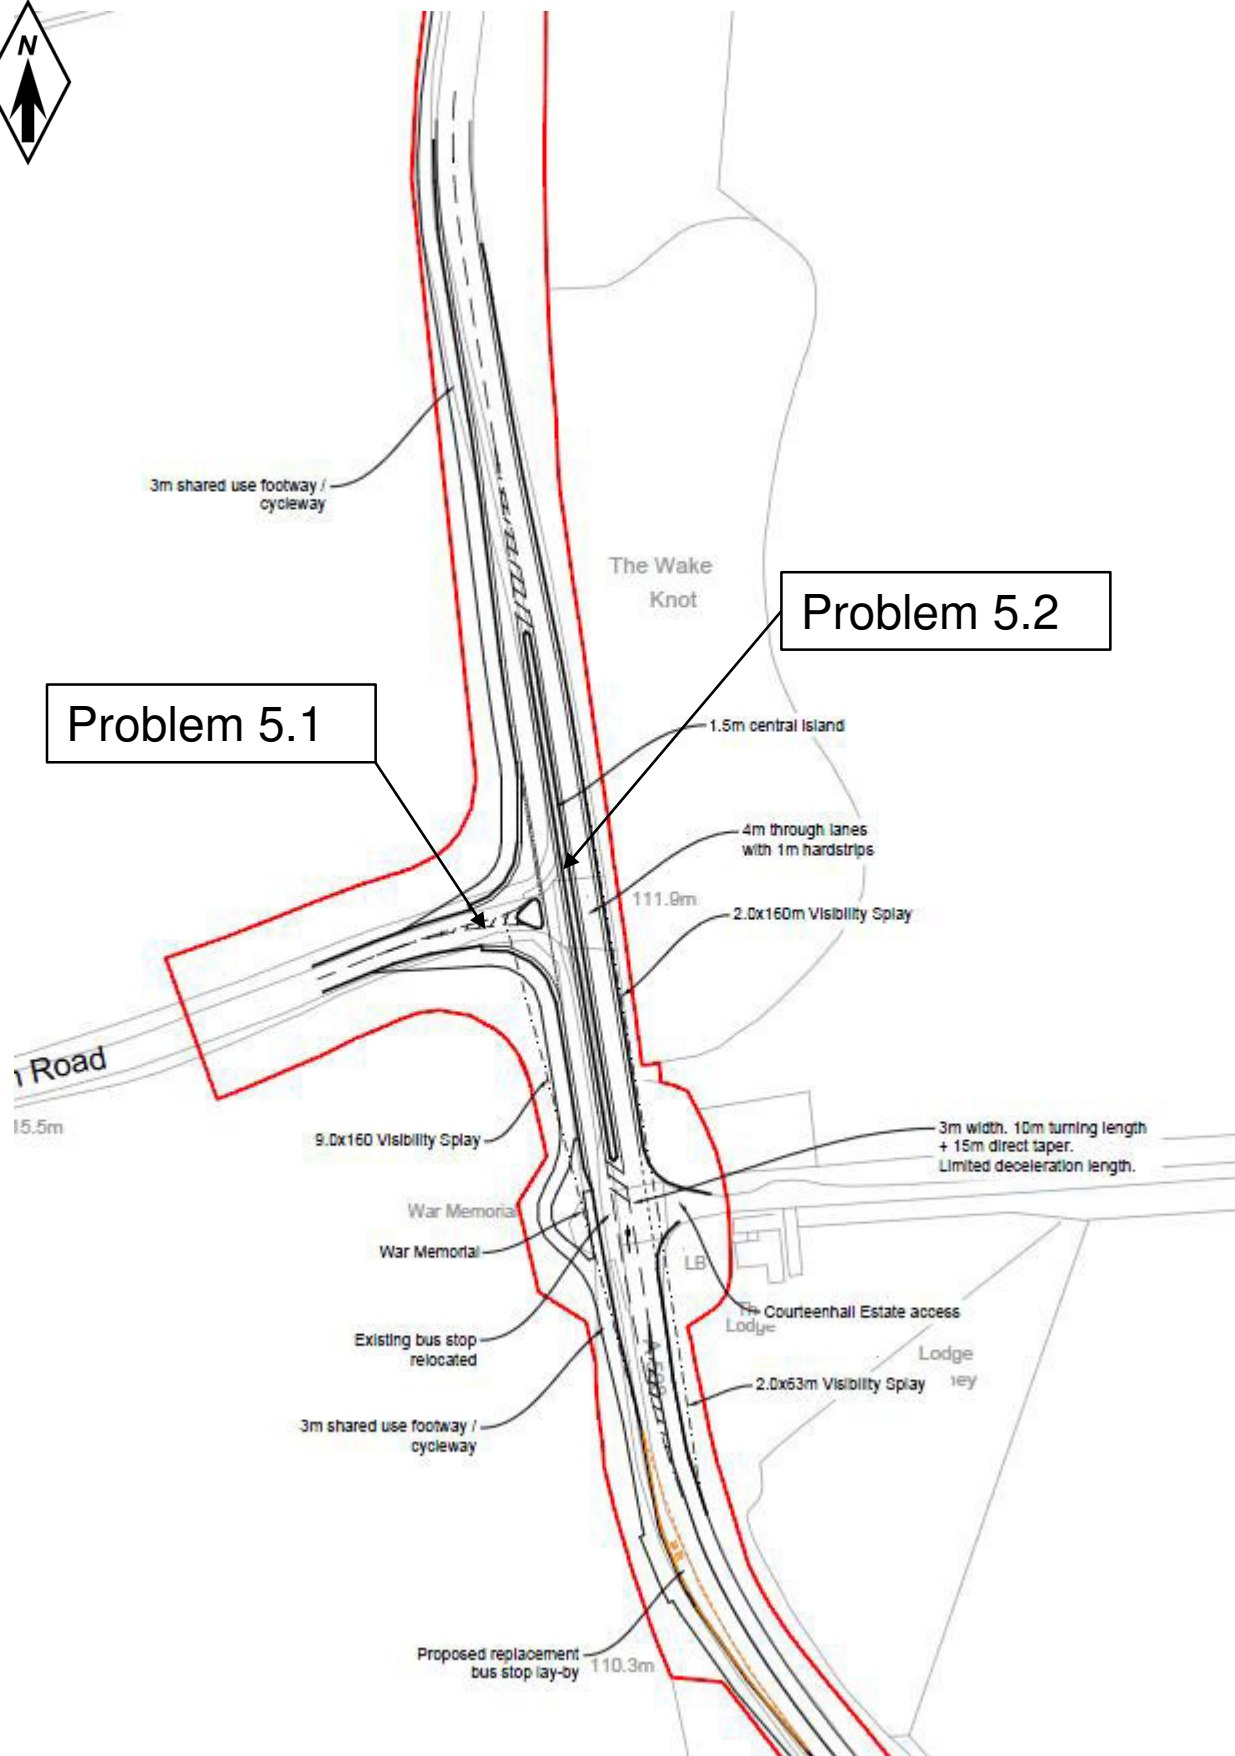
Summary: It is unclear how pedestrians and cyclists would cross Courteenhall Road.

A shared surface pedestrian/cycle route routes along the western side of the A508. A refuge is proposed in the centre of Courteenhall Road to enforce the left-in/left-out arrangement. However, it is unclear at this stage how pedestrians and cyclists would cross Courteenhall Road, because it does not appear that they would be able to make use of the refuge. This could result in such users being put in conflict with vehicles travelling along Courteenhall Road.

Summary: Central island could cause conflict.

The junction of the A508/Courteenhall Road is proposed to be revised to a left-in/left-out junction which is forced by the introduction of a narrow central kerbed central island. If the central island was not provided with bollards or signage, it could be inconspicuous to drivers resulting in them colliding with it.

It is recommended that pedestrians and cyclists are provided with the opportunity to use the refuge to break their crossing of Courteenhall Road.

Whilst more of a detailed design issue, it should be ensured that suitable signage, and bollards are provided to make the central island as visible as possible.

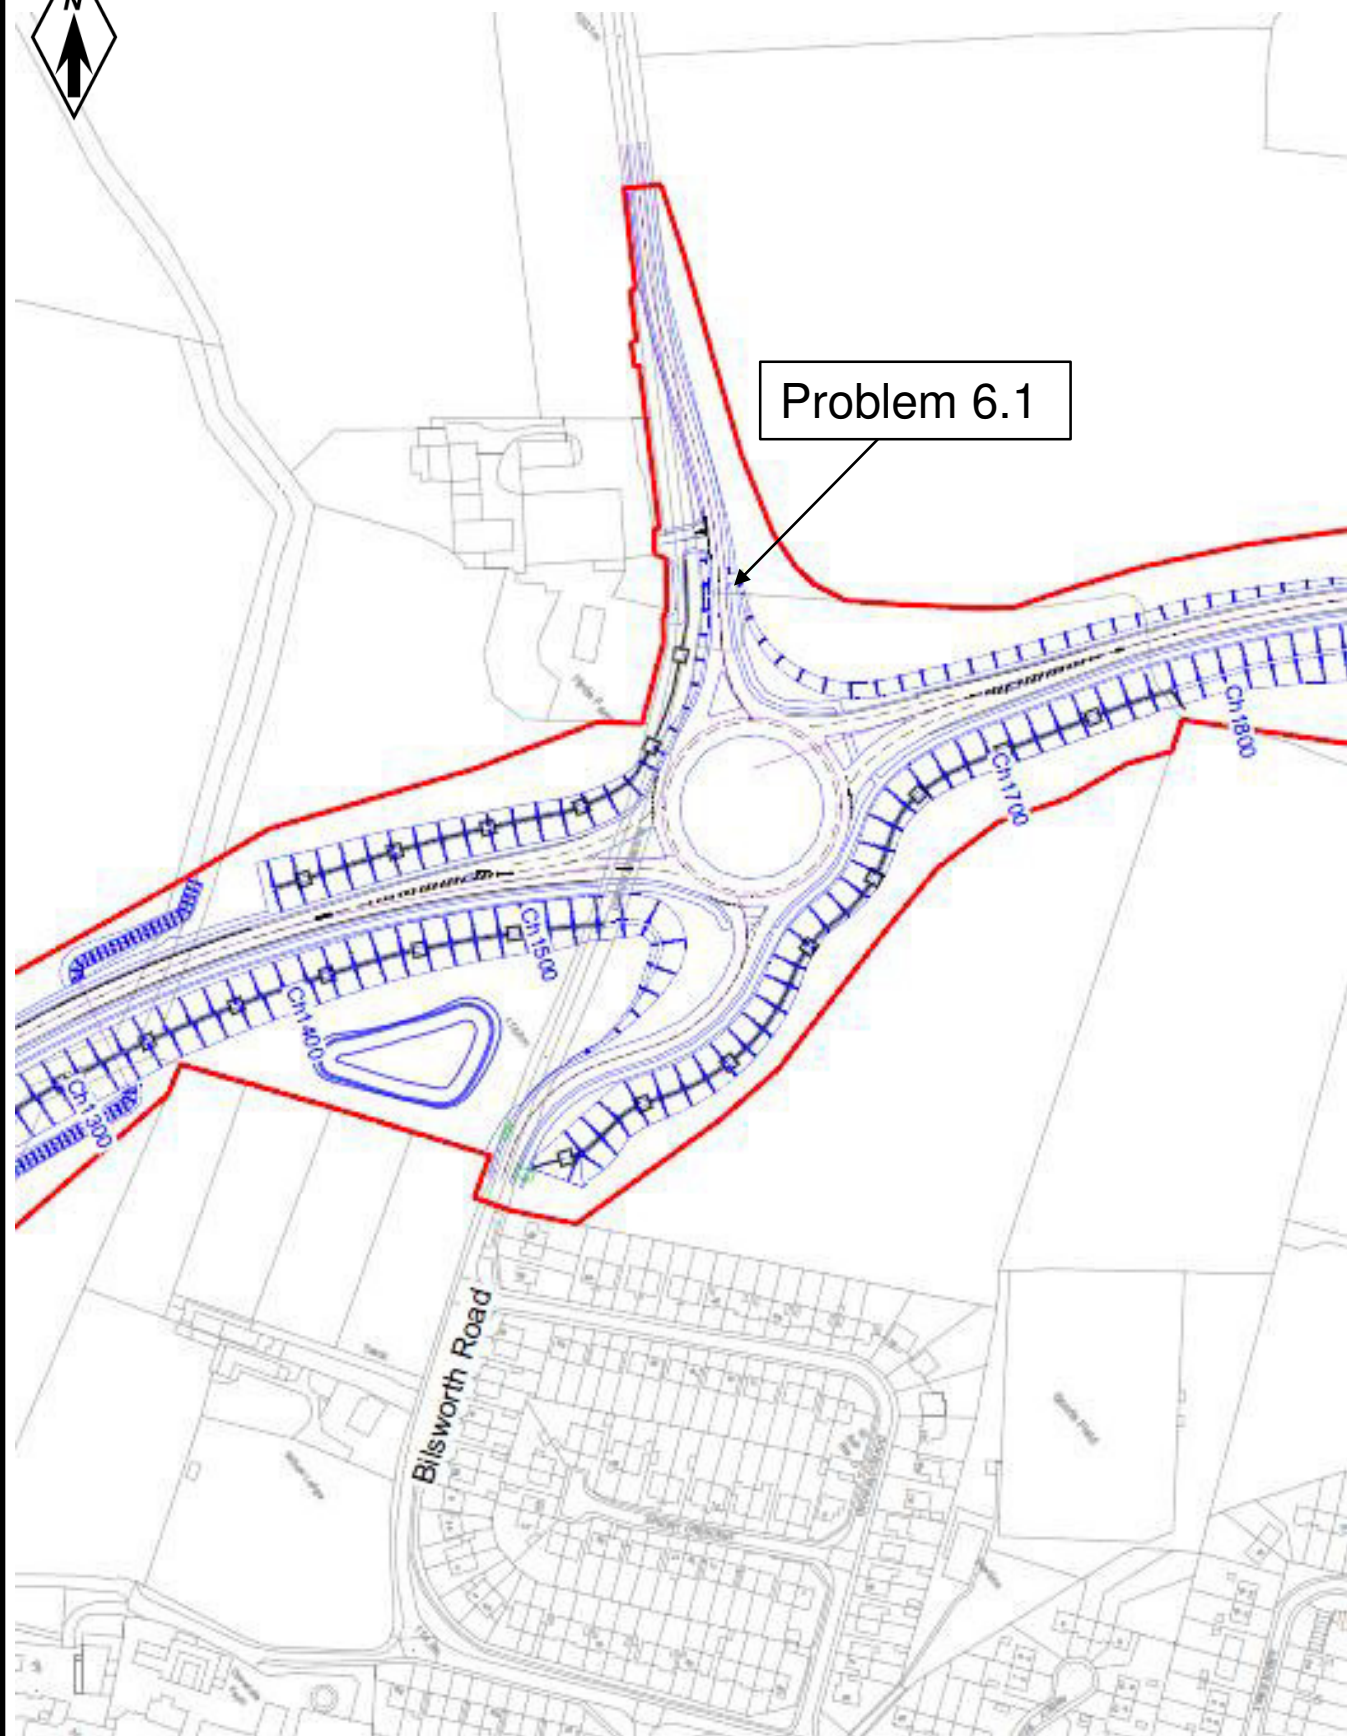
Summary: It is unclear how cyclists would connect onto the off-road cycle facility.

What is understood to be an off-road section of cycleway is proposed on the northeastern side of the Roade Bypass/Blisworth Road roundabout, to provide any cyclists from Blisworth with the opportunity to access the shared surface footway/cycleway on the eastern side of the bypass without travelling around the roundabout on the live carriageway.

However, the facility appears to begin at a newly created farm access. It is therefore unknown at this stage how cyclists would be safely directed onto said facility, avoiding any potential conflict that could be created by the farm access, including any mud on the carriageway which could cause cyclists to come off their bicycles.

Further thought is required as part of the detailed design process, as to how cyclists would safely access the off-road cycle facility. It may be beneficial to provide a separate dropped kerb facility closer to the roundabout, dedicated to cyclists leaving the carriageway to avoid any conflict with the farm access.

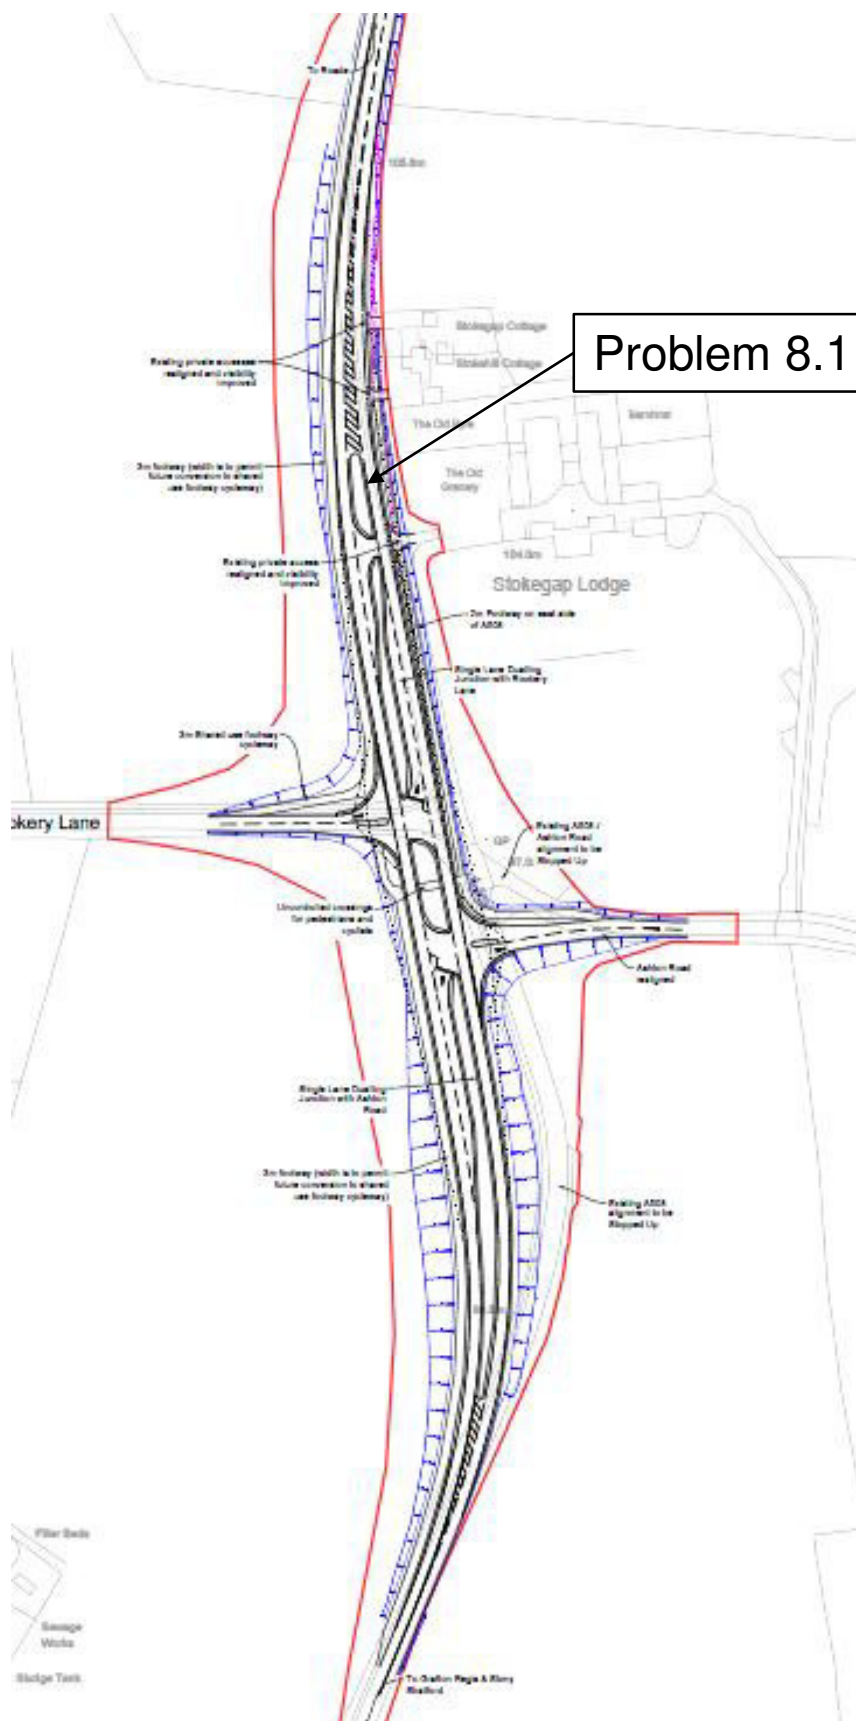
Summary: Lack of crossing facility provided between footways.

There is currently a footway provided along the eastern side of the A508 in the vicinity of the cottages, north of the proposed staggered junction. The proposals include a 3.0 metres wide shared facility on the western side of the A508. However, there is no facility provided to the north of the junction to allow pedestrians to cross the carriageway. This could result in pedestrians attempting to cross where there are no provisions or, where motorists are not expecting them to cross, resulting in them being hit by passing vehicles.

Provide an informal crossing facility across the most northern refuge, in the form of dropped kerbs and tactile paving to allow pedestrians to cross the road, outside of the cottages.

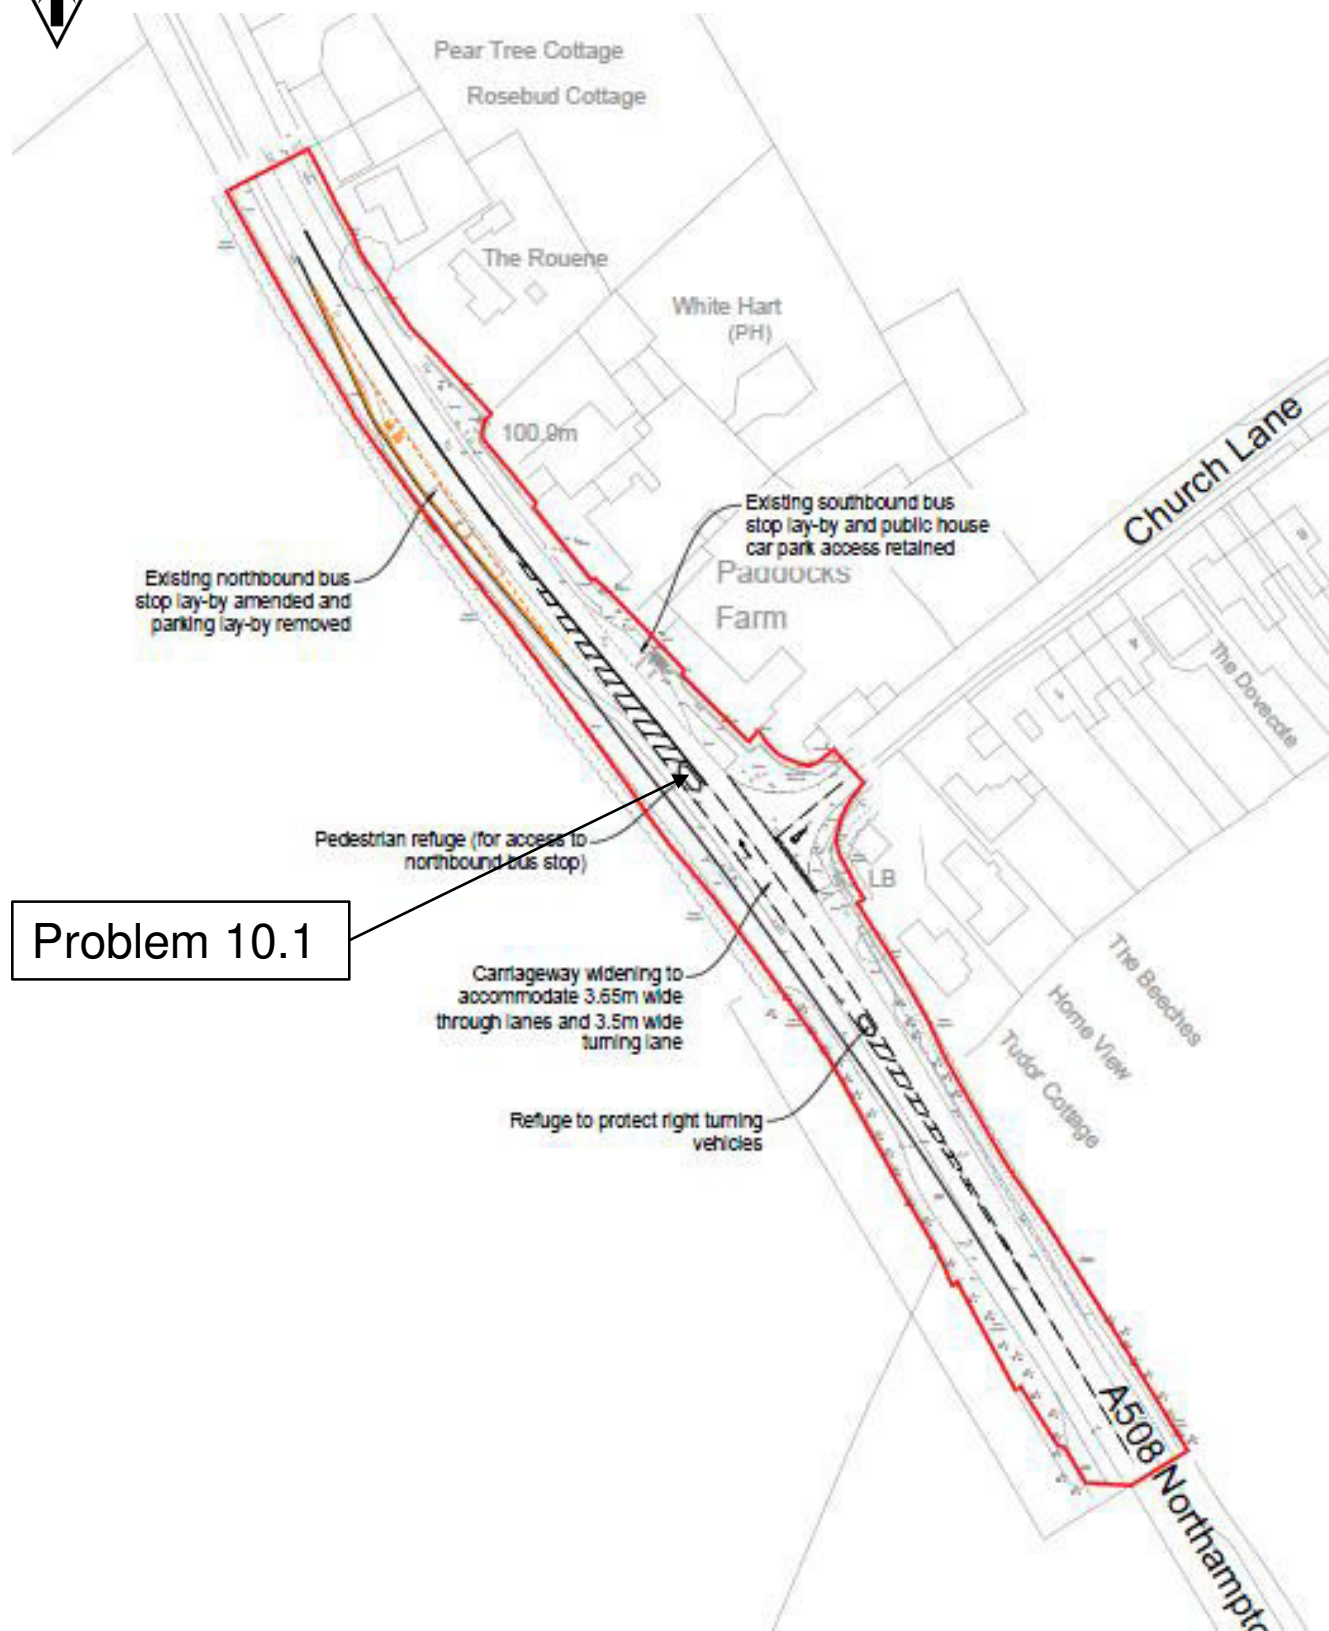
Summary: Refuge could be damaged by agricultural vehicles.

There is a refuge provided on the A508 directly to the north of the Church Lane junction, to allow pedestrian access to the southbound bus stop. During the site visit, a large tractor was witnessed turning right out of Church Lane onto the A508 which used a large amount of carriageway. If the refuge is provided close to the junction this could result in the refuge being run over by these large vehicles, potentially damaging the bollards or the kerbing, which could even leave parts of the kerb in the carriageway leaving a hazard to motorists and motorcyclists.

Ensure that the refuge is provided far enough from the junction to allow agricultural vehicles to enter and exit Church Lane.
