PROPOSED HINCKLEY RAIL INTERCHANGE ACCESS ROAD

M69 JUNCTION 2 / B4668, HINCKLEY

STAGE 1 – ROAD SAFETY AUDIT

REPORT REF: 24-1363.01-RSA1C

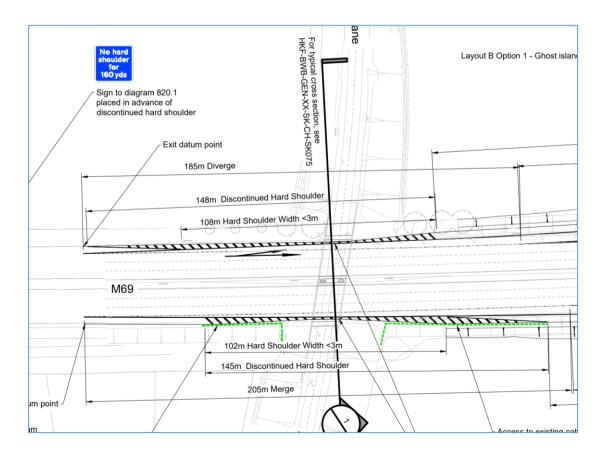
- The audit also comprised of a desk-top study where all documents and plans provided by the Design Team were reviewed. A list of these can be found in Appendix A. The auditors have been made aware of two departures from design standards. Whilst the submission for these departures remains in preparation, the two departures are:

- Proposed section of discontinuous hard shoulder of new south facing diverge slip at M69 J2;
 and
 - Proposed section of discontinuous hard shoulder of new north facing diverge slip at M69 J2.

- 1.7 The location of these departures is detailed below:

- 1.8 Having reviewed the implications of these departures on the safety of the network, whilst amendments to the existing vehicle restraint system will be required to accommodate the works no indication is shown on plan of this. It will be essential that working widths and containment levels past identified hazards are maintained and that adequate protection is afforded to maintenance and emergency workers operating in this area. The formal departures report will be awaited before commenting further.

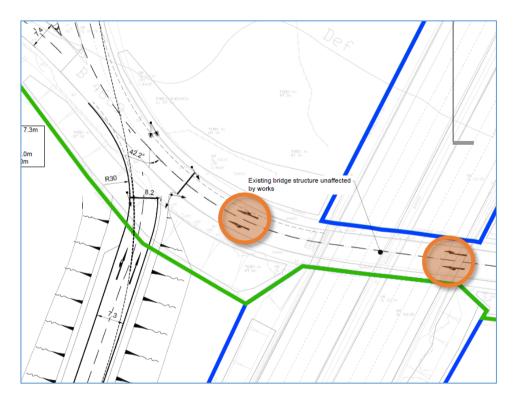
3.2. **Problem 1**

Location: M69 J2 southern circulatory carriageway.

Summary: Confusing road markings risk side swipe type collisions.

Around the southern carriageway of the circulatory the lane destinations show an "ahead" and a "right turn" arrow. However, approaching the junction and on the approaches before this point, "ahead" and "ahead and right" arrows are shown. This could lead to late lane changes, sudden and unexpected braking and side swipe type collisions due to driver confusion and late decision making as a result of confusing and misleading lane destinations.

It is recommended that the markings are amended so that they are consistent with the available movements around the southern half of the circulatory and on the westbound link road exit.

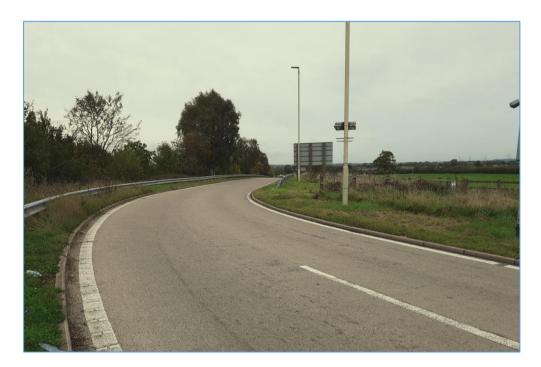
3.3. **Problem 2**

Location: M69 southbound approach to the new signalised junction.

Summary: Poor forward visibility of signals risks late braking and junction overshoot type collisions.

The southbound off-slip approach to the proposed signals at Junction 2 has a significant vertical and horizontal alignment change on the approach to the current Give-Way line. There is a concern that, given these changes and the existing signing infrastructure, that forward visibility towards the signal heads will not be provided for vehicles.

It is recommended that the signals are located and designed, including raised poles and/or gantry signals if needed, so as to provide adequate forward visibility for approaching vehicles. Furthermore, it is recommended that the signing on the approach is amended so as not to pose an obstruction.

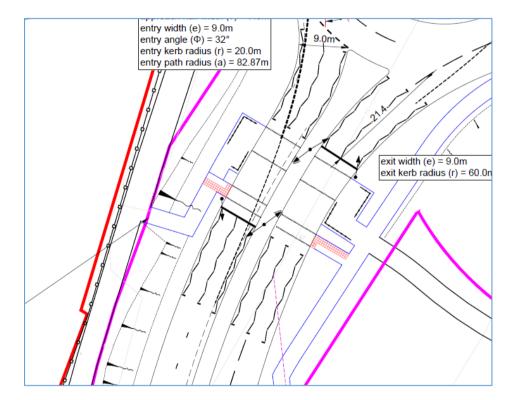
4.1. Additional Observation 1

Between J2 on the M69 and the first internal roundabout it is proposed to install a Pegasus crossing. The crossing is shown as a single stage crossing for all users, with the roundabout to the north shown as only a two-arm junction at this time. The crossing is approximately 18m in length - as part of the detailed design it should be ensured that the crossing timings and on-crossing detection account for slow moving equestrians, especially as the central splitter island is not of sufficient width for equestrian or cyclists to safely wait.

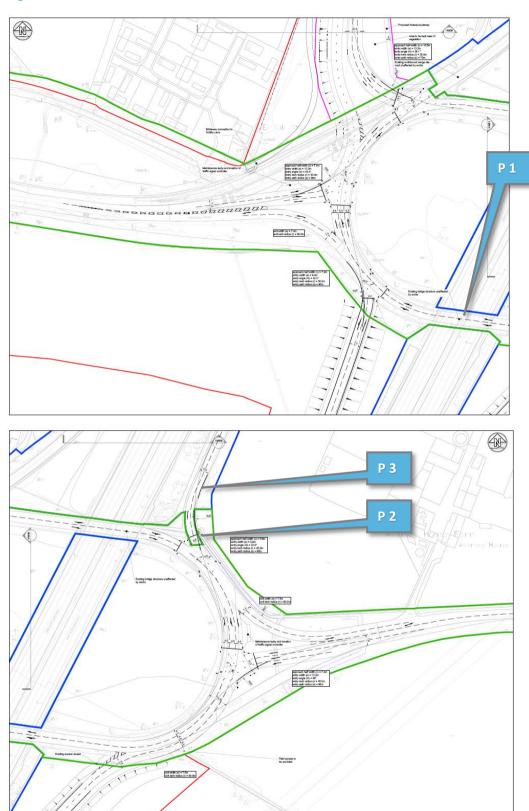
Figure 2 – Problem Location Plan

The location of any problems/observations that have been identified in Section 3 of this report can be seen on the extracts of the drawings supplied to the Audit Team, as listed in Appendix A.
