DESIGN APPROACH DOCUMENT

CENTRAL HUB

Document number 5.5B

MARCH 2026

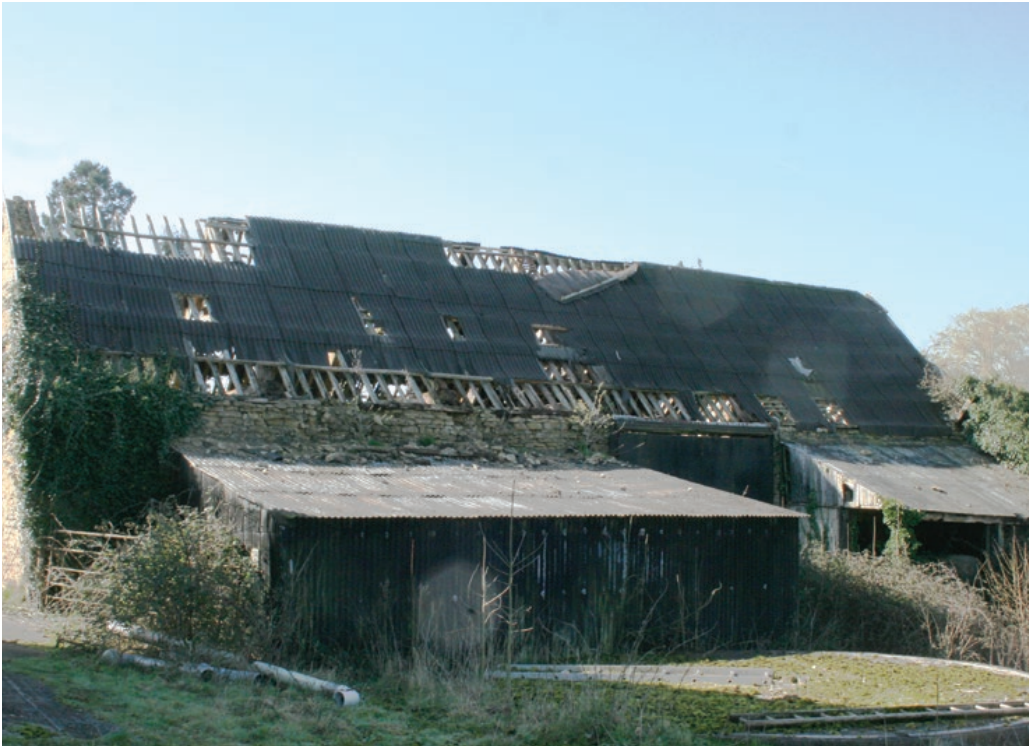
Fig 14. North elevation of Listed Barn building March 2022

- 5.1.1. The listed barn is in a poor state of repair, with 4 of the 6 original bays, and 3 of the original 5 trusses, having collapsed into the barn interior. This also means that the top of the walls are open to weather, further accelerating the decay of these elements.
- 5.1.2. Other issues included the widespread loss of lime mortar pointing, and the loss of stonework from the roof - wall plate areas, as shown in Figure 14 below.
- 5.1.3. DIA were accompanied at this visit by a conservation accredited structural engineer and timber decay specialist, to assess the condition and viability of the remaining timber elements.

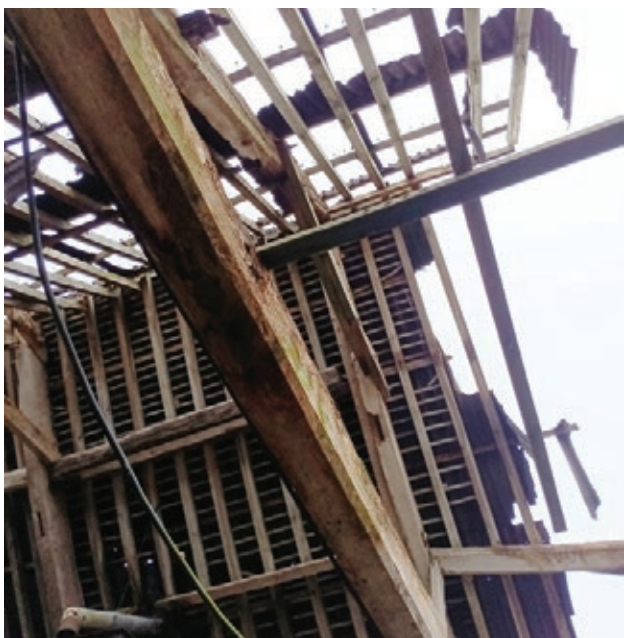
- Failing Primary roof structure, which is at risk of complete loss,
- Damp ingress, both from the top of walls (which are currently open to the elements) and from ground level (where the lack of DPC, and water falling both inside and outside the barn, means the base of walls are currently very damp),
- The external masonry is suffering from a lack of roof, with the inability of the walls to shed moisture resulting in the original soft lime mortar being washed out of joints, which is in turn accelerating the loss of stonework.

Fig 25. Existing Roof, March 2025

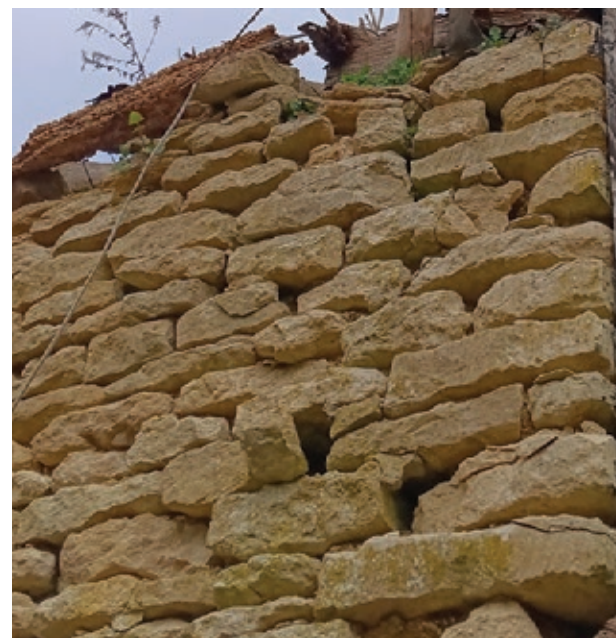
Fig 27. Loose Stonework where mortar has been washed out, March 2025. The stone itself is not generally in bad condition, and can be consolidated and re-used.

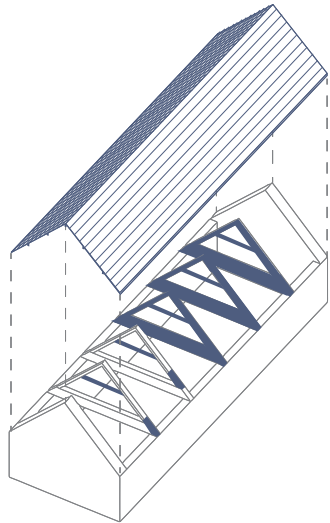
Fig 45. Roof Option 1: Conservation Led Replacement

- 5.11.2. A conservation led approach to the roof is, following exploration by the Structural Engineer and timber decay expert, to repair the two remaining trusses, using material salvaged from the existing materials, and replace the other three missing trusses in a 'like for like' manner, before replacing the roof covering in a small format slate tile. This has the advantage of being 'true' to the current and historic roof form (a key factor of the barn's significance), but the level of damage means the amount of original structural roof timbers and joints able to be retained will be limited.
- 5.11.3. The quantity of new material however are felt to detract from the overall benefits of such a repair approach, so this has been discounted.

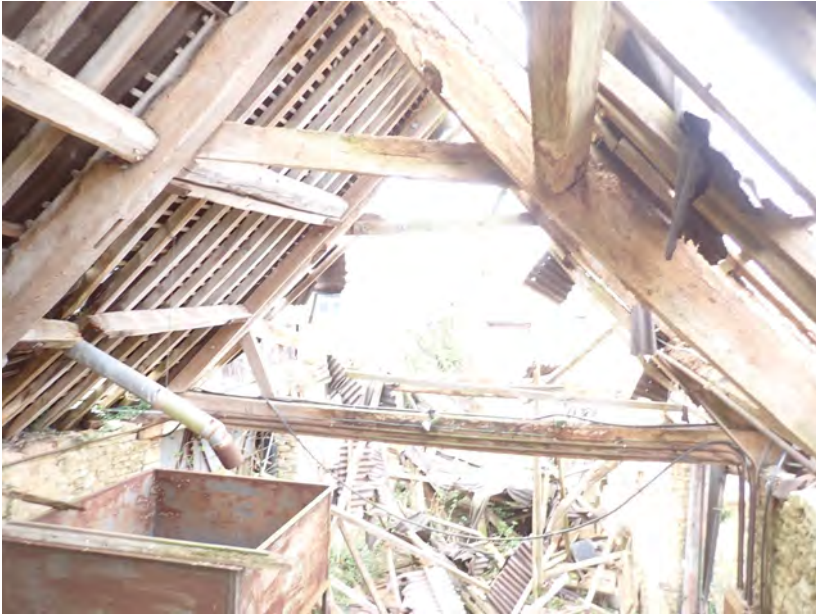
Fig 3:

Bay 1; showing a general view east of the remaining standing 2no. west bays. However, these were subject to severe structural decay issues and themselves deemed highly vulnerable to failure

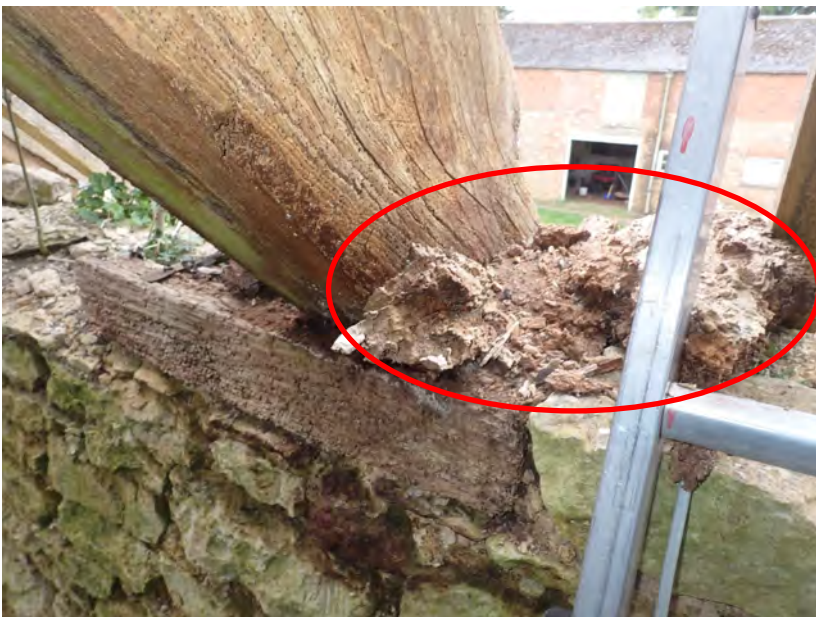
Fig 4:

Bay 1, Truss 1; showing the south bearing end to the principal truss. Note complete structural loss of tie beam bearing end which bore onto the masonry wall head alongside the principal rafter and not jointed directly as conventional. This was the only evidence of this type of truss construction throughout the barn

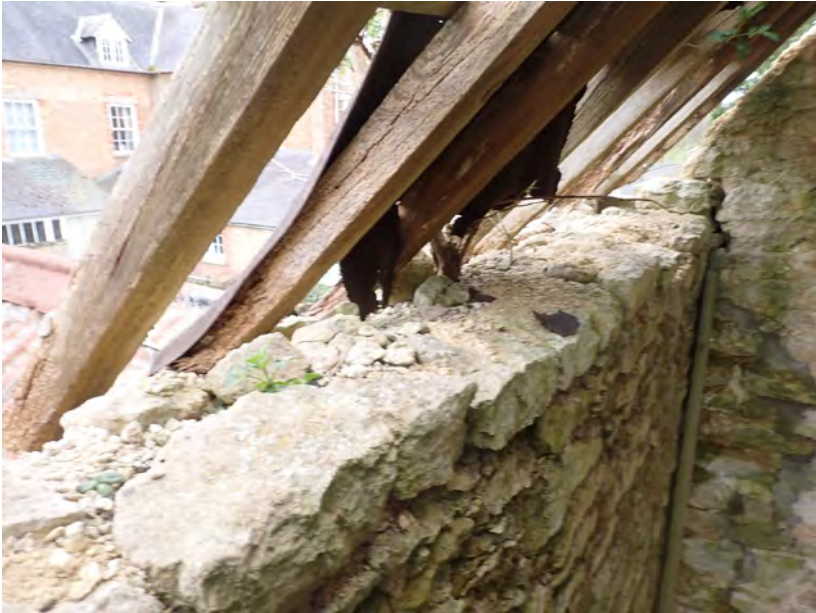
Fig 5:

Bay 1, south eaves; showing a general view to the south eaves subject to total failure of the rafter plate and subsequent collapse/settlement of the rafter ends and wall head

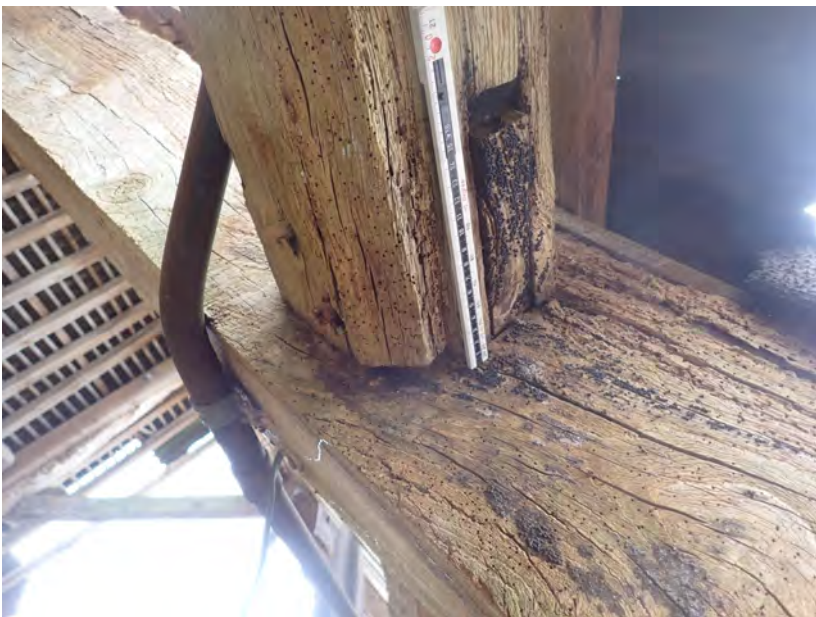
Fig 6:

Bay 1, Truss 1; showing representative detail of the south lower purlin joint to the principal rafter via an inserted slip tenon. Slip tenon structurally decayed

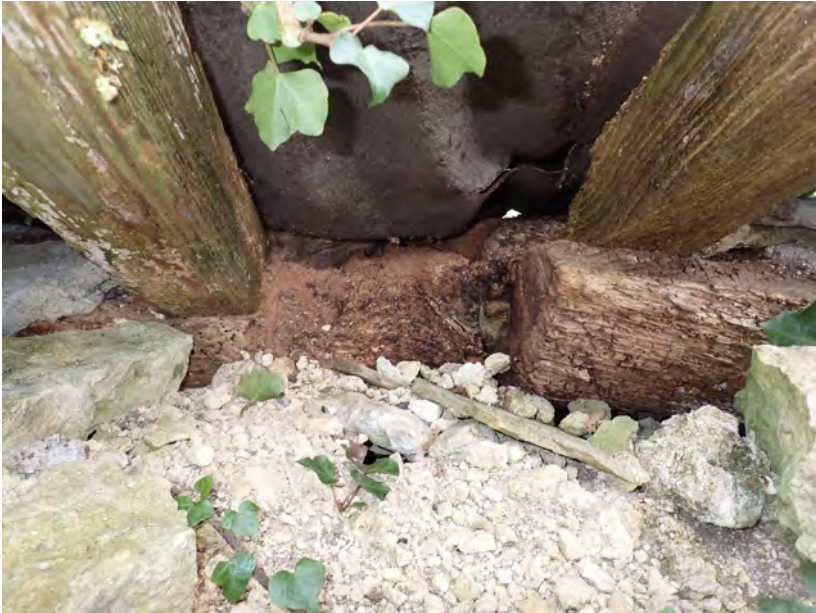
Fig 7:

Bay 2, north eaves; showing representative view to the rafter plate at an historic joint location. Note structural decay identified to the rafter plate for its total remaining length between Bays 1, 2 and 3

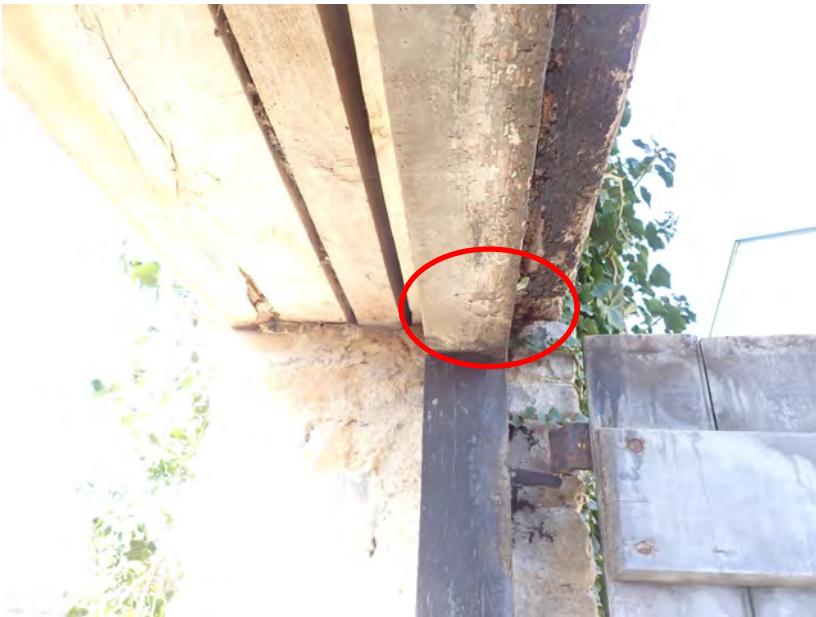
Fig 10:

Bay 6; showing view towards the lintels to the east gable doorway formed of 2no. oak primary external lintels with an inner oak packing lintel. All lintels were deep drilled and moisture probed. Structural decay detected the north bearing end to the outer lintel

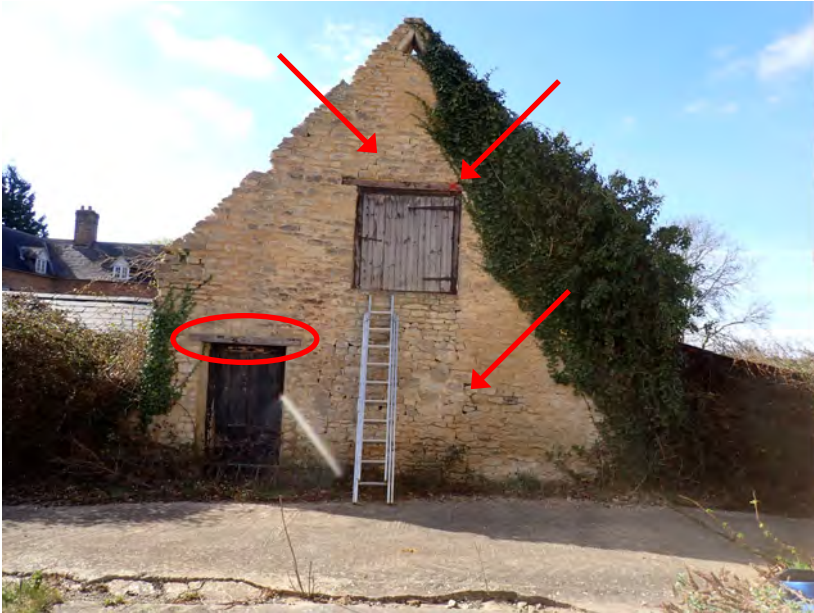
Fig 11:

East gable; showing a general view towards the east gable subject to multiple defects. Including visible structural cracking, decayed external lintel, unstable/exposed wall heads and encroaching invasive ivy growth. Also note that the ground floor lintels were deep drilled and probed. No decay detected, however moisture contents elevated at ~16-19% and species identified as softwood which may not be suitable/robust enough for long term occupancy. Structural Engineer to comment

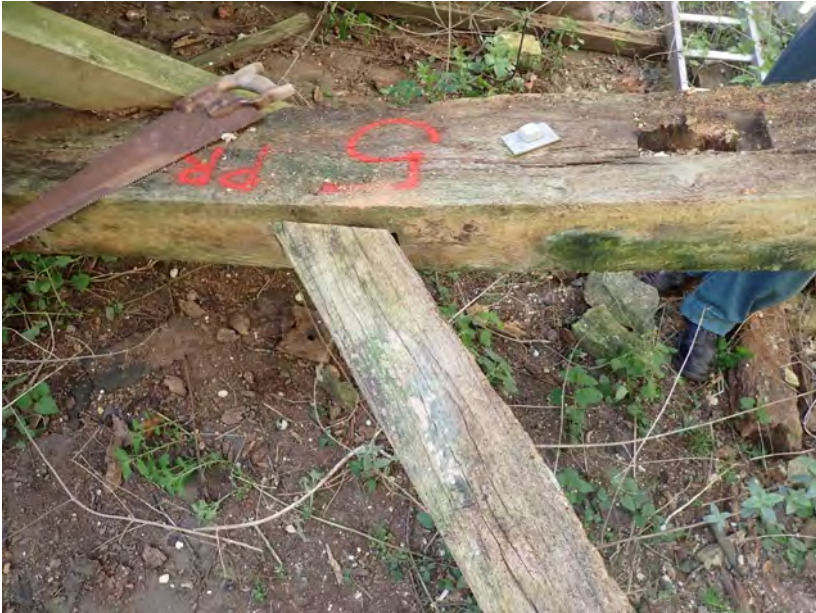
Fig 13:

Bay 6; showing remaining collapsed component identified as the north principal rafter. Item deemed unsuitable for retention/salvage due to excessive decay margins throughout. All primary collapsed roof components identified on-site via red spray paint

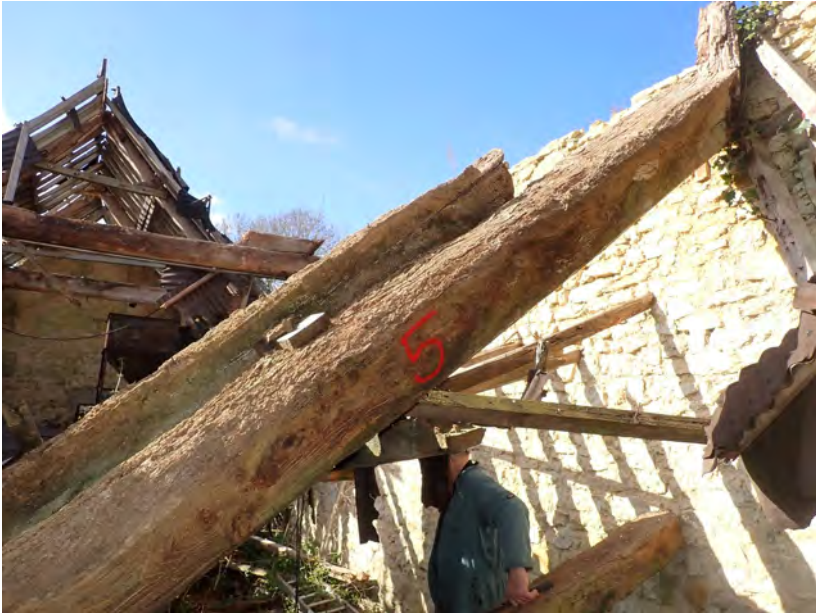
Fig 15:

Bay 6; showing remaining collapsed component identified as principal truss tie beam 5. Item deemed unsuitable for retention/salvage due to excessive decay margins throughout

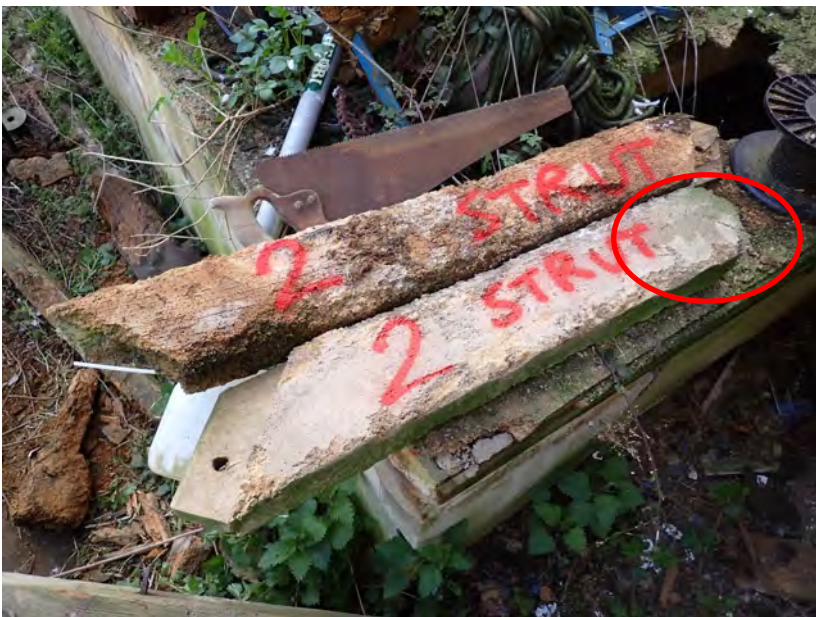
Fig 16:

Bay 2; showing remaining collapsed components identified as truss 2 raking struts. Note that the lower strut in the image might be suitable for retention subject to a suitable scarf repair to its bottom shoulder (indicated via red circle)

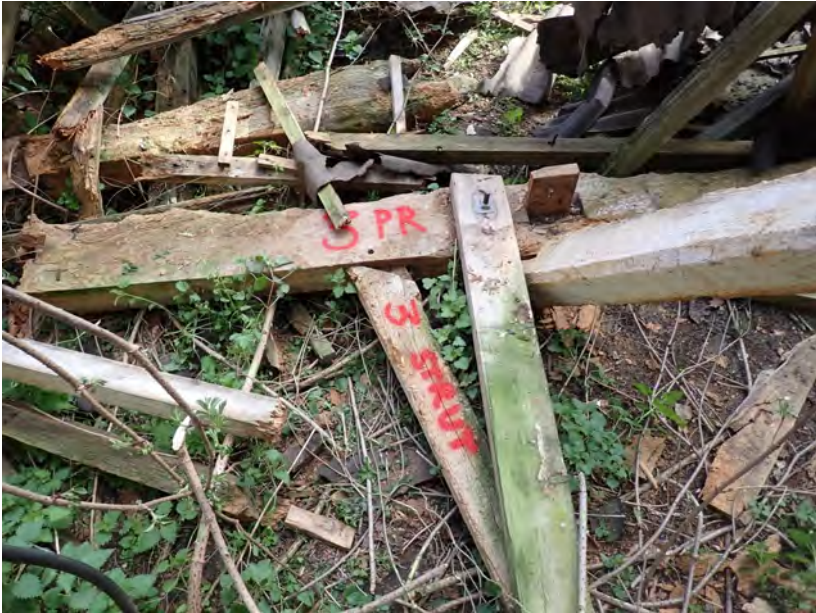
Fig 17:

Bay 3; showing remaining collapsed components identified as the north principal truss rafter and strut to truss 3. Items deemed unsuitable for retention/salvage due to excessive decay margins throughout

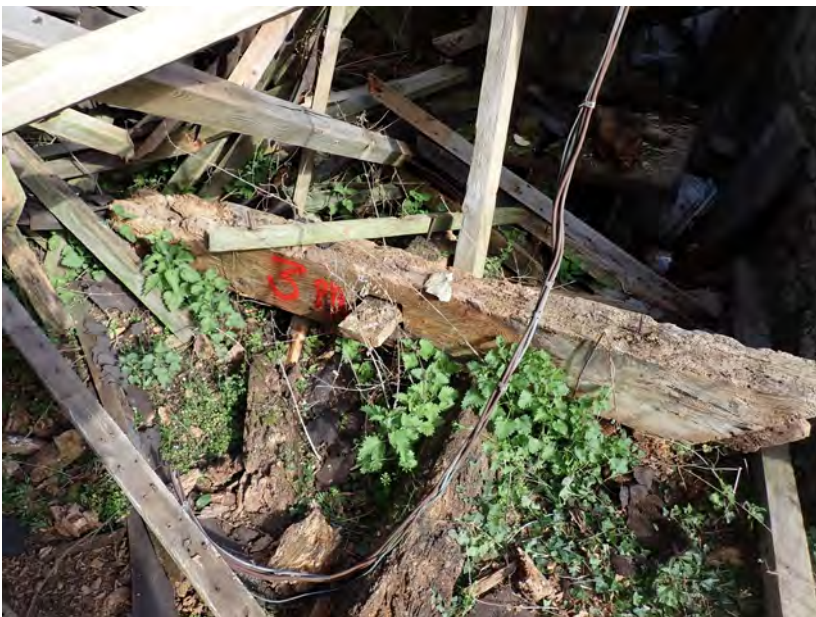
Fig 18:

Bay 3; showing remaining collapsed components identified as the south principal truss rafter. Item deemed unsuitable for retention/salvage due to excessive decay margins/total failure

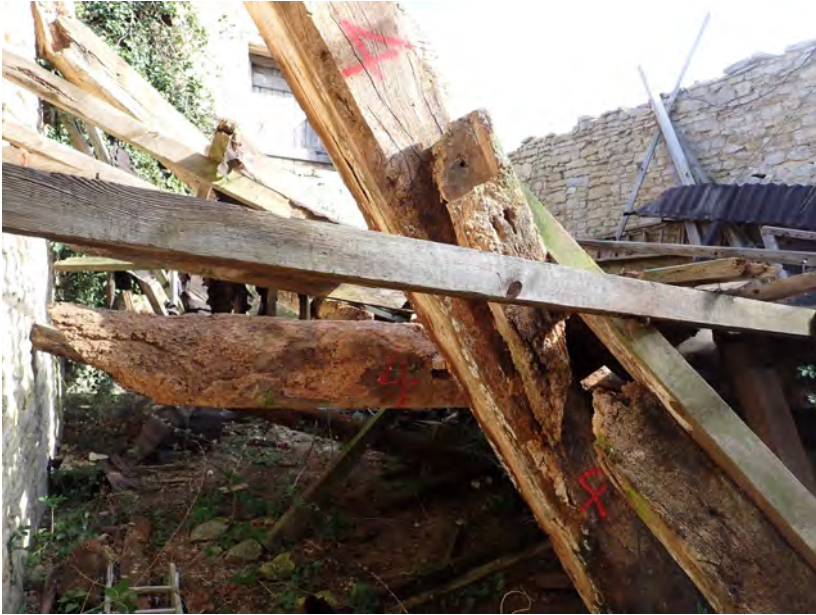
Fig 19:

Bay 4; showing remaining collapsed components identified as the principal tie beam and the north principal truss rafter. Items deemed unsuitable for retention/salvage due to excessive decay margins throughout

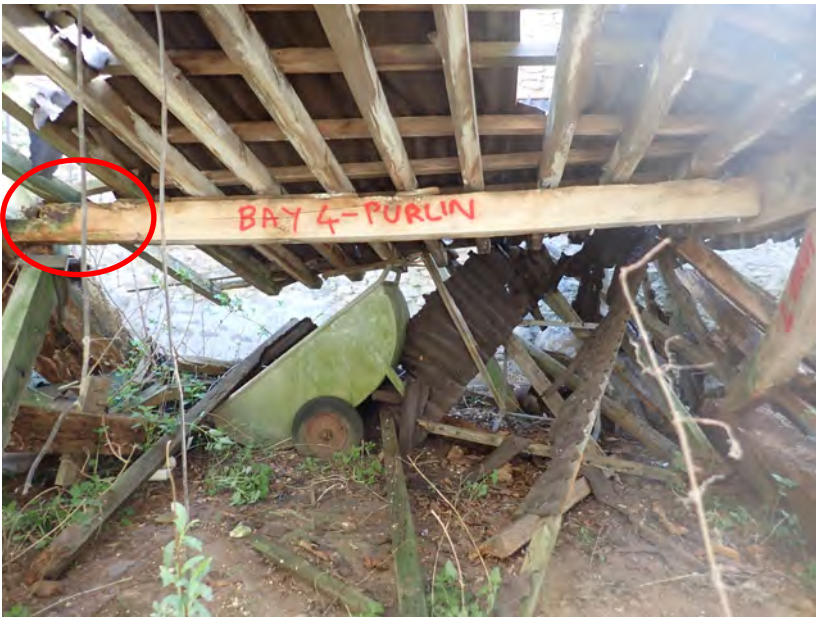
Fig 20:

Bay 4; showing remaining collapsed component identified as the south (lower) purlin. Items deemed suitable for retention/salvage subject to scarf end repairs to receive new slip tenons

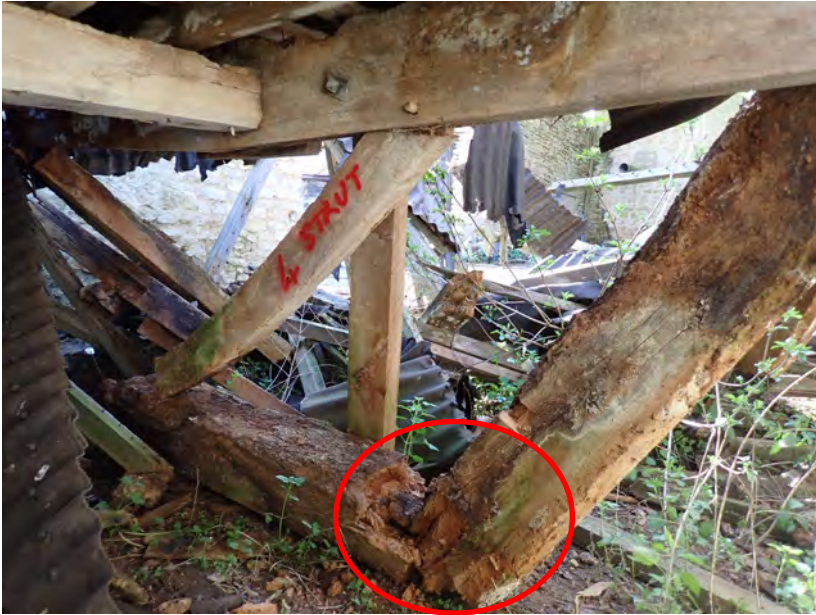
Fig 21:

Bay 4; showing remaining collapsed components identified as the north principal truss elements to truss 4. Note total structural failure of tie beam. Strut potentially suitable for salvage subject to scarf repairs to its bearing ends

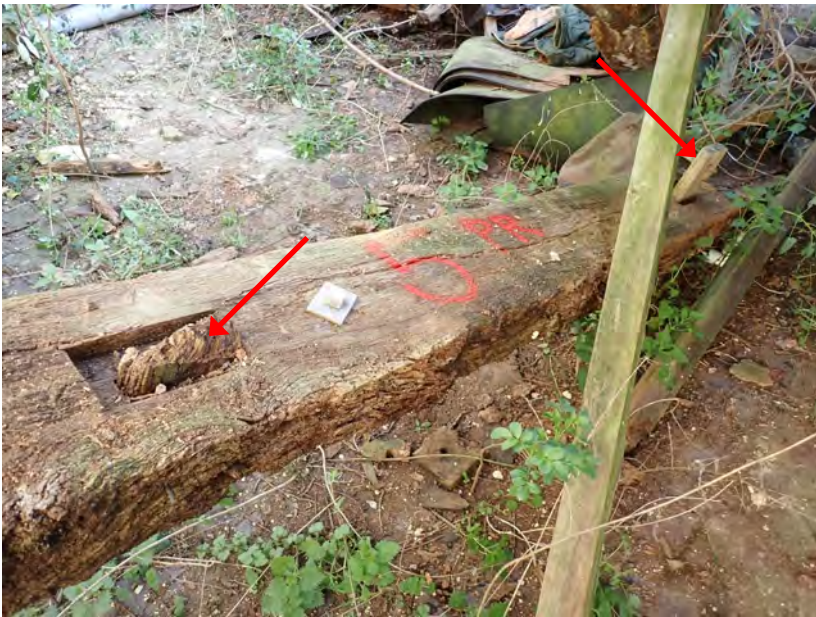
Fig 22:

Bay 5; showing remaining collapsed components identified as the north principal truss rafter. Item deemed unsuitable for retention/salvage. However, note constructional detail of slip tenoned purlin joints with ~1" rebated housings to receive the purlin ends

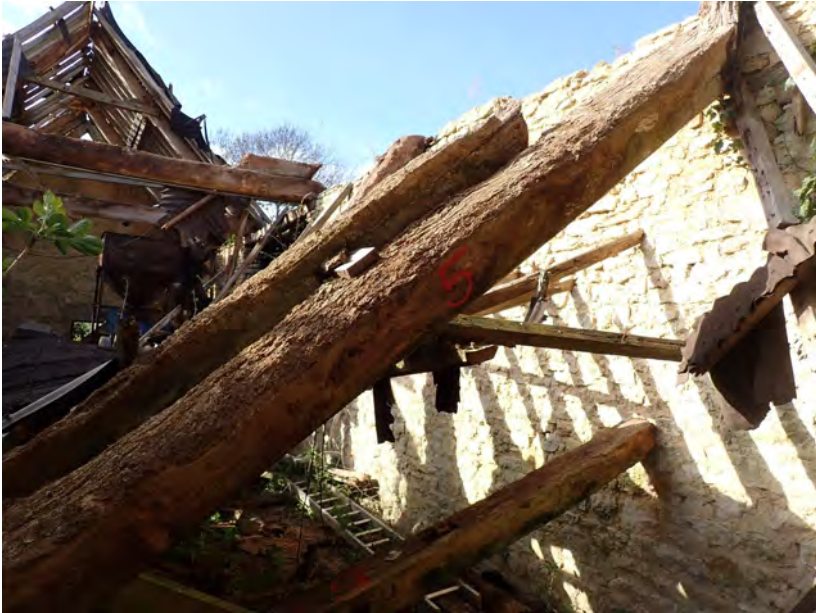
Fig 23:

Bay 6; showing remaining collapsed trusses against the north internal elevation. All timbers remain exposed to wind and rain. Therefore material deemed salvageable at the time of survey are likely to increase proportionality in their respective decay margins unless removed and stored in a suitable environment

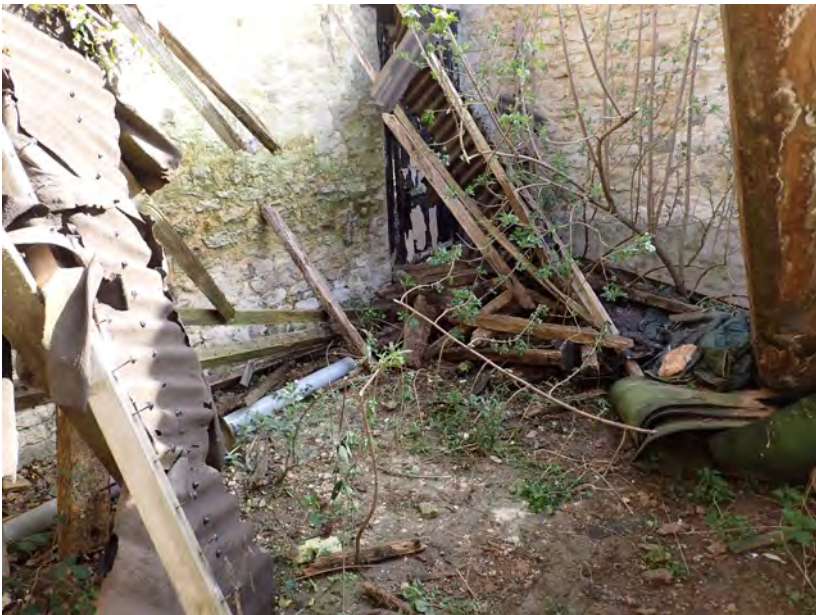
Fig 24:

Bay 6; showing a general view to collapsed members within bay 6 which was understood to have been the initial area of collapse. No timbers identified as suitable for salvage

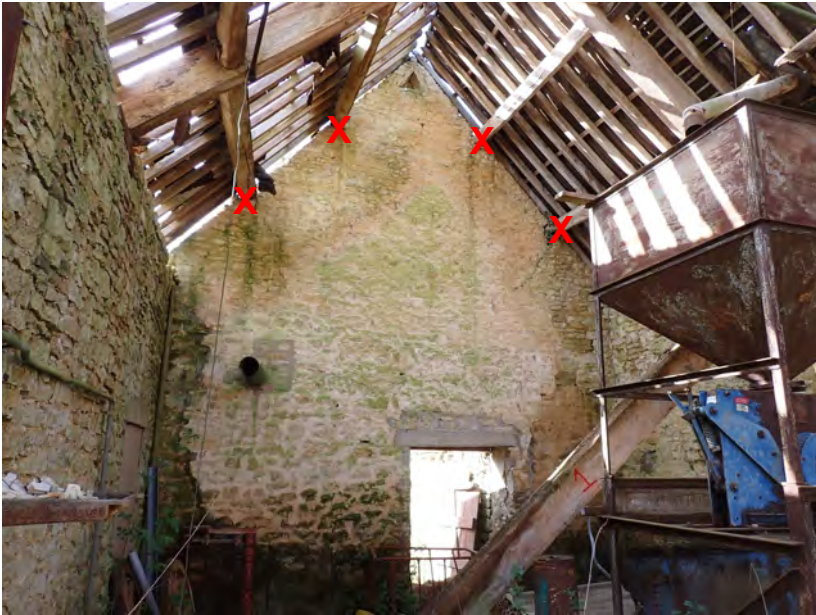
Fig 27:

West gable; showing a general view towards the west gable internal face subject to multiple defects. Including structural decay to all 4no. Remaining historic purlin ends. However, no substantial or structurally significant cracking identified. Ground floor doorway lintel of mixed solid and timber construction (3no. Concrete precast lintels with a inner oak timber packing lintel). Timber lintel deep drilled and moisture probed. No significant decay detected. Timber moisture content stable at ~14 per cent robust enough for long term occupancy. Structural Engineer to comment

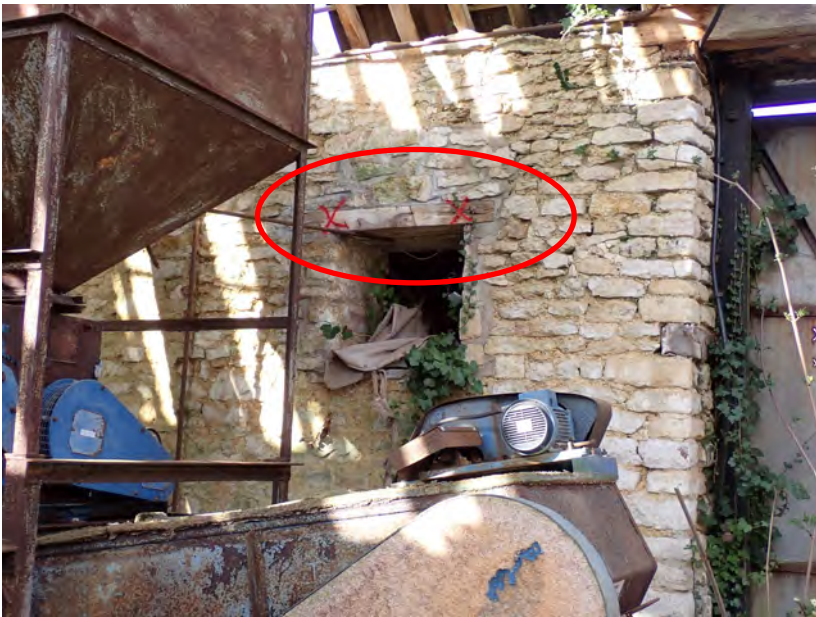
Fig 28:

North elevation, Bay 2; showing structural decay detected to the north façade historic oak lintel

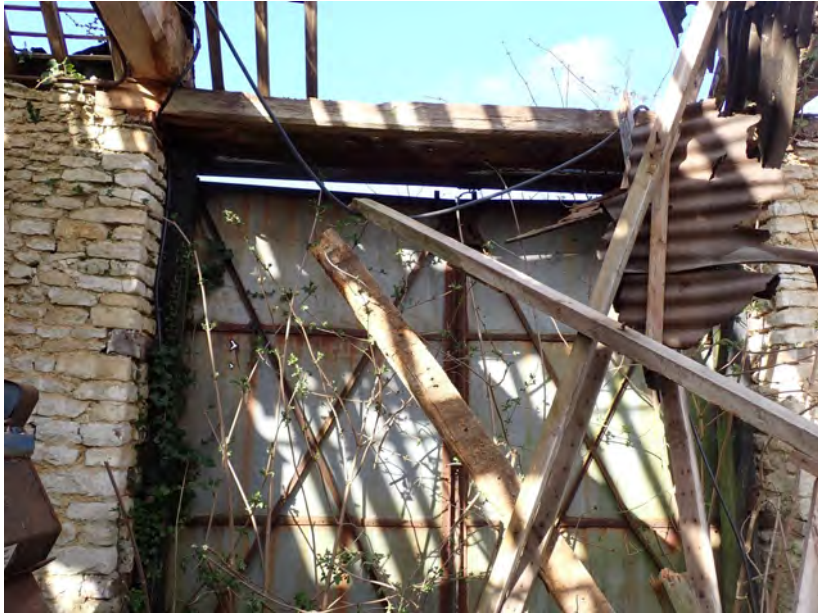
Fig 29:

North elevation, Bay 3; showing structural decay detected to the outermost north bay historic oak lintel. Inner lintel subject to partial decay only. However, deep moisture contents high enough to support the onset of active decay organisms
