**East Midlands Gateway  
Phase 2 (EMG2)**

**Document DCO 6.10C/MCO 6.10C**

# Arboricultural Assessment

## Appendix 10.C ARBORICULTURAL ASSESSMENT

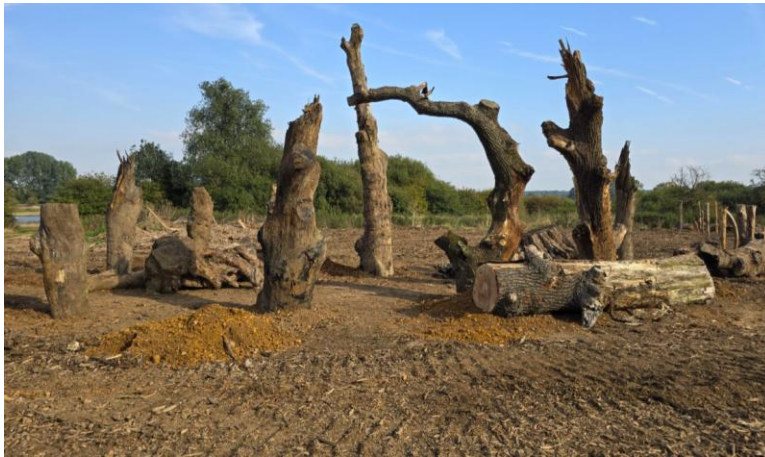
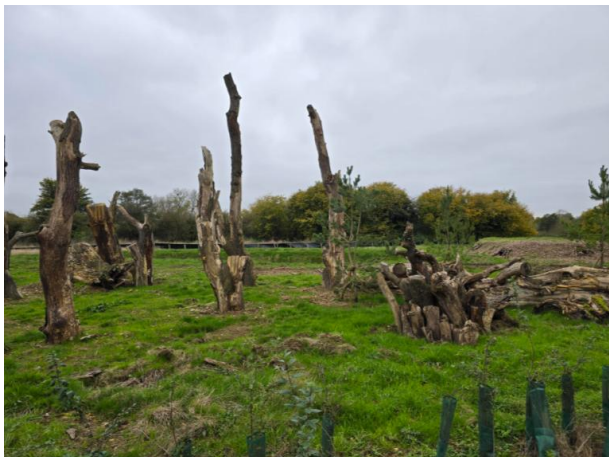
### Photographs 1 & 2: Examples of vertical dead wood habitats
