Wylfa Newydd Project

**6.6.24 ES Volume F - Park and Ride App F9-8
- Dalar Hir: Building 12 Bat Survey 2016**

Dalar Hir: Building 12 Bat Surveys 2016

60PO8062/TER/REP/001 | 1

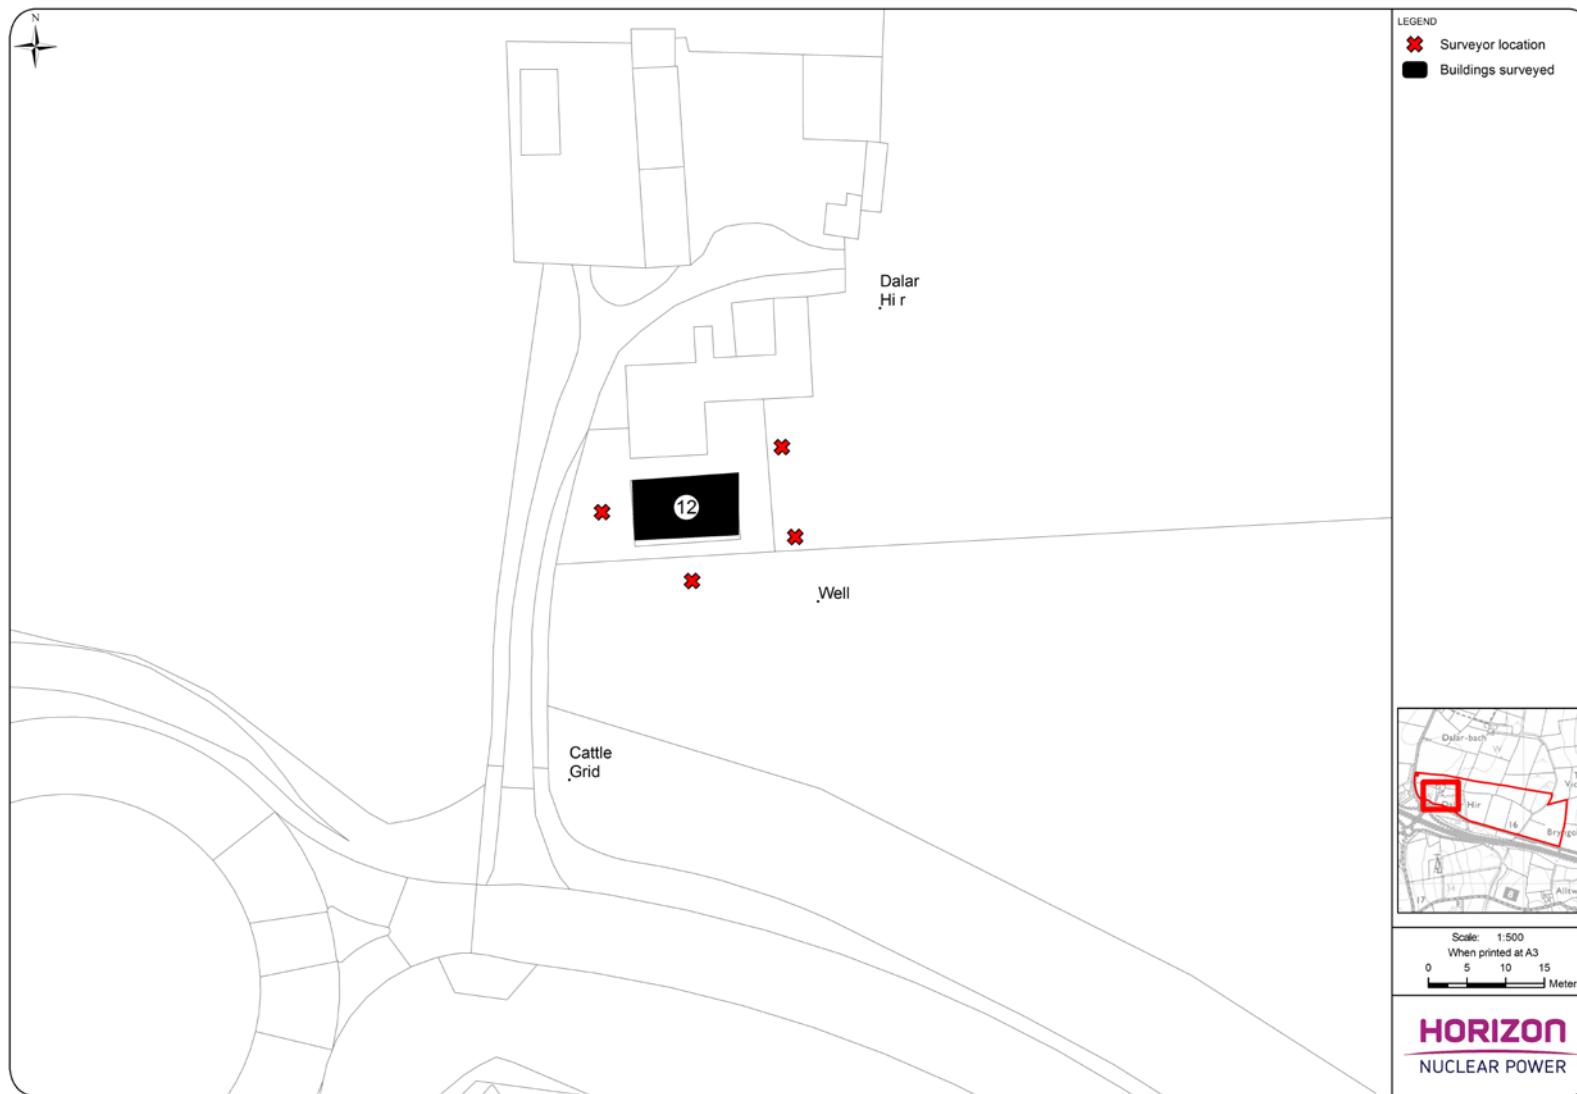
Figure 1: Building 12: Location of surveyors during dusk bat emergence survey

A dusk bat emergence survey of Building 12 was undertaken by four ecologists in accordance with methodologies set out in the Bat Conservation Trust's 'Bat Surveys for Professional Ecologists: Good Practice Guidelines' (Collins, 2016). Surveyors used Elekon Batscanner bat detectors and Anabat Express recorders and were positioned to watch all sides of Building 12 for emerging bats, as shown in Figure 1.

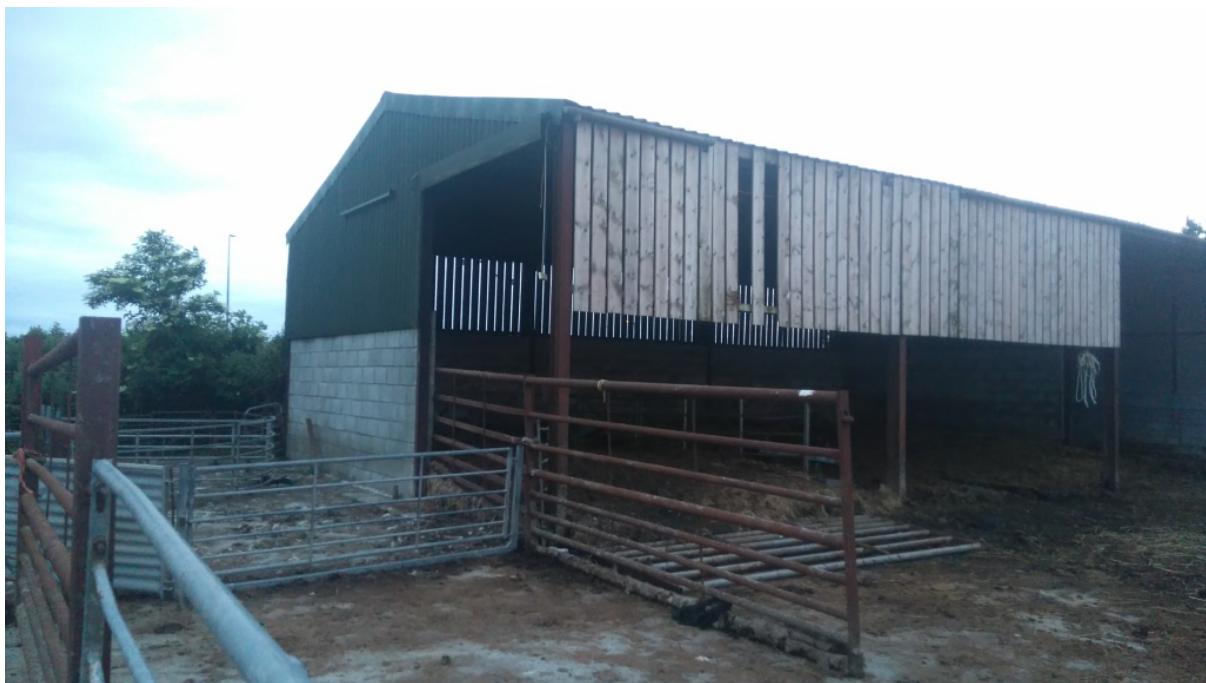
Plate 1: Northern aspect of Building 12

Building 12 was unchanged from its previous condition recorded in 2014 (Jacobs UK Ltd, 2014), and still comprised of an open fronted barn (open to the north) with walls consisting of concrete blocks and wooden planks and a corrugated iron roof as shown in Plate 1. The features identified with the potential to support roosting bats during the 2014 surveys (Jacobs UK Ltd, 2014) were also unchanged. These included gaps behind wooden rafters and where gaps were present on the gable ends between the crimped metal roof and walls. As such, Building 12 still has low potential to support roosting bats.

No evidence of bats was recorded during the internal inspection.
