Norfolk Vanguard Offshore Wind Farm

Appendix 20.3

Geomorphological Walkover Survey

Applicant: Norfolk Vanguard Limited
Document Reference: 6.2.20.3
RHDHV Reference: PB4476-005-0203
Pursuant to: APFP Regulation 5(2)(a)

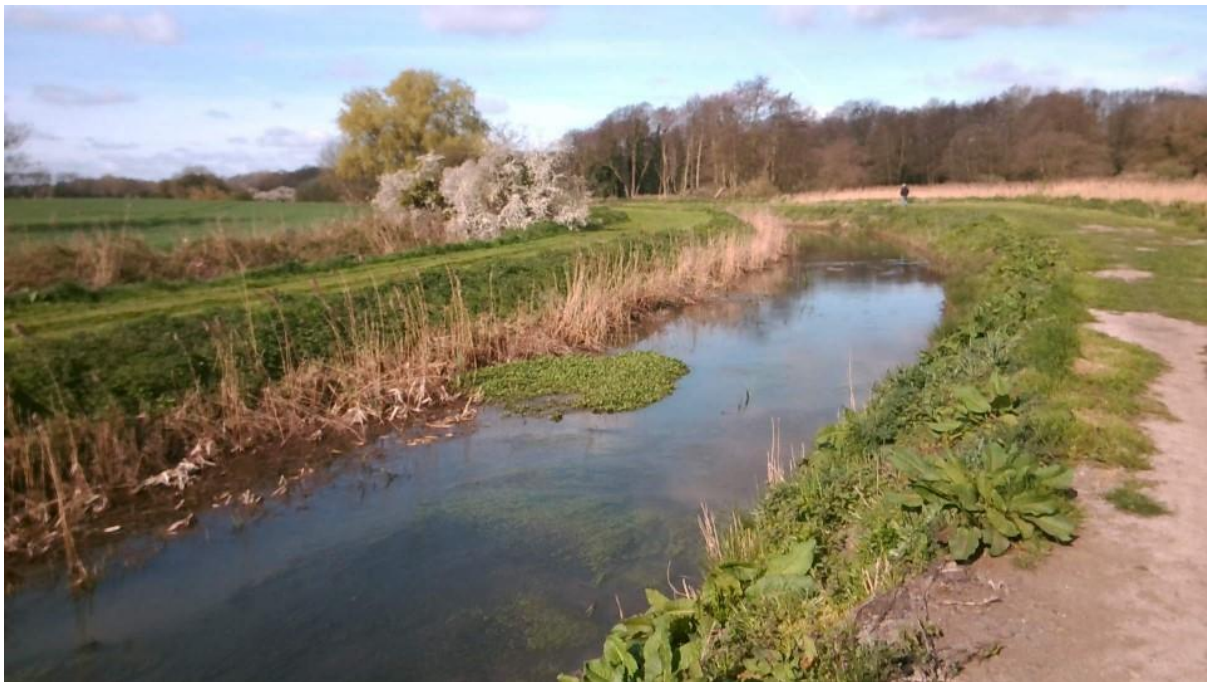
Plate 20.1 North Walsham and Dilham Canal

7. The North Walsham and Dilham Canal is an extensively modified watercourse with a straight planform and uniformly graded banks. The channel is dominated by low energy glide flows and appears to support very little geomorphological diversity (Plate 20.1). The canal was formerly known as the River Ant.

8. The channel has a straight, uniform planform. The banks are steeply graded, approximately 1.5 to 2m high, stable and well vegetated throughout the reach. The channel is approximately 5m wide at the bank base and 7m wide at the bank top.
9. The substrate is dominated by sands and silts. There were no visible bedforms or signs of erosion in the main canal, although siltation was evident in the channel margins and in the lee of emergent vegetation.
10. The main channel is punctuated by an earth dam at the downstream end of the reach (although the channel continues as a reed-filled remnant channel). Flow from the main canal is diverted via a pipe into the drain located immediately to the left, which markedly increases flows in this drain. The discharge from the main channel

enters the side drain perpendicular to the flow, which has resulted in a localised area of scour immediately opposite the outfall.

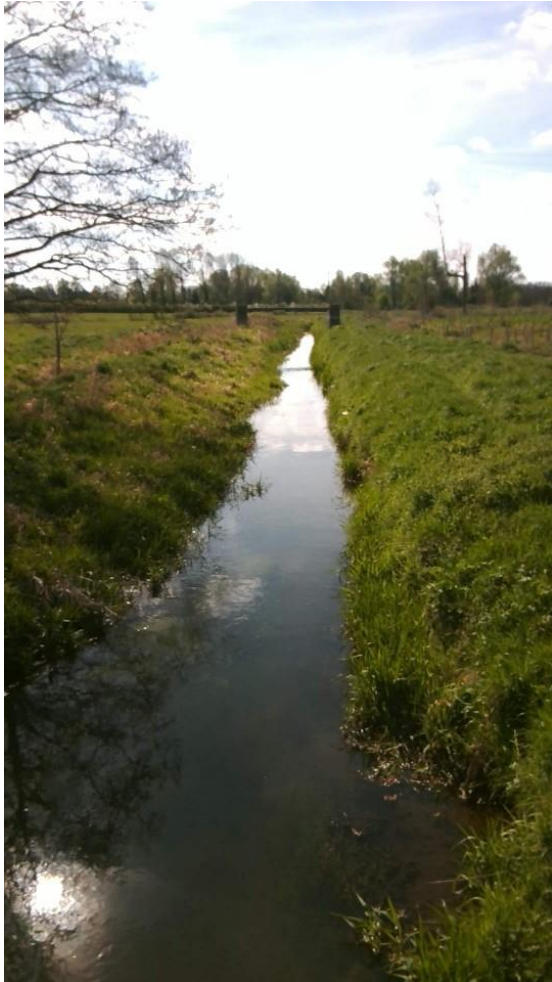
Plate 20.2 King's Beck (main channel)

15. King's Beck is a uniform, incised channel that has been artificially straightened and resectioned (Plate 20.2). The channel is dominated by glide flows and there is extensive in-channel vegetation growth. In addition to the main channel, there are several connected channels that have similar characteristics (Plate 20.3). These are largely artificial, although some reaches may represent a resectioned historical course of the watercourse.

17. The substrate was largely obscured by in-channel vegetation growth, although where visible appear to be dominated by silts and fine sands. There are extensive deposits of fine sediment at the toe of each bank, supporting thick vegetation growth. The channel has cut through the marginal deposits, maintaining a narrow meandering path free of encroaching sediment and vegetation along the thalweg¹.

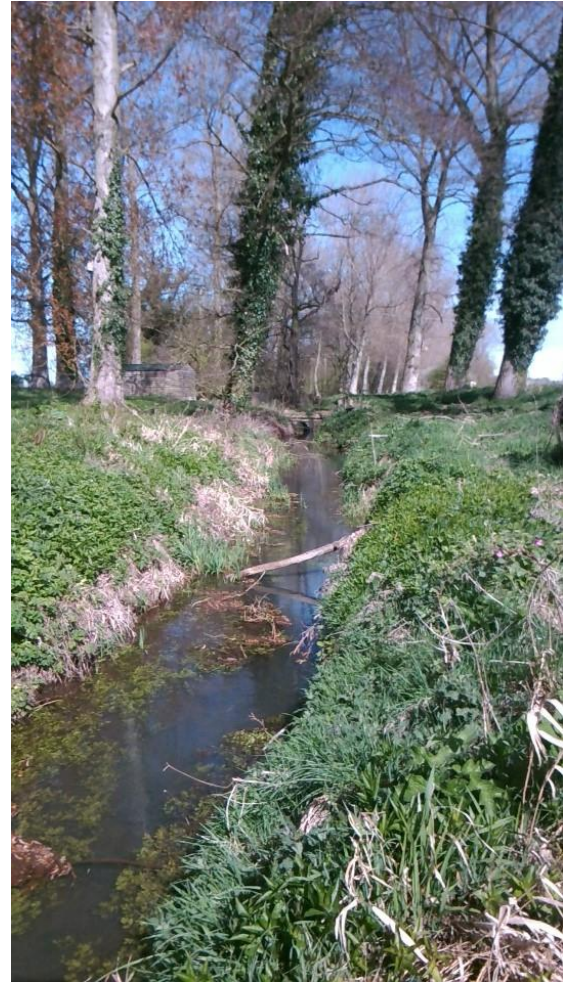
Plate 20.3 Channel adjacent to King's Beck

18. In addition to the main channel, there are several other watercourses that run parallel and are connected with the King's Beck. These channels have similar characteristics to King's Beck, with uniform banks, glide flows and a pronounced thalweg visible within the bank line. The bed of the channel on the right (eastern) side of the beck appears to be slightly lower than the main river and other adjacent channels in this reach (Plate 20.3). This watercourse diverges from King's Beck downstream of Beck Farm, flowing further east along a more sinuous course before re-joining the main river upstream of Aylsham Road. This may represent a historical course of the main King's Beck.

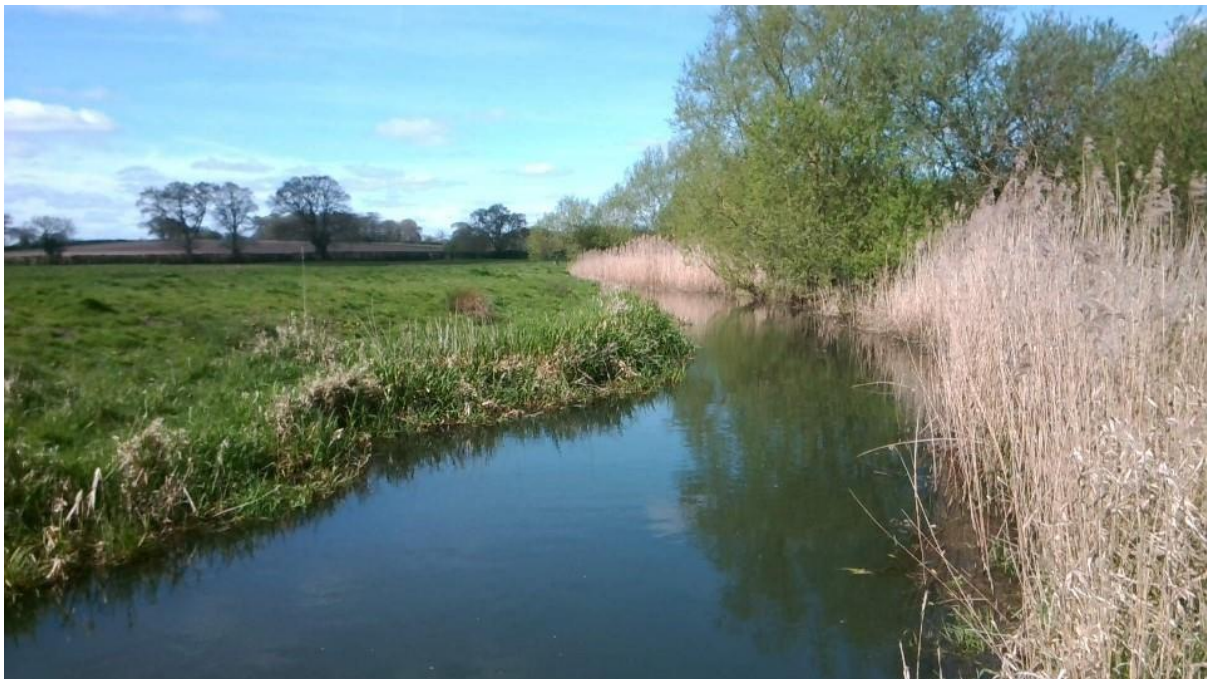
Plate 20.4 River Bure

22. The River Bure is a moderately sinuous watercourse that has been historically resectioned and enlarged (Plate 20.4). The channel has largely uniform banks and flow conditions are dominated by uniform glides. Evidence of lateral accretion (in the form of low berms within the resectioned bank line) suggests that the channel is naturally recovering from historical modifications.

25. Low level floodplain units (berms or inset benches) were apparent throughout the reach, most notably (but not exclusively) on the right bank. These features have formed inside the wider bank line, and are likely to be representative of channel narrowing by lateral accretion. This suggests that channel has been historically enlarged but is now readjusting naturally. This is supported by the uniformly graded banks and localised straightening within the larger-scale meandering planform.

26. Although there was no evidence of erosion at the time of the survey, evidence of cattle poaching was observed in parts of the left bank that lacked the low-level berms.

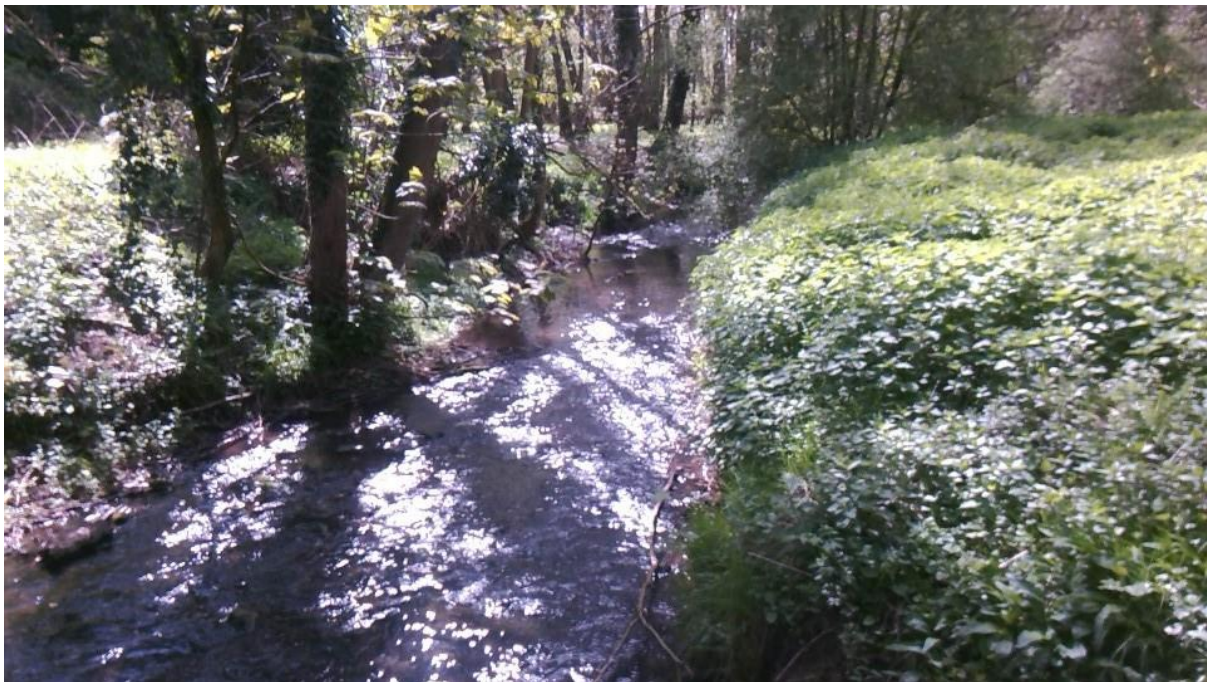
Plate 20.5 Blackwater Drain

30. The Blackwater Drain (also known as the Booton Watercourse at this point) is a narrow, meandering channel that supports a range of different flow types and geomorphological habitat niches (Plate 20.5). Exposed tree roots in the bed indicate that the channel has recently incised.

31. The channel is approximately 3m wide and follows a gently meandering course. The banks are steep, stable and well vegetated. The channel supports a range of habitat niches, including exposed gravel bars, shallow riffles and deeper pools. The substrate is dominated by gravels with occasional cobbles, with silt deposition occurring in the margins and slower flowing areas.
32. Exposed tree roots in the survey reach, particularly downstream of the proposed cable crossing, suggest that the watercourse is currently incising or has done so recently.

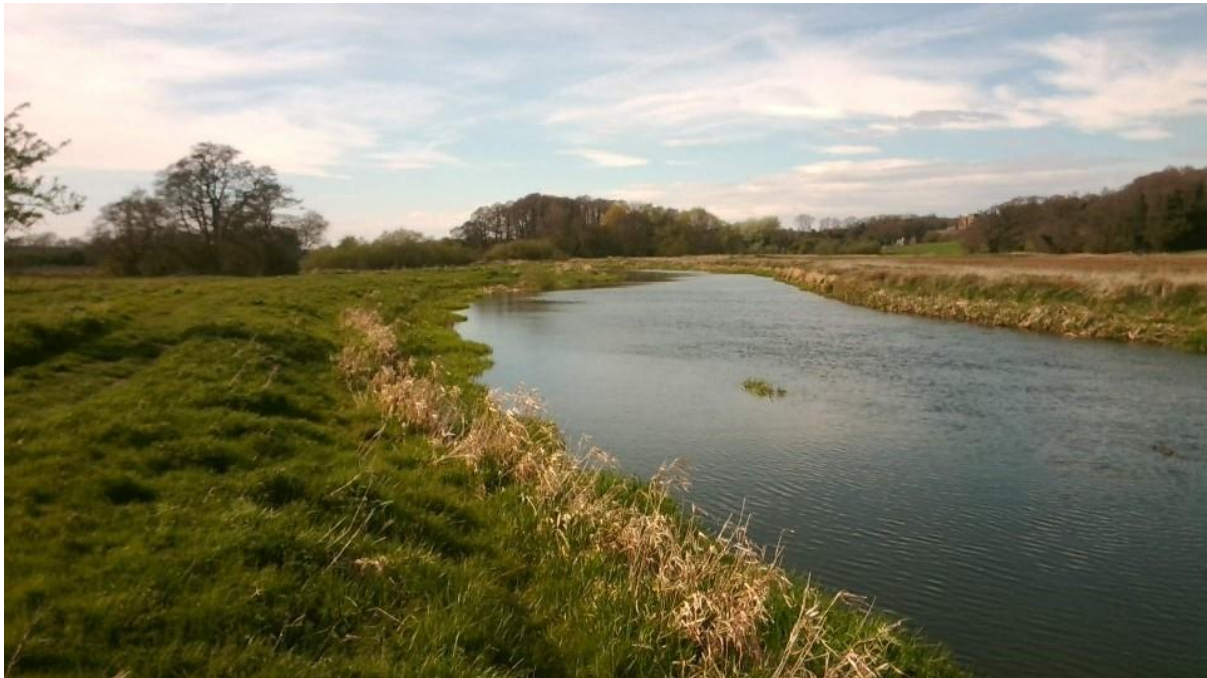
Plate 20.6 River Wensum (upstream end of cable corridor)

36. The River Wensum is a gently meandering chalk river, with a wide, deep channel and very shallow banks (Plate 20.6 and Plate 20.7). Flows are dominated by uniform, low energy glides, and siltation appears to be the dominant geomorphological process. The channel is fringed by low embankments which may reduce floodplain connectivity but are likely to be frequently overtopped.

40. Although deposition is the dominant process in this reach, an area of bank scour and collapse was observed on the right bank at the upstream limit of the proposed cable corridor. This is likely to be a response to the growth of trees and reeds on the opposite side of the channel, which pushes flows towards the right bank.

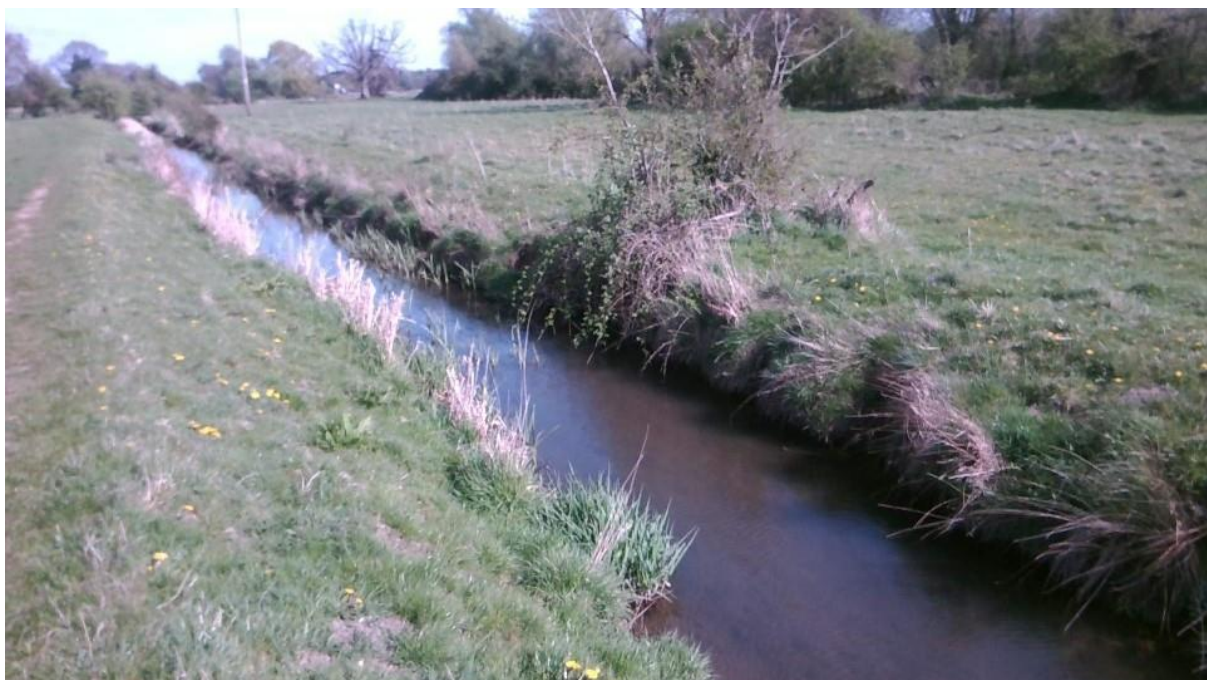
Plate 20.8 Penny Spot Beck

47. The onshore cable corridor also crosses Penny Spot Beck, a tributary of the River Wensum that joins the main river approximately 30m downstream of the outer limit of the corridor (Plate 20.8).

48. The narrow, straight channel is characterised by steep, uniform banks and shallow, low energy glide flows. There is significant impoundment along parts of the reach, as a result of fallen trees or culverts beneath earth bank crossings.
49. Siltation is the dominant geomorphological process along much of the channel, with the natural coarse gravel bed largely obscured by thick deposits of silt. However, flow is sufficiently swift in several isolated steeper reaches that are also free from impoundment to maintain a clean gravel substrate.
50. A large proportion of the channel within the proposed cable corridor is affected by cattle poaching, resulting in localised bank collapse and an extensive supply of fine sediment. The water is highly turbid along the entire reach.

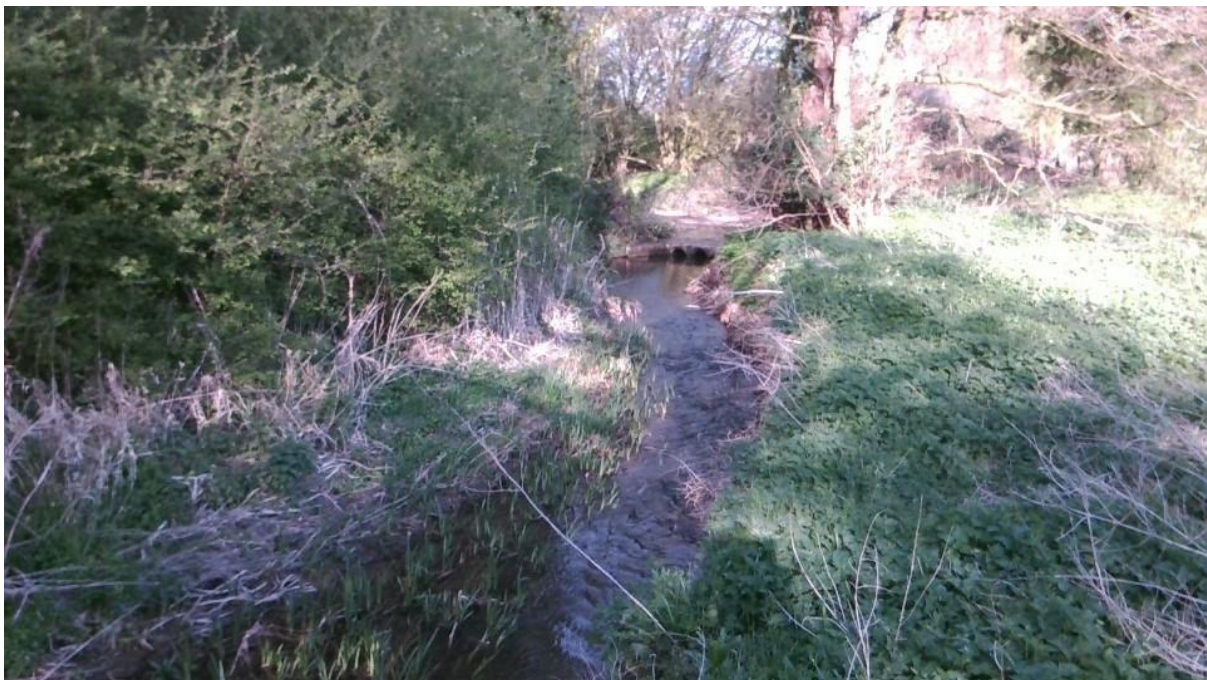
Plate 20.9 Wendling Beck (Bushy Common reach)

51. Wendling Beck is a gently meandering chalk river that has been historically straightened (Plate 20.9). The channel is shallow, with steep, low banks and swift flows. These maintain the natural coarse substrate along the majority of the reach, although there is evidence of fine sedimentation along the channel margins and upstream of a twin pipe culvert.

53. The banks are steep and very low (<0.5m high). Although they are largely well vegetated, there is some evidence of localised toe scour, and exposed tree roots on the right bank indicate that the channel has migrated by at least 0.3m.
54. The channel flows through twin pipe culverts beneath the road at the downstream end of the onshore cable corridor.
55. The substrate is dominated by coarse gravels, although there is evidence of fine sedimentation in the channel margins. The proportion of silts increases upstream of the culverts, which reduce energy sufficiently to promote enhanced deposition.

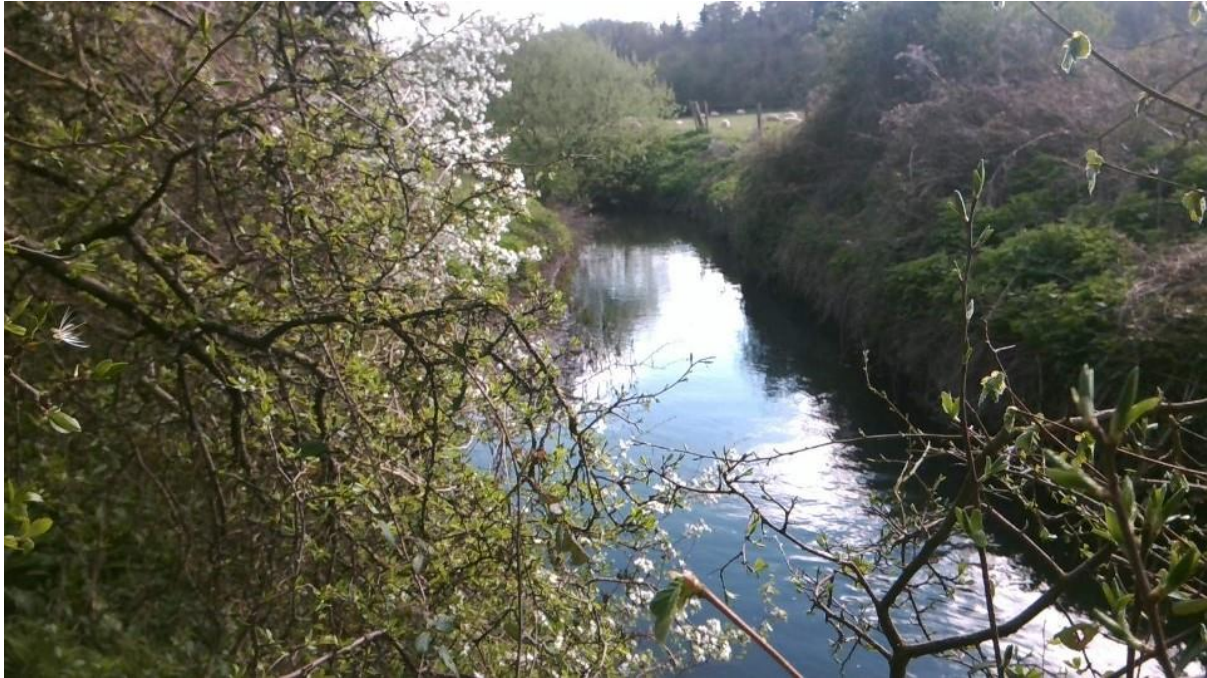
Plate 20.10 Wendling Beck (Old Brigg reach)

59. Wendling Beck is a gently meandering channel with low energy glide flows and extensive siltation which obscures the coarse substrate that would typically be associated with chalk rivers (section 20.3.6). The deep, narrow channel has steep banks, and much of the watercourse is likely to have been historically resectioned (Plate 20.10).

61. The channel is narrow (approximately 4m wide) and incised. The banks are vertical or steeply graded, and frequently obscured by extensive vegetation growth. The substrate is dominated by silts, which overlie the natural coarse bed observed further upstream (see section 20.3.6). The steep banks and straightened nature of the channel at sub-reach scale suggest that the beck has been historically resectioned and potentially dredged.
