Dogger Bank South Offshore Wind Farms

**Appendix 18-5 Bats Report - Ground Level Tree
Assessment (Revision 3) (Clean)**

Ground Level Tree Assessment 2023

Dogger Bank South (DBS) Offshore Wind Farms

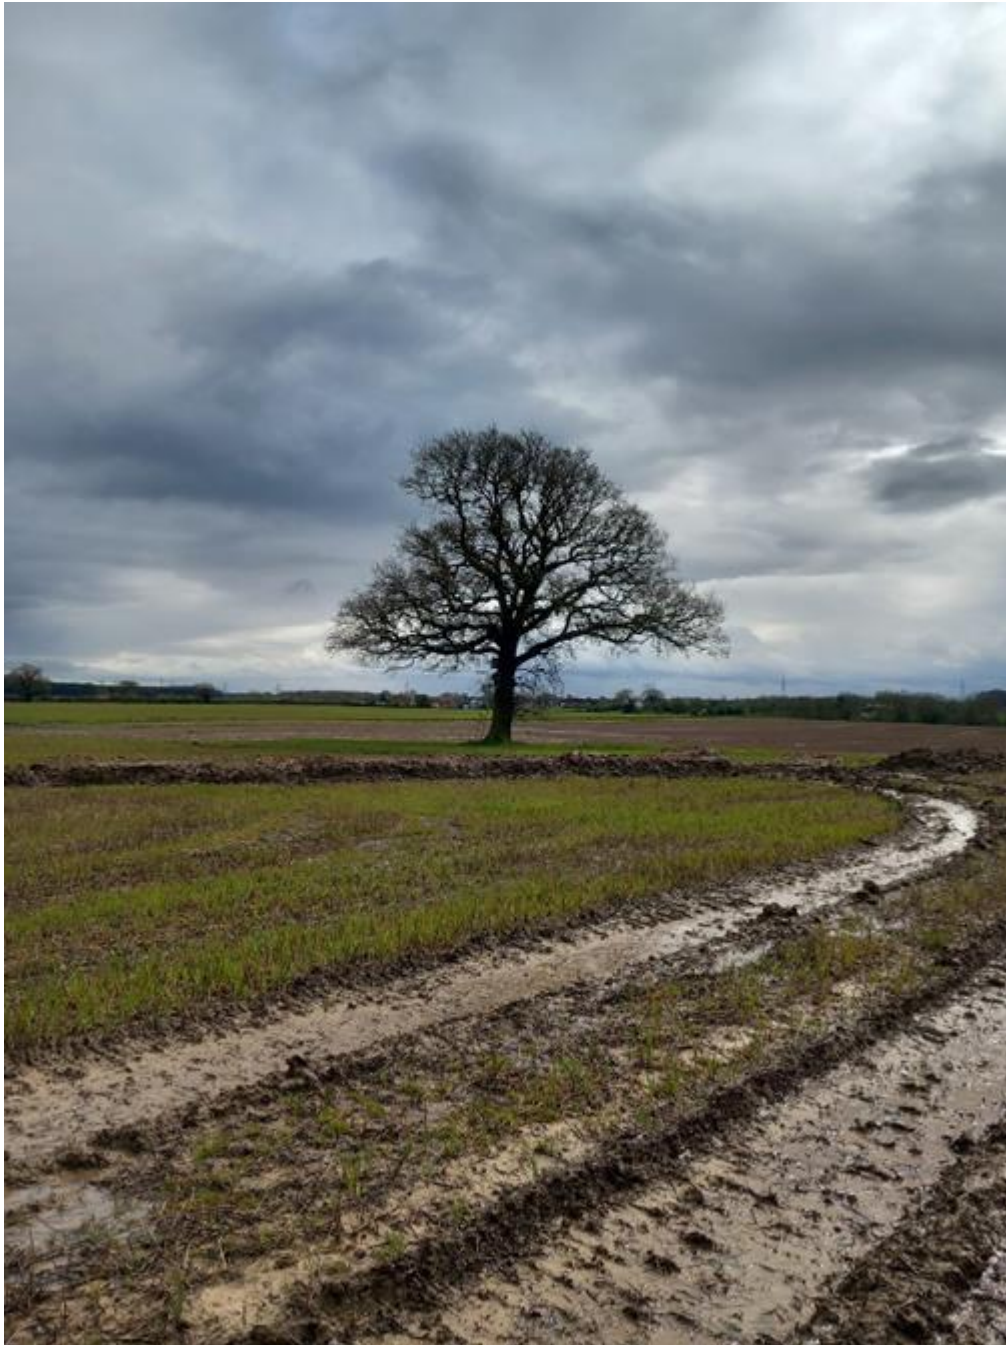
Plate 1 Tree To21 located within the DBS Onshore Substation Zone that will require further assessment

Tree reference	Species	TCI Assessment	Overall Assessment	Survey recommendation
To21	Pedunculate oak <i>Quercus robur</i>	Not surveyed in November 2024	FAR (added to scope)	Three close inspection aerial surveys between May - September, with at least two undertaken in the period May – August. If features are inaccessible via ladder, climbing or MEWP, emergence surveys with NVA's may need to be considered ^a
To26	Pedunculate oak <i>Quercus robur</i>	08/11/2024	FAR Parts of tree were unsafe to climb	Three separate dusk Survey visits ^{b*}
To38	Pedunculate oak <i>Quercus robur</i>	08/11/2024	FAR Deemed unsafe to climb	Three separate dusk Survey visits ^{b*}
To75	Ash <i>Fraxinus excelsior</i>	08/11/2024	FAR (Barn owl roost present)	Three separate dusk Survey visits ^{b*}
To76	Ash <i>Fraxinus excelsior</i>	08/11/2024	FAR Deemed unsafe to climb (Ash dieback)	Three separate dusk Survey visits ^{b*}
G31.2	Ash <i>Fraxinus excelsior</i>	11/11/2024	FAR Unsafe limb to access	Three separate dusk Survey visits ^{b*}
