# BOTLEY WEST SOLAR FARM

## Veteran & Ancient Tree Survey

Veteran Tree Survey –  
Botley West  
V3

May 2025

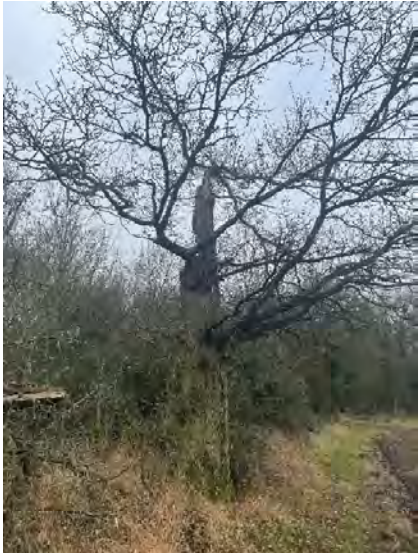
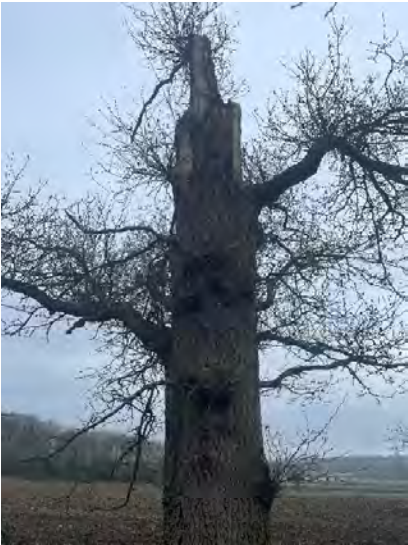
| Crown spread (m) | | | | | | | | | | | | | | | | | Tree Typology |
|---|---|---|---|---|---|---|---|---|---|---|---|---|---|---|---|---|---|
| T1 | <i>Quercus robur</i> - Pedunculate Oak | 5.0 | 2.0 | 4.0 | 4.0 | 6.0 | 1100 | 1 | 2.00 | N/A | V | Fair | Field border | Decay loss, whole stem. Evidence of hollow entirety. Complete leader loss at 5m. Brown rot core. Vigorous nonetheless | 40+ | A3 | Field |

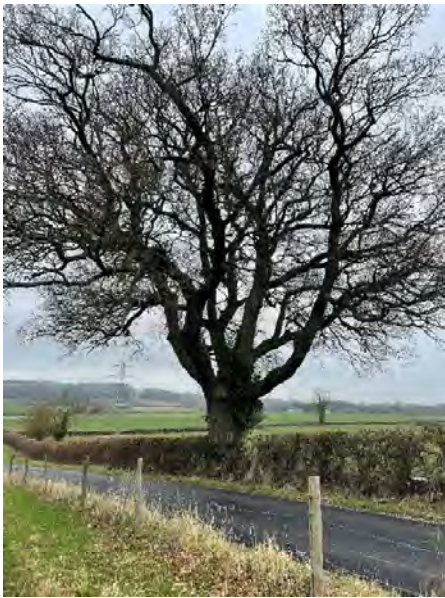
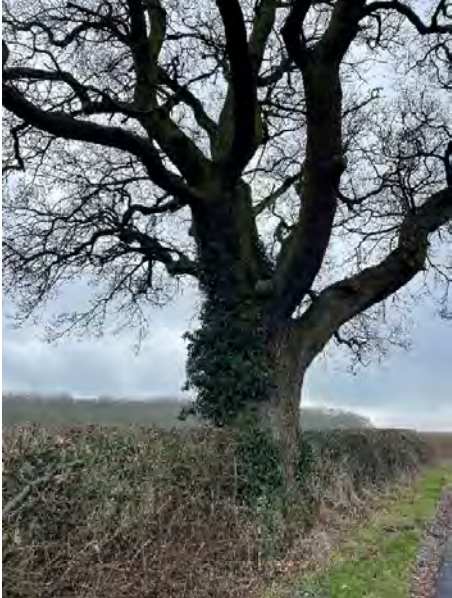
| Crown spread (m) | | | | | | | | | | | | | | | | | Tree Typology |
|---|---|---|---|---|---|---|---|---|---|---|---|---|---|---|---|---|---|
| T3 | Quercus robur - Pedunculate Oak | 16.0 | 12.0 | 12.0 | 10.0 | 10.0 | 1500 | 1 | 3.00 | - | V | Good | Hedgerow | Fine hedgerow oak, former pollard, huge bole, ivy in places, attached deadwood – up to 20cm diameter. Various decay stubs. | 40+ | A2/3 | Hedgerow |

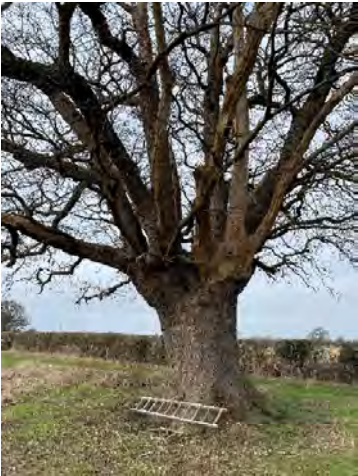
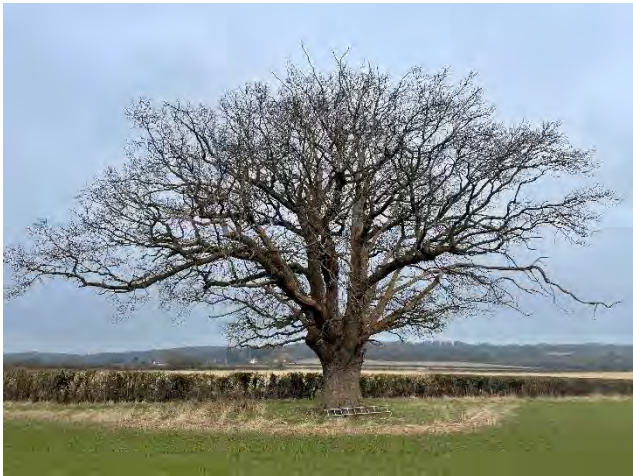
| Crown spread (m) | | | | | | | | | | | | | | | | | Tree Typology |
|---|---|---|---|---|---|---|---|---|---|---|---|---|---|---|---|---|---|
| T4 | <i>Quercus robur</i> - Pedunculate Oak | 12.0 | 13.0 | 11.0 | 12.0 | 12.0 | 1700 | 1 | 2.00 | - | V | Fair | Field | Superb, former pollard, major decline/decay. Decayed hollow pocket at roof flare, Attached and hung deadwood greater than 30cm diameter. Pollard head circa 3m diameter | 30+ | A2/3 | Field |

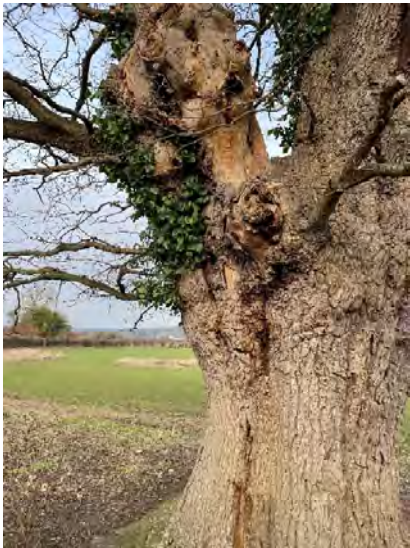
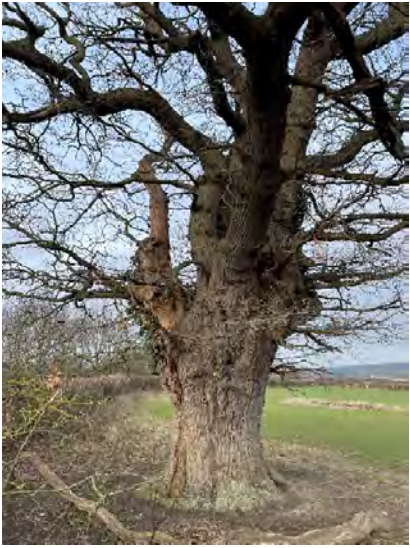
| Crown spread (m) | | | | | | | | | | | | | | | | | | Tree Typology |
|---|---|---|---|---|---|---|---|---|---|---|---|---|---|---|---|---|---|---|
| T5 | Quercus robur - Pedunculate Oak | 13.0 | 8.0 | 10.0 | 9.0 | 9.0 | 1400 | 1 | 2.00 | - | V | Fair/good | Field | Superb, former pollard. Pollard head circa 2.5m diameter. Major decay to west, evident to root flare. Dry saddle at pollard head, ivy and fluted buttress. | 40+ | A3 | Field | |

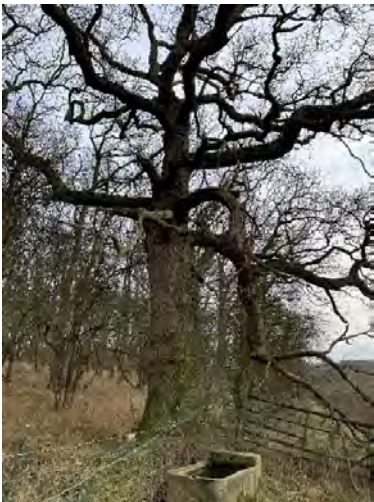
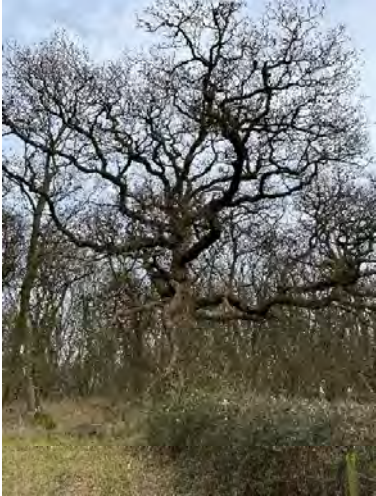
| Crown spread (m) | | | | | | | | | | | | | | | | | | Tree Typology |
|---|---|---|---|---|---|---|---|---|---|---|---|---|---|---|---|---|---|---|
| T6 | <i>Quercus robur</i> - Pedunculate Oak | - | 12.0 | 12.0 | 14.0 | 10.0 | 1300 | 1 | 3.00 | NW | V | Good | Woodland | Fine, maiden oak on edge of sloping copse. Huge main bole to 8m. Major snags and storm damage attached/ Various stubs and deadwood. | 40+ | A2/3 | Woodland | |

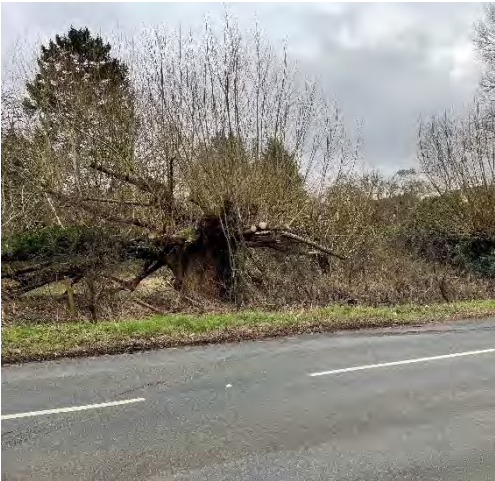
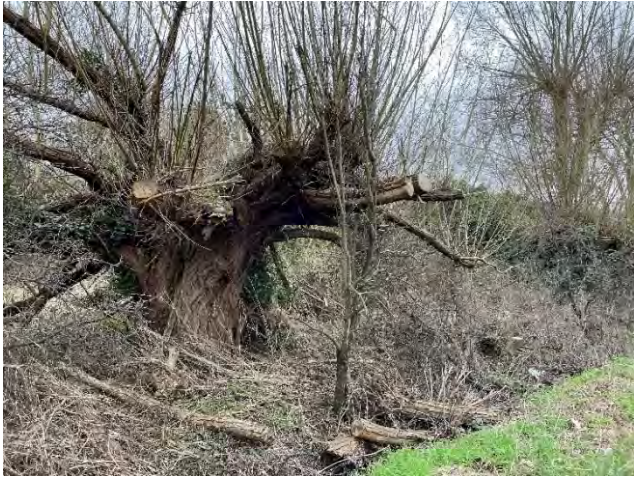
| Crown spread (m) | | | | | | | | | | | | | | | | | Tree Typology |
|---|---|---|---|---|---|---|---|---|---|---|---|---|---|---|---|---|---|
| T7 x2 | <i>Salix x fragilis</i> – Crack Willow | 5.0 | 8.0 | 3.0 | 3.0 | 3.0 | 1200 | 1 | 1.00 | E | V | Fair/Poor | Specimen | Pair of close, low pollard. Major decay. Lapsed bough. Repollarded recently. Various hollows, decay forks, mosses, ivy and habitat features. | 10+ | A3 | Specimen |
