Rosefield Solar Farm

Environmental Statement

Volume 4
Appendix 11.1: Preliminary Risk
Assessment (Part 1)

EN010158/APP/6.4
September 2025
Rosefield Energyfarm Limited

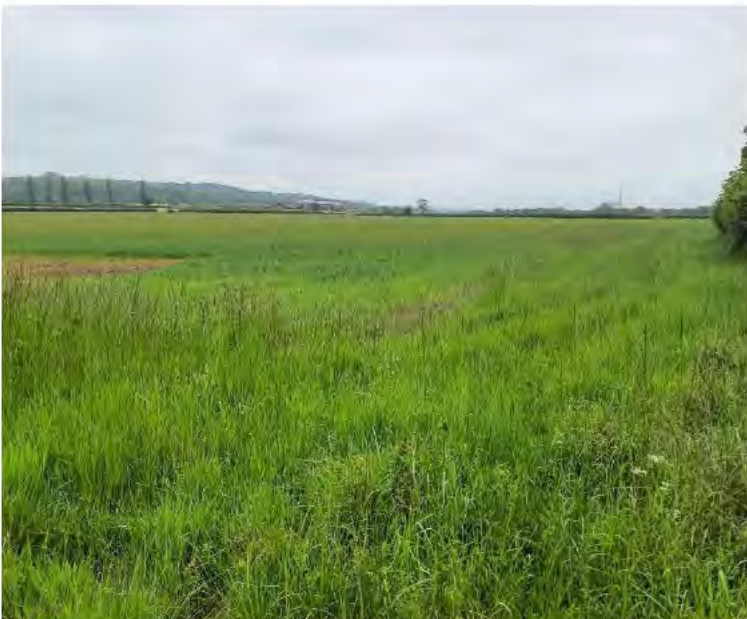
<p>Photo No. 41 Date 21/05/2024 13:21:00</p> <p>Description Below ground water tank in SW corner of B19</p> <p>Co-ordinates 51.910309435;-0.976261053</p>	 
<p>Photo No. 42 Date 21/05/2024 13:21:00</p> <p>Description B19</p> <p>Co-ordinates 51.909047905;-0.973110576</p>

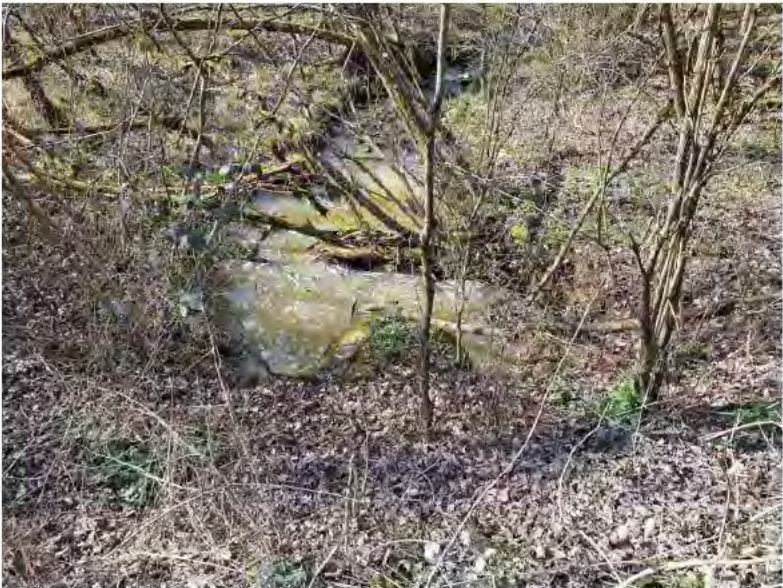
<p>Photo No. 74 Date 26/03/2025</p> <p>Description Brook running beneath the road the access track will use</p> <p>Co-ordinates 51° 54' 10.565" N 0° 57' 51.859" W</p>
