# **WHITESTONE SOLAR FARM**

## **Volume 6: Environmental Statement**

### **6.20 Appendix 6.4.1: River Condition Assessment**

Application Document ref. EN0110020/APP/6.20

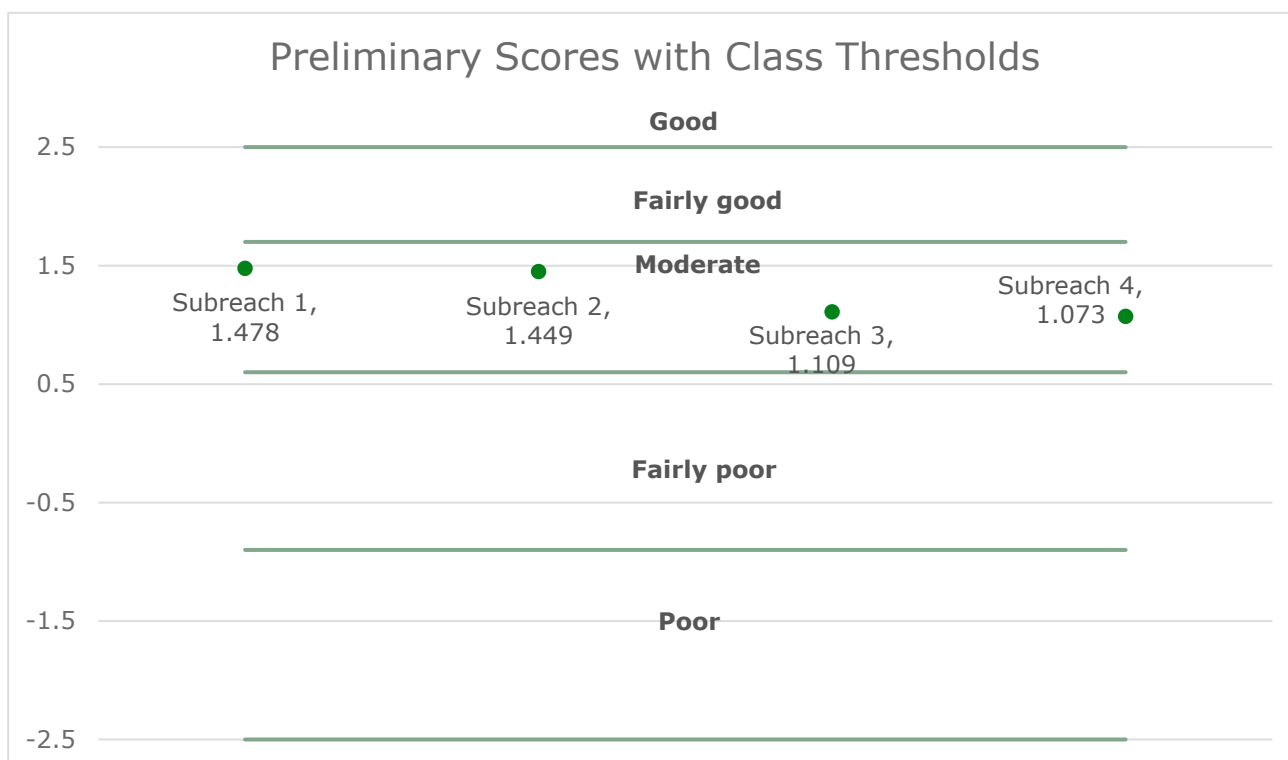
**Plate 6.4.1 Preliminary Condition Scores for Firsby Brook and the Condition Class Thresholds for River Type I**

| Subreach Number | Grid Reference | Preliminary Condition Score | Final Condition Class | Watercourse Encroachment | Riparian Encroachment |
|---|---|---|---|---|---|
| 4 | SK 49962 95416 | 1.109 | Fairly good | No encroachment | No encroachment /no encroachment |
| 5 | SK 49732 95589 | 1.073 | Moderate | No encroachment | Major/moderate |

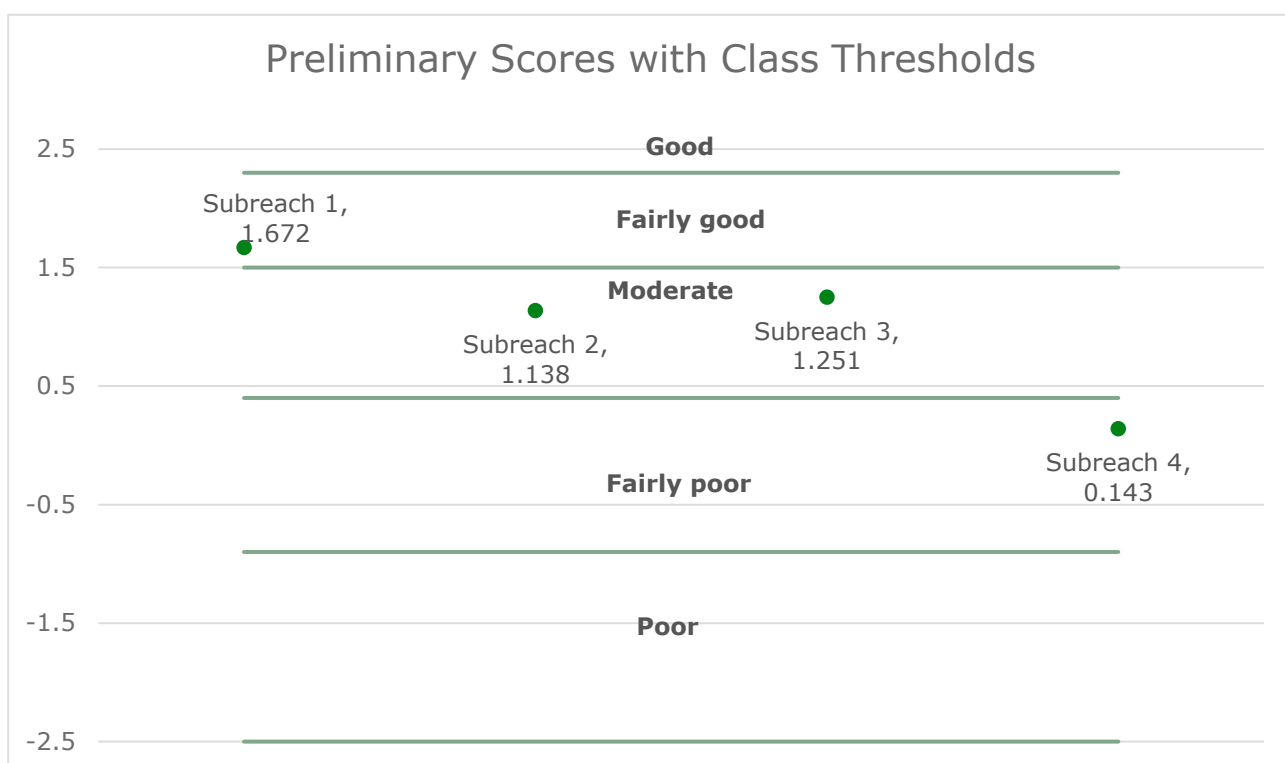
**Plate 6.4.2 Preliminary Condition Scores for Kearsley Brook and the Condition Class Thresholds for River Type F**

| Subreach Number | Grid Reference | Preliminary Condition Score | Final Condition Score | Watercourse Encroachment | Riparian Encroachment |
|---|---|---|---|---|---|
| 3 | SK 51121 97134 | 1.251 | Moderate | No encroachment | No encroachment/<br>no encroachment |
| 4 | SK 50909 97236 | 0.413 | Moderate | No encroachment | Major/major |

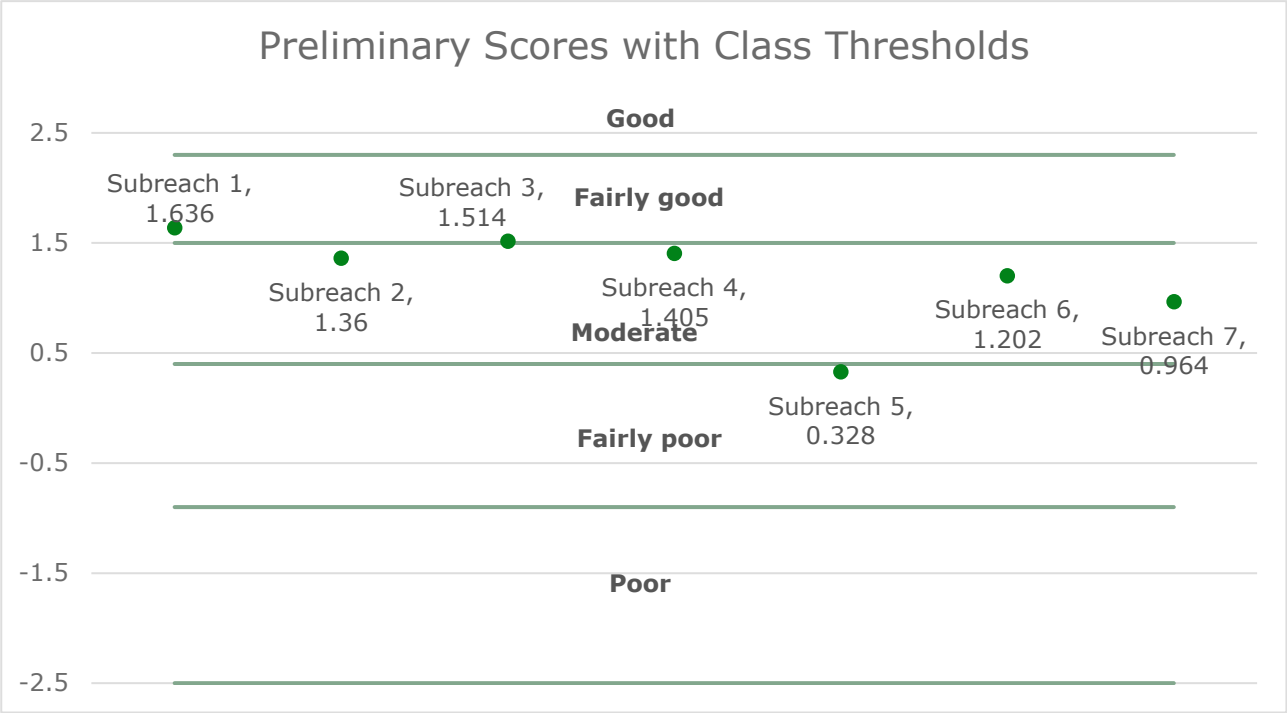
**Plate 6.4.3 Preliminary Condition Scores for The Brook and the Condition Class Thresholds for River Type F**

| Subreach Number | Grid Reference | Preliminary Condition Score | Final Condition Score | Watercourse Encroachment | Riparian Encroachment |
|---|---|---|---|---|---|
| 6 | SK 50925<br>96859 | 1.202 | Moderate | No encroachment | No encroachment/<br>no encroachment |
| 7 | SK 51056<br>97136 | 0.964 | Moderate | No encroachment | Major/major |

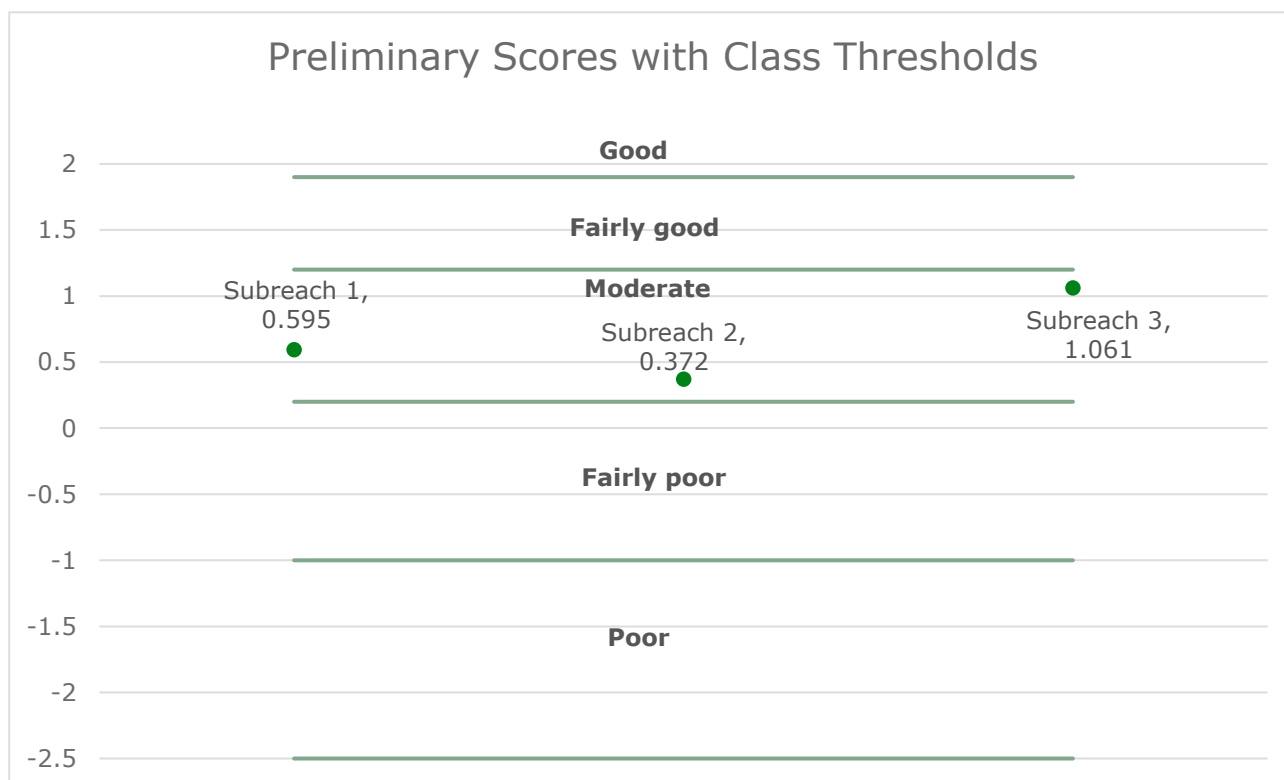
**Plate 6.4.4 Preliminary Condition Scores for Anston Brook 1 and the Condition Class Thresholds for River Type K**

| Subreach Number | Grid Reference | Preliminary Condition Score | Final Condition Score | Watercourse Encroachment | Riparian Encroachment |
|---|---|---|---|---|---|
| 2 | SK 49476 86101 | 0.372 | Moderate | No encroachment | Major/ no encroachment |
| 3 | SK 49690 86106 | 1.061 | Moderate | No encroachment | No encroachment/ no encroachment |

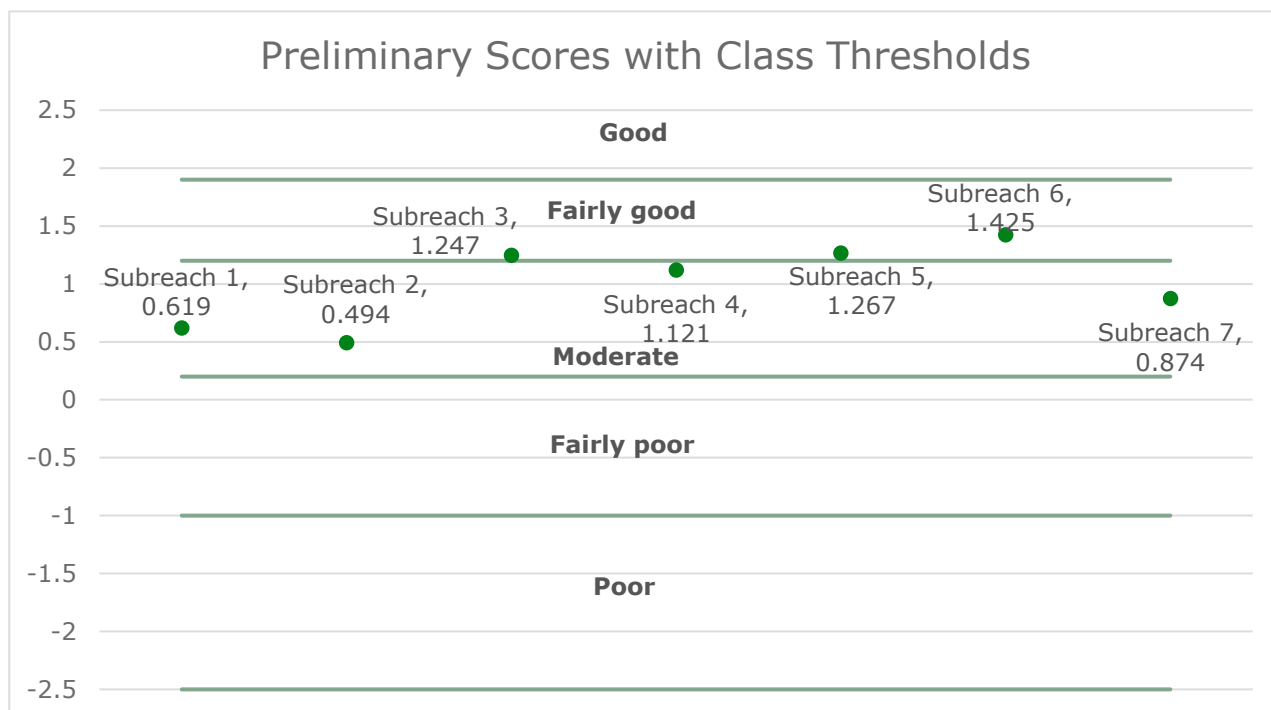
**Plate 6.4.5 Preliminary Condition Scores for Anston Brook 2 and the Condition Class Thresholds for River Type K**

| Subreach Number | Grid Reference | Preliminary Condition Score | Final Condition Score | Watercourse Encroachment | Riparian Encroachment |
|---|---|---|---|---|---|
| 6 | SK 51075 84424 | 1.425 | Fairly good | No encroachment | Major/ moderate |
| 7 | SK 51307 84231 | 0.874 | Moderate | No encroachment | Major/major |

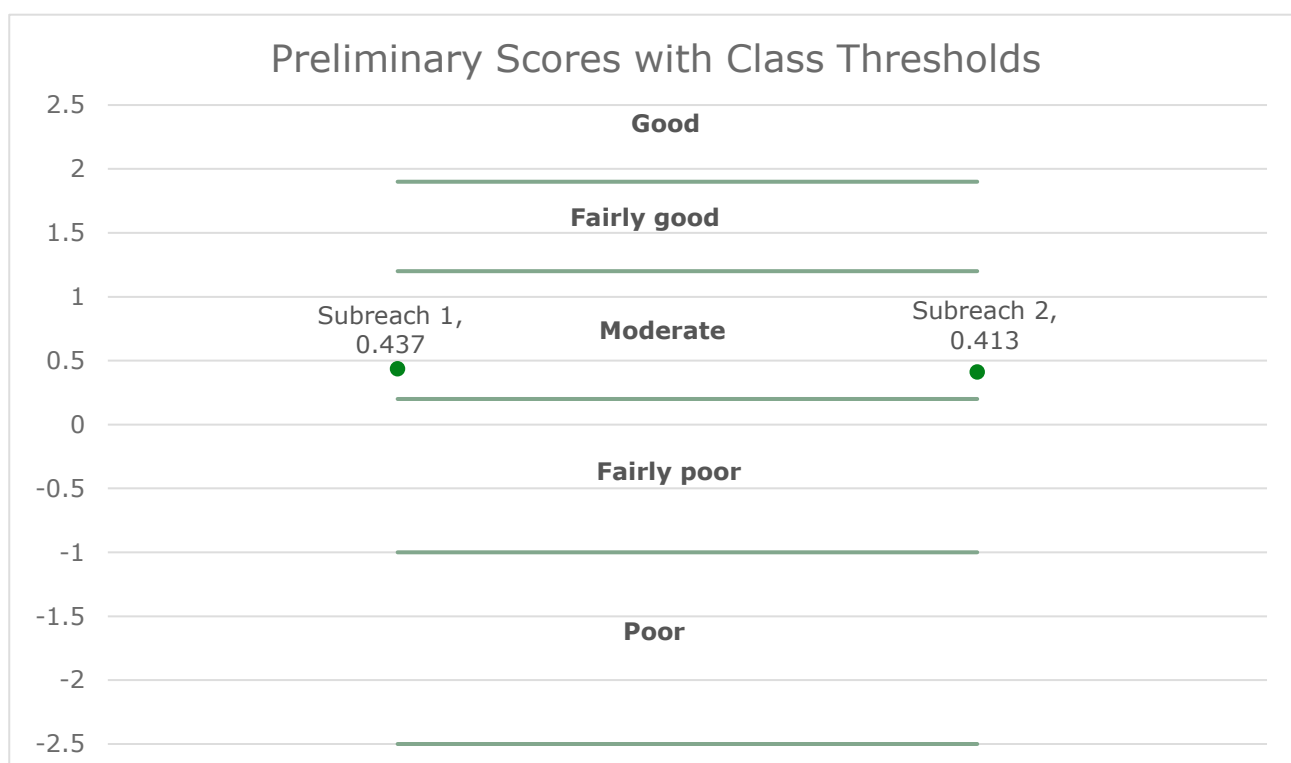
**Plate 6.4.6 Preliminary Condition Scores for Cramfit Brook and the Condition Class Thresholds for River Type K**

| Subreach Number | Grid Reference | Preliminary Condition Score | Final Condition Score | Watercourse Encroachment | Riparian Encroachment |
|---|---|---|---|---|---|
| 1 | SK 50913 85428 | 0.437 | Moderate | No encroachment | Major/major |
| 2 | SK 50739 85290 | 0.413 | Moderate | No encroachment | Major/major |

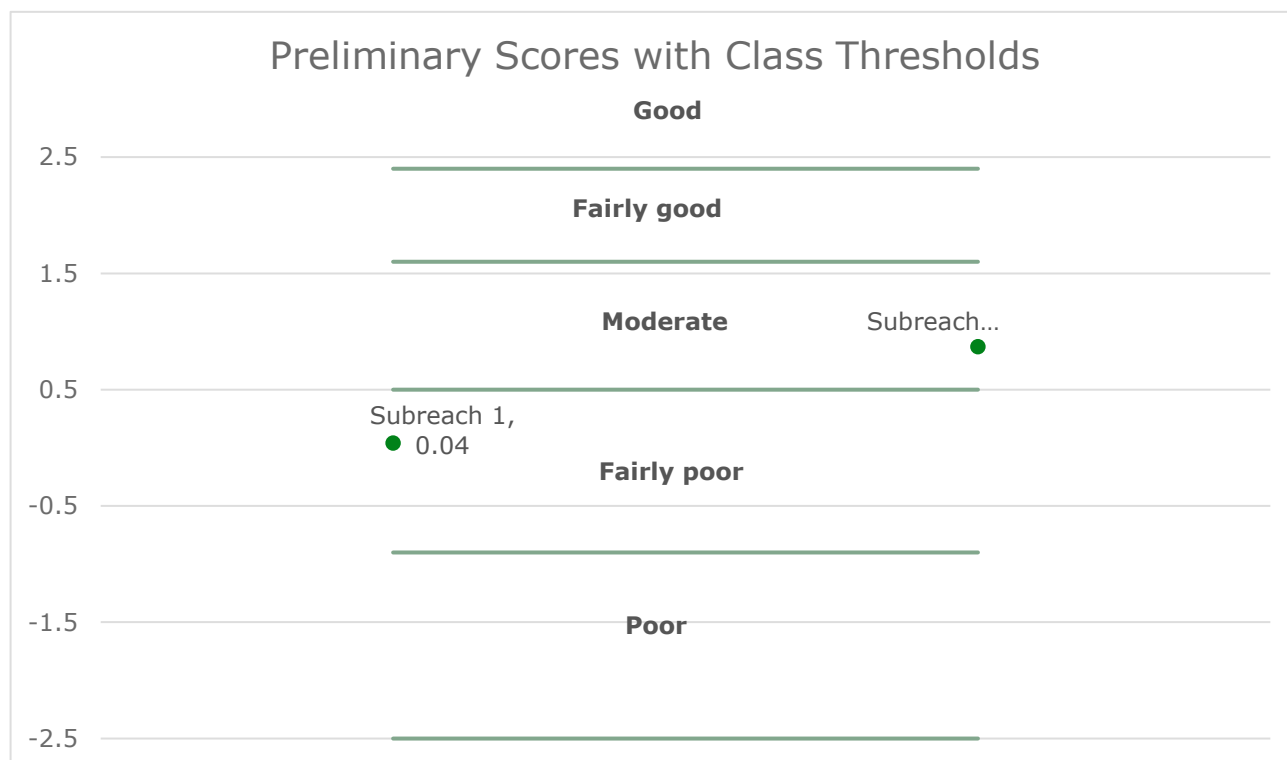
**Plate 6.4.7 Preliminary Condition Scores for Kingsforth Brook and the Condition Class Thresholds for River Type H**

| Subreach Number | Grid Reference | Preliminary Condition Score | Final Condition Score | Watercourse Encroachment | Riparian Encroachment |
|---|---|---|---|---|---|
| 1 | SK 48980 90702 | 0.040 | Fairly poor | No encroachment | Major/ no encroachment |
| 2 | SK 49323 90723 | 0.870 | Moderate | Minor | Major/major |

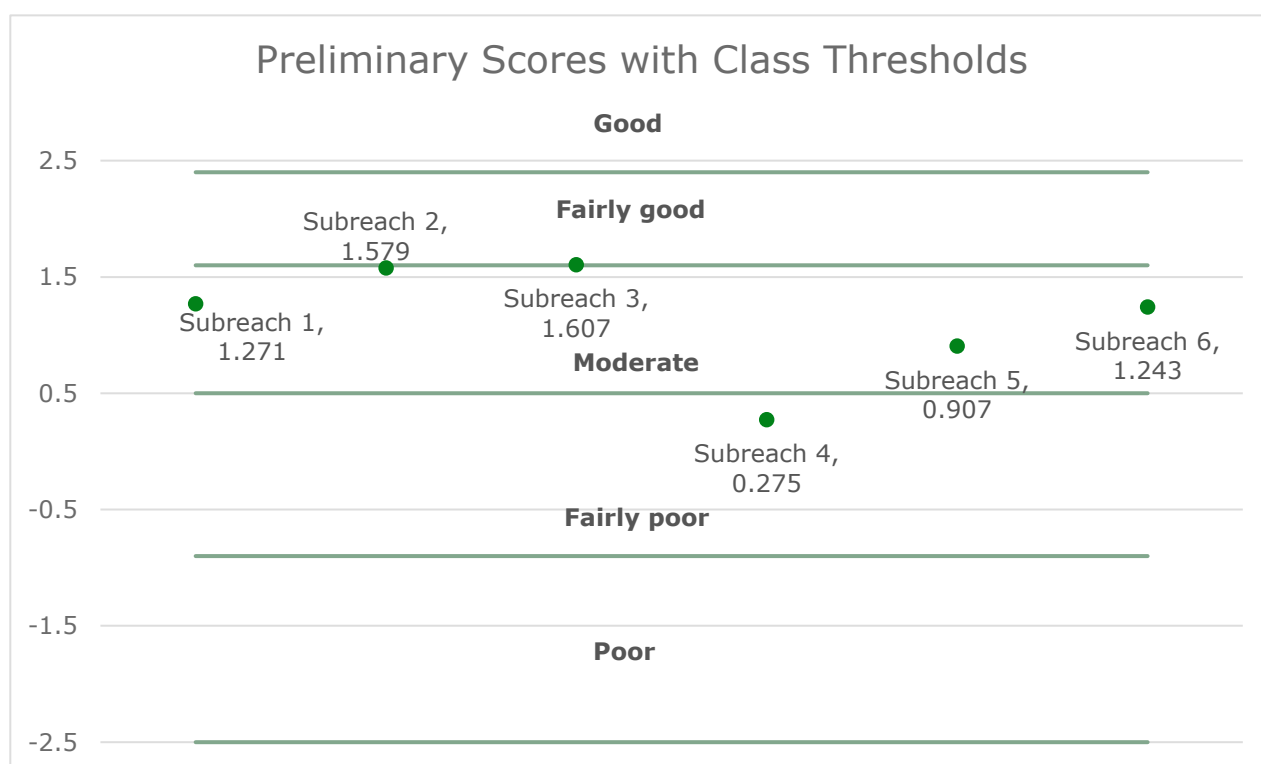
**Plate 6.4.8 Preliminary Condition Scores for Ulley Brook 1 and the Condition Class Thresholds for River Type H**

| Subreach Number | Grid Reference | Preliminary Condition Score | Final Condition Score | Watercourse Encroachment | Riparian Encroachment |
|---|---|---|---|---|---|
| 5 | SK 46195 88265 | 0.907 | Moderate | No encroachment | Major/major |
| 6 | SK 45989 88124 | 1.243 | Moderate | No encroachment | Minor/no encroachment |

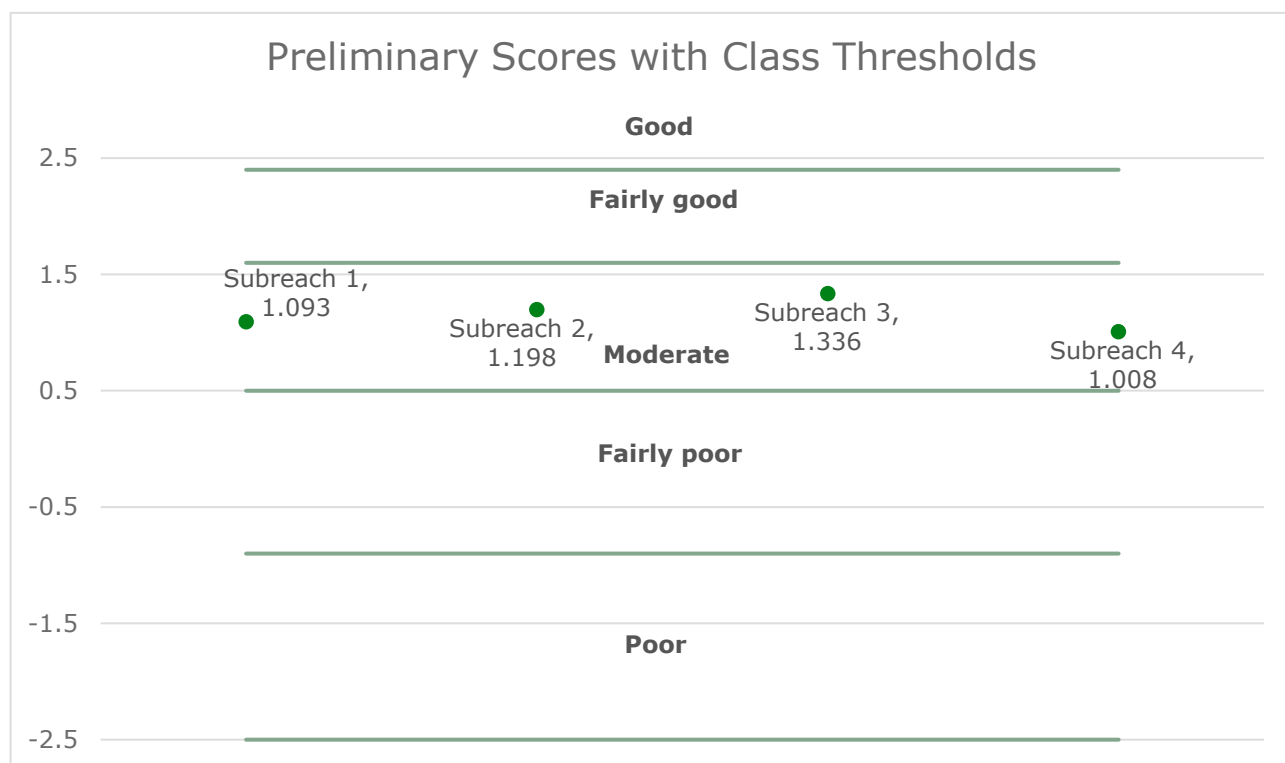
**Plate 6.4.9 Preliminary Condition Scores for Ulley Brook 2 and the Condition Class Thresholds for River Type H**

| Subreach Number | Grid Reference | Preliminary Condition Score | Final Condition Score | Watercourse Encroachment | Riparian Encroachment |
|---|---|---|---|---|---|
| 3 | SK 46184<br>86463 | 1.336 | Moderate | No encroachment | Major/ moderate |
| 4 | SK 46129<br>86669 | 1.008 | Moderate | Major | Moderate/ no encroachment |

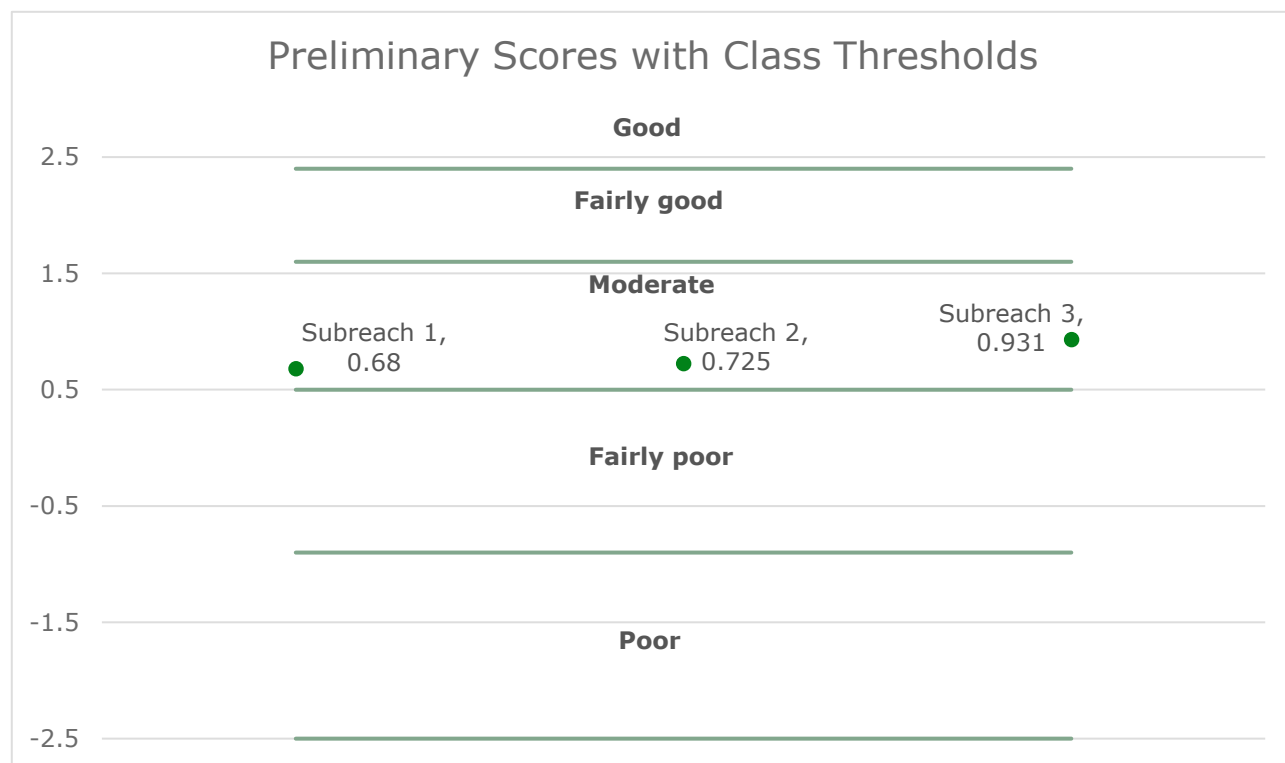
**Plate 6.4.10 Preliminary Condition Scores for Ulley Brook 3 and the Condition Class Thresholds for River Type H**

| Subreach Number | Grid Reference | Preliminary Condition Score | Final Condition Score | Watercourse Encroachment | Riparian Encroachment |
|---|---|---|---|---|---|
| 2 | SK 44845 88164 | 0.725 | Moderate | No encroachment | Major/major |
| 3 | SK 44690 88409 | 0.931 | Moderate | No encroachment | Major/major |

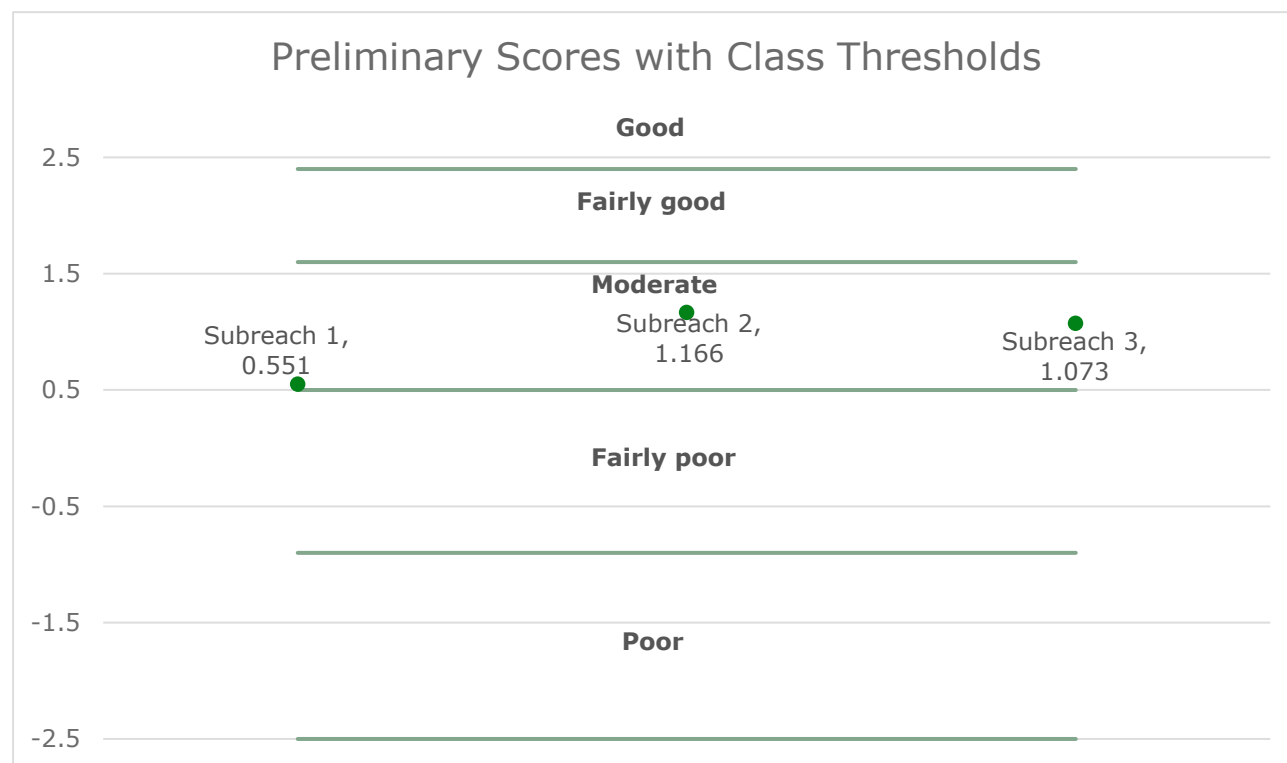
**Plate 6.4.11 Preliminary Condition Scores for the Tributary of Ulley Brook 2 and the Condition Class Thresholds for River Type H**

| Subreach Number | Grid Reference | Preliminary Condition Score | Final Condition Score | Watercourse Encroachment | Riparian Encroachment |
|---|---|---|---|---|---|
| 2 | SK 46871 87041 | 1.166 | Moderate | No encroachment | Major/major |
| 3 | SK 46806 86816 | 1.073 | Moderate | No encroachment | Major/major |

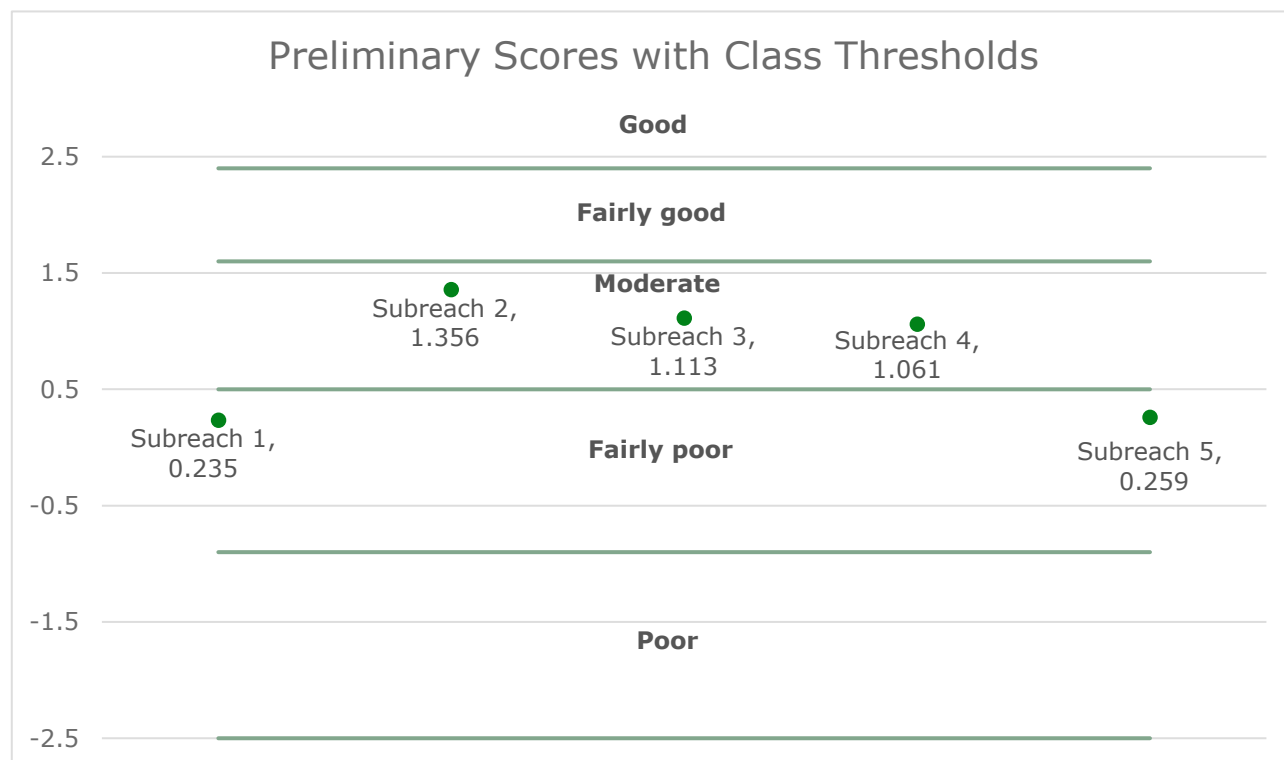
**Plate 6.4.12 Preliminary Condition Scores for Broadbridge Dike and the Condition Class Thresholds for River Type H**

| Subreach Number | Grid Reference | Preliminary Condition Score | Final Condition Score | Watercourse Encroachment | Riparian Encroachment |
|---|---|---|---|---|---|
| 4 | SK 49036 81935 | 1.061 | Moderate | No encroachment | Major/major |
| 5 | SK 49181 82089 | 0.259 | Fairly poor | Major | Major/major |

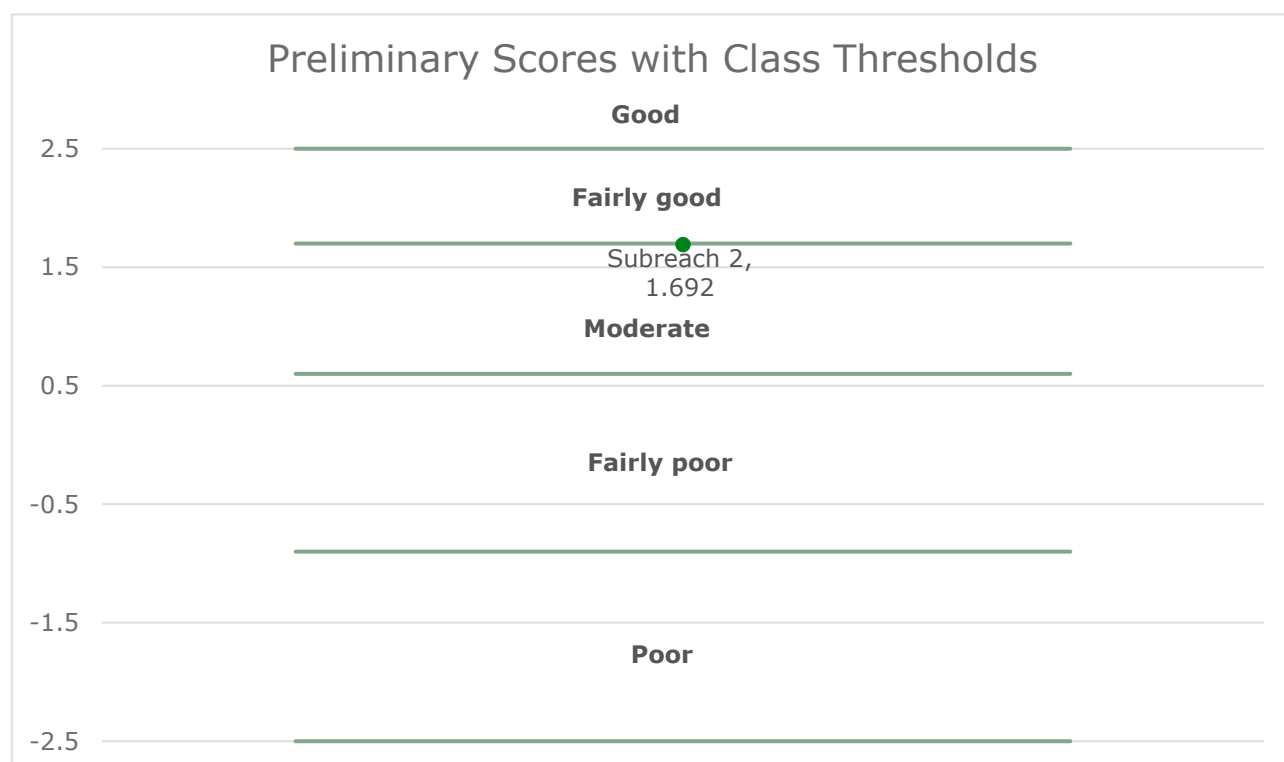
**Plate 6.4.13 Preliminary Condition Scores for Firsby Brooke 1 and the Condition Class Thresholds for River Type I**

| Subreach Number | Grid Reference | Preliminary Condition Score | Final Condition Score | Watercourse Encroachment | Riparian Encroachment |
|---|---|---|---|---|---|
| 1 | SK 50694 94930 | 1.692 | Moderate | No encroachment | Major/Major |

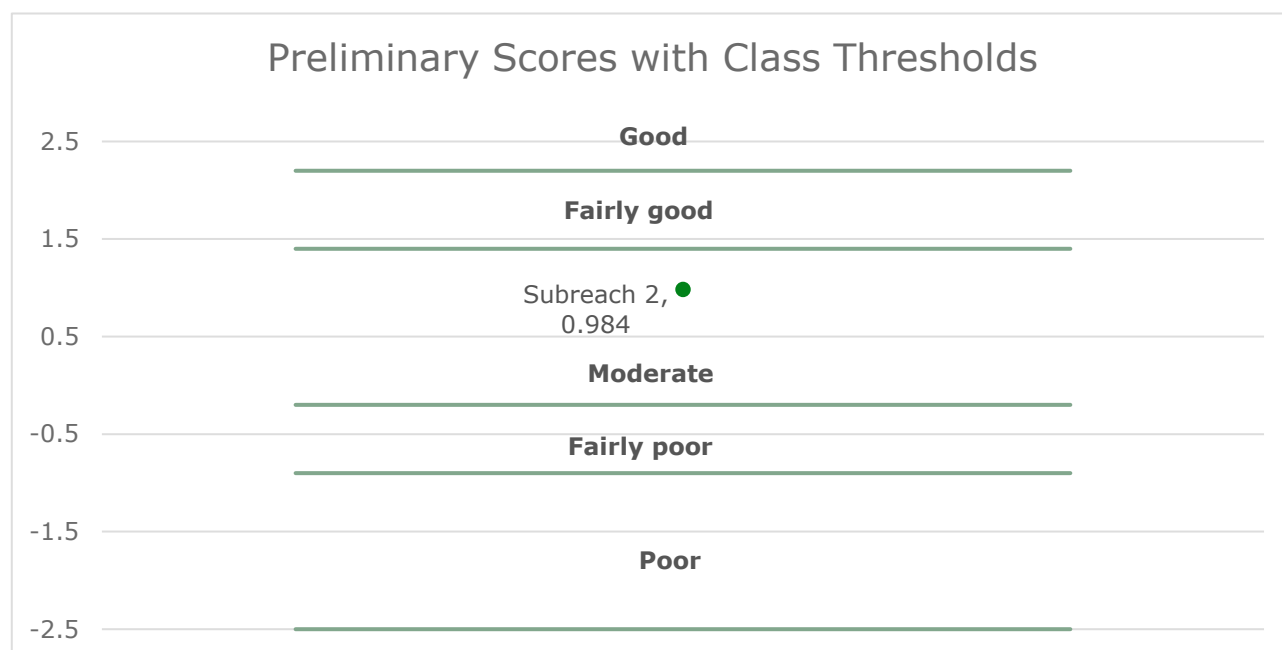
| Subreach Number | Grid Reference | Preliminary Condition Score | Final Condition Score | Watercourse Encroachment | Riparian Encroachment |
|---|---|---|---|---|---|
| 1 | SK 47898 90002 | 0.984 | Moderate | No encroachment | Major/Major |

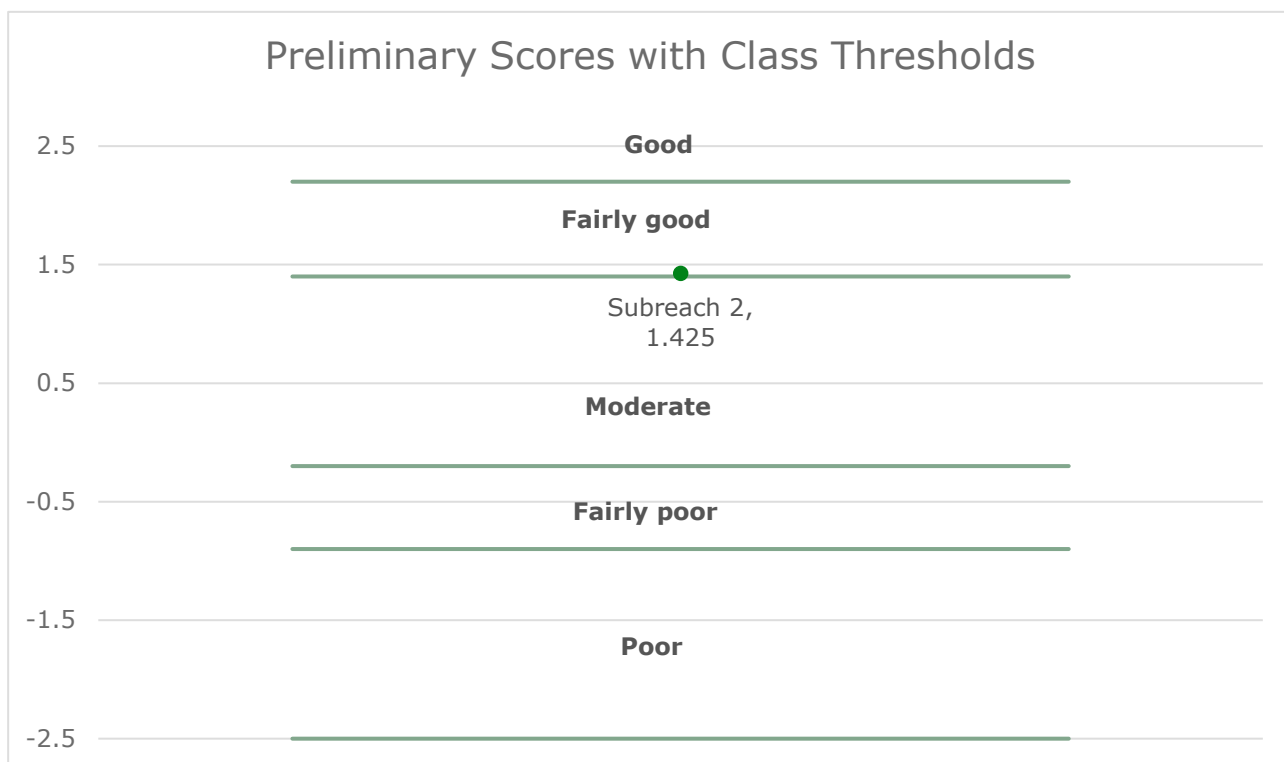
**Plate 6.4.15 Preliminary Condition Scores for Unnamed Watercourse (Wc25) and the Condition Class Thresholds for River Type D**

| Subreach Number | Grid Reference | Preliminary Condition Score | Final Condition Score | Watercourse Encroachment | Riparian Encroachment |
|---|---|---|---|---|---|
| 1 | SK 46821 89582 | 1.425 | Fairly Good | No encroachment | No encroachment/no encroachment |

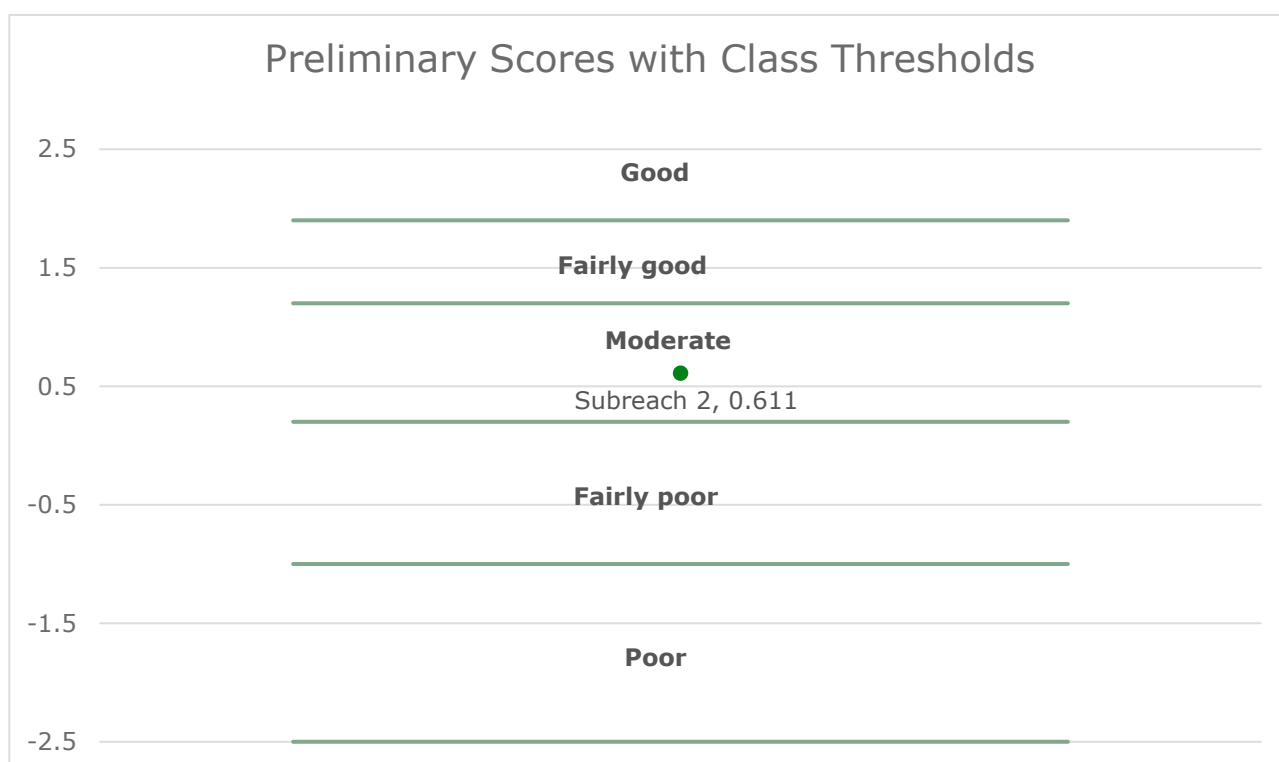
**Plate 6.4.16 Preliminary Condition Scores for Unnamed Watercourse (Wc24) and the Condition Class Thresholds for River Type K**

| Subreach Number | Grid Reference | Preliminary Condition Score | Final Condition Score | Watercourse Encroachment | Riparian Encroachment |
|---|---|---|---|---|---|
| 1 | SK 45770 89827 | 0.61133605 | Moderate | No encroachment | Major/Major |

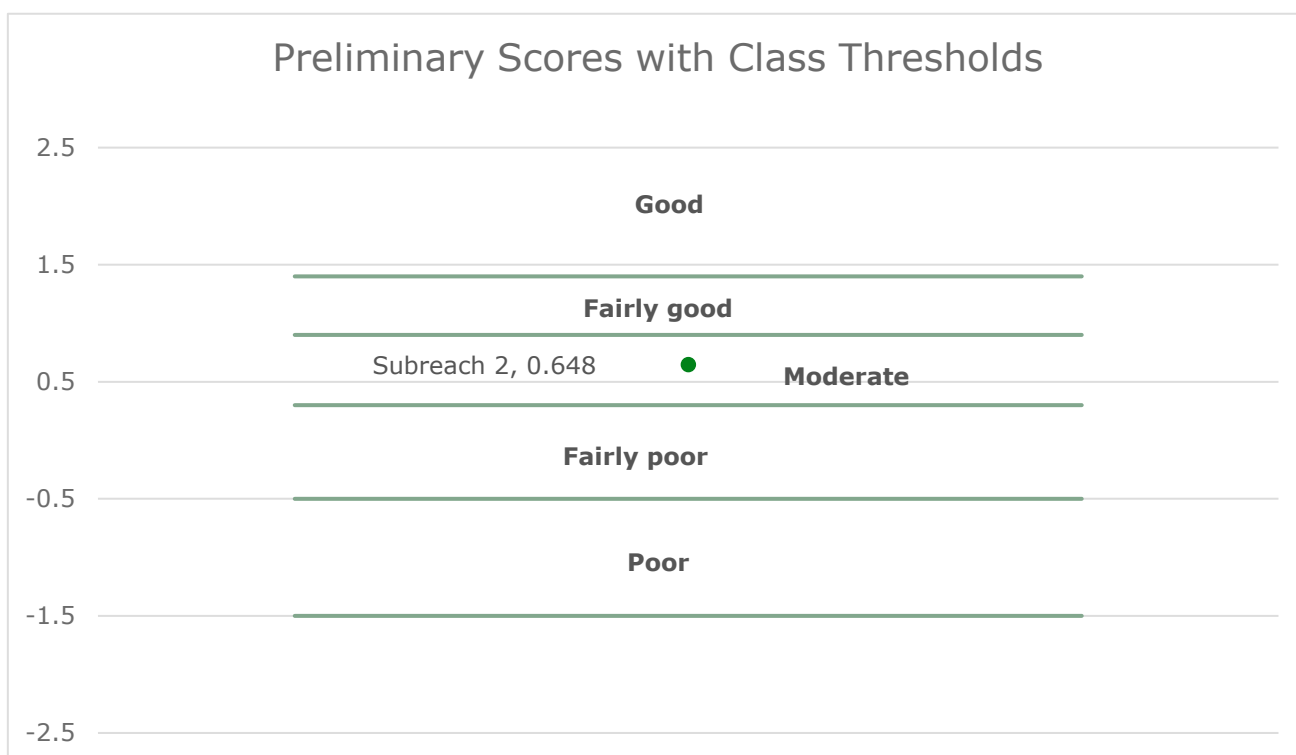
**Plate 6.4.17 Preliminary Condition Scores for Chesterfield Canal and the Condition Class Thresholds for Canals**

| Subreach Number | Grid Reference | Preliminary Condition Score | Final Condition Score | Watercourse Encroachment | Riparian Encroachment |
|---|---|---|---|---|---|
| 1 | SK 51675 82223 | 0.648 | Moderate | Major | No encroachment/no encroachment |
