Sea Link

Volume 9: Examination Submissions

Document 9.76.5.10: Change Request Appendix J Change 4 Phase 1 Habitat Survey Results

Planning Inspectorate Reference: EN20026

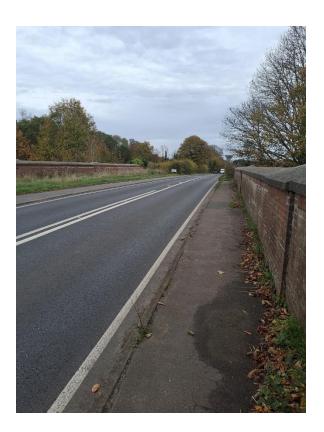
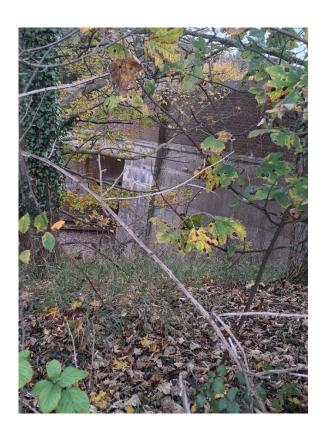
- Benhall Railway Bridge itself is a concrete structure with an opening approximately 6 m high by 15 m wide. The main bridge structure was constructed from large concrete blocks, with the surrounding structure of brick construction. Some features of low suitability for bats were present approximately 1 m high inside the tunnel portion of the bridge, in the form of drainage holes that were viewed from the public footpath. While it is unlikely that these features would support roosting bats due to their function for drainage, there is some possibility for them to do so, depending on their internal structure and if they are blocked, resulting in no water passing through them. No potential roost features (PRFs) with higher suitability were observed anywhere in the bridge's structure. However, access could not be gained under the bridge, so it is not possible to conclude that there is an absence of PRFs in this location at this time. Therefore, the bridge has been assessed as likely low (rather than negligible) suitability to support roosting bats.

Plate 1 Bridge at TN1

Plate 2 Bridge at TN1

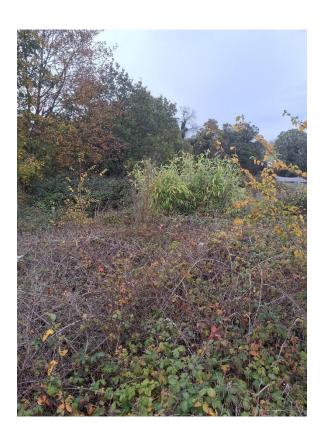
- stand of the invasive and non-native species, bamboo (*Bambusa* sp.), at OS grid reference TM 38003 61351 (TN2) (see Plate 3).
- The surrounding area was dominated by mixed semi-natural woodland to the west of the railway line and around the A12. Arable cereal crops were present to the south of the road, to the east of the railway line, and a semi-improved neutral grassland verge to the north of the road. To the east of the bridge, the road was bordered by a species-rich native hedge to the north, comprising elm, hawthorn (*Crataegus monogyna*), hazel, spindle (*Euonymus europaeus*), and field maple (*Acer campestre*); and a species-poor native hedge to the south, dominated by elm, along with a 1 m wide semi-improved neutral grassland roadside verge, similar in composition to the verge over the bridge.

Plate 3 INNS bamboo at TN2

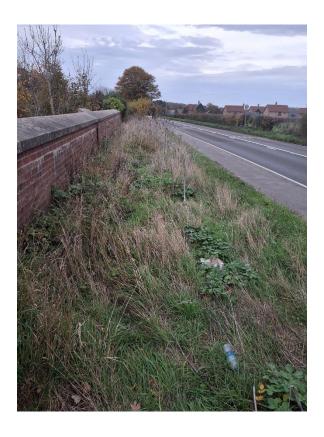
- The bridge (TN1) (see Plate 1 and 2 below) supported a semi-improved neutral grassland road-side verge approximately 4 m wide to the north of the road (TN3) (see Plate 4). This was dominated by false oat-grass (*Arrhenatherum elatius*), with frequent red fescue (*Festuca rubra*), cock's foot (*Dactylis glomerata*), Alexanders (*Smyrnium olusatrum*), yarrow (*Achillea millefolium*), and doves' foot cranesbill (*Geranium molle*).

Plate 4 Semi-improved grassland verge at TN3

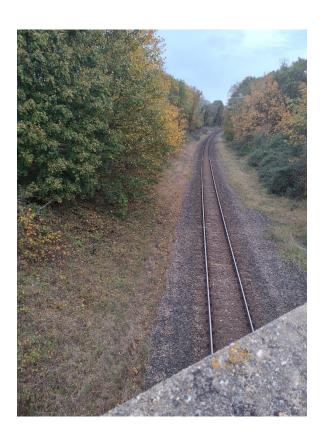
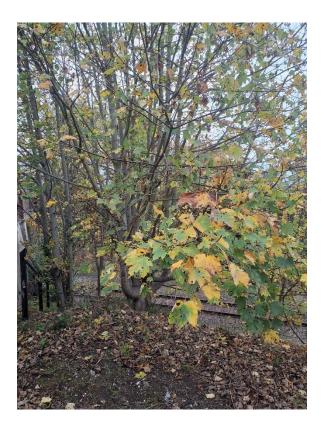
Plate 5 Adjacent railway habitats

Plate 6 Adjacent railway habitats
