**A38 Derby Junctions**

**Appendix 8.5a: River Habitat Survey in  
2018**

## **River Habitat Survey Report**

**Report Number: HE514503-ACM-EBD-A38\_SW\_PR\_ZZ-RP-EG-0020 P02 S4**  
**December 2018**

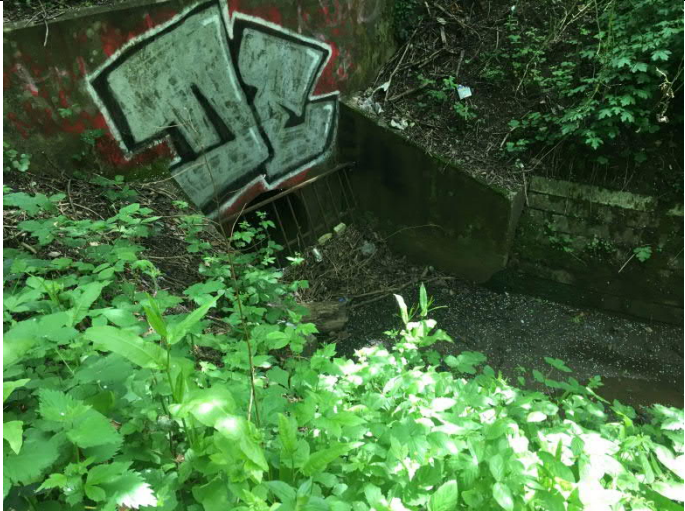
Watercourse	Photo No.	Description	Photo
Bramble Brook	1	Culverted and reinforced section upstream of A38

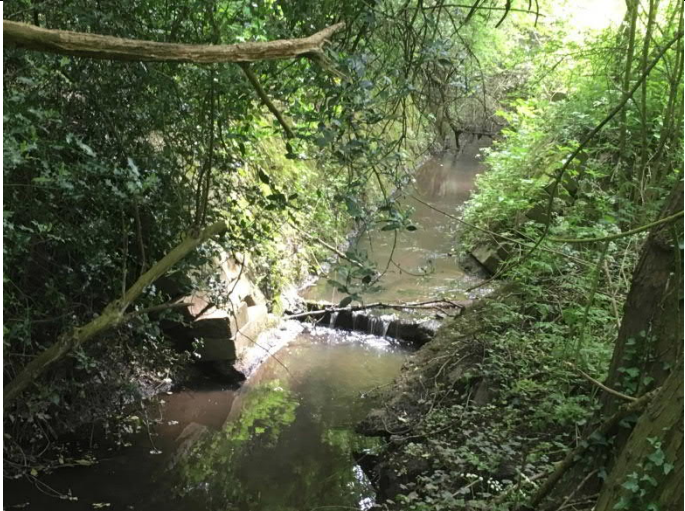
Bramble Brook	2	Reinforced section within Kingsway roundabout

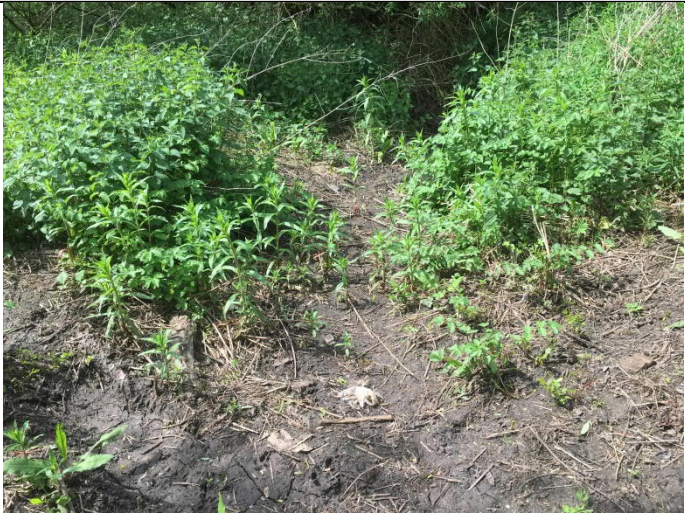
Watercourse	Photo No.	Description	Photo
Bramble Brook	3	Dry section of Bramble Brook upstream of A38

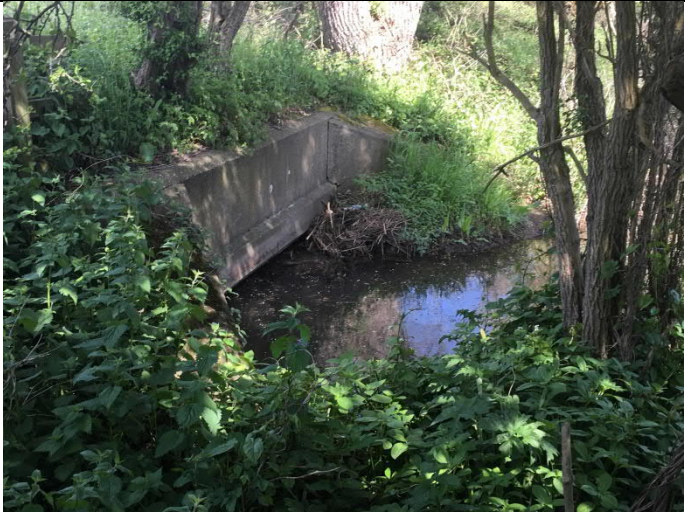
Dam Brook	4	Upstream end of culvert beneath A61

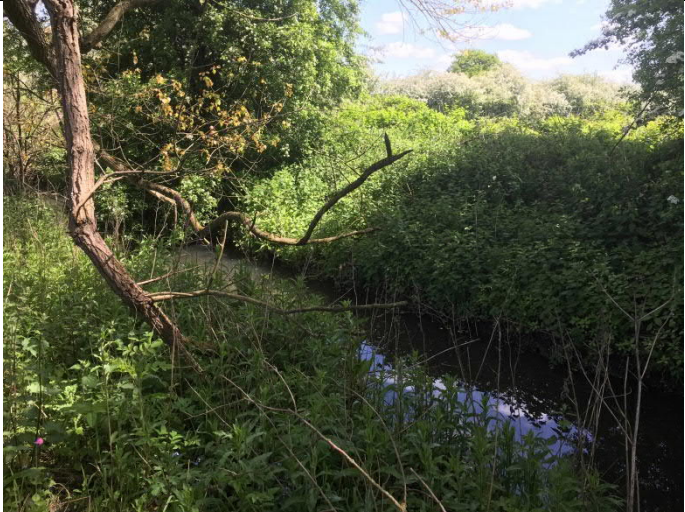
Dam Brook	5	Representative section of Dam Brook

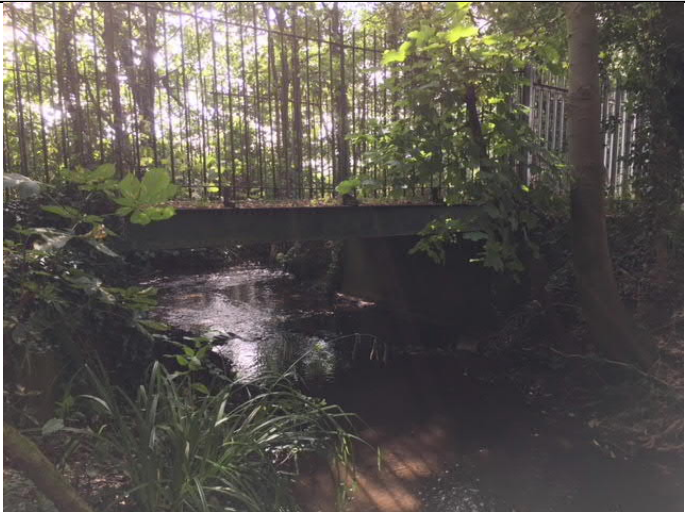
Watercourse	Photo No.	Description	Photo
Middle Brook	6	Minor bridge downstream of wide shallow section (proposed location of temporary bridge crossing)

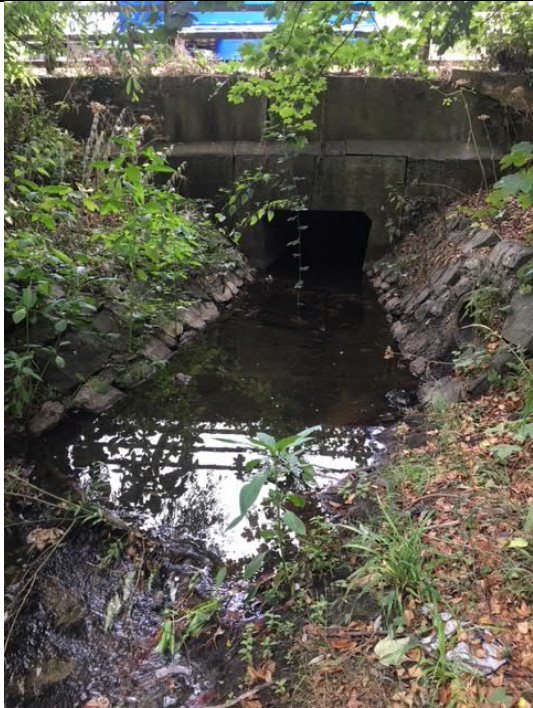
Middle Brook	7	Culvert, immediately downstream of A38, with outfall pipe on left bank (right of picture)

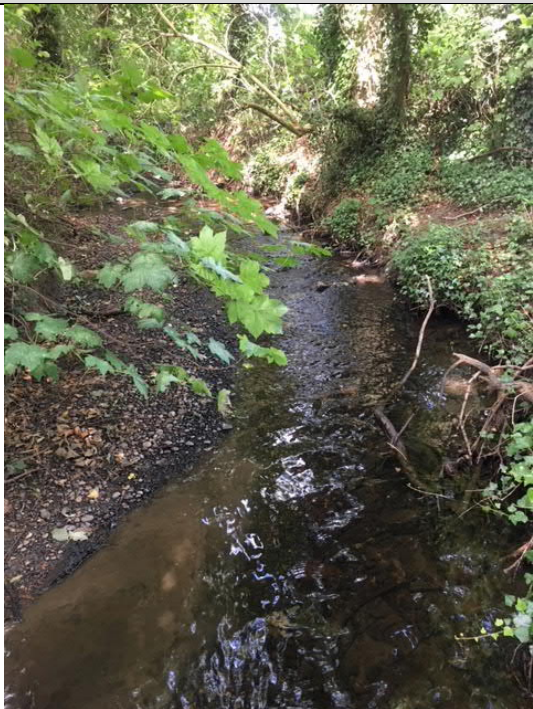
Watercourse	Photo No.	Description	Photo
Middle Brook	8	Representative section of Middle Brook
