A38 Derby Junctions

**Appendix 8.9c: Bat Tree Climbing
Survey 2017 Report**

6.3 Environmental Statement Appendices Appendix 8.9c: Bat Tree Climbing Survey 2017 Report

A38 DERBY JUNCTIONS – TREE CLIMBING SURVEY

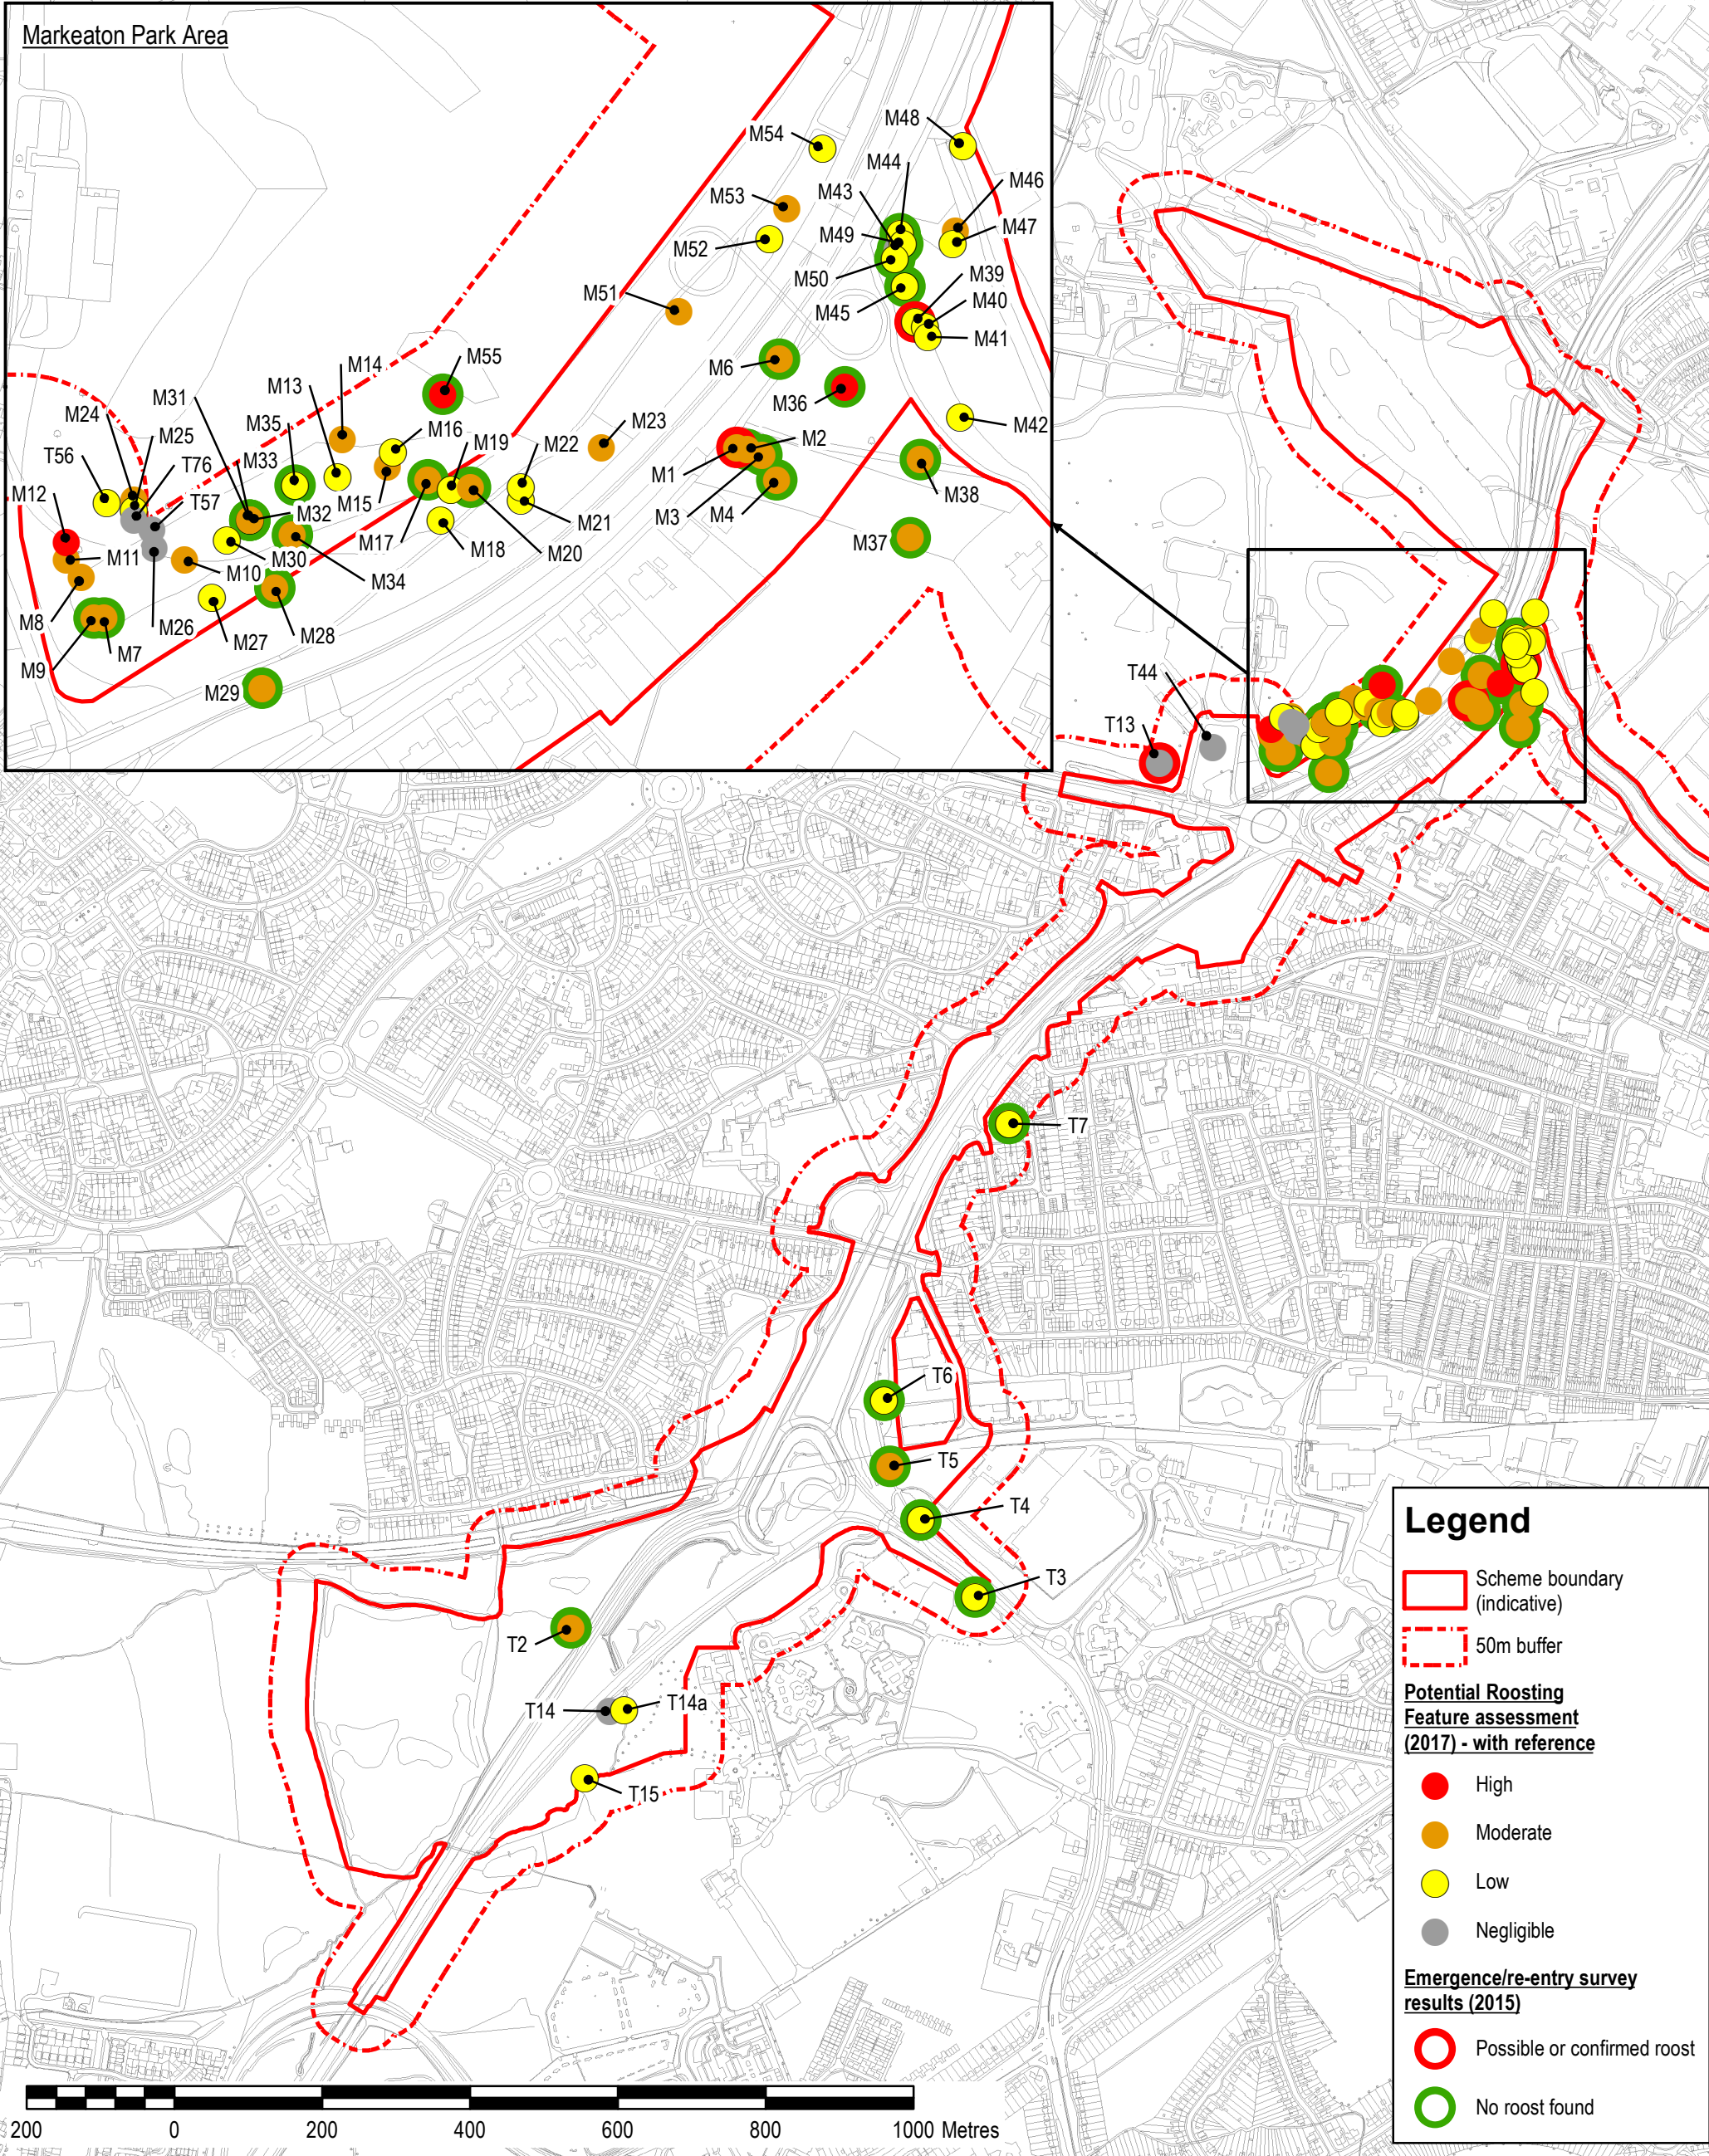
Figure 1: Kingsway – Markeaton, Bat surveys 2017. Potential Roost Feature Assessment

4.1.1 A summary of the Potential Roosting Features (PRFs) from the preliminary roost assessment and aerial tree climbing inspection are presented in Table 2. The location of the trees surveyed is presented in Appendix A, Figures 1 and 2 along with their roost potential grading.
