# **M25 junction 28 improvement scheme TR010029**

## **6.3 Environmental Statement Appendix 7.7: Arboricultural impact assessment**

#### 6.3 ENVIRONMENTAL STATEMENT APPENDIX 7.7: ARBORICULTURAL IMPACT ASSESSMENT

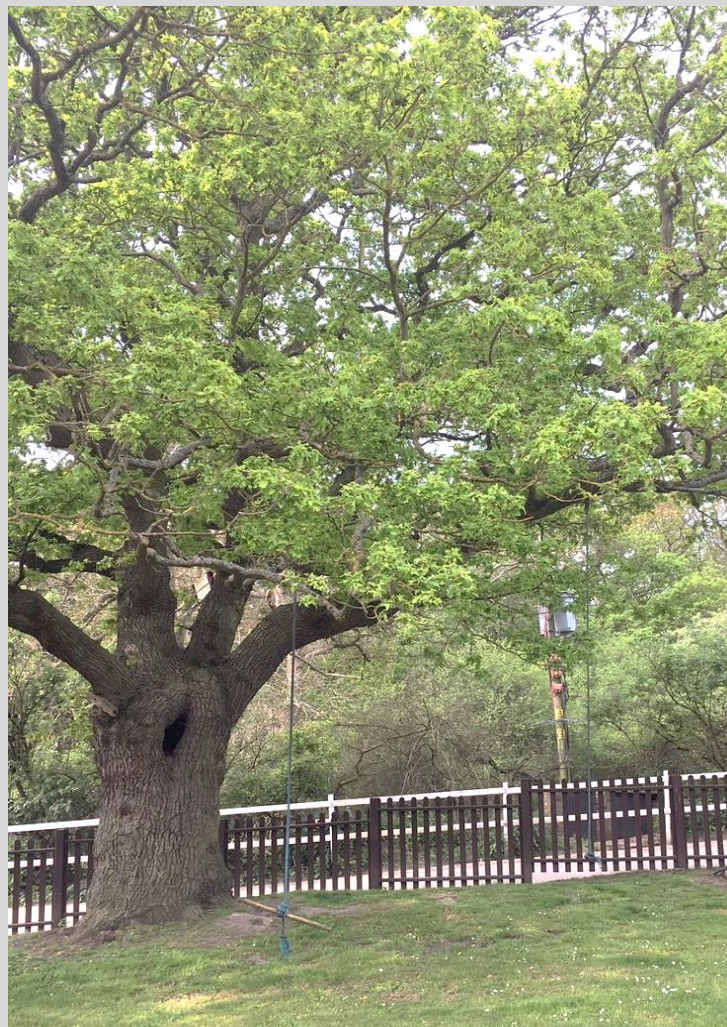
Tree ref	Species	Location	Summary of value	Tree photographs
T002	Common Oak	Easing:55658547 Northing:19242145  Grove Farm, garden.  TPP: HE551519-ATK-ELS-XX-DR-LL-000202 (Appendix C)	<p><b><u>Size:</u></b> Large stem girth in comparison to other trees in locality.</p> <p><b><u>Condition:</u></b> Multi-stem form from approximately 3m, suggesting historic past pollard. Decay features present including hollowing main stem, revealing heartwood decay. Dead branches in crown with desiccated white rot.</p> <p><b><u>Biodiversity value:</u></b> Decayed heartwood rot and white rot providing habitat for saproxylic invertebrates.</p> <p><b><u>Cultural and heritage value:</u></b> Tree appears to be present on 1866 OS mapping. Partially visible from M25 westbound on-slip.</p> <p><b><u>Age:</u></b> It's diameter of 1110mm means it has a girth of 3.48m and means it is included within the 'locally notable' criterion of girth in relation to age as shown in Figure 1.3 of 'Ancient and other veteran trees: further guidance on management' (Lonsdale, 2013).</p>

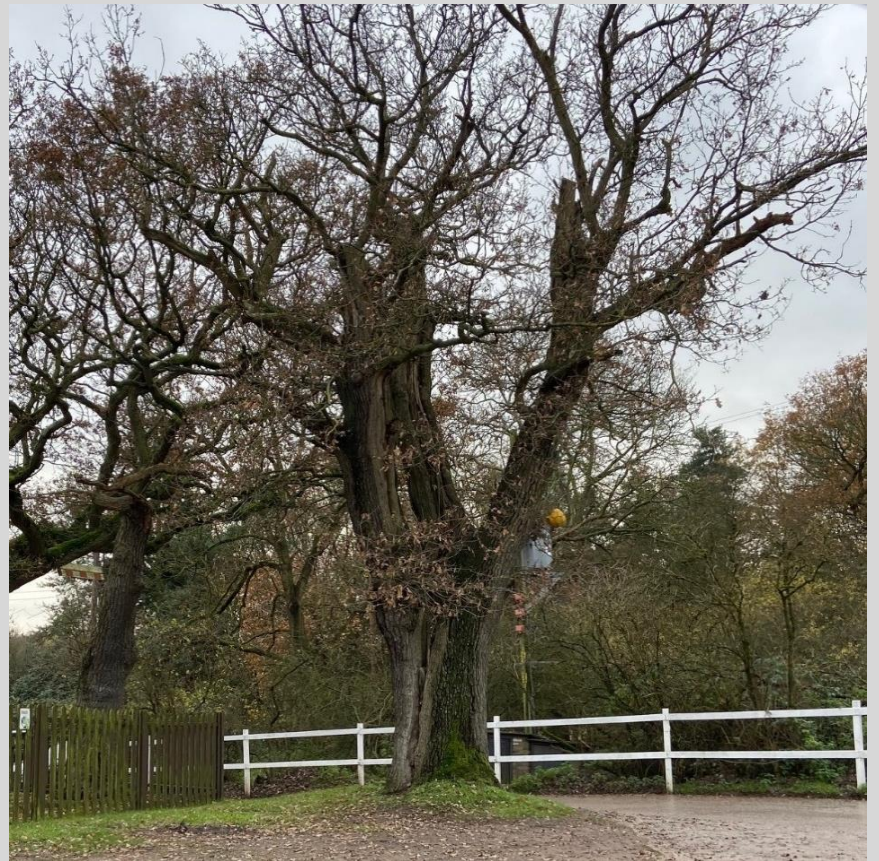
Tree ref	Species	Location	Summary of value	Tree photographs
T004	Common Oak	Easing: 556575.05 Northing: 192428.7  Grove Farm, garden.  TPP: HE551519-ATK-ELS-XX-DR-LL-000202 (Appendix C)	<p><b><u>Size:</u></b> Large stem girth in comparison to other trees in locality.</p> <p><b><u>Condition:</u></b> Crown previously reduced in places. Decay features present including hollowing main stem, revealing heartwood decay. Extensive dead branches in crown with desiccated white rot.</p> <p><b><u>Biodiversity value:</u></b> Decayed heartwood rot and extensive dead branches in crown with desiccated white rot. Habitat value for saproxylic invertebrates.</p> <p><b><u>Cultural and heritage value:</u></b> Tree appears to be present on 1866 OS mapping. Partially visible from M25 westbound on-slip.</p> <p><b><u>Age:</u></b> It's diameter of 1000mm means it has a girth of 3.14m and means it is included within the 'locally notable' criterion of girth in relation to age as shown in Figure 1.3 of 'Ancient and other veteran trees: further guidance on management' (Lonsdale, 2013).</p>

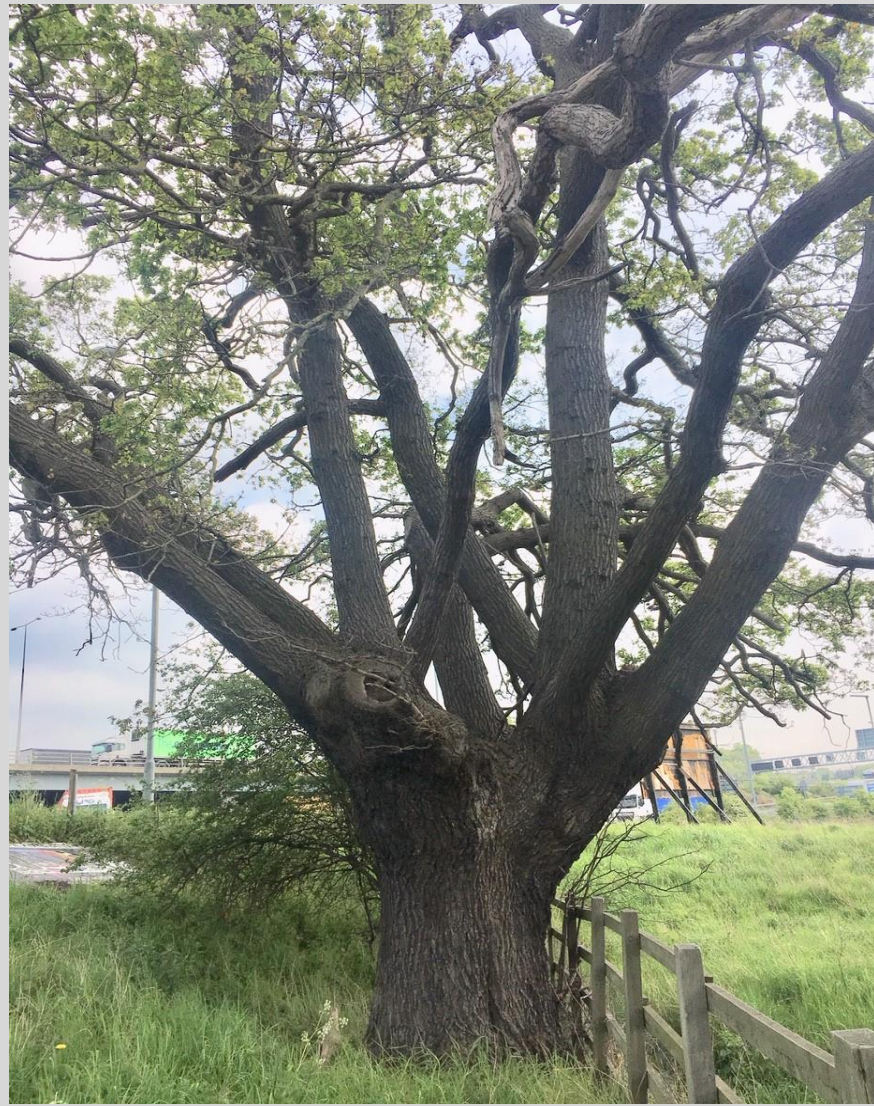
Tree ref	Species	Location	Summary of value	Tree photographs
T019	Common Oak	<p>Easing: 55675922 Northing:19227193</p> <p>Adjacent to A12 SB on-slip from junction 28 roundabout.</p> <p>TPP: HE551519-ATK-ELS-XX-DR-LL-000202 (Appendix C)</p>	<p><b><u>Size:</u></b> Large stem girth in comparison to other trees in locality.</p> <p><b><u>Condition:</u></b> Multi-stem form from approximately 3-4m, suggesting historic past pollard. Decay features present including hollowing main stem, revealing heartwood decay. Dead branches in crown with desiccated white rot. Further large diameter old branch wounds in crown, showing heartwood decay. Water pockets.</p> <p><b><u>Biodiversity value:</u></b> Decayed heartwood rot and white rot providing habitat for saproxylic invertebrates.</p> <p><b><u>Cultural and heritage value:</u></b> Tree appears to be present on 1866 OS mapping. Highly visible location – views from A12 and M25</p> <p><b><u>Age:</u></b> It's diameter of 1290mm means it has a girth of 4.05m and means it is included within the 'locally notable' criterion of girth in relation to age as shown in Figure 1.3 of 'Ancient and other veteran trees: further</p>

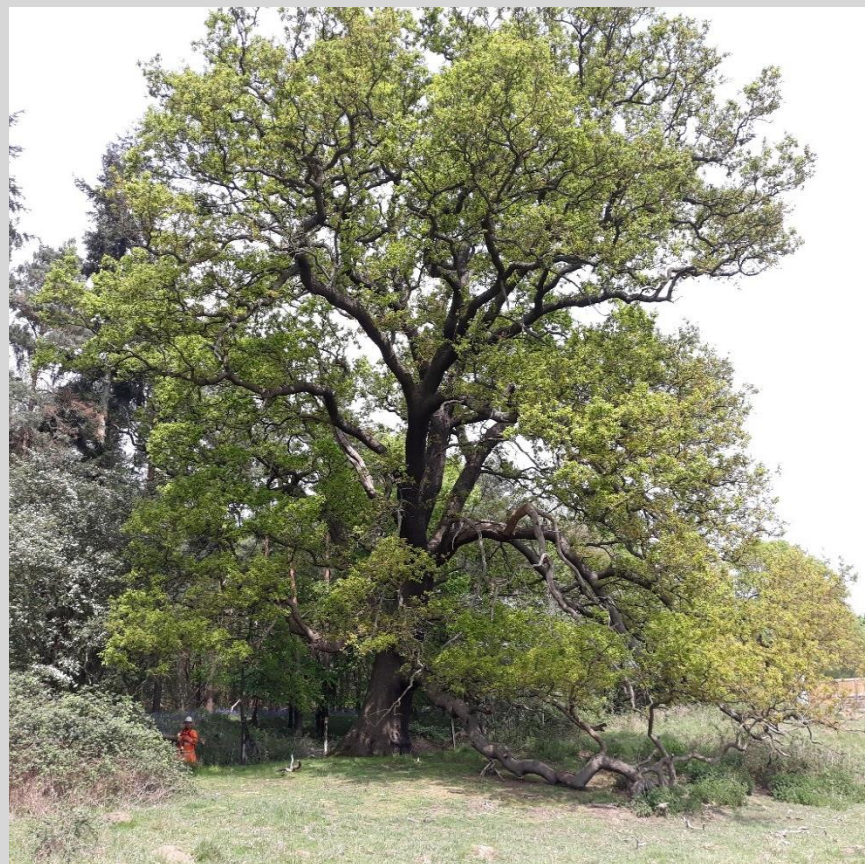
Tree ref	Species	Location	Summary of value	Tree photographs
			guidance on management' (Lonsdale, 2013).	
T021 A	Common Oak	Easing: 556555.2 Northing: 192334.1  Grove Farm, South edge of The Grove Wood.  TPP: HE551519-ATK- ELS-XX-DR-LL- 000202 (Appendix C)	<p><b><u>Size:</u></b> Large stem girth in comparison to other trees in locality.</p> <p><b><u>Condition:</u></b> Decay features present including hollowing main stem, revealing heartwood decay. Basal cavity and raised buttress roots indicative of reaction wood laid down to an internal defect. Dead branches in crown with desiccated white rot. Further large diameter old branch wounds in crown, showing heartwood decay. Water pockets. Crown to south bending low to ground, one large limb resting on ground; small entrances to hollow basal cavities.</p> <p><b><u>Biodiversity value:</u></b> Decayed heartwood rot and white rot providing habitat for saproxylic invertebrates. Woodpecker holes.</p> <p><b><u>Cultural and heritage value:</u></b> Tree appears to be present on 1866 OS mapping. Partially visible from A12 and M25.</p> <p><b><u>Age:</u></b> It's diameter of 1460mm means it has a girth of 4.58m and means it is included</p>

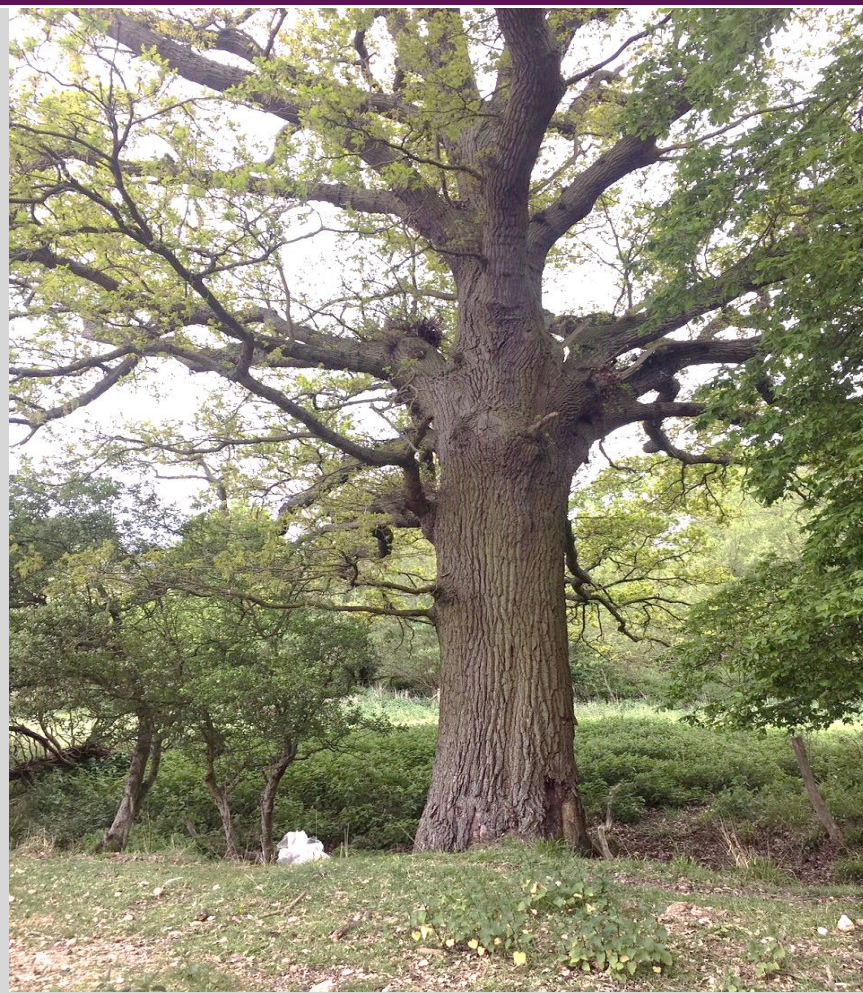
T059	Common Oak	Easing: 55629447 Northing: 19266471  Grove Farm, growing within hedgerow linking The Grove Wood and Alder Wood.  TPP:	<b><u>Size:</u></b> Large stem girth in comparison to other trees in locality.  <b><u>Condition:</u></b> Decay features present including hollowing main stem, revealing developing heartwood decay. Occasional dead branches in crown with desiccated white rot.

Tree ref	Species	Location	Summary of value	Tree photographs
		HE551519-ATK-ELS-XX-DR-LL-000203 (Appendix C)	<p>Crown lost vitality to east, dieback and dead wood present in upper and middle crown extents. Potential natural retrenchment given age, or ground compaction in root zone to east. Sections of loose bark.</p> <p><b><u>Biodiversity value:</u></b></p> <p>Decayed heartwood rot and white rot providing habitat for saproxylic invertebrates.</p> <p><b><u>Cultural and heritage value:</u></b></p> <p>Tree appears to be present on 1866 OS mapping.</p> <p>Limited visibility from surrounding views given existing tree stock and site topography.</p> <p><b><u>Age:</u></b></p> <p>It's diameter of 1100mm means it has a girth of 3.45m and means it is included within the 'locally notable' criterion of girth in relation to age as shown in Figure 1.3 of 'Ancient and other veteran trees: further guidance on management' (Lonsdale, 2013).</p>

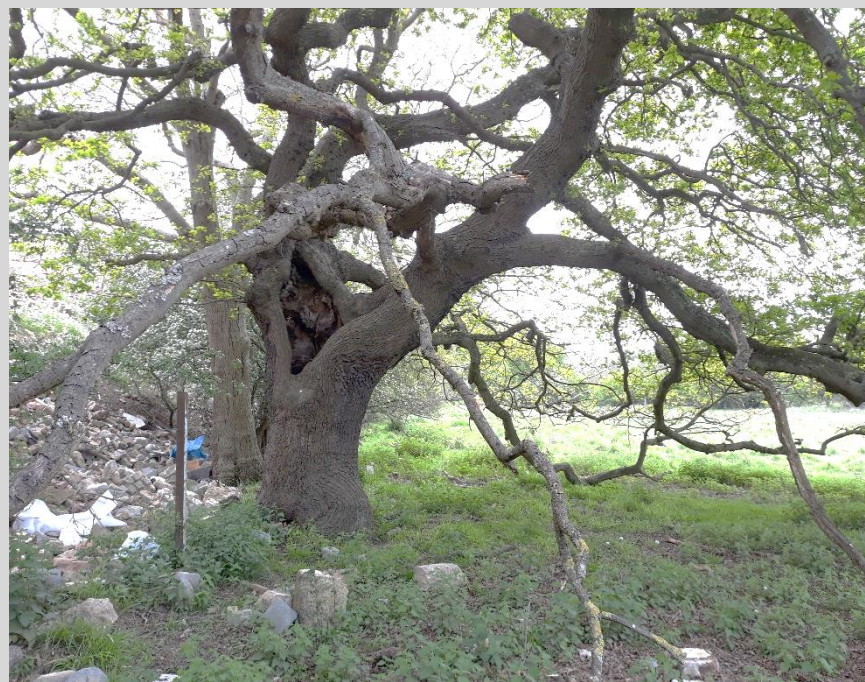
Tree ref	Species	Location	Summary of value	Tree photographs
T065	Common Oak	<p>Easing: 556365.3 Northing: 192516.1</p> <p>Grove Farm, growing within hedgerow linking The Grove Wood and Alder Wood.</p> <p>TPP: HE551519-ATK-ELS-XX-DR-LL-000203 (Appendix C)</p>	<p><b><u>Size:</u></b> Large stem girth in comparison to other trees in locality.</p> <p><b><u>Condition:</u></b> Decay features present including hollow main stem, revealing developing heartwood decay. Occasional large diameter dead branches in crown with desiccated white rot. Sections of loose bark.</p> <p><b><u>Biodiversity value:</u></b> Decayed heartwood rot and white rot providing habitat for saproxylic invertebrates.</p> <p><b><u>Cultural and heritage value:</u></b> Tree appears to be present on 1866 OS mapping. Limited visibility from surrounding views given waster site to east and site topography.</p> <p><b><u>Age:</u></b> It's diameter of 1120mm means it has a girth of 3.51m and means it is included within the 'locally notable' criterion of girth in relation to age as shown in Figure 1.3 of 'Ancient and other veteran trees: further guidance on management' (Lonsdale, 2013).</p>

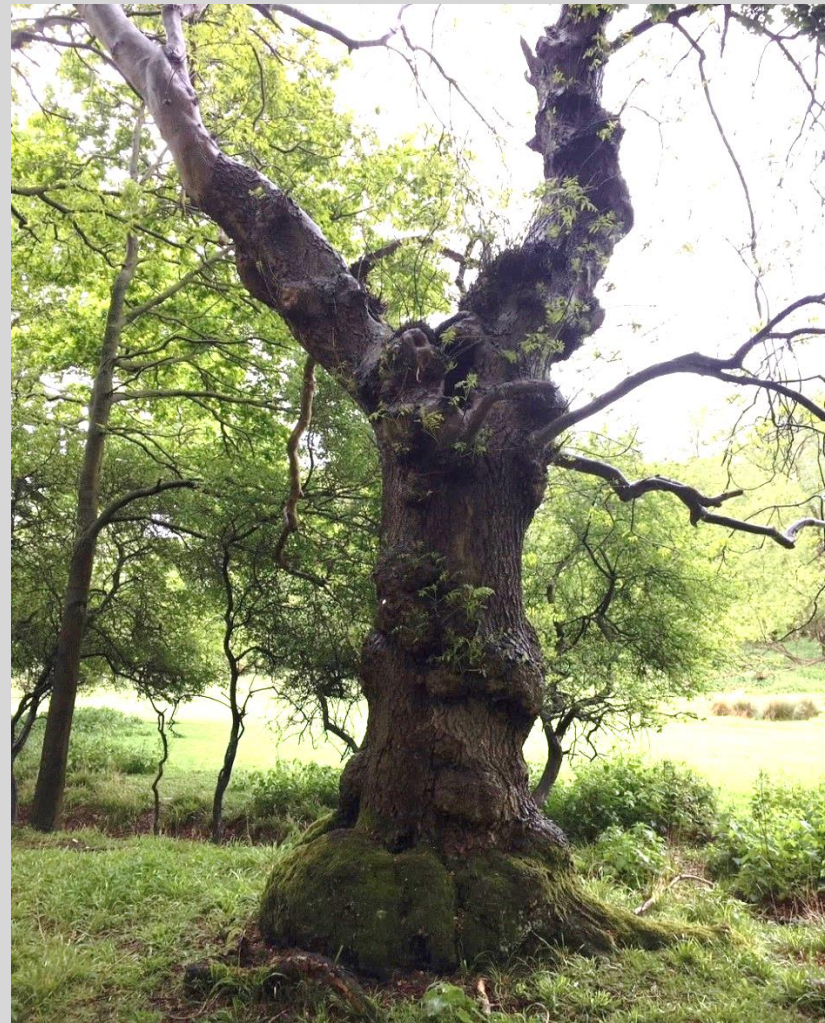
Tree ref	Species	Location	Summary of value	Tree photographs
T074	Common Ash	Easing: 55626752 Northing:19271439  Grove Farm, west boundary of Alder Wood.	<p><b><u>Size:</u></b> Large stem girth in comparison to other ash trees in locality.</p> <p><b><u>Condition:</u></b> Decay features present including extensive internal decay and hollowing main stem, revealing heartwood decay. Pronounced basal swelling, indicative of reaction wood to an internal defect. Cavities on main stem and at old branch wounds and storm damage in crown. Elongated cavities visible in middle crown, and exposed decayed desiccated white rot.</p> <p><b><u>Biodiversity value:</u></b> Decayed heartwood rot and white rot providing habitat for saproxylic invertebrates.</p> <p><b><u>Cultural and heritage value:</u></b> Tree does not appear present on 1866 OS mapping. Limited visibility from surrounding views given existing tree stock and site topography.</p> <p><b><u>Age:</u></b> It's diameter of 900mm means it has a girth of 2.82m and means it is included within the 'locally notable' criterion of girth in relation to age as shown in Figure 1.3 of 'Ancient and other veteran trees: further</p>

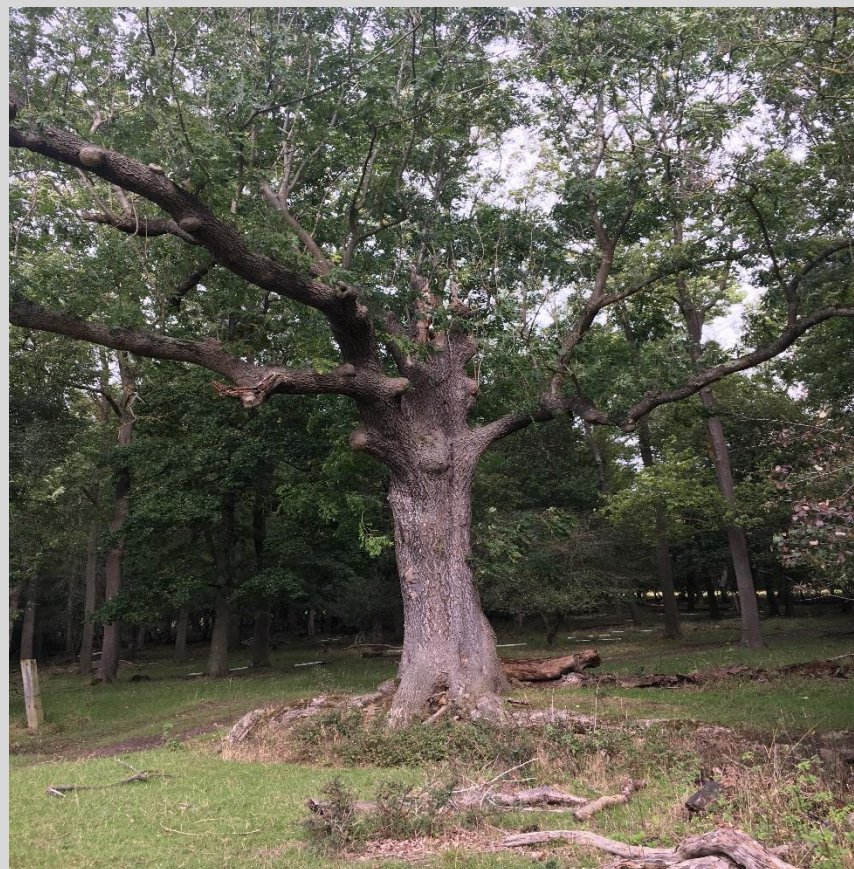
Tree ref	Species	Location	Summary of value	Tree photographs
			guidance on management' (Lonsdale, 2013).	
T077	Common Ash	<p>Easing: 556250 Northing:192753</p> <p>Grove Farm, west boundary of Alder Wood.</p> <p>TPP: HE551519-ATK-ELS-XX-DR-LL-000203 (Appendix C)</p>	<p><b><u>Size:</u></b> Large stem girth in comparison to other ash trees in locality.</p> <p><b><u>Condition:</u></b> Decay features present including extensive internal decay and hollowing main stem, revealing heartwood decay. Pronounced basal swelling, indicative of reaction wood to an internal defect. Cavities on main stem and at old branch wounds and storm damage in crown. Large diameter dead wood in crown.</p> <p><b><u>Biodiversity value:</u></b> Decayed heartwood rot and white rot providing habitat for saproxylic invertebrates.</p> <p><b><u>Cultural and heritage value:</u></b> Tree potentially present on 1866 OS mapping. Limited visibility from surrounding views given existing tree stock and site topography.</p> <p><b><u>Age:</u></b> It's diameter of 950mm means it has a girth of 2.98m and means it is included within the 'locally notable' criterion of girth in relation to age as shown in Figure 1.3 of 'Ancient and other veteran trees: further</p>

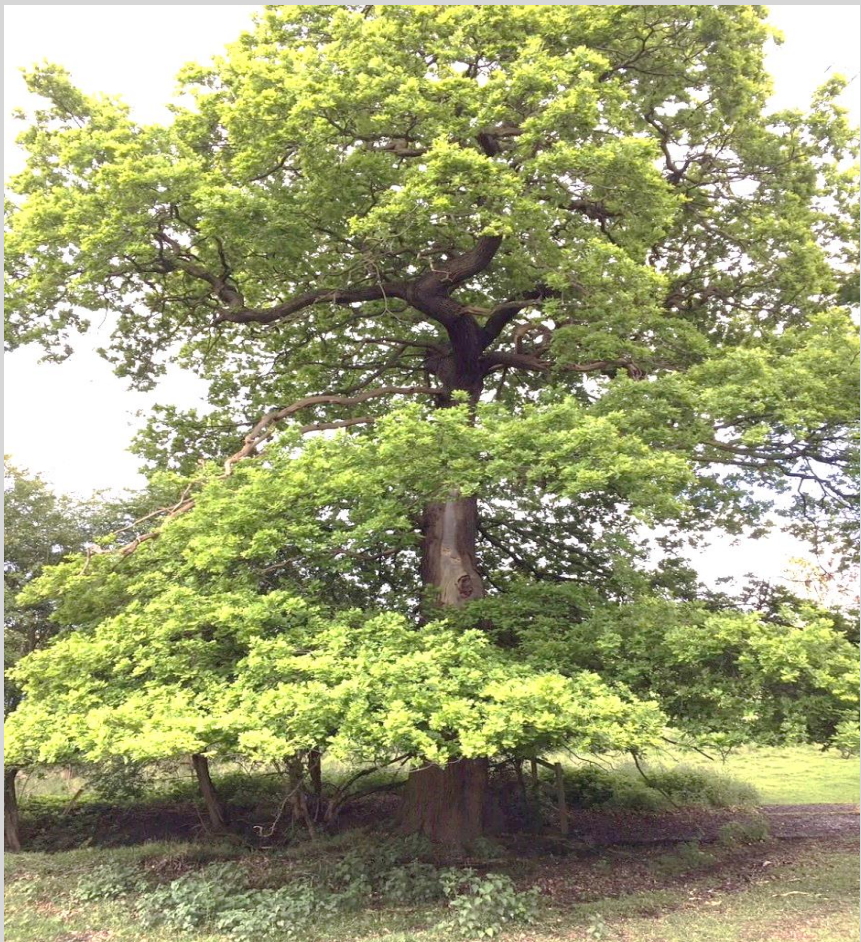
Tree ref	Species	Location	Summary of value	Tree photographs
			guidance on management' (Lonsdale, 2013).	
T095	Common Oak	Easing: 55617256 Northing:19309512  Grove Farm, north of Alder Wood.  TPP: HE551519-ATK-ELS-XX-DR-LL-000205 (Appendix C)	<p><b><u>Size:</u></b> Large stem girth in comparison to other trees in locality.</p> <p><b><u>Condition:</u></b> Decay features present including elongated wound on north west side of main stem, exposed and desiccated dead wood. Heartwood decay developing. Moderate diameter dead wood in middle crown. Frayed old branch sounds. Cracks and fissures in pieces of dead wood.</p> <p><b><u>Biodiversity value:</u></b> Decayed heartwood rot and white rot providing habitat for saproxylic invertebrates.</p> <p><b><u>Cultural and heritage value:</u></b> Tree appears to be present on 1866 OS mapping. Partially visible from views to east from M25, and views to west from golf course.</p> <p><b><u>Age:</u></b> It's diameter of 1010mm means it has a girth of 3.17m and means it is included within the 'locally notable' criterion of girth in relation to age as shown in Figure 1.3 of 'Ancient and other veteran trees: further guidance on management' (Lonsdale, 2013).</p>

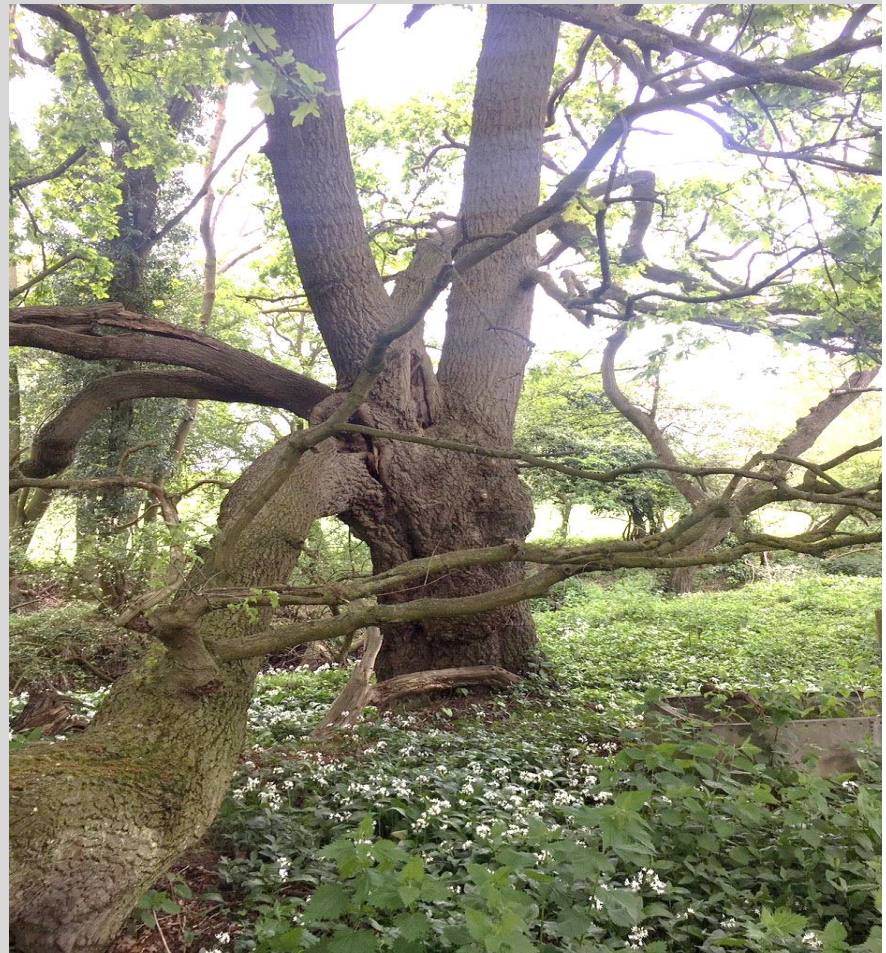
Tree ref	Species	Location	Summary of value	Tree photographs
T097	Common Oak	<p>Easing: 55610556 Northing:19319146</p> <p>Grove Farm, north extents of scheme, adjacent to M25.</p> <p>TPP: HE551519-ATK-ELS-XX-DR-LL-000206 (Appendix C)</p>	<p><b><u>Size:</u></b> Large stem girth in comparison to other trees in locality.</p> <p><b><u>Condition:</u></b> Decay features present including hollowing main stem, revealing heartwood decay.</p> <p>South west scaffold branch historically failed, now resting on the ground and partially attached to main stem. Large wound remaining.</p> <p>Exposed desiccated dead wood visible. Crossing and natural propping of branches in crown. Elongated cavity at old branch failure to south at 6m, and further storm damage recorded in crown.</p> <p><b><u>Biodiversity value:</u></b> Decayed heartwood rot and white rot providing habitat for saproxylic invertebrates.</p> <p><b><u>Cultural and heritage value:</u></b> Tree appears to be present on 1866 OS mapping. Partially visible from views to east from M25, and views to west from golf course.</p> <p><b><u>Age:</u></b> It's diameter of 1430mm means it has a girth of 4.49m and means it is included within the 'veteran/notable' criterion of girth in relation to age as shown in Figure 1.3 of 'Ancient and other veteran trees:</p>

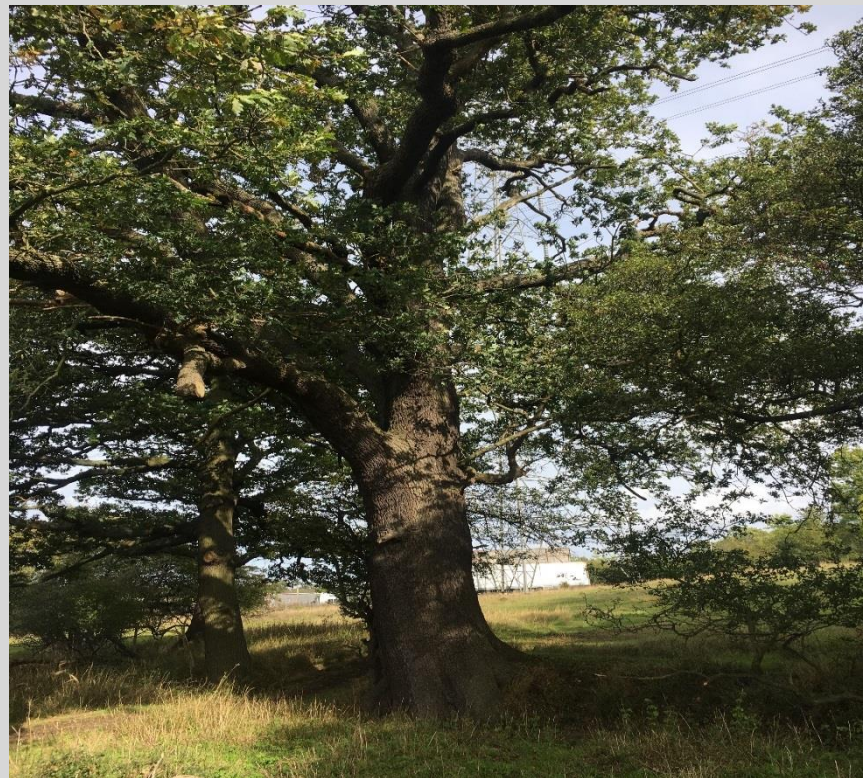
Tree ref	Species	Location	Summary of value	Tree photographs
			further guidance on management' (Lonsdale, 2013).	
T109	Common Oak	<p>Easing: 556189.4 Northing: 193014.5</p> <p>Grove Farm, growing within hedgerow extending north of Alder Wood.</p> <p>TPP: HE551519-ATK-ELS-XX-DR-LL-000205 (Appendix C)</p>	<p><b><u>Size:</u></b> Large stem girth in comparison to other trees in locality.</p> <p><b><u>Condition:</u></b> Decay features present including occasional deadwood branches to 250mm diameter with desiccated white rot.</p> <p><b><u>Biodiversity value:</u></b> Decayed white rot providing habitat for saproxylic invertebrates.</p> <p><b><u>Cultural and heritage value:</u></b> Tree appears to be present on 1866 OS mapping. Partially visible from views to east from M25, and views to west from golf course.</p> <p><b><u>Age:</u></b> It's diameter of 1290mm means it has a girth of 4.05m and means it is included within the 'locally notable' criterion of girth in relation to age as shown in Figure 1.3 of 'Ancient and other veteran trees: further guidance on management' (Lonsdale, 2013).</p>

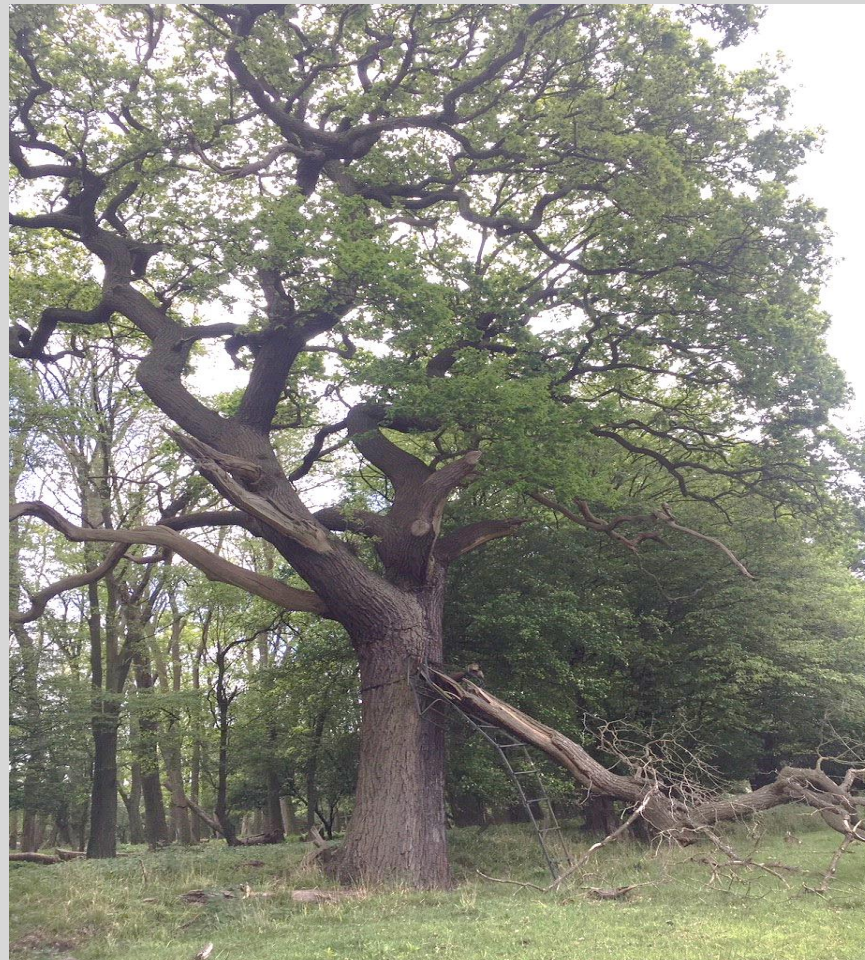
Tree ref	Species	Location	Summary of value	Tree photographs
T112	Common Oak	<p>Easing: 556186.5 Northing: 192911.4</p> <p>Grove Farm, west extents of Alder Wood.</p> <p>TPP: HE551519-ATK-ELS-XX-DR-LL-000205 (Appendix C)</p>	<p><b><u>Size:</u></b> Large stem girth in comparison to other trees in locality.</p> <p><b><u>Condition:</u></b> Decay features present including extensive dead branches in crown with desiccated white rot. Developing heartwood decay at old branch wounds.</p> <p><b><u>Biodiversity value:</u></b> Decayed heartwood rot and white rot providing habitat for saproxylic invertebrates.</p> <p><b><u>Cultural and heritage value:</u></b> Tree appears to be present on 1866 OS mapping. Tree not visible from views to the east given existing tree stock and topography, potentially view from golf course views to west.</p> <p><b><u>Age:</u></b> It's diameter of 1060mm means it has a girth of 3.33m and means it is included within the 'locally notable' criterion of girth in relation to age as shown in Figure 1.3 of 'Ancient and other veteran trees: further guidance on management' (Lonsdale, 2013).</p>

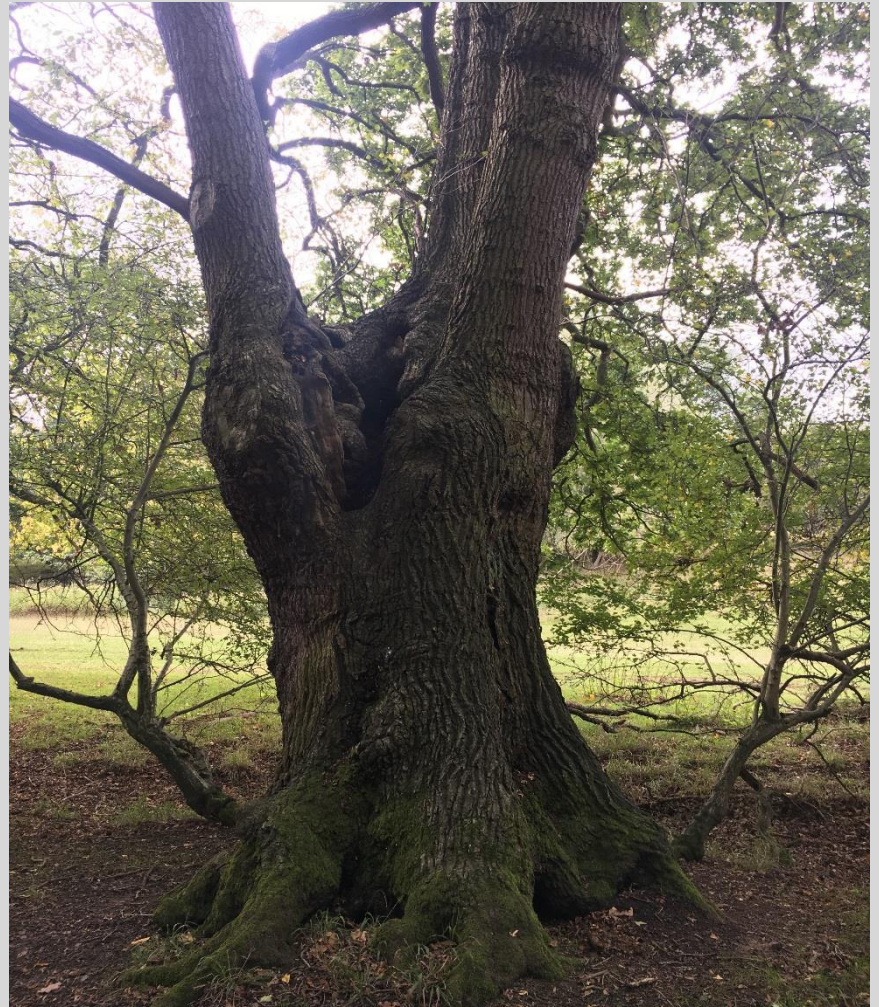
Tree ref	Species	Location	Summary of value	Tree photographs
T114	Common Oak	Easing: 556206.7 Northing: 192805.1  Grove Farm, west extents of Alder Wood.  TPP: HE551519-ATK-ELS-XX-DR-LL-000205 (Appendix C)	<p><b><u>Size:</u></b> Large stem girth in comparison to other trees in locality.</p> <p><b><u>Condition:</u></b> Decay features present including hollow main stem, revealing extensive heartwood decay.  Large diameter dead branches in crown with desiccated white rot. Historic pollard.</p> <p><b><u>Biodiversity value:</u></b> Decayed heartwood rot and white rot providing habitat for saproxylic invertebrates.</p> <p><b><u>Cultural and heritage value:</u></b> Tree appears to be present on 1866 OS mapping.  Tree not visible from views to the east given existing tree stock and topography, potentially view from golf course views to west.</p> <p><b><u>Age:</u></b> It's diameter of 1380mm means it has a girth of 4.33m and means it is included within the 'veteran/notable' criterion of girth in relation to age as shown in Figure 1.3 of 'Ancient and other veteran trees: further guidance on management' (Lonsdale, 2013).</p>

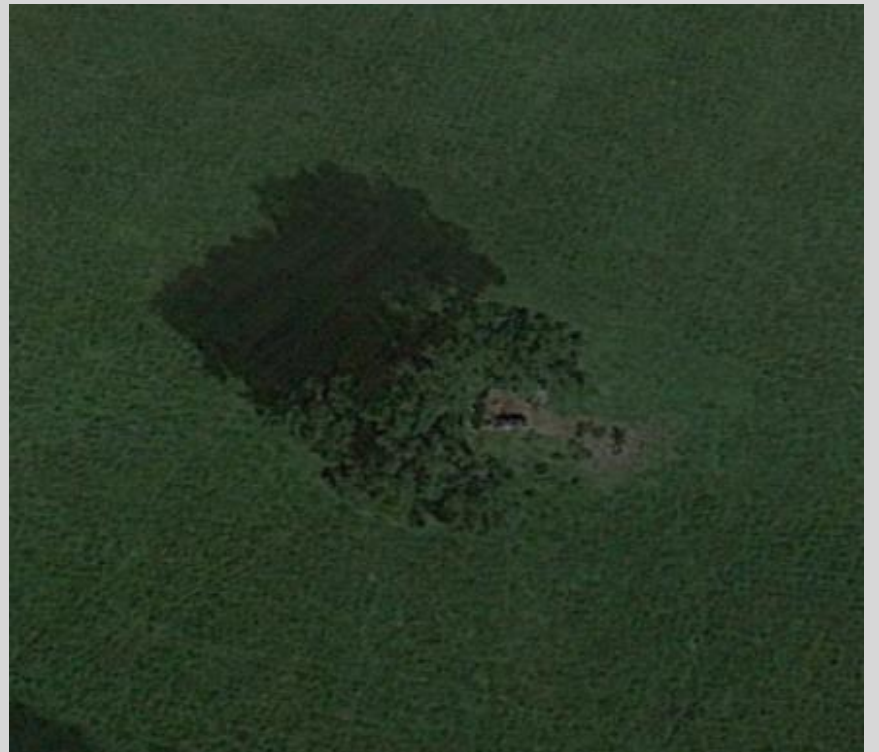
Tree ref	Species	Location	Summary of value	Tree photographs
T168	Common Oak	<p>Easing: 55687514 Northing:19265226</p> <p>Growing within grassed field to west of A12, north of junction 28.</p> <p>TPP: HE551519-ATK-ELS-XX-DR-LL-000204 (Appendix C)</p>	<p>Partially visible from surrounding views from M25 junction 28 off-slip.</p> <p><b><u>Size:</u></b> Large stem girth in comparison to other trees in locality.</p> <p><b><u>Condition:</u></b> Decay features present including hollow main stem, revealing extensive heartwood decay.</p> <p>Extensive storm damage recorded, loss of main leader. Exposed heart wood decay. Water pocket in main stem. Remaining crown relatively intact. Dead wood piled at base. Desiccated white rot in crown. Occasional dead branch.</p> <p><b><u>Biodiversity value:</u></b> Decayed heartwood rot and white rot providing habitat for saproxylic invertebrates.</p> <p><b><u>Cultural and heritage value:</u></b> Tree potentially present on 1866 OS mapping. Tree not visible from views to the east given existing tree stock and topography, potentially view from golf course views to west. Tree outside of Lower Vicarage ancient woodland.</p> <p><b><u>Age:</u></b> It's diameter of 1380mm means it has a girth of 4.33m and means it is included</p>

<p>Aerial photo of T168 from taken from Google Earth, March 2020 as health and safety concerns restricted photograph being taken.</p>

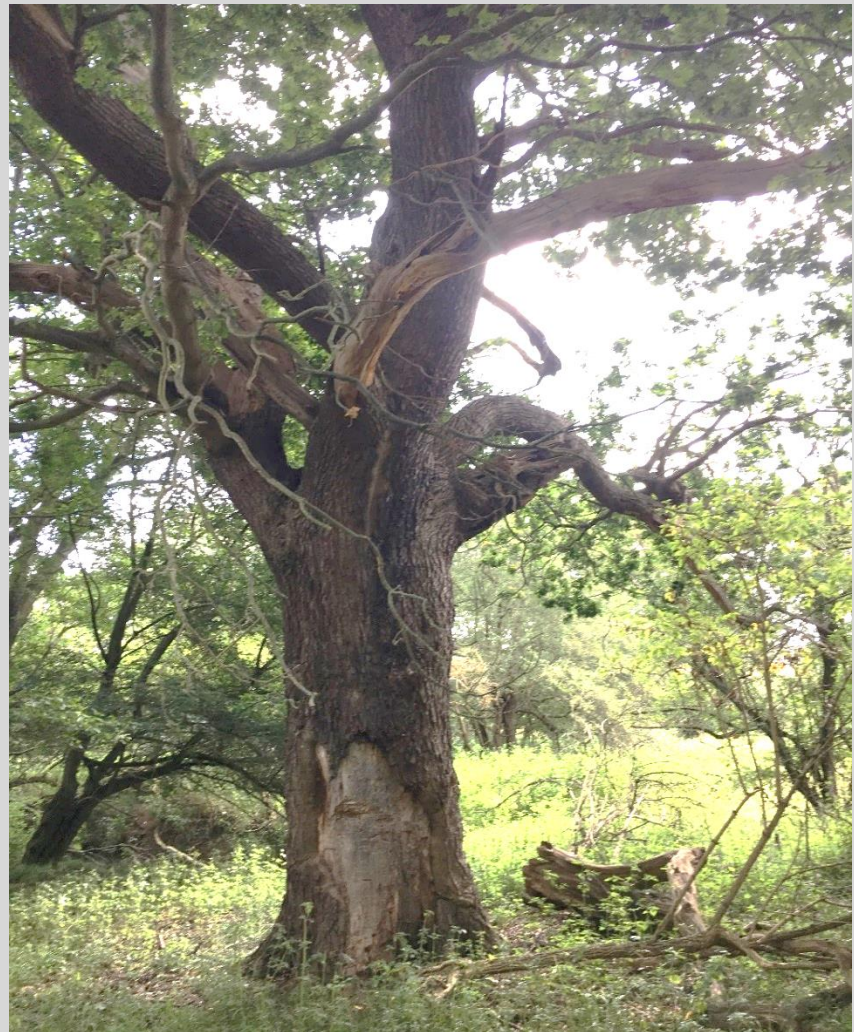
Tree ref	Species	Location	Summary of value	Tree photographs
T180	Common Oak	Easing: 55625384 Northing: 19260157  Glebelands Estate, west of The Weald Brook  TPP: HE551519-ATK-ELS-XX-DR-LL-000203 (Appendix C)	<p><b><u>Size:</u></b> Large stem girth in comparison to other trees in locality.</p> <p><b><u>Condition:</u></b> Decay features present including extensive basal wounds to east and west, revealing onset of hollowing and heartwood decay. Large area of desiccated white rot on surface of dysfunctional wood. Extensive large diameter (&gt;200mm) storm damage recorded in crown. Frayed wounds. Large diameter dead wood in crown and around base.</p> <p><b><u>Biodiversity value:</u></b> Decayed heartwood rot and white rot providing habitat for saproxylic invertebrates.</p> <p><b><u>Cultural and heritage value:</u></b> Tree potentially present on 1866 OS mapping. Partially visible from views from golf course to west.</p> <p><b><u>Age:</u></b> It's diameter of 1250mm means it has a girth of 3.92m and means it is included within the 'locally notable' criterion of girth in relation to age as shown in Figure 1.3 of 'Ancient and other veteran trees: further guidance on management' (Lonsdale, 2013).</p>
