M25 junction 28 improvement scheme TR010029 6.3 Environmental Statement Appendix 7.15: Otter and water vole survey

6.3 ENVIRONMENTAL STATEMENT 7.15: OTTER AND WATER VOLE SURVEY

Otter and Water Vole Survey Report: Junction 28 M25

Date: January 2020

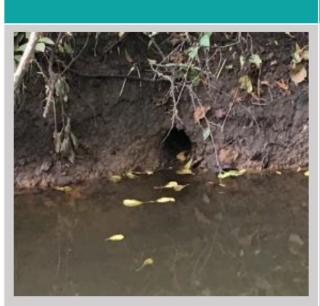
No signs of water vole were recorded during any of the survey visits. A burrow (Photograph 1, Annex 3) was recorded on the Weald Brook near its confluence with the Ingrebourne River (grid reference TQ5643992222). However, no other evidence of water voles was recorded and as such it is considered likely that the hole was made by either rats or signal crayfish (*Pacifastacus leniusculus*) which have been recorded in the watercourses. In May 2018 approximately 10 burrows were recorded south of the A12, south of the DCO boundary, which were consistent with that of signal crayfish.

Photograph 1: Burrow recorded on Weald Brook, likely to be rat or signal crayfish.

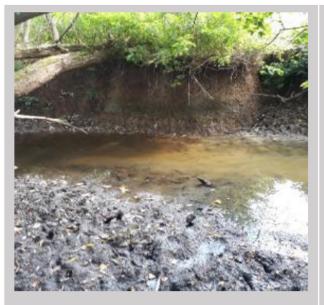
Weald Brook has been heavily impacted by deer crossing the watercourse and the banks were predominantly devoid of vegetation due to shading from trees (Photographs 5 and 6). There was also no in-channel aquatic vegetation. In addition there was a lot of undermining of the banks associated with variations in water levels. Areas of scrub were present along its length which could provide suitable shelter for otters. Weald Brook provides suitable commuting habitat for otters due to its connectivity to other watercourses.

Due to the impact of fallow deer crossing the brook, the banks of Weald Brook within the Survey Area are considered to be unsuitable for supporting water voles. In addition there was a lack of food source as a result of shading from trees along the brook. As such Weald Brook is considered to be sub-optimal for water voles.

Photograph 5: Weald Brook (damage from fallow deer shown at front of photo)

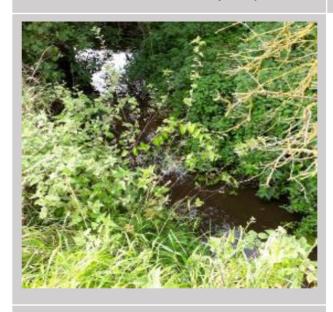
The Ingrebourne River located within the DCO boundary just north of the A12 was considered to be more suitable for water voles than the Weald Brook, , with bank vegetation suitable for providing a foraging source (Photograph 7). However bank profiles were typically shallow which was less suitable for the creation of burrows. In addition an extensive box culvert (over 100m in length) is present where the watercourse flows under the M25 Junction 28. This box culvert was likely to restrict movement of water voles. A stretch of the Ingrebourne River immediately south of Oak Farm (south of A12) measuring approximately 20m in length supported sedge habitat typically required to support foraging water vole.

Photograph 7: River Ingrebourne
