# **A46 Coventry Junctions (Walsgrave) Scheme number: TR010066**

### **Appendix 8.10 Otter and Water Vole Report**

November 2024

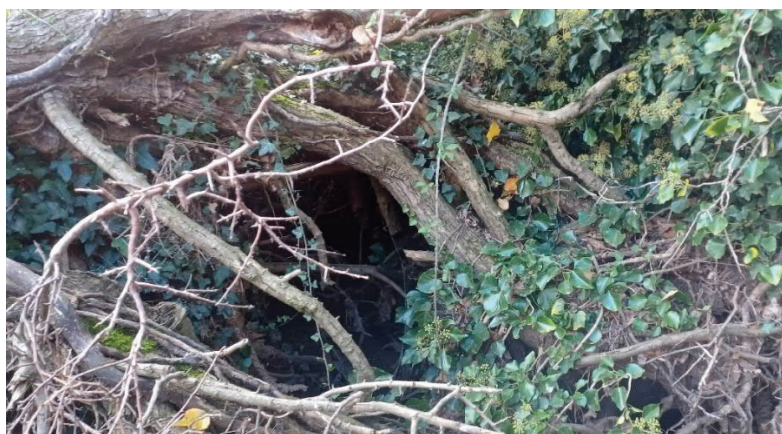
Plate 1 A potential resting place on the River Sowe

- 3.2.5. One potential couch was identified on the river within the roots of a fallen tree (see Appendix A and Plate 1). Footprints were present on the exposed mud at the channel margin; however, these were unidentifiable due to the recent heavy rainfall. The potential couch was reidentified during the 2023 survey however no field signs were noted indicating use.

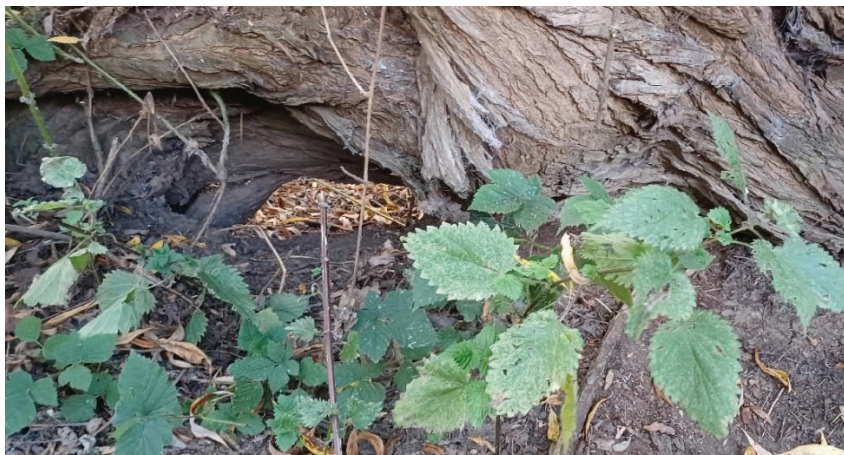
Plate 2 A potential couch at the base of a tree on Smite Brook

- 3.2.10. Evidence of otter foraging (cockle shell remains) was also recorded on the section of Smite Brook within Coombe Pool SSSI.
- 3.2.11. There was no evidence of otter recorded during the 2023 survey along Smite Brook.

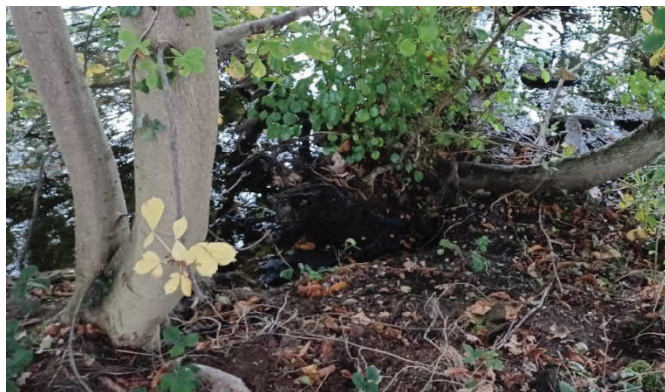
Plate 3 A confirmed otter couch beneath horse chestnut on the banks of Coombe Pool Fishery

- 3.2.17. The couch within the horse chestnut was reidentified during the 2023 survey however no field signs were noted indicating use.

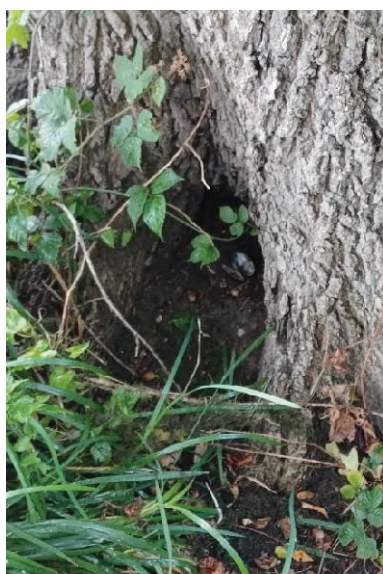
Plate 4 A confirmed otter couch within a bankside tree trunk on Coombe Pool Fishery

- A confirmed couch within the trunk of a bankside tree with feeding remains (mollusc shells) present (see Appendix A and Plate 4).

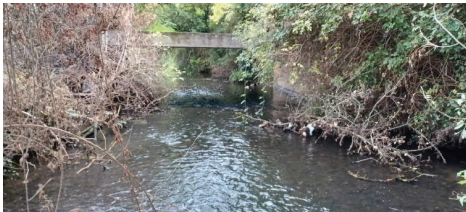
Section 2	0	0	1	1	1	0	0	0	3 – sub-optimal
<p>Description: The river was 10cm deep with a fast rippled flow. The bed is pebble/cobble with an unidentified submerged species growing between the pebbles. Public footpaths are present on both banks. The eastern bank was largely bare with the exception of bankside trees dominated by ash <i>Fraxinus excelsior</i> and hawthorn <i>Crataegus monogyna</i>. The western bank was wooded with ash and sycamore <i>Acer pseudoplatanus</i> noted and nettles <i>Urtica dioica</i> and ivy <i>Hedera helix</i> on the bank itself. <b>Section length: 35m</b></p>

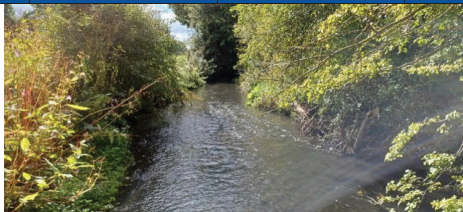
Section 5	1	0	1	1	1	0	0	0	4 – sub-optimal
Description: The river was 30cm deep with both smooth and rippled flows and a rocky bed. Vegetation on the eastern bank comprises ivy, grass and nettles, leading into a grazed field. The western bank was dominated by bramble <i>Rubus fruticosus</i> agg. with a footpath behind. <b>Section length: 55m.</b>

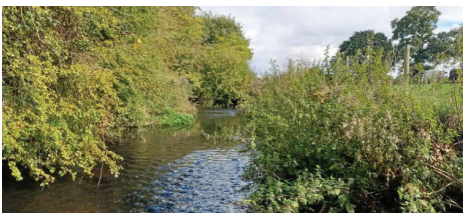
Section 6	1	0	1	1	1	0	0	0	4 – sub-optimal
Description: The river was 5-20cm deep with a fast rippled flow and a rocky bed. Water starwort <i>Callitriche</i> sp. was present in areas. Vegetation on the eastern bank included nettle, grass species and bramble and lead into a grazed field. The western bank was vegetated by bramble and hawthorn leading to a footpath. <b>Section length: 190m.</b>

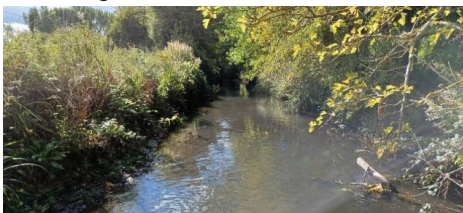
Section 7	0	0	1	1	1	1	0	0	4 – sub-optimal
Description: A section on a bend in the river, where water level was 1m deep and the bed was silt. The river was slow flowing with some watercress <i>Nasturtium officinale</i> growing on the margins. The eastern bank was vegetated by bramble with a grazed field behind it. Vegetation on the western bank included nettles with bankside trees, and a public footpath. Evidence of hand pulling of Himalayan balsam was recorded. <b>Section length: 30m.</b>

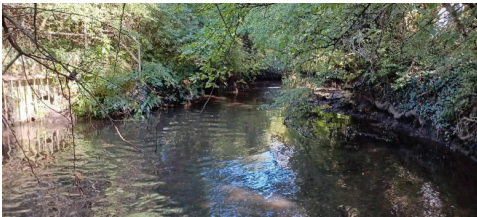
<b>Section 9</b>	1	1	1	1	1	1	0	1	<b>7 – optimal</b>
<p>Description: The river was 30cm deep with a smooth fast flow, with a rocky bed. Common reed <i>Phragmites australis</i> was present on the 45 degrees eastern bank with hawthorn trees and Himalayan balsam present. The common reed offers potential nesting habitat. The western bank was 80 degrees in profile with tall ruderal willowherb <i>Epilobium</i> sp., Himalayan balsam, nettle and some grass species. Potential disturbance could come from the public footpath on the west bank. <b>Section length: 60m.</b></p>

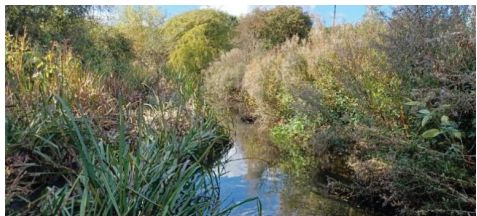
<b>Section 10</b>	0	0	1	1	1	0	0	0	<b>3 – sub-optimal</b>
<p>Description: The river was 5-10 cm deep with a fast rippled flow on a pebble bed. The south bank was composed of a mix of stone and earth, with a steep profile and ivy cover and bankside hawthorn. The northern bank had a steep profile and comprised earth, with nettle, ivy and hawthorn present. A lack of food sources and cover for water voles was noted. <b>Section length: 55m.</b></p>

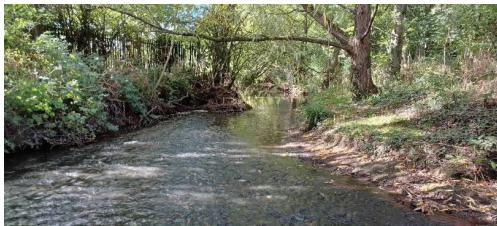
<b>Smite Brook</b>									
<b>Section 1</b>	1	1	1	0	1	1	0	0	<b>5 – sub-optimal</b>
<p>Description: The brook was 40cm deep with a smooth flow and a pebble and silt bed. The vegetation on the north bank comprised willow trees with nettle, hogweed <i>Heracleum sphondylium</i> and grass species whilst the south bank comprised nettle, apple <i>Malus</i> sp., bramble and willow. Common Reed was present within the channel. The banks were shallow and 45 degrees in profile. <b>Section length: 85m.</b></p>

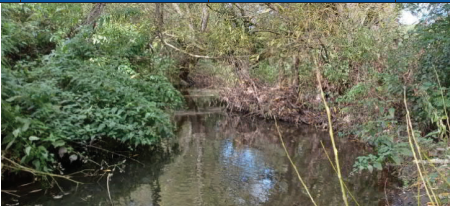
Section 2	1	1	1	0	1	1	1	0	6 - optimal
Description: The brook was 20cm deep and slow flowing with a silty bed with small amounts of pebbles. The west bank 40cm tall steep and earthen with nettles and a stone wall behind the bank. The eastern bank was shallow and stone with willow <i>Salix</i> sp., common reed and willowherb. <b>Section length: 20m.</b>

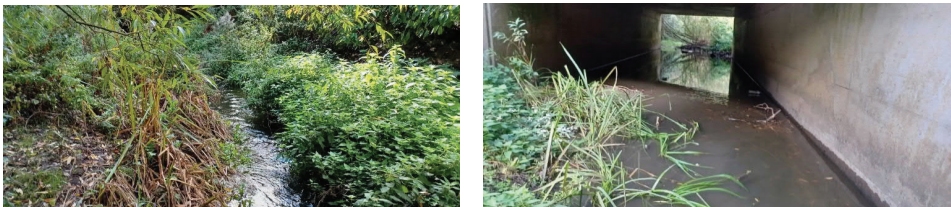
Section 3	0	0	1	1	1	0	1	0	4 – sub-optimal
Description: The brook was 10cm deep with a slow flow and a pebble and sand bed. The western bank was 40cm high and comprised bare earth with some nettle. The eastern bank was 2m high with some shallow and steeper profile areas. Vegetation on the eastern bank included the bankside trees Norway maple <i>Acer platanoides</i> and hawthorn, and ivy and privet <i>Ligustrum</i> sp. ground flora. <b>Section length: 80m.</b>

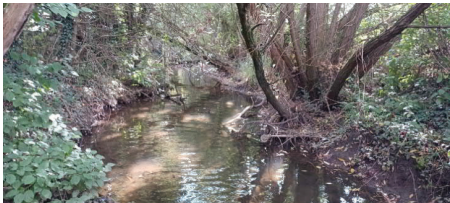
Section 4	0	0	1	0	1	1	0	0	3 – sub-optimal
Description: The brook was 10cm deep with a fast rippled flow and a cobbles and silt bed. The eastern bank was a concrete wall and the western bank was earthen and shallower in profile at 45 degrees with ivy cover. This section is close to public footpaths and dogs are likely to use the water regularly. <b>Section length: 10m.</b>

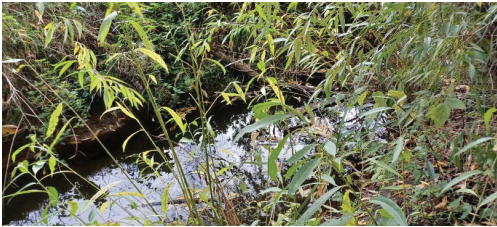
<b>Section 6</b>	0	0	1	0	1	1	0	0	<b>3 – sub-optimal</b>
<p>Description: The brook was 40cm deep with a slow rippled flow. The northern bank was shallow in profile (45°) with some nettle however mostly bare of vegetation. The southern bank was vegetated by ivy, hawthorn and willow; however areas of bare bank were present. Disturbance was recorded on both sides and the bed was recorded as silt. <b>Section length: 160m.</b></p>

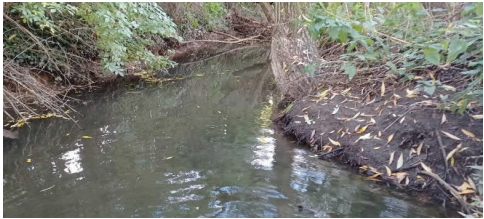
<b>Section 7</b>	1	0	1	1	1	0	0	0	<b>4 – sub-optimal</b>
<p>Description: The brook was 20cm deep with a silt bed and a slow rippled flow. The northern bank was 1.5m high and earthen with nettle and willow trees. The southern bank was shallow with very dense nettle and willow which would provide cover for water voles. Disturbance was recorded on both sides of the brook. <b>Section length: 55m.</b></p>

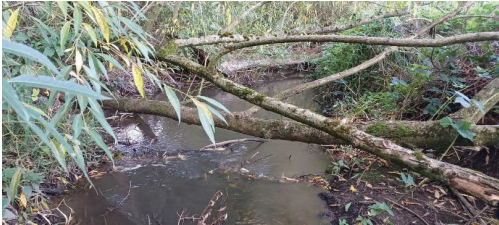
<b>Section 8</b>	1	1	0	0	1	0	1	1	<b>5 – sub-optimal</b>
<p>Description: The brook section leads to a culvert under the A46 and is 40cm deep. The bed was silt and the water flow was fast and rippled. The northern bank was shallow and dominated by common reed with nettles and willowherb present. The emergent vegetation common reed was noted as suitable water vole nesting building habitat. The south bank was composed of stone for the bottom-most 20cm, whilst the upper bank was earthen and steep in profile and dominated by grass species and the occasional hawthorn and oak <i>Quercus</i> sp. <b>Section length: 60m.</b></p>

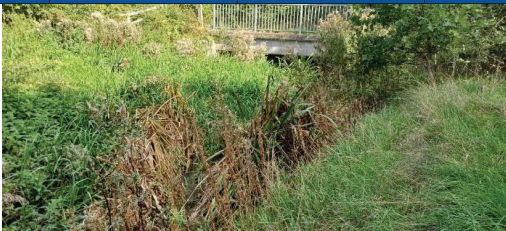
<b>Section 9</b>	1	1	1	0	1	0	1	0	<b>5 – sub-optimal</b>
Description: This section of the brook flows underneath the A46. The section is characterised by a slow flow and a silty bed, with water depth at the time of survey approximately 50cm. Common reed was present within the channel. The banks were steep and made of stone, and as such unsuitable for water vole. <b>Section length: 30m.</b>

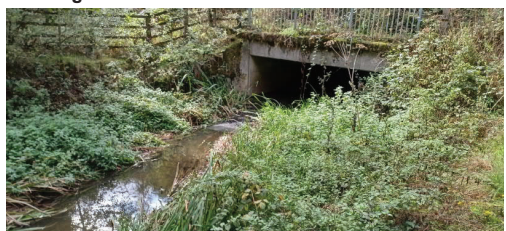
<b>Section 10</b>	1	1	1	0	1	0	1	0	<b>5 – sub-optimal</b>
Description: The section of the brook meets the outfall from Coombe Pool Fishery and creates a body of water with no apparent flow. The turbidity was high, preventing an observation on the water depth. Vegetation on the shallow banks was bramble dominated with some grass species. Common reed was present within the waterbody. <b>Section length (diameter): 30m.</b>

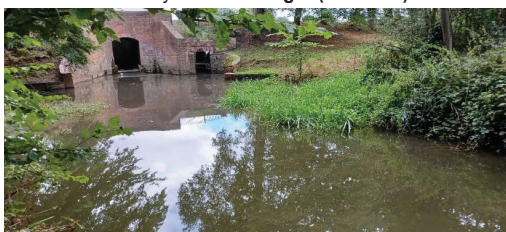
<b>Section 11</b>	0	0	1	1	1	0	1	0	<b>4 – sub-optimal</b>
Description: The brook had a slow flow is 40cm deep water and a sandy/silty bed. The banks are steep and dominated by bramble and nettle which leads into woodland. <b>Section length: 50m.</b>

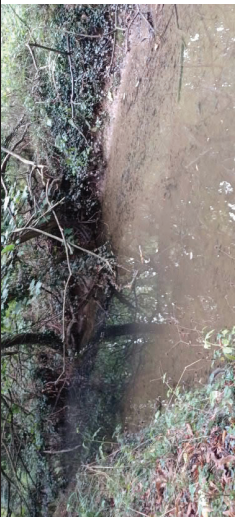
Section 12	0	0	0	1	1	0	1	0	4 – sub-optimal
Description: This section of the brook was fast flowing from an outfall of Coombe Pool Fishery. The bed was rocky. Shallow areas of approximately 10cm deep were present, with a deeper pool present behind a 50cm waterfall. Banks were composed of earth and their profile was approximately 90 degrees. Banks were mostly bare, however some ivy was present. <b>Section length: 65m.</b>

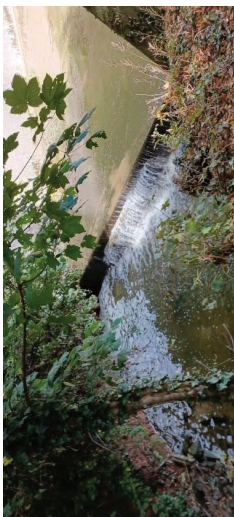
Unnamed Watercourse 1									
Section 1	0	0	1	0	0	0	1	0	2 – unsuitable

Description: A ditch which is 5cm deep and 50cm wide. The flow was rippled and the bed silt. Vegetation on the east bank comprised scrub and nettle, whilst the west bank was vegetated by ivy and hawthorn trees. <b>Section length: 55m.</b>

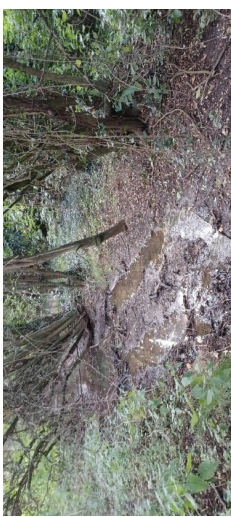
Section 2	0	0	1	1	0	0	0	0	2 – unsuitable
Description: This section of the ditch was 5-10 cm deep with a slow rippled flow at the northern extent and a silt bed. The ditch section dries out further south. The eastern bank was approximately 50cm high and mostly bare ground with some ivy and hawthorn. The west bank was steep in profile and approximately 3m high, with mostly bare ground and ivy and hawthorn present. <b>Section length: 145m.</b>

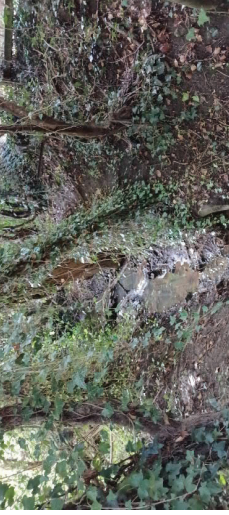
<b>Section 2</b>	0	0	1	1	1	0	0	0	<b>3 – sub-optimal</b>
Description: The watercourse was 5-30cm deep water with a silty bed containing cobbles and pebbles and a slow flow and bare banks. The eastern bank was shallow and the western bank vertical. Both banks were composed of earth with a higher amount of organic material. <b>Section length: 105m.</b>

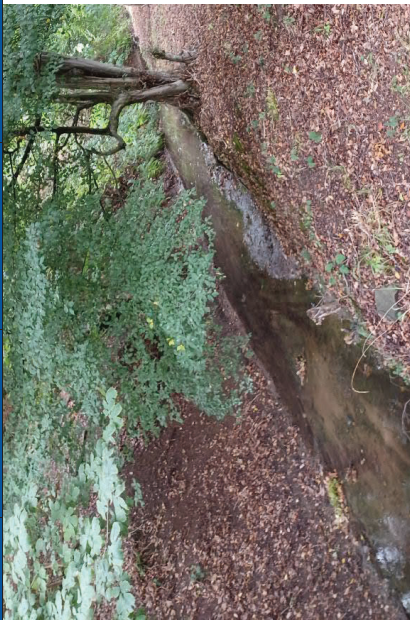
Section 3	0	0	0	0	1	0	0	0	1 – unsuitable
Description: The watercourse was shallow, had a slow flow, a silty bed containing pebbles and a high amount of organic matter. The eastern bank was composed of gabions with ferns growing between the stones. The western bank was vertical and composed of earth, covered in ferns and moss. <b>Section length: 220m</b>

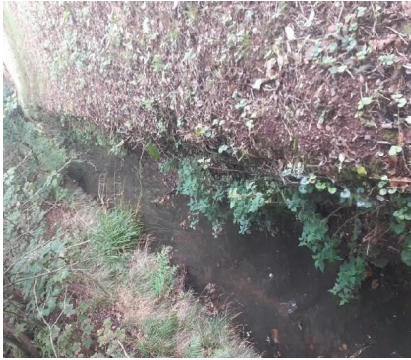
Section 4	0	0	0	1	0	0	0	0	1 – unsuitable
Description: The depth of the water was approximately 5cm, with a slow flow and sandy bed. The eastern and western banks were composed of earth. The western bank was steep with beech <i>Fagus sylvatica</i> trees and the eastern bank was reinforced with a gabion and covered with nettles. <b>Section length: 70m</b>
