**East Midlands Gateway
Phase 2 (EMG2)**

EMG1 Factual Ground Investigation Report

Zone 1 Main Development Plateau and Rail Freight Terminal

Factual Ground Investigation Report

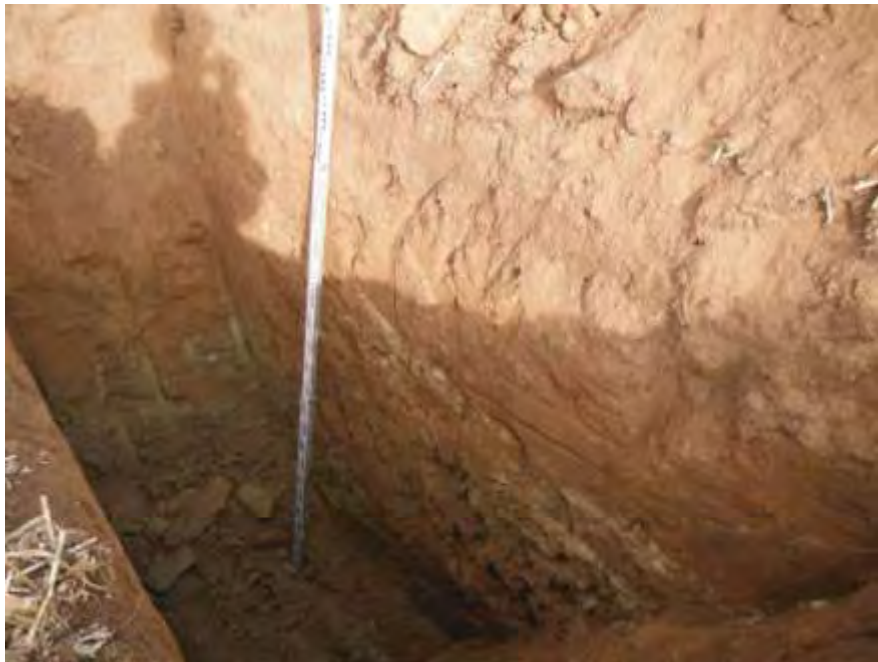
Photo No. 12	Date: 24.09.13
Direction Taken: N/A	Photo
Description: TP313

A photograph showing a vertical cross-section of a soil profile. A white measuring tape is positioned vertically against the left wall of a deep, narrow excavation. The soil is a reddish-brown color and shows distinct horizontal layering or stratification. The bottom of the excavation is dark and appears to be composed of loose soil and some small rocks. The right side of the image shows the continuation of the soil face.

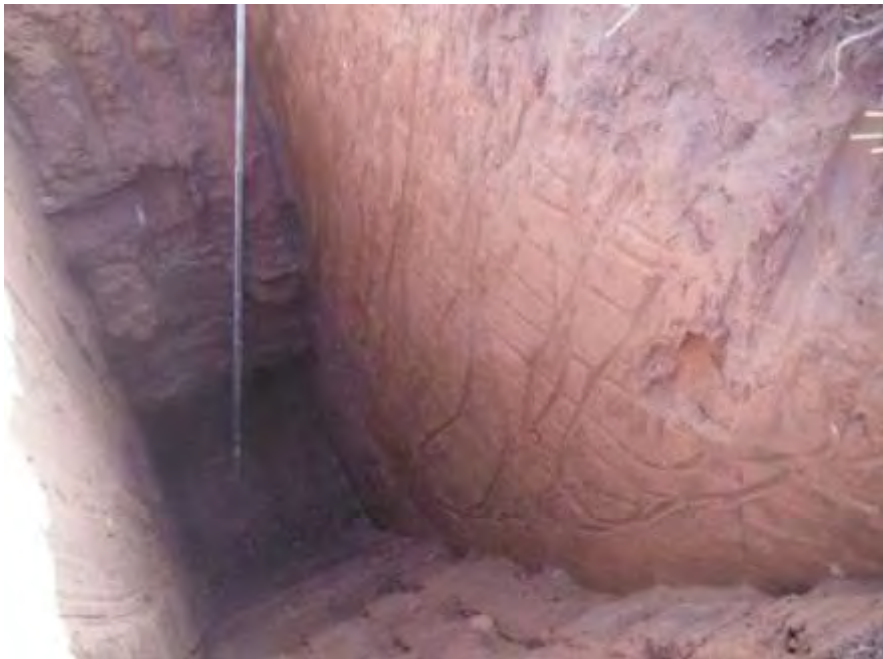
Photo No. 24	Date: 24.09.13
Direction Taken: N/A	Photo
Description: TP326

A photograph of a vertical borehole in reddish-brown soil. A metal rod is inserted into the hole, and the soil wall shows some horizontal layering or fracturing.
