# Wylfa Newydd Project

## 6.4.27 ES Volume D - WNDA Development App D8-2 - Fluvial Geomorphology Baseline Report

### **Fluvial Geomorphology Baseline Report**

60PO8007-GEO-REP-001 | V2.0

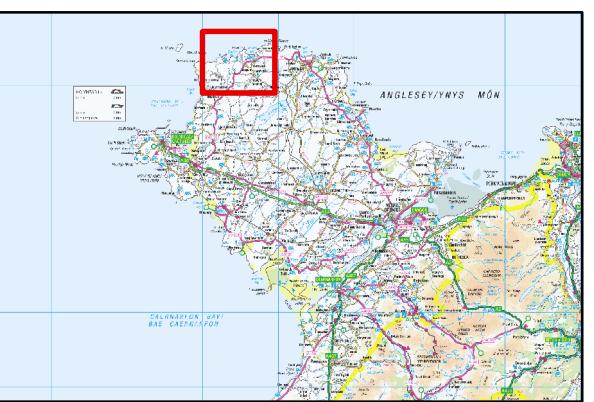
The coastal areas shown within the study area are considered within the fluvial geomorphology assessment to determine potential downstream effects; however, the direct impacts are assessed within the Marine Environment chapter.

MAR 18	DCO submission	HNPWL	HNPWL	HNPWL	HNPWL
Date	Purpose of revision	Drawn	Check'd	Rev'd	App'r'd
<p>ent</p> <p><b>HORIZON</b> NUCLEAR POWER</p> <p>ject</p> <p>WYLFA NEWYDD PROJECT ENVIRONMENTAL STATEMENT</p> <p>owing Title</p> <p>FLUVIAL GEOMORPHOLOGY STUDY AREA AND KEY RECEPTORS</p>					
ale @ A3	1:30,000	DO NOT SCALE			
obs No.	60PO8077				
ent No.					
owing No.	60PO8077 DCO D 08 02

The following locations were observed during the geomorphological reconnaissance surveys and are shown on Figure 1.1:

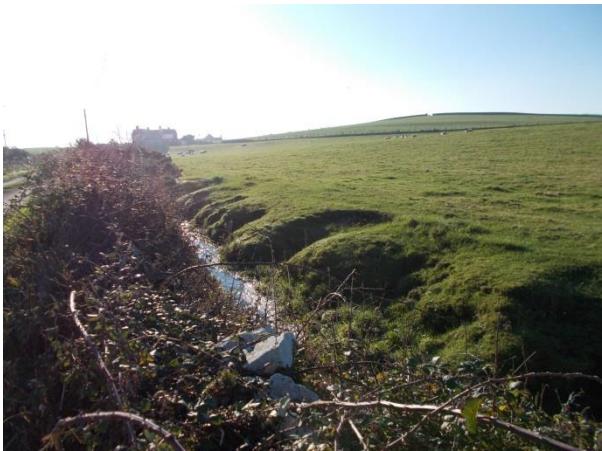
The Nant Cemlyn is a small channel demarking a field boundary within the Wylfa Newydd Development Area. During the surveys the channel was found to be approximately 2m in width as it flowed north towards Neuadd. The watercourse was observed to become a narrower channel, approximately 1m wide, continuing to flow north alongside Nanner Road. Some areas of natural adjustment were found, with erosion and deposition creating a sinuous planform within the artificially constrained channel (figure 5.1). Several areas of poaching and consequent slumping were noted on the left bank of the channel.

Figure 5.1: Erosion present on the left bank of the Nant Cemlyn, primarily caused by poaching

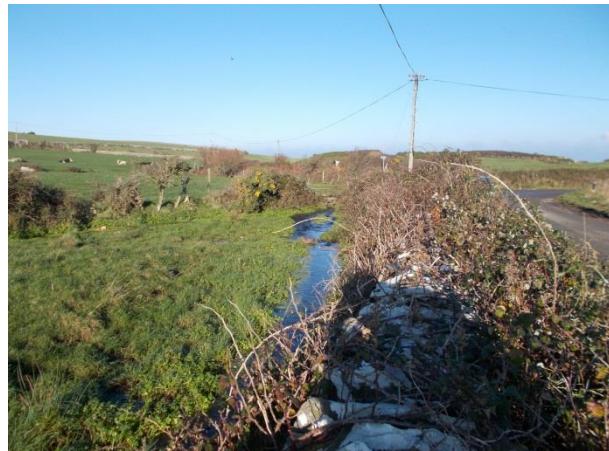
Culverts and bridges were present along the entire reach. Some terrestrial vegetation was present within the channel and on banks (figure 5.2), and the substrate consisted of gravel, cobbles and pebbles (figure 5.3).

Figure 5.2: Nant Cemlyn flowing downstream alongside Nanner Road

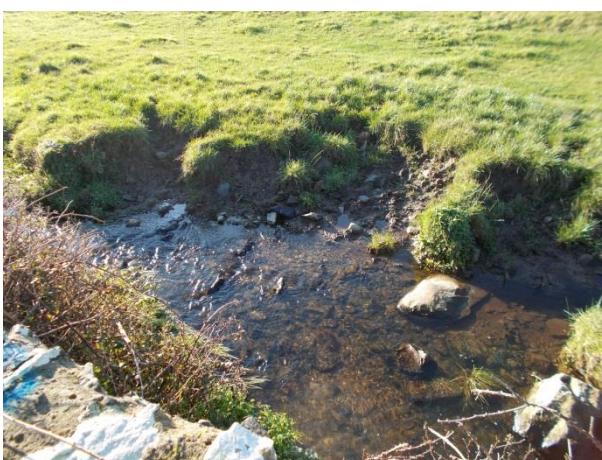
Figure 5.3: Gravel and cobble substrate present in the downstream section of the Nant Cemlyn

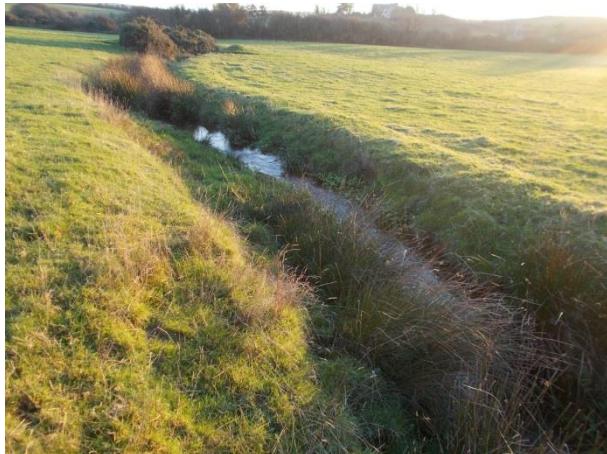
The Afon Cafnan is a small channel routed north from Llyn Llygeirian to Porth-y-pistyll. It has a relatively straight artificial planform forming the boundary between several fields (figure 5.4). During the surveys the water body was noted as showing signs of natural processes and adjustment between Mynydd-Ithel and Cafnan, with a slightly meandering channel and areas of deposition and erosion. Significant poaching was also observed within this section (figure 5.5). A natural bedrock cascade was found to be present within the upstream reach immediately downstream of the small road (referred to as Mountain Road) crossing (figure 5.6).

Figure 5.4: Straight planform of Afon Cafnan running parallel to the A5025

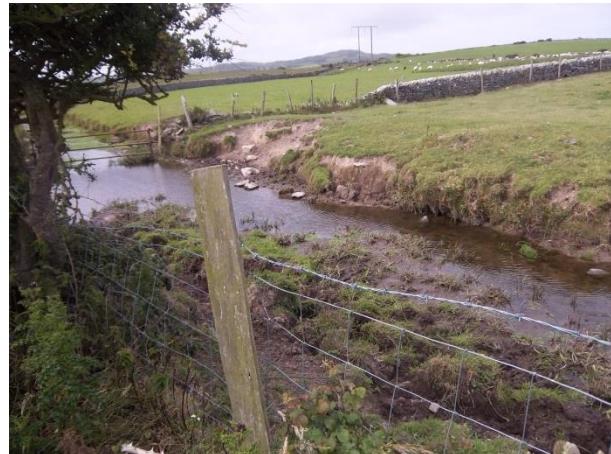
On average, the channel width was recorded as being approximately 0.8m–1m with areas of poaching and erosion causing it to be enlarged in some sections. Between Mynydd-Ithel and Cafnan, the watercourse increased in width to approximately 1m–2m. The water depth was noted to range from 0.1m–0.3m upstream of Mynydd-Ithel and 0.5m–1m downstream of Mynydd-Ithel. The longitudinal connectivity of the watercourse was found to be affected by culverts and bridges throughout its length.

Figure 5.5: Poached banks along the watercourse between Mynydd-lthel and Cafnan

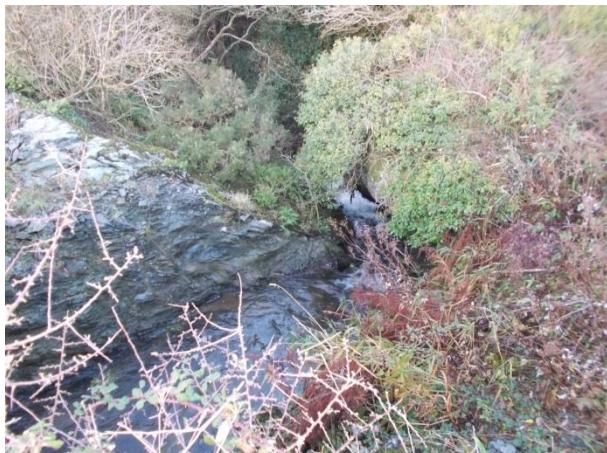
Figure 5.6: Natural bedrock cascade located immediately north of a B-road bridge within the upstream section of the watercourse

Quality Elements	Description
<b>Quantity and dynamics of water flow</b>	Four to five flow types were observed including smooth flow, runs, glides, riffles and cascade flow.
<b>Connection to groundwater bodies</b>	The Afon Cafnan lies above the Ynys Môn Secondary WFD groundwater body (GB41002G204400). The river is unlikely to be in continuity with the Ynys Môn Secondary groundwater body as low permeability drift deposits are present beneath most of the Afon Cafnan.
<b>River continuity</b>	The reaches of the Afon Cafnan surveyed were found to be impacted longitudinally. A collapsed twin culvert, a weir and several fences and gates were noted to cross the water body. Several clear span structures also cross the channel, locally altering the lateral connectivity as a result of the bridge abutments. Lateral connectivity with the floodplain was found to be impacted by embankments along both banks (0.2m–0.3m high) for approximately 300m upstream of the A5025 (not continuous). Lateral connectivity was also found to be naturally constrained in the downstream reach by Mountain Road as a result of exposed bedrock rising approximately 1.5m–2m up the right bank in some locations (figure 5.6).

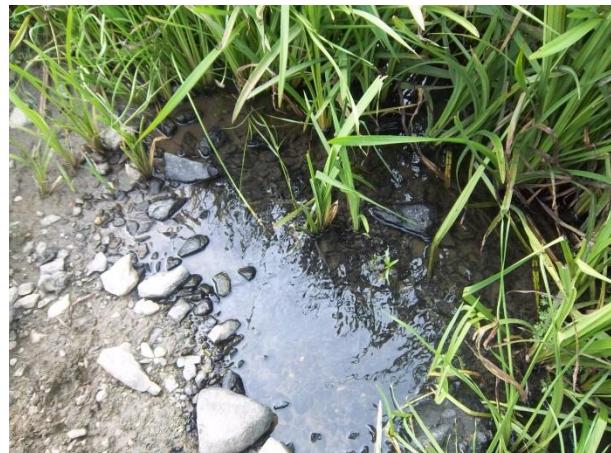
There were some areas of good flow diversity, gravel substrate (figure 5.7) and riparian vegetation. The water body was observed to support some macrophytes, their abundance being greater in those areas with reduced tree and scrub cover (figure 5.8).

Figure 5.7: Gravel substrate observed between Mynydd-lthel and Cafnan

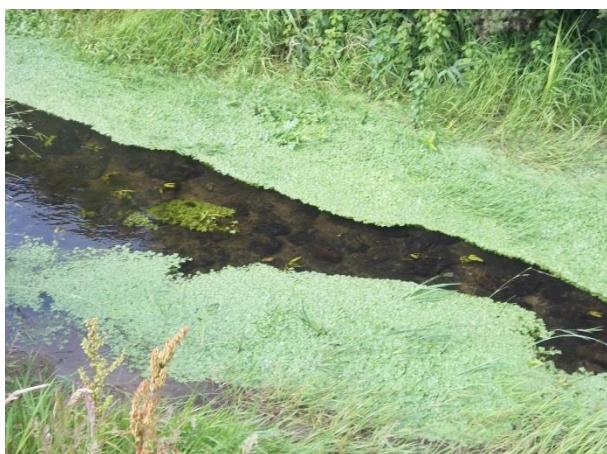
Figure 5.8: Macrophytes observed within the watercourse approximately 350m downstream of the confluence with Caerdegog Isaf

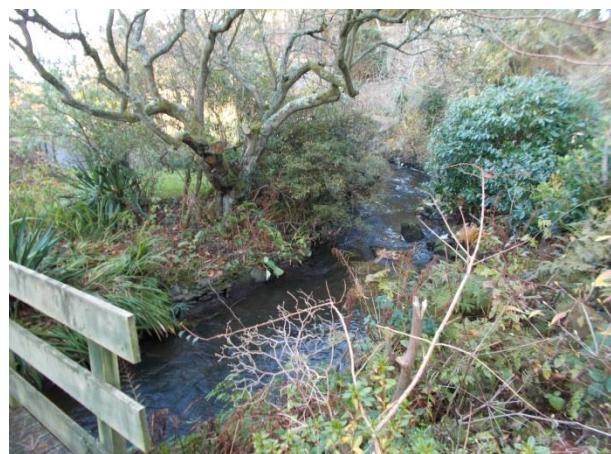
At the downstream reach at Felin Gafnan large trees and shrubs were found to form a riparian corridor, shading the left bank. Ferns dominated the steeper right bank (figures 5.9 and 5.10). The river was observed to flow over a rocky foreshore into Porth-y-pistyll (figure 5.11).

Figure 5.9: Shaded downstream section of the watercourse at Felin Gafnan

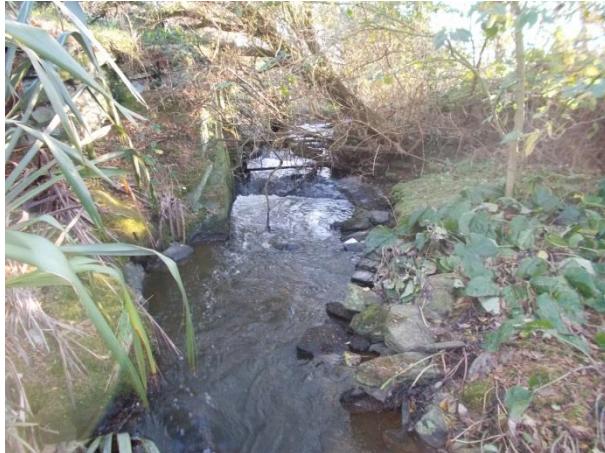
**Figure 5.10: Water body with bedrock forming right bank and pebble/cobble substrate at the downstream reach at Felin Gafnan**

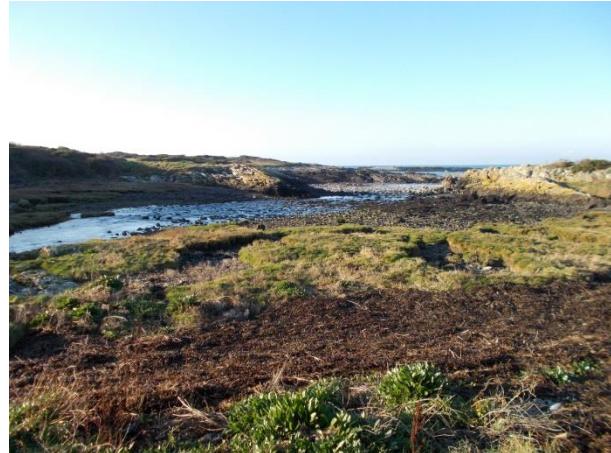
**Figure 5.11: Watercourse flowing over rocky foreshore of Porth y Felin into Porth-y-pistyll**

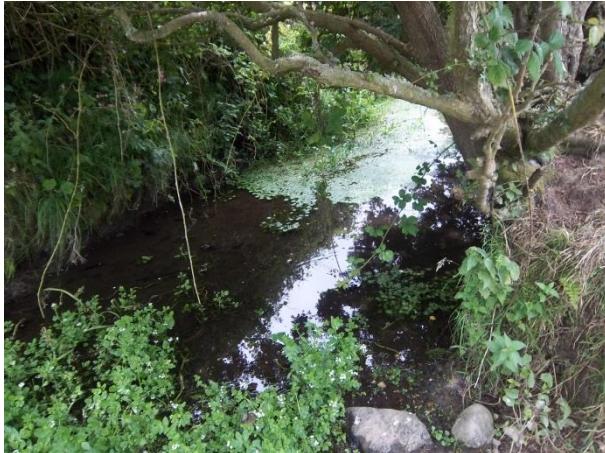
The Nant Caerdegog Isaf is located east of the Afon Cafnan and west of Tregele and the A5025. The watercourse rises within the Cae Gwyn SSSI, which is designated for wetland areas which feed into the Nant Caerdegog Isaf. The watercourse has a straight artificial planform with a uniform and modified channel cross-section. The watercourse width was noted to range from 1.5m–3.5m, with an average depth of approximately 0.6m (figure 5.12) and a water depth typically between 0.05m and 0.15m.

Figure 5.12: Section of no perceptible flow 400m upstream of the confluence with Afon Cafnan

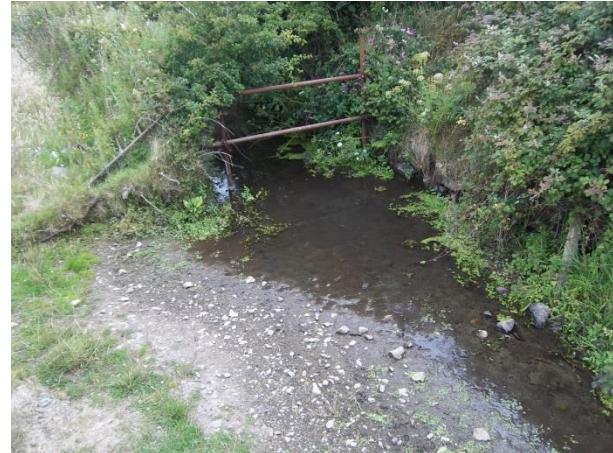
The substrate was found to consist mainly of silt with some fine gravel (figure 5.13). However, the channel bed was observed to be obscured in several lengths by overgrown terrestrial vegetation. At the time of survey, lengths of no perceptible flow and other lengths of smooth flow were observed. The watercourse was assessed to be a sediment sink and appeared to be narrowing locally (figure 5.14).

Figure 5.13: Silt and gravel substrate 600m upstream of the confluence with the Afon Cafnan

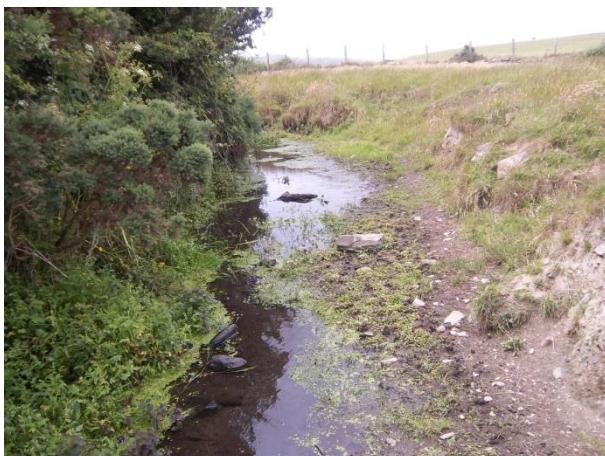
Figure 5.14: Watercourse narrowing 600m upstream of the confluence with the Afon Cafnan

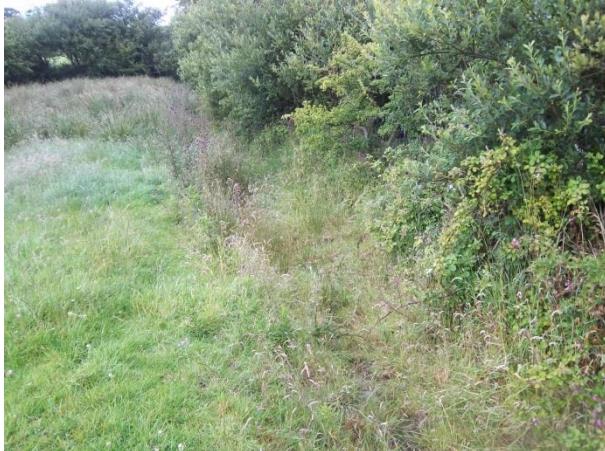
The Afon Cefn Coch is located east of the Afon Cafnan, adjacent to Pandy bungalow at Cefn Coch. The watercourse has a straight planform with a uniform channel cross-section and several sections were observed to be choked with terrestrial vegetation (figure 5.15). The watercourse was noted to be approximately 1.5m in width with a typical depth of 0.4m.

Figure 5.15: Upstream length of the Afon Cefn Coch choked with vegetation

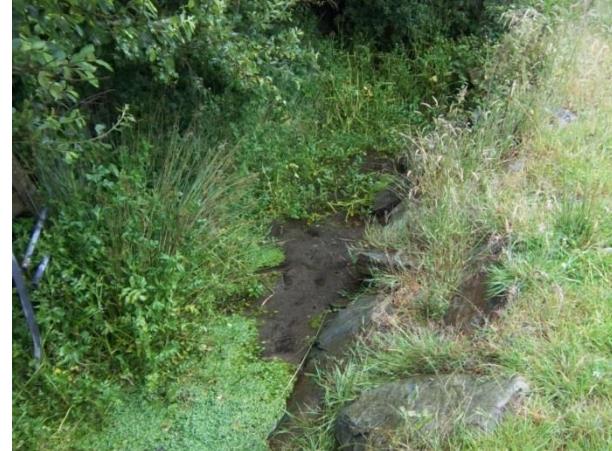
The substrate was found to consist mainly of silt (figure 5.16) and lengths of the watercourse were poached by livestock (figure 5.17). There was no perceptible flow at the time of surveys. The watercourse was assessed as being overwide and overdeep<sup>2</sup> and to be a sediment sink.

Figure 5.16: Silt substrate in the Afon Cefn Coch, 400m upstream of the confluence with the Afon Cafnan

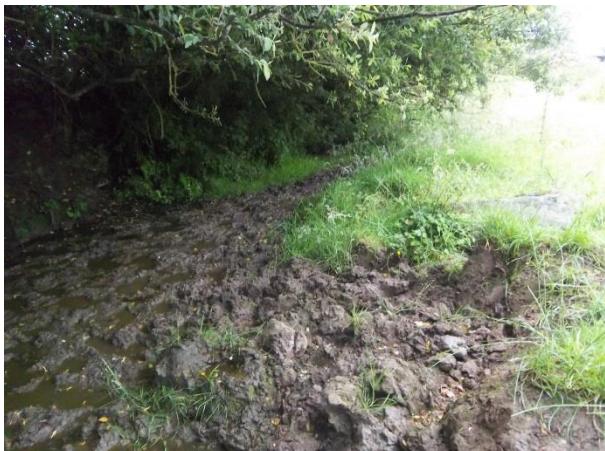
Figure 5.17: Livestock poaching the banks of the Afon Cefn Coch, 400m upstream of the confluence with the Afon Cafnan

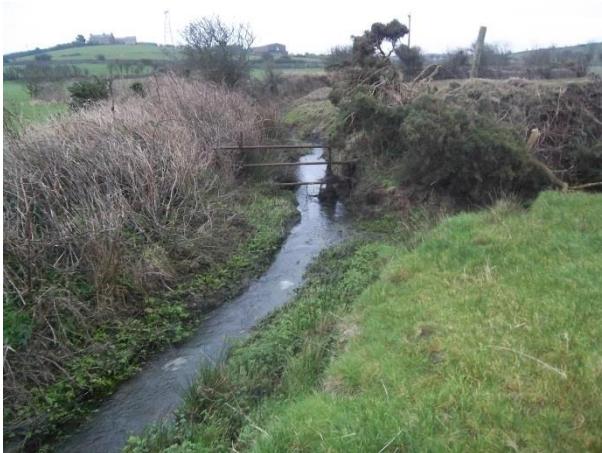
Bod-hedd Drain is predominantly a small artificial straight drain with a uniform cross-section and with no vegetated riparian buffer. The channel was noted as approximately 0.2–0.5m wide with a 1.5m deep left bank and a shallower right bank. There appeared to be some local deposition of silt at the channel margins (figure 5.18), particularly upstream of the confluence with the Afon Cafnan. The bed substrate was found to be typically fine and coarse gravel and some silt. The left bank appeared to be poached, potentially acting as a sediment source.

Figure 5.18: Bod-hedd Drain immediately upstream of confluence with the Afon Cafnan

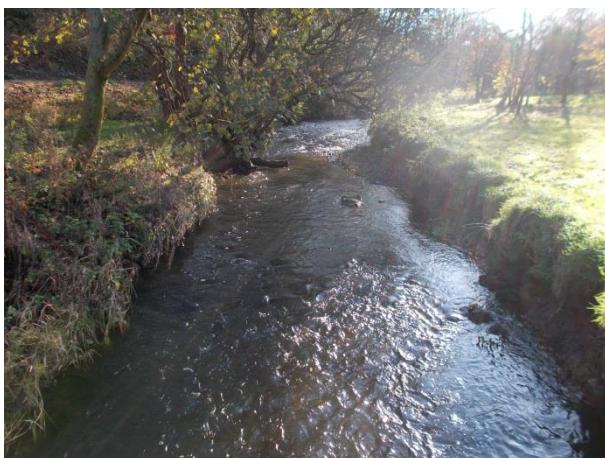
The Afon Wygyr at Cemaes is a fairly uniform channel, noted to be approximately 4m wide throughout (figure 5.19). The substrate was found to consist mainly of gravel and pebbles, the flow being mainly glide and runs. Some areas of erosion were observed in the form of undercutting. Poaching was also observed at some locations along the banks, reducing the bank slope and leading to erosion (figure 5.20). Depositional features were also observed, including side bars.

Figure 5.19: Afon Wygyr watercourse shaded by large trees on the left bank

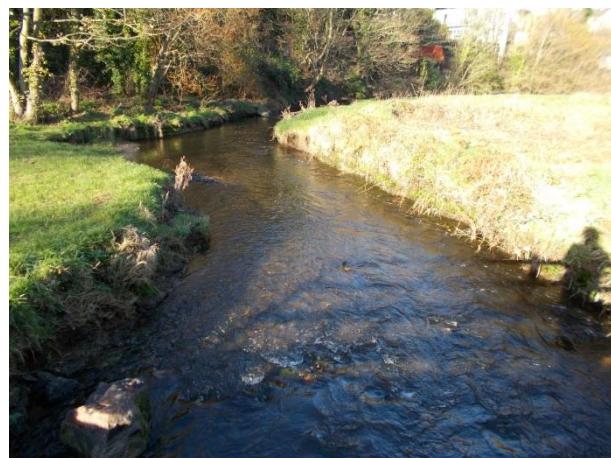
Figure 5.20: Gravel substrate and eroded left bank and gravel bar in the Afon Wygyr

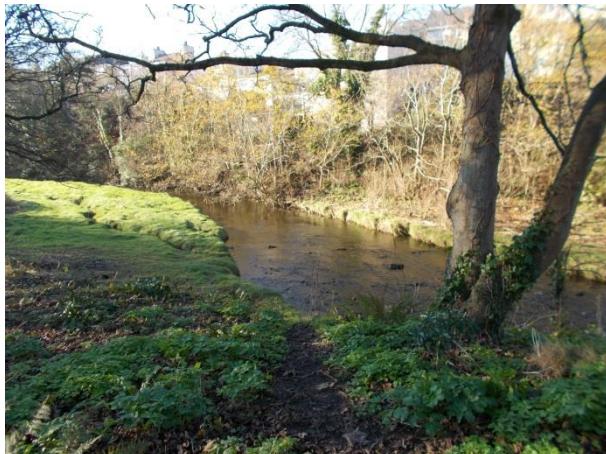
The channel at Cemaes was found to be shaded by large isolated trees along both banks (figure 5.21). However, other than this, only a simple vegetated riparian zone was observed consisting mainly of grasses. Bank reinforcement in the form of gabion mattresses and riprap were found to be present adjacent to the footbridge in the downstream reach near Cemaes Bay (figure 5.22). Some woody material was also noted to be present within the channel.

Figure 5.21: Afon Wygyr looking upstream

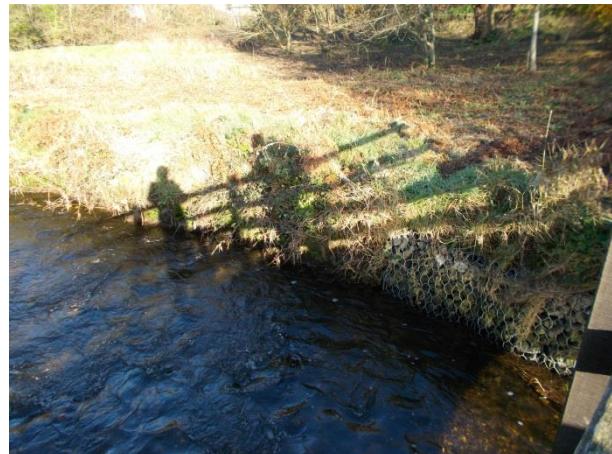
Figure 5.22: Gabion baskets along the right bank under a footbridge crossing the Afon Wygyr

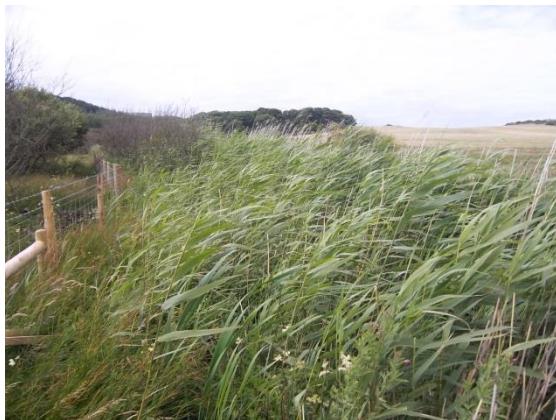
The Tre'r Gof SSSI drains were surveyed only during the August 2015 site visit. The watercourses have an artificially straight planform, with a uniform channel cross-section assessed as being overdeep and overwide. The watercourses were found to be choked with terrestrial vegetation (figure 5.23) and assessed as being a sink for sediment and narrowing locally. The channel substrate was found to consist predominantly of silt.

**Figure 5.23: Choked channel forming part of Tre'r Gof SSSI Drains**

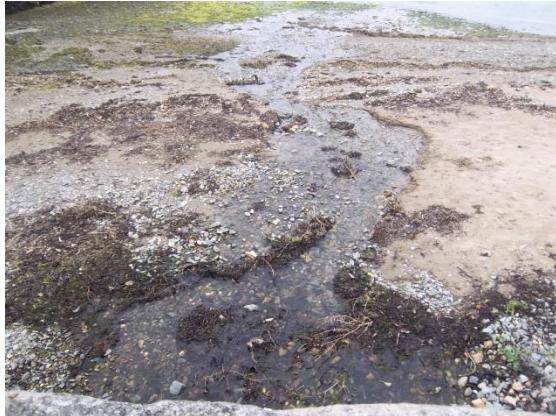
The Nant Cemaes, which is a small watercourse that flows from its source west of Llanfechell for approximately 3.5km before flowing through Cemaes and discharging into Cemaes Bay (figure 5.24), was surveyed only during the August 2015 site visit. The watercourse was noted to have a straight artificial planform with a uniform channel cross-section which was overdeep and overwide. Smooth flow was found to be the predominant flow type at the time of survey. Rippled flow was also observed at the mouth of the watercourse where it flowed into Cemaes Bay. The upstream reach along the A5025 was observed to be artificially reinforced (figure 5.25) with a silty substrate. The downstream reach immediately upstream of Cemaes Bay was found to have fully vegetated banks (figure 5.26).

Figure 5.24: Nant Cemaes discharging into Cemaes Bay

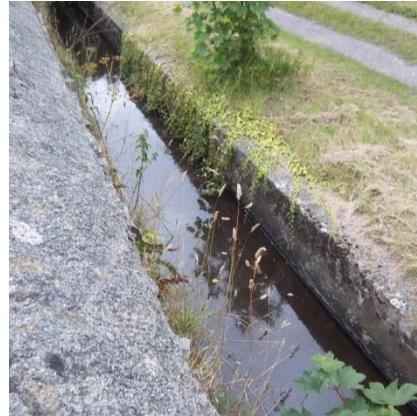
Figure 5.25: Bank and bed reinforcement on the Nant Cemaes

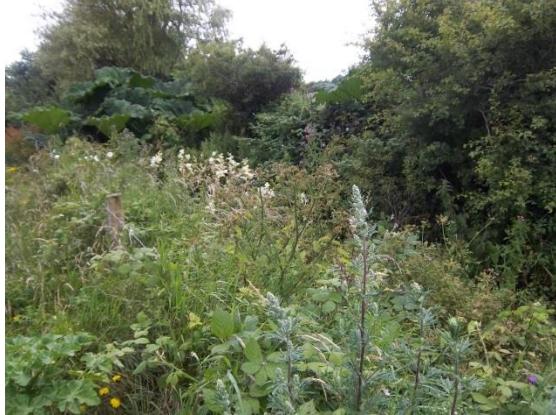
Figure 5.26: Vegetated banks along the Nant Cemaes
