Wylfa Newydd Project

**6.4.31 ES Volume D - WNDA Development App
D8-6 - Cae Gwyn Hydroecological Assessment**

Cae Gwyn SSSI Hydroecological Assessment

HYD\REP\001 | 3.0

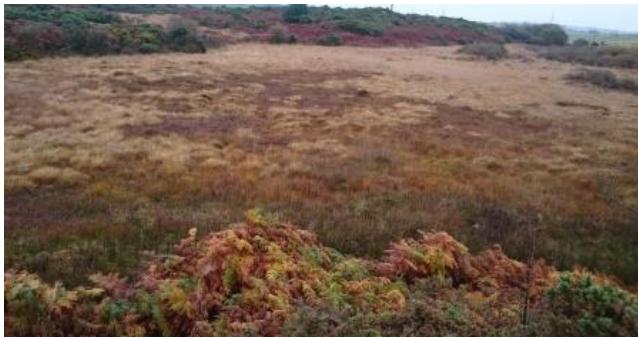
Plate 1 View north-west across the Southern Basin (November 2015)

- The Southern Basin is an elevated peat surface, with *Sphagnum* at the surface, as shown in plate 1. The surface was observed to be slightly domed, however access was restricted from the centre so the amount of doming could not be quantified.
- The Northern Basin comprises an elongated area incorporating reeds and rushes, as shown in plate 2. The Northern Basin also incorporates a small and shallow pond.
- The POB is boggy, flat land with grass and reeds (plate 3), however this bog 'quaked' during the wetter months. The boggy area was to the north and west of the basin, while the southern area incorporates some man-made ditches and is well drained. There is a significant block of willow carr in the centre of the POB, while the north-western area has extensive grass and rush communities.
- The Western Basin comprises two circular depressions with a coarse grass covering (plate 4).

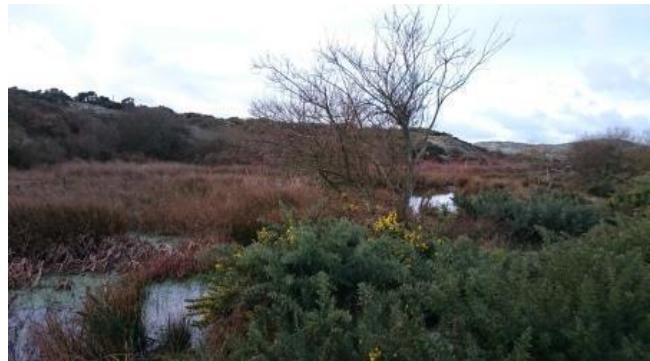
Plate 2 View west across Northern Basin (January 2016)

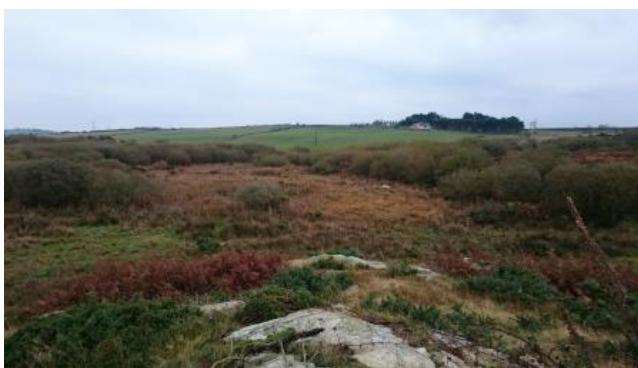
Plate 3 View south-east across POB (November 2015)

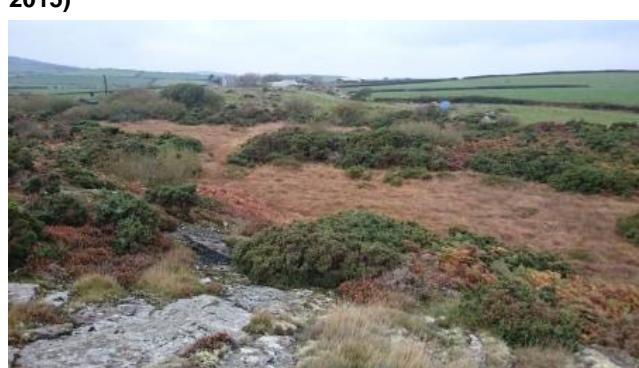
Plate 4 View west across Western Basin (November 2015)

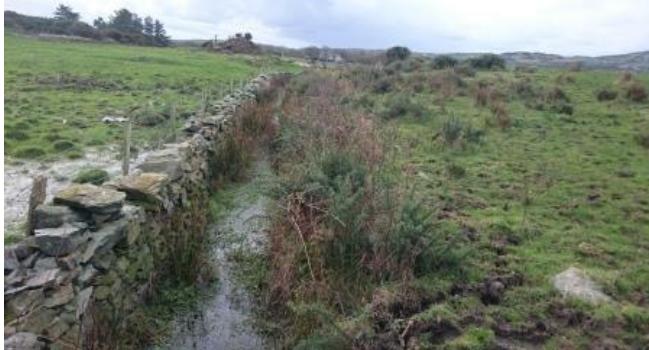
Plate 5 Western drain view west (January 2016)

- The Western Drain was observed and sampled during walkovers. The drain was wet during the winter months, however the water was largely static with minimal flows along the drain (plate 5). The Western Drain dried up during the summer months, and no sample could be obtained in August 2016.

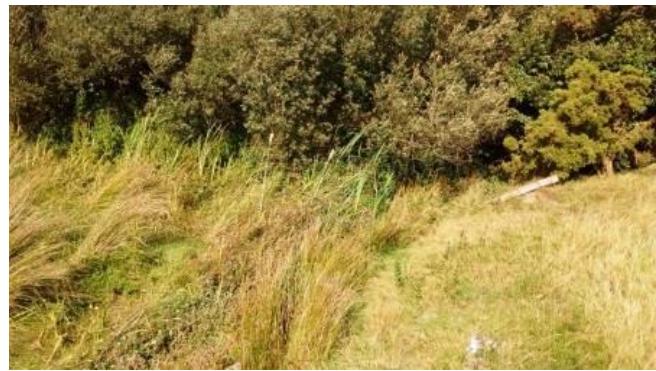
**Plate 6 View towards Nant Caerdegog Isaf (August 2016)**

- The connection of the Southern Drain from the SSSI to Nant Caerdegog Isaf could not be observed during the walkovers due to the thick vegetation in the area (plate 6). Nant Caerdegog Isaf at the SSSI boundary was observed to be overly wide and deep (compared to the volume of water that flows along the channel), which meant that flow was imperceptible even during the wetter winter months. The width and depth of the channel meant that spot flow monitoring was not possible as it was unsafe to enter the water.

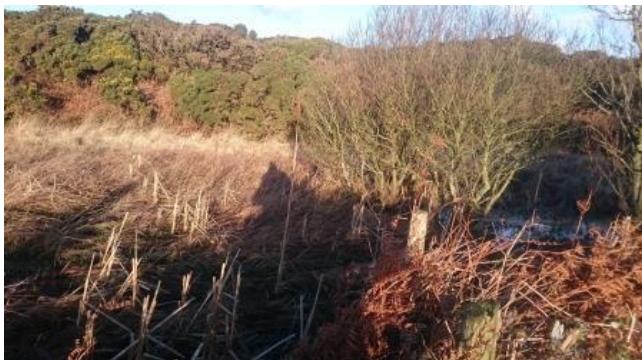
**Plate 7 Southern Basin flowing into Southern Drain (January 2016)**

- The Southern Drain (outflow from the Southern Basin) was only observed in winter and autumn months (January, February, October and November 2016, January 2017) due to land access constraints. Additionally, there was no access to the bank of the Southern Drain as it is fenced off. The north of the Southern Basin was observed to be different in character from the rest of the basin, and appeared to be a wetland (plate 7). The Southern Drain flows from this area and flows adjacent to the field boundary (beyond the fence) in a north-easterly direction. The channel is sinuous and shallow with a gravel sized substrate. At the northern extent of the SSSI the channel flows north-west; the channel could not be observed beyond this point. The flow has been visually estimated (from the opposite side of the fence) to range between approximately 15l/s immediately following a rainfall event to 0.3l/s under drier conditions. It appears that the larger flows are only present immediately following rainfall events and are not representative of general conditions.

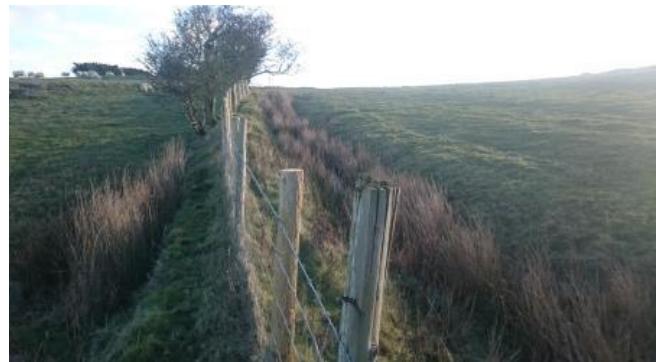
**Plate 8 Drain from A5025 flowing to Southern Basin, view south (January 2016)**

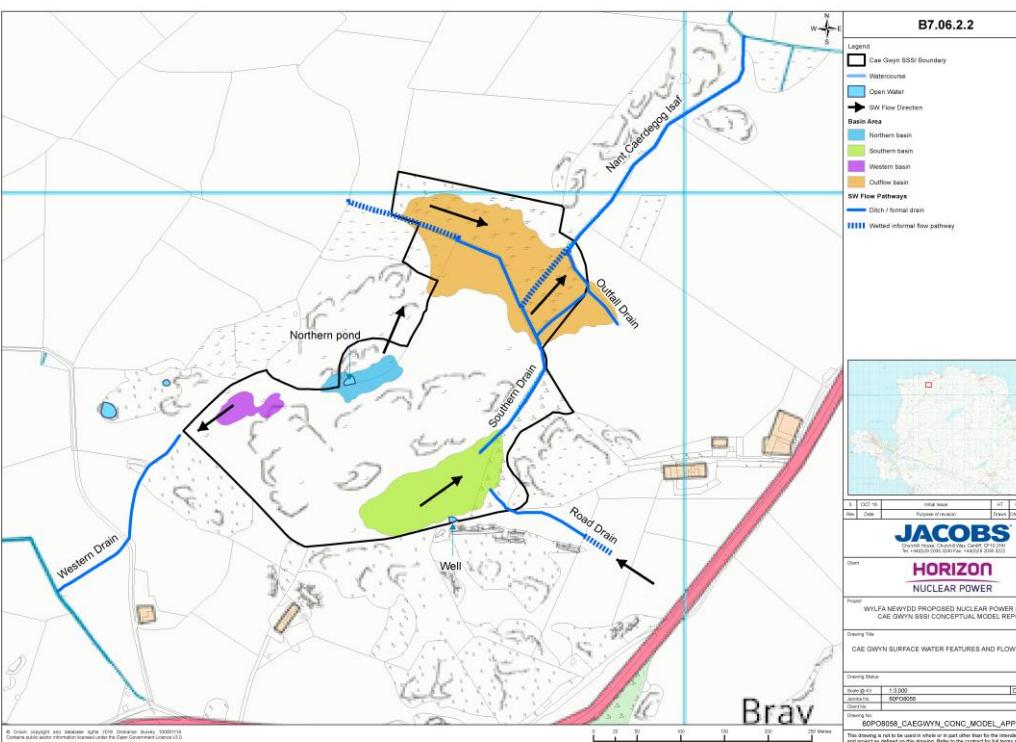
HYDROECOLOGICAL BASELINE							
MAP

SOILS	<p>Peat deposits are proven within the basin to a depth of over 7m. Peat comprised sphagnum at the basin surface. Mineral soils were found along the edges of the basin.</p>						
FLOW	<p>Receives inflows from direct rainfall, the surrounding catchment and a small drain (Road Drain). The basin discharges via the Southern Drain.</p> <p>The drains were observed to be flowing during late autumn and winter months, but were not monitored</p> <table border="1" style="margin-left: 20px;"> <tr> <td style="text-align: center;">SOUTHERN DRAIN (VISUAL ESTIMATE IN WINTER)</td> <td style="text-align: center;">MIN</td> <td style="text-align: center;">MAX</td> </tr> <tr> <td style="text-align: center;">0.3l/s (likely to be 0l/s in summer)</td> <td style="text-align: center;">16l/s</td> <td></td> </tr> </table>	SOUTHERN DRAIN (VISUAL ESTIMATE IN WINTER)	MIN	MAX	0.3l/s (likely to be 0l/s in summer)	16l/s	
SOUTHERN DRAIN (VISUAL ESTIMATE IN WINTER)	MIN	MAX					
0.3l/s (likely to be 0l/s in summer)	16l/s

HYDROECOLOGICAL BASELINE									
	for flows due to access issues; therefore flows are visual estimates. The drains were not observed during the summer months.				ROAD DRAIN (VISUAL ESTIMATE IN WINTER)	0.2l/s (likely to be 0l/s in summer)	7.5l/s		
WATER LEVELS	The maximum variation in water levels in the peat is 0.3m throughout the year and is lowest in summer and autumn.				CG_PZ_S	27.6mAOD	27.9mAOD		
					RGMBH13	27.1mAOD	30.7mAOD		
WATER BALANCE	Poor balance between inflow and outflow (134%) with likely infiltration to groundwater, but high uncertainty due to limited flow data.				For available data: Estimated inflows = 45,447m ³ Estimated outflows = 33,940m ³				
WATER QUALITY	SOUTHERN BASIN PIEZOMETER			SOUTHERN AND ROAD DRAIN			WELL AND BASIN SURFACE		
	MIN	MAX	Avg	MIN	MAX	Avg	MIN	MAX	Avg
pH	5.0	6.6	6.1	5.3	8.0	6.6	5.5	7.8	6.2
EC (µS/cm)	235	496	381	186	396	281	66	217	179
NITRATE AS N (mg/l)	<0.07	<0.07	<0.07	<0.07	1.1	0.36	<0.07	<0.07	<0.07

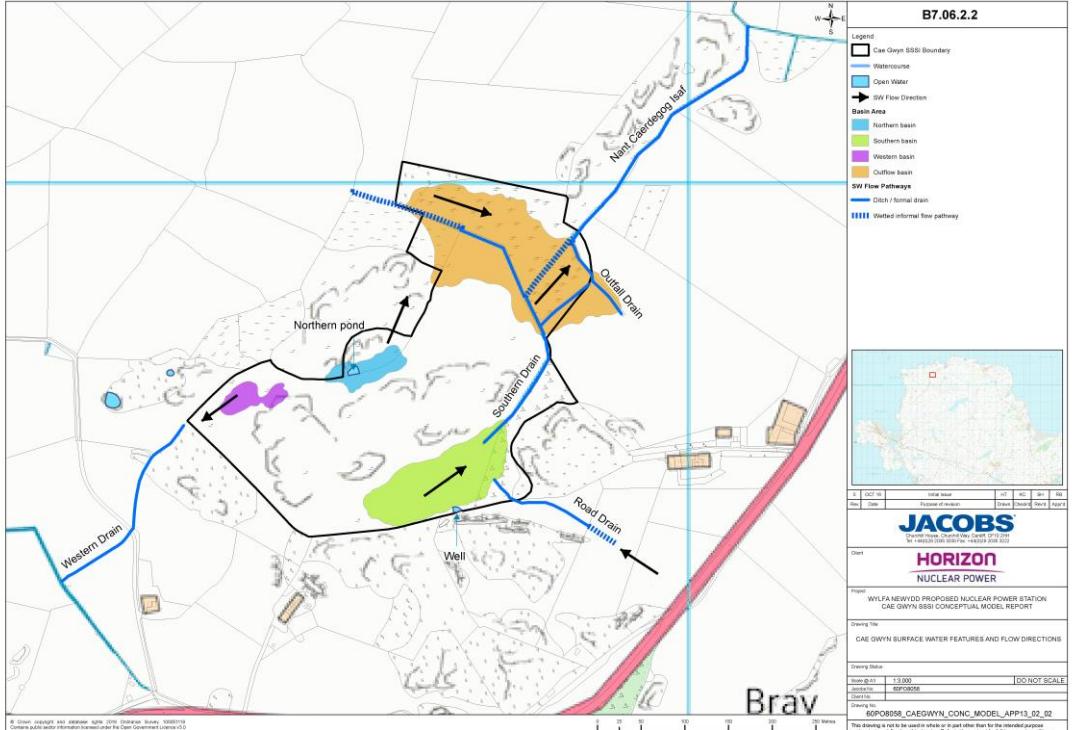
WESTERN BASIN HYDROECOLOGICAL BASELINE						
MAP

SOILS	No peat was encountered within the Western Basin. Mineral soils were proven to a depth of at least 0.4m; these soils had significant volumes of plants and roots within the upper 0.3m.					
FLOW	No flow routes were observed during any site walkover, although the basin may drain informally to the Western Drain.					
WATER LEVELS	Based on the available information the water levels within the piezometer have a maximum range of 0.4m, which is likely limited by the small depth of soil.			CG_PZ_W	24.3mAOD	24.7mAOD
WATER BALANCE	Based on limited data it is estimated that inflows significantly exceed outflows (by about 289%), suggesting leakage to groundwater and/or informal overland flow.			For available data: Estimated inflows = 2,988m ³ Estimated outflows = 1,032m ³		
WATER QUALITY	WESTERN BASIN PIEZOMETER			WESTERN DRAIN		
	MIN	MAX	Avg	MIN	MAX	Avg

pH	5.0	7.4	6.2	5.0	6.8	6.2
EC (µS/cm)	112	314	205	117	355	293
NITRATE AS N (mg/l)	<0.07	<0.3	0.2	0.4	4.4	3.7
POTASSIUM (mg/l)	<1	1.4	1.1	4.4	30.4	17.4
PHOSPHATE AS P (mg/l)	<0.02	<0.02	<0.02	<0.02	0.03	<0.02
CALCIUM (mg/l)	2.0	5.0	3.4	5.3	25.4	12.3

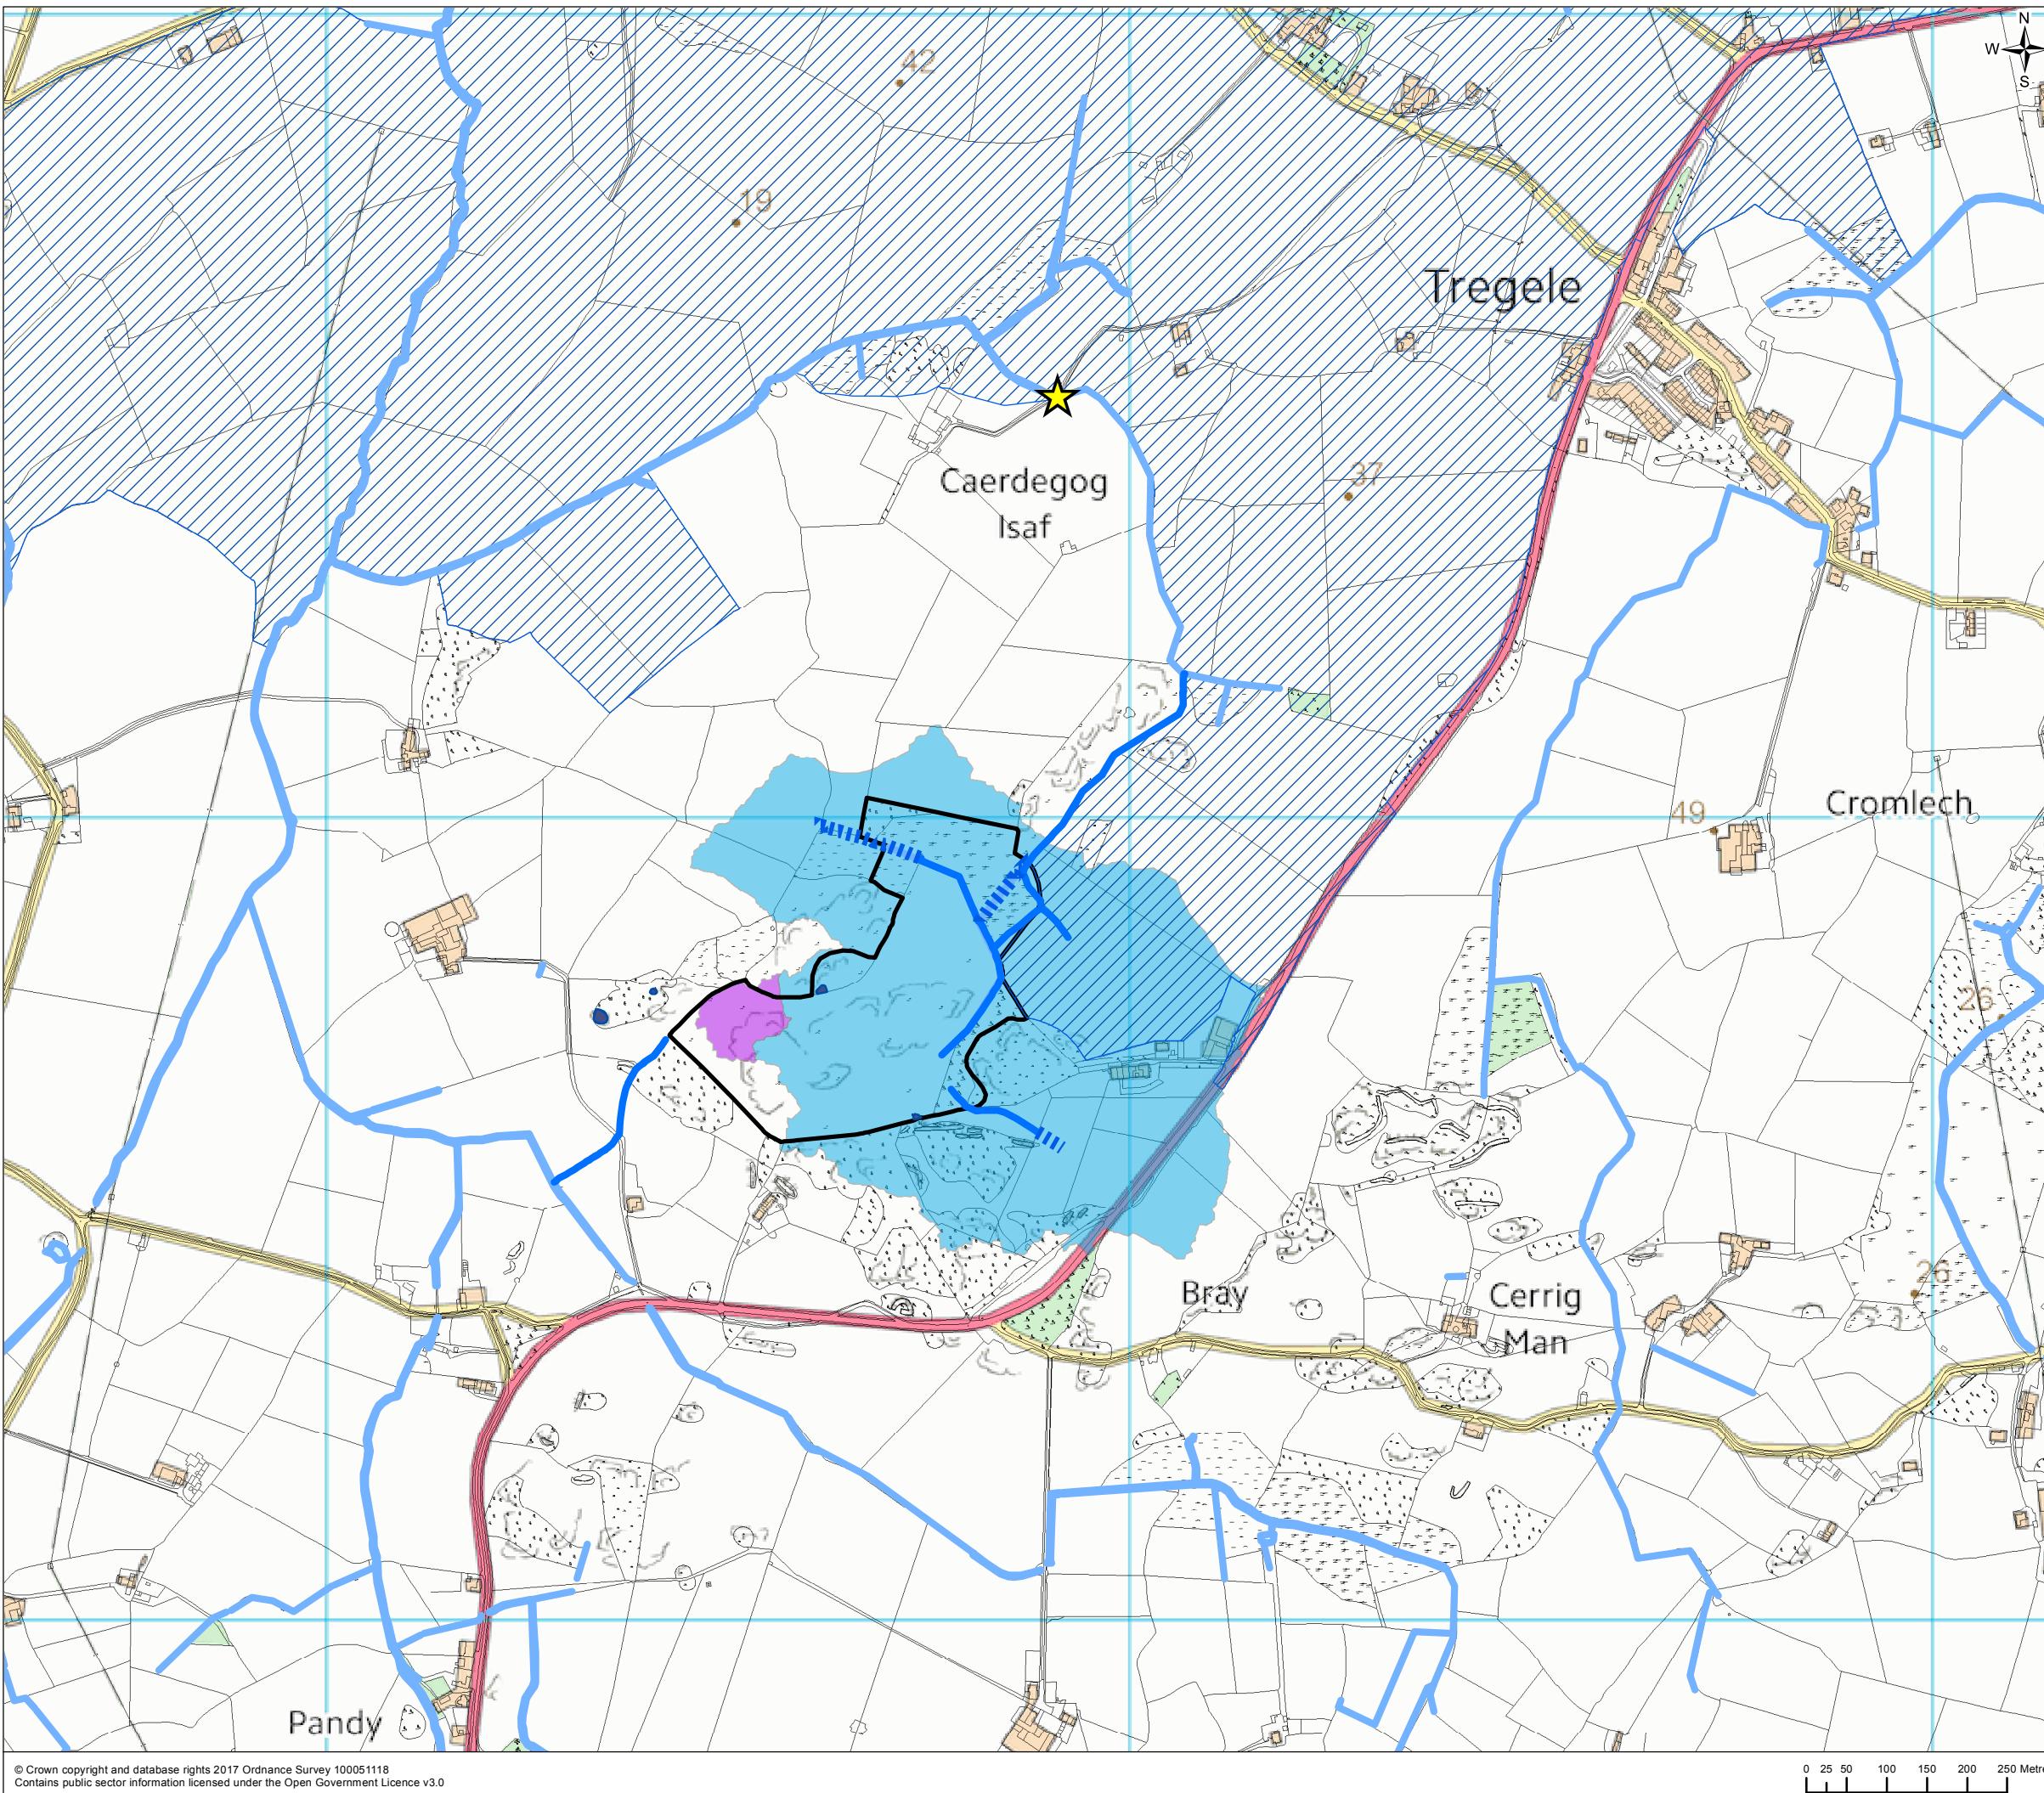
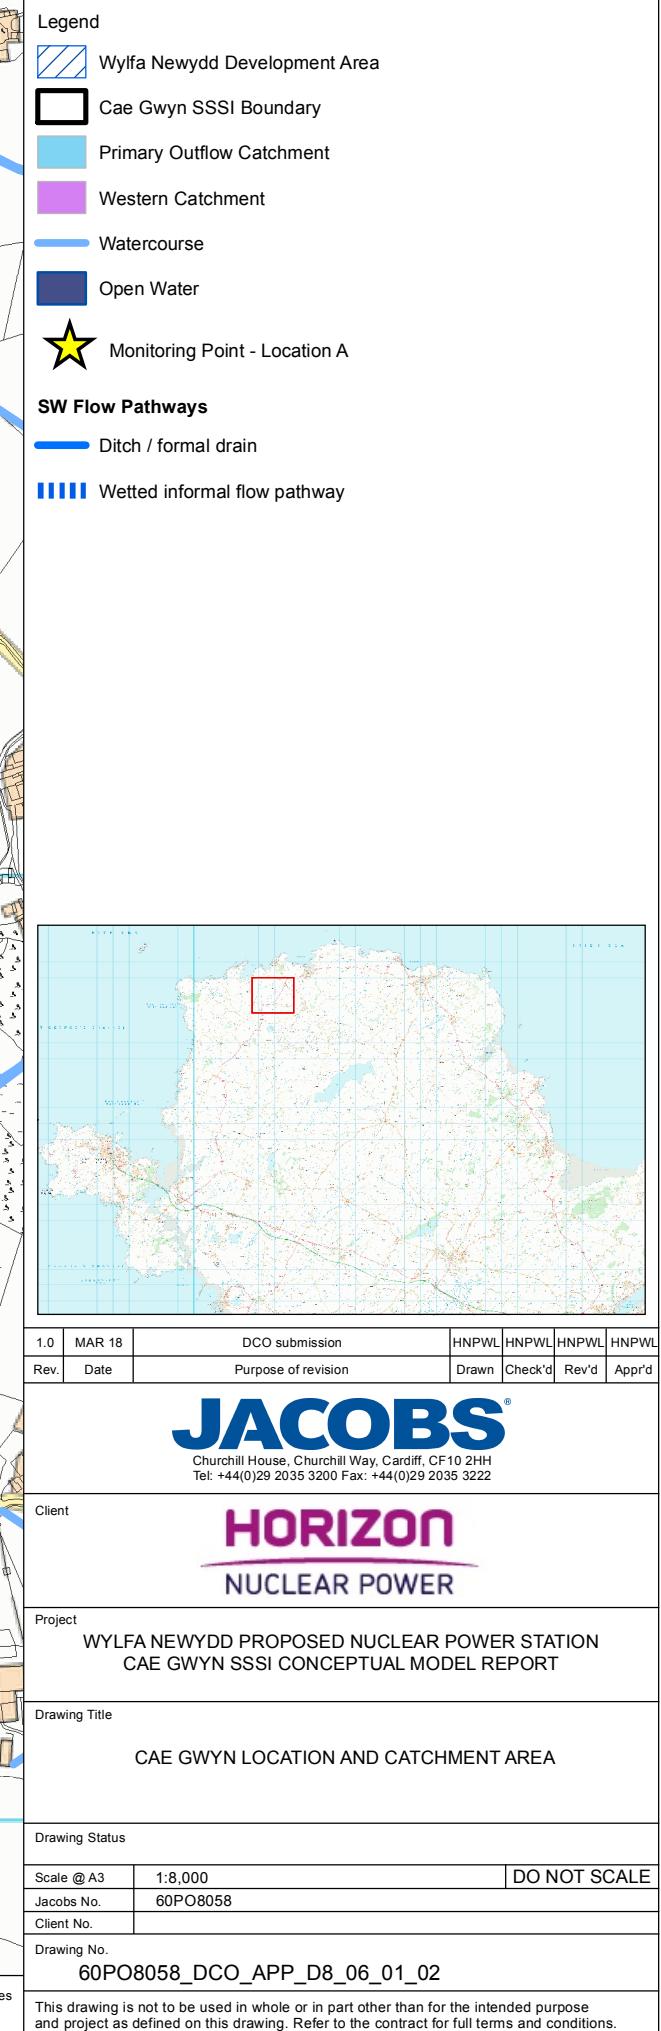
FIGURE D8-6-1-2

Flow data have been gathered from Nant Caerdegog Isaf approximately 800m downstream of Cae Gwyn SSSI since November 2014 at Location A shown on figure D8-6-1-2**Error! Reference source not found.**. The surface catchment at Location A is approximately 0.64km², which is just over twice the size of Cae Gwyn SSSI catchment draining to it.

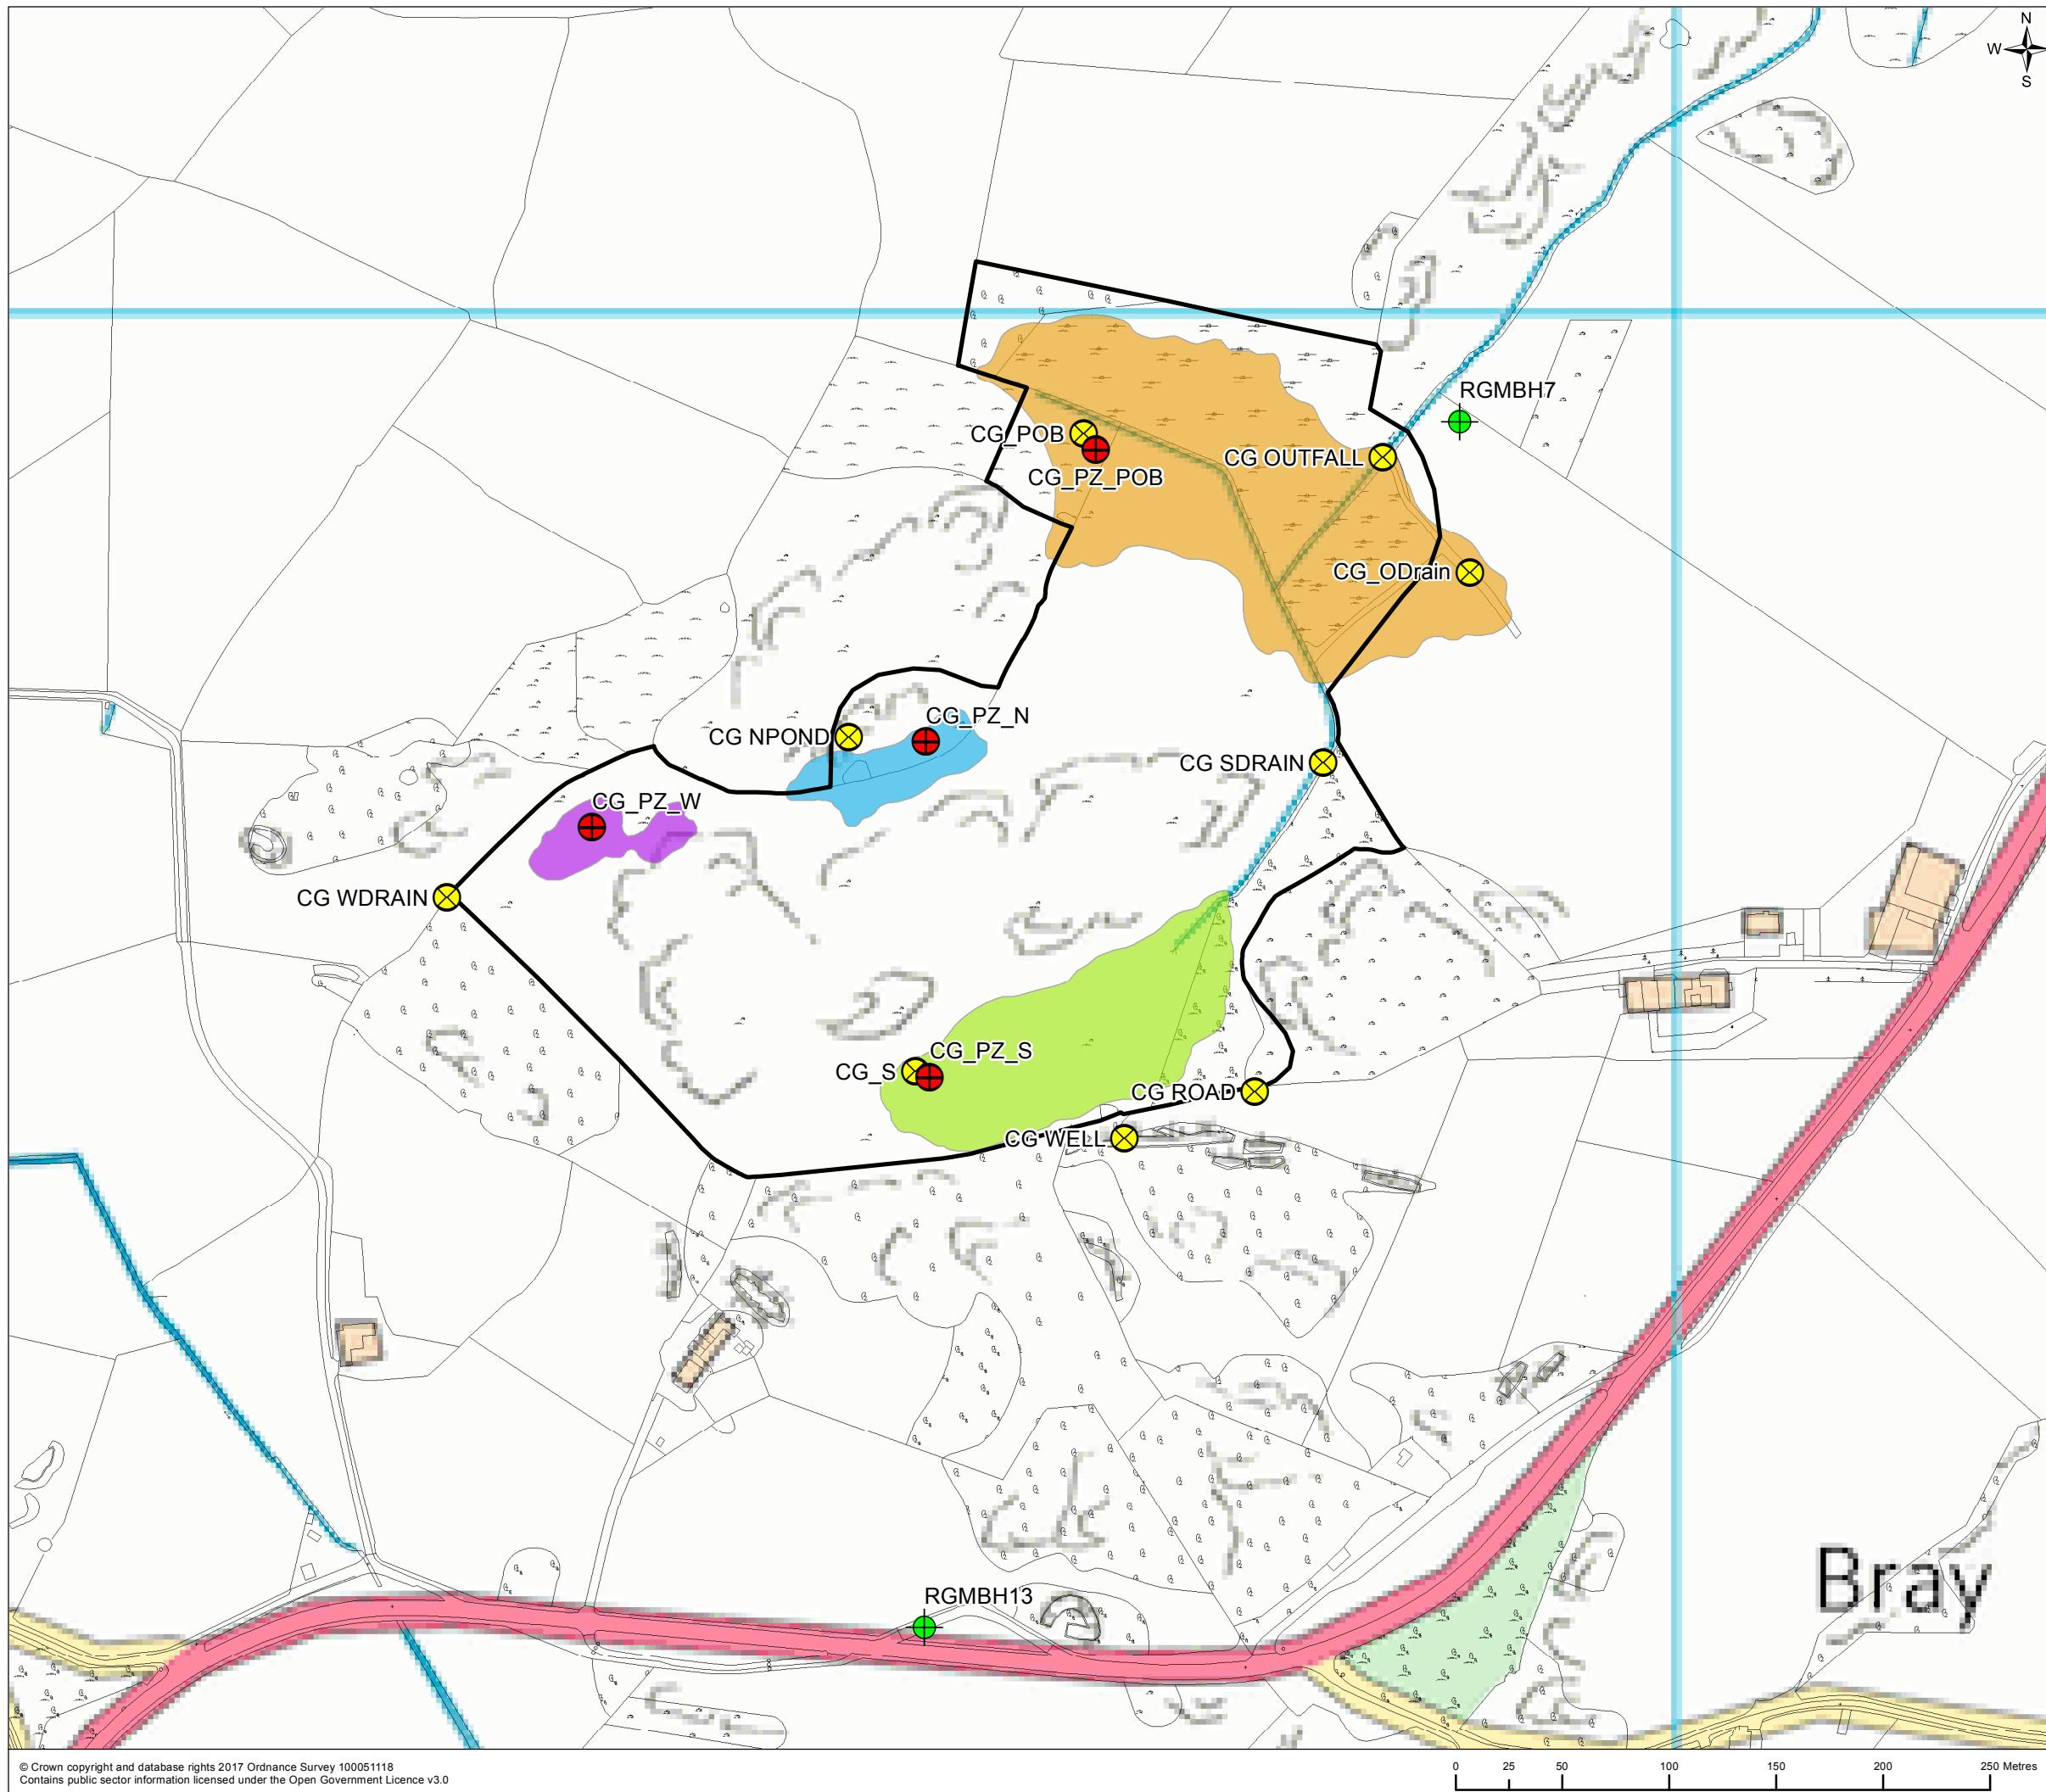
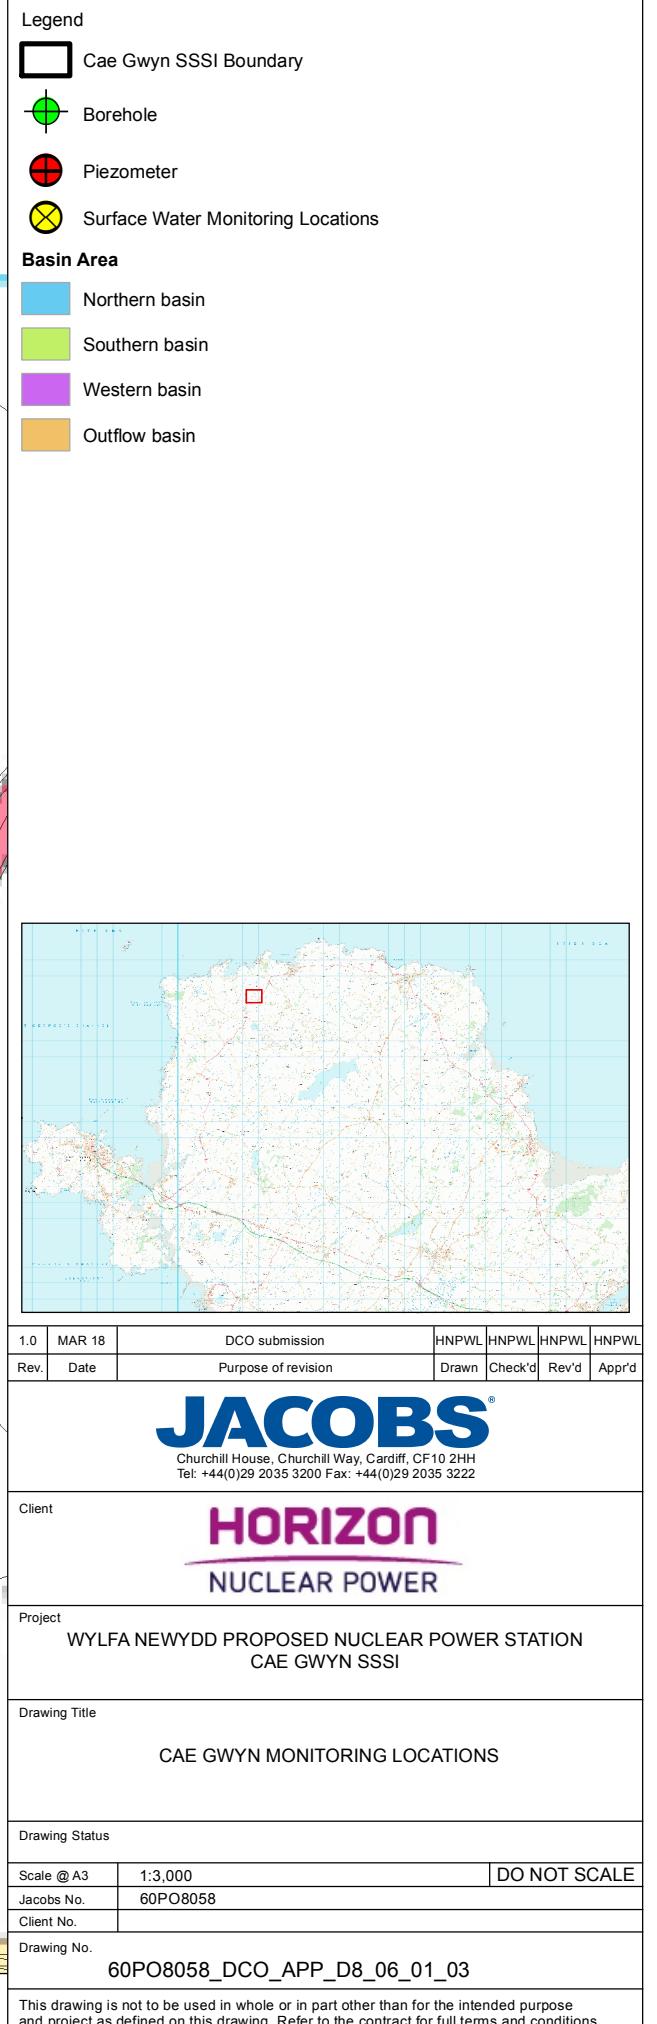
FIGURE D8-6-1-3

Four piezometers were installed across Cae Gwyn SSSI in January 2016, one in each of the four basins, the locations of which are shown in figure D8-6-1-3. Fifteen soil cores were also taken across the site during the investigation carried out by Jacobs in January 2016, which identified a layer of peat across both the Southern Basin and POB, details of which are contained within annex C. The results show that mineral soils are typically found along the edges of the rocky outcrops in the site and that peat is encountered in only two of the site's basins.

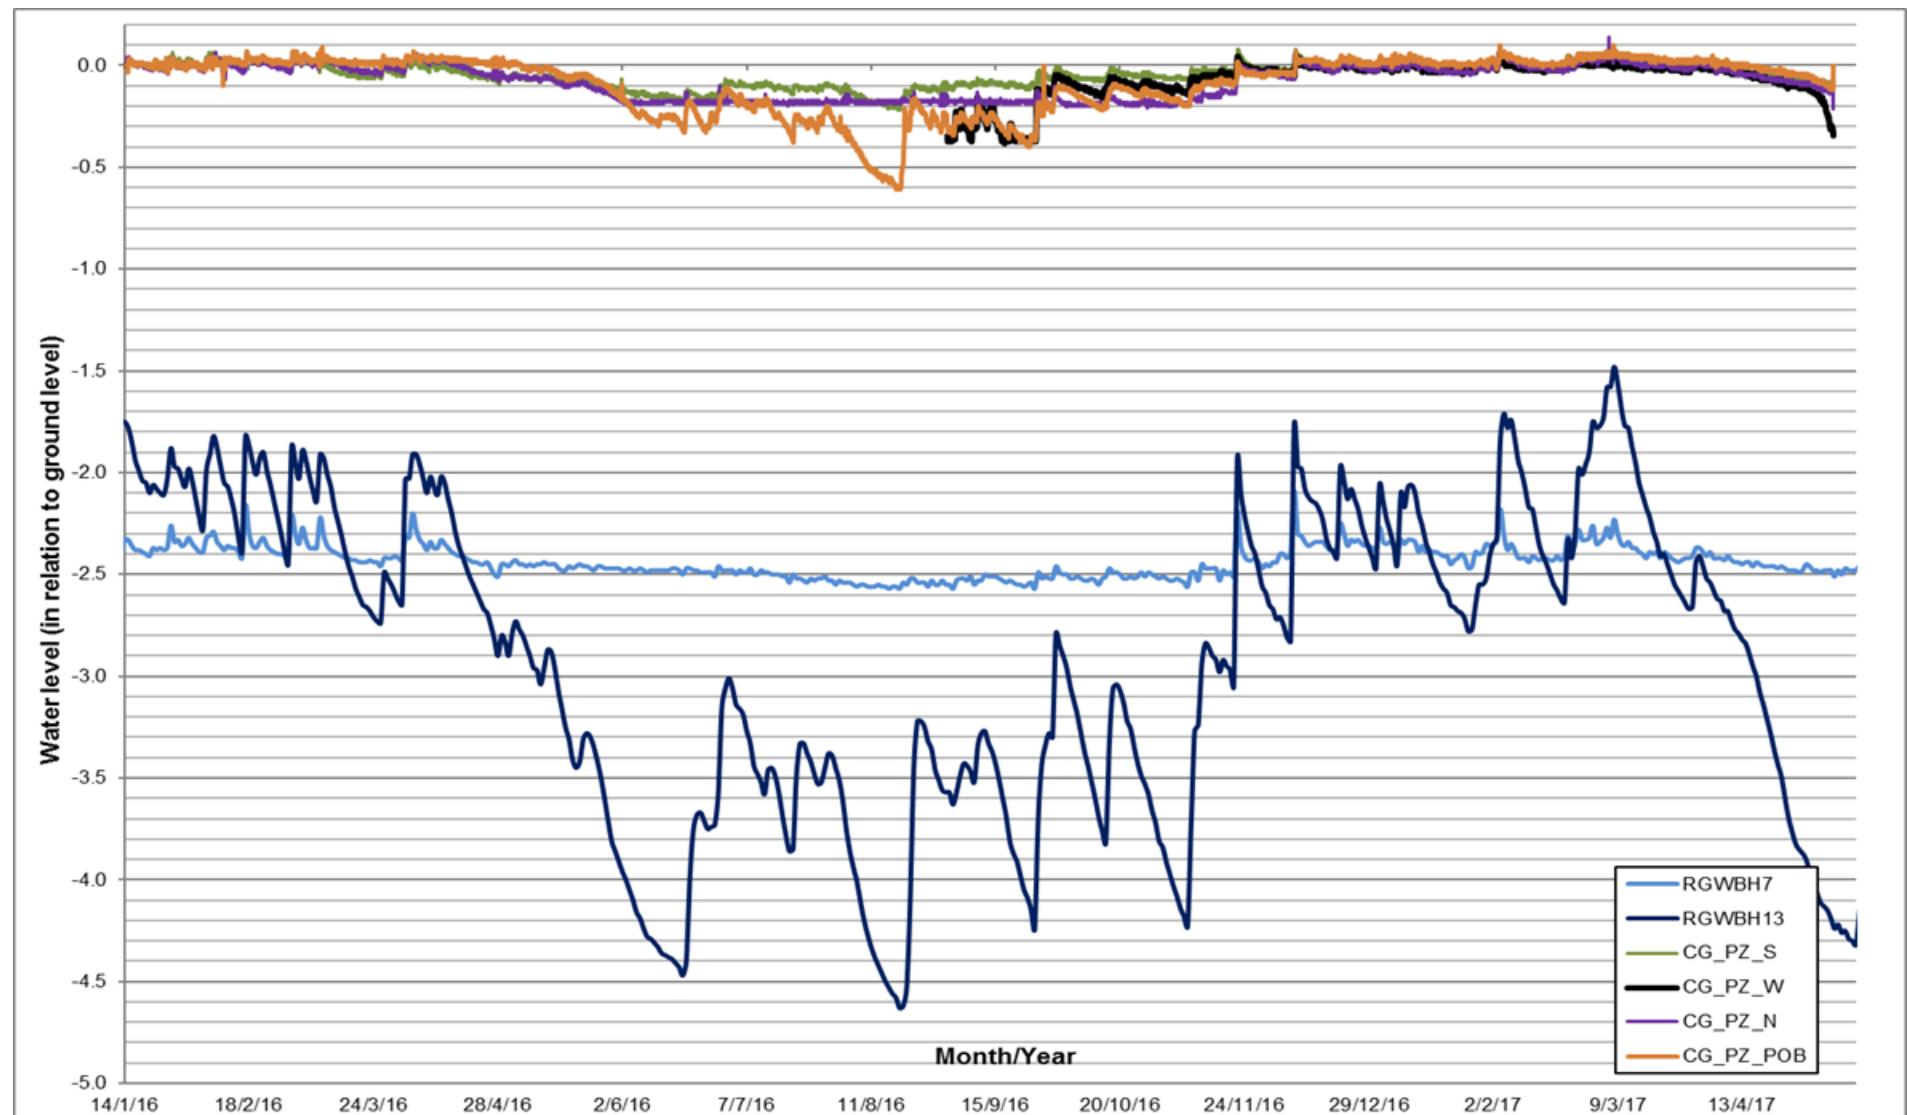
Figure D8-6-2-3 Water levels below ground level recorded in the piezometers and boreholes

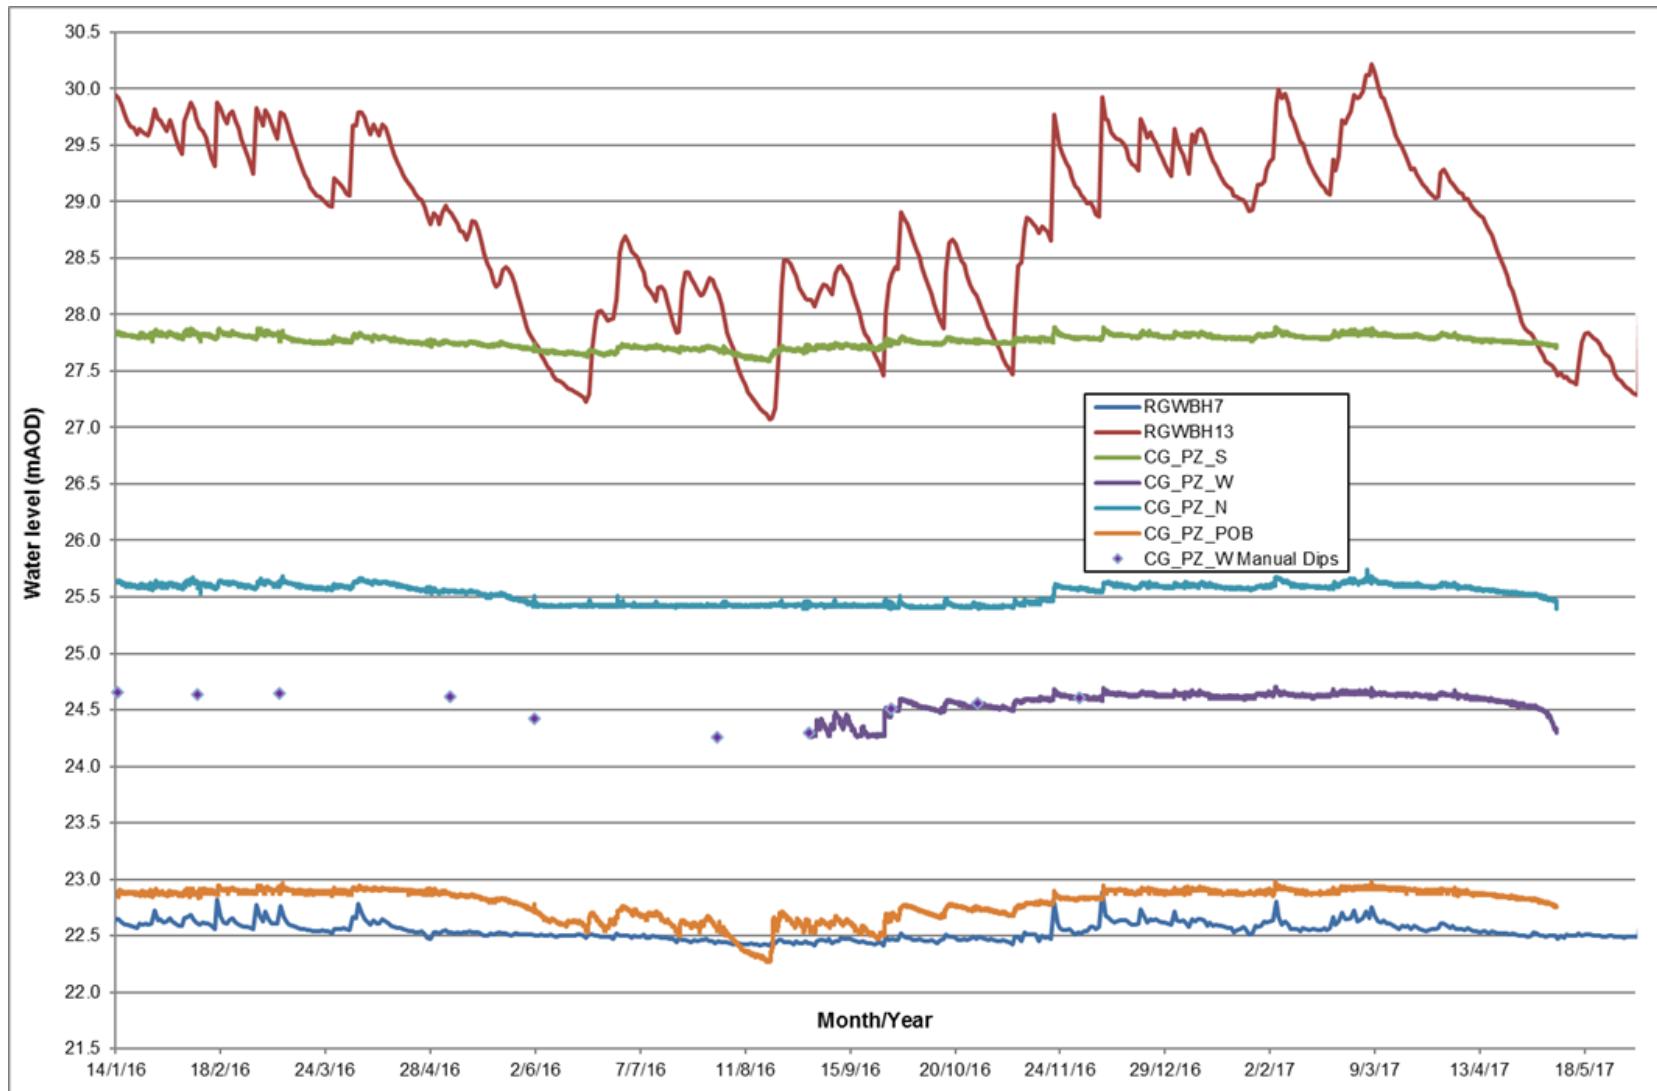
Figure D8-6-2-4 Water levels mAOD recorded in the piezometers and boreholes

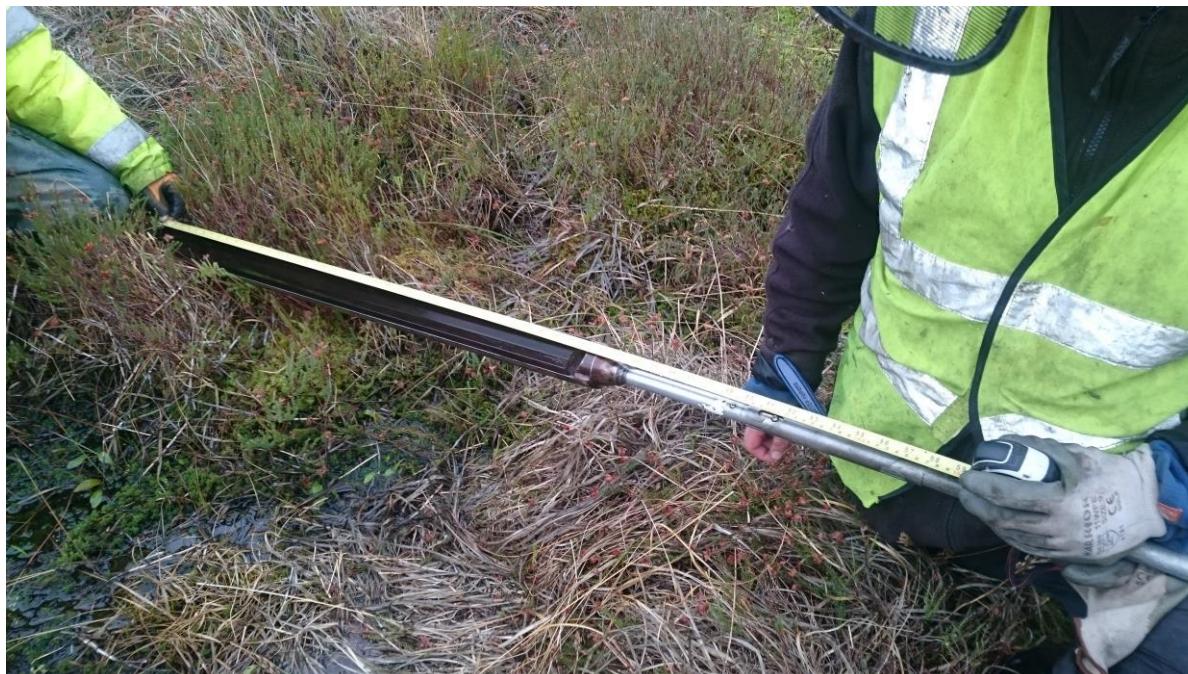
Saturated peat, poor core recovery

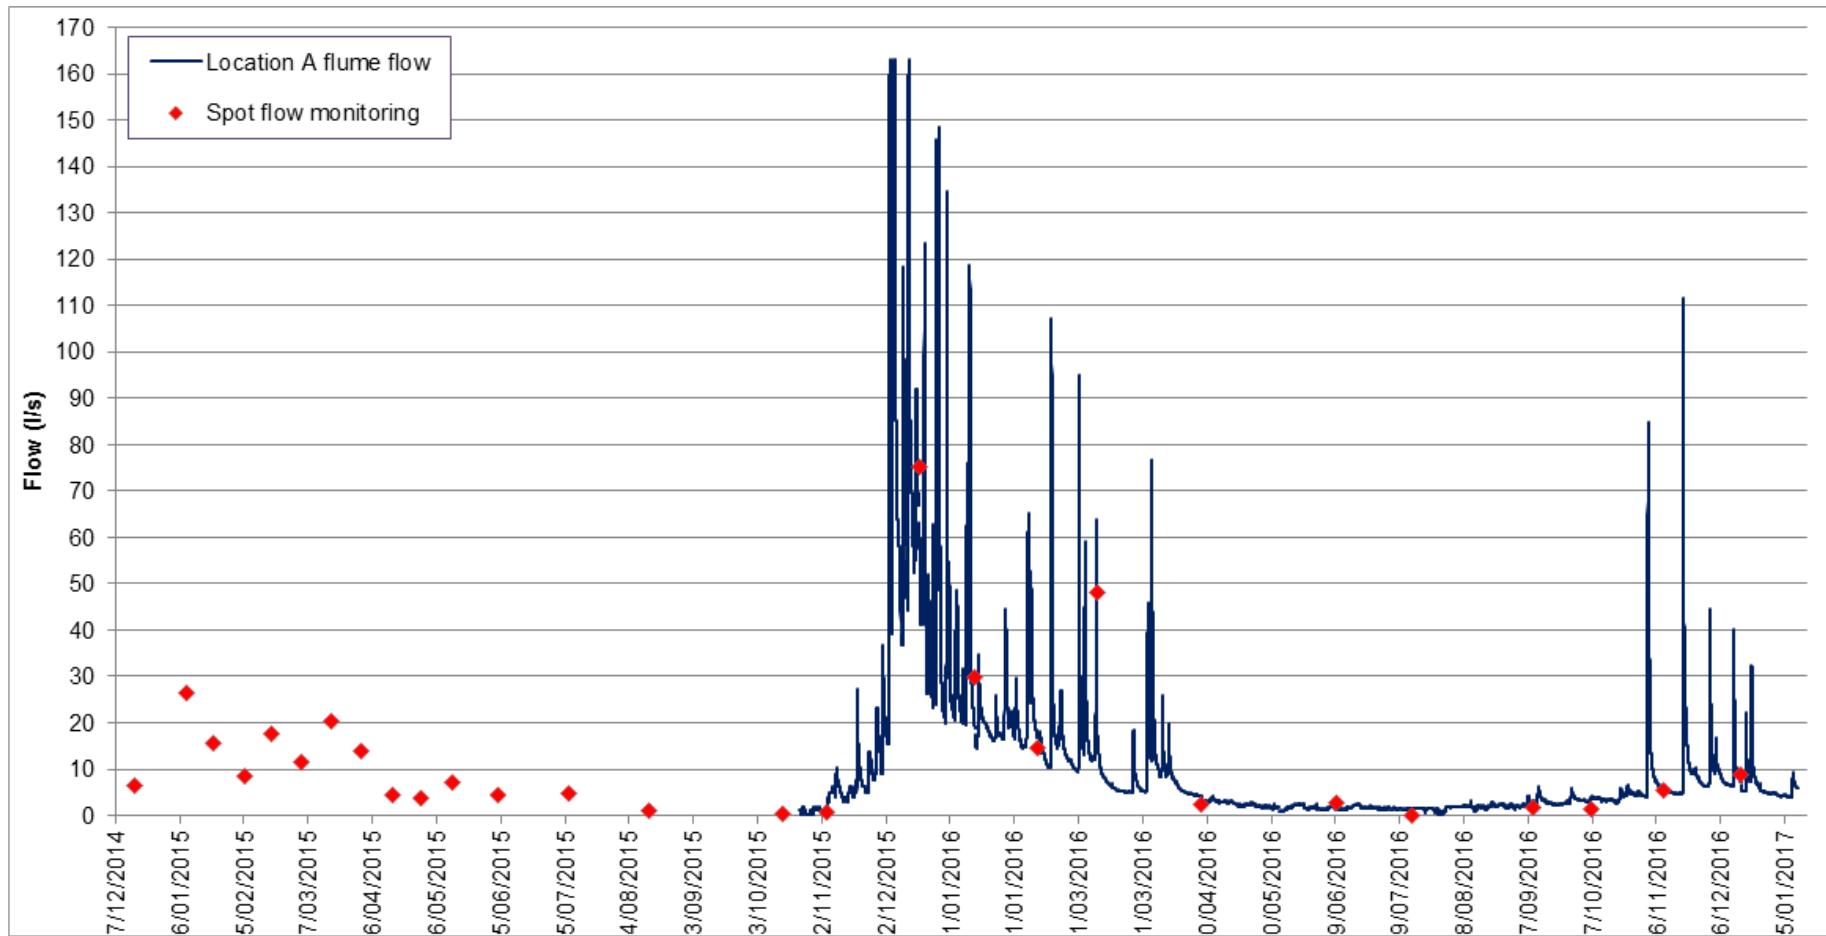
Flow in Nant Caerdegog Isaf at Location A
