Wylfa Newydd Project

**6.4.31 ES Volume D - WNDA Development App
D8-6 - Cae Gwyn Hydroecological Assessment**

Cae Gwyn SSSI Hydroecological Assessment

HYD\REP\001 | 3.0

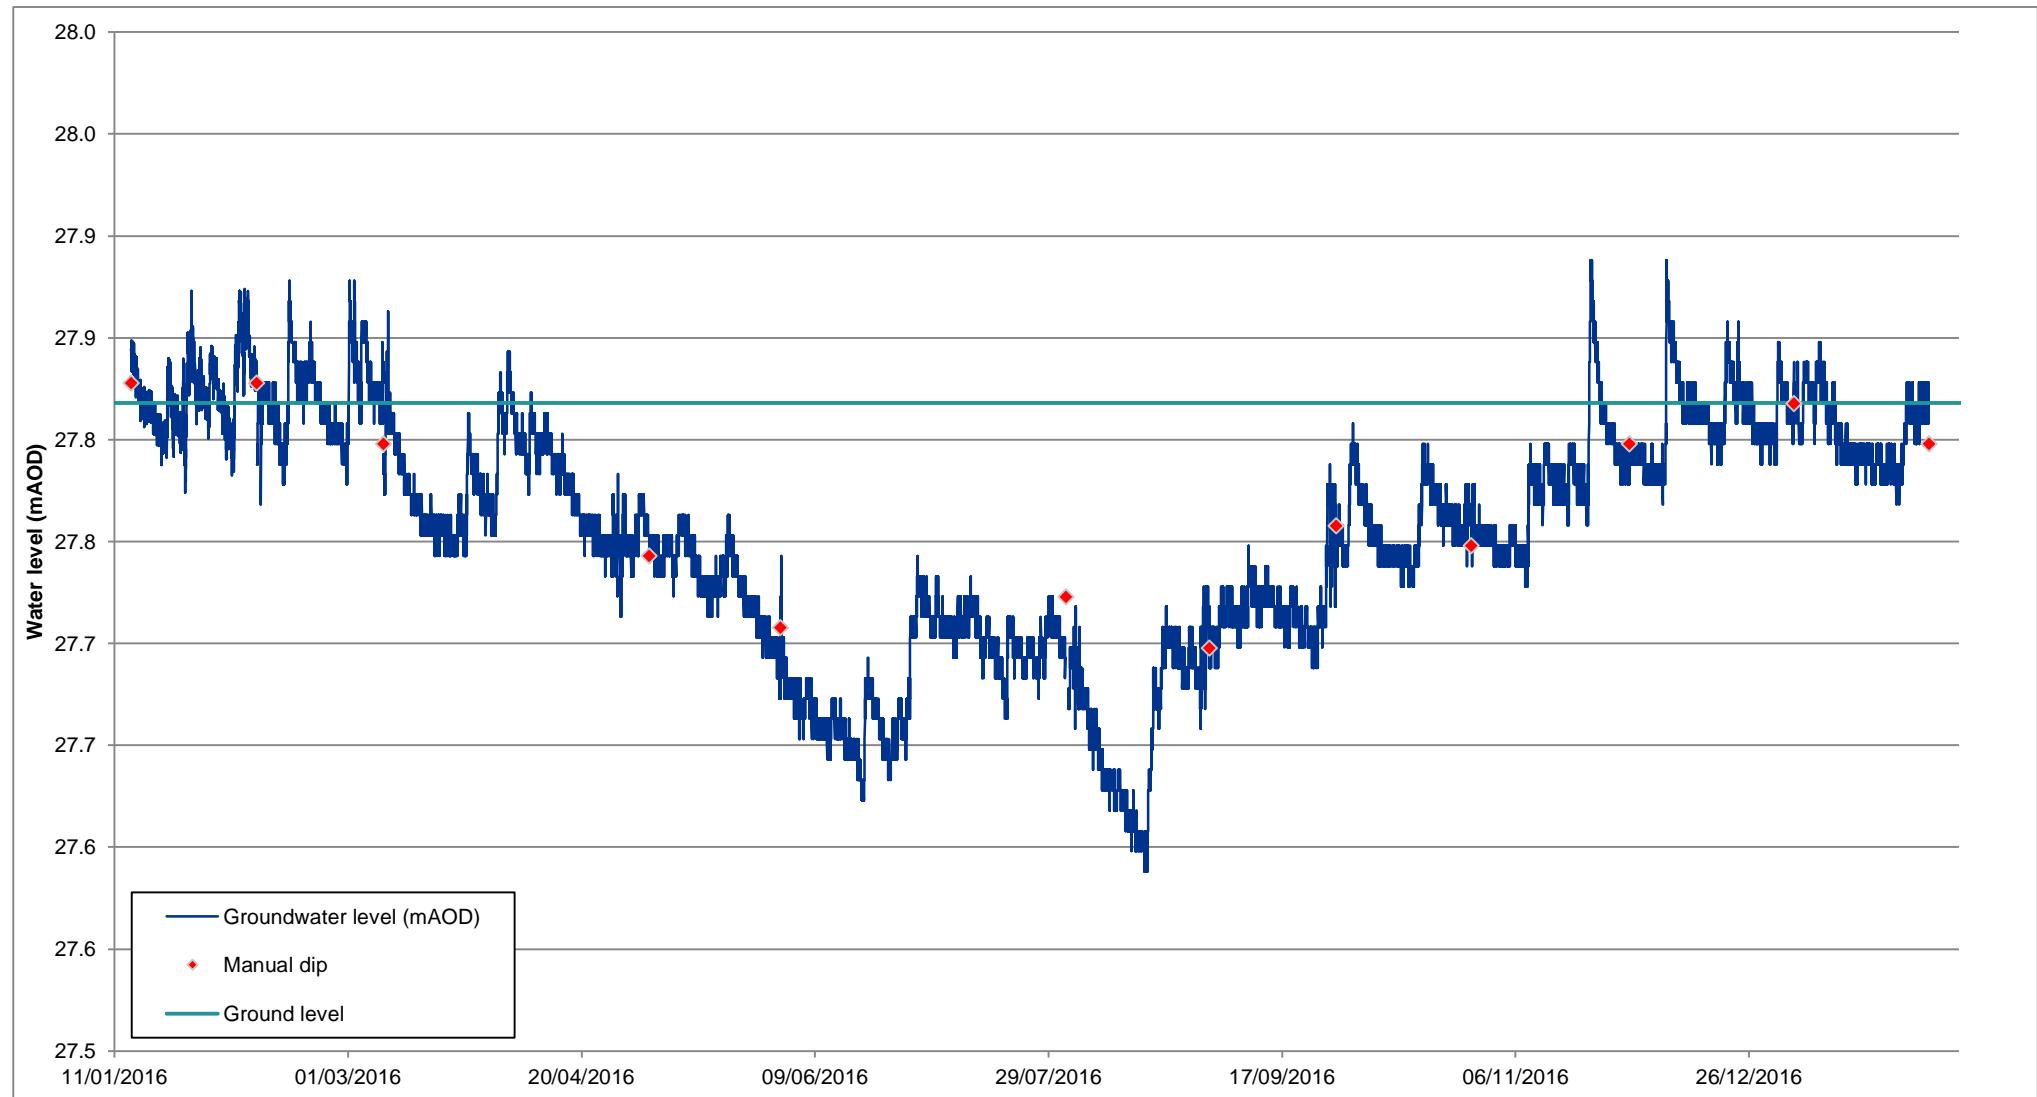
Water levels from Southern Basin piezometer logger

Between January and March 2016, the water level in the Southern Basin remained at or just above ground level. A steady decline in water level is then observed between March and August, followed by an equally steady rise back to above ground level in August 2016 to February 2017. The maximum variation in water level throughout the year is in the order of 0.30m (see table D8-6-2-4), although several notable responses to rainfall events are observed in late July, mid-August, late September and late November/early December, with rises in water level in the order of 0.10m for each event. These responses are attributed to the wetting-up phase of the peat.

The gradual decline in water level between March and August 2016 could be the result of a number of factors including flow along the Southern Drain, a reduction in any groundwater inflow into the basin due to the bedrock water table dropping below the basin floor, leakage to groundwater from the peat, as well as evapotranspiration from the basin surface, creating a soil moisture deficit in the peat. In the winter months, any inflowing water (direct rainfall, surface water runoff and groundwater) which exceeds that being lost from the basin will likely be used to recharge this deficit. The plateau observed in water levels in January/February 2016 and again in December 2016 to February 2017 (in all four basins) suggests that there are no further increases in water level in the winter months as the basins are likely to be overflowing at the surface. In the Southern Basin, this is attributed to the Southern Drain transporting excess flows to the POB (see Section 2.4.2) in winter.

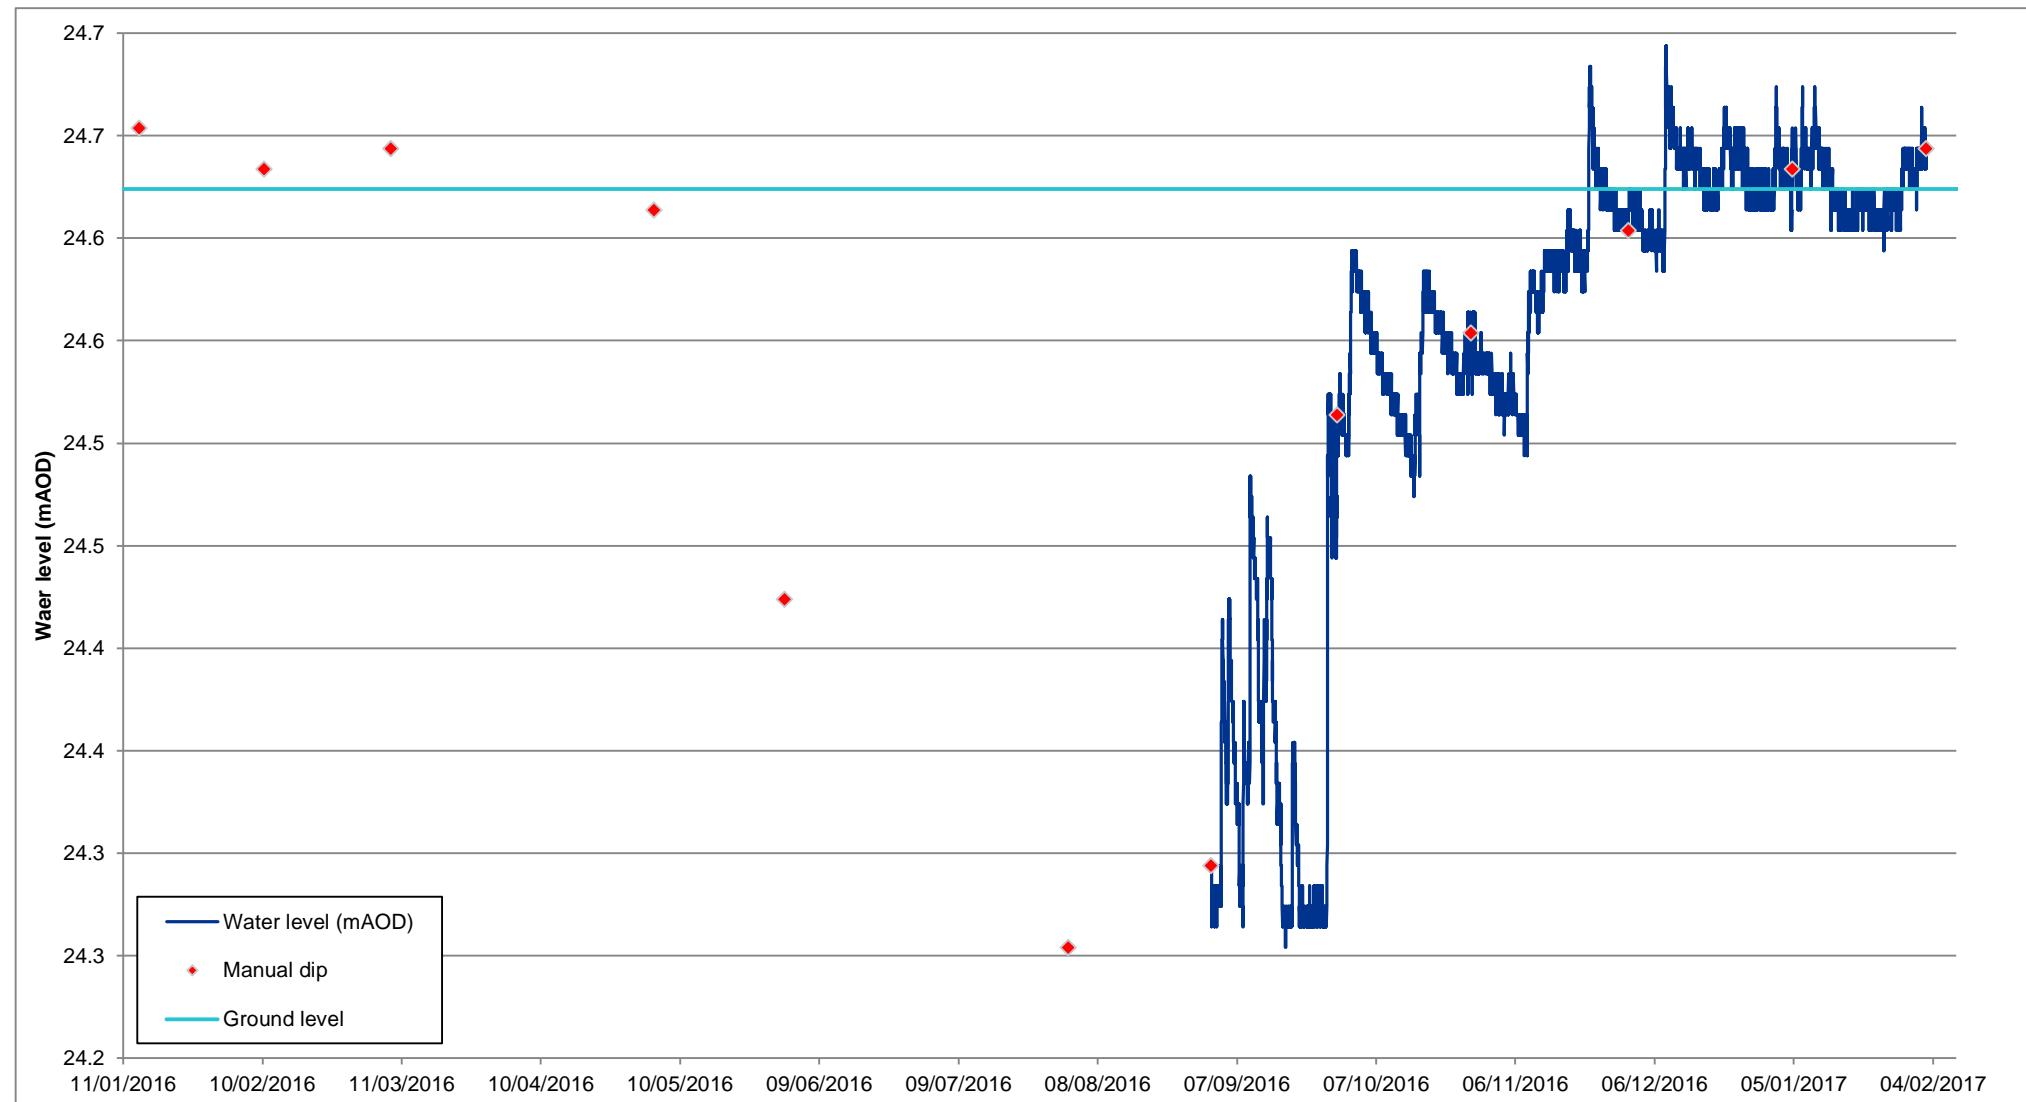
Water levels from Western Basin piezometer logger

The water level variations in the Northern and Western Basins follow a broadly similar trend to those observed in the Southern Basin and POB with water at ground level in winter, dropping in spring and summer. During the late spring/early summer months, water levels in these two basins show a steady decline, with a limited store of water in the soil and subsoil and groundwater levels in the bedrock at a lower elevation than the basin floors. However, from June through to October 2016, water levels in the Northern Basin appear to remain relatively steady, at a depth of around 0.2mbgl, which indicates that the basin is dry, and with limited recovery in early autumn. It isn't until mid-November that water levels in the Northern Basin begin to rise steadily back to ground level, responding in a similar manner to the other basins to the rainfall events in late November/early December 2016. It should be noted that water levels within the Northern Basin remain below the level of the elevation of the overflow point (25.7mAOD), which could indicate that levels above this would overflow the basin.

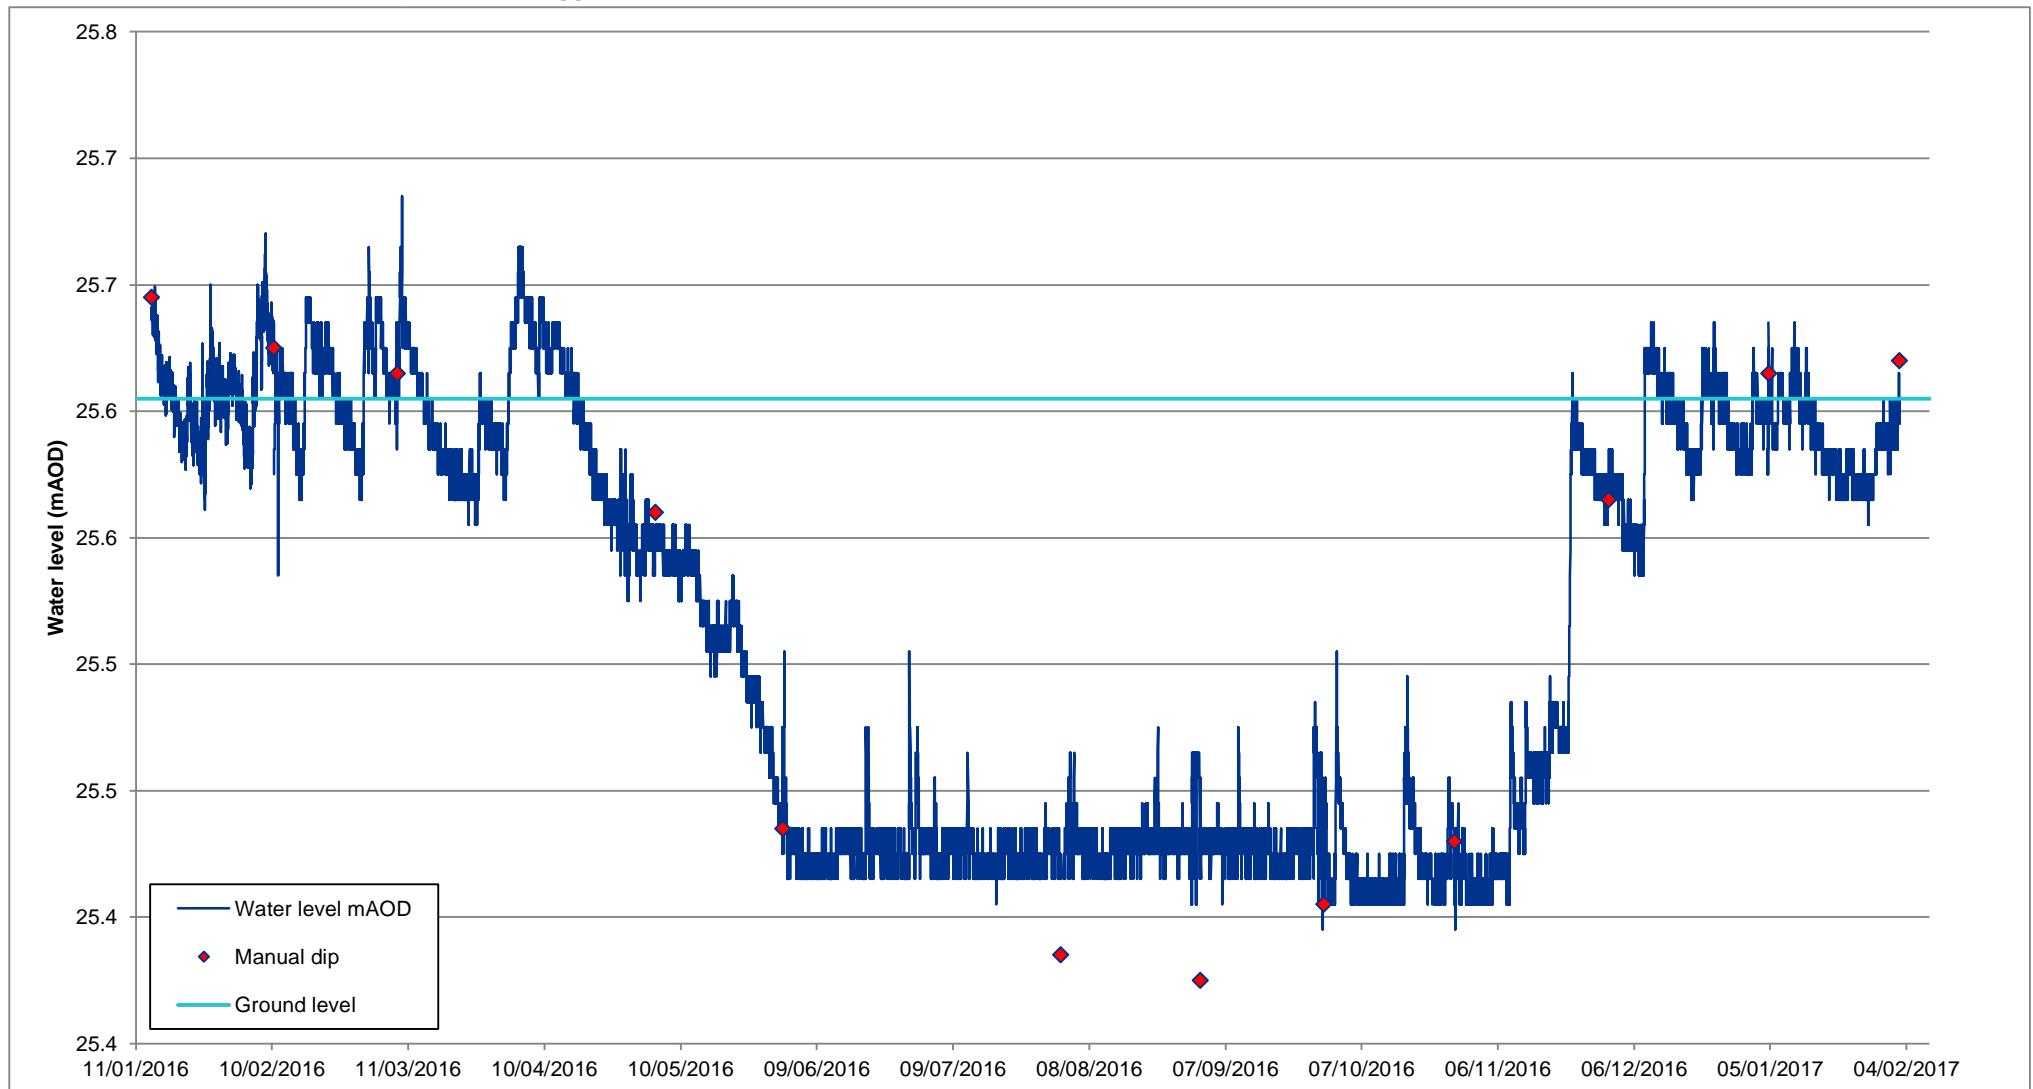
Water levels from Northern Basin piezometer logger

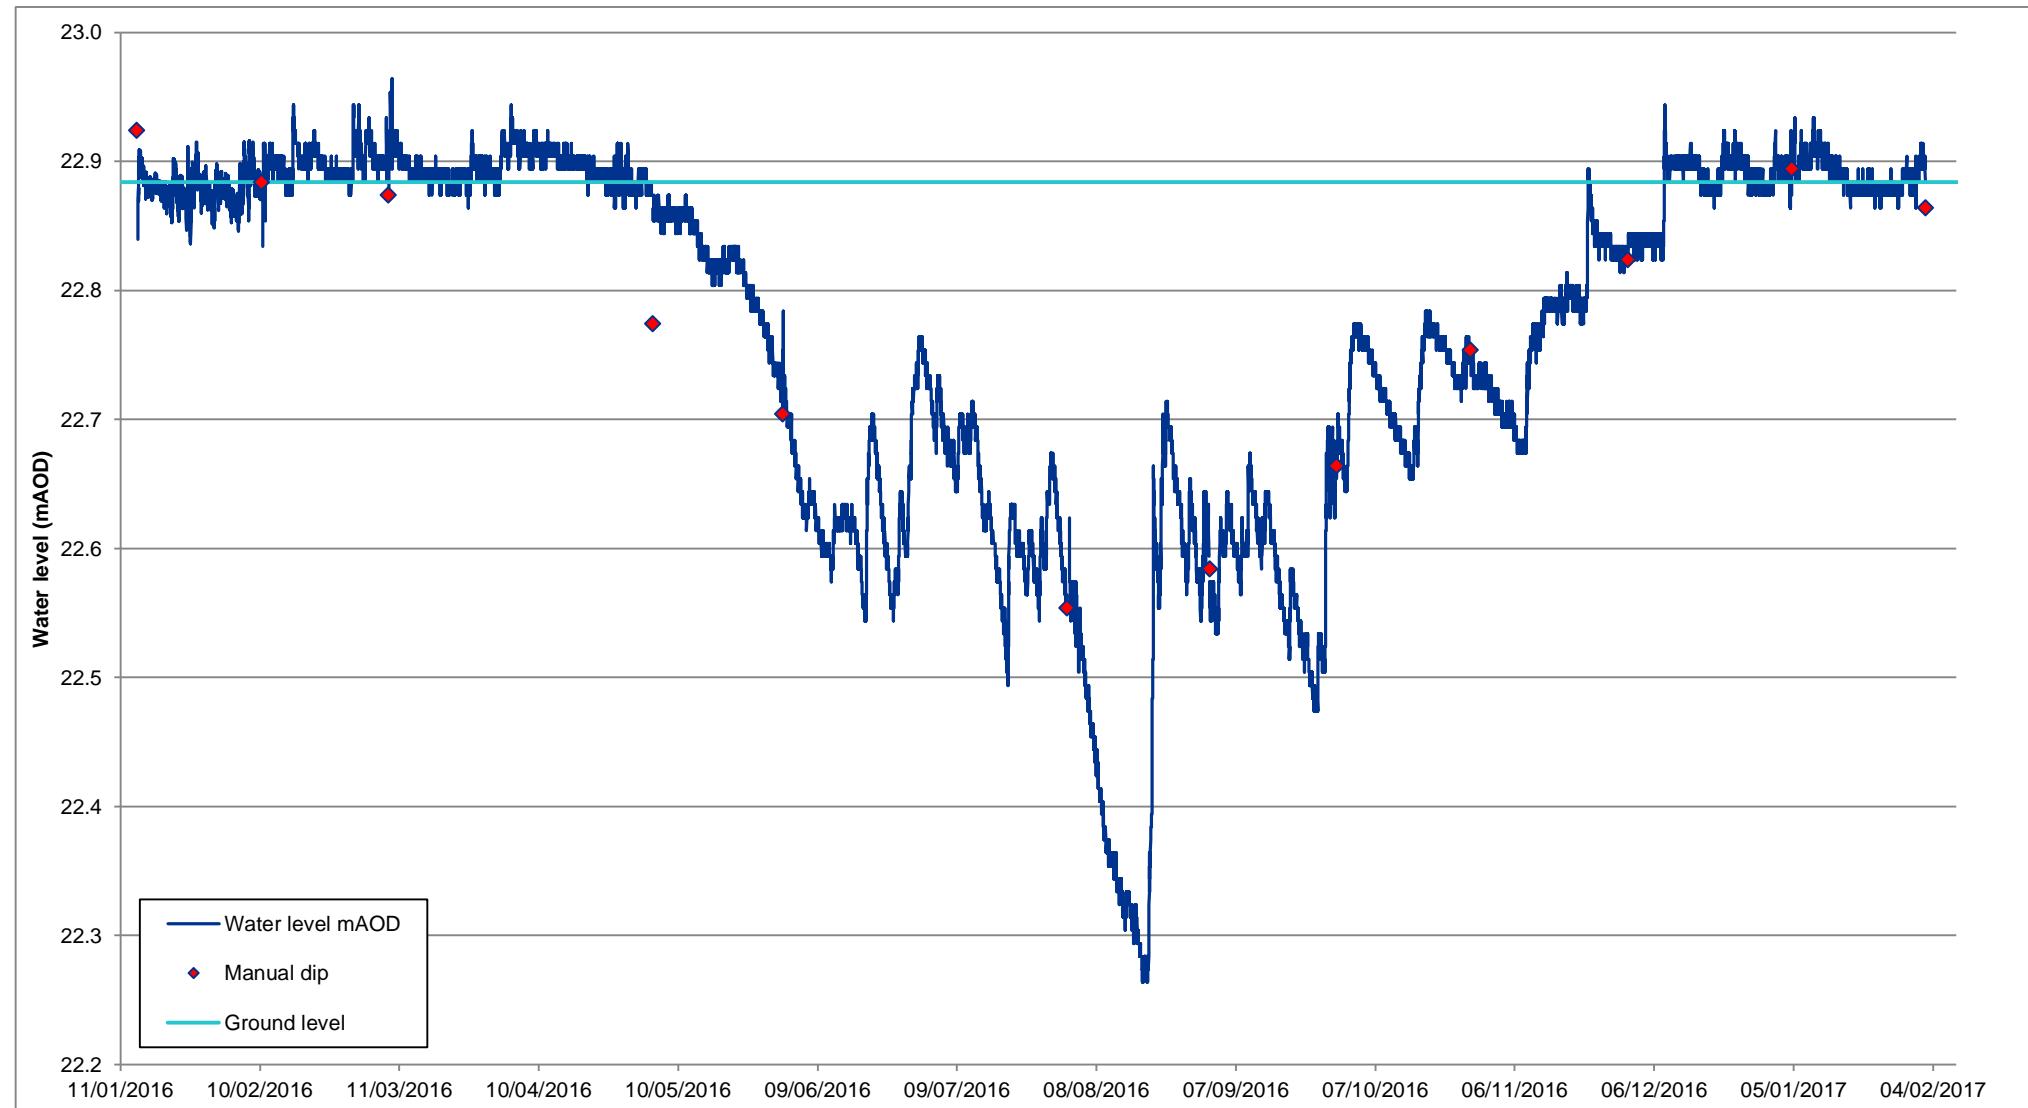
Water levels from POB piezometer logger

The water level in the POB shows a similar trend to that observed in the Southern Basin, including the responses to the rainfall events observed in late July through to early December 2016 (similar responses are also observed in the Northern and Western Basins), suggesting that the water levels in the two basins function in a similar way. However, water levels in the POB show a greater response to rainfall events, with an overall variation throughout the year of around 0.70m (see table D8-6-2-3), more than double that of the Southern Basin. In addition, the water level remains at ground level until late April 2016, compared to early March for the Southern Basin, showing a two-month lag in the POB response. This indicates that either the POB receives a more sustained inflow (groundwater or runoff) in the winter/spring months than the Southern Basin, the greater depths of peat in the POB are able to retain greater quantities of water, or the high bedrock groundwater table at the POB prevents drainage of the peat into the underlying bedrock.

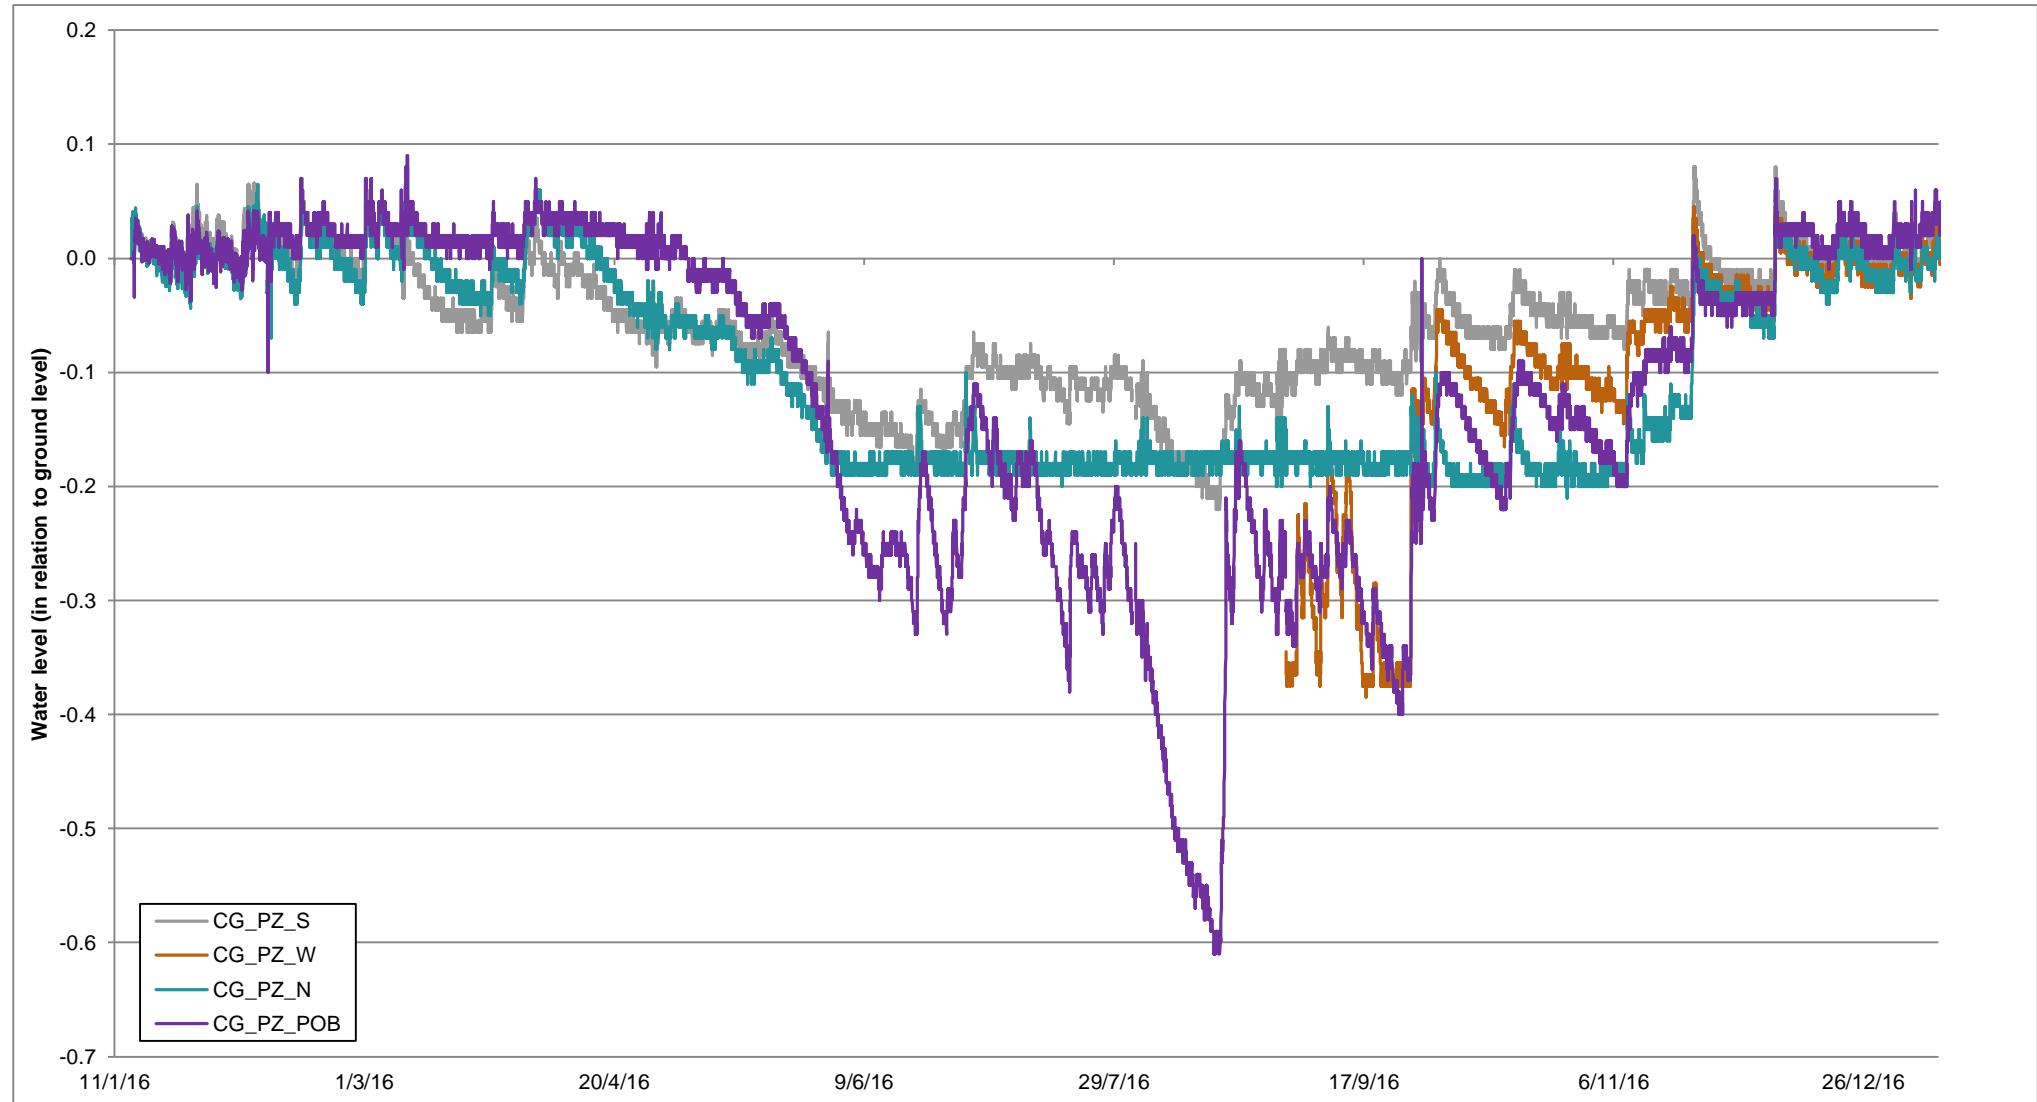
Water levels in all four piezometer loggers (in relation to ground level)

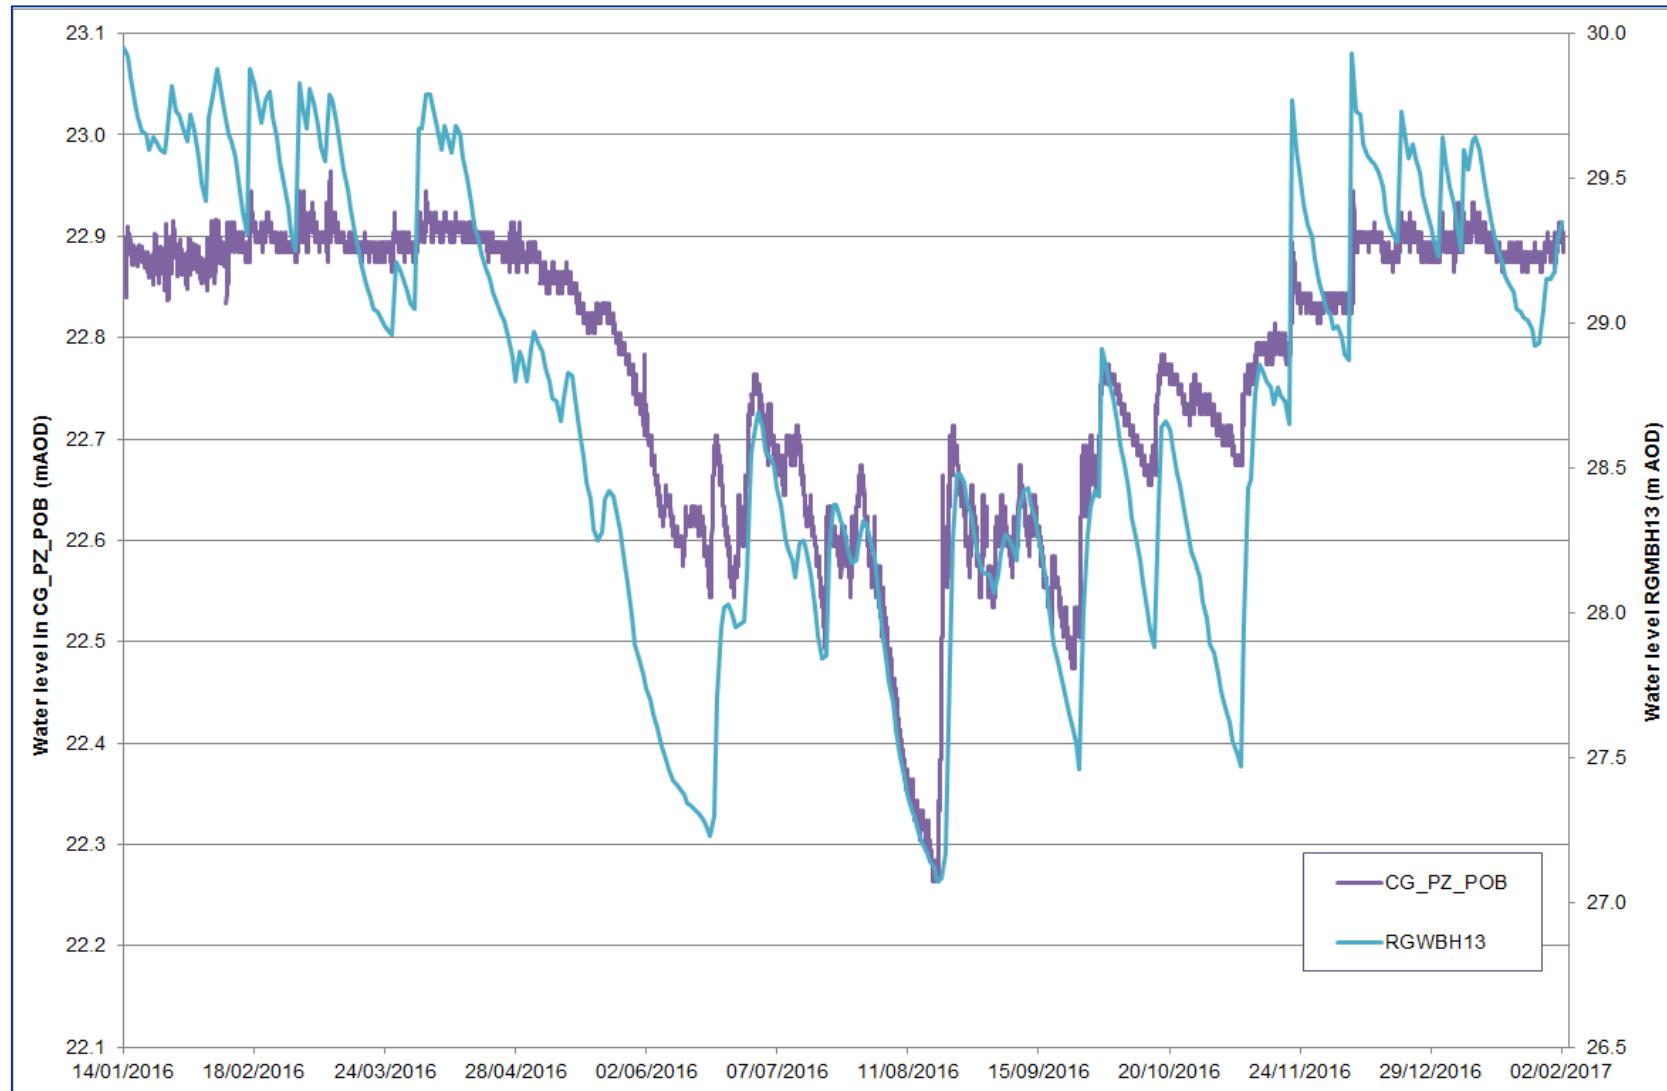
Water levels in the POB compared to groundwater levels in RGWBH13 (note different vertical scales)

The water balance suggests that there is a small inflow to the POB that is not identified in the calculations, the source of which is likely to be associated with a combination of groundwater influx, flow from the Northern Basin and uncertainties in the calculation. Overall the water balance does not indicate substantial groundwater inflow or outflow, although groundwater could be important at a local scale in supporting particular vegetation assemblages.

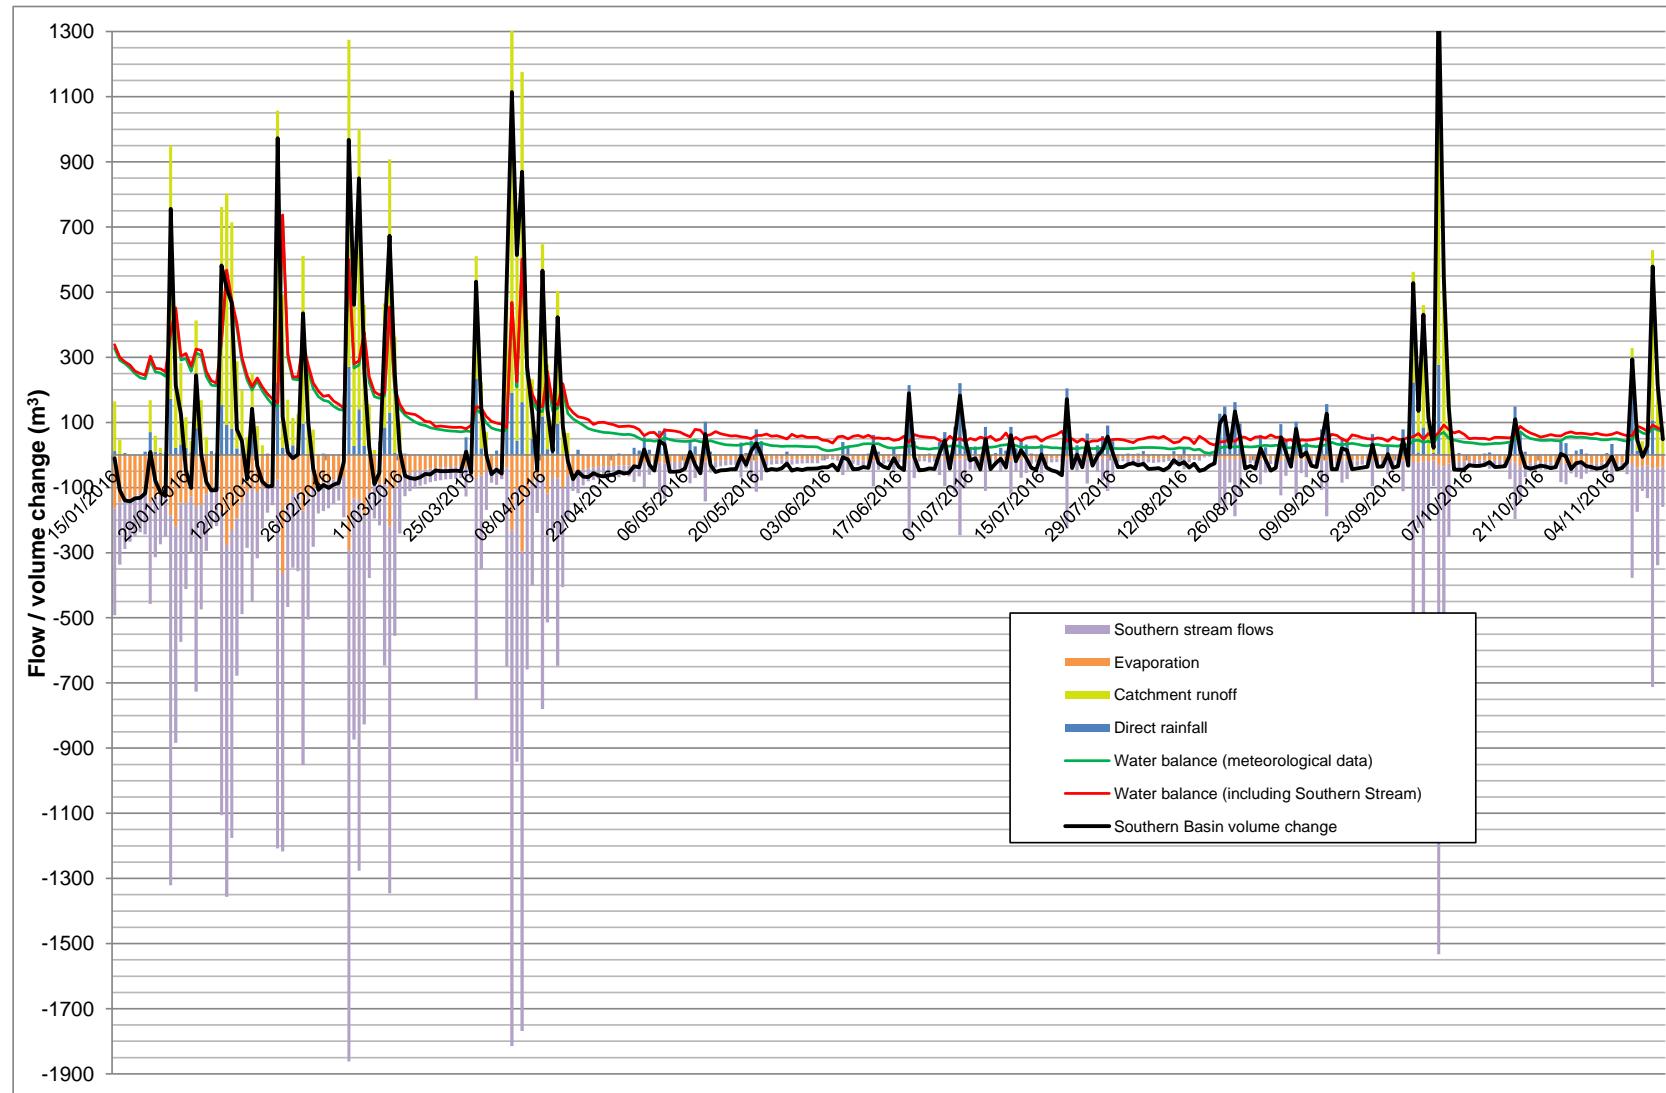
Southern Basin water balance

The water balance found that inflows generally exceeded outflows indicating that it is unlikely that there are any substantial groundwater inflows to the Southern Basin. However, there could be substantial outflows to groundwater during winter and autumn.

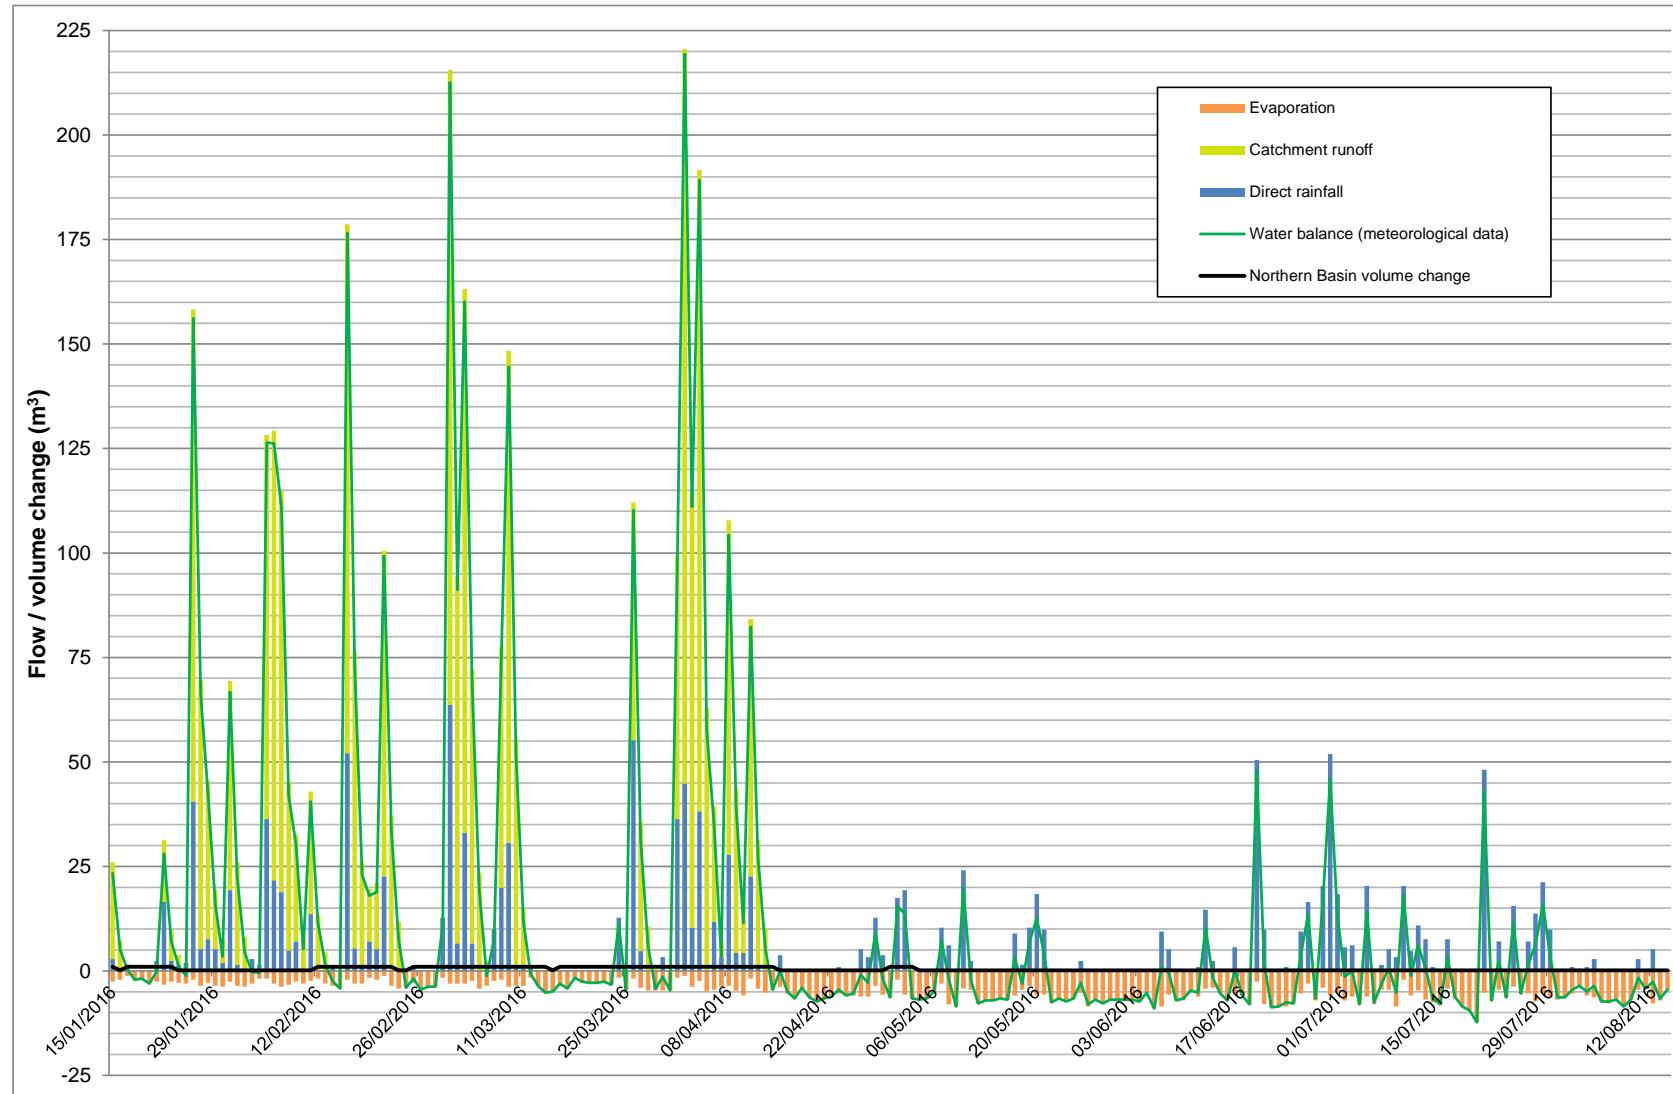
Northern Basin water balance

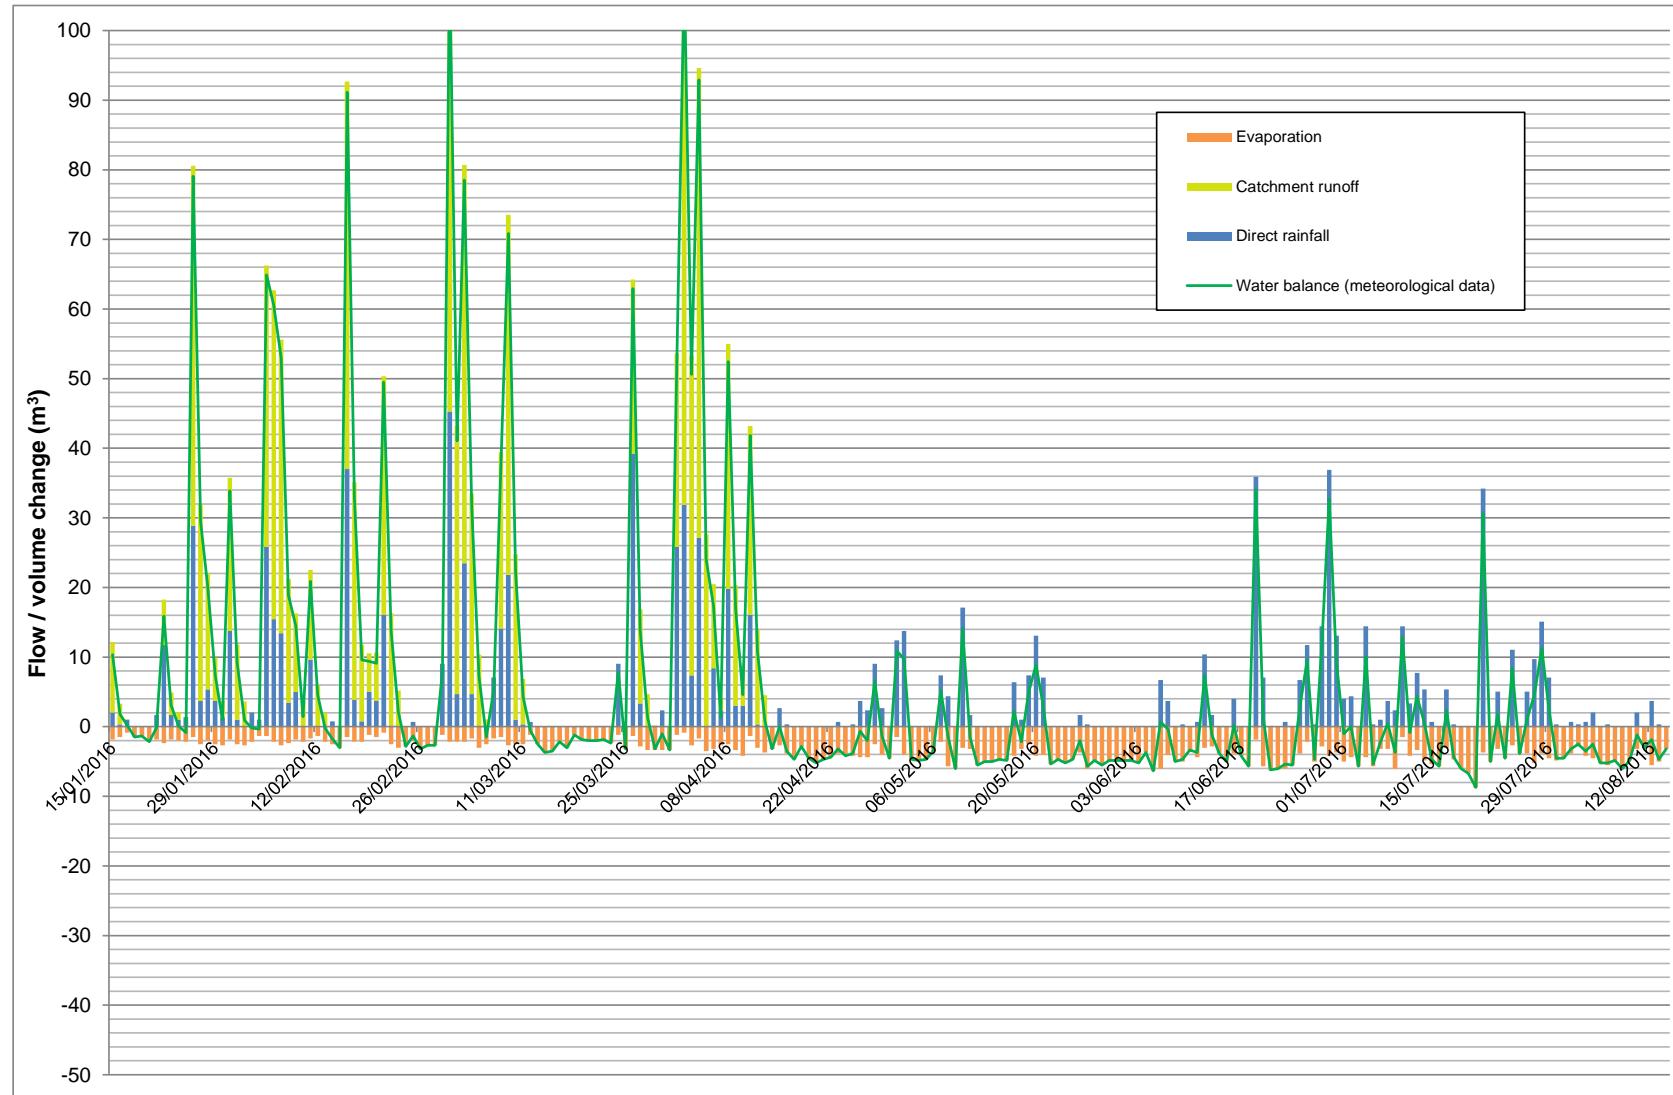
Western Basin water balance

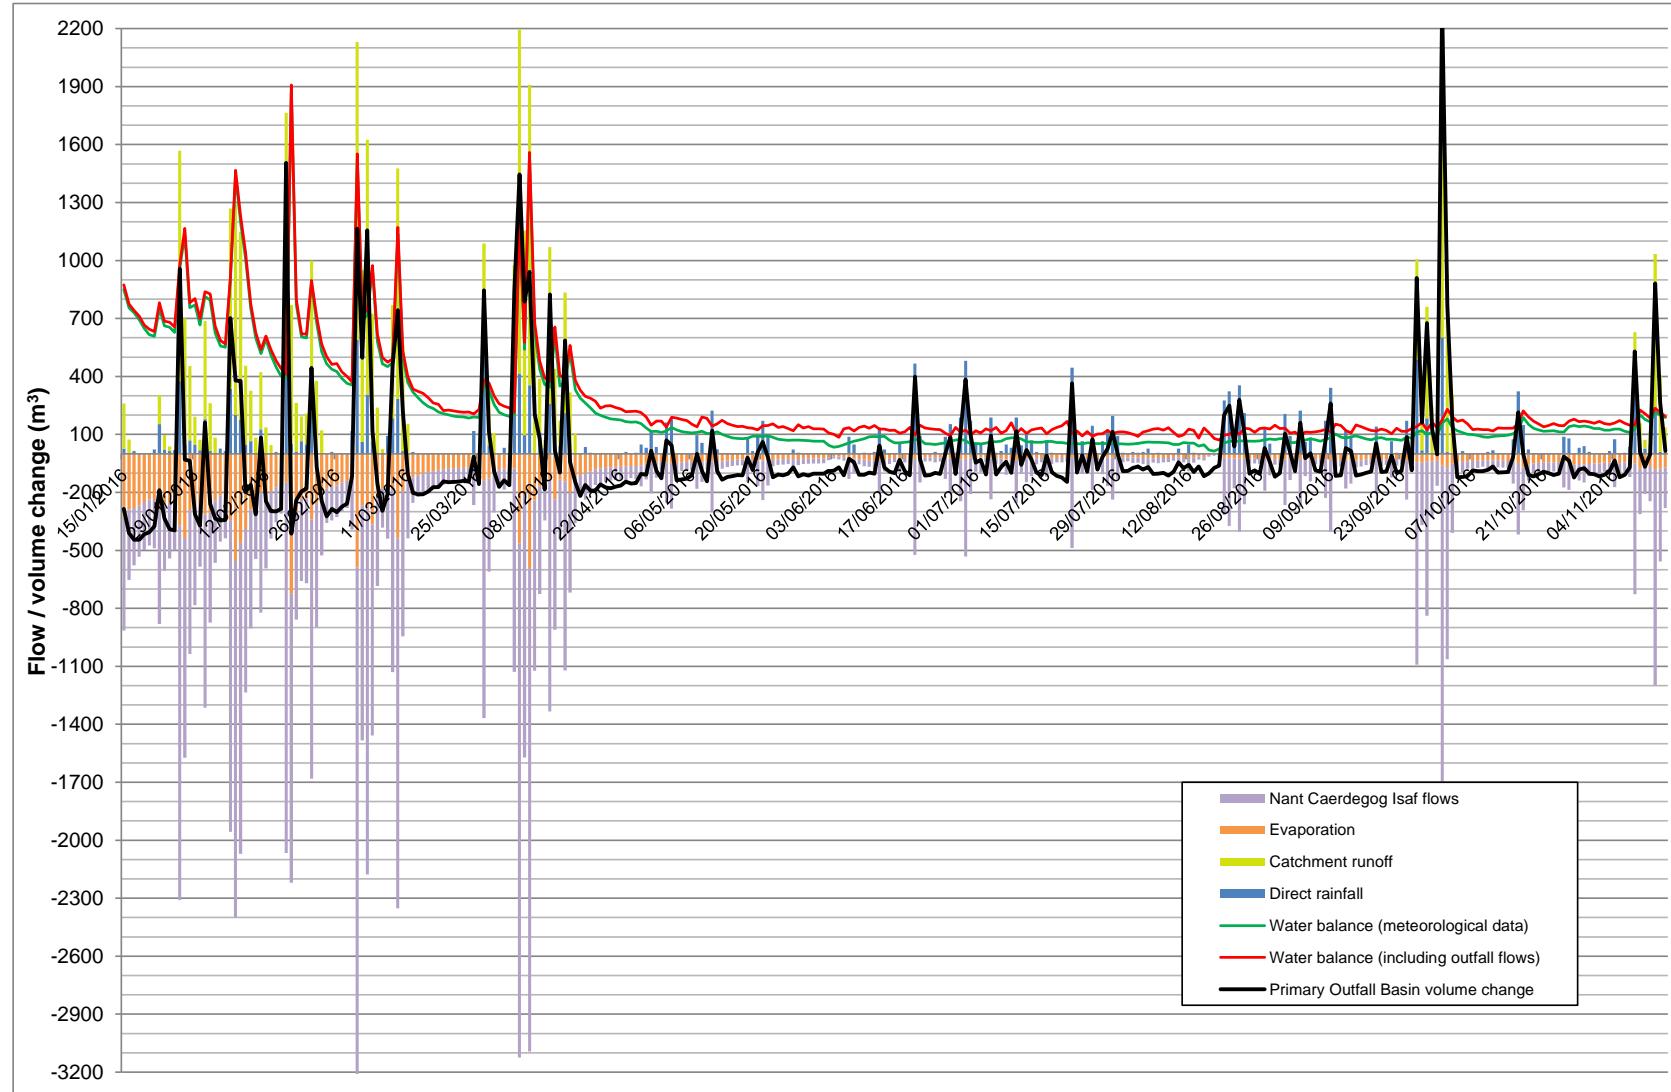
POB water balance

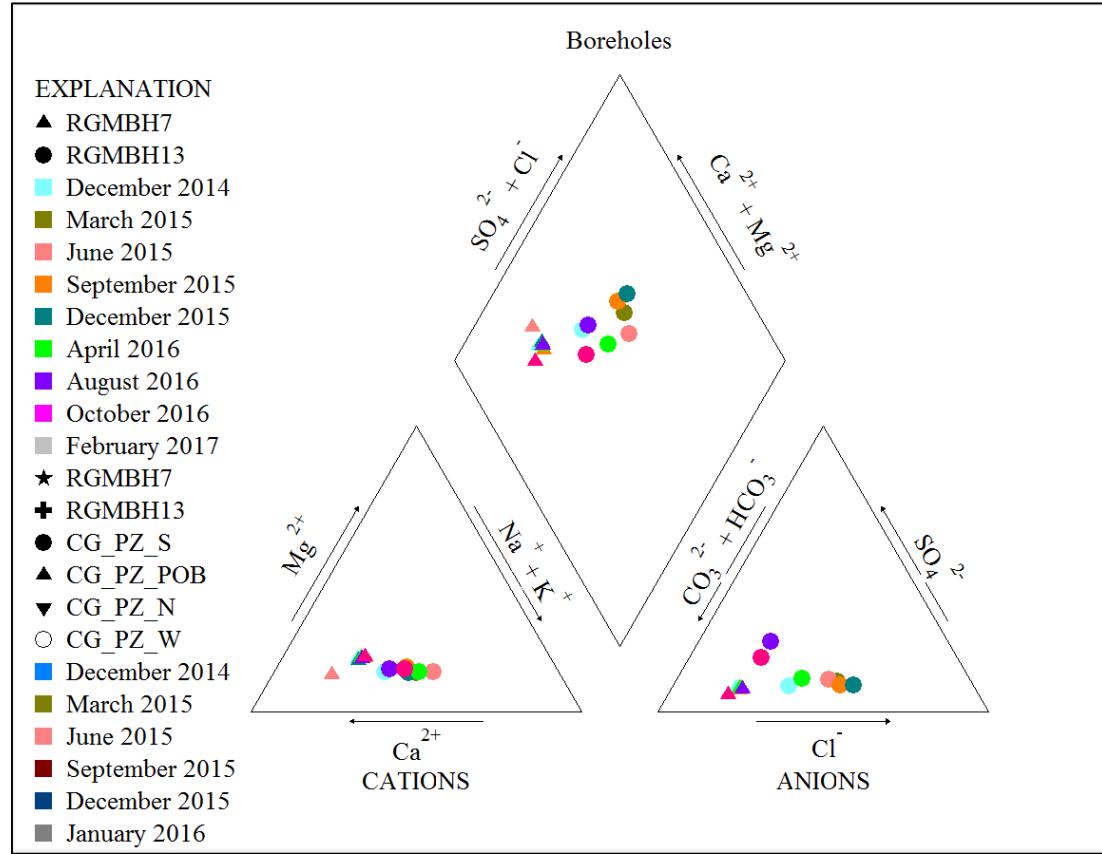
Boreholes piper plots (RGMBH7 and RGMBH13)
