Wylfa Newydd Project

**6.4.31 ES Volume D - WNDA Development App
D8-6 - Cae Gwyn Hydroecological Assessment**

Cae Gwyn SSSI Hydroecological Assessment

HYD\REP\001 | 3.0

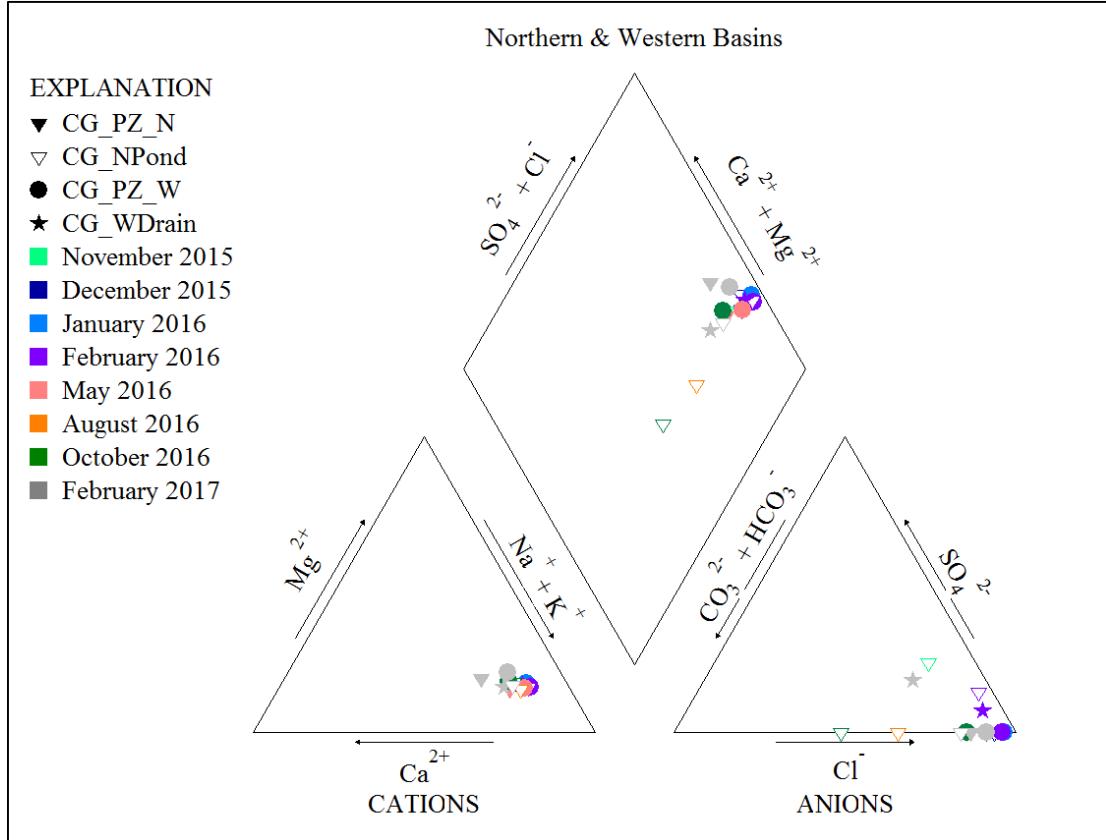
Northern & Western Basins piper plots

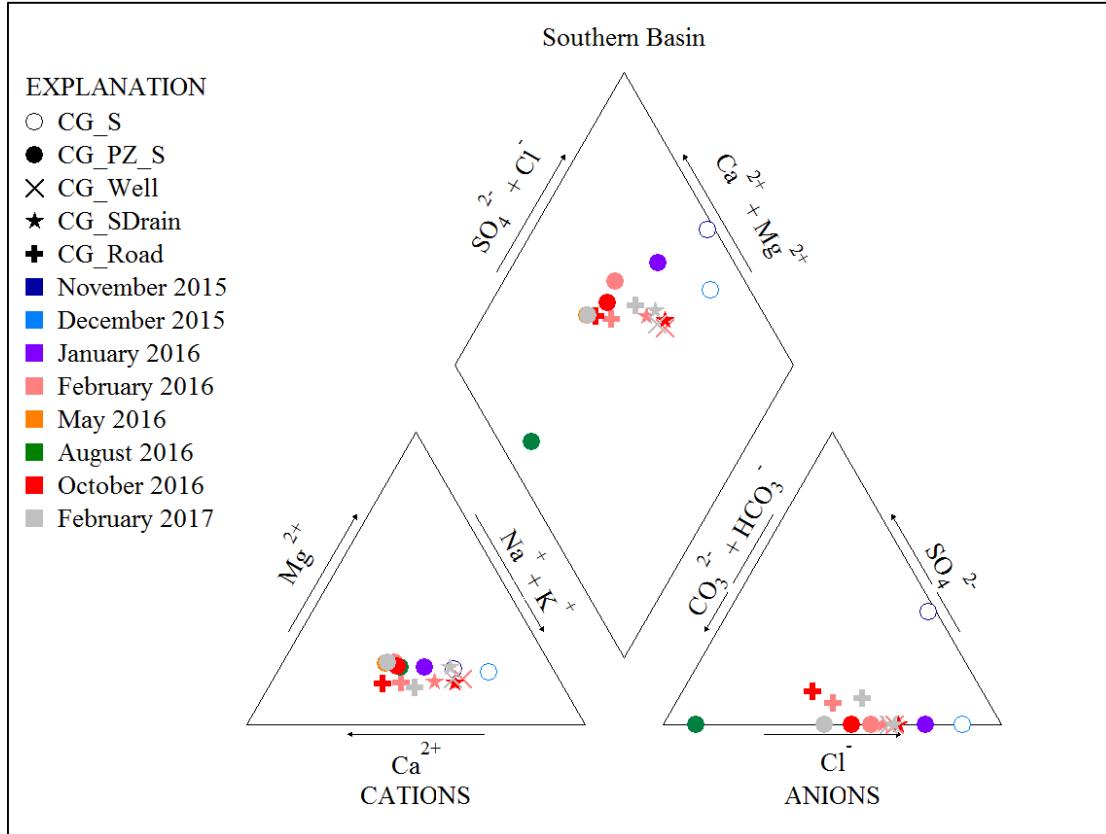
Southern Basin piper plots

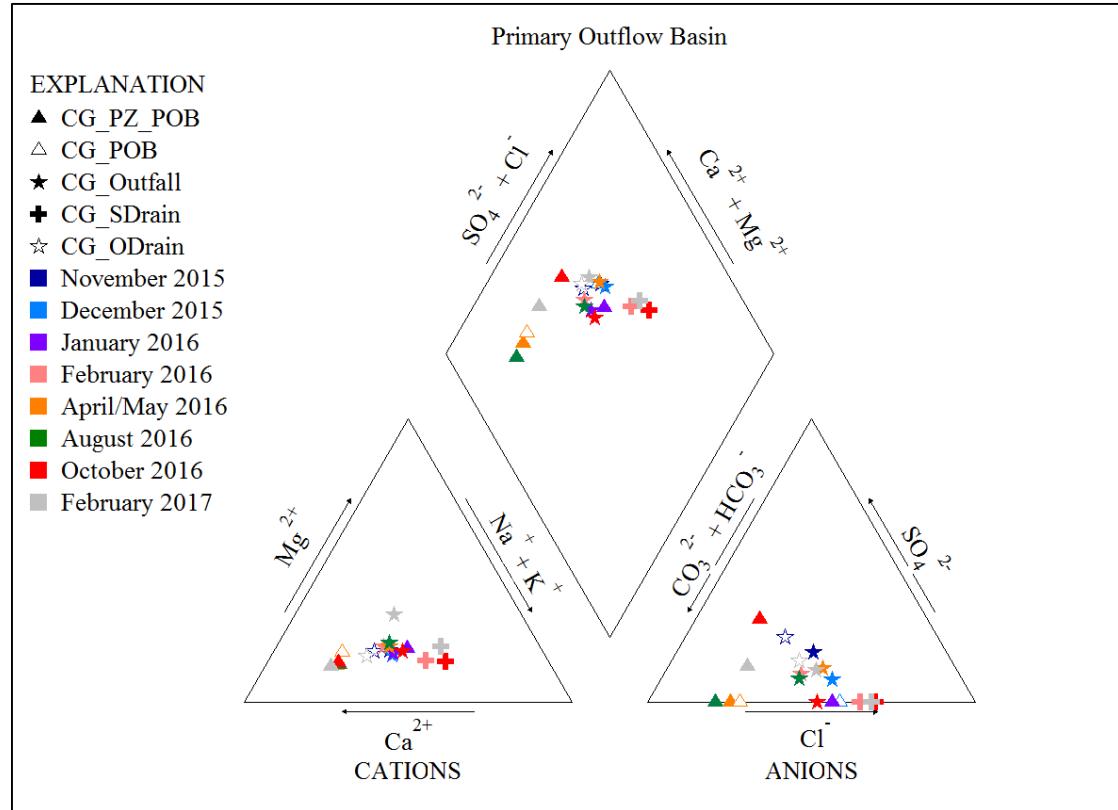
Primary Outflow Basin piper plots

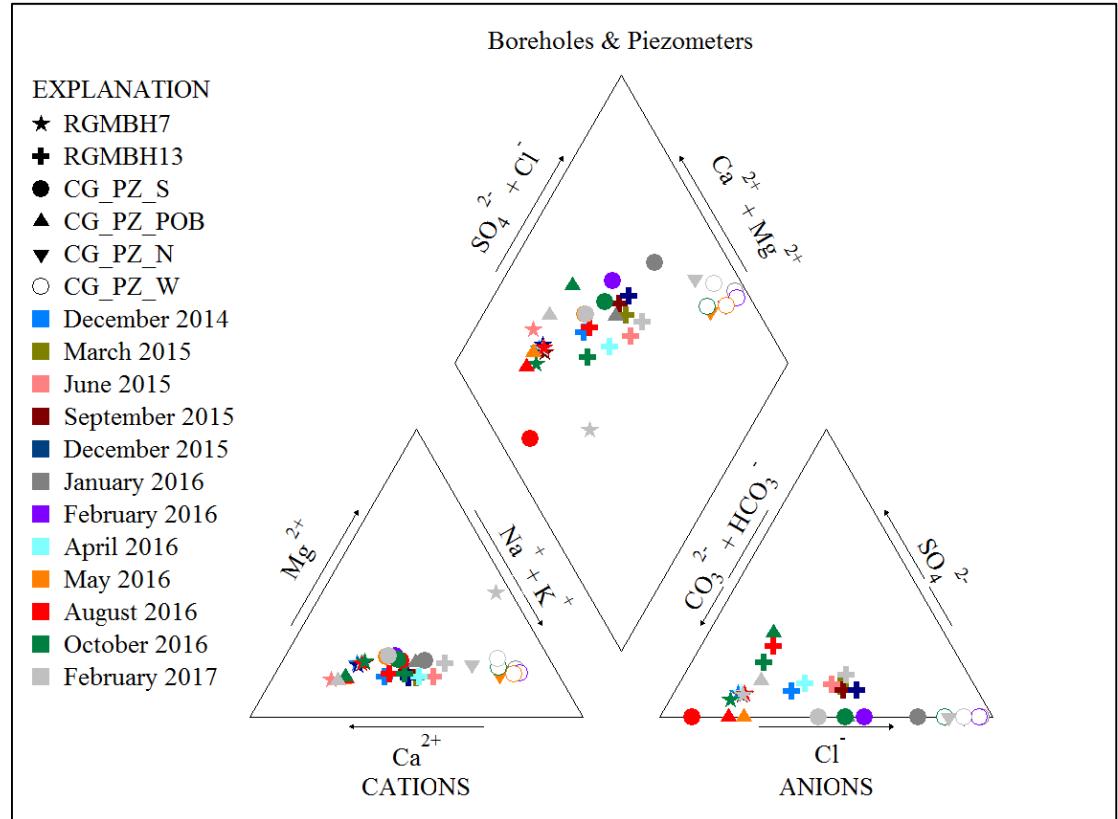
Borehole and Piezometer piper plots
