## **Wylfa Newydd Project**

**6.5.17 ES Volume E - Off-Site Power Station Facilities: AECC, ESL and MEEG App E9-1 - Terrestrial ecology survey at proposed MEEG site, Llanfaethlu**

### **Terrestrial ecology surveys at proposed MEEG site**

60PO8058/TER/REP/008 | 0

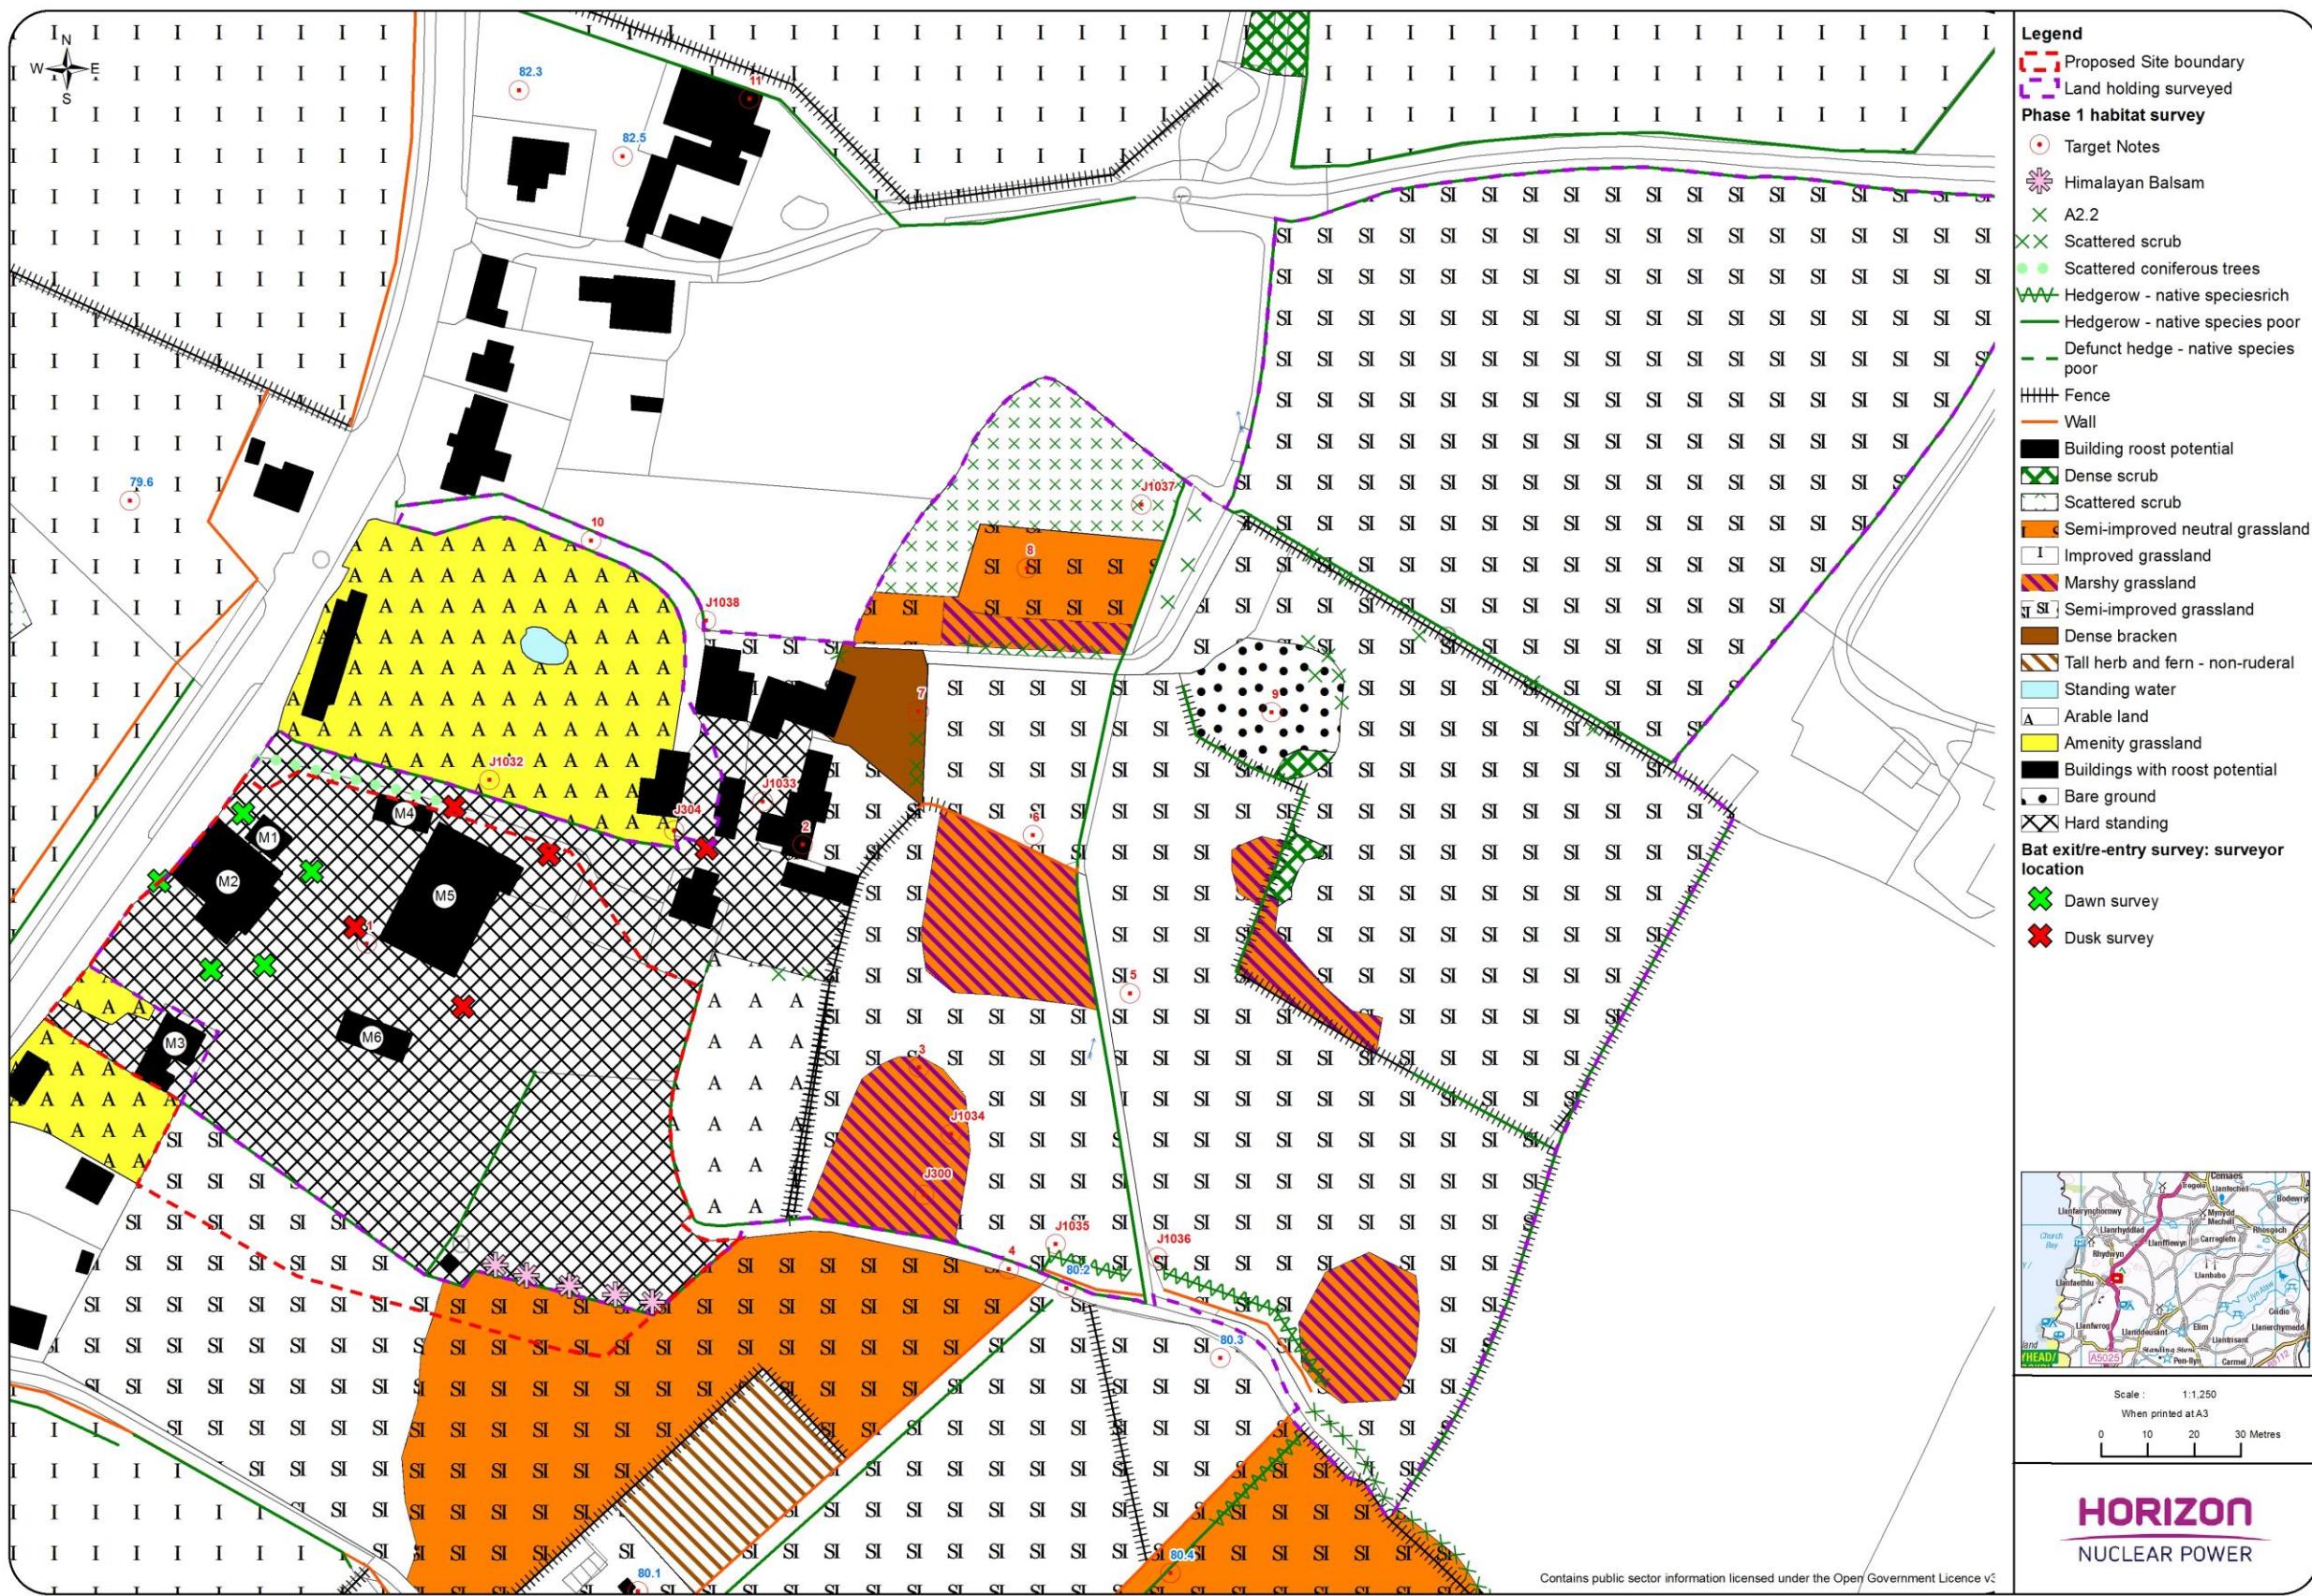
## Figure 1: Phase 1 Habitat and Bat Roost Surveys

The broad habitats types and target notes recorded are displayed in Figure 1. Target Note (TN) descriptions and a species list are provided in Appendix A.

- hard standing: Buildings and hard standing with scattered stands of ephemeral vegetation (target note 1)
- scattered trees – coniferous: a line of conifers on the northern boundary.
- tall ruderal vegetation (Himalayan balsam): Himalayan balsam recorded at the edge of the hard standing on the southern boundary (figure 1).

Buildings M1, M2 and M5 were considered to have low potential for roosting bats based on the external and internal inspections (Table 2.1). One re-entry/emergence survey was carried out on each building as a result. Surveyor locations during each survey can be seen in Figure 1.

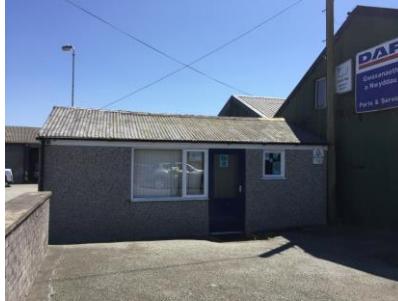
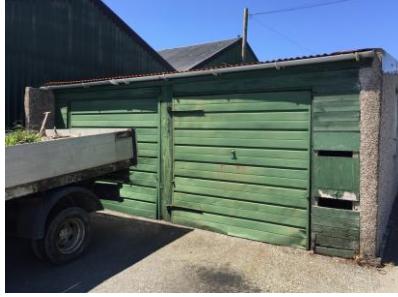
Building number	Survey date	Description	Potential for roosting bats	Photo of building	Roost potential	Further survey carried out
M1	2 June 2016	<p>Small pebble dashed building with corrugated iron roof in generally good condition. Some windows smashed but boarded up.</p> <p>On the southern side are garage doors with shiplap wood around them.</p>	<p>Some small gaps (very few) where plastic has come away from fascia.</p> <p>Gaps into building due to missing boards</p>

Low	<ul style="list-style-type: none"> <li>Internal inspection</li> <li>Emergence/re-entry survey</li> </ul>

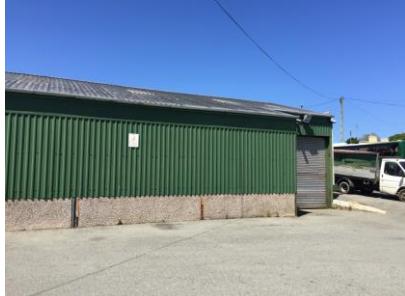
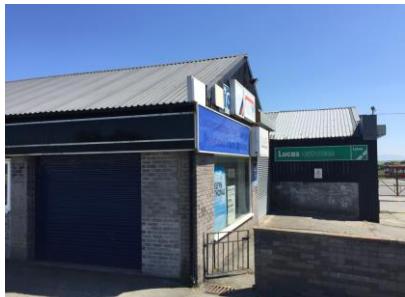
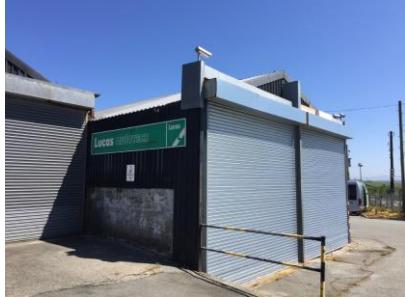
Building number	Survey date	Description	Potential for roosting bats	Photo of building	Roost potential	Further survey carried out
M2	2 June 2016	Large garage with corrugated metal sheeting and roof. The old shop area is also in good condition.	Space between the sheets and the fascia.

Low	<ul style="list-style-type: none"> <li>Internal inspection</li> <li>Emergence/re-entry survey</li> </ul>

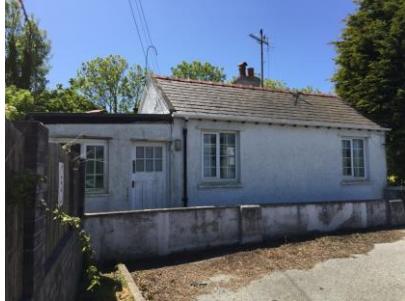
<b>Building number</b>	<b>Survey date</b>	<b>Description</b>	<b>Potential for roosting bats</b>	<b>Photo of building</b>	<b>Roost potential</b>	<b>Further survey carried out</b>
M3	2 June 2016	Old bungalow residence with tiled roof and adjacent flat roofed building. Limited external inspection as no access.	Potential for roosting opportunity in tiled roof

Moderate	No further survey as not within proposed site boundary.
M4	2 June 2016	Porta-cabin in good condition, currently in use.	None

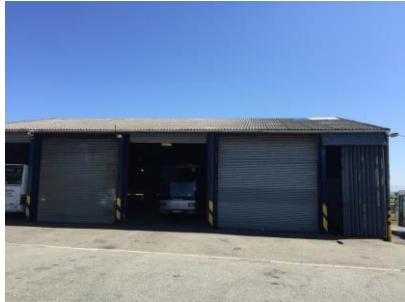
Negligible	No further survey
M5	2 June 2016	Large garage in generally good condition with asbestos side panels to the east.	Roosting opportunity under panels

Low	<ul style="list-style-type: none"> <li>Internal inspection</li> <li>Emergence/re-entry survey</li> </ul>

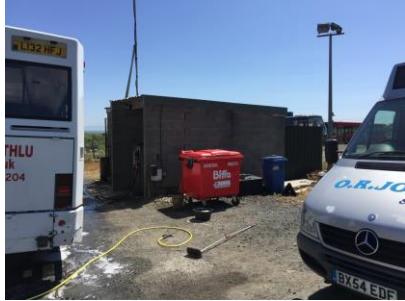
<b>Building number</b>	<b>Survey date</b>	<b>Description</b>	<b>Potential for roosting bats</b>	<b>Photo of building</b>	<b>Roost potential</b>	<b>Further survey carried out</b>
M6	2 June 2016	Breeze-block building of fairly new construction. Cracks in wall and space between wall and fascia boards. Large spaces between blocks in places. Houses oil, tank and petrol pump. Corrugated iron roof	Limited roosting opportunity

Negligible	No further survey
Target note 2	2 June 2016	Group of old stone farm buildings. In various stages of disrepair, but likely to offer bat roosting potential.  These buildings are not within the proposed works area, but were adjacent and within the land holding.	Offers good roosting potential

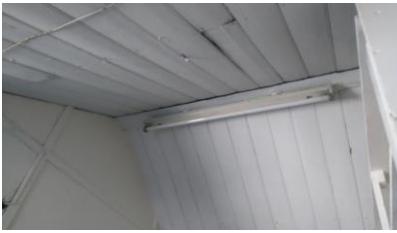
<b>Building number</b>	<b>Survey date</b>	<b>Description</b>	<b>Photos</b>	<b>Roost potential</b>	<b>Further survey recommended?</b>
M1	21 June 2016	Brick/block built room with large windows and ceiling at front of building. A swallow nest was present suggesting potential access points for bats although no signs were observed. Stored items of furniture were covered in bird droppings. No bat droppings were recorded.

Low	One emergence/re-entry survey
M2	21 June 2016	Steel framed building with pitched steel sheet roof and steel walls with concreted floors. Completely open inside with limited/low bat roosting potential. Upstairs office rooms contained no access or roosting opportunities for bats and no evidence for bats.  Everywhere was inspected with a cluelite.

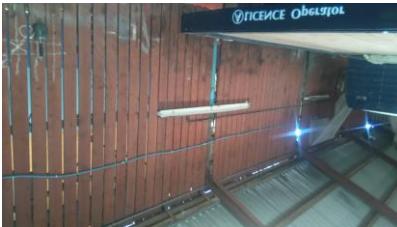
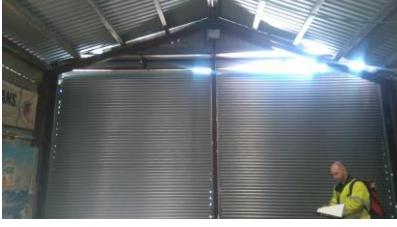
M5	21 June 2016	Steel frame building with asbestos cladding panels and extension to east with flat sheet roof. Main building is very open with limited roosting opportunities and in frequent use by mechanics. Building extension has low roost potential.

Low	One emergence/re-entry survey
