## **Wylfa Newydd Project**

**6.7.26 ES Volume G - A5025 Off-line Highway  
Improvements App G9-5 - A5025 Route  
Improvement Contract EIA: Great Crested Newt  
Field Survey Results**

# A5025 Route Improvement Contract EIA

Great Crested Newt Field Survey Results

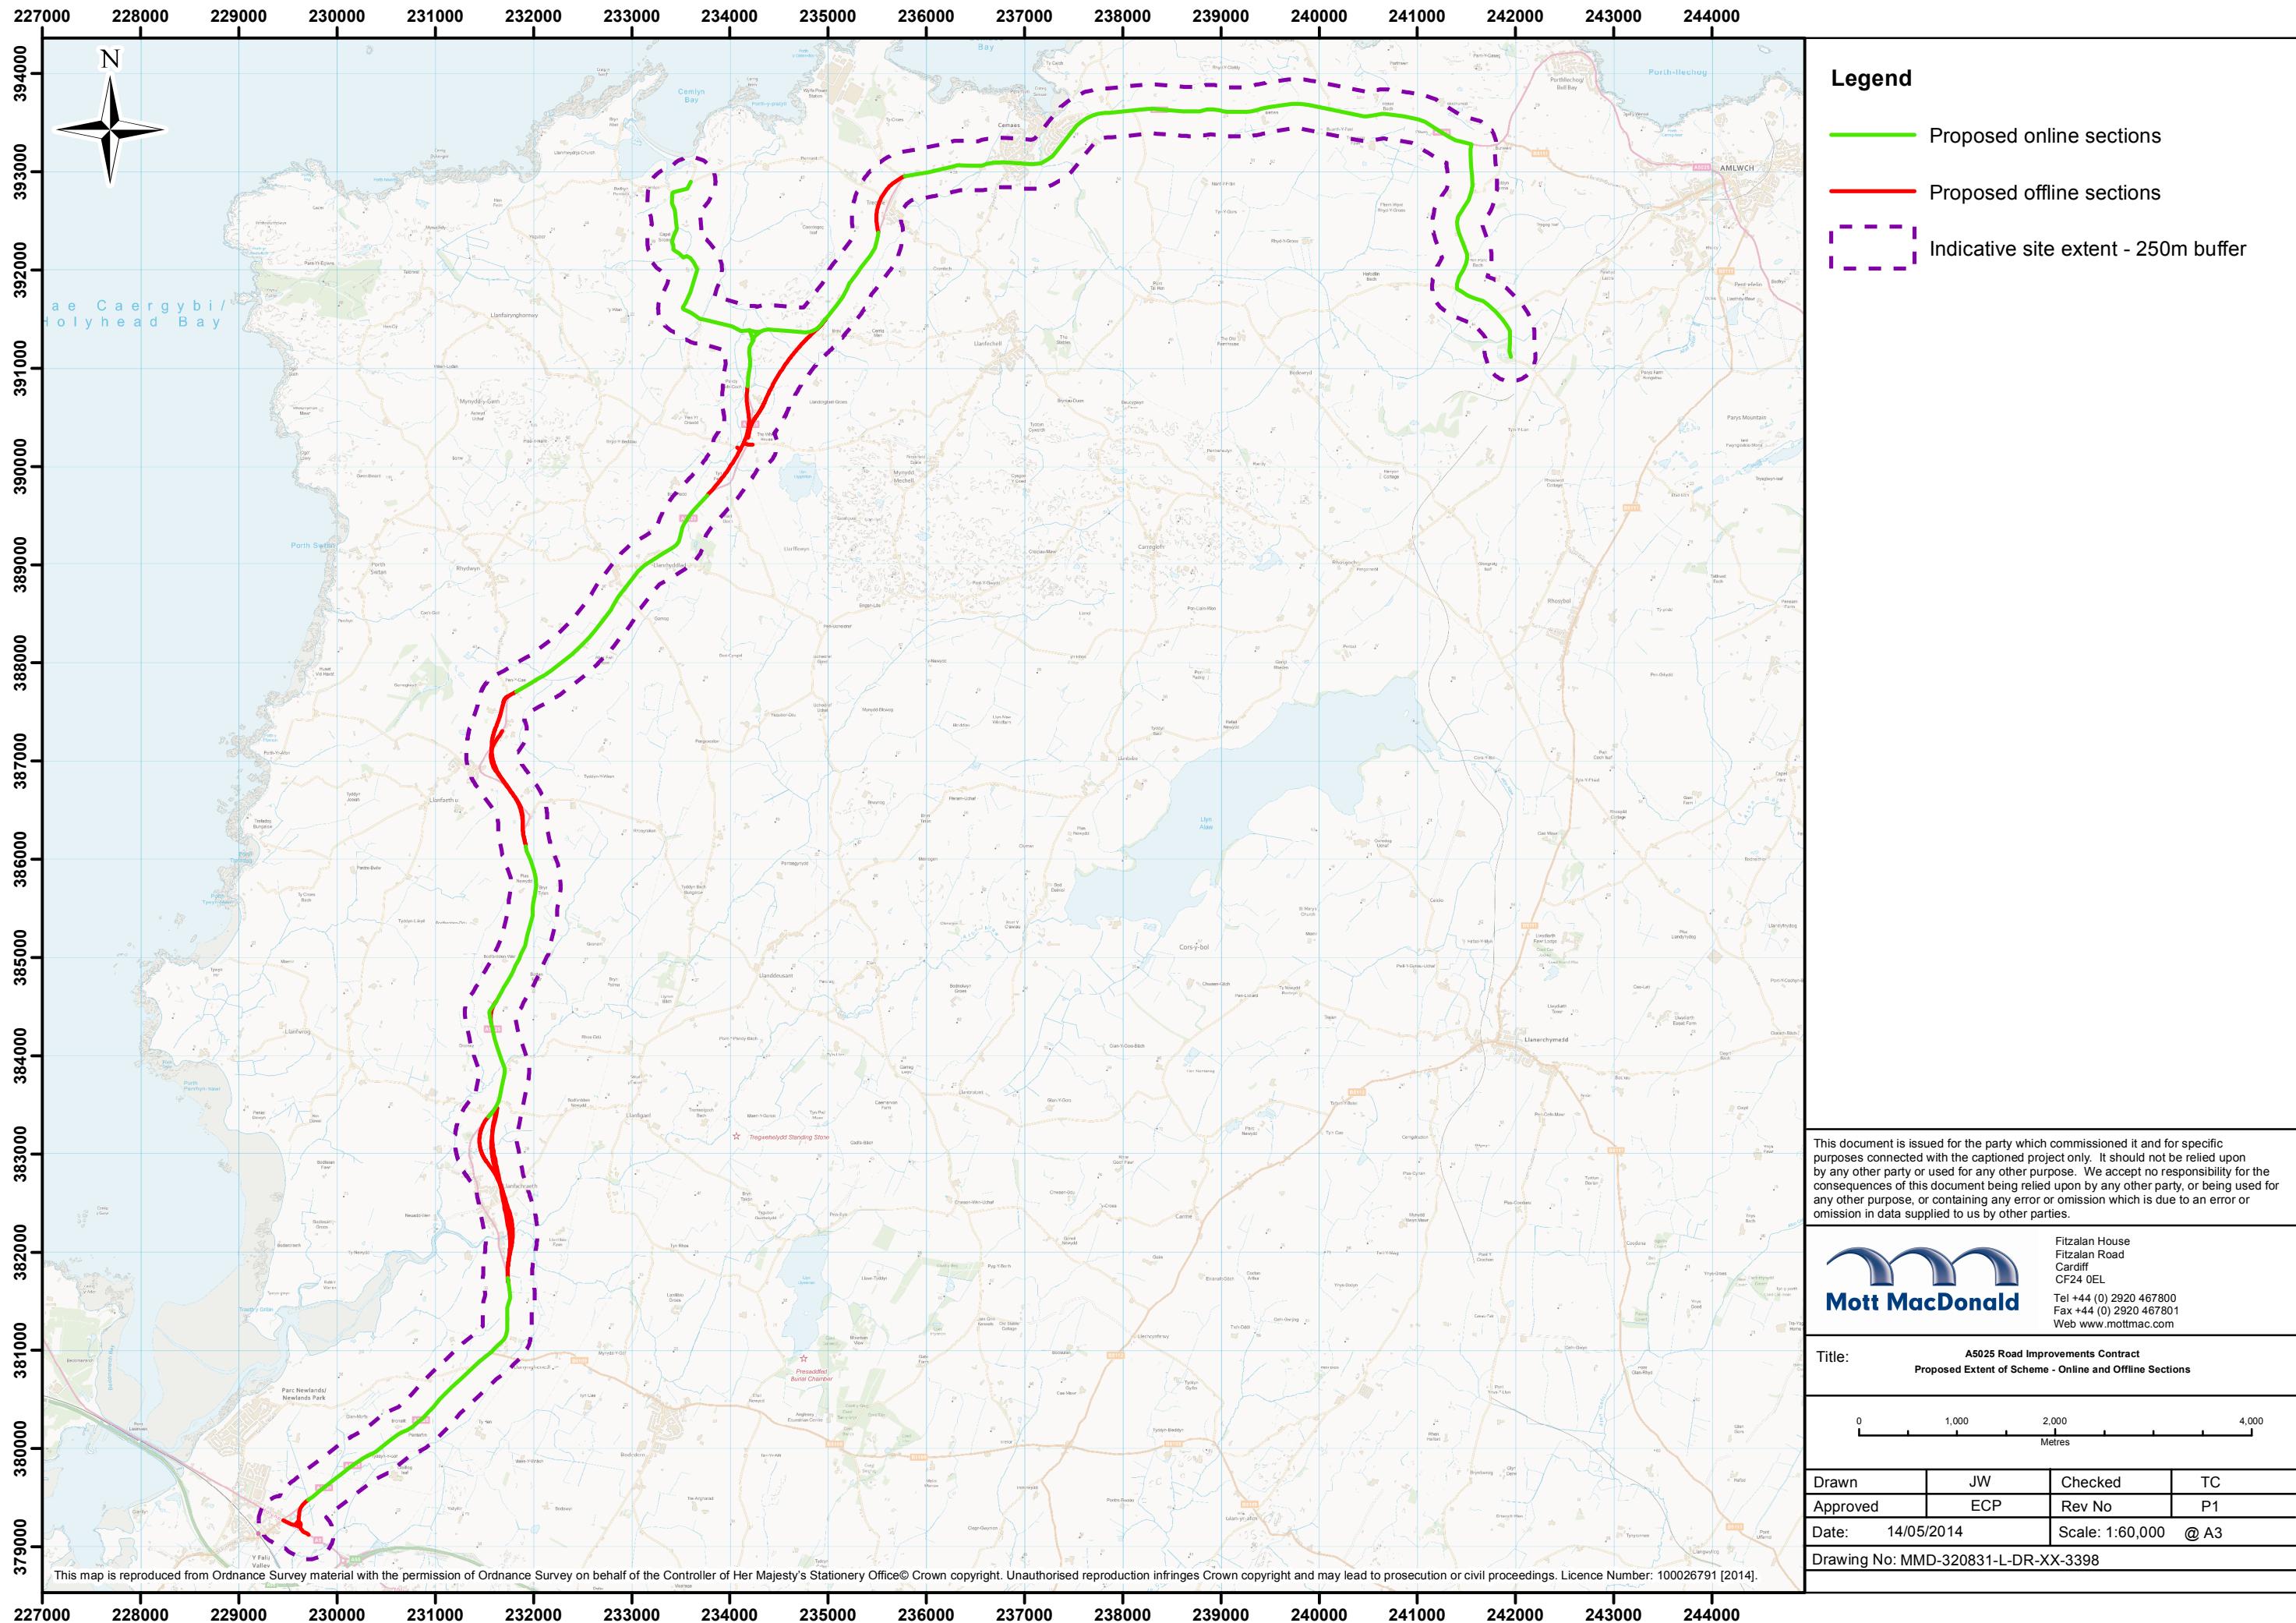
## Appendix A. A5025 Online and Offline Works

A map is provided in Appendix A highlighting both the online and offline works proposed along the A5025.

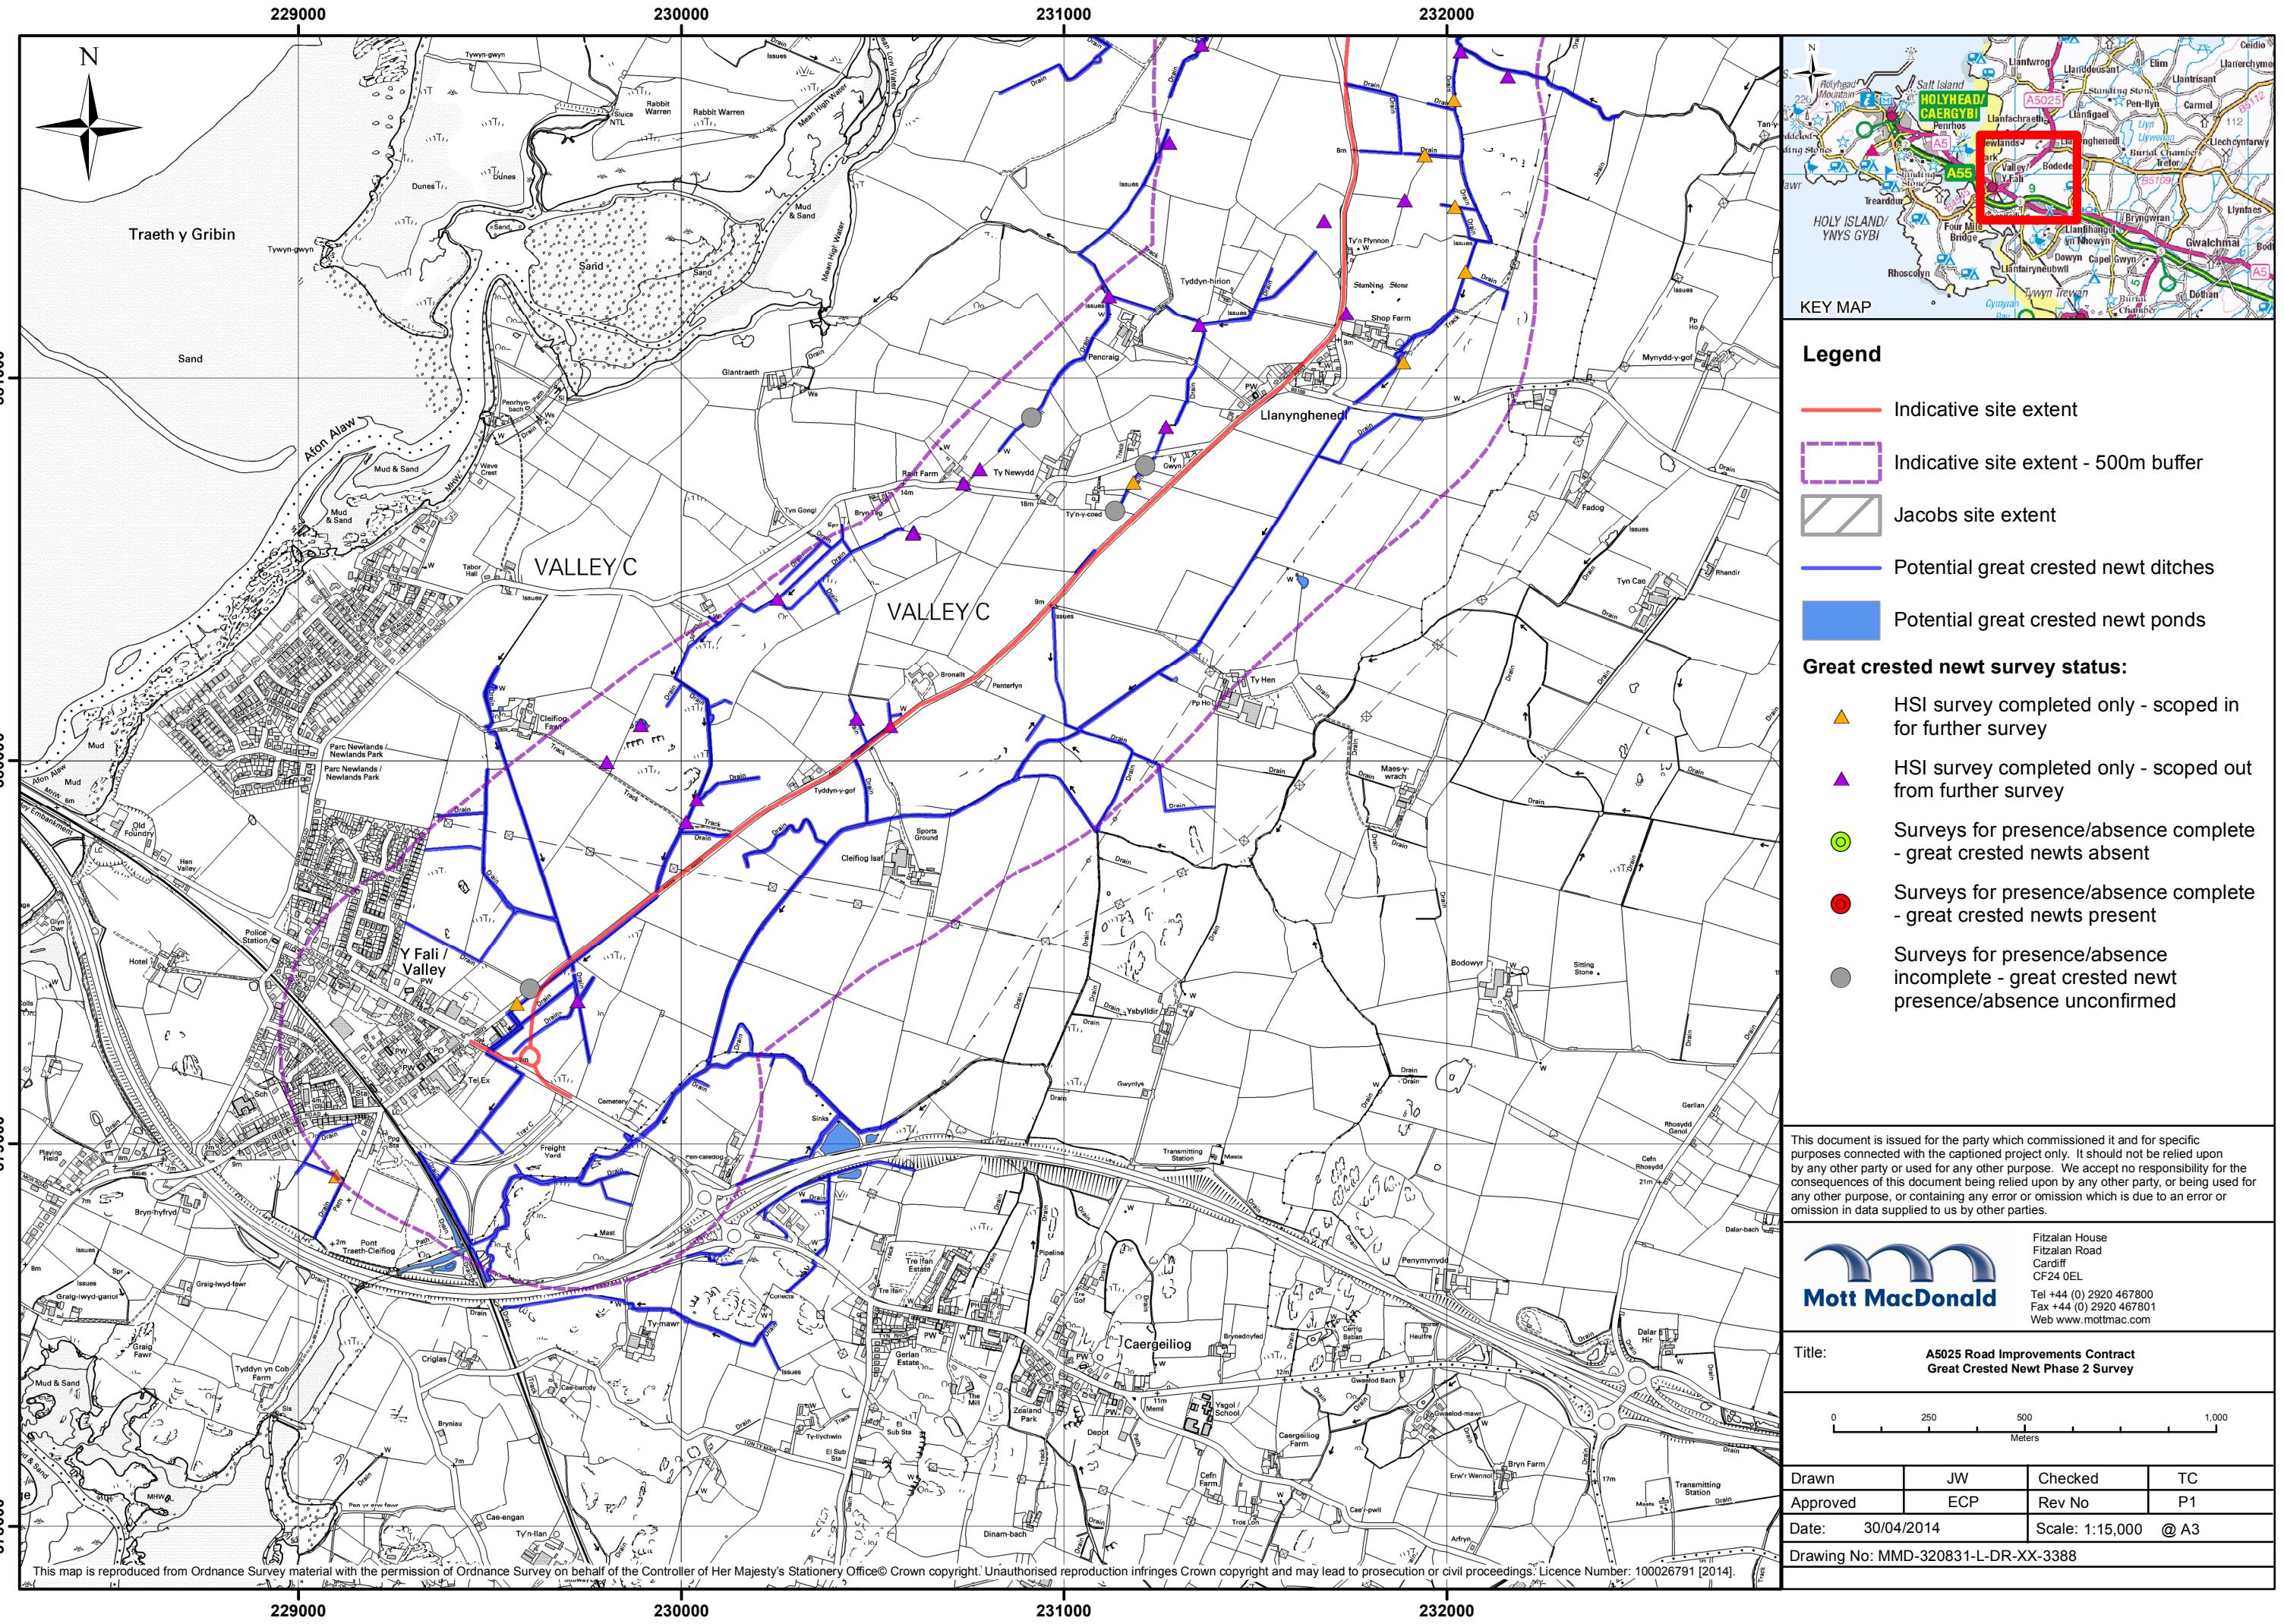
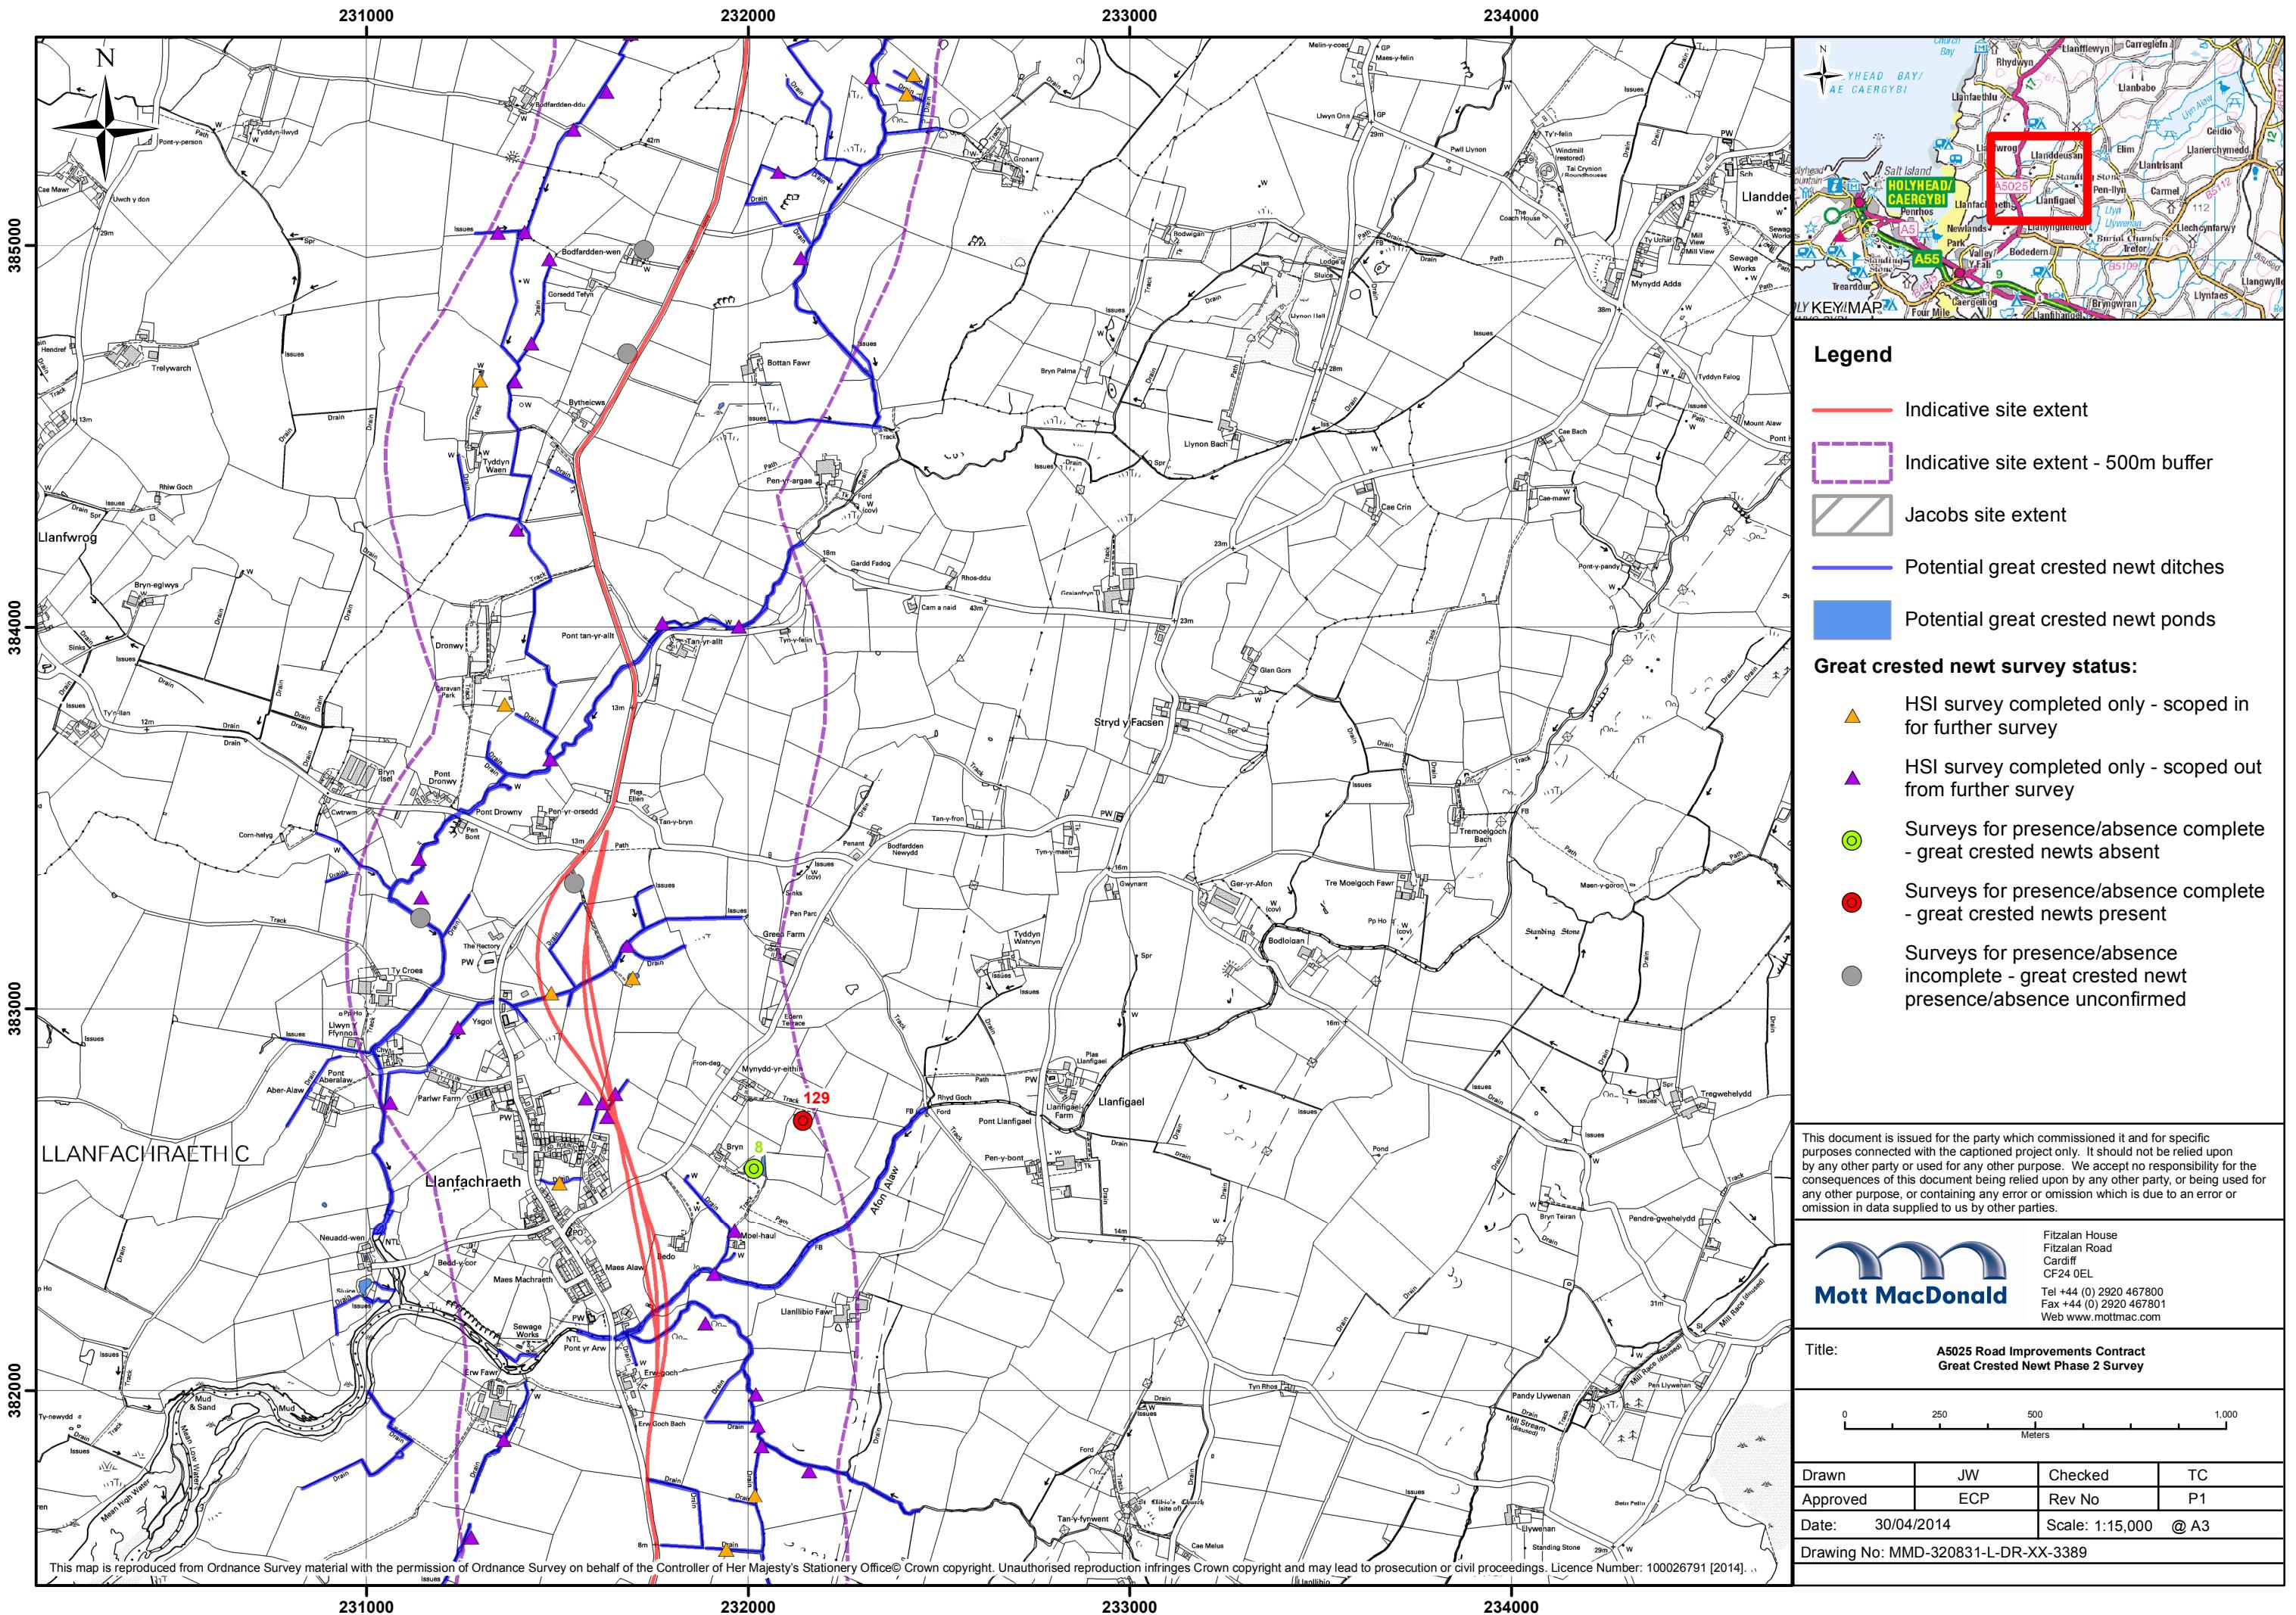
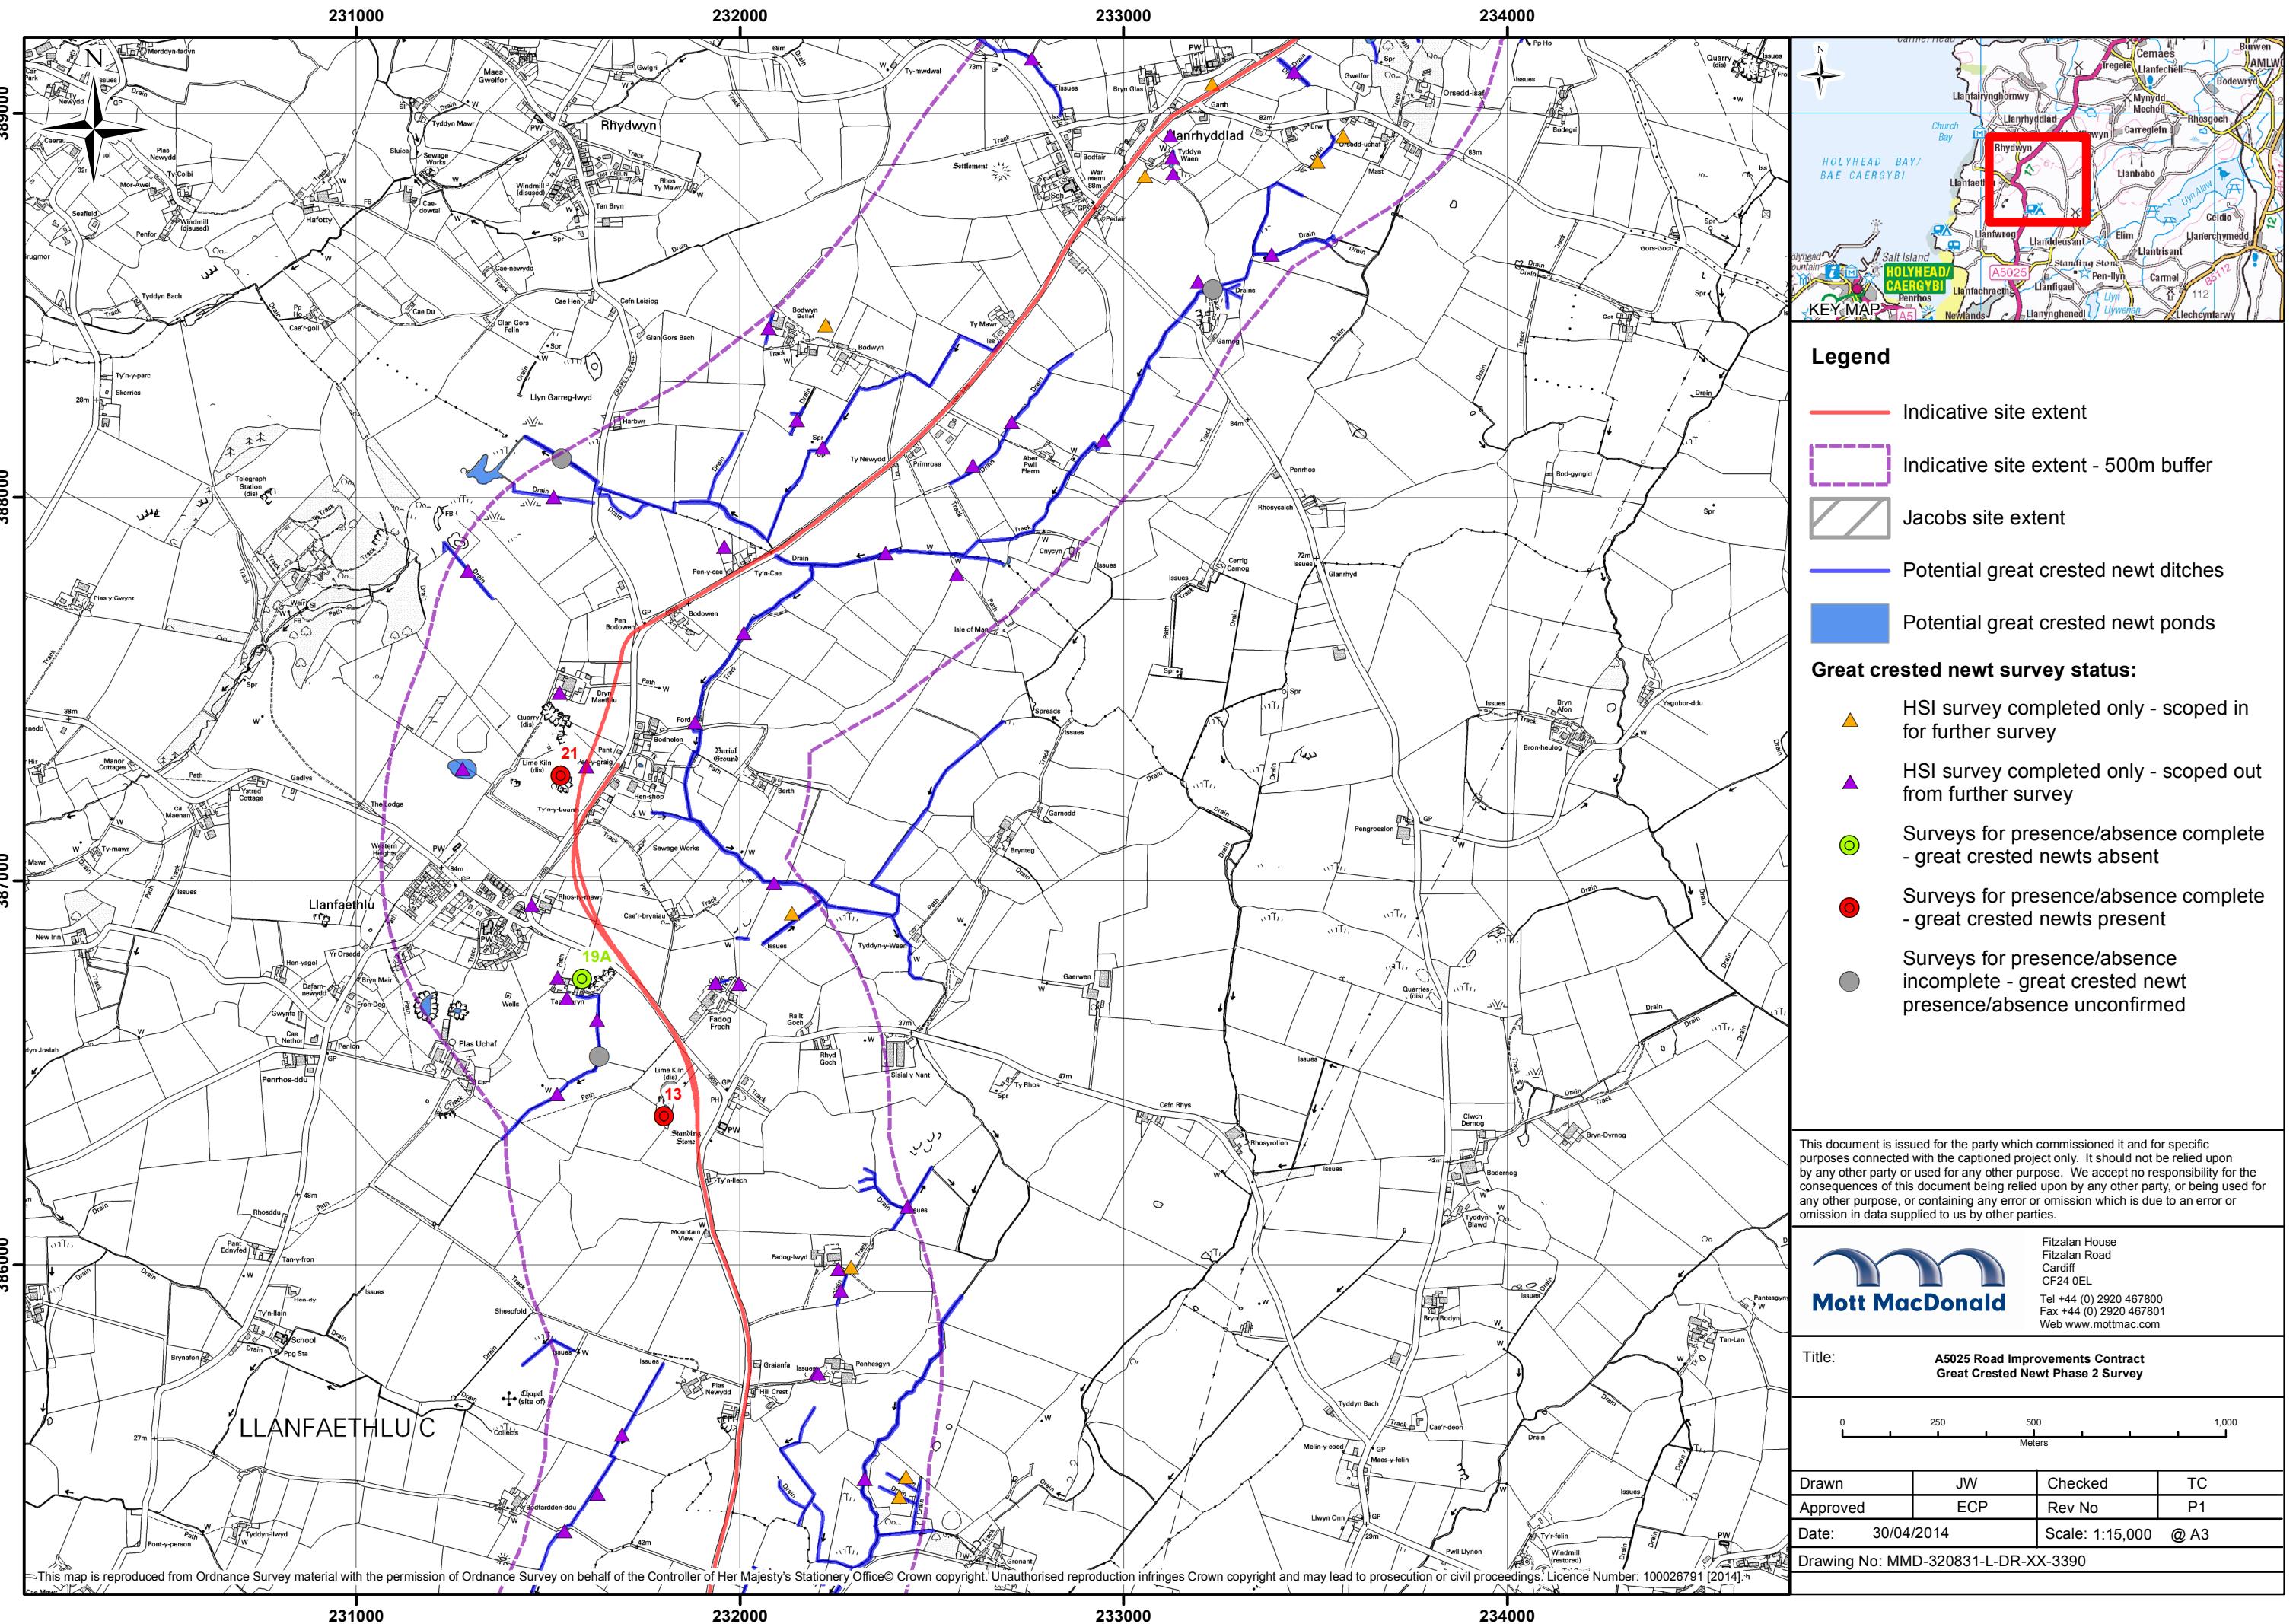
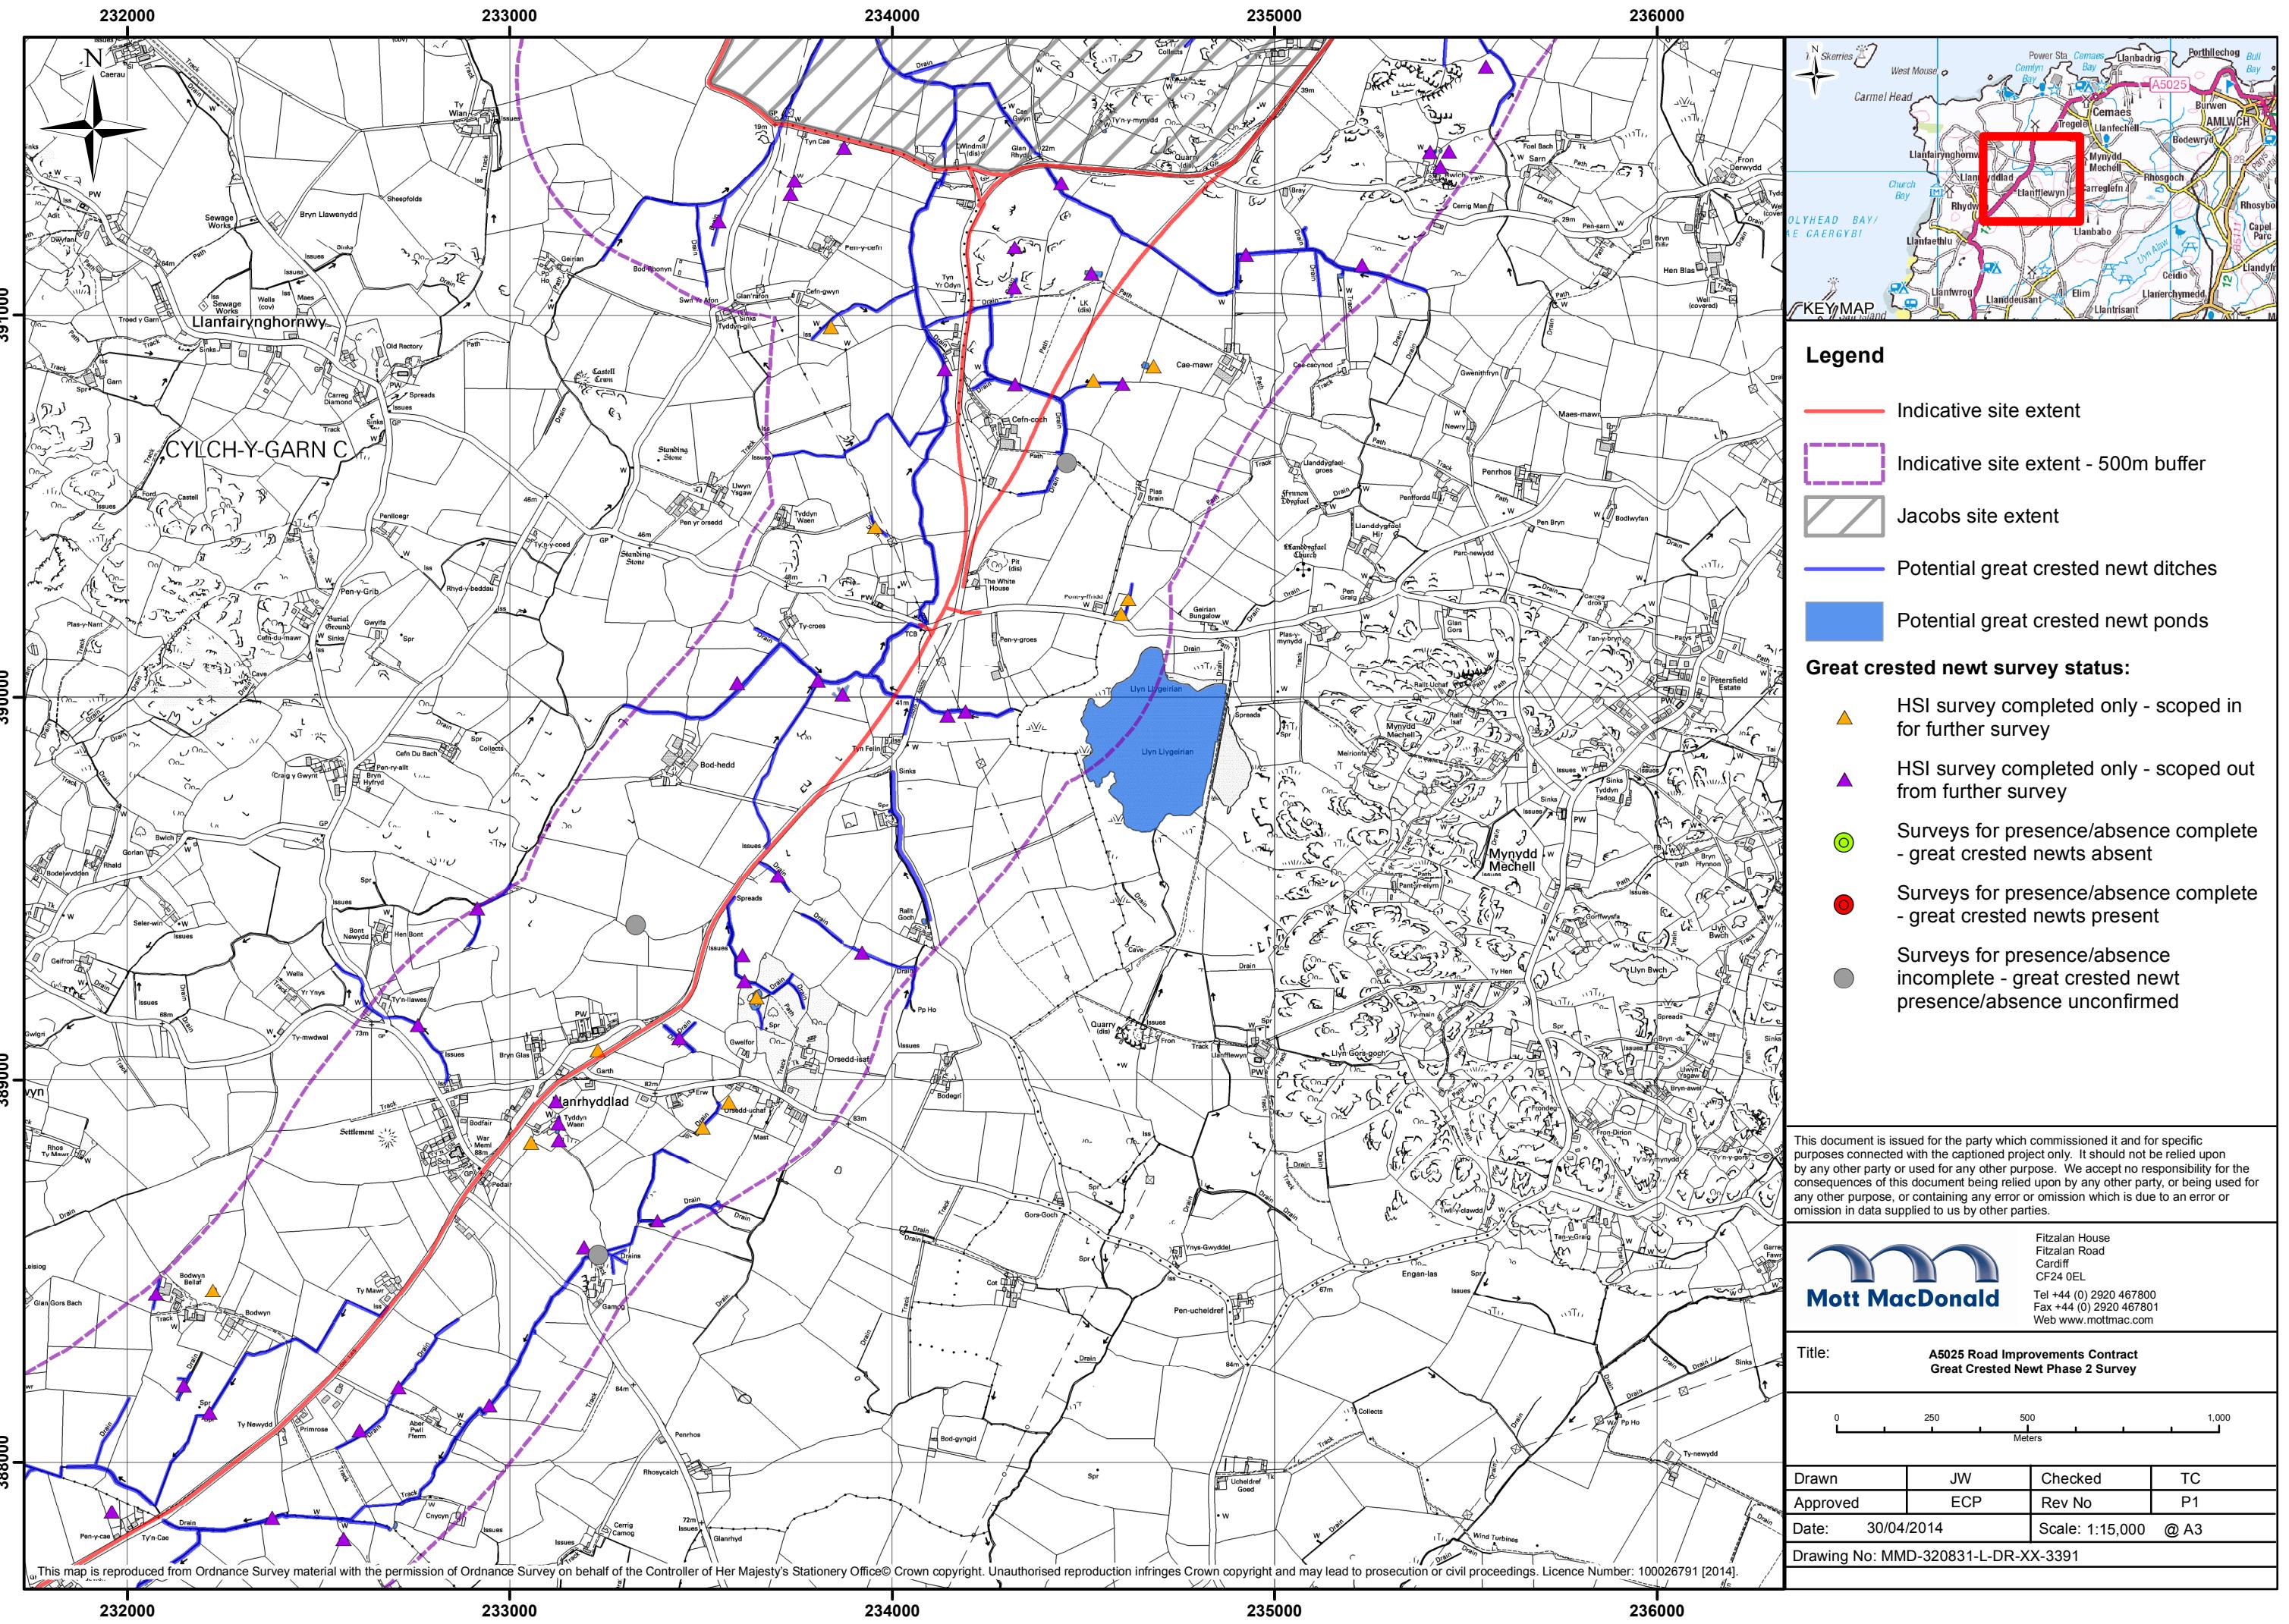
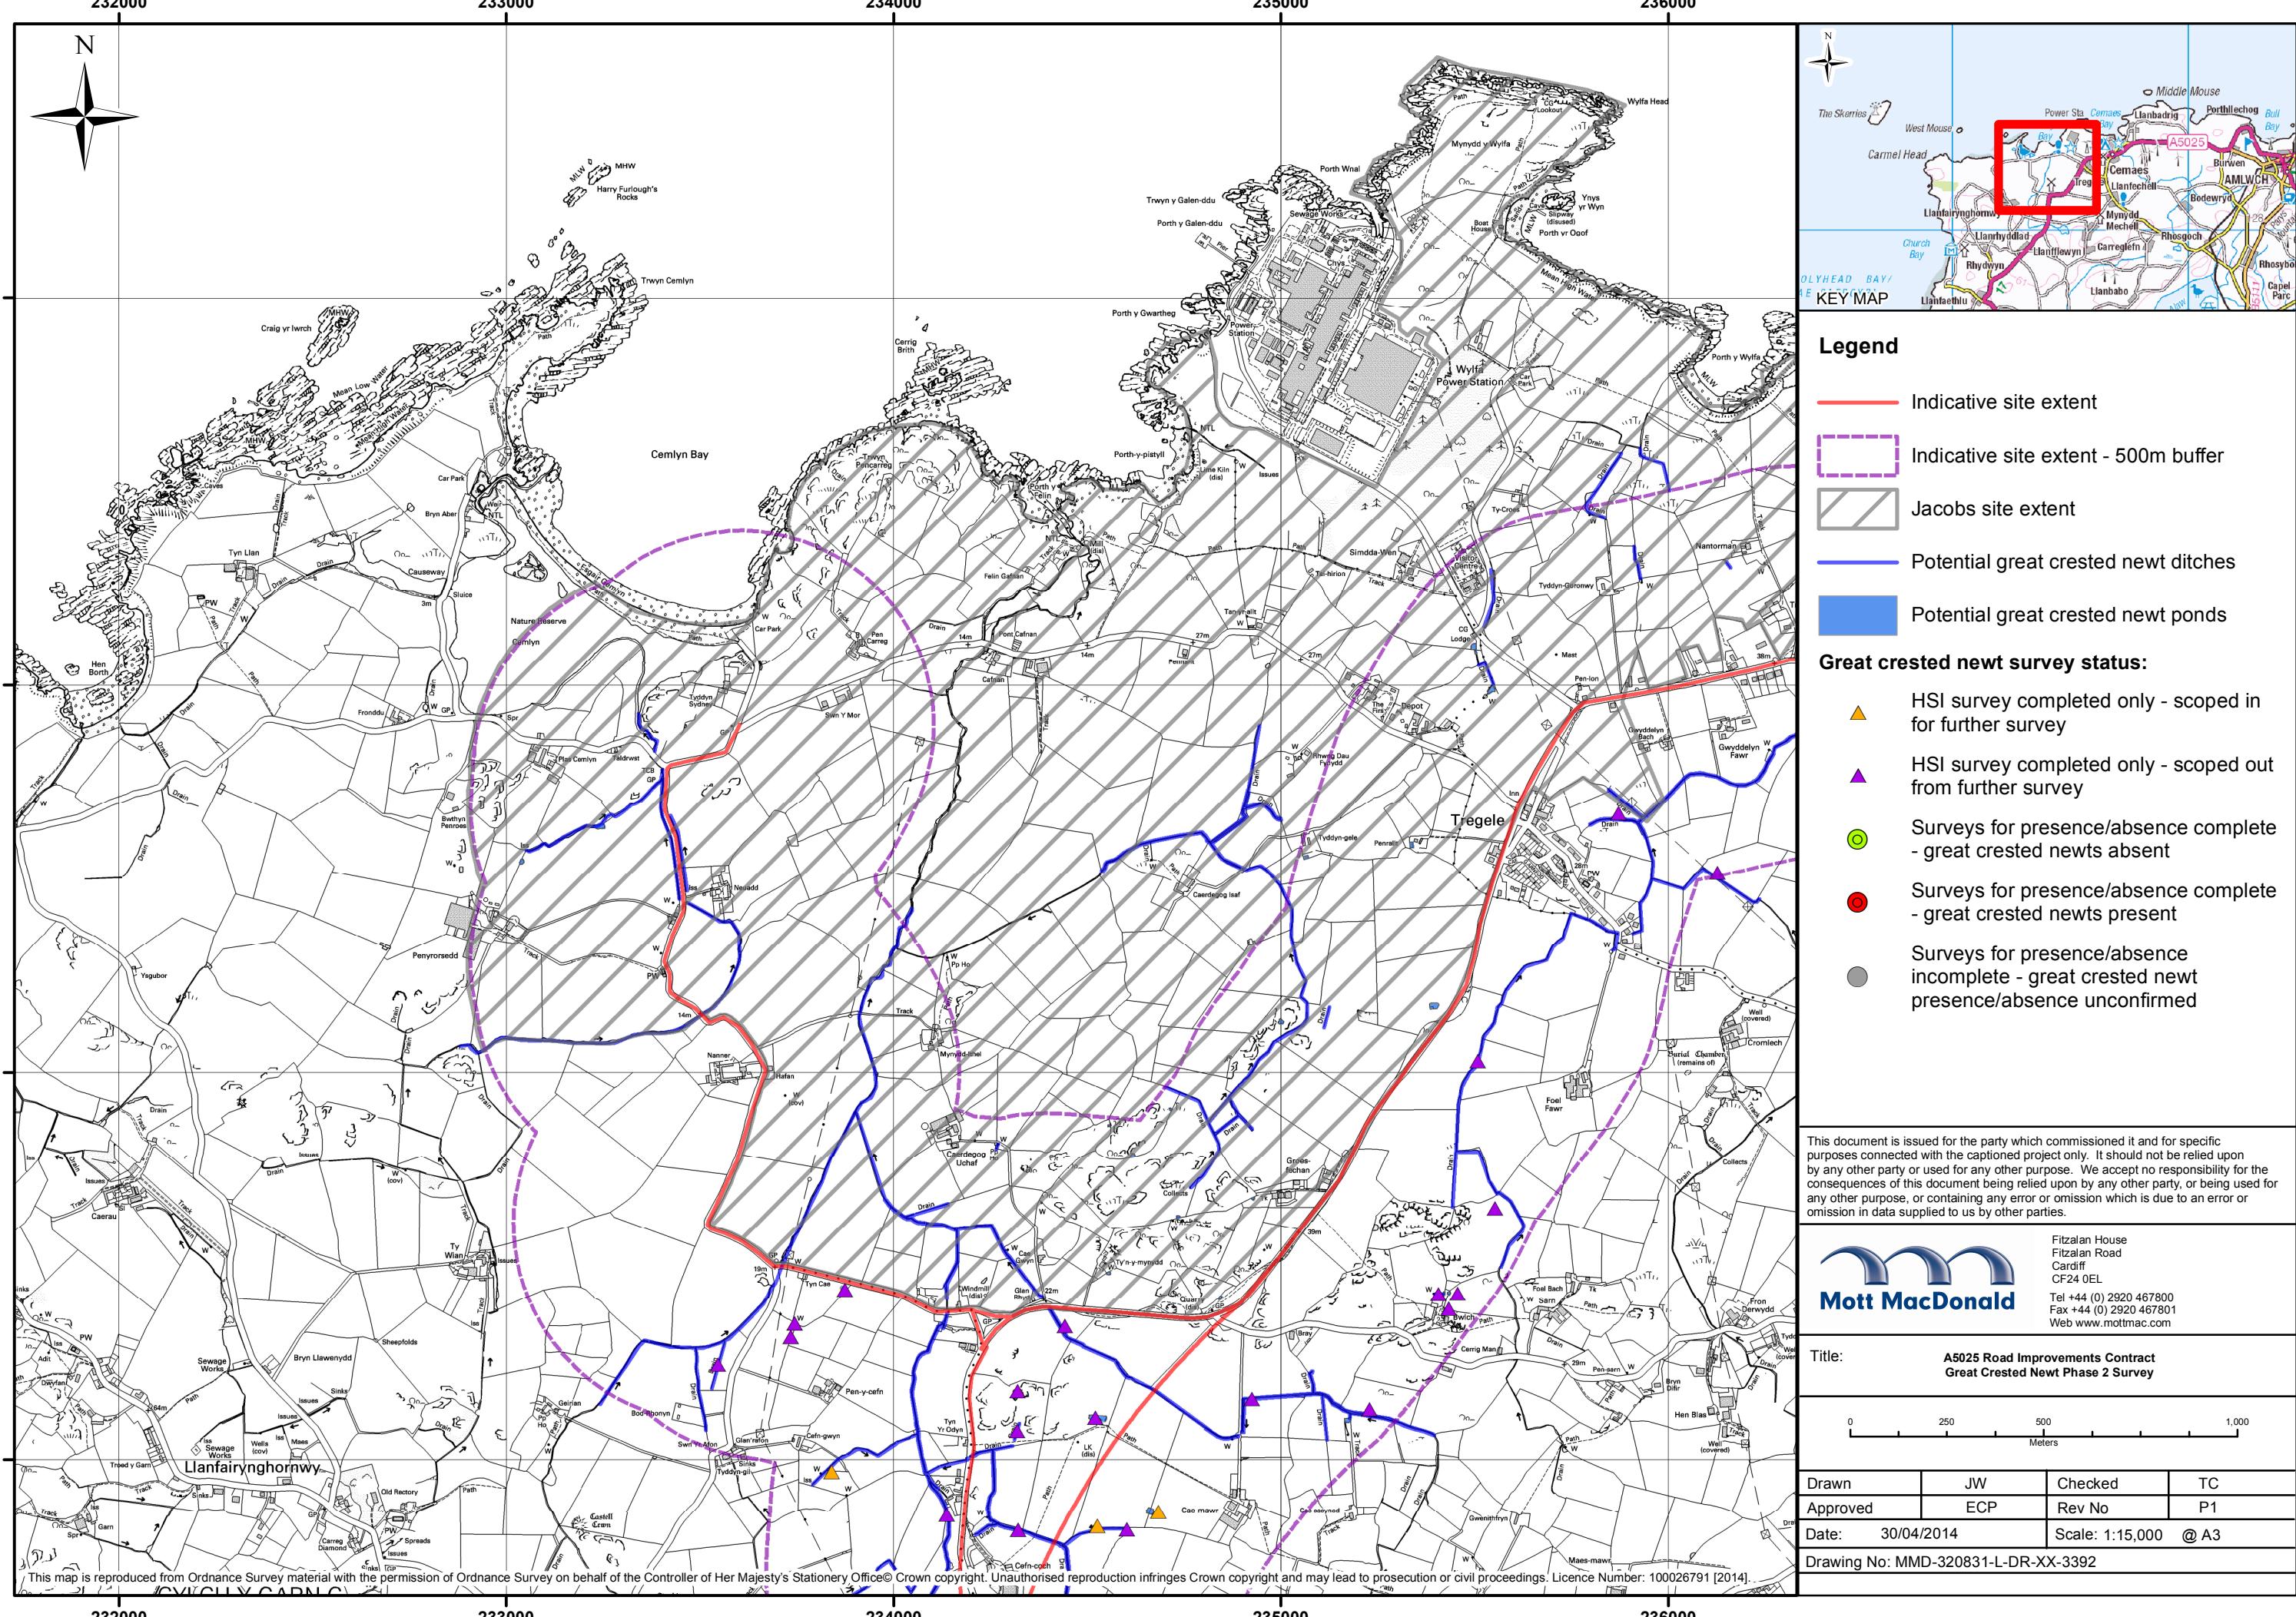
## Appendix C. Maps of GCN Survey Results

Appendix B provides all HSI scores and the locations of the ponds are provided on plans contained within Appendix C.

The following table outlines the details of these surveys and maps showing locations of surveys can be found within Appendix C.
