## Wylfa Newydd Project

Highways App G11-3 - Wylfa Newydd: A5025  
Highway Improvements, Isle of Anglesey:  
Evaluation report

# Wylfa Newydd: A5025 Highway Improvements Isle of Anglesey

## Evaluation Report

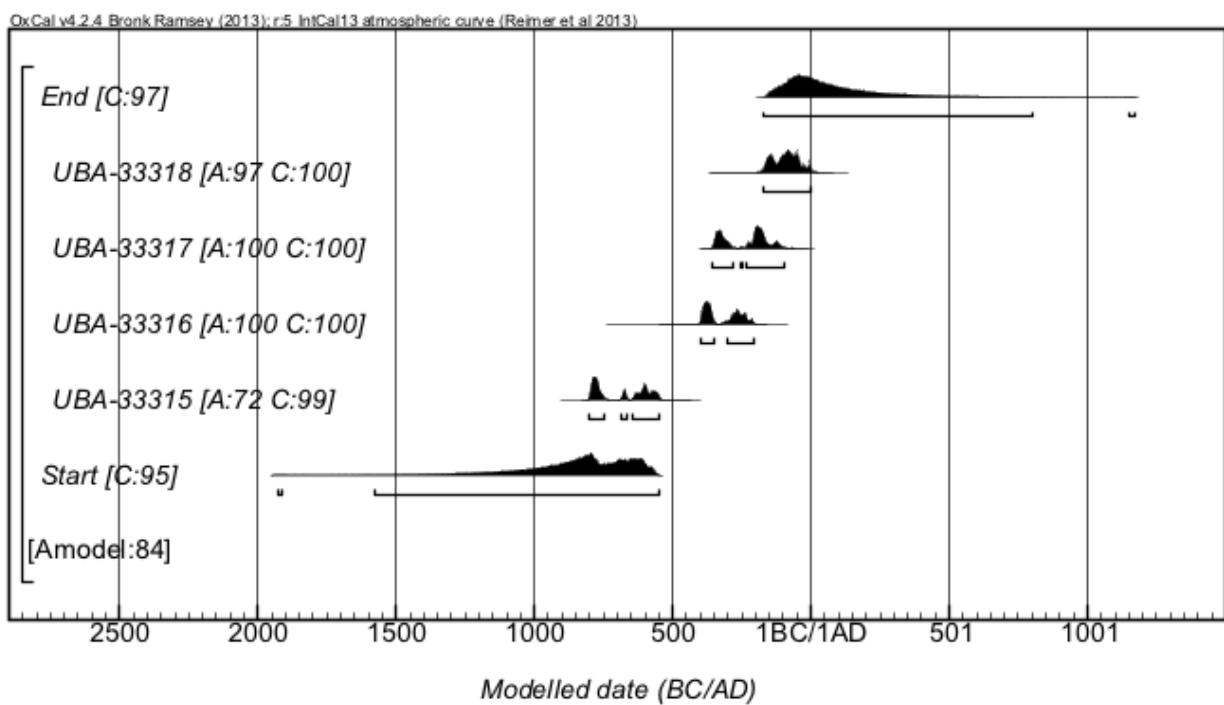
#### **10.4 Appendix 4: Radiocarbon results**

UBANo	Sample ID	Material Type	$^{14}\text{C}$ Age	$\pm$	F14C	$\pm$
UBA-33315	113670_(10904) <10901>	Barley grain	2559	30	0.7272	0.0027
UBA-33316	113670_(10908) <10903>	3 Wheat glume bases	2273	34	0.7536	0.0031
UBA-33317	113670_(10929) <10907>	Wheat grain	2155	28	0.7647	0.0027
UBA-33318	113670_(10952) <10909>	emmer/einkorn grain fragment	2059	30	0.7739	0.0029
UBA-33319	113670_(5810)<5802>	Indet. non-woody plant tissue	31879	284	0.0189	0.0007

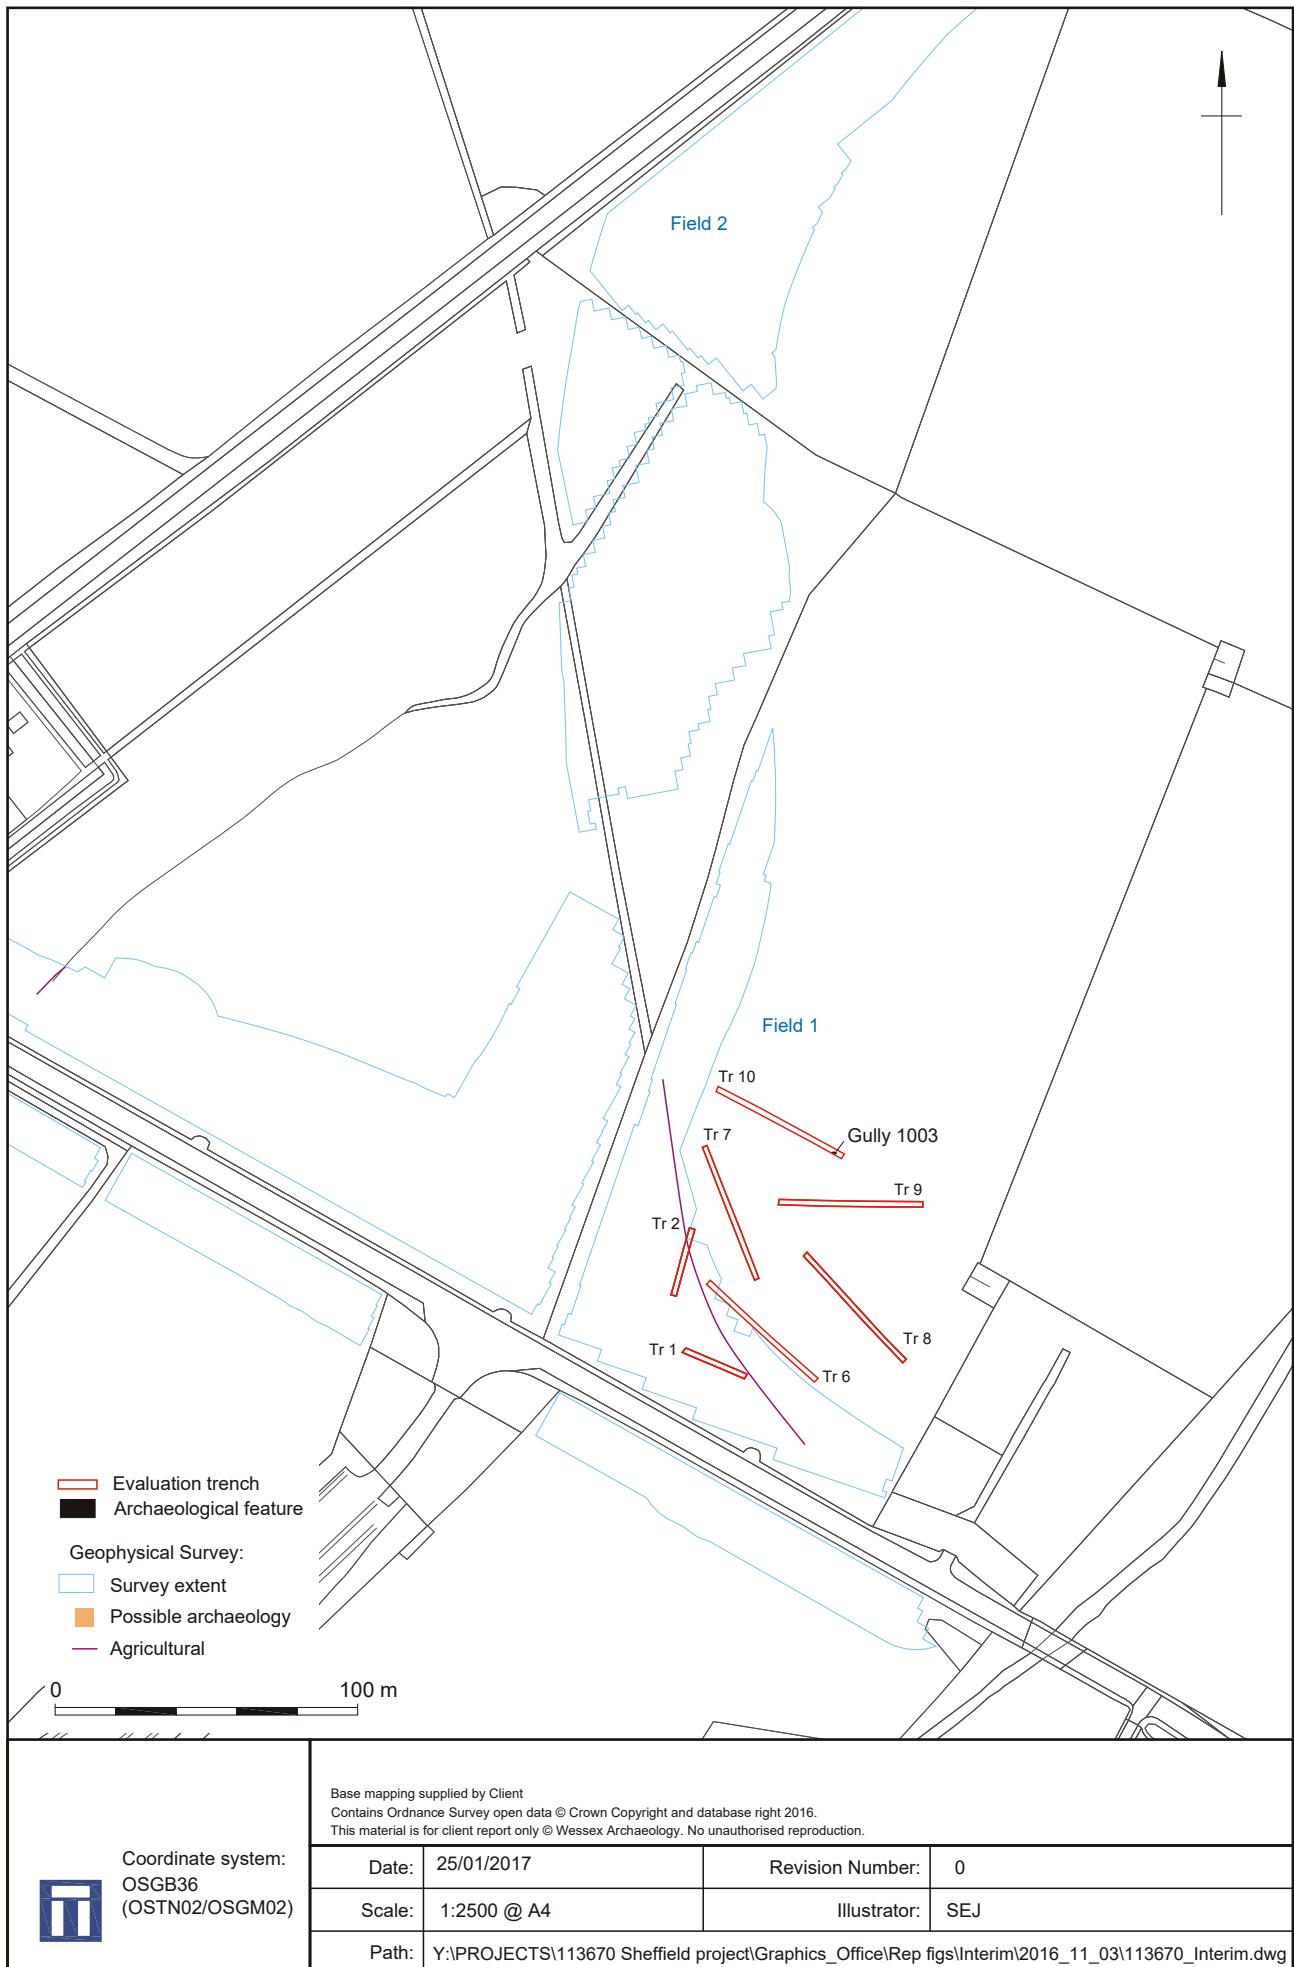
Figure 3

Plan of Site 1 - Valley

4.4.3 No further archaeological features or deposits were recorded from Site 1 (Valley). Possible burnt mounds identified by geophysical survey in this area were investigated by auger but did not translate into below-ground features. The anomalies may relate to geology or soil conditions, probably to the presence of natural iron panning.

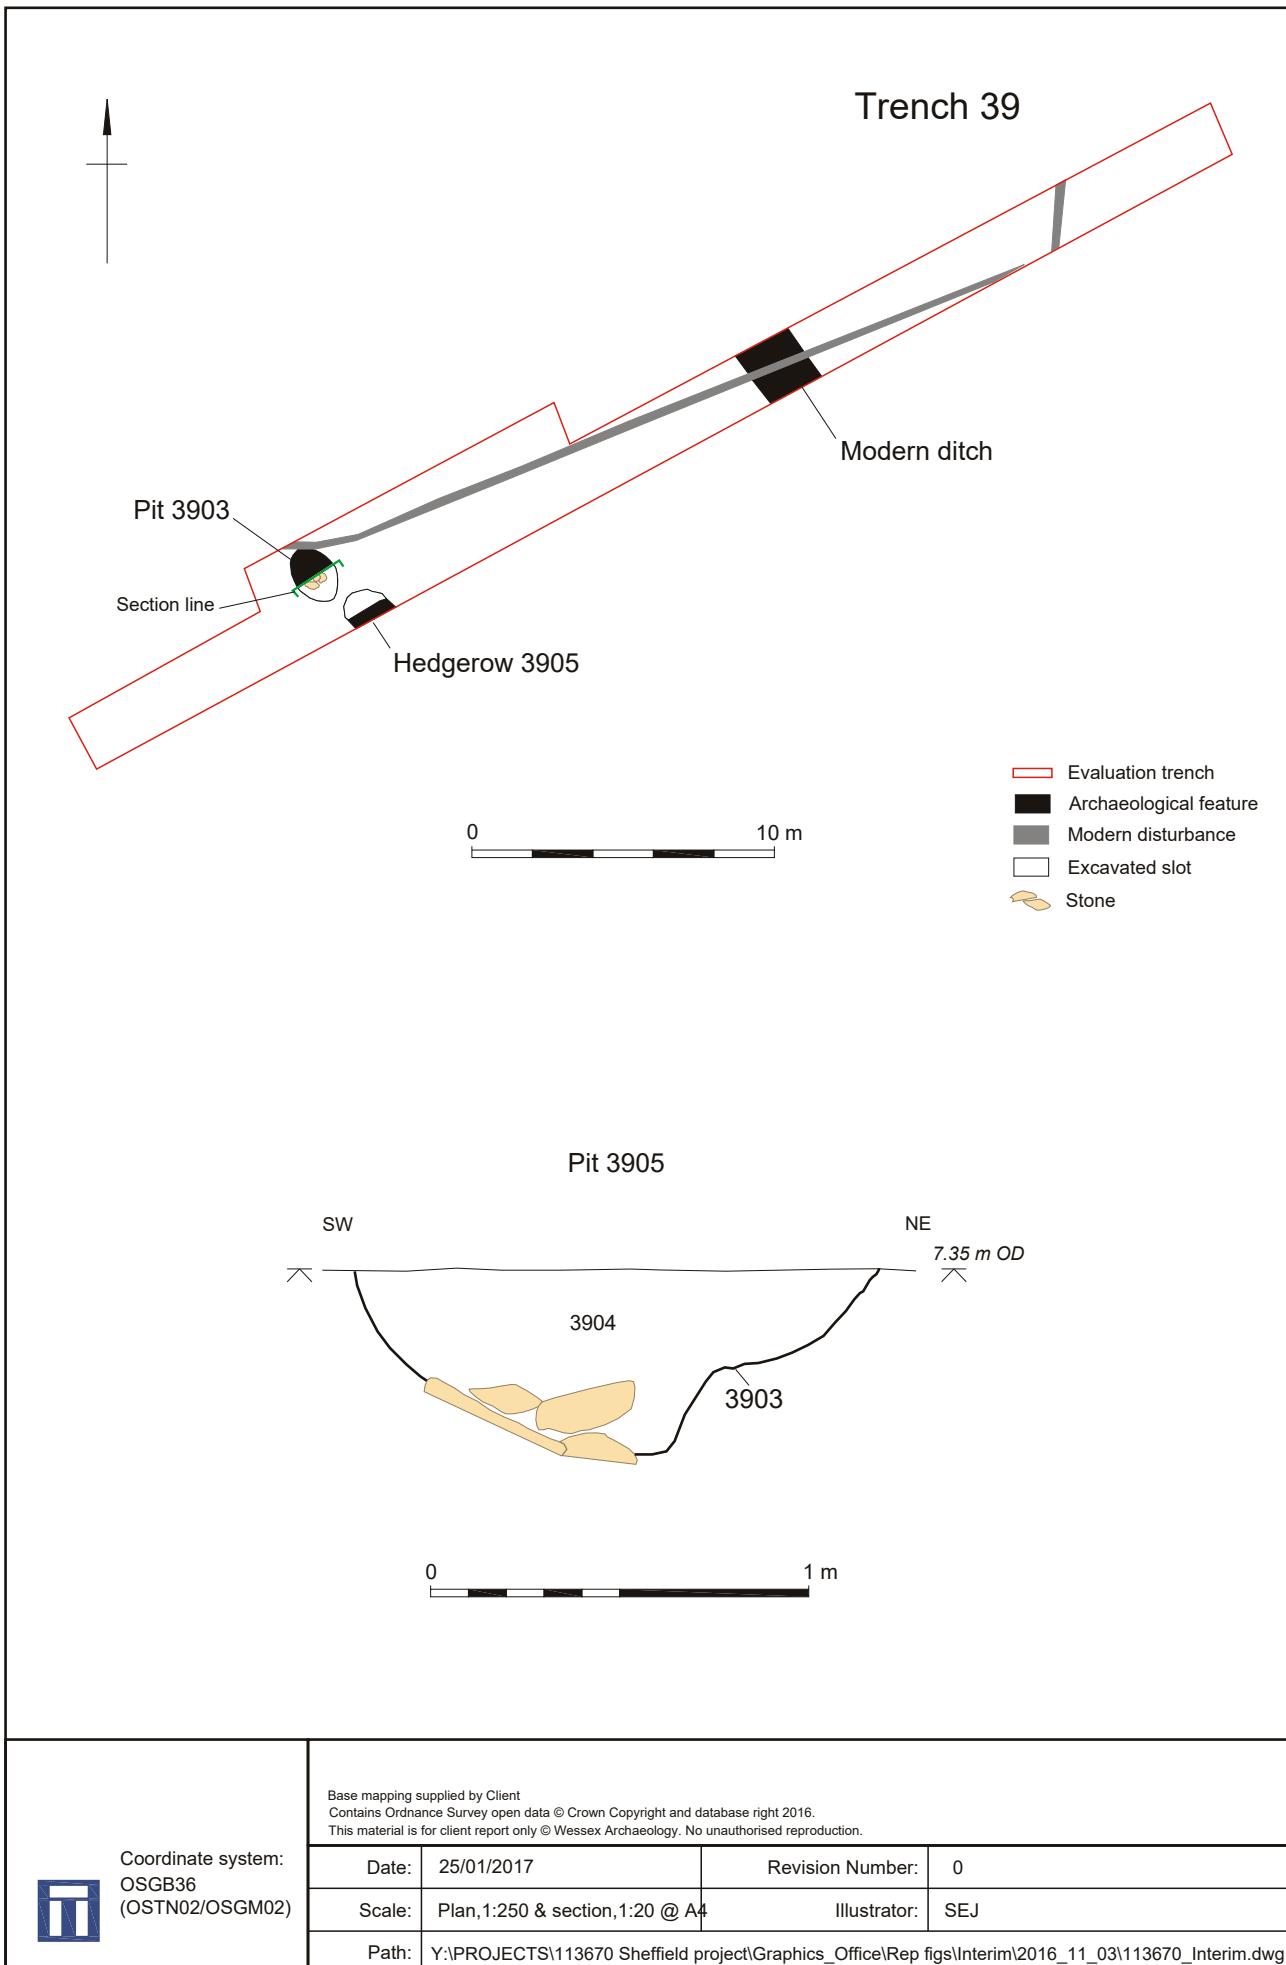
Figure 13

Plan of Trench 39 with section of pit 3903

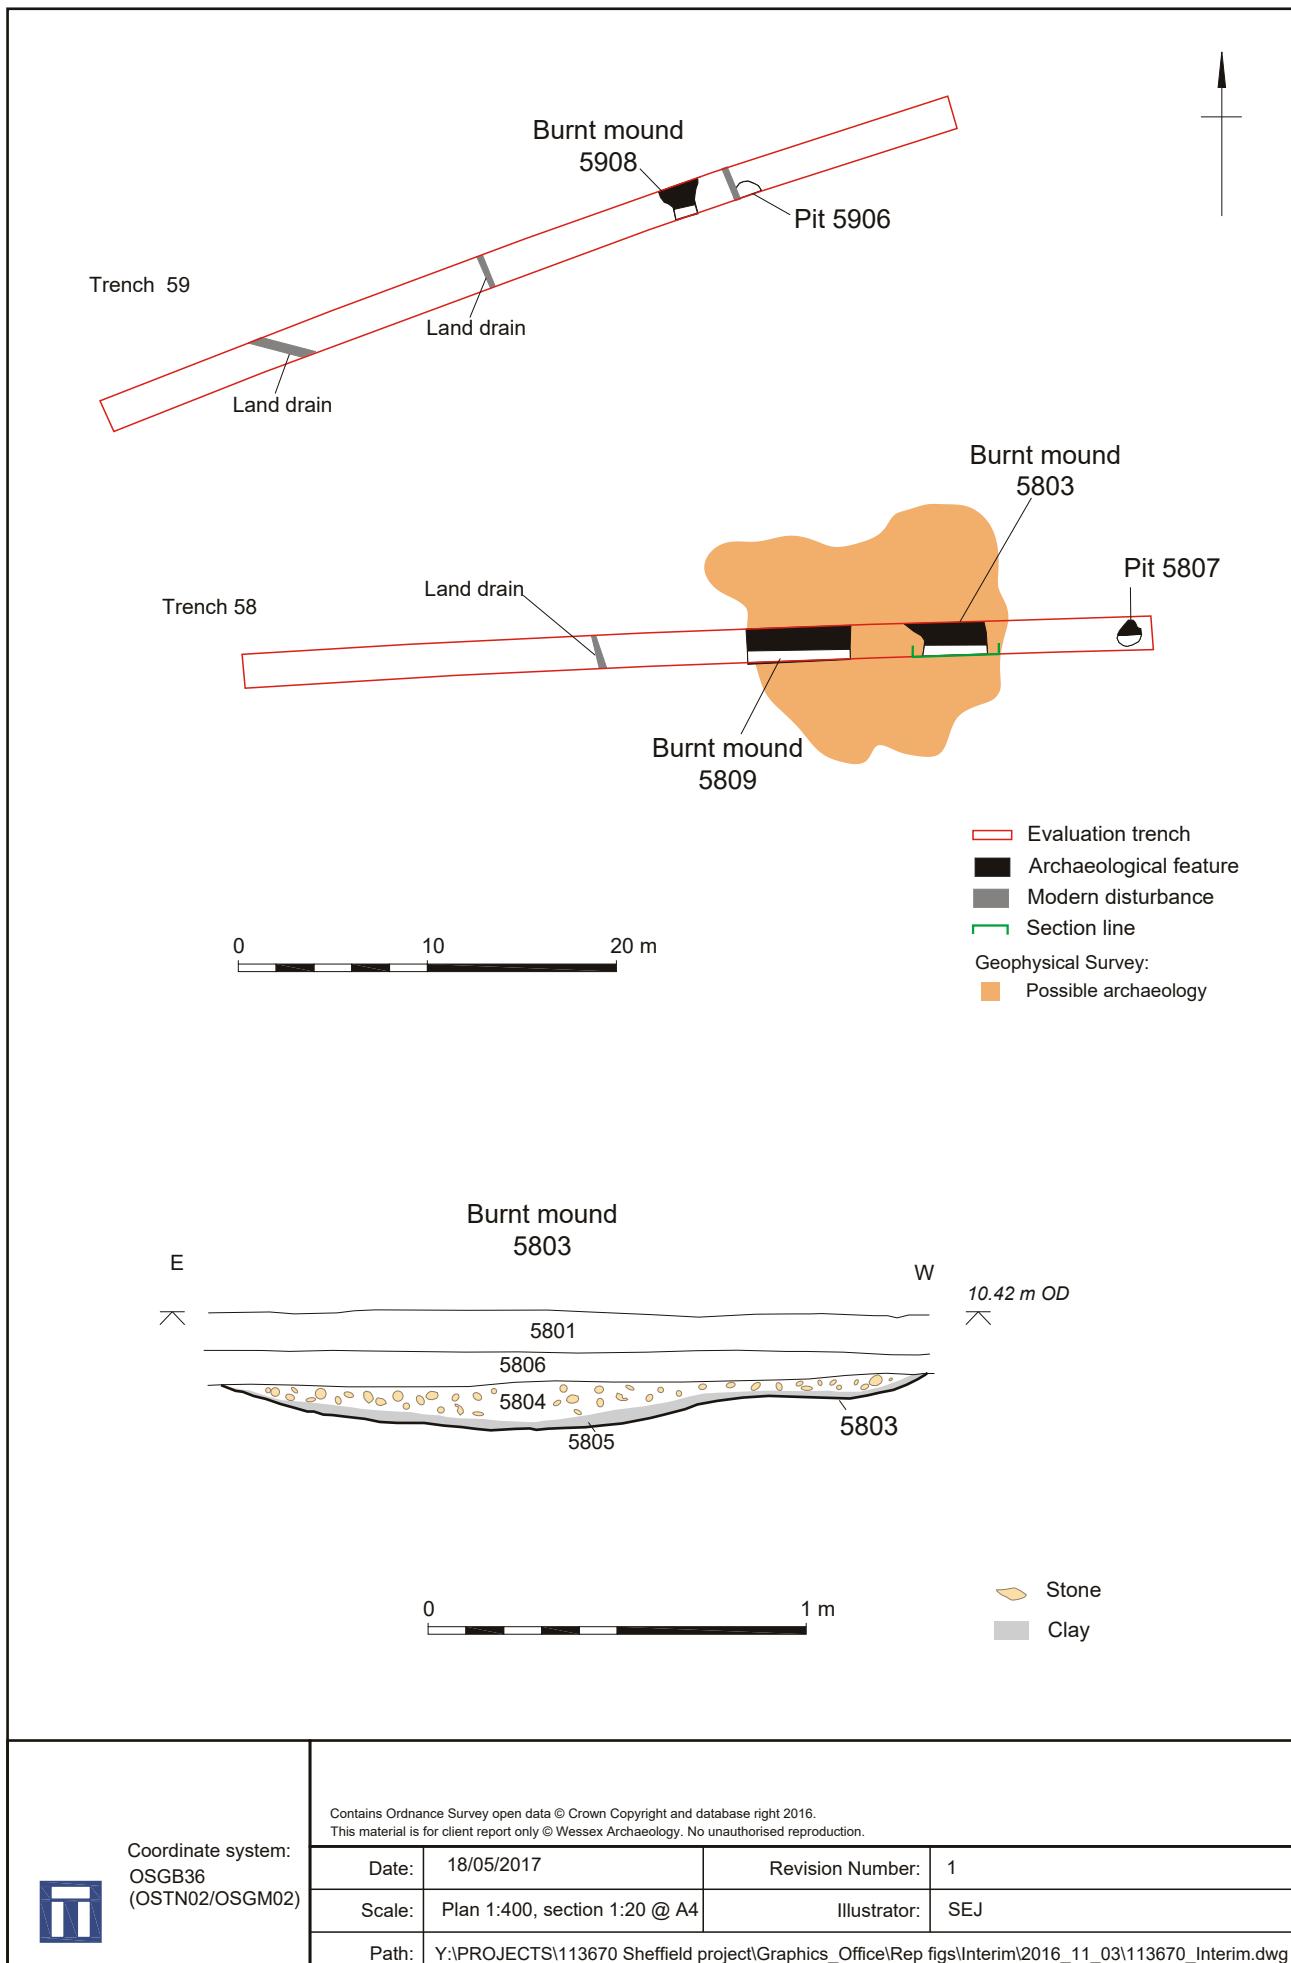
Figure 16

Plan of Trenches 58 and 59 showing burnt mounds, with inset section of burnt mound 5803 showing clay lining

4.5.45 The interpretation of the features from trench 58 is not straightforward and is detailed in the discussion section below. The features are thought to relate to a burnt mound.

4.5.46 In trench 59, a large, shallow cut feature, 5908 (Plate 24, Figure 16) was 0.1 m deep. The shape of 5908 in plan was unusual, forming approximately a “funnel” shape within the evaluation trench with the narrow end pointing to the north (Figure 16). No termini of 5908 lay within the evaluation trench. The wide end of 5908 was 2.25 m wide and the narrow end 1.35 m wide. Unlike features in trench 58, no clay lining was present within 5908. The main fill 5909 resembled the fills of burnt mounds and of the fills of 5803 and 5809 in

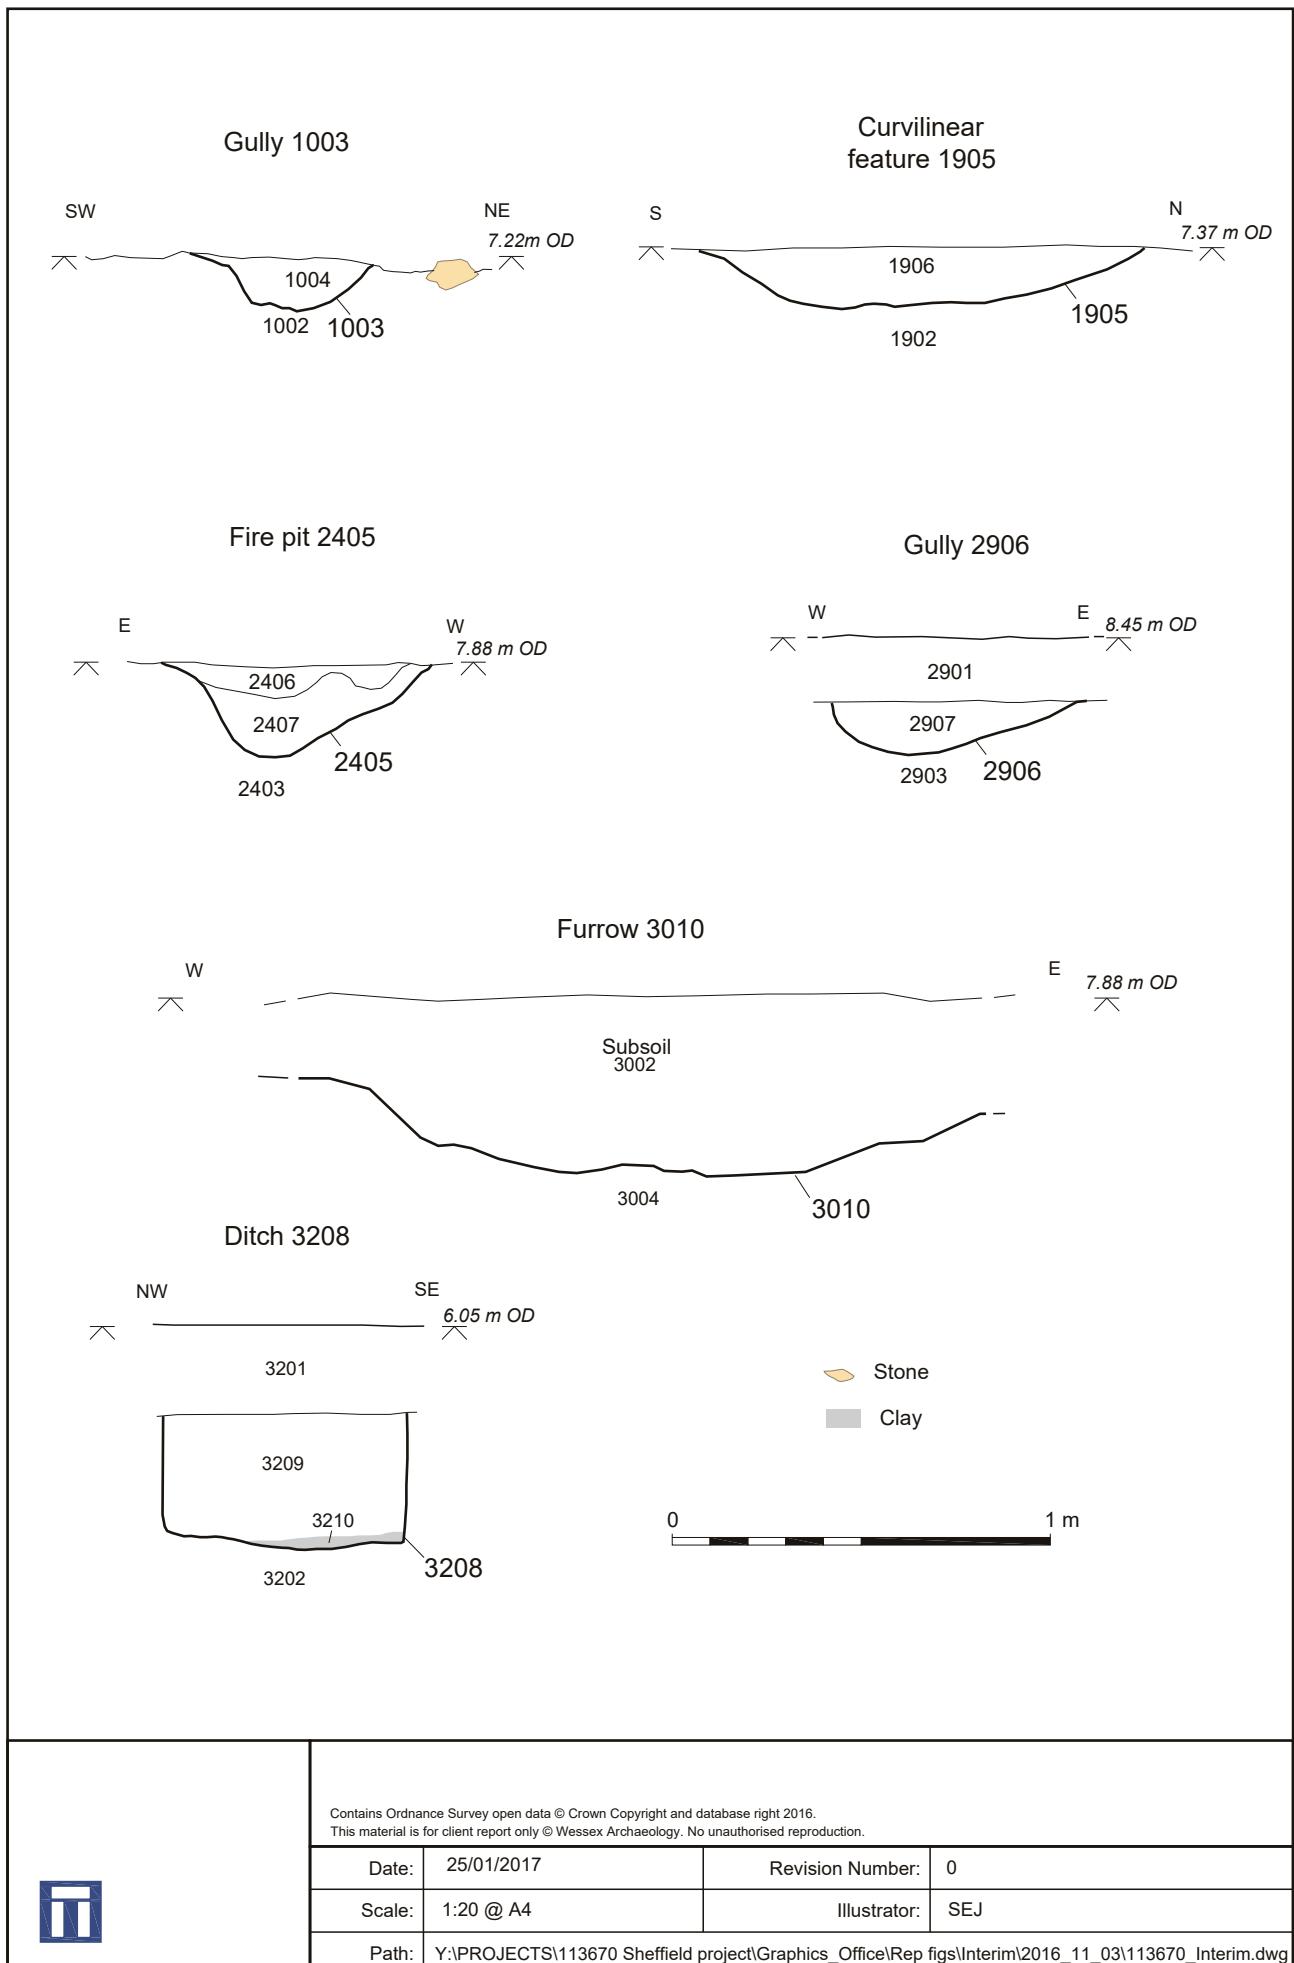
Sections from Site 1 (Valley) and Site 2 (Llanfachraeth): gully 1003, curvilinear feature 1905, fire pit 2405, Figure 21  
gully 2906, furrow 3101 and ditch 3208

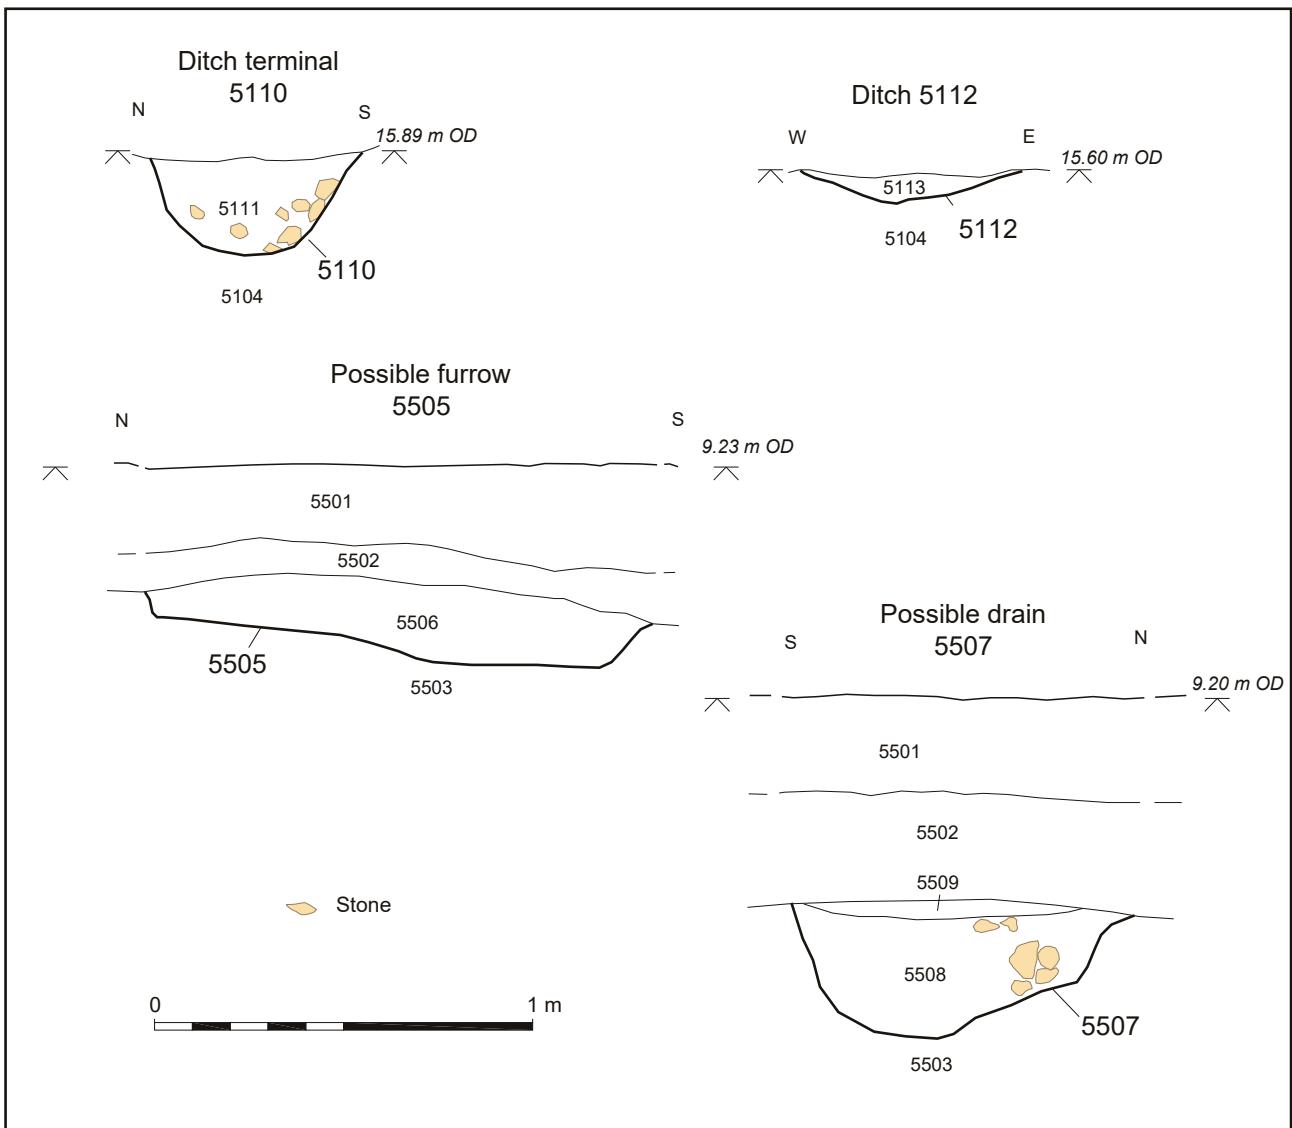
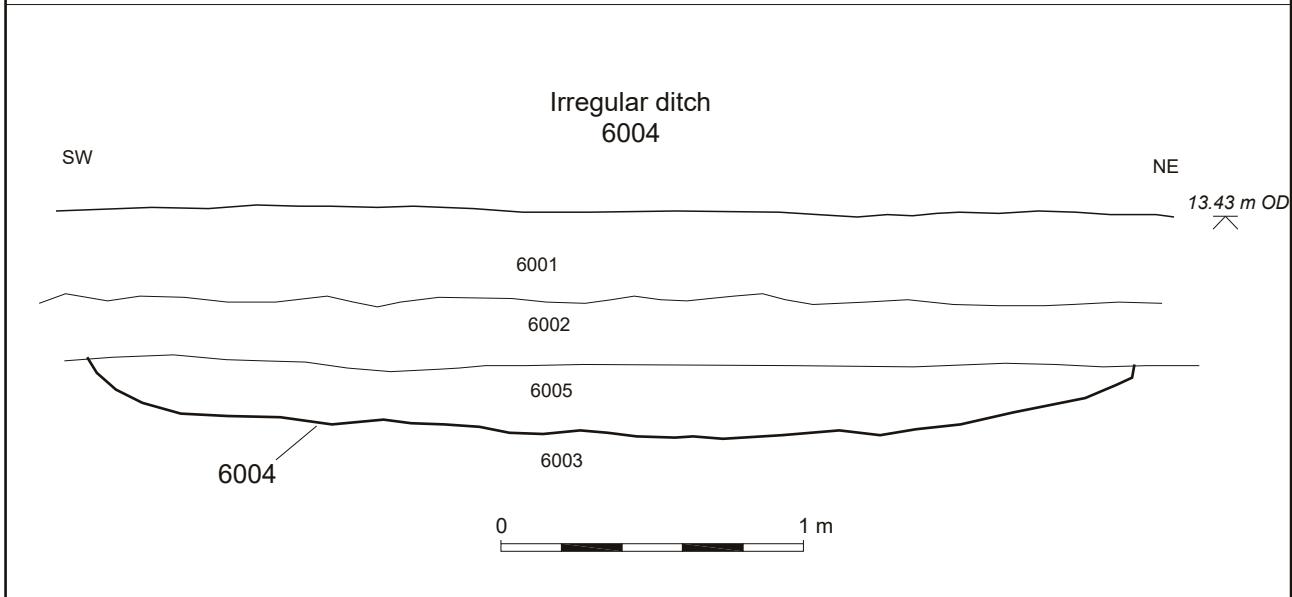
Figure 23

Sections from Site 2 (Llanfachraeth): ditch terminal 5110, ditch 5112, possible furrow 5505, possible drain 5507 and irregular ditch 6004

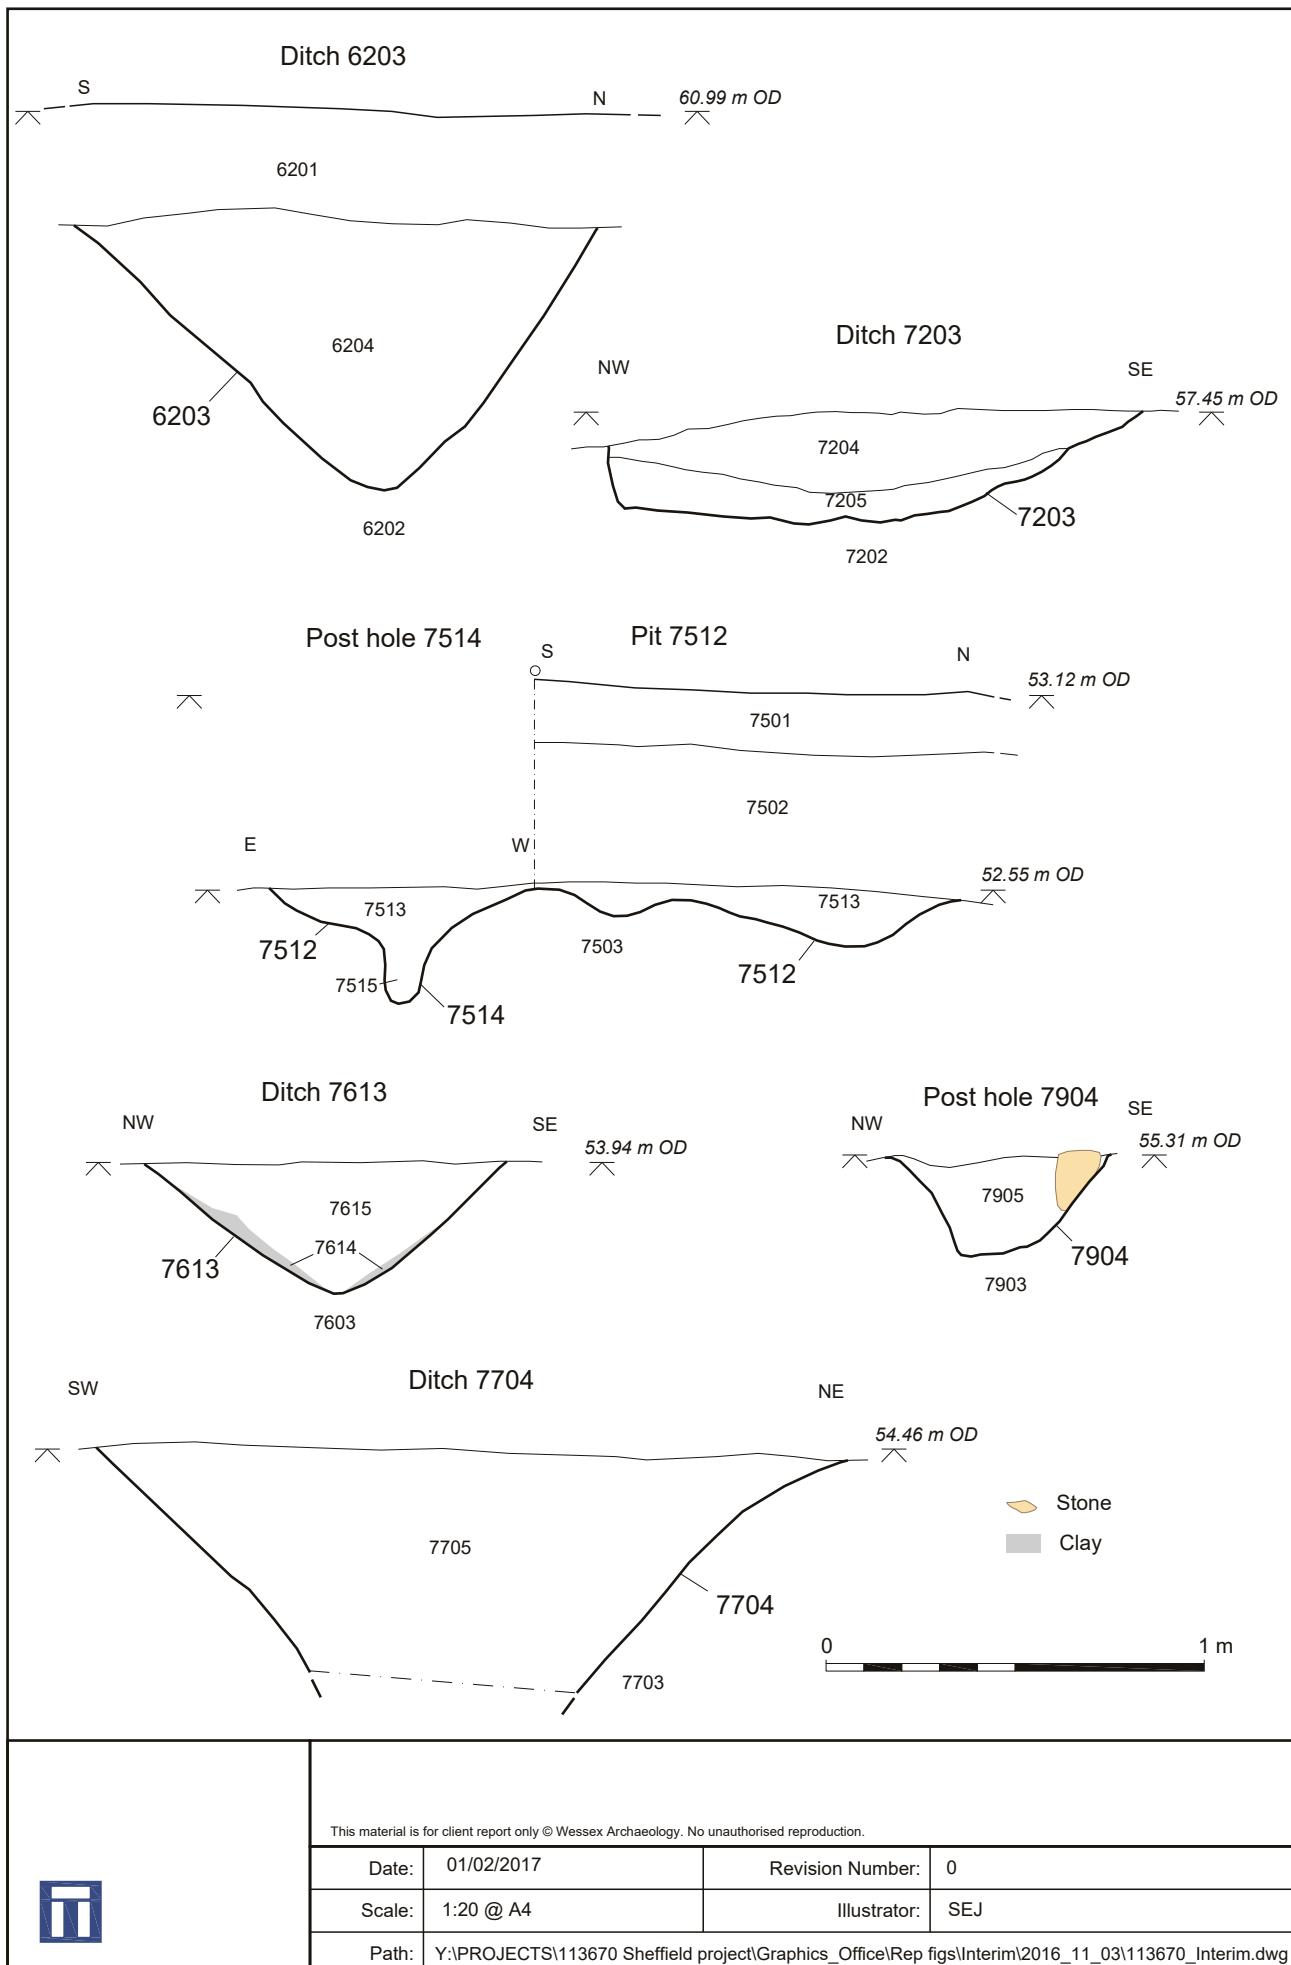
Figure 24

Sections from Site 3 (Llanfaeathlu): ditch 6203, ditch 7203, posthole 7514 and pit 7512, ditch 7613, ditch 7704 and posthole 7904

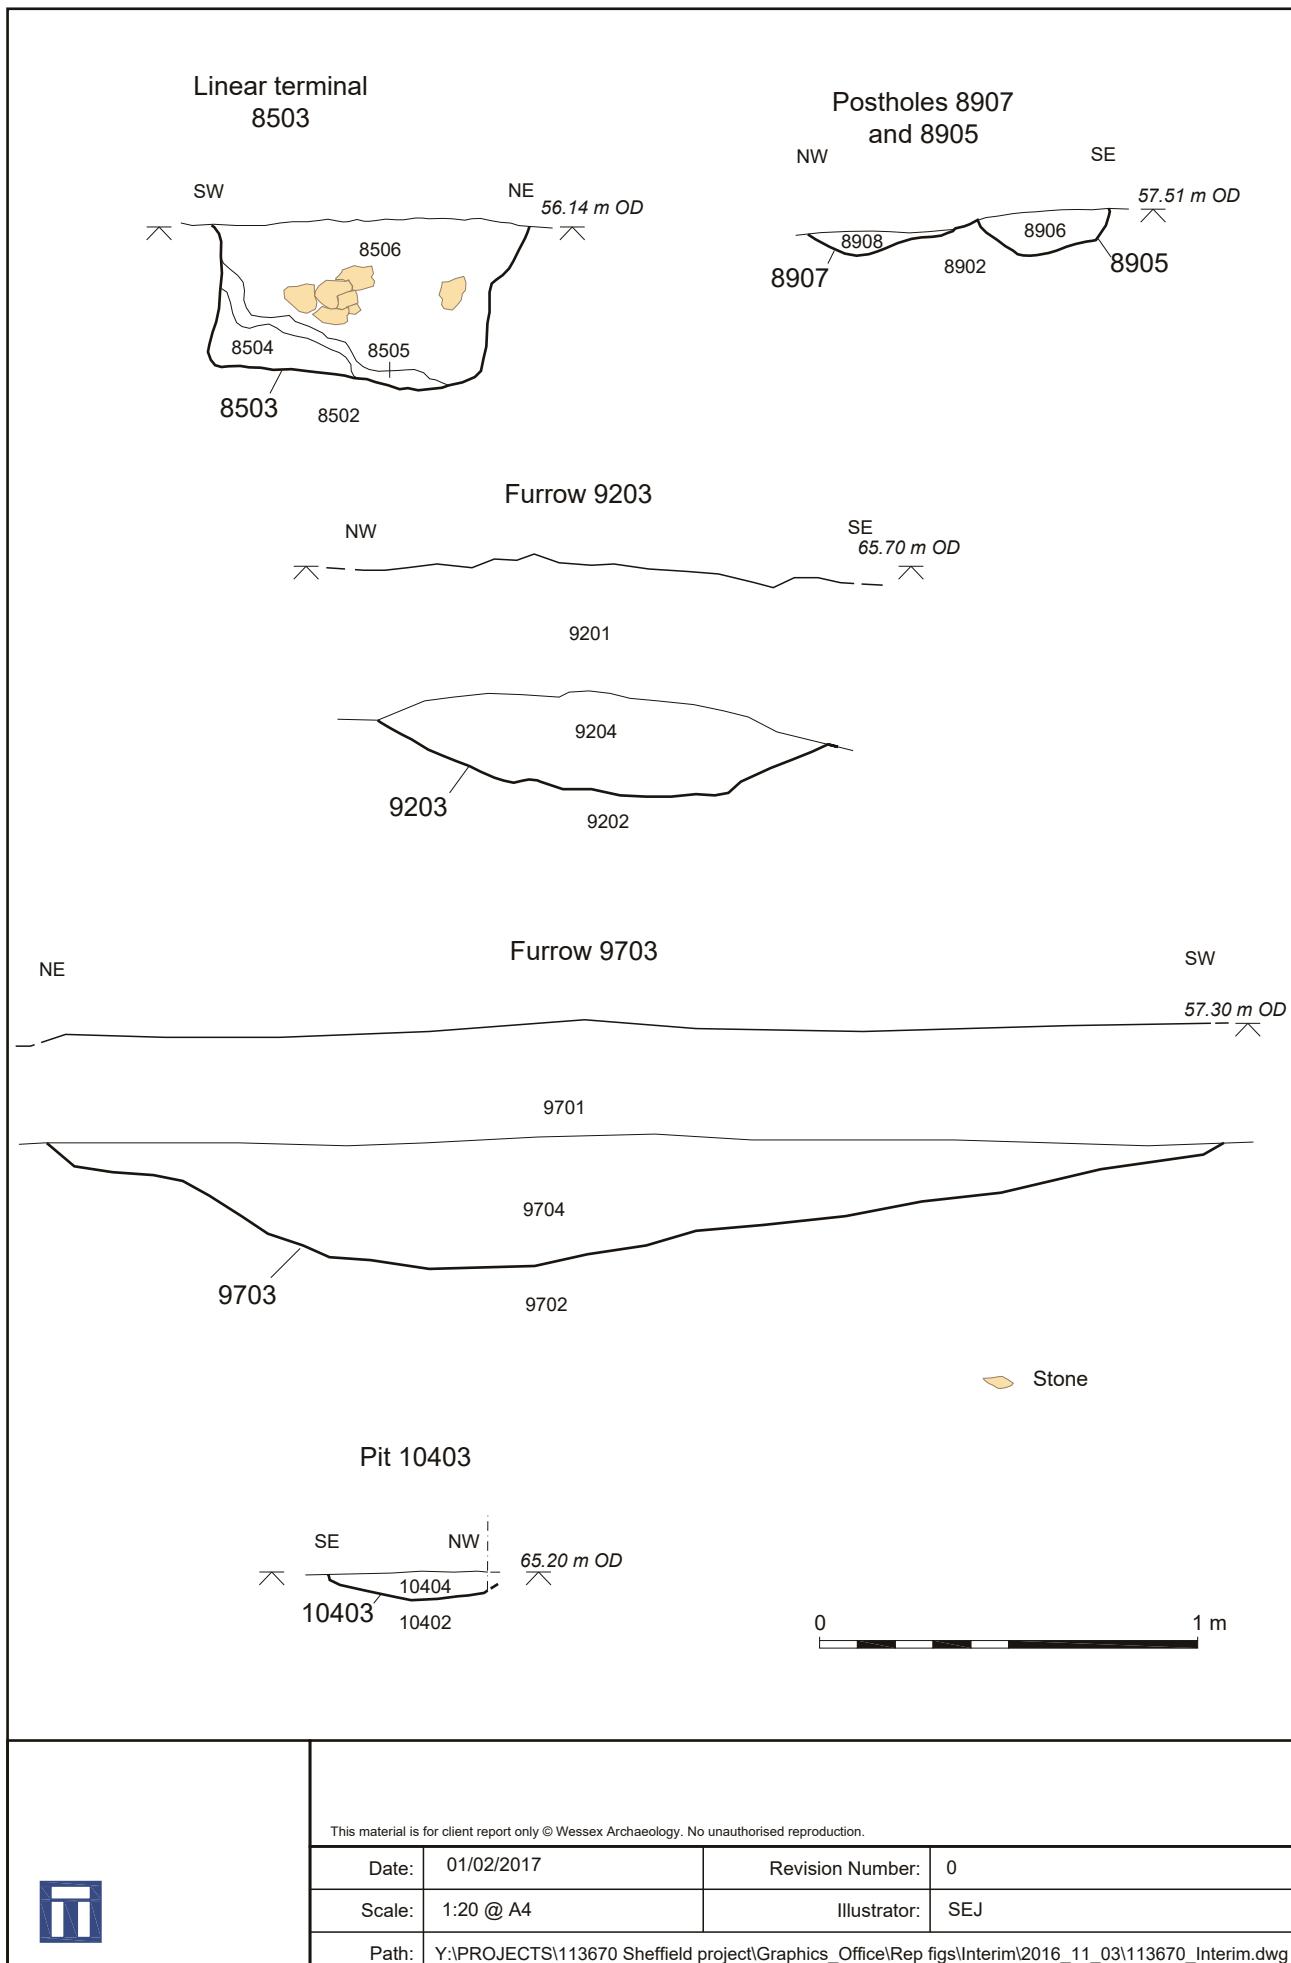
Figure 25

Sections from Site 3 (Llanfaeathlu): linear terminal 8503, postholes 8907 and 8905, furrows 9203 and 9703 and pit 10403

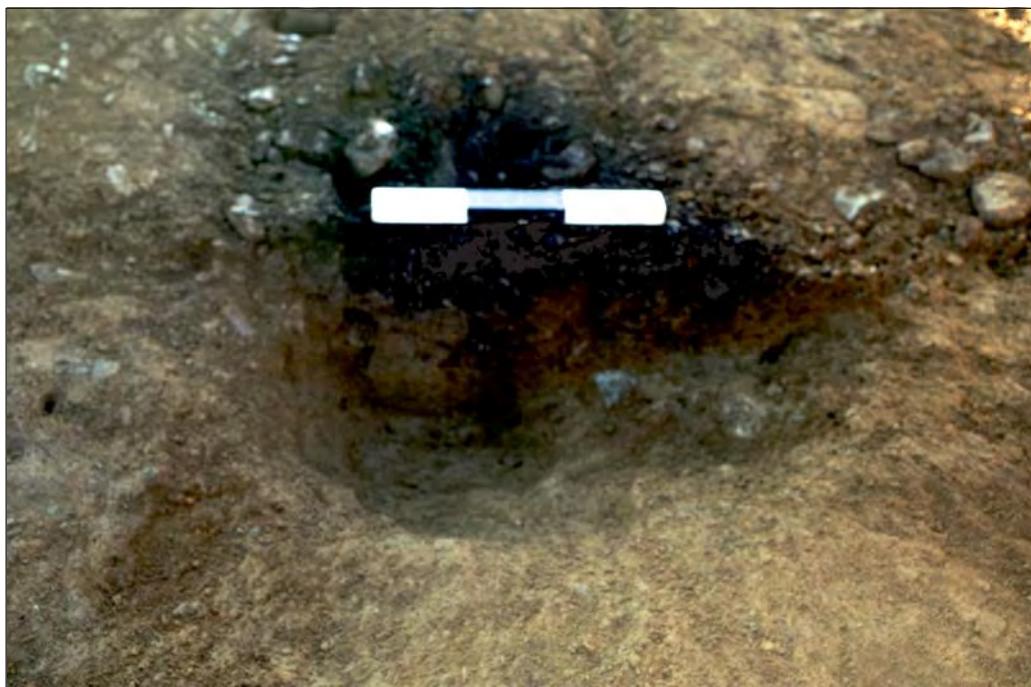
Plate 5: Fire pit hearth 2405 from south

A fire pit hearth in trench 24 (Llanfachraeth) resembles pits in trenches 58 and 59 and may possibly be associated with a further unidentified burnt mound. Other features seen across Site 2 (Llanfachraeth) include post-medieval boundaries, furrows and other linear and discrete features which remain undated.

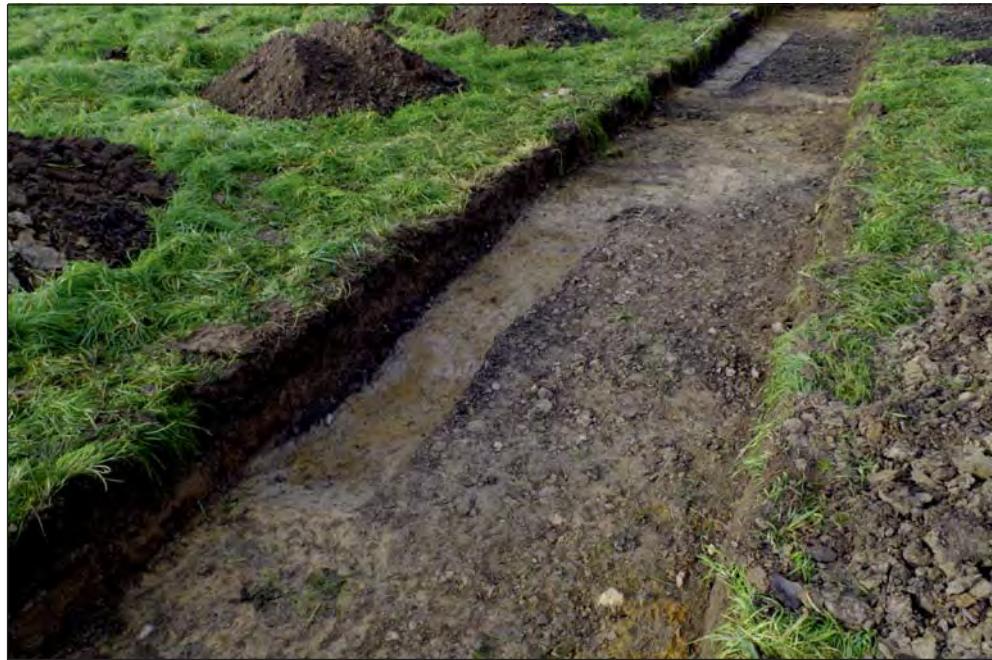
Plate 22: Overview of burnt mound 5803 and 5809 from north-east

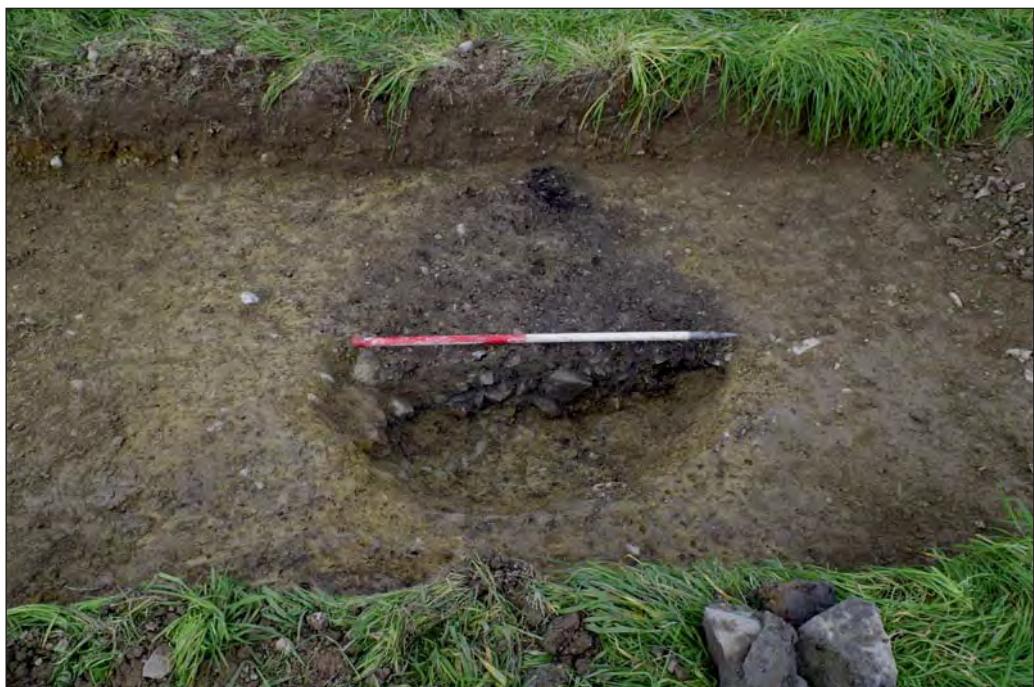
Plate 23: Pit 5807 from south

4.5.44 An oval pit, 5807 (Plate 23), was found close to the burnt mound, and was 1.3 m by 1.4 m in plan and 0.3 m deep. The fill (5808) was dark grey silt clay with abundant sub-angular stones up to cobble size, a minority of which showed signs of heat transformation. Although the fill appeared to consist of degraded ashy material with some heat affected stones, there was no positive evidence of *in situ* burning.

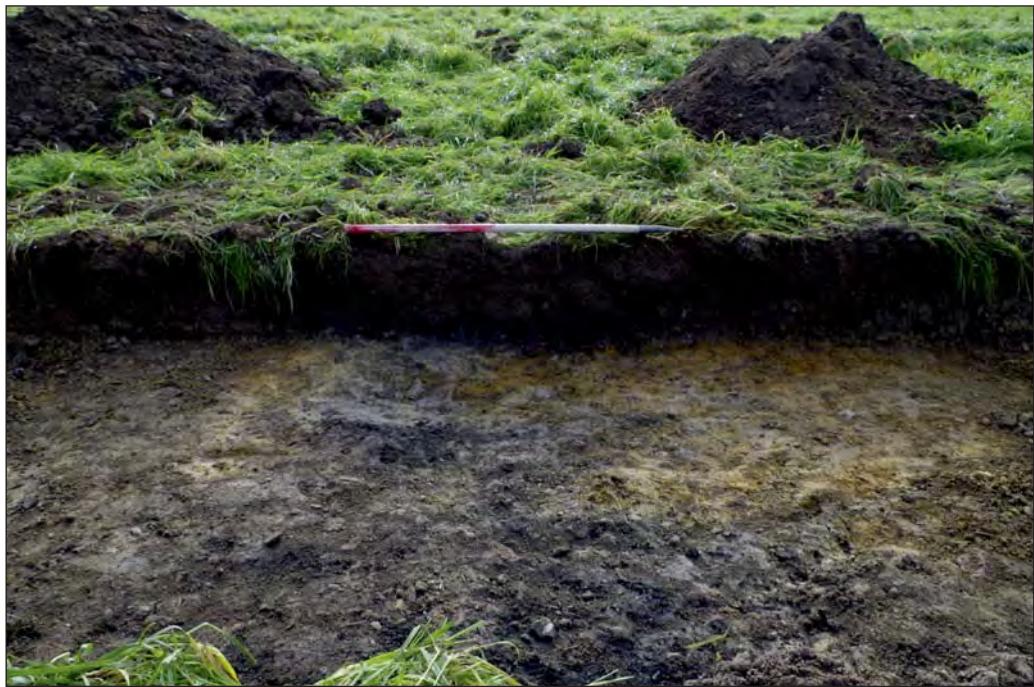
Plate 24: Burnt mound 5908 from north

trench 58, comprising dark blackish grey silt clay with fractured and sub rounded stones, of which 75% showed signs of heat transformation.

4.5.48 Interpretation of the features of trench 59 is not straightforward and is detailed in the discussion section below. It is likely that 5908 represents a burnt mound or an associated feature.

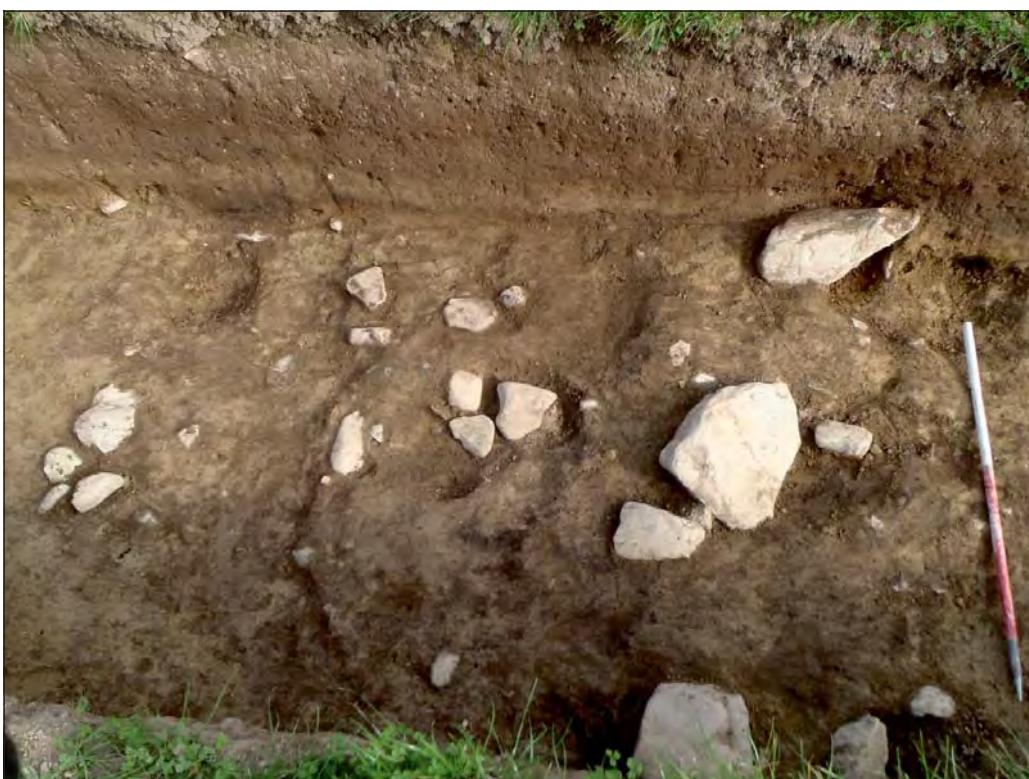
Plate 28: Stratigraphy of trench 68 showing colluvium and buried soil from west

4.6.1 Appendix 1 gives full stratigraphic details and descriptions. Excluding trench 62, the topsoil found over the rest of field 14 was 0.27 m to 0.40 m deep. Excavation in trench 62 halted at the top of the archaeological horizon, represented by ditch 6203 (Plate 27) which was cut into a layer of colluvium resembling the colluvium seen in site 2 (Llanfachraeth). The natural geological substrate was not reached in trench 62. The topsoil in trench 62 was 0.17 m deep and likely derived from the colluvial layer. Trench 68 contained an atypical stratigraphic profile. The natural 6805 was overlain by buried soil 6804, colluvium 6803, subsoil 6802 and finally topsoil 6801 (Plate 28). An environmental sample taken from buried soil 6804 was uninformative. Both the colluvium and the subsoil were absent in the northern 30 m of the trench. The total depth of overburden in trench 68 was 0.9 m.
