## Wylfa Newydd Project

Highways App G11-3 - Wylfa Newydd: A5025  
Highway Improvements, Isle of Anglesey:  
Evaluation report

# Wylfa Newydd: A5025 Highway Improvements Isle of Anglesey

## Evaluation Report

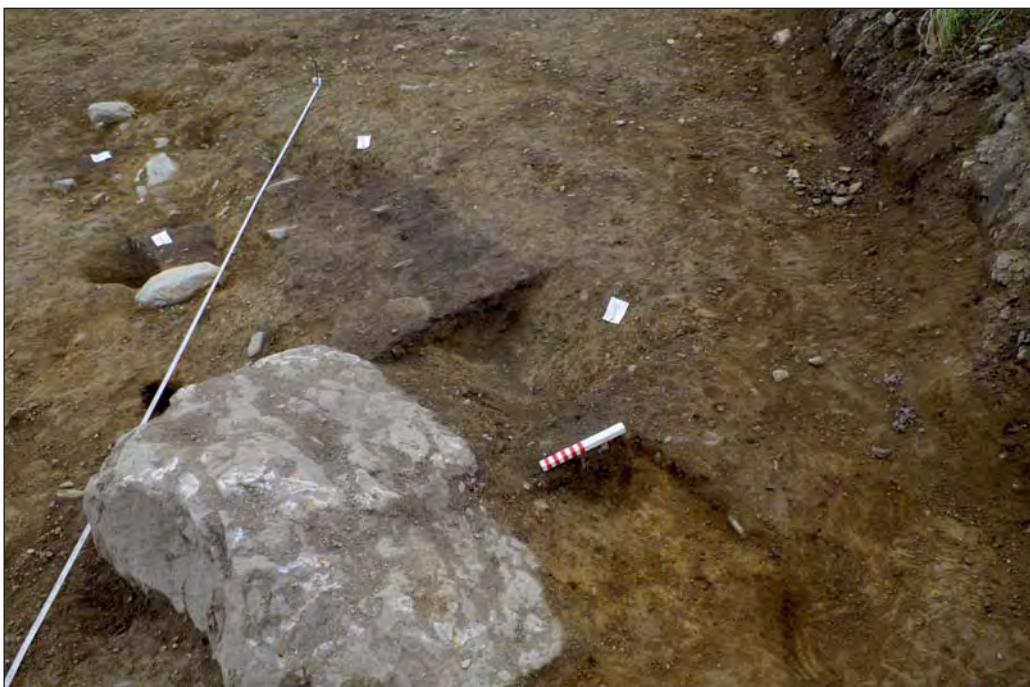
Plate 39: Trench 109 working shot from west showing object 10901

4.7.12 Near the west end of 10909, a large stone initially interpreted as a possible standing stone (object 10901, Plate 39) was set in construction cut 10951 (Figure 26). Cut 10951 was partially excavated and seen to be 0.25 m deep and extended 0.25 m away from the stone. The stone was deeper than the observed cut, suggesting that it had either been rammed into place, had sunk, or that the cut was close in size to the size of the stone, at least on the northern side. A radiocarbon date obtained from environmental material in the fill of cut 10951 was Middle to Late Iron Age. Such a date, if reliable, requires the interpretation of Object 10901 as a standing stone to be abandoned. It is possible that the material from which the date was obtained was intrusive. However, taking the four Iron Age radiocarbon dates from trench 109 at face value is consistent with the observed stratigraphy. Pit 10951 could therefore be reinterpreted as a pit for the disposal of a large stone, or for the use of that stone as a large post pad or similar foundation, cutting through earlier Neolithic features which had gone out of use.
