# Wylfa Newydd Project

6.8.15 ES Volume H - Logistics Centre

App H7-1 - Soils and Geology Baseline  
Conditions Report

### **Soils and Geology Baseline Conditions Report**

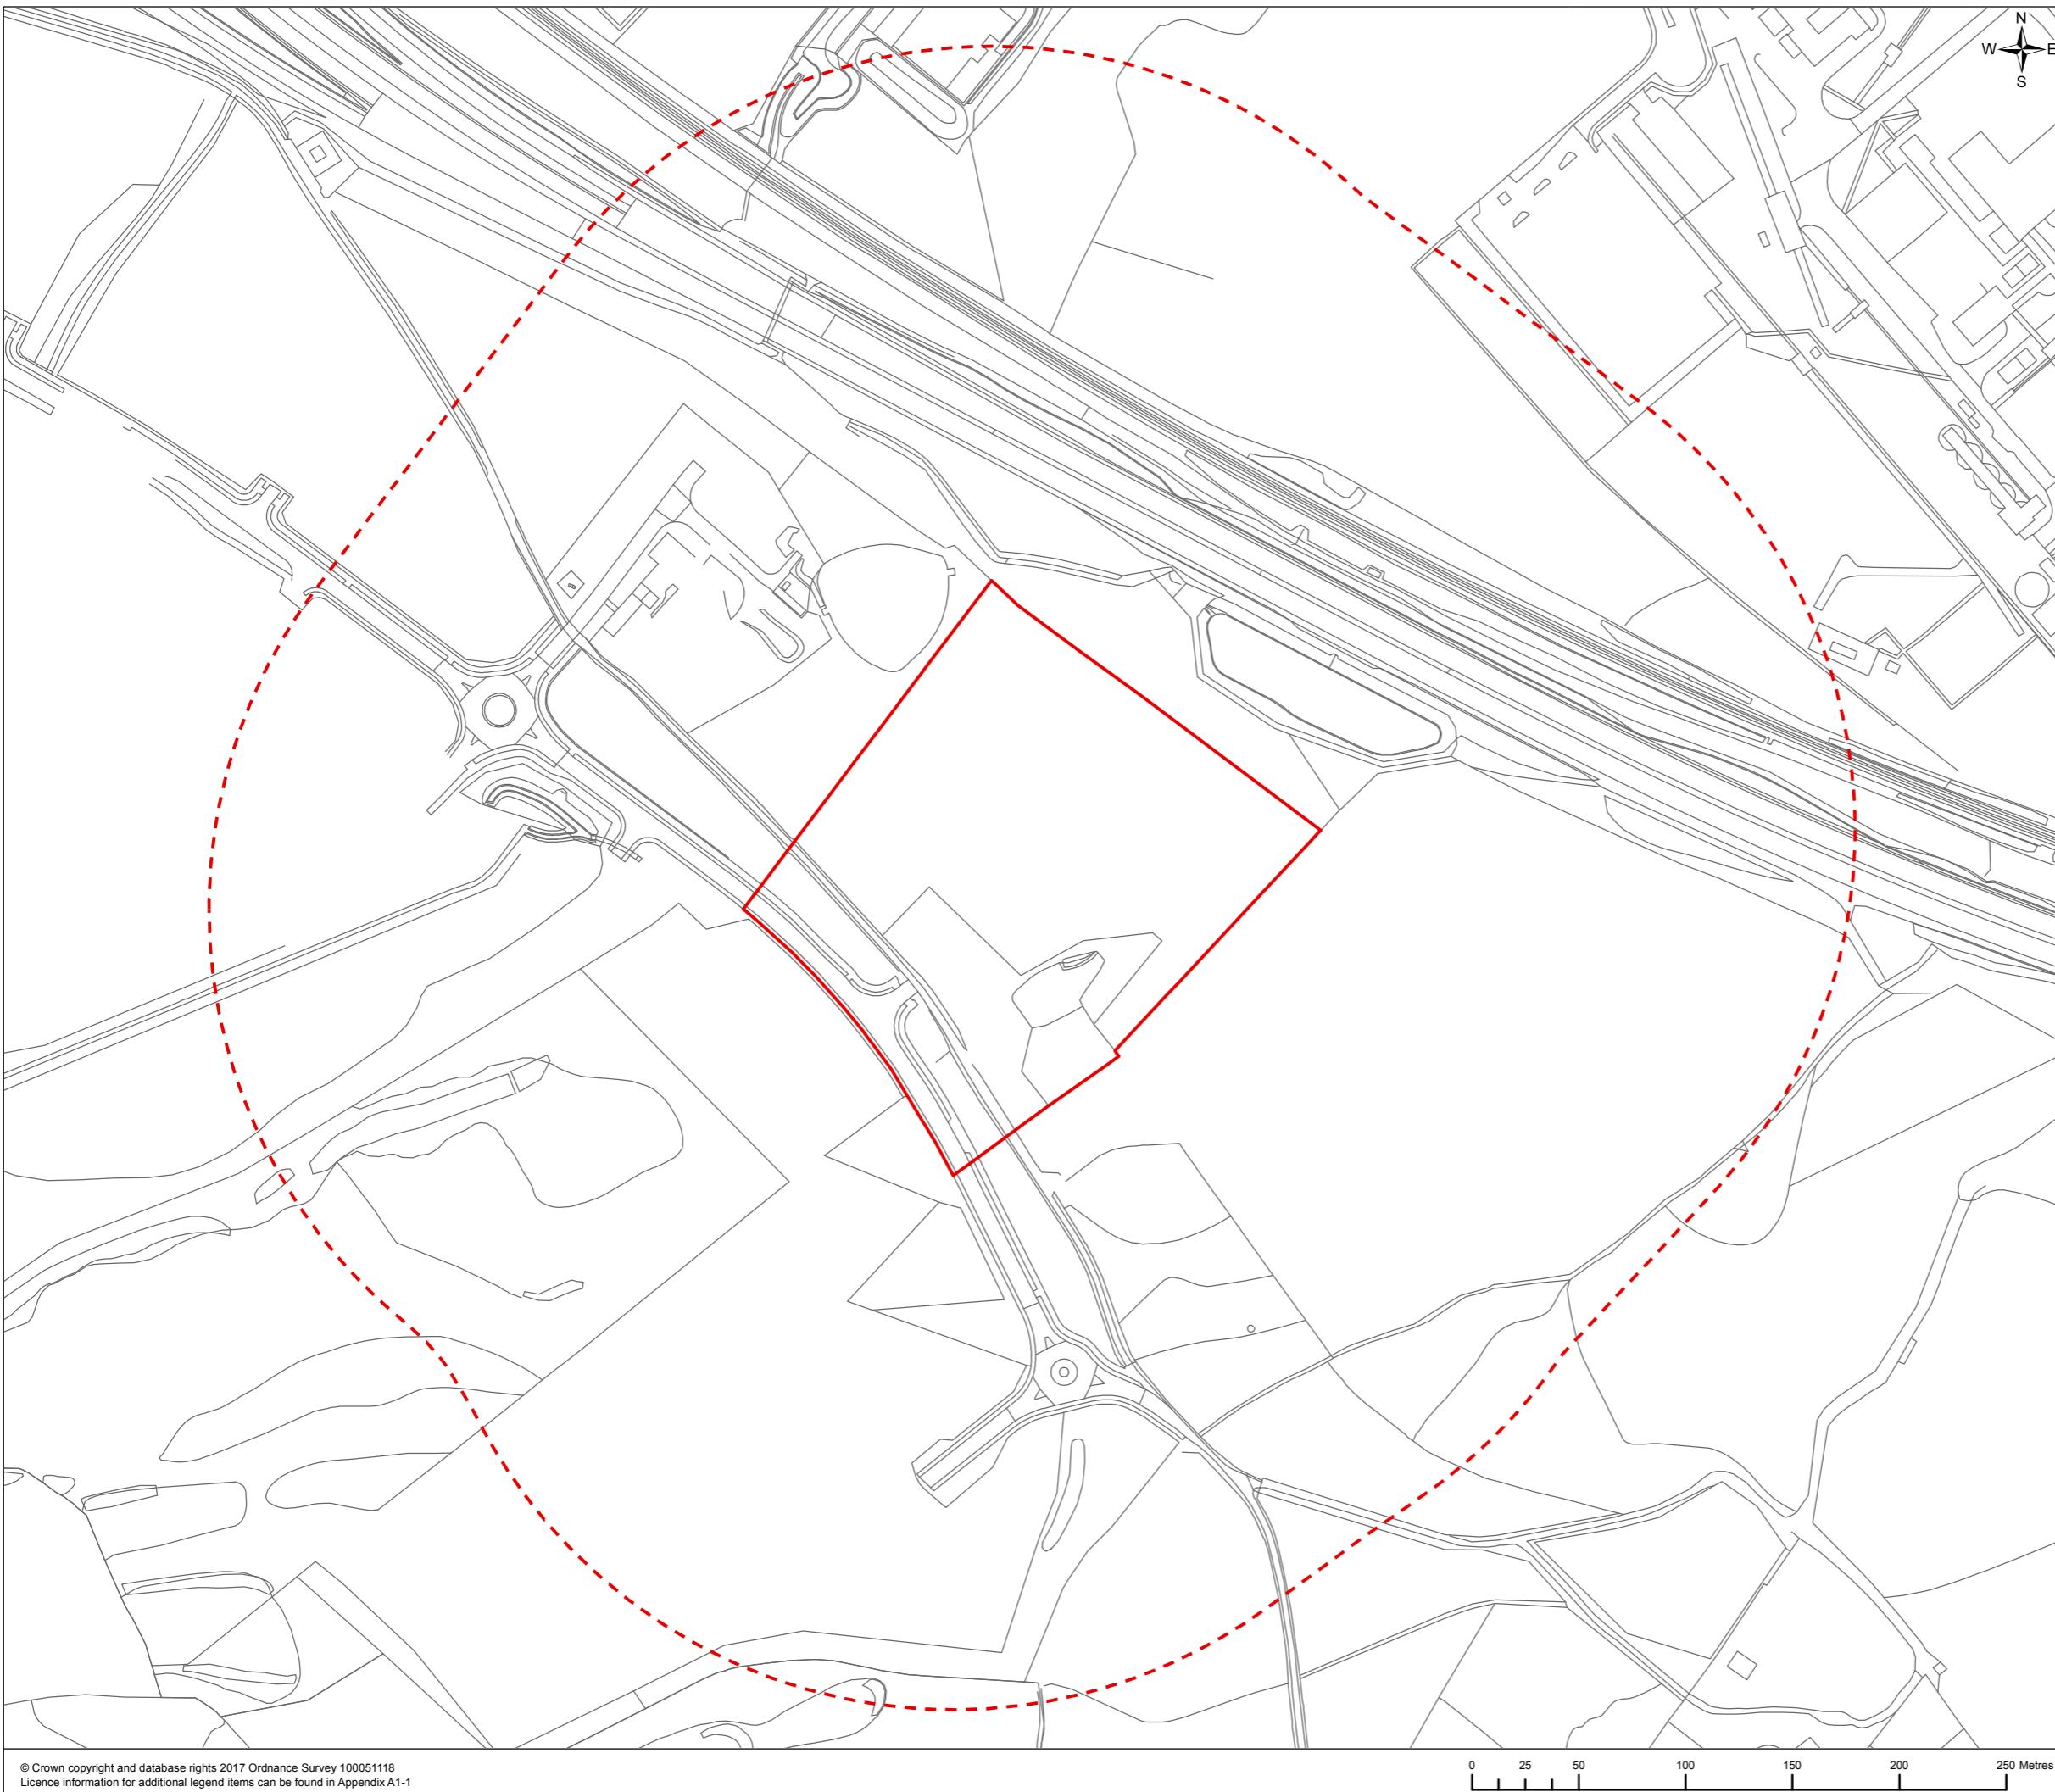
**FIGURE 1**

**Figure 1. Soils and Geology Study Area**

The potential effects on receptors from the proposed activities relevant to soils and geology are likely to be associated with direct disturbance of ground conditions on-site or the migration of contaminants to/from areas immediately adjacent to the site. As a result, the study area has been limited to a 250m buffer around the site; this is shown on Figure 1.

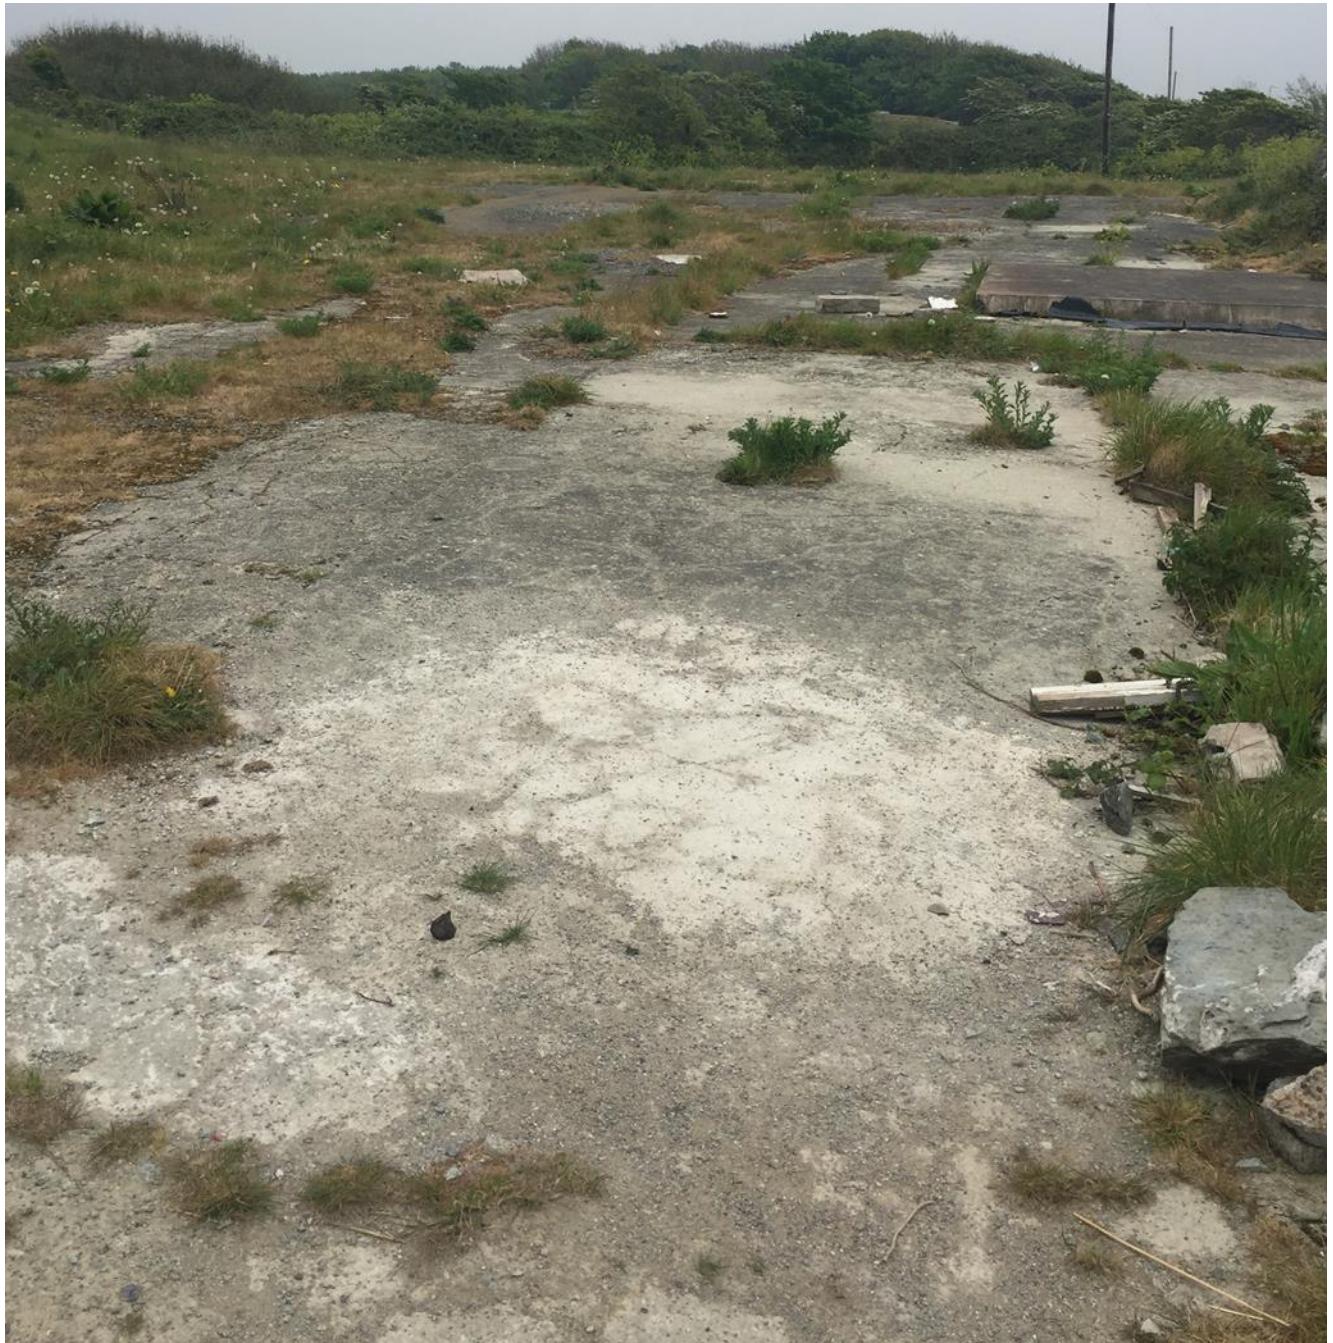
### C.1 An image of the hardstanding coverage in the southern area of the site.

The site reconnaissance indicated the presence of hardstanding cover in the southern area of the site. This area includes a 10m<sup>2</sup> concrete remnant foundation for the Tre-fignath farmstead, which may be associated with made ground. In the northern area of the site is a concrete platform with plastic pipes inset, a concrete pipe and a concrete base supporting a large sign. Two areas of discarded material are present in the southern area of the site, including a large approximately 15m<sup>2</sup> spoil heap (brick, stone, rubble, general litter, office and car materials) and a second smaller approximately 2m<sup>2</sup> area of discarded materials (building and car materials, brick rubble and general litter).

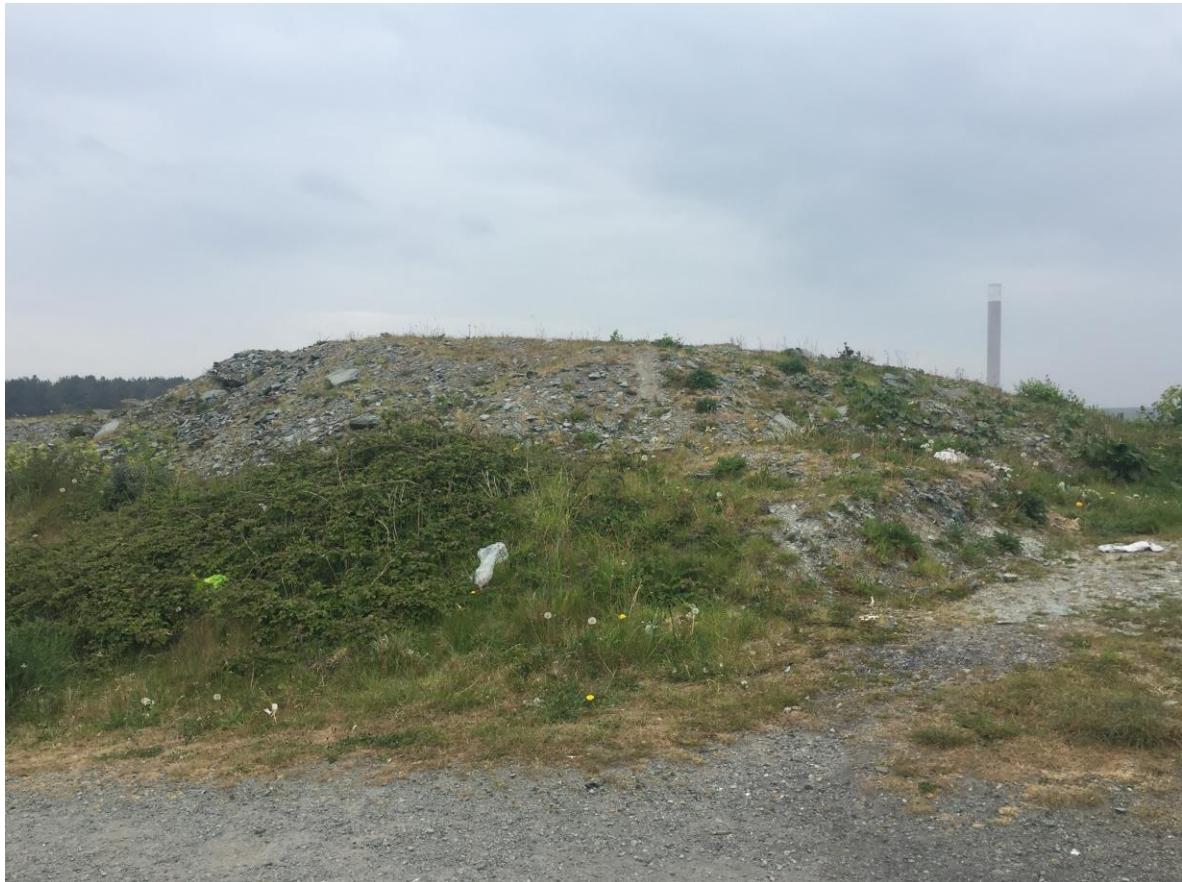
**C.2 An image of the spoil heap in the southern area of the site.**

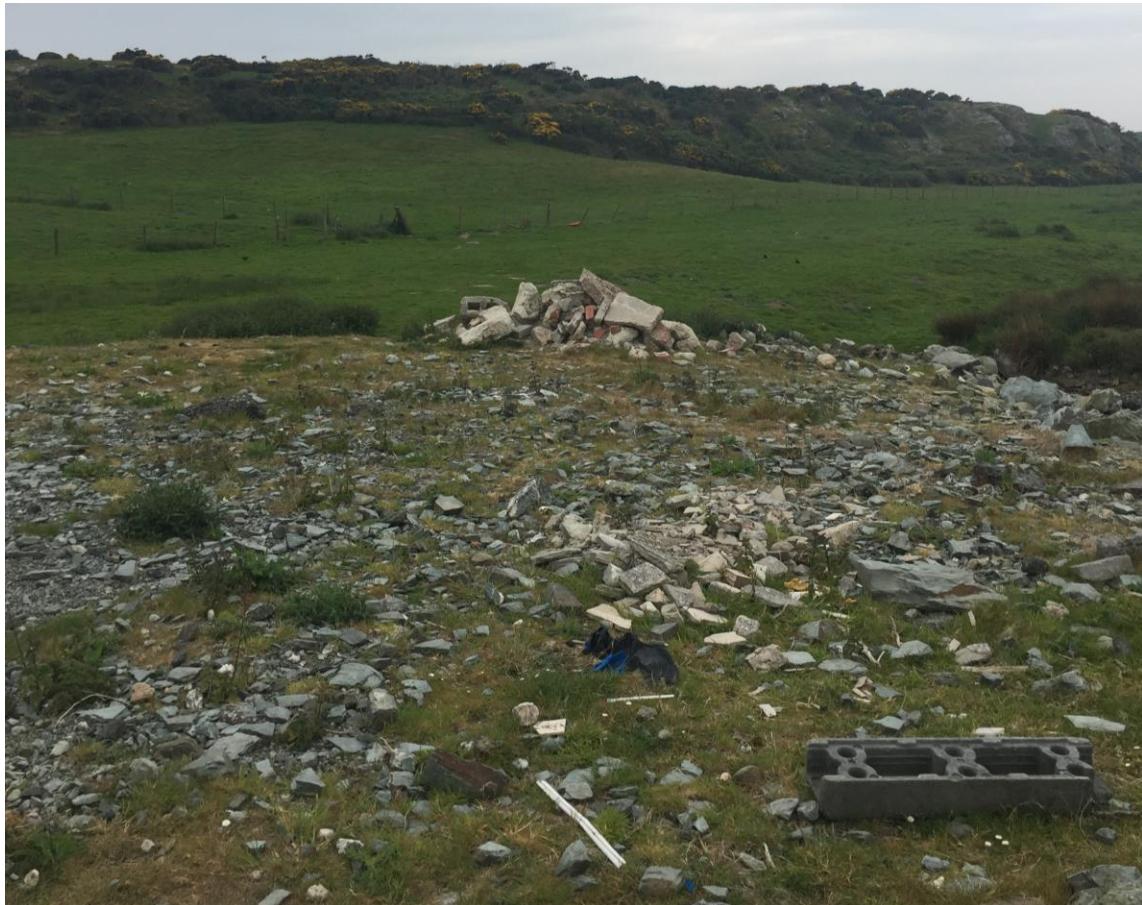
**C.3 An image of the fly tipping located in the southern area of the site.**

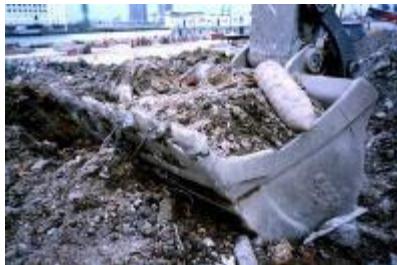
**SC 50**

Bomb Weight:	40-54kg (110-119lb)
Explosive Weight:	c25kg (55lb)
Fuze Type:	Impact fuze/electro-mechanical time delay fuze
Bomb Dimensions:	1,090 x 280mm (42.9 x 11.0in)
Body Diameter:	200mm (7.87in)
Use:	Against lightly damageable materials, hangars, railway rolling stock, ammunition depots, light bridges and buildings up to three stories.
Remarks:	The smallest and most common conventional German bomb. Nearly 70% of bombs dropped on the UK were 50kg.

50kg bomb, London Docklands

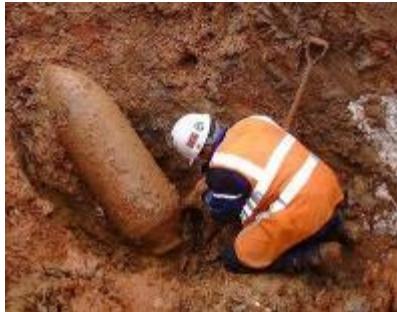
**SC 250**

Bomb weight:	245-256kg (540-564lb)
Explosive weight:	125-130kg (276-287lb)
Fuze type:	Electrical impact/mechanical time delay fuze.
Bomb dimensions:	1640 x 512mm (64.57 x 20.16in)
Body diameter:	368mm (14.5in)
Use:	Against railway installations, embankments, flyovers, underpasses, large buildings and below-ground installations.

250kg bomb, Hawkinge

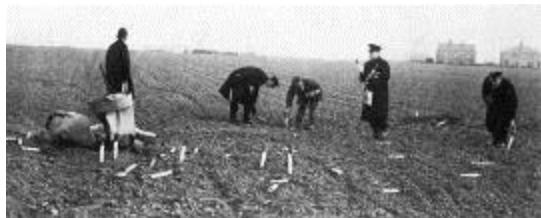
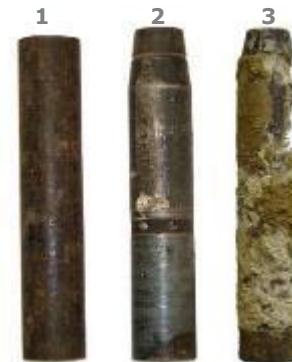
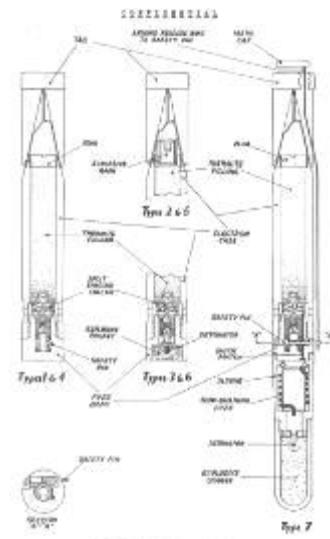
## 1kg Incendiary Bomb

Bomb weight:	1.0 and 1.3kg (2.2 and 2.87lb)
Filling:	680gm (1.3lb) Thermite
Fuze type:	Impact fuze
Bomb dimensions:	350 x 50mm (13.8 x 1.97in)
Body diameter:	50mm (1.97in)
Use:	As incendiary – dropped in clusters against towns and industrial complexes
Remarks:	Jettisoned from air-dropped containers. Magnesium alloy case. Sometimes fitted with high explosive charge

1. Scaffold pipe
2. Incendiary 1kg bomb
3. Incendiary bomb recently found on site in UK

GERMAN 1 Kg.  
INCENDIARY & MODIFICATIONS  
(INCLUDING 1.3 and 2.2 Kg.)

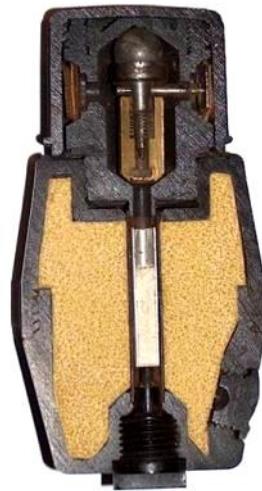
**No. 69 Grenade**

Weight: 0.38kg filled (0.8lb)  
 Type: Percussion/Blast  
 Date Introduced: December 1940  
 Remarks: Black Bakelite body. Blast rather than fragmentation type. After unscrewing the safety cap, a tape is held when throwing the grenade releasing the safety bolt in the throwing motion. Detection is problematic due to its very low metal content.

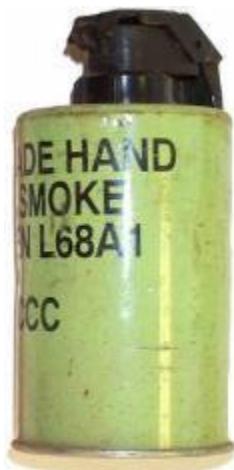
**Typical Smoke Grenade**

Dimensions: Approx. 65 x 115mm (2.5 x 4.5in)  
 Type: Smoke  
 Date Introduced: Current MoD issue  
 Remarks: Smoke grenades are used as ground-to-ground or ground-to-air signalling devices, target or landing zone marking devices, and screening devices for unit movement.

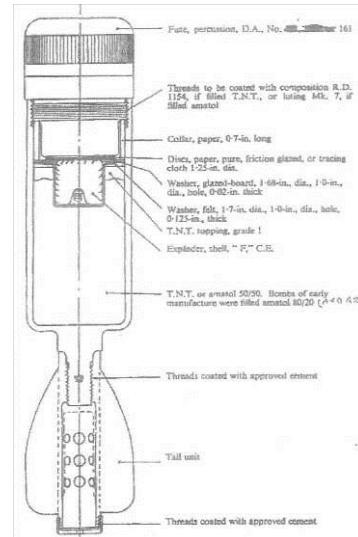
## Typical 2 inch High Explosive Mortar

Bomb Weight: 1.02kg (2.25lb)  
 Type: High Explosive  
 Dimensions: 51 x 290mm (2in x 11.4in)  
 Filling: 200g RDX/TNT  
 Maximum Range: 457m (500yds)  
 Remarks: Fitted with an impact fuze which detonates the fuze booster charge (exploder) and, in turn, the high explosive charge. The main charge shatters the mortar bomb body, producing near optimum fragmentation and blast effect at the target.

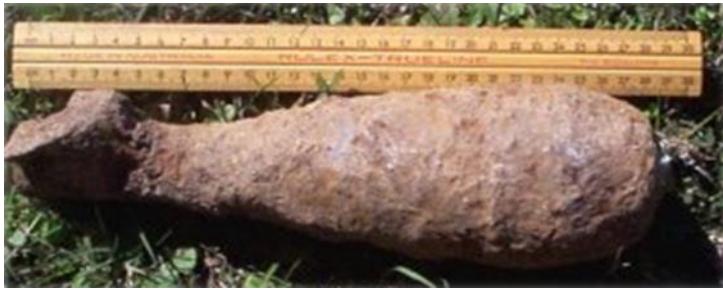
## Typical 3 inch Smoke Mortar

Type: Smoke  
 Dimensions: c490 x 76mm (19.3in x 3in)  
 Filling: Typically white phosphorous  
 Maximum Range: 2515m (2,750yds)  
 Remarks: On impact, the fuze functions and initiates the bursting charge. The bursting charge ruptures the mortar bomb body and disperses the white phosphorous filler. The white phosphorous produces smoke upon exposure to the air.

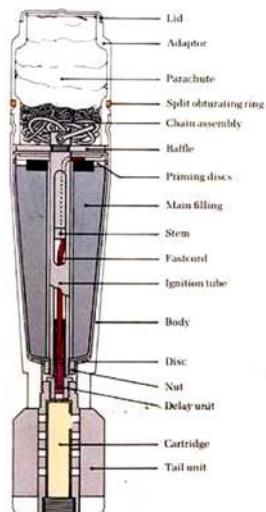
## Typical 2 inch Illuminating Mortar

Type: Illum.  
 Dimensions: 51 x 290mm  
 Filling: Various  
 Remarks: The expulsion charge ignites and ejects the candle assembly. A spring ejects the parachute from the tail cone. The parachute opens, slowing the descent of the burning candle which illuminates the target.

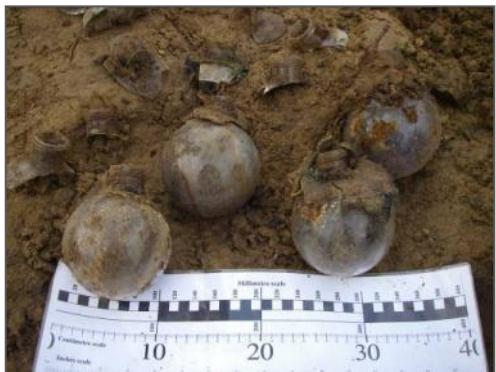
## No 74 Grenade (Sticky Bomb)

Remarks: Designed as an anti-tank grenade and used by the Home Guard. The grenade consisted of a glass ball on the end of a Bakelite (plastic) handle. Inside the glass ball was an explosive filling whilst on the outside was a very sticky adhesive covering. Until used, this adhesive covering was encased in a metal outer casing.

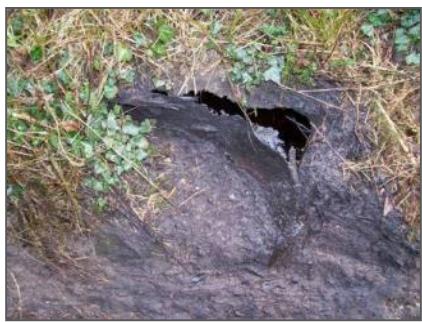
## Flame Fougasse Bomb

A Flame Fougasse was a weapon in which the projectile was a flammable liquid, typically a mixture of petrol and oil. It was usually constructed from a 40-gallon drum dug into the roadside and camouflaged. Ammonal provided the propellant charge which, when triggered, caused the weapon to shoot a flame 3m (10ft) wide and 27m (30 yards) long. Initially a mixture of 40% petrol and 60% gas oil was used, this was later replaced by an adhesive gel of tar, lime and petrol known as 5B.

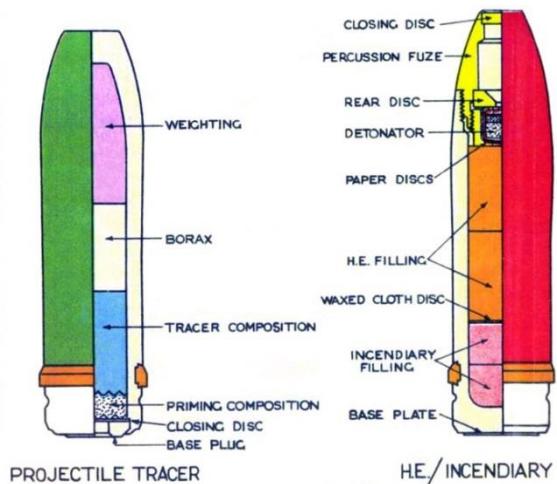
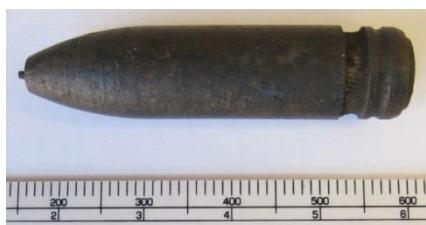
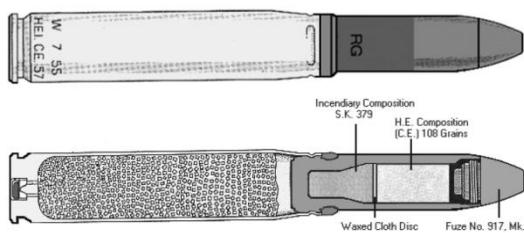
## 20mm Hispano HEI Ammunition

Type: Live canon round  
 Markings: Upper half of projectile painted 'buff' colour, lower half is red.  
 Cartridge Weight: 256 grams  
 Dimensions: Total cartridge / projectile length - 182mm  
 Fuzed: Contact fuze – No.253, No.254 or No.917  
 Filling: 108 grains of contact explosive + 68 grains of SR.379 incendiary composition.  
 Threat: Explosives within unspent cartridge as well as the projectile.  
 Deployment: Royal Navy, RAF and British Army Light Anti-Aircraft guns. Also RAF aircraft canons.  
 Remarks: Cartridges are belted or supplied loose in cartons.

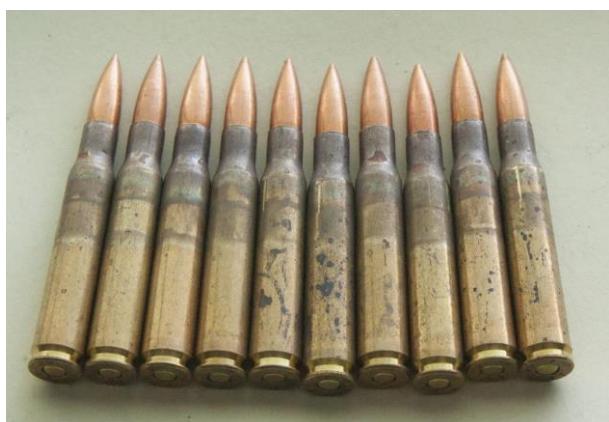
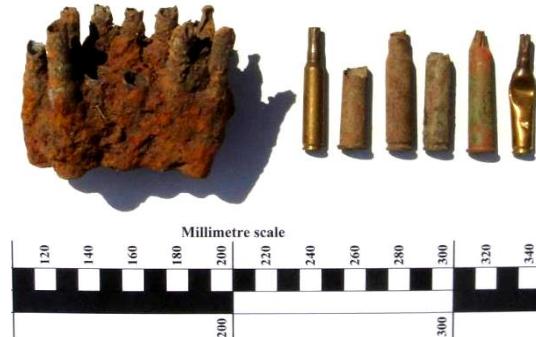
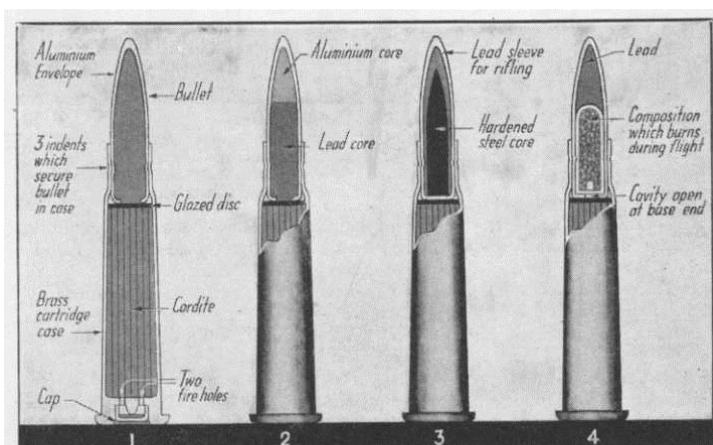
## .303" Ammunition

Type: Rifle / machine gun round  
 Markings: Regular round - none. Tracer round – red Primer  
 Bullet Weight: 150 - 180 grams  
 Dimensions: Total cartridge /projectile length - 78mm  
 Filling: Regular round – none. Tracer round - small incendiary fill  
 Threat: Explosive cordite within unspent cartridge  
 Deployment: Royal Navy, RAF and British Army Light Anti-Aircraft guns, machine guns and rifles. Standard British and Commonwealth military cartridge from 1889 until the 1950s.  
 Remarks: Cartridges are belted or supplied loose in cartons.

TYPES OF SMALL ARMS AMMUNITION  
 Fig. 1. Four types of ammunition used by modern infantry. 1 and 2 are ball cartridges, 3 is an armour-piercing bullet, and 4 a tracer bullet which burns and makes its flight visible.

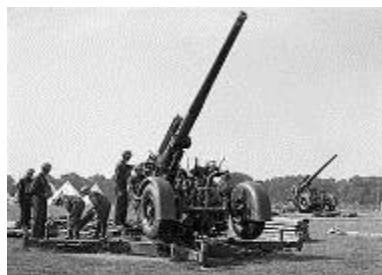
This AA shell was uncovered on a construction site in North London in February 2009.

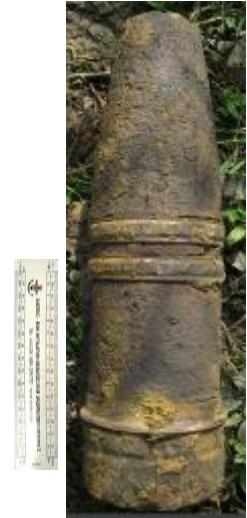
3.7 inch AA Projectile Minus Fuze

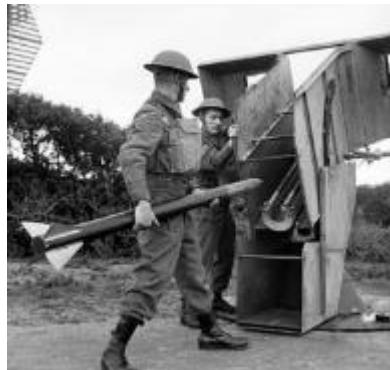
Home Guard soldiers load an anti-aircraft rocket at a 'Z' Battery

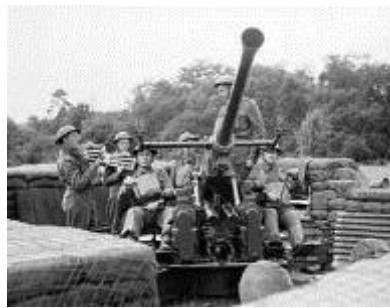
40mm Bofors gun and crew at Stanmore in Middlesex, 28 June 1940.
