**From:** [Pearson, John](#)  
**To:** [Wylfa Newydd](#)  
**Subject:** Deadline 4 Submission for Wylfa Newydd Development Consent Order EN010007  
**Date:** 17 January 2019 13:29:01  
**Attachments:** [image001.png](#)  
[NT Wylfa Deadline 4 Intro letter FINAL.docx](#)  
[NWWT and eNGO oral case FINAL.pdf](#)  
[Post ISH Note on Coastal Processes and Geomorphology Wylfa DCO Deadline 4.pdf](#)  
[Post-hearing note eNGO - Biodiversity FINAL.pdf](#)  
[Wylfa DCO Post Hearing Note Section 106 Jan 2019 Final.docx](#)

**EN010007 Wylfa Newydd Nuclear Power Station: Deadline 4.**

-post hearing note on Coastal Processes and Geomorphology including Kenneth Pye Associates Ltd Report on Cemlyn Wave Regime and Sediment Demand;

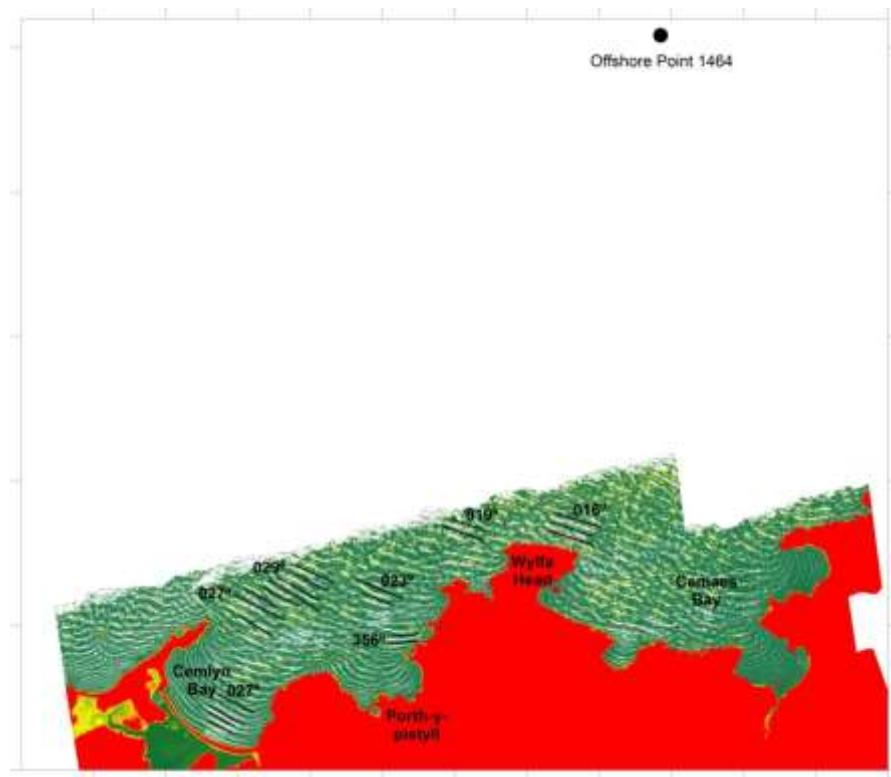
**Figure 17.** LiDAR image from airborne survey on 27<sup>th</sup> November 2010, scaled to show the wave crests observed during the flight, between Cemlyn Bay in the west and Cemaes Bay in the east. The angles of the wave crests have been highlighted, and the position of the offshore hind-cast point (number 1464) is also shown.

Figures 17 & 18 illustrate a condition on 27 November 2010 of waves approaching Cemlyn Bay from the northeast, close to the angle of the axis of the Bay. The approach direction recorded at offshore point 1464 around the time of the LiDAR overflight changed from NNW through N to NNE, and at the time of overflight was very close to the central axis of Cemlyn Bay. On this occasion the maximum  $H_s$  was approximately 1.1 m and the maximum  $T_z$  approximately 3.5 s (Figure 19). A degree of refraction and spreading of approaching wave crests into Porth-y-pystll and Cemlyn Bay is clearly evident in Figures 17 & 18. Larger wave events from this direction, coincident with high still water levels, are relatively rare.

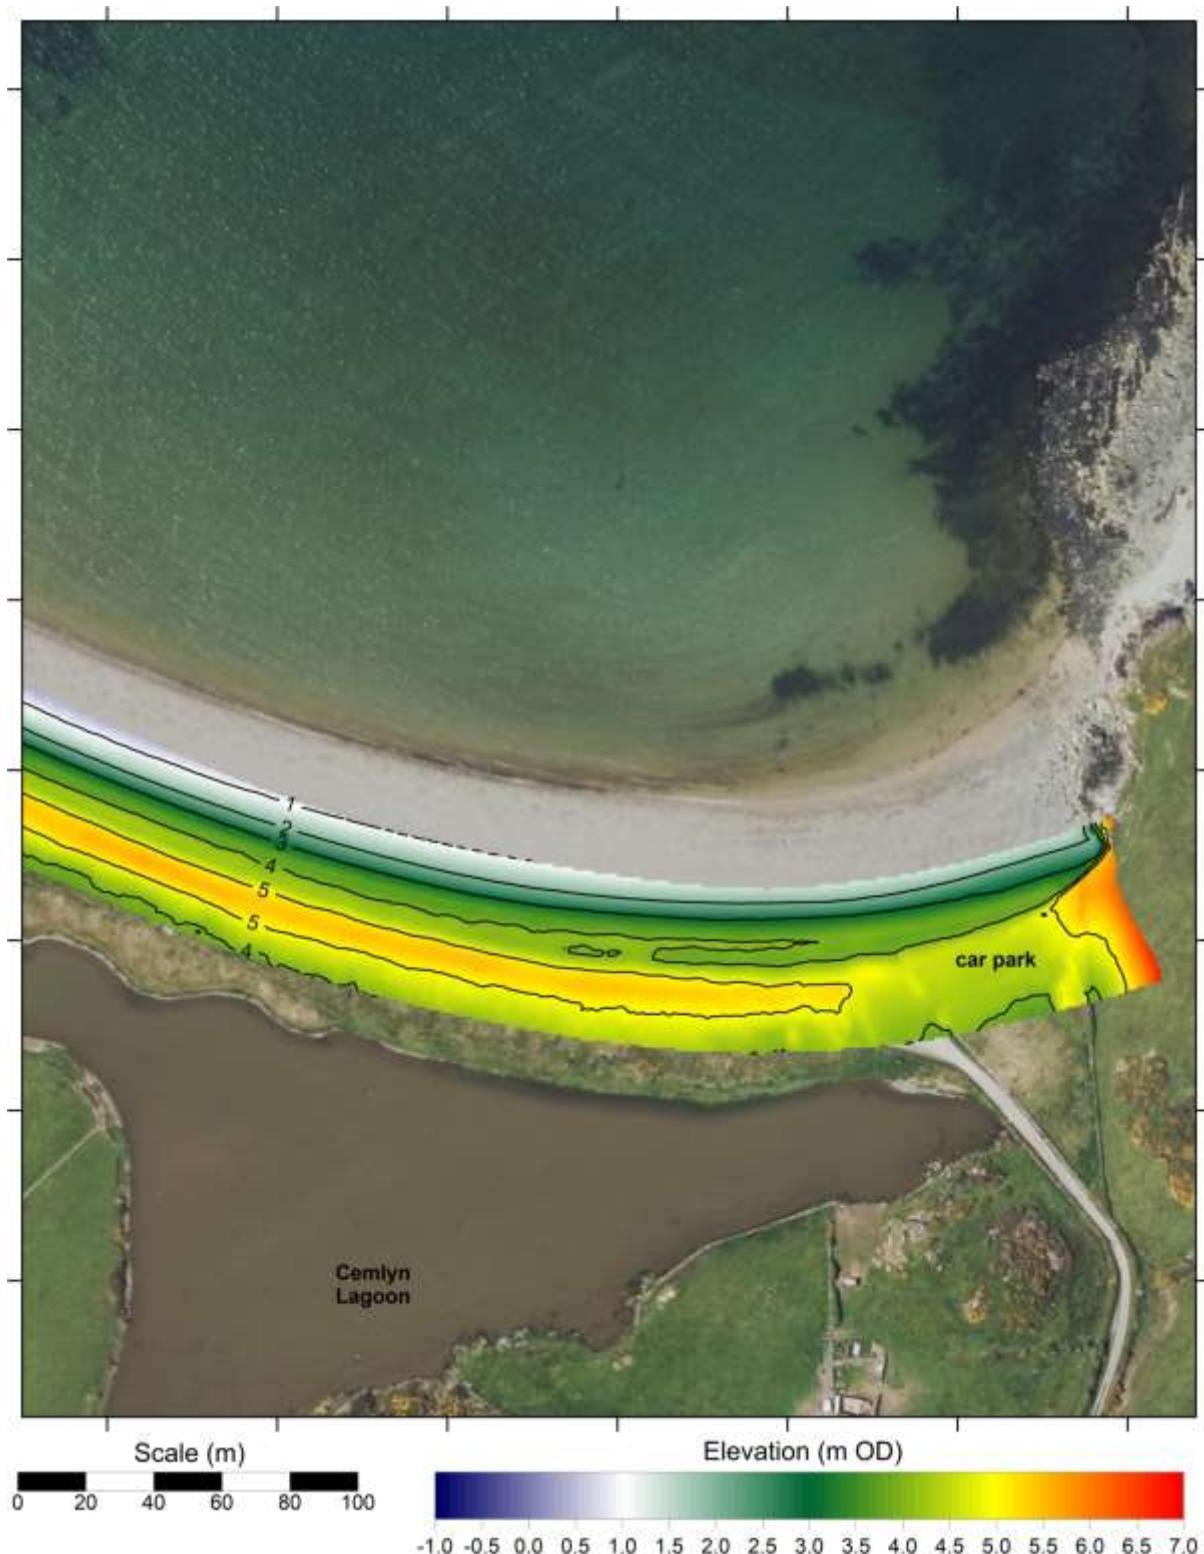
**Figure 62.** Enlargement of the SE half of the May 2017 DEM, showing interpolated 1 m contours

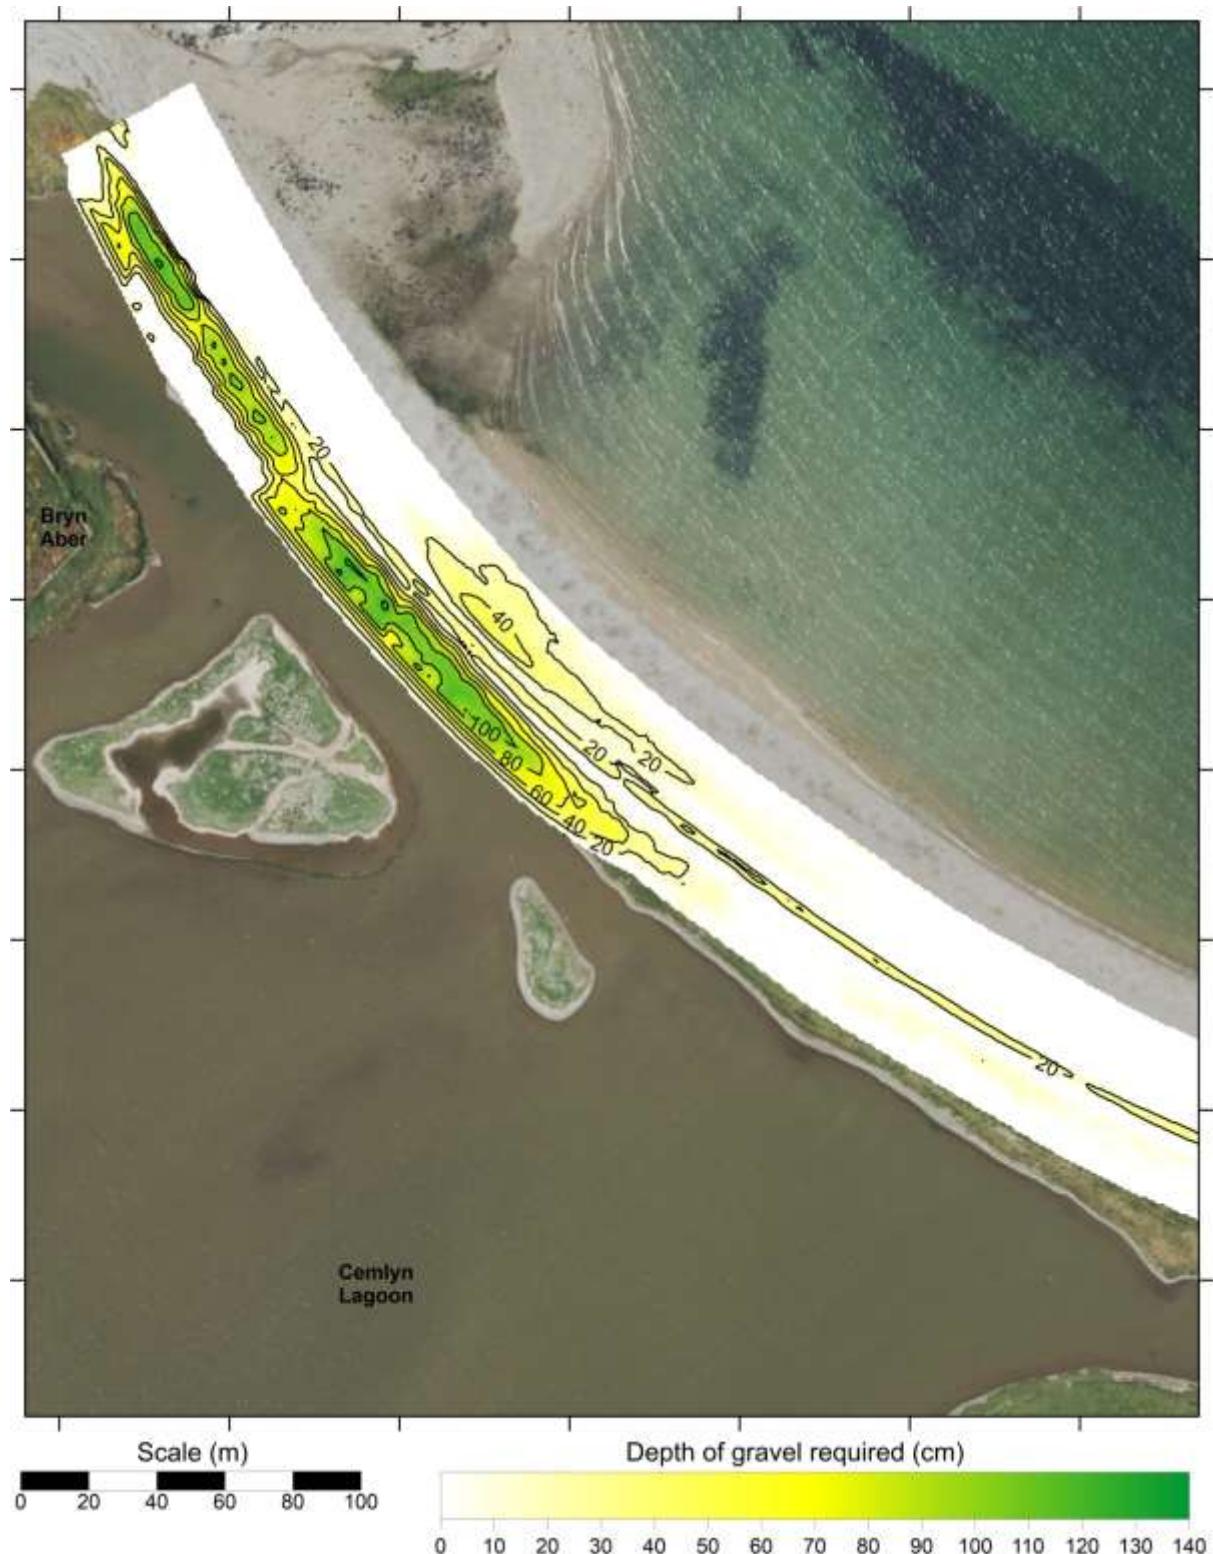
**Figure 64.** Enlargement of the NW section of the Cemlyn Barrier showing the depth of gravel required (in cm) to raise and widen the barrier to that shown in Figure 62.

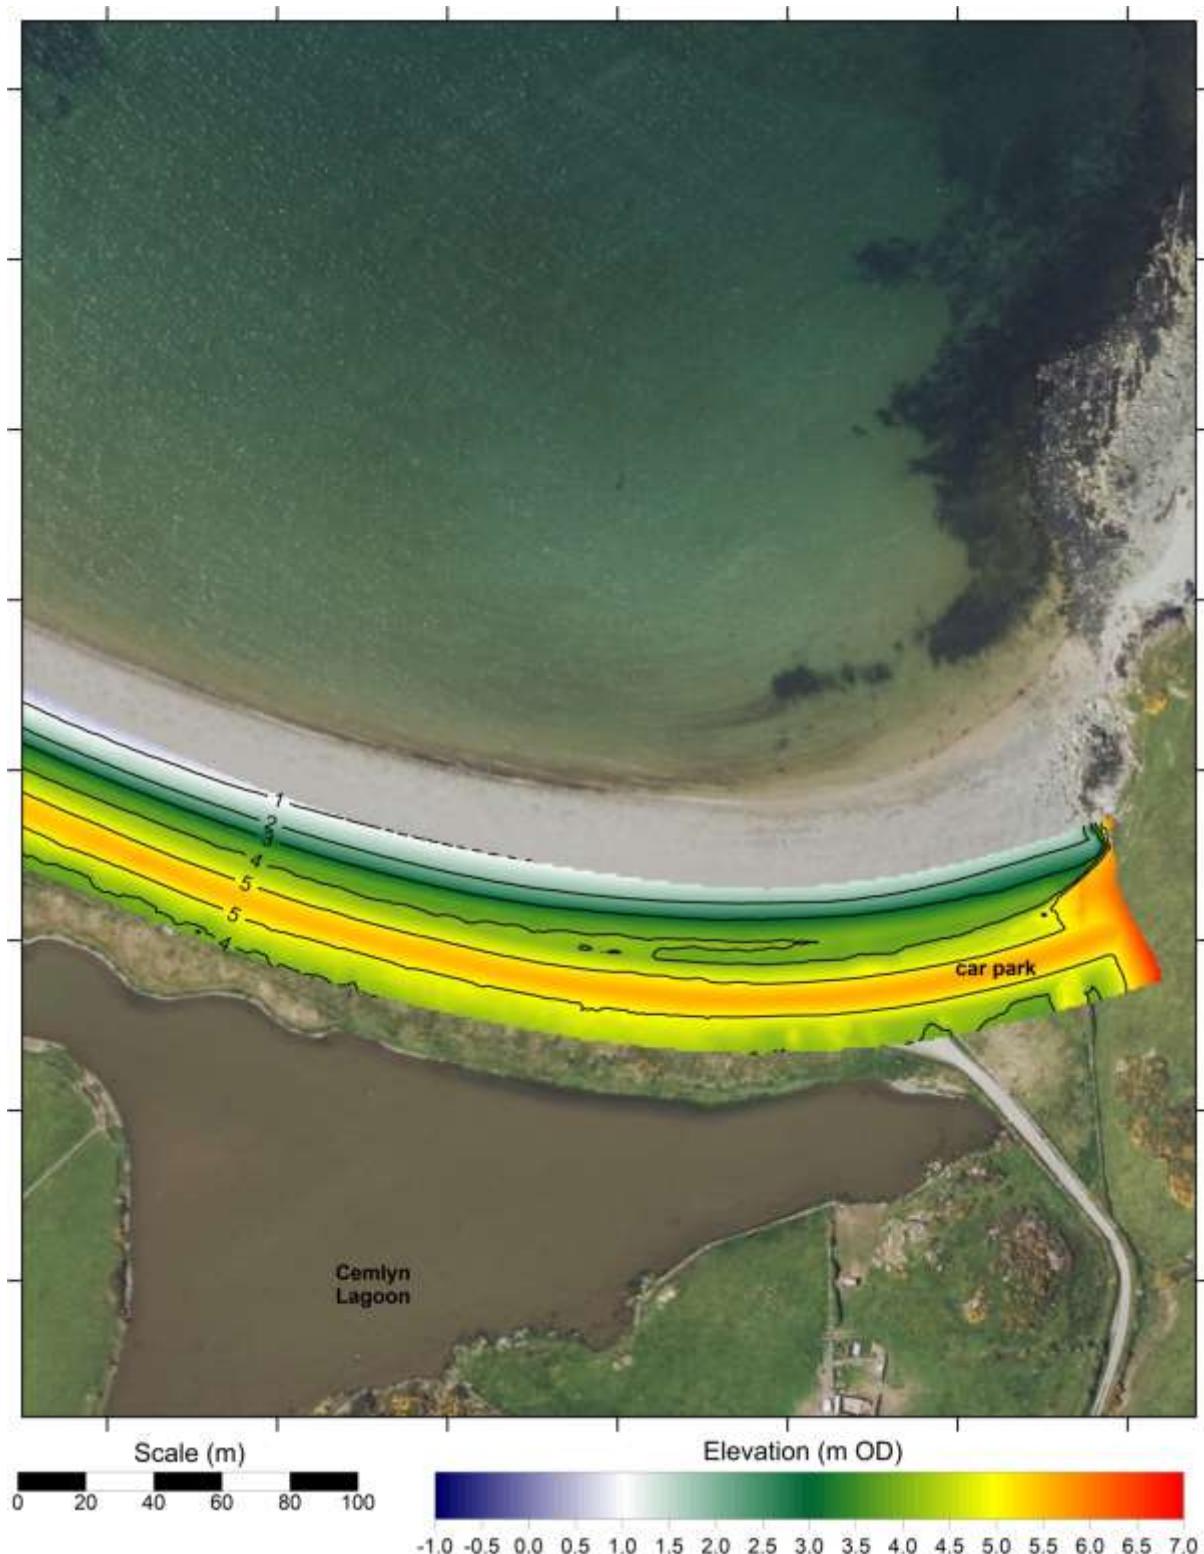
**Figure 65.** Enlargement of the SE section of a modified DEM, with superimposed hypothetical contours following the addition of gravel from an external source. The modified ridge slopes slightly from 5.2 m at the NW end to 5.7 m OD at the SE end. The modified barrier as shown has been graded into the existing 0 m OD seaward contour, and the 3 m OD landward contour.

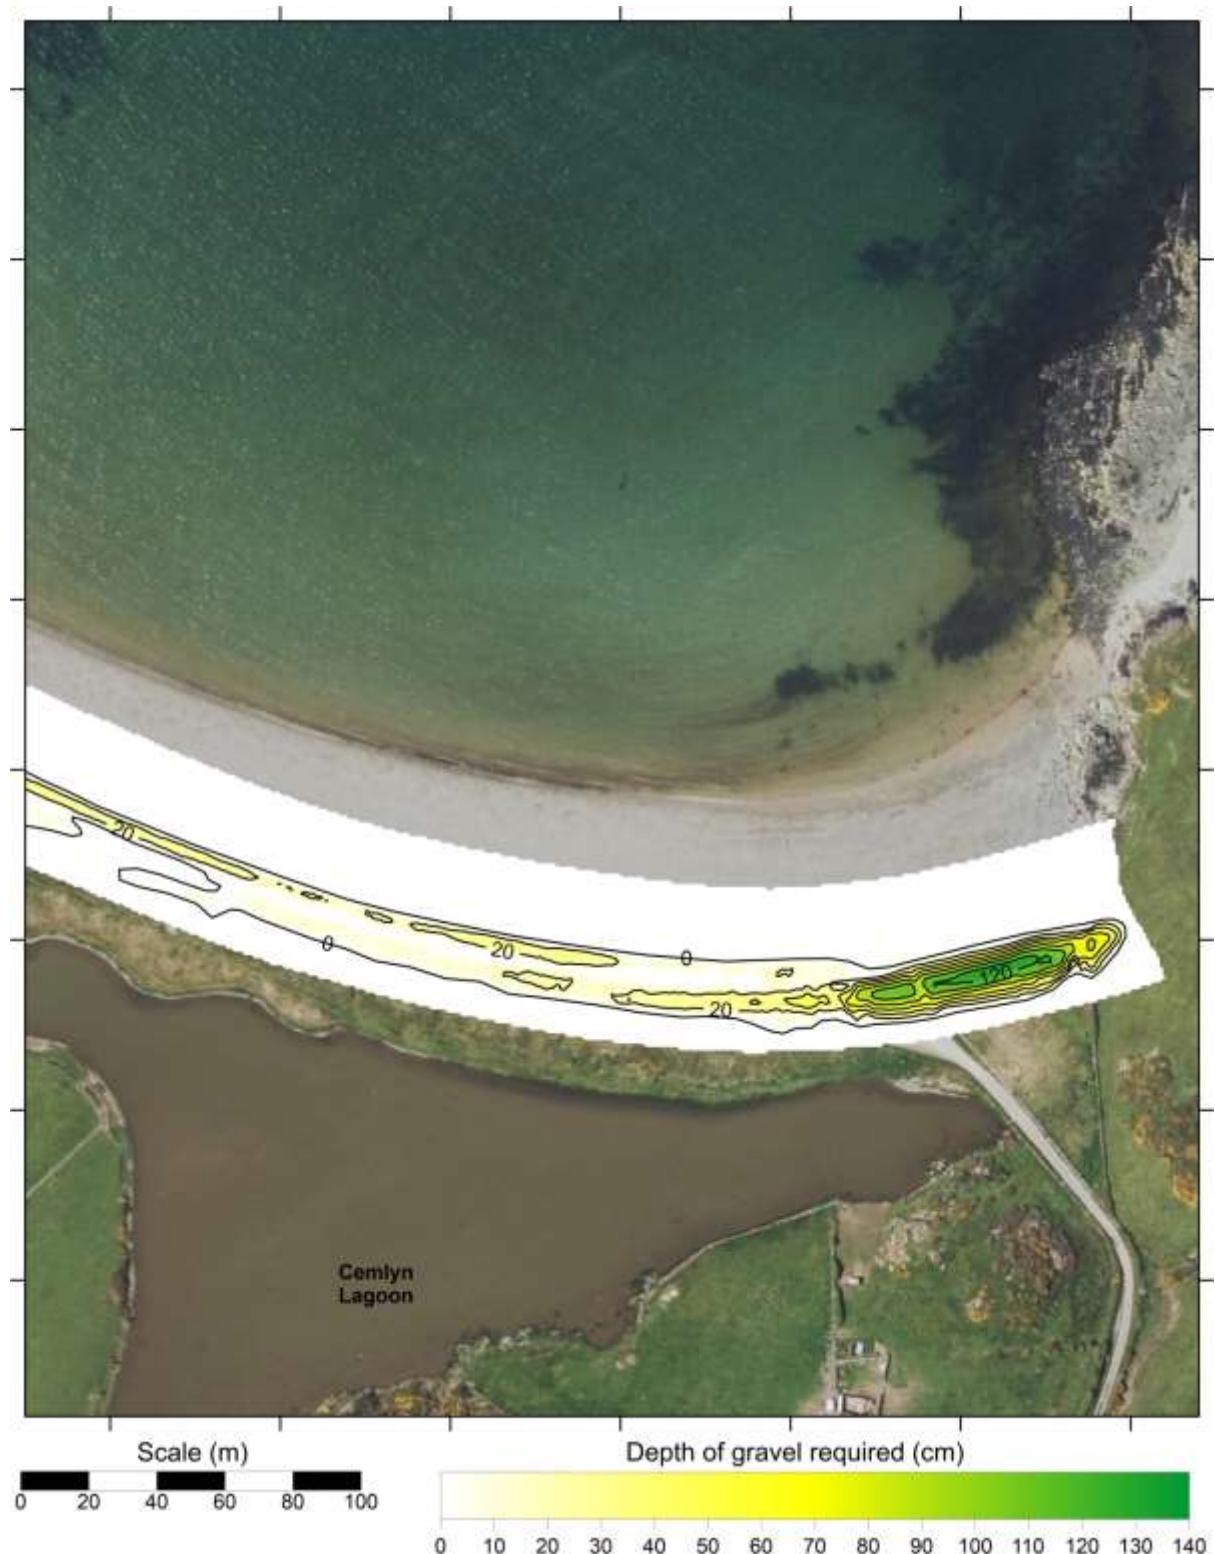
**Figure 66.** Enlargement of the SE section of the Cemlyn Barrier showing the depth of gravel required (in cm) to raise and widen the barrier to that shown in Figure 21.

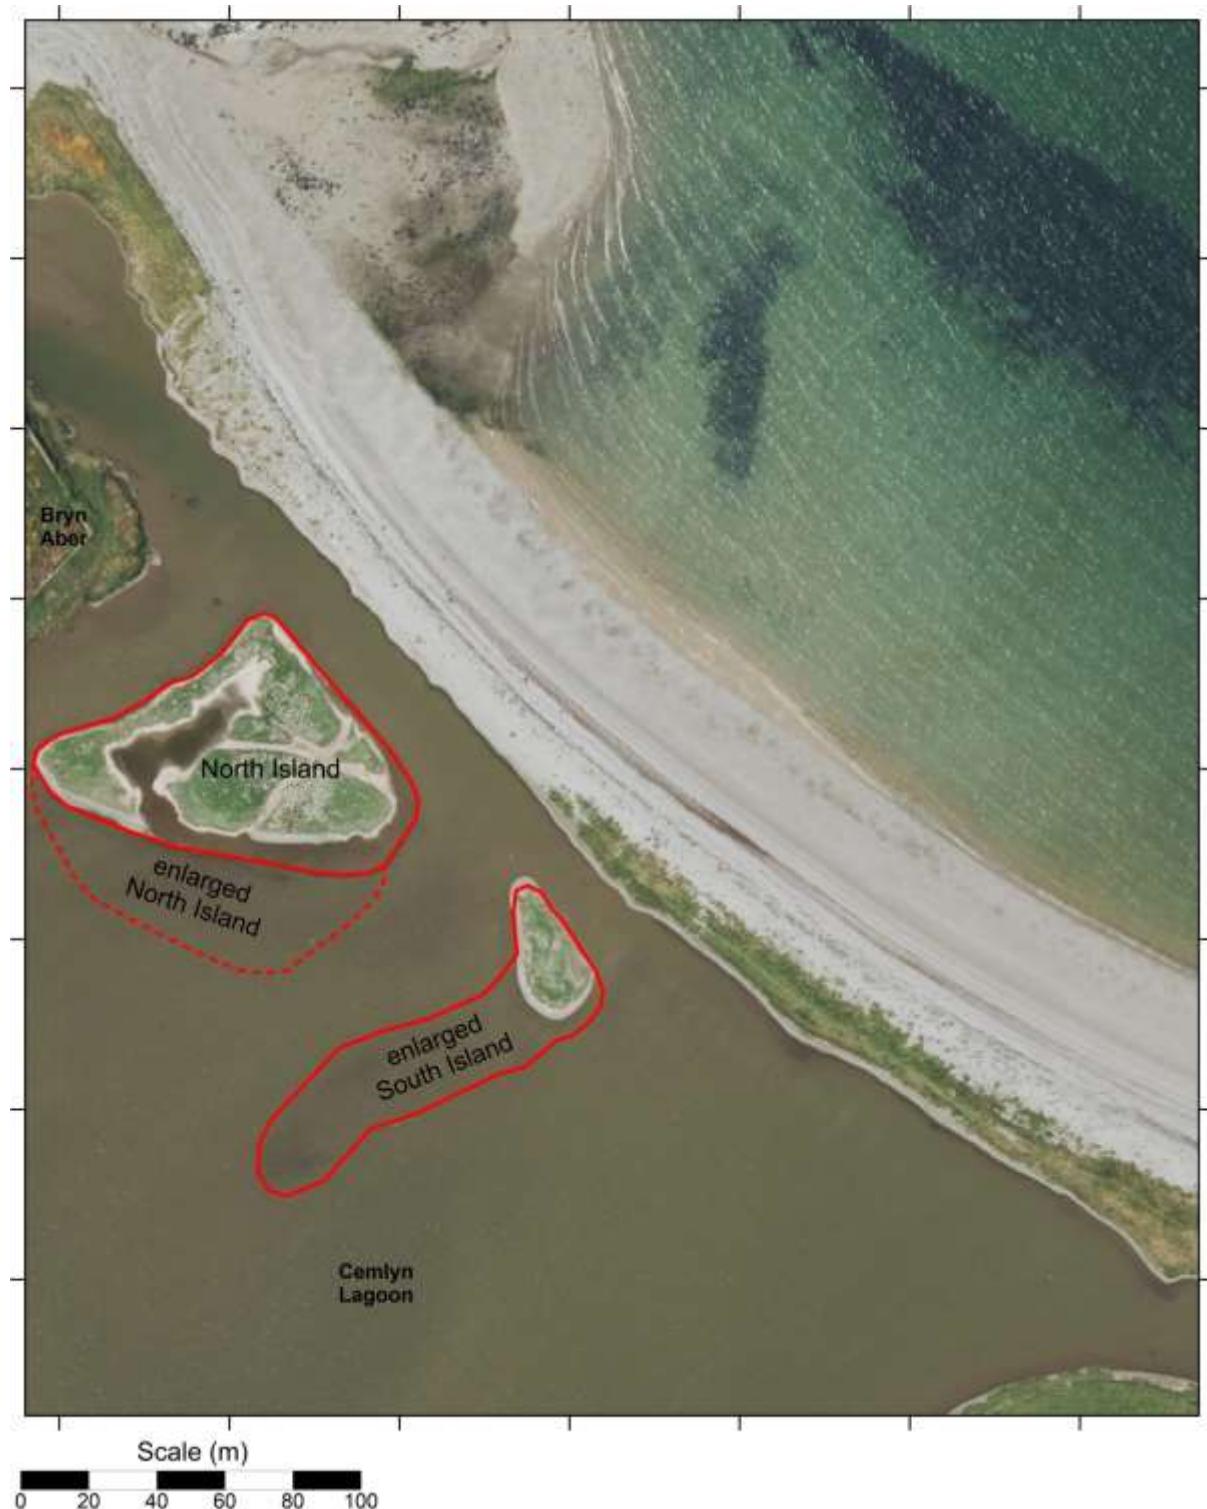
**Figure 67.** One possible enlargement to the tern islands in the lagoon, used in sediment demand calculations

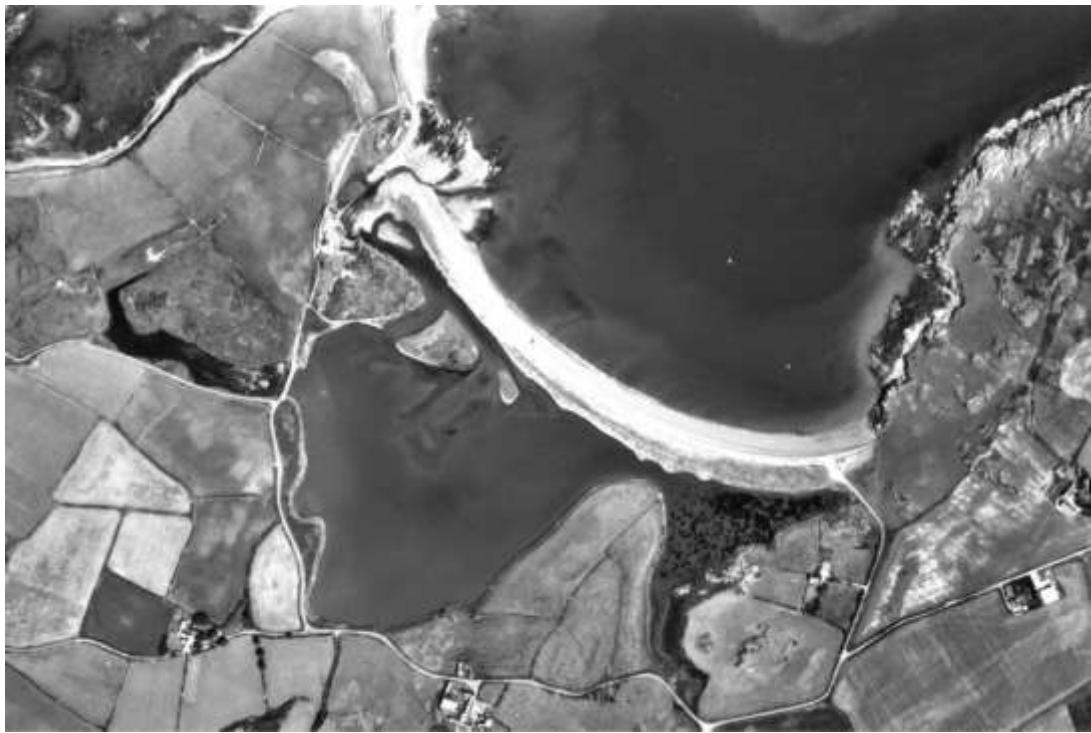
**Figure A1.8** 1:10,000 National Grid Ordnance Survey Map, published in 1978 (surveyed in 1973, revised for major changes in 1977, MHW surveyed in 1973, MLW surveyed in 1972). MHW and MLW lines in 1887 overlaid in red and blue for comparison.

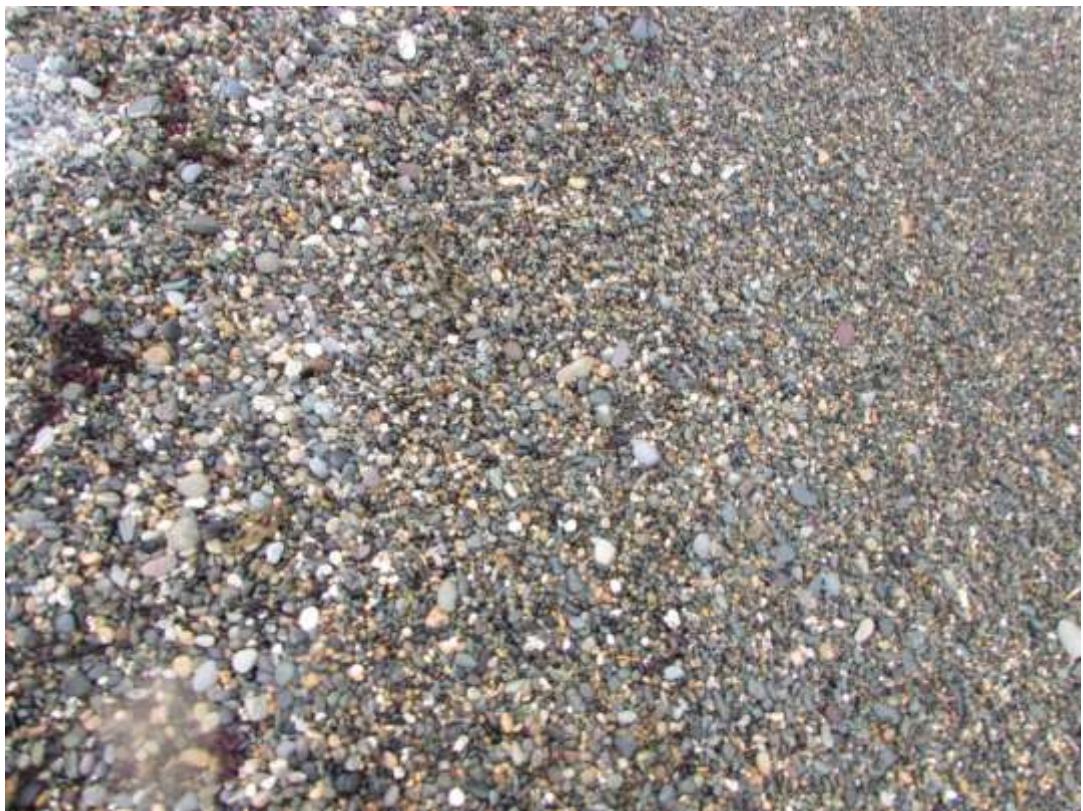
**Figure 11.** Fine to medium gravel- on the mid part of the upper beach slope, western end of the barrier

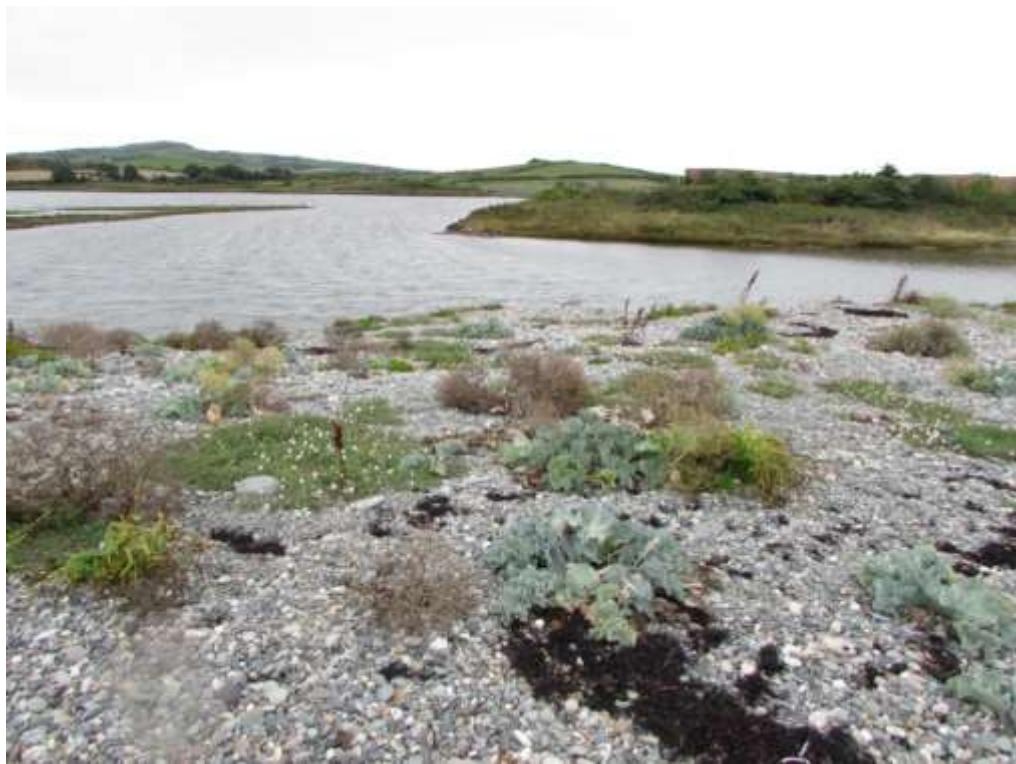
**Figure 13.** Recent vegetation growth on shingle wash-over lobe, landward side of the west-central part of the barrier , view looking towards Bryn Aber

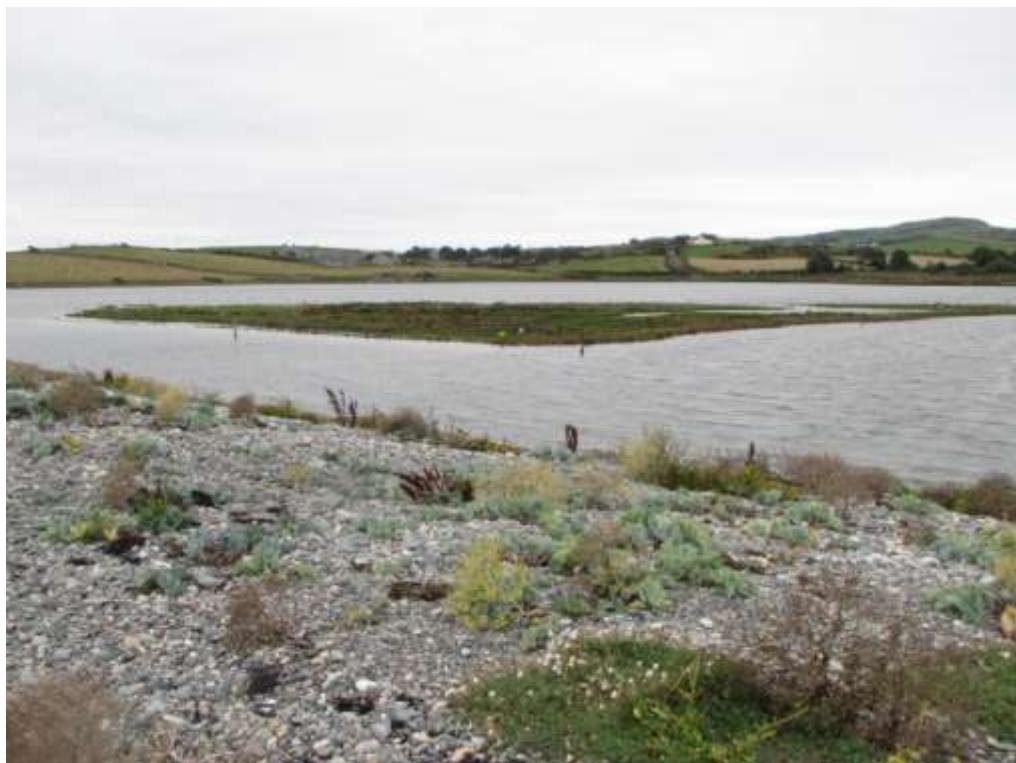
**Figure 14.** Recent vegetation growth on shingle wash-over lobe, landward side of the west-central part of the barrier , view looking towards the larger Tern island

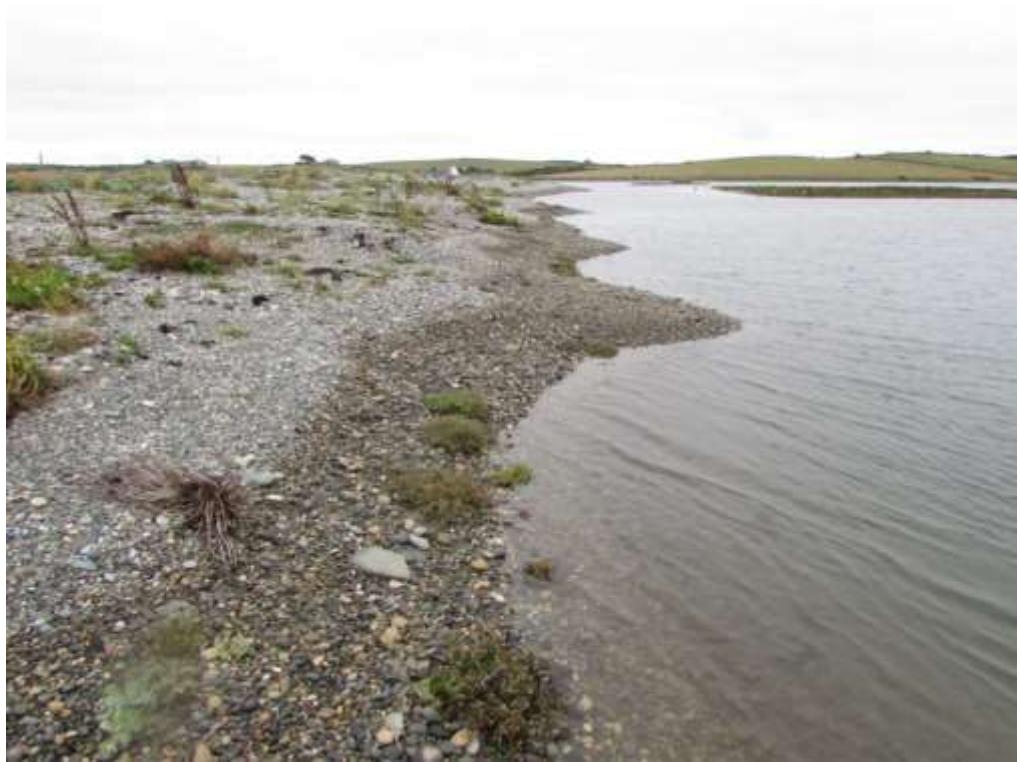
**Figure 15.** View eastwards along the recent shingle wash-over lobes, landward side of the west-central part of the barrier

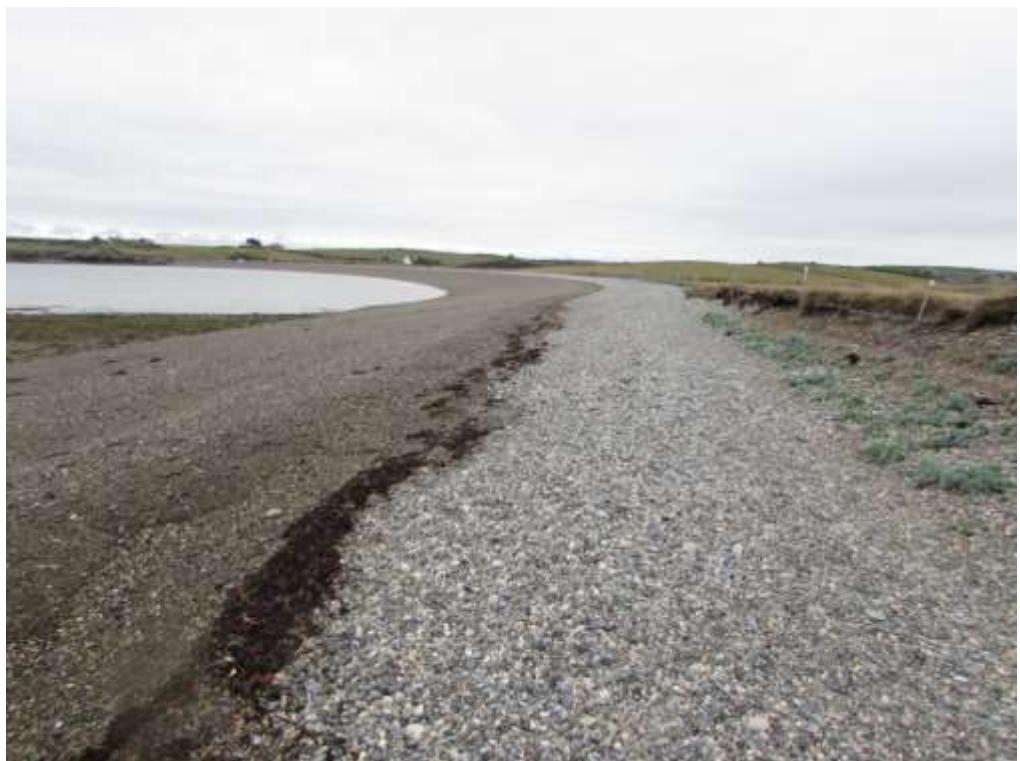
**Figure 16.** View eastwards along the western end of the barrier; wave eroded shingle-soil mixture on the right, with juvenile Sea Holly growing to seaward

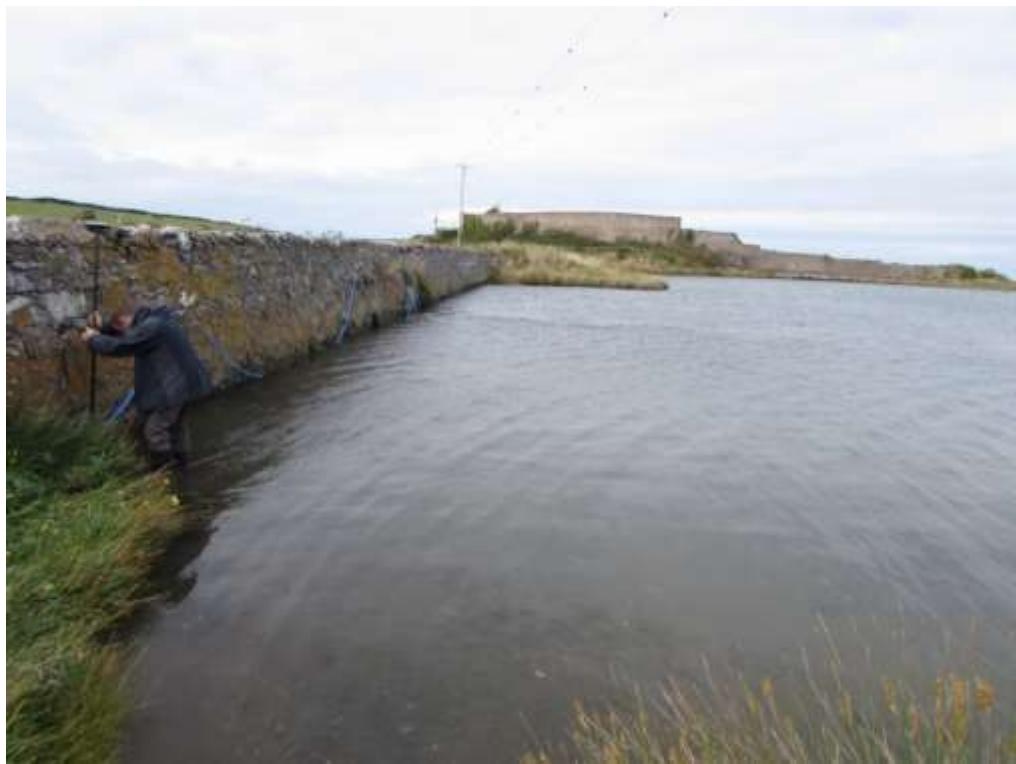
**Figure 17.** Temporary tide gauge location adjacent to the Tyn Llan sluice, southern side of Cemlyn Lagoon

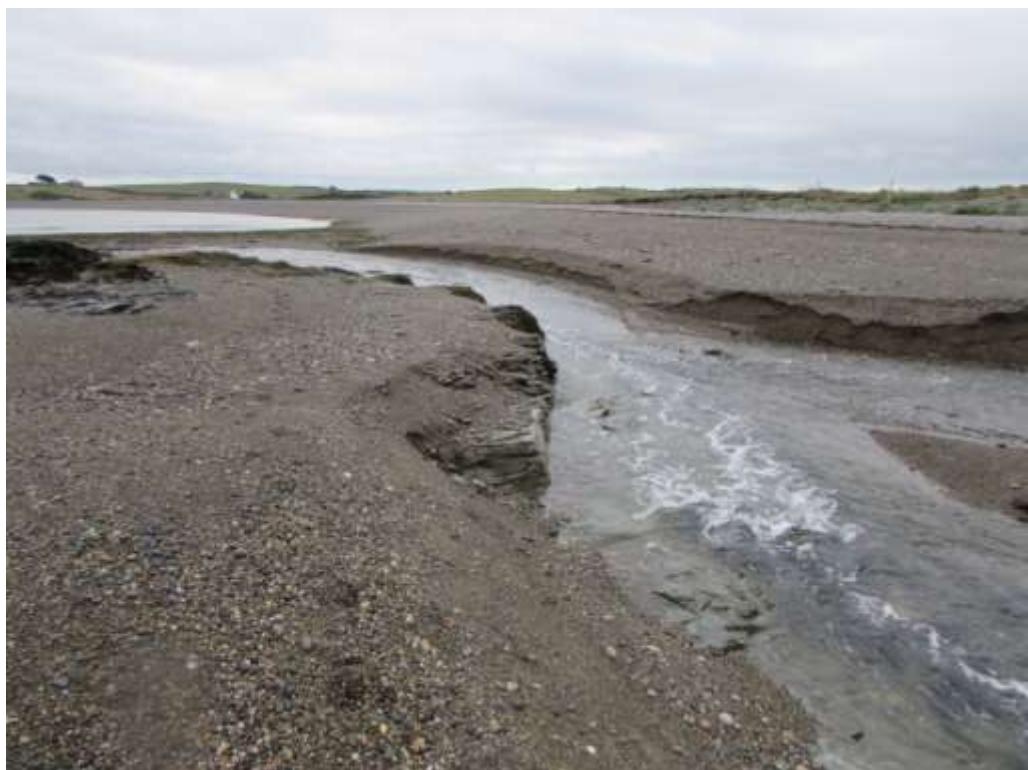
**Figure 21.** The inlet channel to Cemlyn lagoon, view seaward from near the old harbour office

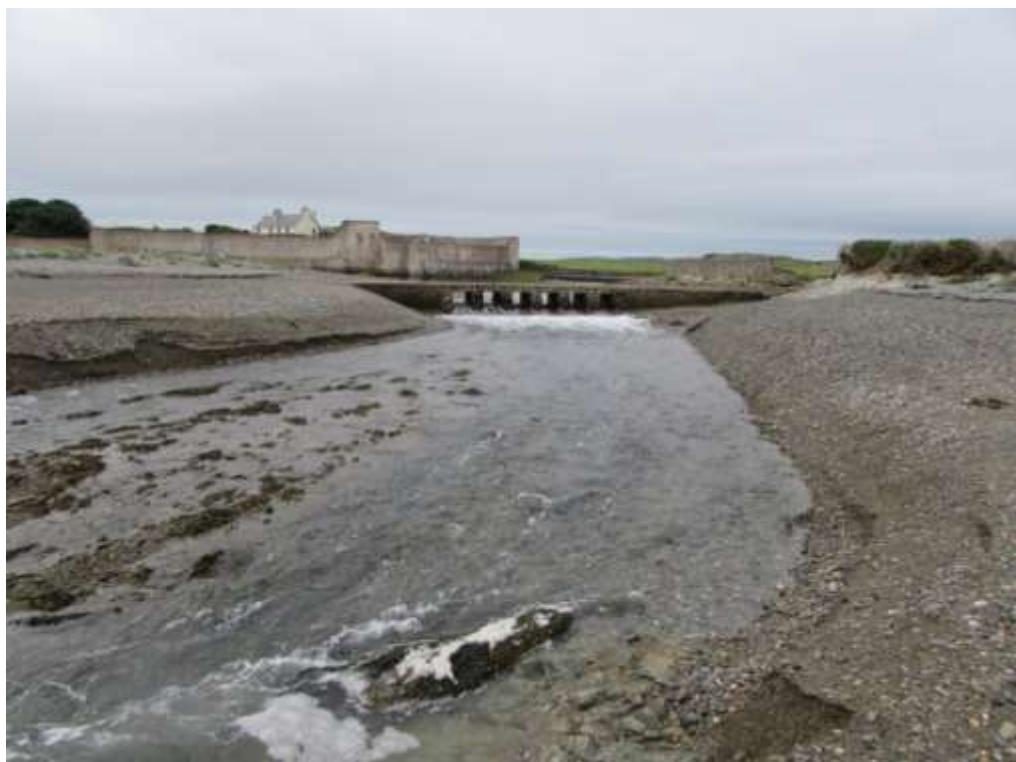
**Figure 22.** The inlet channel to Cemlyn lagoon, view landward towards the Coastal Path footbridge and Bryn Aber from near the old harbour office

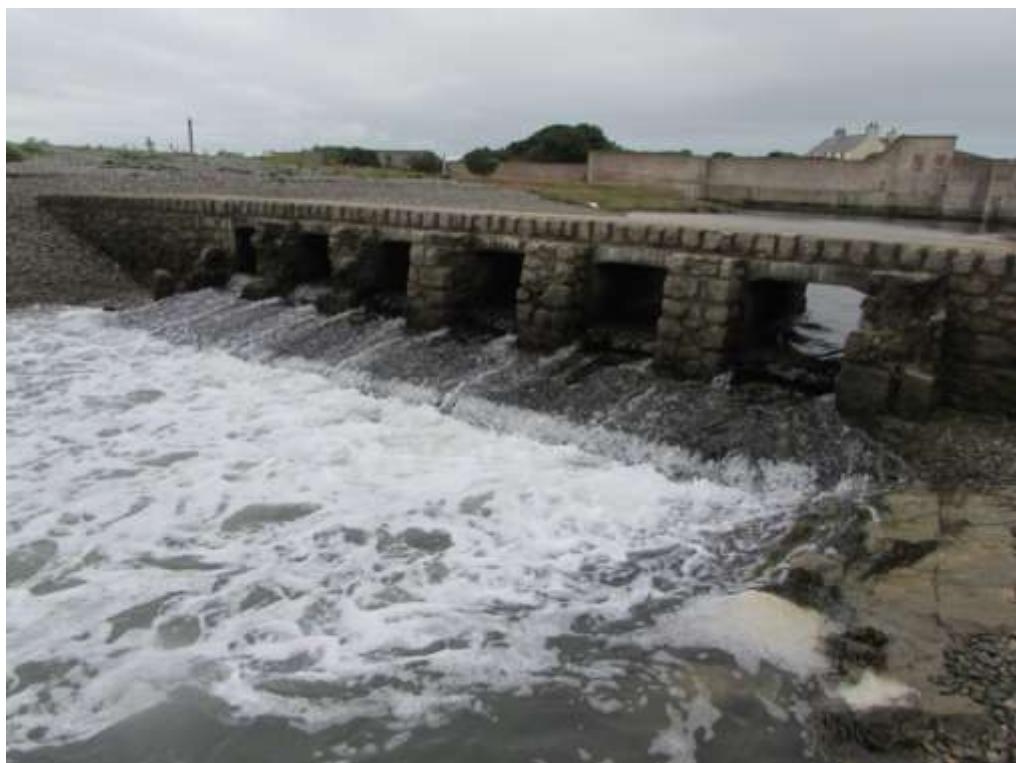
**Figure 23.** Ebb tidal flow under the Coastal Path footbridge

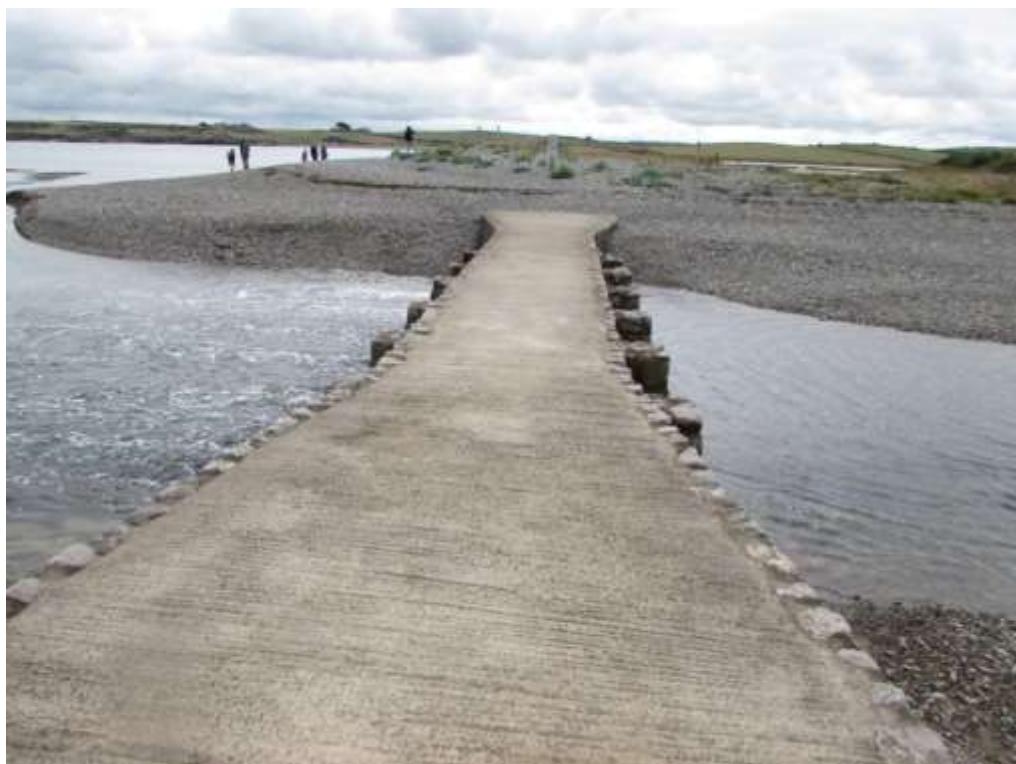
**Figure 24.** View eastwards across the Coastal Path footbridge on an ebbing tide

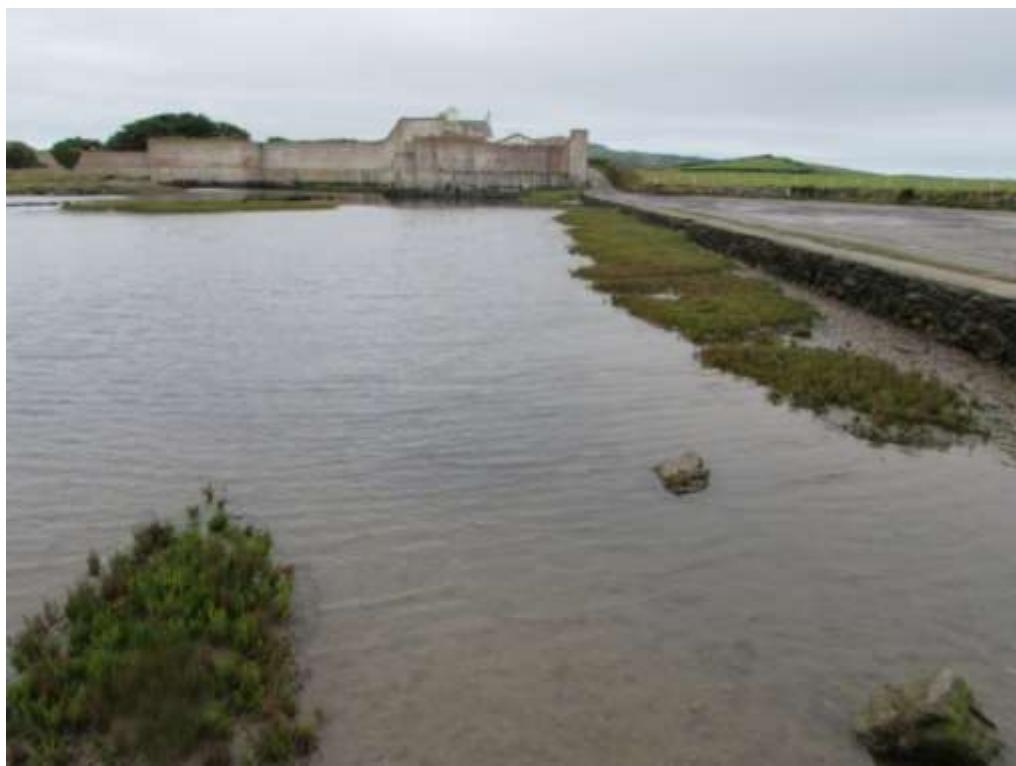
**Figure 25.** The outer lagoon between the Coastal Path footbridge and the weir, view towards Bryn Aber, late stage of an ebbing tide

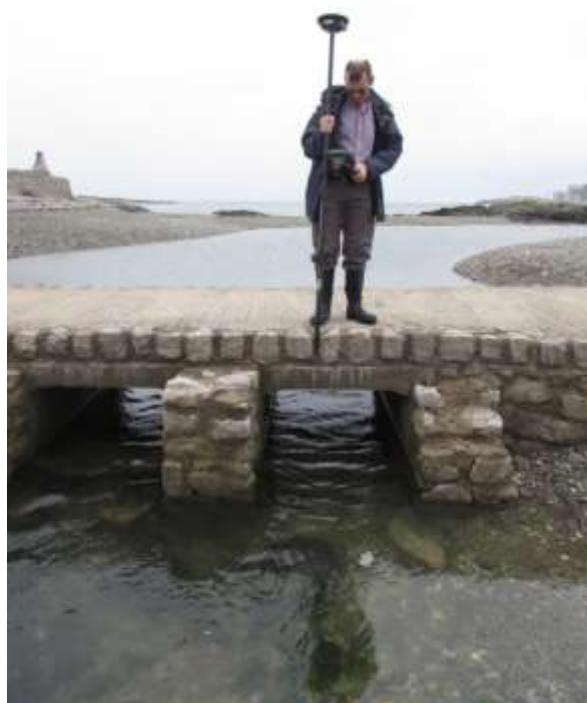
**Figure 26.** Surveying the elevation of the footbridge using Leica GNSS RTK GPS equipment

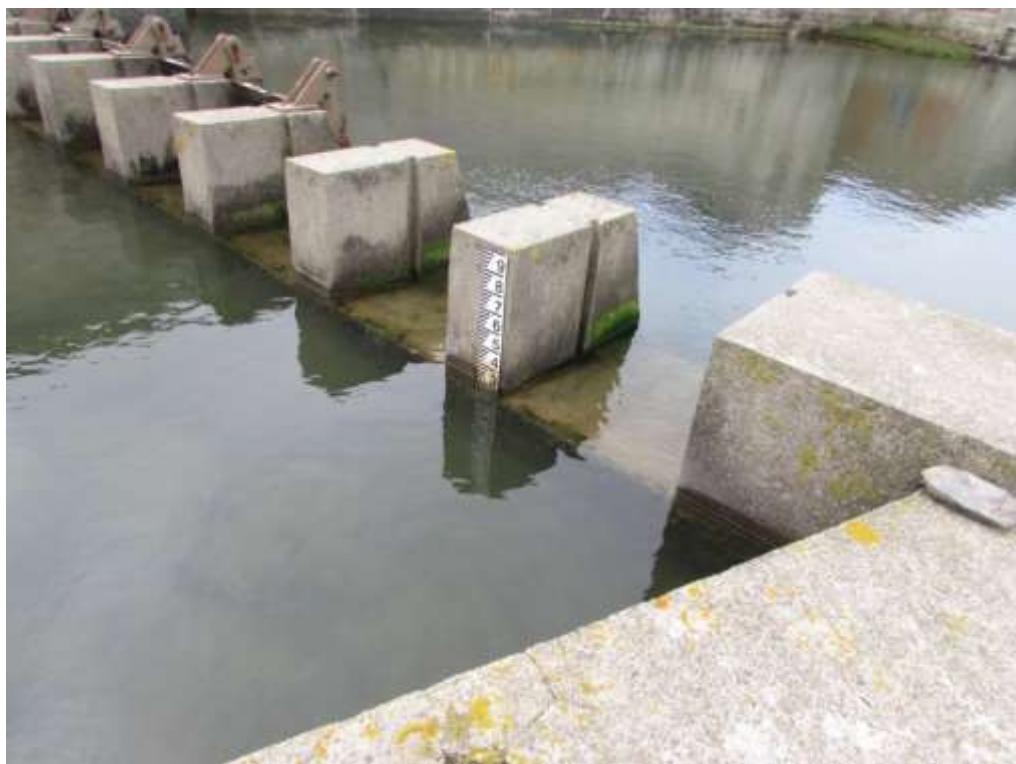
**Figure 28.** Time of zero flow across the weir, just before the flood tide started to run, 09.10 14 August 2018

The present weir was constructed in May 1978 following storm damage to an earlier structure built by Captain Vivian Hewett in the 1930s to control water levels and salinity in the lagoon. The weir has ten ‘gates’, the central four of which have one-directional flaps which were designed to release water to the sea during extreme rainfall events. One flap is currently broken and allows partial passage of water in each direction. The remaining six gates can be fitted with stop logs to limit the ingress of seawater during the tern breeding season. Over the past 10 years the stop logs have generally been put in place during the second half of March and removed in late August or early September, at the end of the tern breeding season. In 2018 the logs were installed in early April and removed in early August, prior to the field survey. When the logs are in place a gap of about 10 cm is left beneath the boards to permit some ingress of seawater. Prior to 2010 gaps were left beneath the boards in three or fewer of the gates, but since 2011 gaps have been left beneath the boards in all six gates. Outside the bird breeding season, when the logs are removed, the ingress of water to the lagoon remains partially restricted by the concrete piers between the gates and by the basal sill, but is considerably greater than during the summer months.
