**From:** [Pearson, John](#)  
**To:** [Wylfa Newydd](#)  
**Subject:** Deadline 4 Submission for Wylfa Newydd Development Consent Order EN010007  
**Date:** 17 January 2019 13:29:01  
**Attachments:** [image001.png](#)  
[NT Wylfa Deadline 4 Intro letter FINAL.docx](#)  
[NWWT and eNGO oral case FINAL.pdf](#)  
[Post ISH Note on Coastal Processes and Geomorphology Wylfa DCO Deadline 4.pdf](#)  
[Post-hearing note eNGO - Biodiversity FINAL.pdf](#)  
[Wylfa DCO Post Hearing Note Section 106 Jan 2019 Final.docx](#)

**EN010007 Wylfa Newydd Nuclear Power Station: Deadline 4.**

-post hearing note on Coastal Processes and Geomorphology including Kenneth Pye Associates Ltd Report on Cemlyn Wave Regime and Sediment Demand;

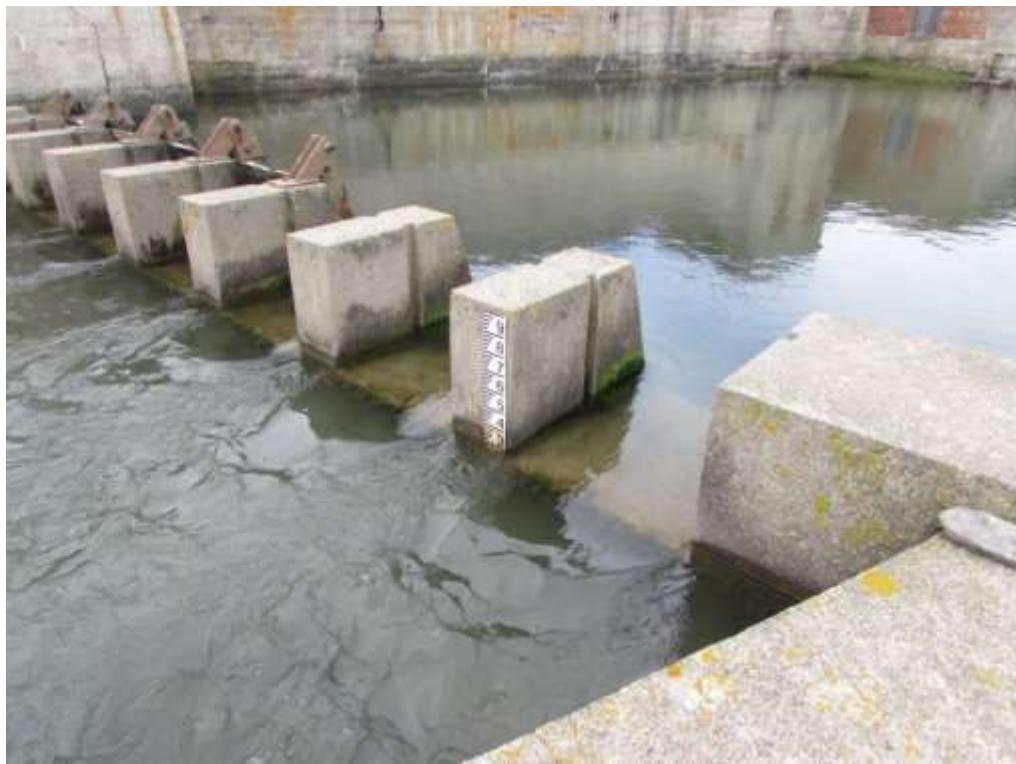
**Figure 29.** Early inward flow across the weir, 09.30 on 14 August 2018

The present weir was constructed in May 1978 following storm damage to an earlier structure built by Captain Vivian Hewett in the 1930s to control water levels and salinity in the lagoon. The weir has ten ‘gates’, the central four of which have one-directional flaps which were designed to release water to the sea during extreme rainfall events. One flap is currently broken and allows partial passage of water in each direction. The remaining six gates can be fitted with stop logs to limit the ingress of seawater during the tern breeding season. Over the past 10 years the stop logs have generally been put in place during the second half of March and removed in late August or early September, at the end of the tern breeding season. In 2018 the logs were installed in early April and removed in early August, prior to the field survey. When the logs are in place a gap of about 10 cm is left beneath the boards to permit some ingress of seawater. Prior to 2010 gaps were left beneath the boards in three or fewer of the gates, but since 2011 gaps have been left beneath the boards in all six gates. Outside the bird breeding season, when the logs are removed, the ingress of water to the lagoon remains partially restricted by the concrete piers between the gates and by the basal sill, but is considerably greater than during the summer months.

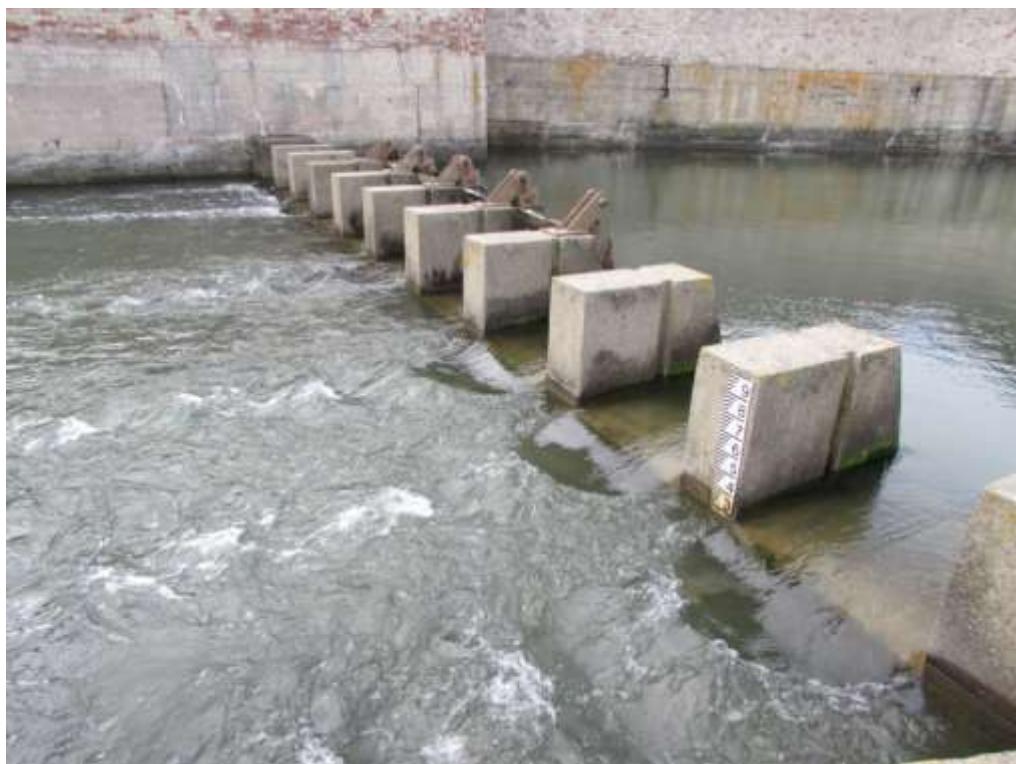
**Figure 30.** Inward flow over the weir, mid stage of the flood tide, 10.15 on 14 August 2018

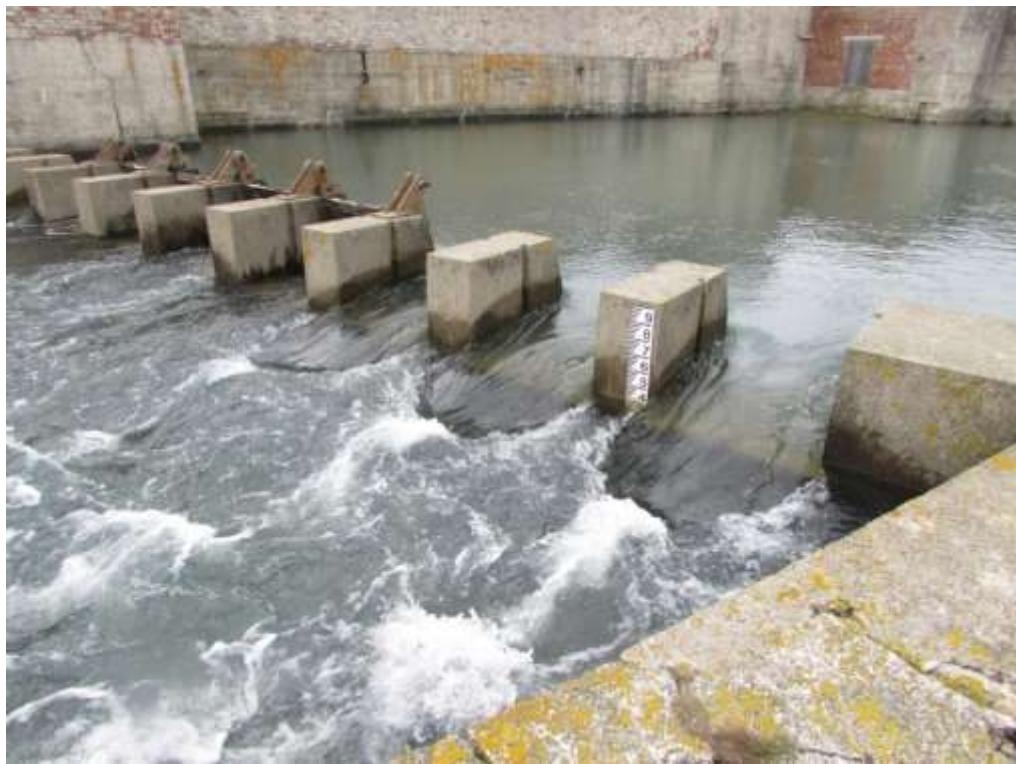
**Figure 31.** Onward flow across the weir at time of maximum flood tide stage rise, 11.00 on 14 August 2018

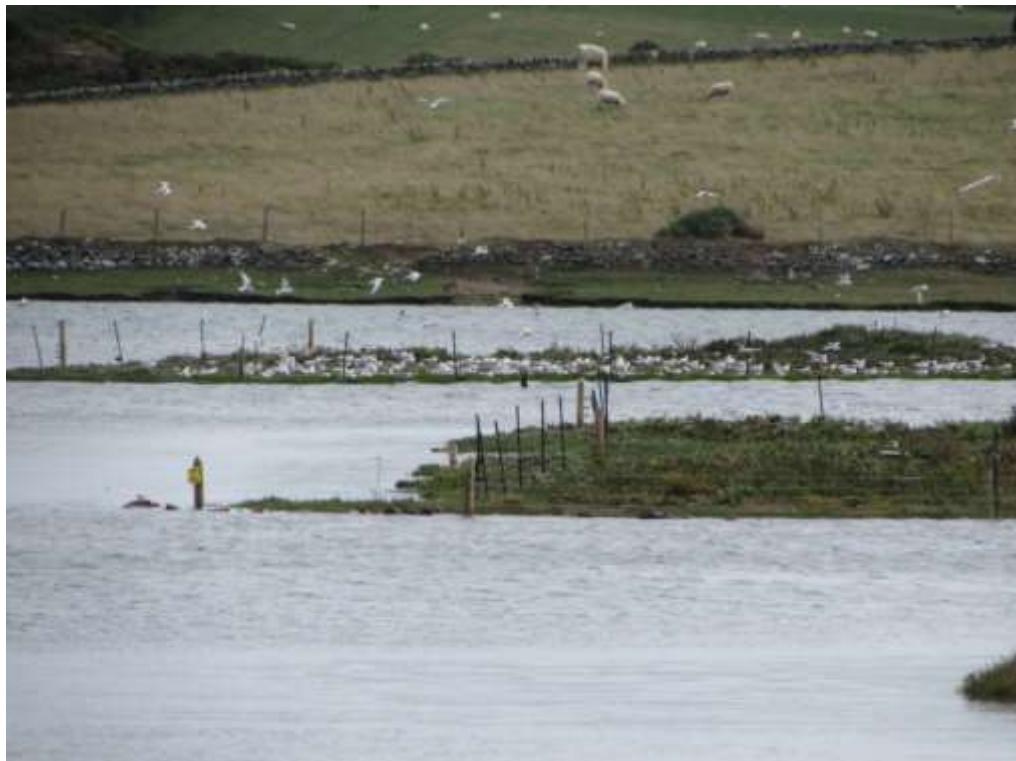
**Figure 32.** The maximum water level attained in the lagoon, 12.00 on 14 August 2018, view towards the Tern island from the weir

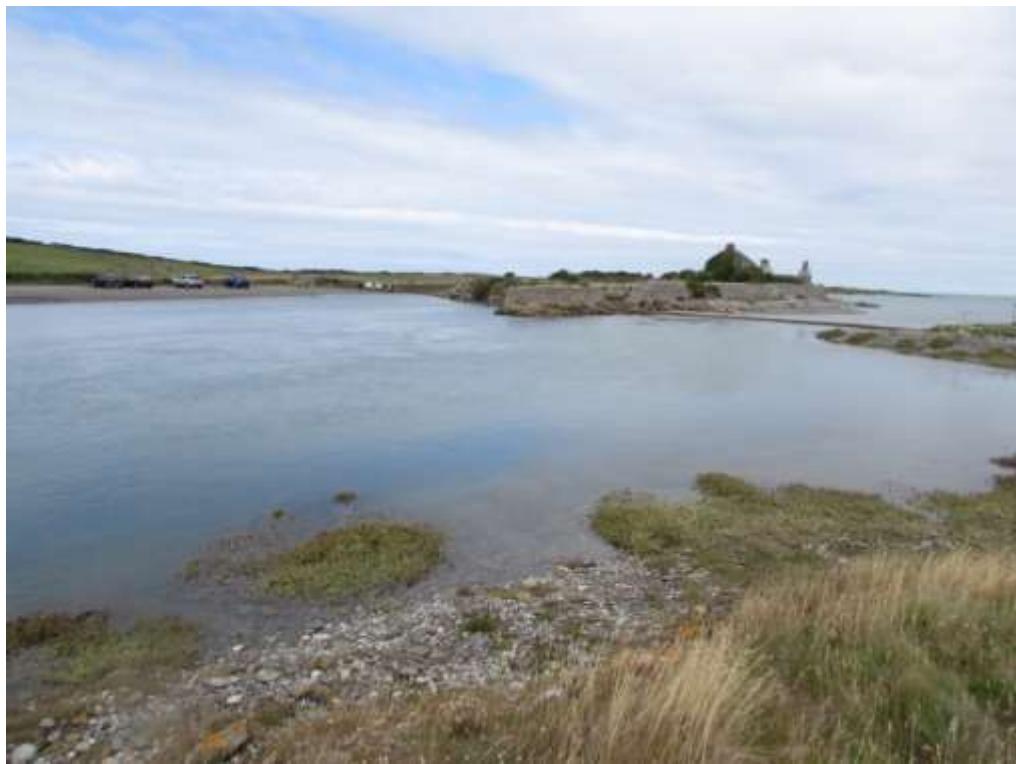
**Figure 33.** The maximum water level attained in the 'outer lagoon', 12.00 on 14 August 2018, view towards the Coastal Path footbridge from the weir

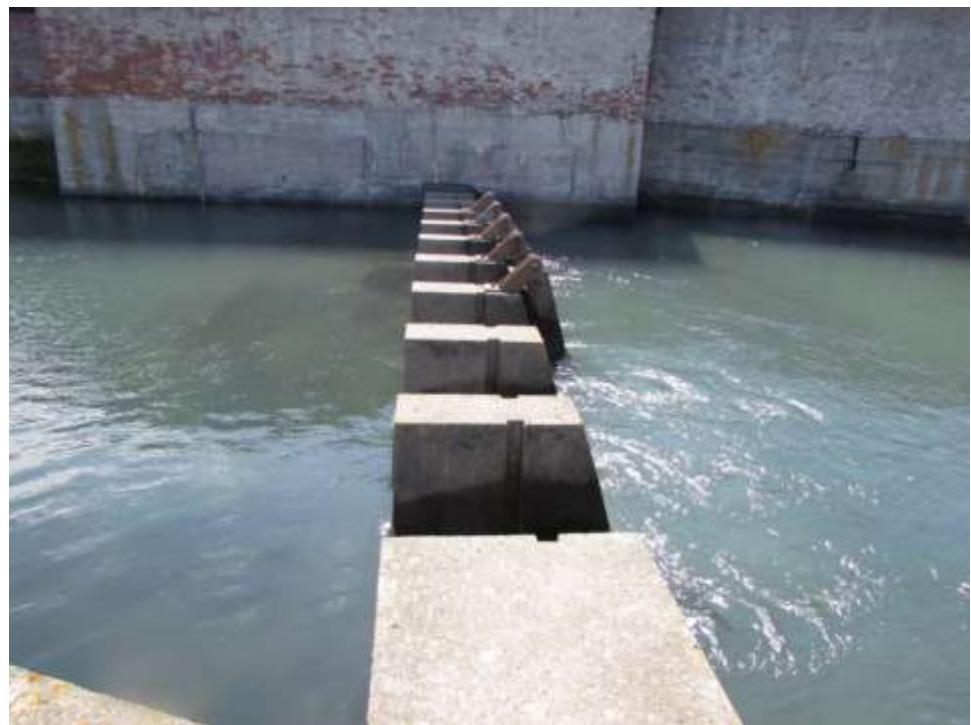
**Figure 34.** The beginning of outward flow over the weir, just after the tide started to ebb, 13.00 on 14 August 2018

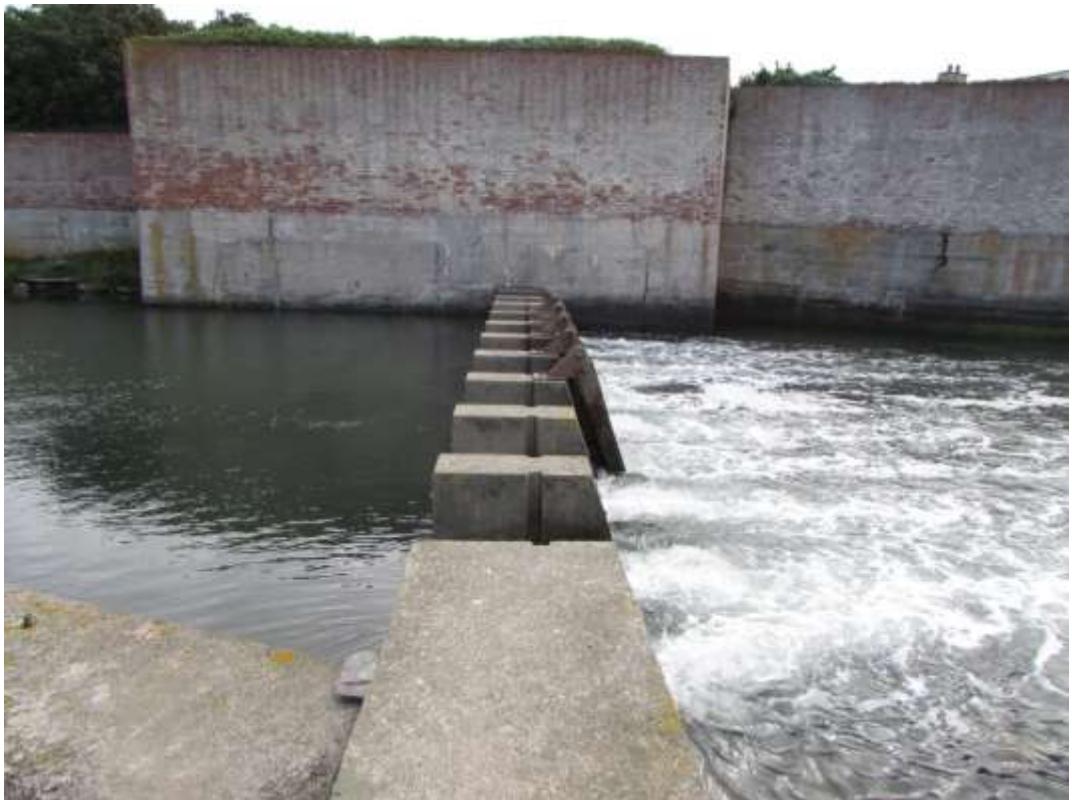
**Figure 35.** Peak outward flow over the weir, approximately 1 hour after the time of high water, 13.45 on 14 August 2018
