## Wylfa Newydd Project

Horizon's Deadline 5 Responses to actions set  
in Issue Specific Hearing on 10 January 2019

PINS Reference Number: EN010007

## Appendix 1-1 Technical Clarification

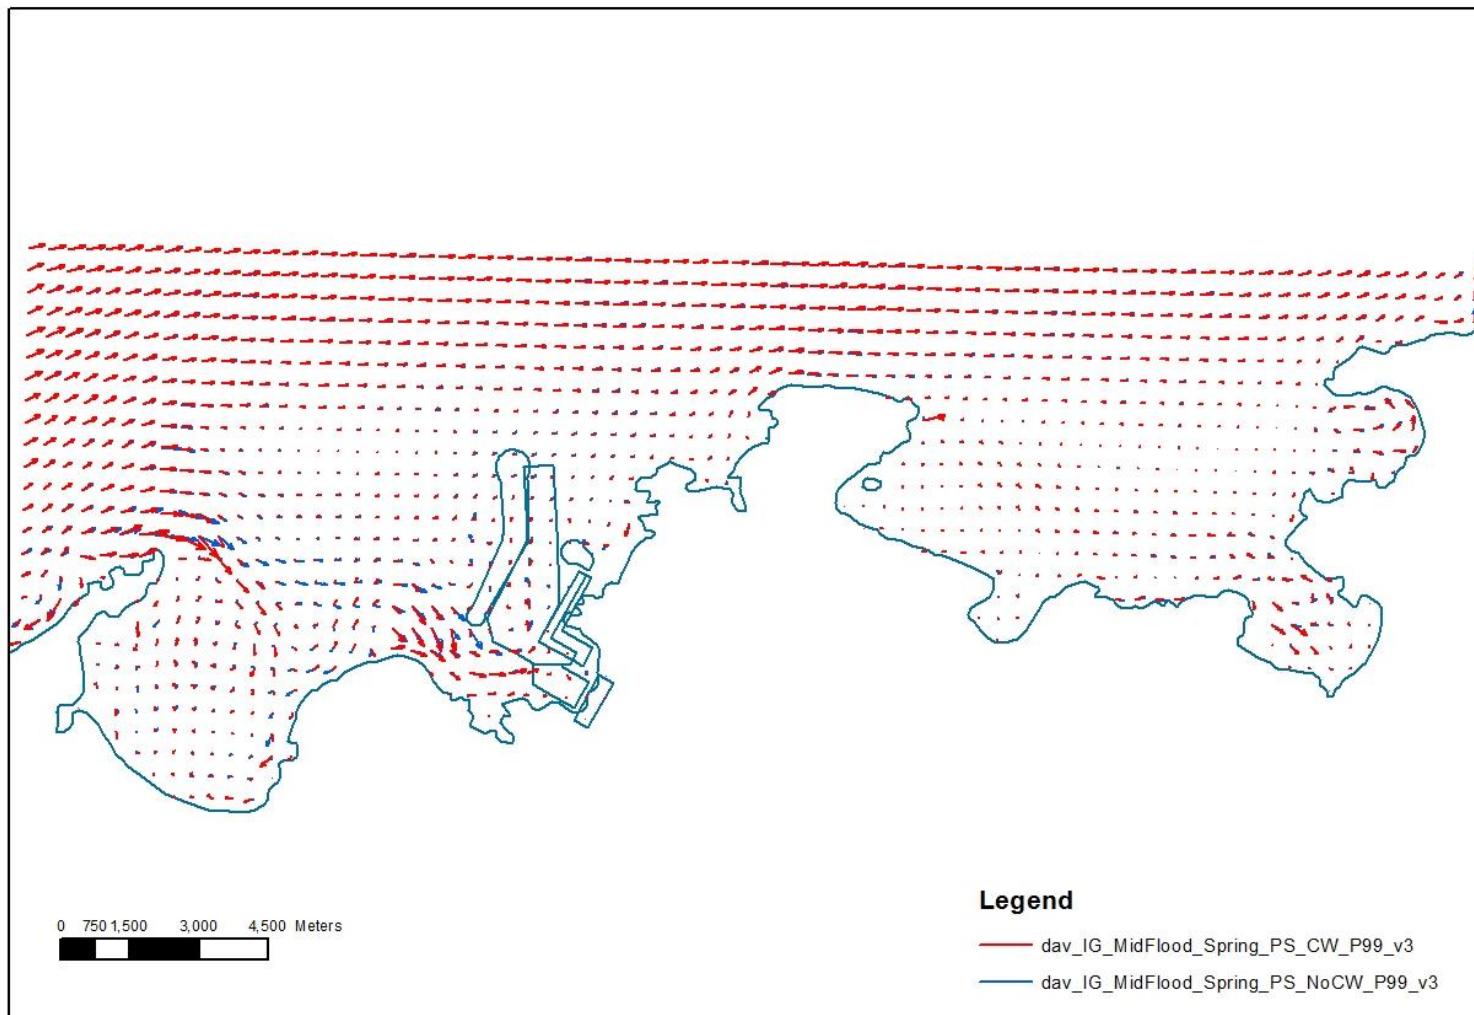
**Figure 1-1 Worst-case effect of CW flow on tidal vectors during spring tide mid-flood with 99%ile winter wave**

- 1.2.2 Horizon's Wylfa hydrodynamic model was used to examine the effect of the CW flow on the tidal vectors in the vicinity of the CW outfall as well as the wider environment. The worst-case magnitude of the change in the predicted flow field for the case with the Marine Works and the 99%ile winter wave can be seen in Figure 1-1 and Figure 1-2. In these figures the flow conditions with the CW flow on are shown in red and without the CW flow in blue.
- 1.2.3 Figure 1-1 shows the plotted depth averaged mid flood velocity on a spring tide. Results show a small increase in velocity near the outfall with the CW flow included. There are also some differences north of Cemlyn Bay in the wave induced flow towards the southern end of the breakwater. In general, the differences on the flood tide are fairly localised and the inclusion of the CW

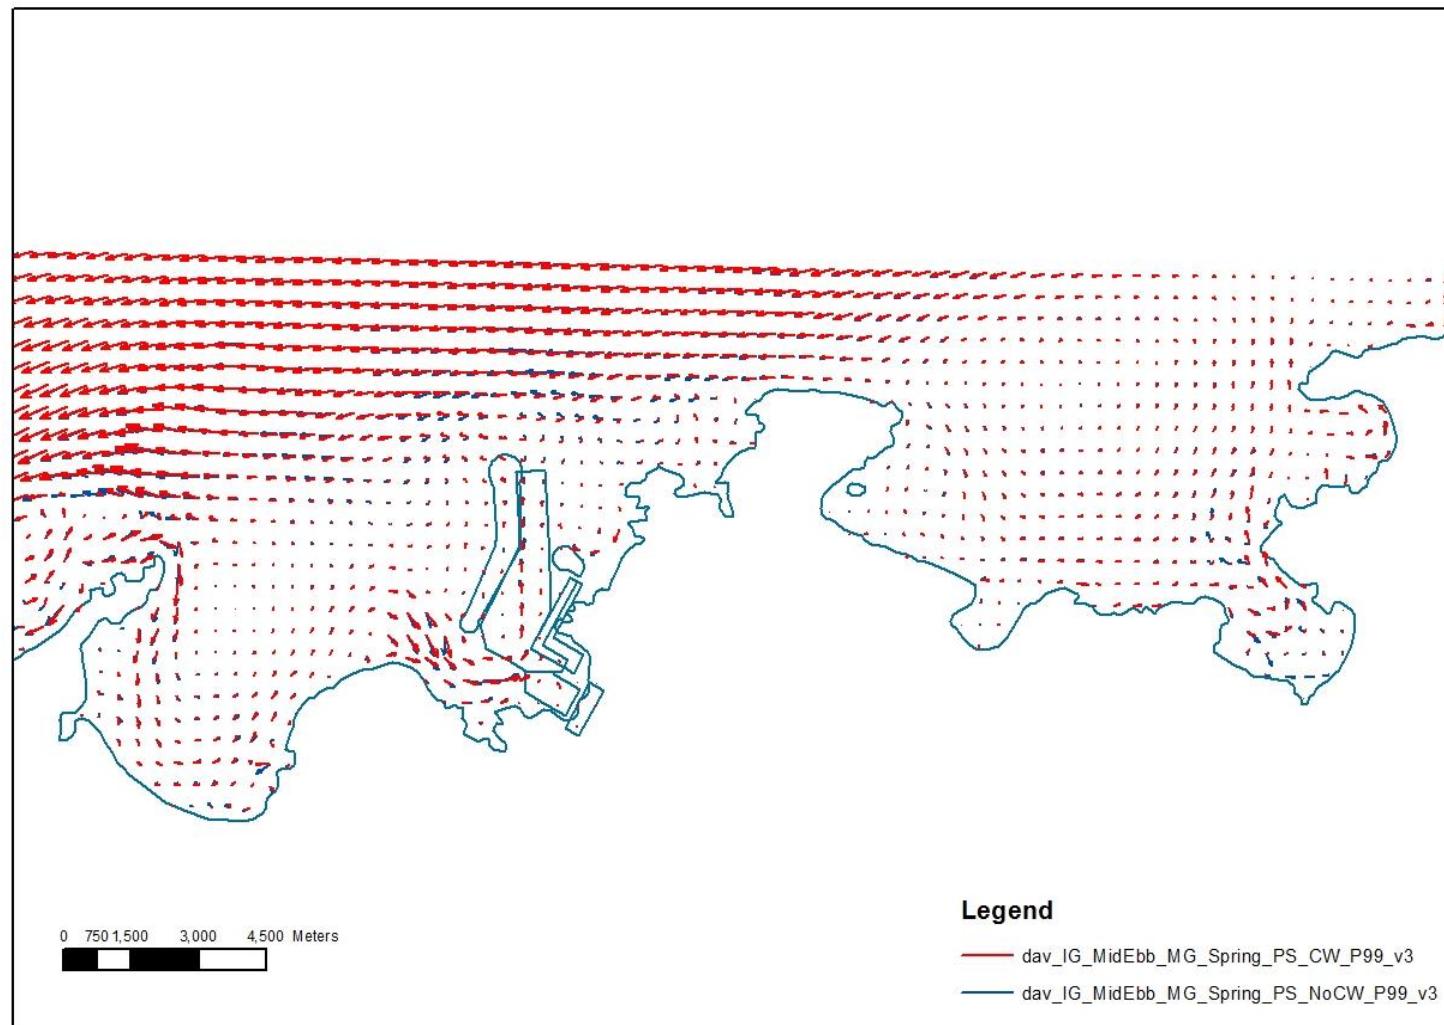
**Figure 1-2 Worst-case effect of CW flow on tidal vectors during spring tide mid-ebb with 99%ile winter wave**

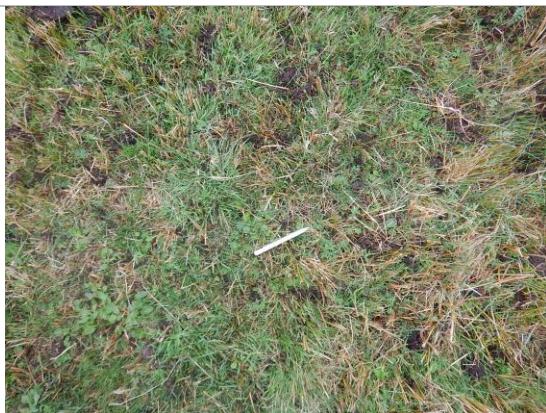
Photographs illustrating the habitat at A5025 off-line locations at TN1 and TN3

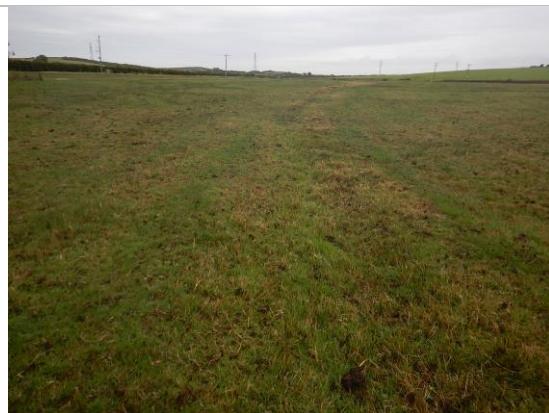
Photograph 1 showing close-up of the semi-improved field at TN1

Agricultural extensification was recorded for the field at TN1 which had been previously classified as poor semi-improved grassland, but in 2018 was classified as semi-improved grassland. However, it is considered likely that this field was mis-classified in earlier surveys, rather than that agricultural practices have changed significantly since 2013, as the species composition of this grassland would take a few years to establish. Forbs present within the sward included marsh pennywort (*Hydrocotyle vulgaris*), usually associated with bogs and fens, and lesser spearwort (*Ranunculus flammula*), also associated with marshes and wet places. It was noted at the time of survey that a light scattering of manure had been applied across this field, and that it had recently been cut, with cutting removed. The entire field was managed in the same way, including two slight depressions crossing the field (TN3) in the field that previous surveys had recorded as standing water, and which were now clearly part of the management of the entire field; this is illustrated by the close-up view of the vegetation in this field (Photograph 1) and a more distant view of one of the depressions in it (Photograph 2). In the same field, an area previously recorded as marshy grassland in 2018 was recorded as semi-improved neutral grassland (Target Note 2 and Photograph 3).

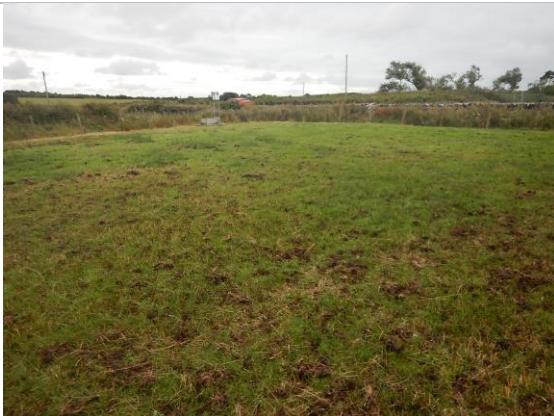
Photograph 2 showing slight depression (TN3) in the same field as TN1, showing how the depression is integrated into the field's management. Note the light covering over manure.

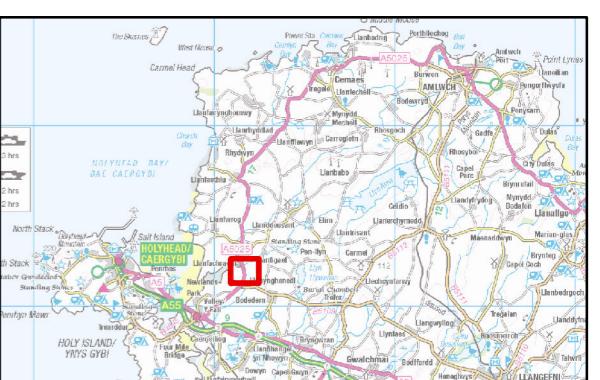
**FIGURE 2.2**

Rev.	Date	1.0 OCT 18	PHASE 1 VALIDATION	HNPWL	HNPWL	HNPWL	HNPWL
Client		Purpose of revision					
Project		WYLFA NEWYDD PROJECT					
Drawing Title		CHANGES DETECTED IN PHASE 1 HABITAT SURVEY OF A5025 OFF-LINE HIGHWAY IMPROVEMENTS					
Scale @ A3		1:5,000		DO NOT SCALE			
Jacobs No.		60PO80AG					
Client No.							
Drawing No.		60PO80AG_A8_P1V_A5025OFFLINE 2.2

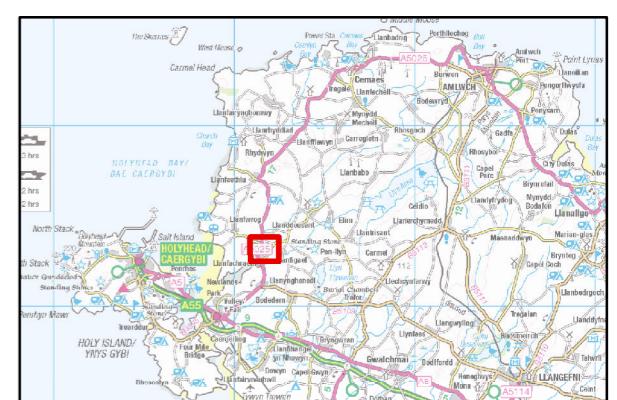
**FIGURE 2.3**

1.0	OCT 18	PHASE 1 VALIDATION	HNPWL	HNPWL	HNPWL	HNPWL
Rev.	Date	Purpose of revision	Drawn	Check'd	Rev'd	App'd
Client						
Project						
Drawing Title						
CHANGES DETECTED IN PHASE 1 HABITAT SURVEY OF A5025 OFF-LINE HIGHWAY IMPROVEMENTS						
Scale @ A3 1:5,000 DO NOT SCALE						
Jacobs No. 60PO80AG						
Client No.						
Drawing No. 60PO80AG_A8_P1V_A5025OFFLINE 2.3

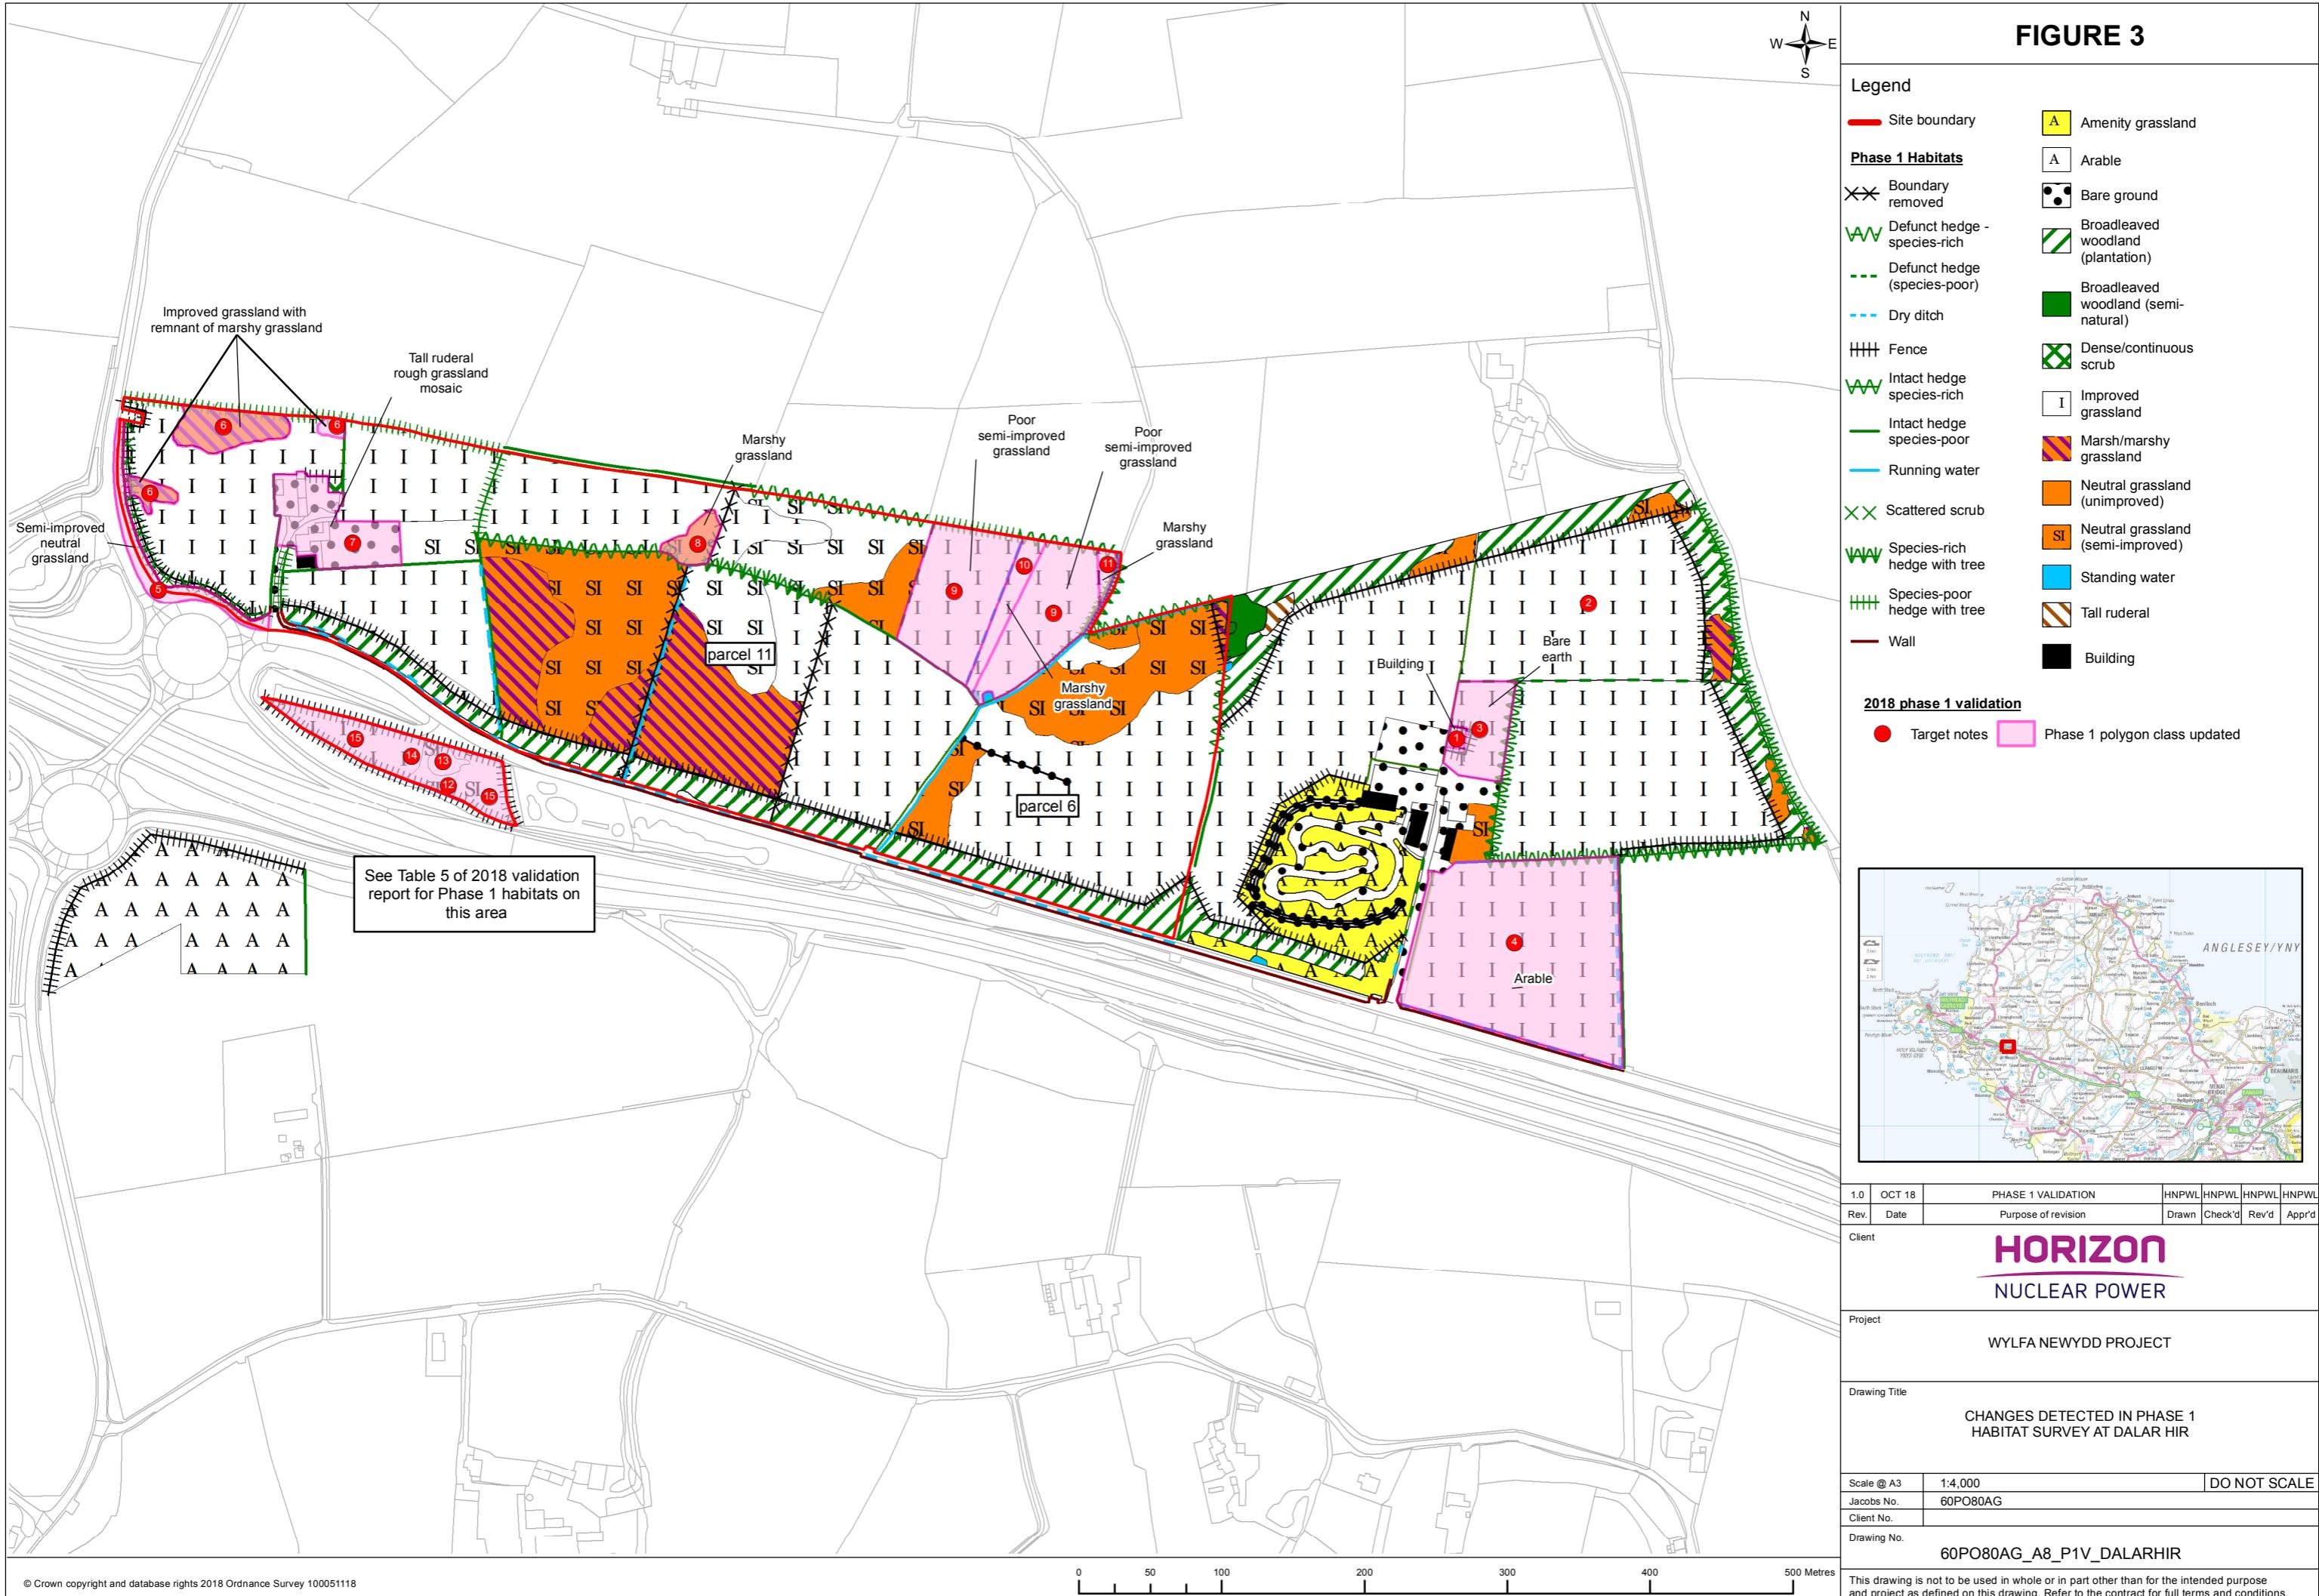
**FIGURE 3**

Figure 3 Changes Detected in Phase 1 Habitat Survey at Dalar Hir

Agricultural land use change was responsible for the changes noted at TN1, TN2, TN3 and TN4, and included construction of a new barn and conversion of arable to improved grassland.

Agricultural intensification was noted at TN6, where improved grassland had taken the place of marshy grassland.

A relaxation in agricultural management appears to be responsible for the changes noted at TN8, TN9, TN10 and TN11. They include two instances of the reversion of improved grassland to marshy grassland (TN10 and TN11).
