**From:** [REDACTED]  
**To:** [Sizewell C](#)  
**Subject:** Suggested site visit locations  
**Date:** 12 May 2021 13:16:55  
**Attachments:** [Suggested site visit locations for Sizewell C ExA.pdf](#)

### Thorpeness Beach

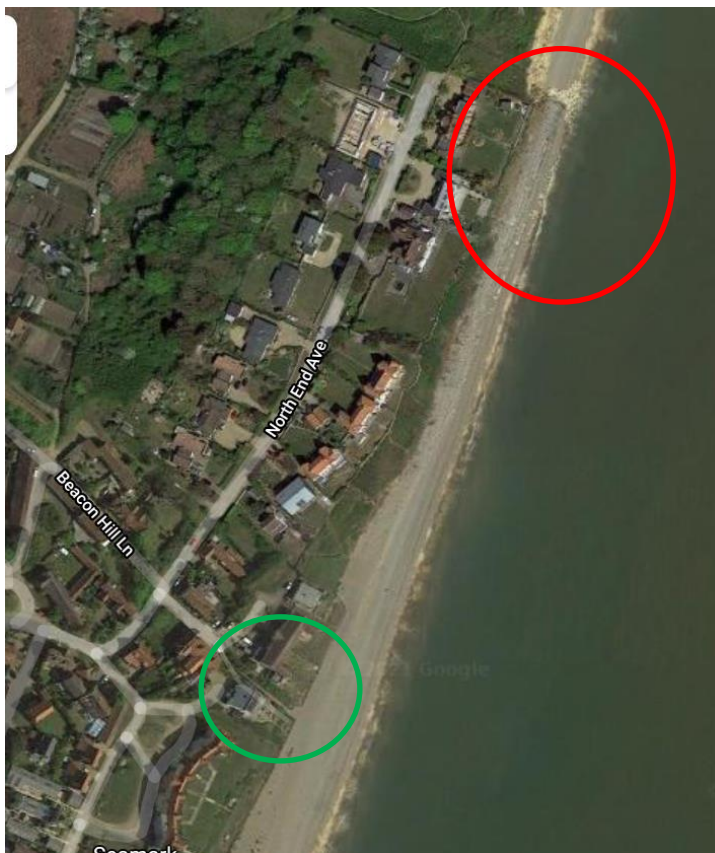
Red circle – Location of failed sea defences

Green circle – Access to beach from Old Holmes road

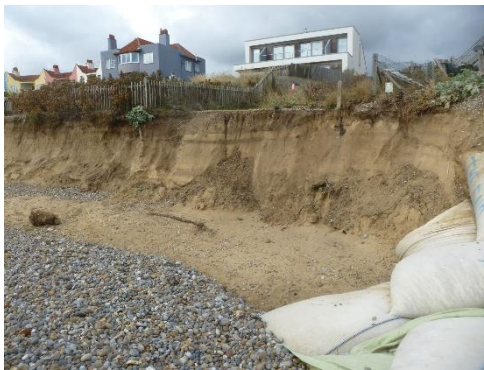
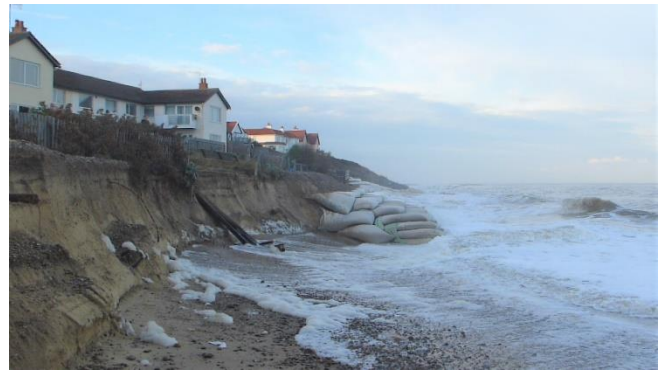
In 2013 during the St Judes storm, 3m of beach depth was lost in 24 hours. This part of the English coastline is capable of sudden, unpredictable and dramatic spikes of erosion.

St Judes storm October 2013 – Access to the beach from Old Holmes road.

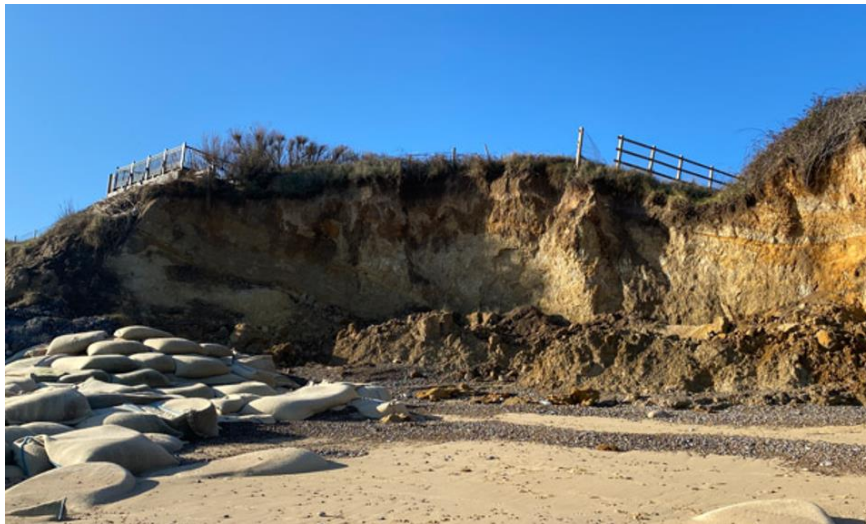
- b. As the soft coastline naturally erodes the defence then becomes prominent and depending on the direction of long-shore drift (the natural process of beach sediment movement) then one side of the defence may see a build-up of material and the other a starvation of replenishment material and therefore a more rapid rate of erosion. In Thorpeness (as with Sizewell) the direction of long shore drift is often north south but due to off shore changes in sand banks and the direction of the wind this can vary and are difficult to predict. As the coast erodes the ability to maintain effective defences becomes more difficult the further forward the defence becomes from the natural beach / cliff line.
