Thermal runaway and fire of electric vehicle Li-ion battery and contamination of infrastructure facility

Authors: M. Held, M. Tuchschmid, M. Zennegg, R. Figi, C. Schreiner, L.D. Mellert, U. Welte, M. Kompatscher, M. Hermann, and L. Nacheff
Journal: *Renewable and Sustainable Energy Reviews*
Date: Accepted 3 April 2022, Version of Record 21 May 2022
Citation: Volume **165**, 112474, DOI: 10.1016/j.rser.2022.112474

Thermal runaway and fire of electric vehicle lithium-ion battery and contamination of infrastructure facility

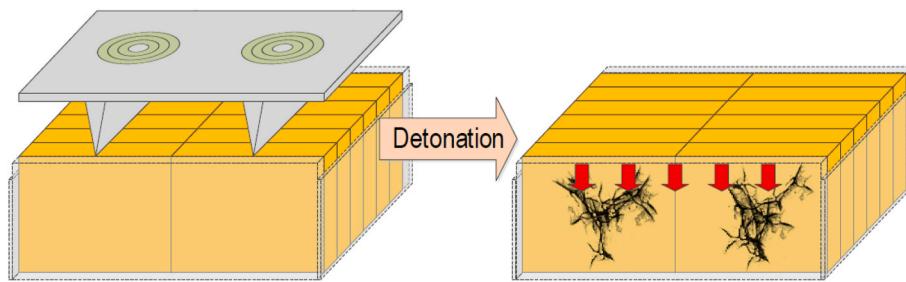
Fig. 1. Battery module (orange) and overlying steel plate with wedges (grey) with detonating fuse (green) before and after application of force (red).

The objective of all test scenarios was the simultaneous damaging of all battery cells in order to cause a thermal runaway of the complete module. Therefore, a steel plate (38 cm × 27 cm × 2 cm) with two 8-cm-long sharpened steel wedges (8 cm × 25 cm × 0.8 cm) running the entire length of its underside was loosely placed atop the battery module, which was attached to the ground, see Fig. 1. Two 100 g bundles of detonating fuse (Detonex, 40 g/m) were affixed to the upper side of the steel plate. Through the simultaneous detonation of both blasting charges, the steel plate was accelerated down into the battery module. The wedges penetrated all 12 cells and caused short-circuiting.

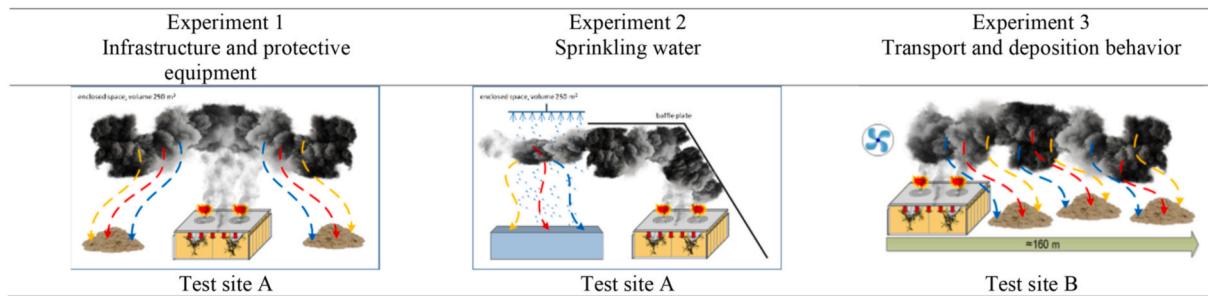
Fig. 2. Illustration of the three test scenarios.

To examine potential secondary damage caused by battery fire in underground traffic infrastructures, three battery modules were tested in three experiments illustrated in Fig. 2.

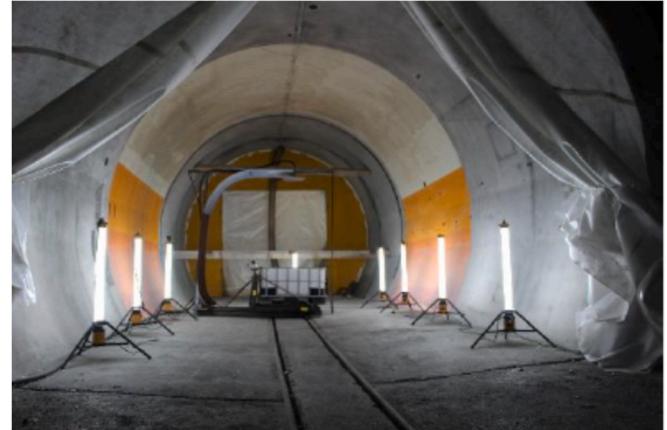
Fig. 3. Test site A.

28 × 2.5 m for 30 cars) ≈ 250 m³. Thermal runaway is initiated on the battery module in this enclosed test site without ventilation and without extinguishing the fire. Thus, the battery module is completely burned down in order to enable a free deposition of fire emissions on surfaces and in devices.

- Clearly defined space ($\approx 250 \text{ m}^3$) without mechanical ventilation: The boundary was created on both sides by means of a construction fleece that was freely suspended at the lower edge (expansion possibility) and wetted with water (fire protection), see Figs. 3 and 4
- Tunnel and parking garage-like environment
- Explosion-proof and smoke-insensitive environment
- Chemically inert surfaces

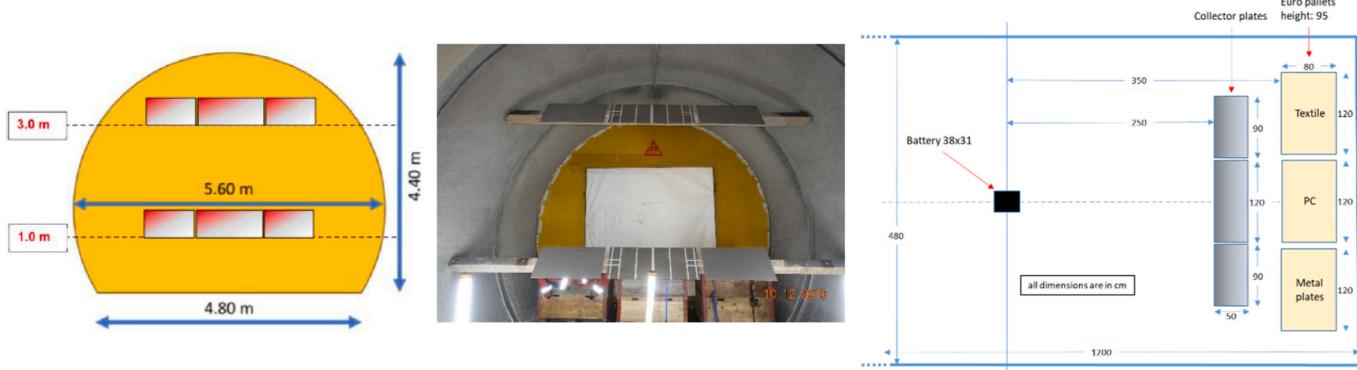
Fig. 4. Position of collector plates, textile, PC, and corrosion metal plates, test site A, experiment 1.

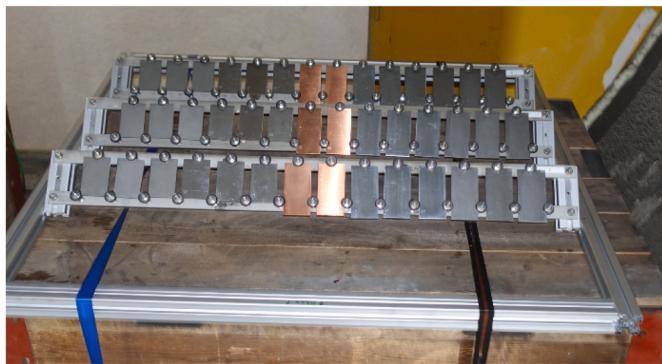
Fig. 5. Rack with corrosion monitoring metal plates.

The corrosion metal plates were examined for the first time after three days under ambient conditions and after one and three months of storage at room temperature and 90% relative humidity to assess the corrosion induced mass loss. The mass loss rate due to corrosion is determined via gravimetric measurements.

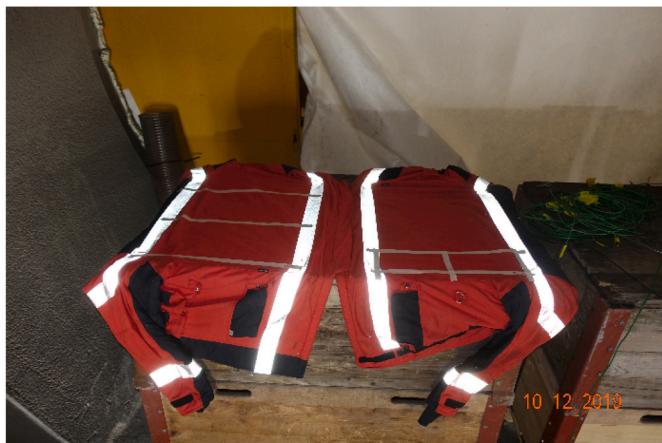
Fig. 6. Firefighter's textile protective suit.

- Mechanical air purification and smoke evacuation to the outside possible at any time
- Six sample collector plates (2 pieces 50 × 120 cm, 4 pieces 50 × 90 cm, stainless steel 1.4401) at heights of 1 and 3 m, tilted 45° towards experiment, see Figs. 3 and 4
- A rack with corrosion monitoring metal plates at a height of 0.95 m, tilted 45° towards experiment. Metal plates (100 × 50 × 1 mm) are carbon steel, zinc, copper, aluminum alloy AlMgSi1 and stainless steel 1.4404, see Fig. 5
- A firefighter's textile protective suit typically used in such operations consisting of 93% aramid (Nomex), 5% p-aramid (Kevlar), and 2% P140 (carbon), see Fig. 6

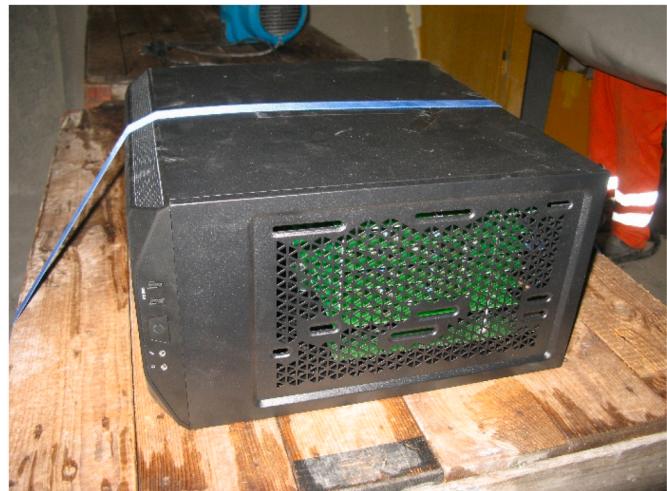
Fig. 7. PC housing with printed circuit boards.

- Printed circuit boards in a PC housing with 2 fans for optical inspection and electrical characterization of surface insulation resistance (SIR) before and after test with measuring comb, see Figs. 7 and 8
- Temperature sensors within and around the battery module
- Several lighting devices and video cameras.

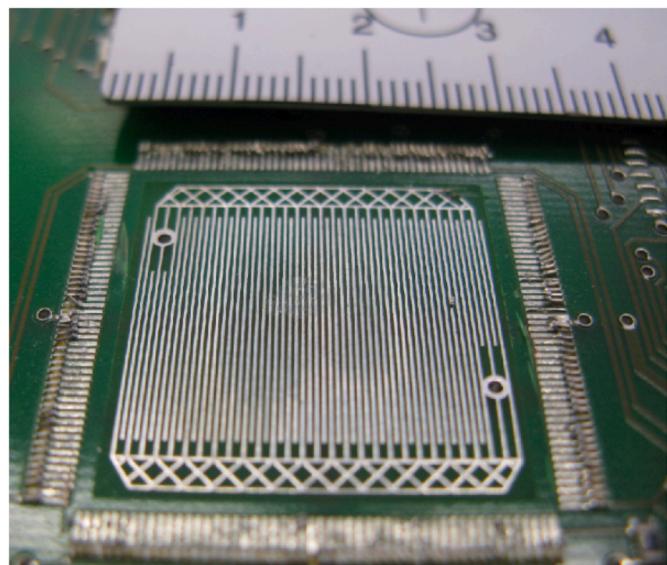
Fig. 8. Measuring comb for surface insulation resistance (SIR) characterization.

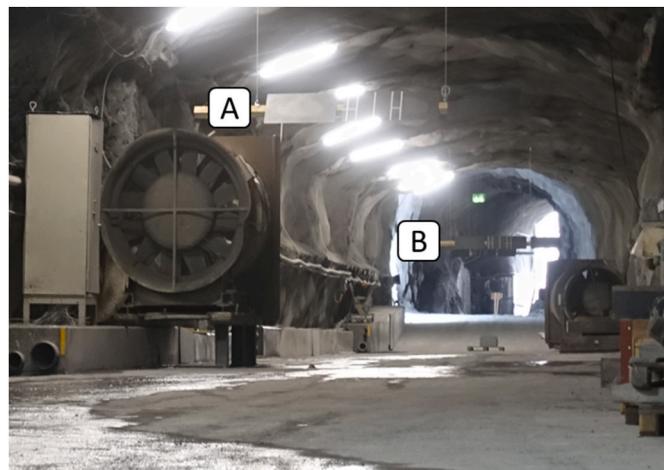
Fig. 10. Fan and collector plates at 100 m (A) and 150 m (B) in tunnel of test site B.

flow. Sets were placed at distances of 50, 100 and 150 m from the battery fire, see Fig. 10

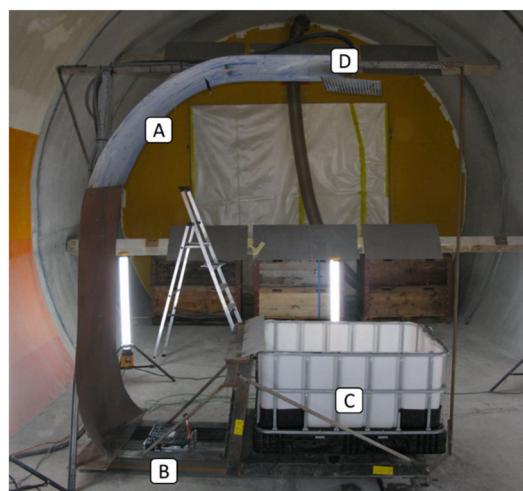
Fig. 9. Position of baffle plate (A), battery (B), collection container (C), and sprinkler (D), test site A, experiment 2.

The goals of this scenario is the quantitative chemical analysis of toxicologically relevant contamination of water that in a real scenario would be generated by the mixture of sprinkling water and smoke emissions of the battery fire. In this scenario, the emissions from the battery fire are sprinkled with a pressure-less water curtain and collected in a large container next to the battery. The battery module itself is not sprinkled and is completely burned down and then stored in a separate container filled with water. Test site A, depicted in Fig. 9, is therefore equipped with:

- Baffle plates on one side and above the battery to direct the fire emissions to the sprinkling zone above the container
- A sprinkler (400 mm × 400 mm) with 324 nozzles at a height of 2.5 m using conventional tap water with a continuous volume flow rate of approximately 20 l/min
- A chemically inert plastic container with a volume of ≈400 l for the collection of all sprinkling water
- A container (570 × 370 × 320 mm) to store the burned down battery in water
- Temperature sensors within and around the battery module
- Several lighting devices and video cameras.

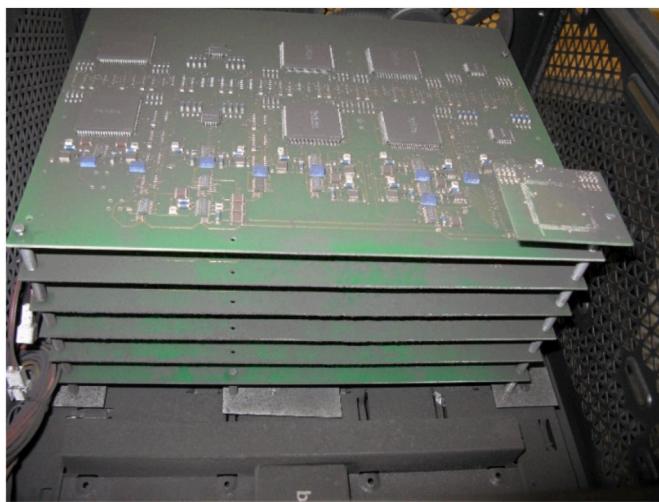
Fig. 11. Soot on printed circuit boards in PC.

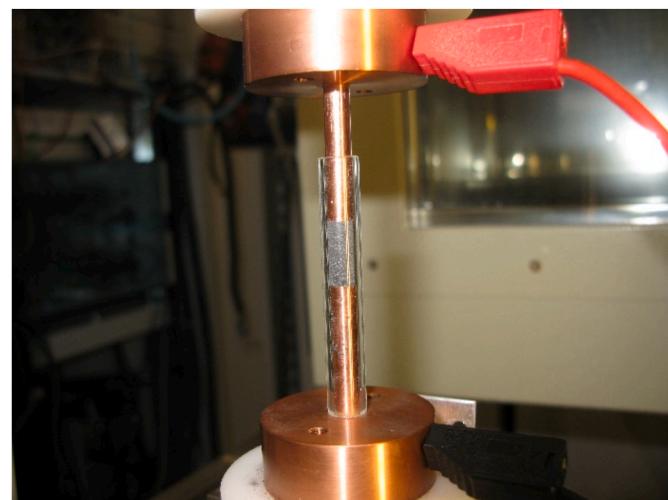
Fig. 14. Soot conductivity measurement under pressure.

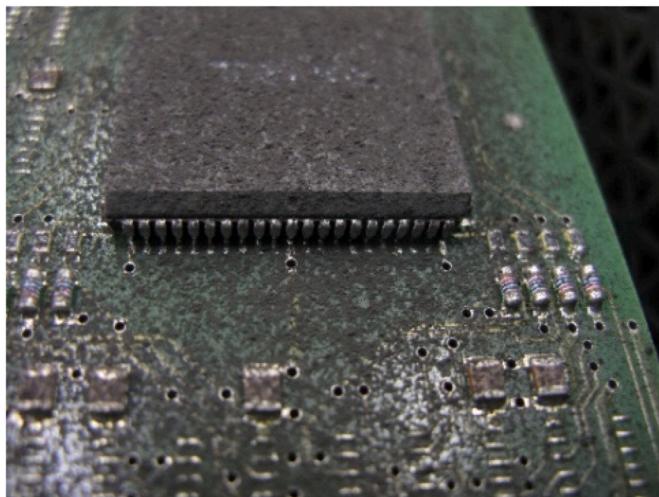
Fig. 12. Close-up of soot on printed circuit boards in PC.

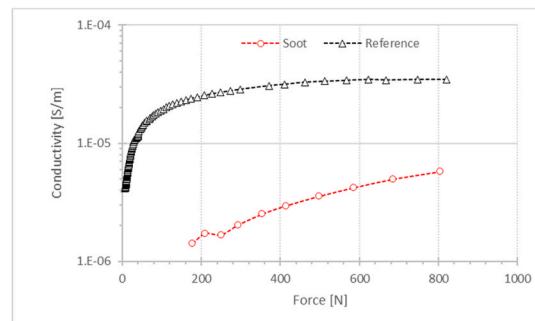
Fig. 15. Conductivity of soot on printed circuit boards compared to reference NMC sample.

that the heavy metals are present in the form of poorly conducting oxides.

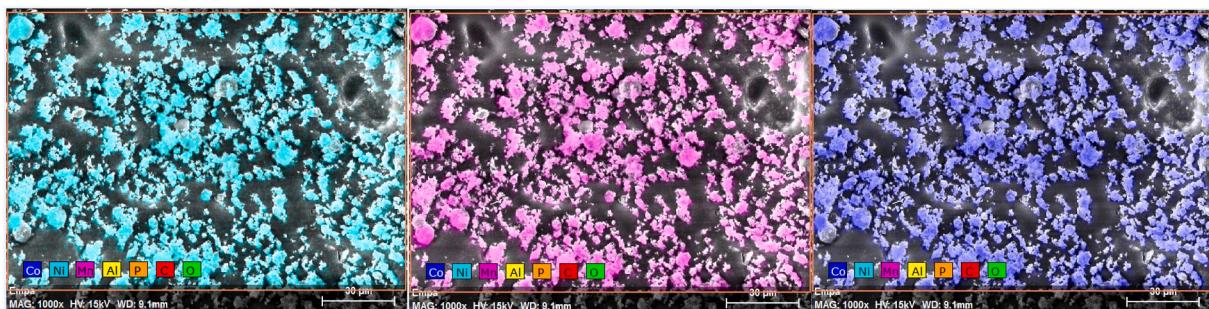
Fig. 13. SEM/EDX elemental analysis of a soot sample on printed circuit boards, Nickel (left), Manganese (center), Cobalt (right).

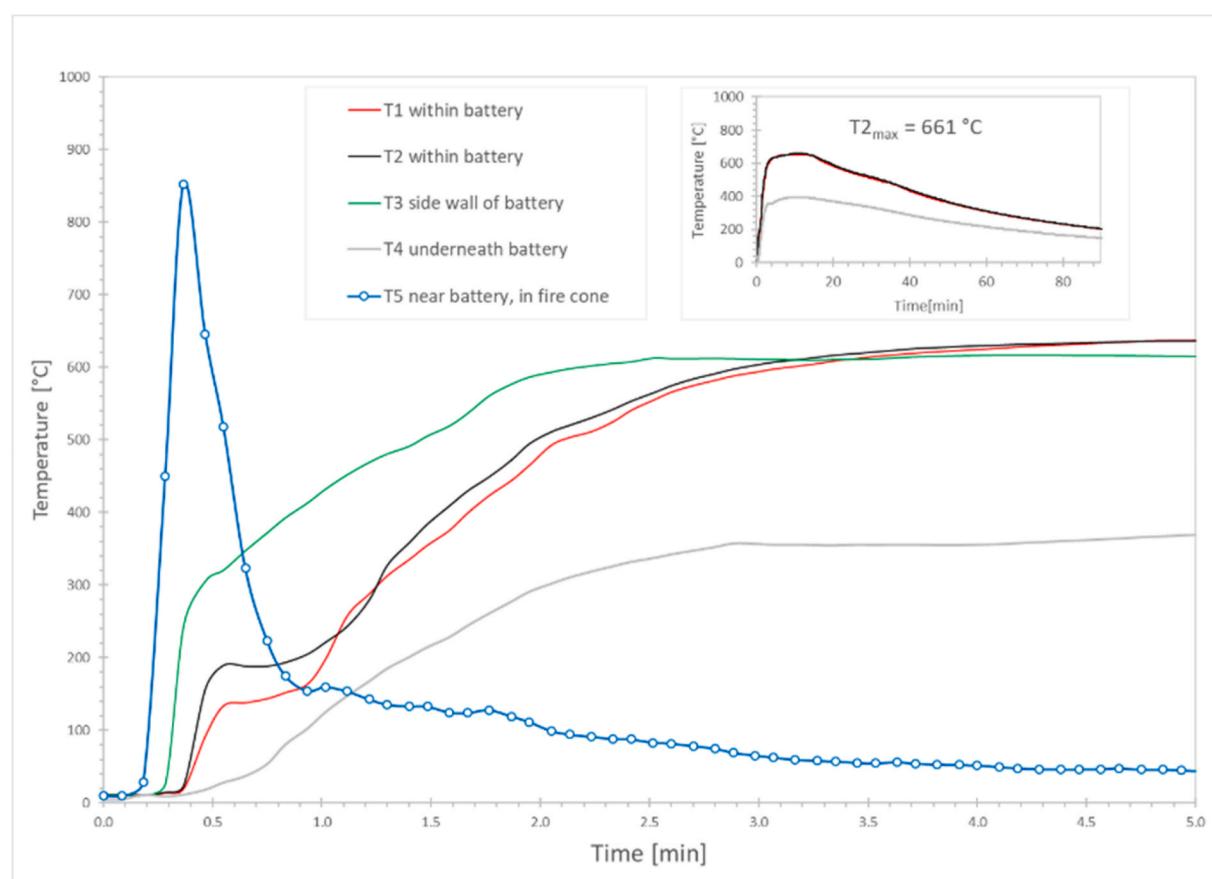
Fig. 16. Temperatures during and after thermal runaway.

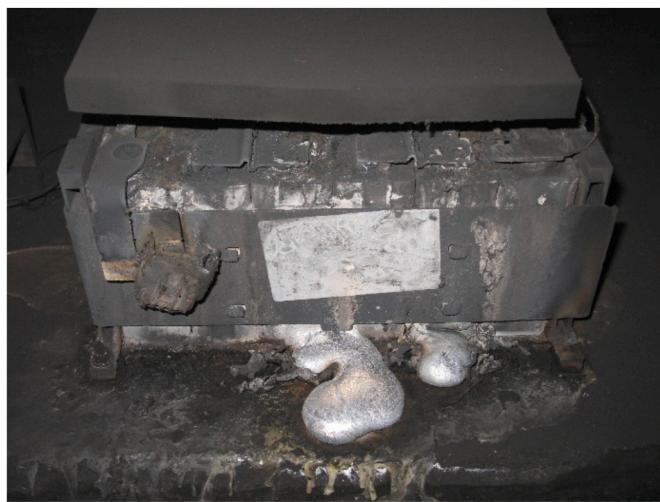
Fig. 17. Molten aluminum leaked from the battery.

The molten and subsequently solidified aluminum leaking from the battery, see Fig. 17, indicates that the temperatures in the core of the battery were higher than the melting point of aluminum, i.e. 660 °C.
