Heckington Fen Solar Park

Environmental Statement | Volume 3: Technical Appendices Appendix 16.5: Construction Methodology (as it affects soils)

Document Reference: 6.3.16.5

APPENDIX 16.5: CONSTRUCTION METHODOLOGY (AS IT AFFECTS SOILS)

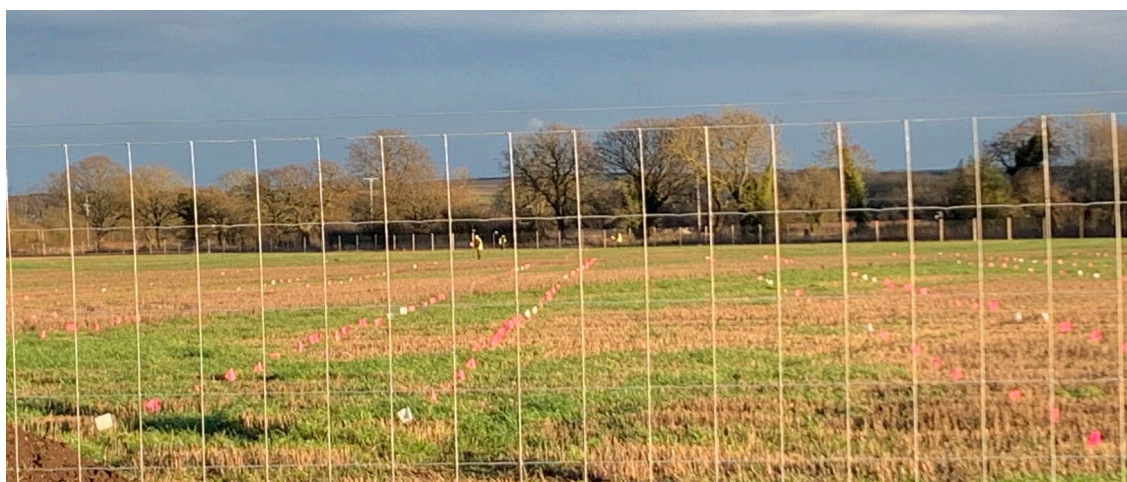
16.7.3 **Marking out Site.** This stage is non-intrusive, carried out on foot.

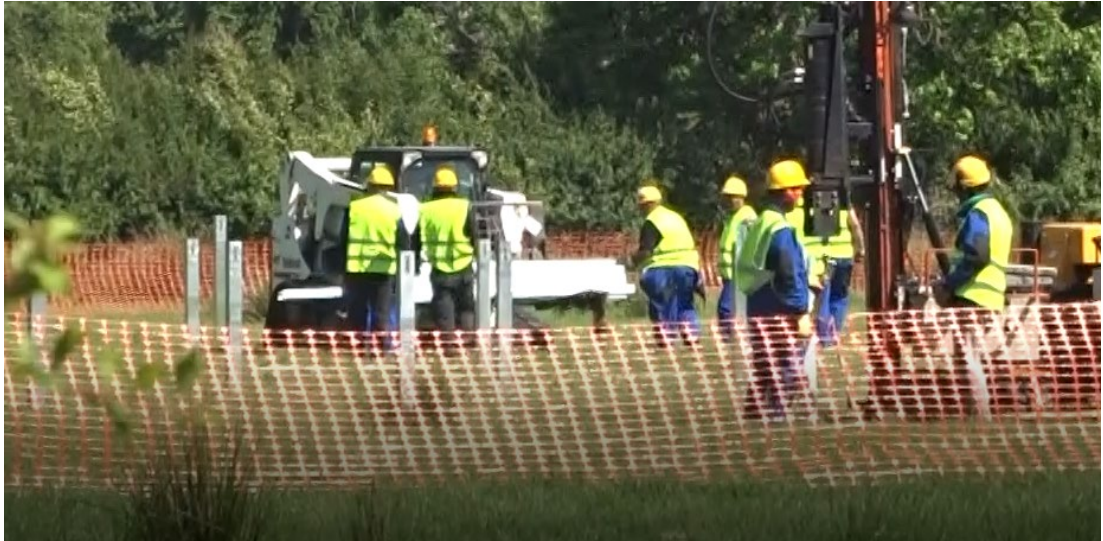
Loadall Delivering Legs

16.7.5 Alternatively the machinery used will also involve an agricultural loadall or, as per the example below, a smaller loadall in this case with tracks to spread the weight.

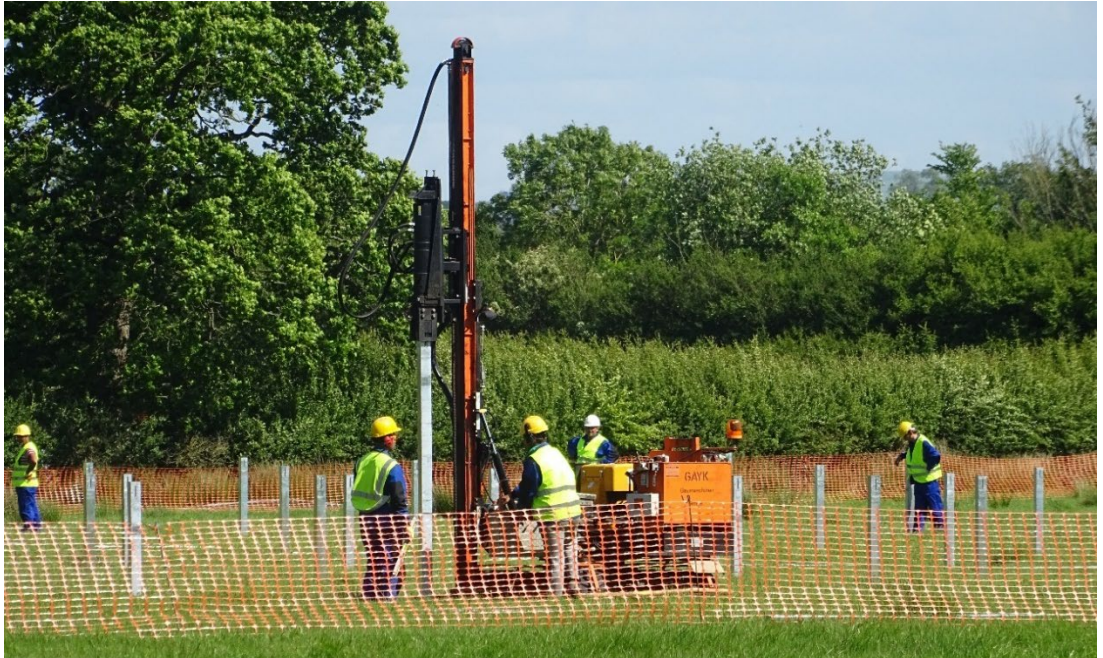
Inserting a Stanchion

- 16.7.6 A team then arrives to knock the stanchions / legs in. From operations we have observed it takes a little over a minute per pole to knock the pole into the ground and move the machine to the next pole¹. This operation is shown in the photograph below. This was inserting legs into a clay soil, but the deep stoneless soil at Heckington Fen will be similar.

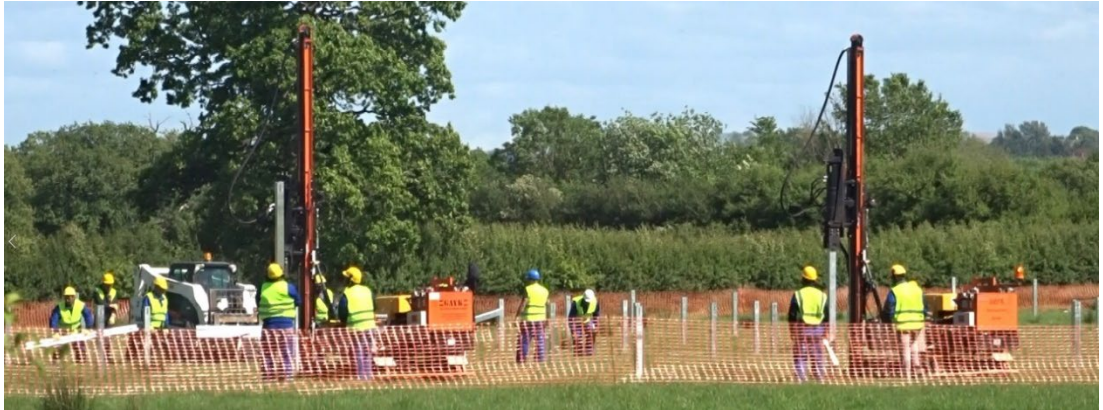
Team Installing Panels

16.7.7 Typically there will be two or more teams working simultaneously, as shown below.

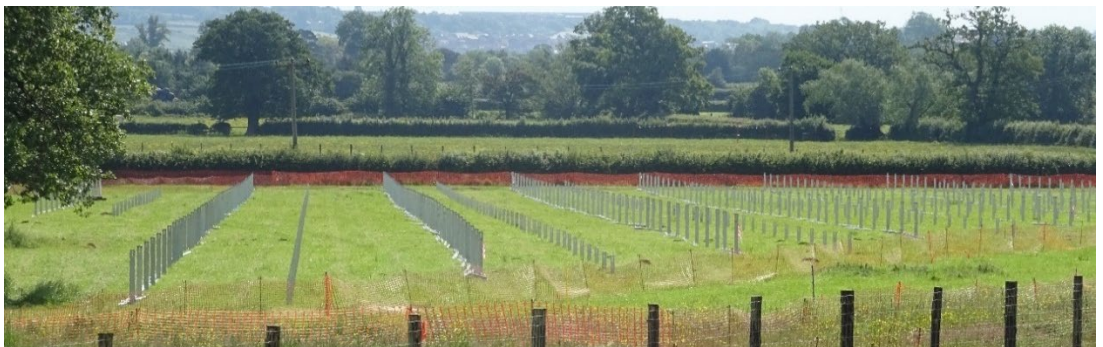
Stanchions Inserted (example in Wiltshire)

16.7.8 The details vary slightly between panel manufacturers, but the panels will have a taller and shorter stanchion, as shown below. The lack of damage or disturbance to the grassland and ground conditions from this operation is evident in this photograph.

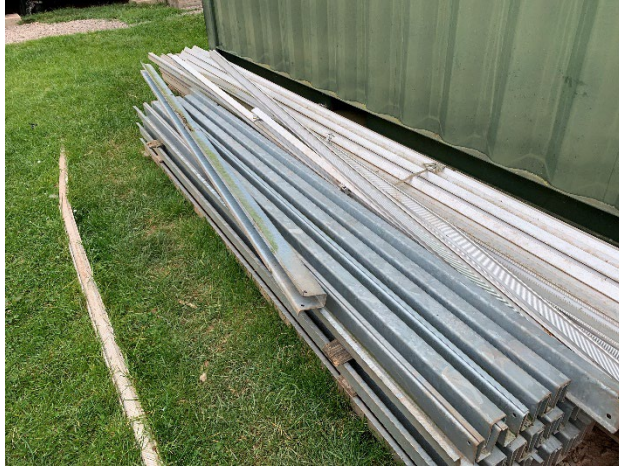
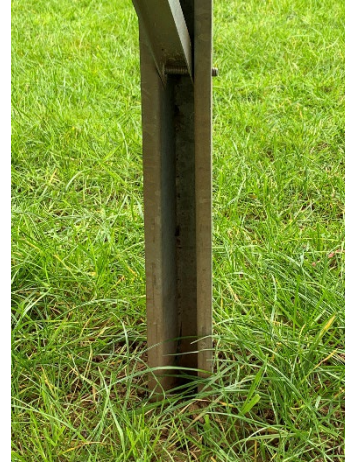
Framework Example

- 16.7.9 Leg designs vary. A pile of legs is shown below, and the cross section can be seen below and in the ground.

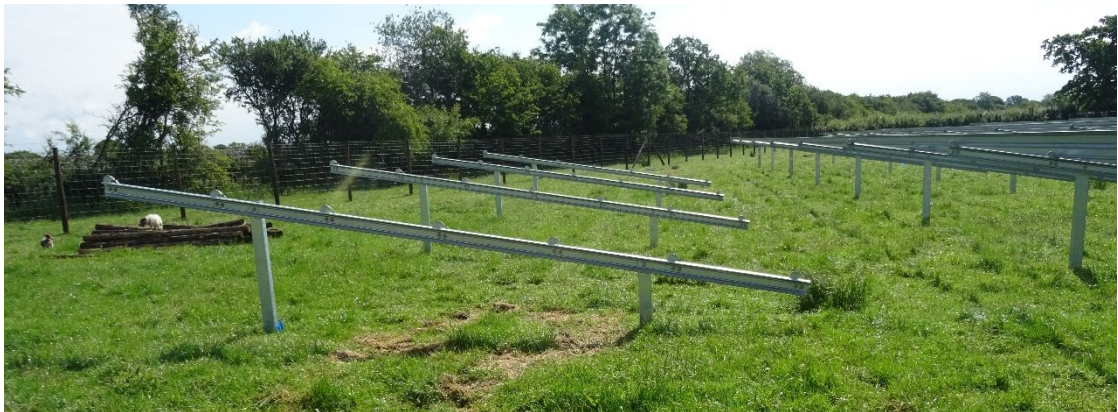
Constructing the Frame (Bentham Farm, Wiltshire)

- 16.7.10 **Bolting Together.** The next task is to construct the subframe, which is bolted onto the legs. This does not affect the soil. A loadall machine carries in the subframe and so as long as ground conditions are suitable there is no damage. The assembly team then lift the frame off the loadall and assemble the frame by hand. There are many different designs. The first below is a design not intended for grazing. The second is an installation at Manor Farm, Lanvapley².

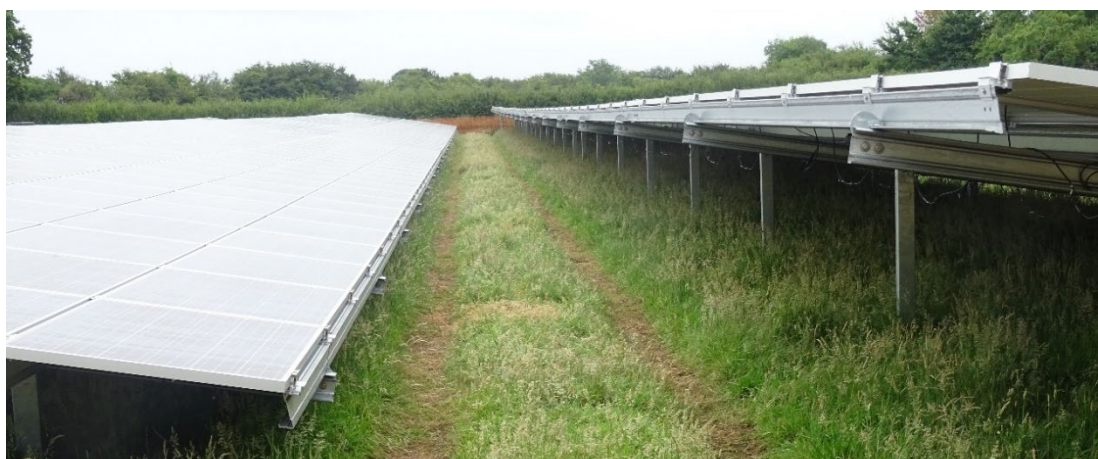
Panels Added

16.7.11 **Bolting-on Panels.** The panels are then attached to the frame. This stage is also non-intrusive to the ground and the only impact is from vehicular access, carrying in the panels. It can be seen that if ground conditions are suitable, there is no damage. The photo simply shows bruised grass from the passage of vehicles.

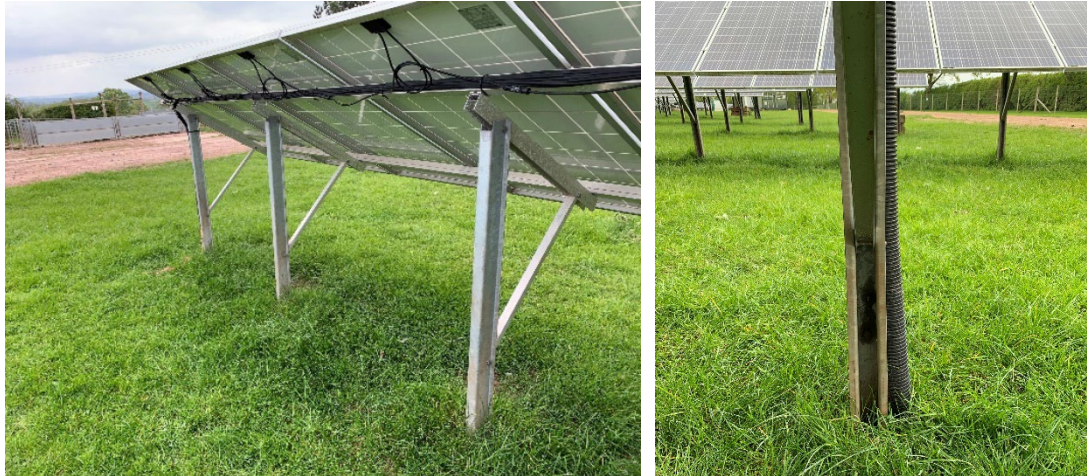
Cabling Along Panels

- 16.7.12 The cabling along the length of the panels is hung underneath the panels (out of the reach of sheep) and then, at the end of a row, it goes underground, as shown below.

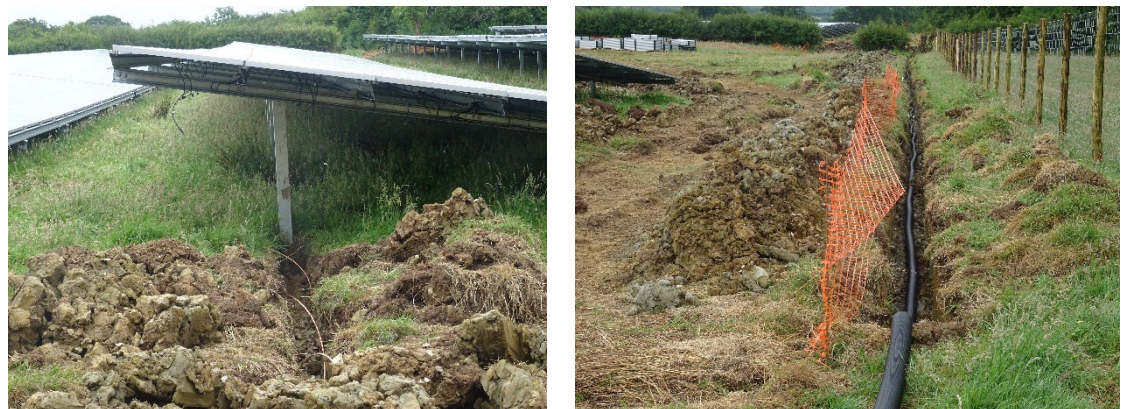
Cabling Channels

- 16.7.13 **Cabling and Trenching.** It is necessary to connect electric cables between the panels and to run the cables back to the substation. This involves trenches, dug with a machine. Immediately after digging these look disruptive to the soil, but they are installed in a similar way to field drainage pipes. Topsoil and subsoil are separated, as below, and this is good practice that needs to be followed.

- 16.7.14 The installation of cables is one of the few operations that involves digging whereby the soil structure could potentially be affected. The trenches are always narrow, but soil does have to be dug up to install the cable. In this country we have been burying services (water, oil, gas, telecomms) for many years. In areas where there is a clear subsoil and topsoil distinction, the topsoil should be placed on one side of the trench, and the subsoil on the other. Then once the cable has been laid the subsoil can be added back first, then the topsoil second, to reinstate the soil structure to its original order and state.

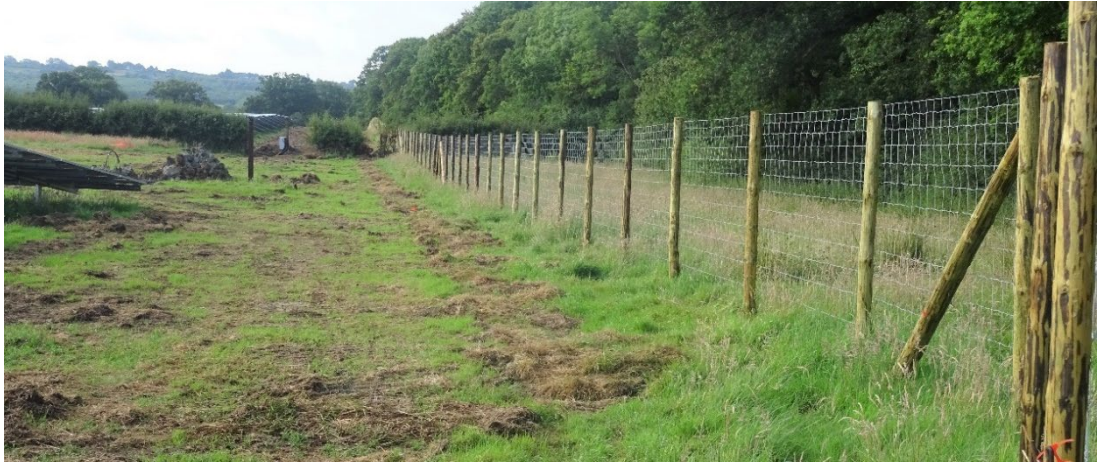
The Area Two Weeks Later

16.7.15 That means that soils are restored and settle within days, and return to grass growth rapidly.

This photo was taken 14 days after the trench was first dug.

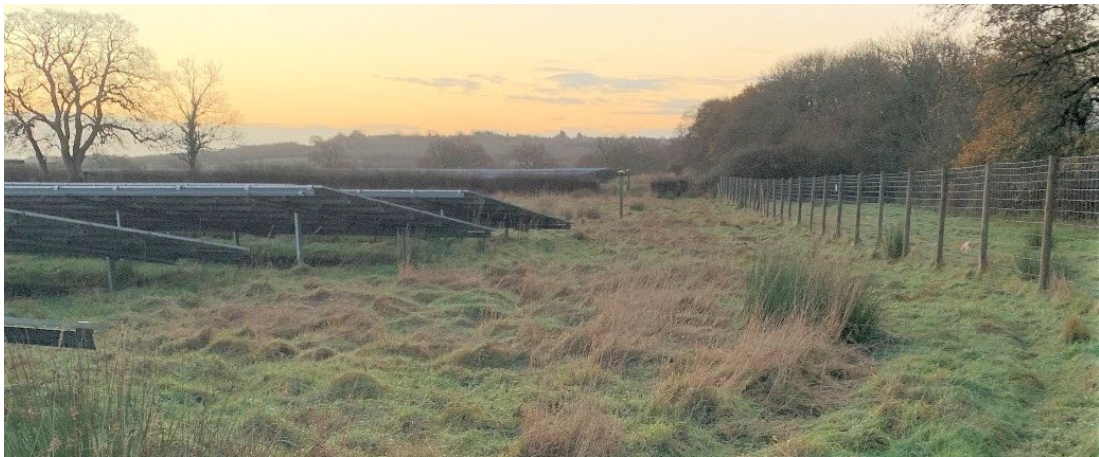
Panels After Five Years

16.7.16 This particular set of panels is set with the lower edge low to the ground, and so the site is not grazed. The photo shows that there is no evidence of differentiated forage growth over the trench.

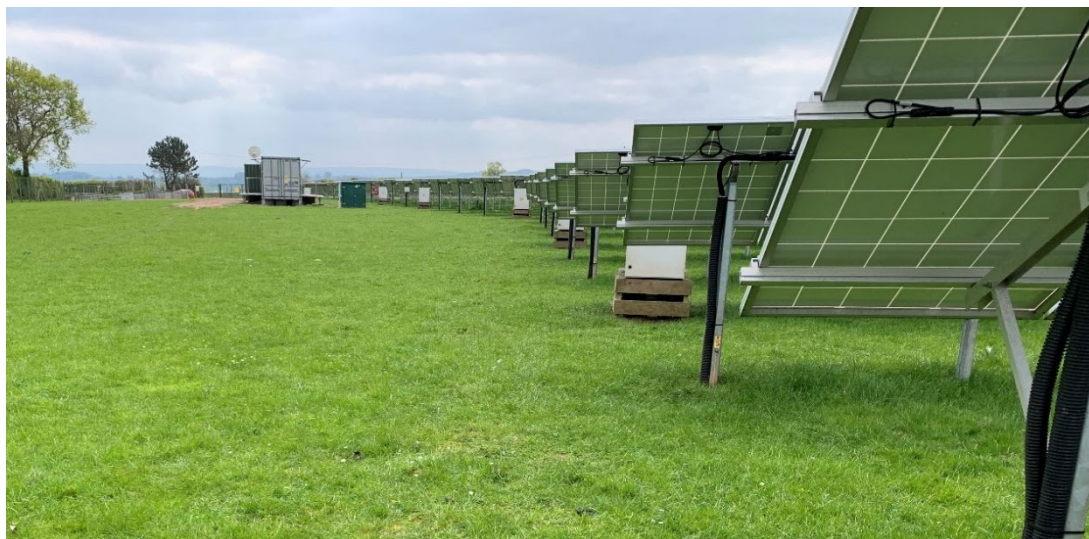
Buried Cables, Monmouthshire

- 16.7.17 The route between the legs and the substation is indistinguishable at the Llanvapley site, as shown below. The site is grazed by sheep.

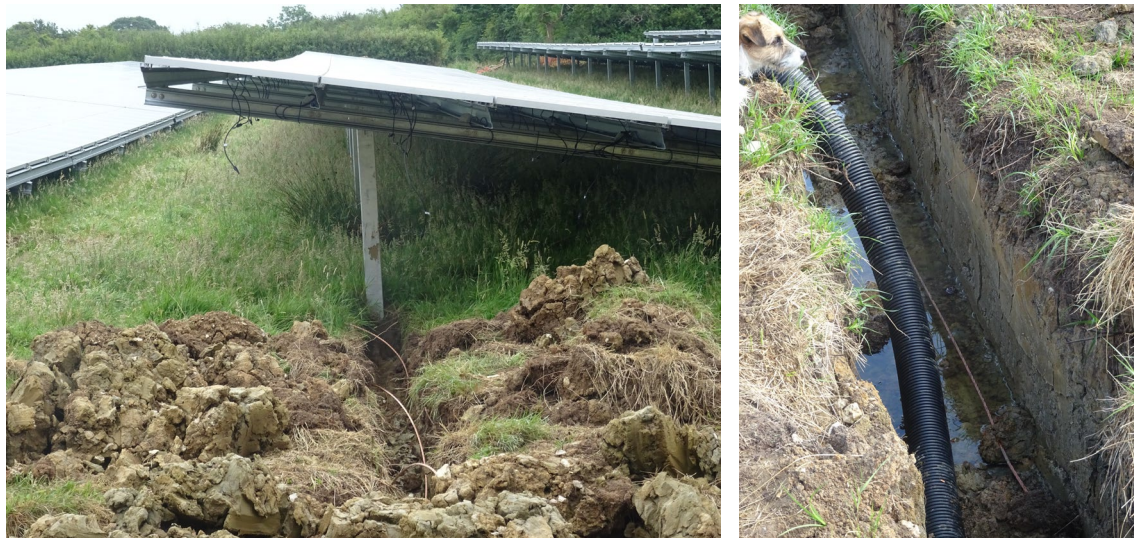
Tracking Works

- 16.7.20 The photographs below give an idea of width of trenching works. Depths may vary – at this site cables will be buried deeper than shown in the photos below.

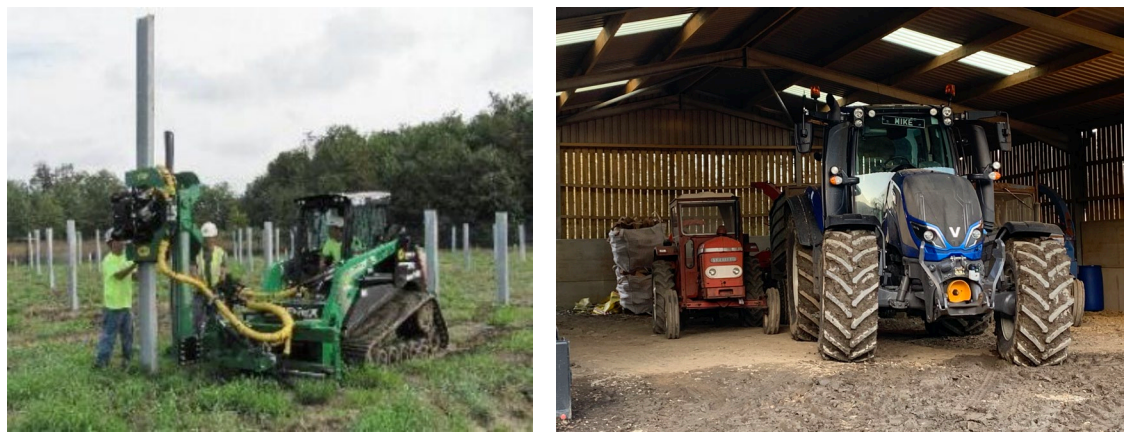
Three Tonne Cabbed Pile Driver and Modern Tractor

16.7.21 Soil damage should be limited if good practice is followed. Some of the soils are clayey, and therefore sticky when wet but hard and easily trafficked when dry. The installation of legs involves small machinery. The example above involved a pile driver without a cab, at about two tonnes. A three tonne cabbed version is shown below, with people. That is compared, for a size comparison, to a modern tractor, with an older one beside.

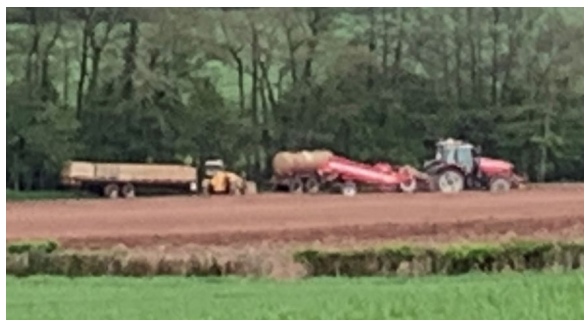
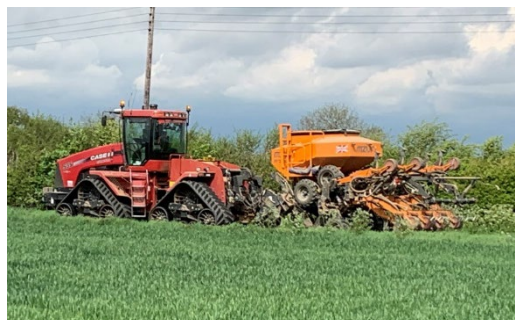
Planting Potatoes

16.7.22 Machines of the tractor size work farmland all the time. The photos below, whilst poor, show potatoes being planted in Monmouthshire in May 2022, and a large tractor photographed in the Lincolnshire fens in May 2022.

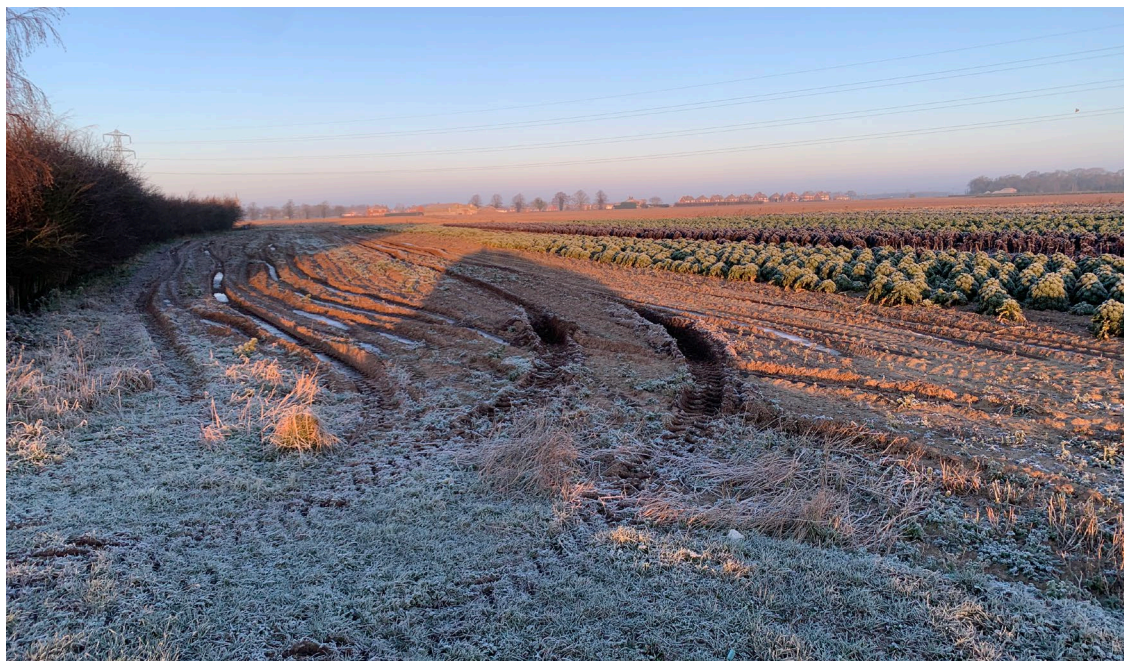
Vegetable Harvesting, Lincolnshire

- 16.7.23 Soil should not be damaged during the installation of legs, because the machinery used is lightweight compared to modern farm machinery.
- 16.7.24 If soil was damaged it can easily be rectified. Soil is frequently affected by agricultural practice. Below is a photograph of typical soil damage on vegetable land in Lincolnshire (photographed January 2023). This will be rectified when the field is next cultivated.

- 16.7.25 Even if done poorly it should be possible, and easy, to run a tractor down between the rows of panels with a subsoiler or tines to loosen and restore any compaction. There will be no long-term impact on soils as a result of construction of the panel arrays.
- 16.7.26 There are different models of transformer on the market, so the final details may vary depending upon availability. These stand on concrete bases or pads, and are connected to a drainage system for the water run-off.

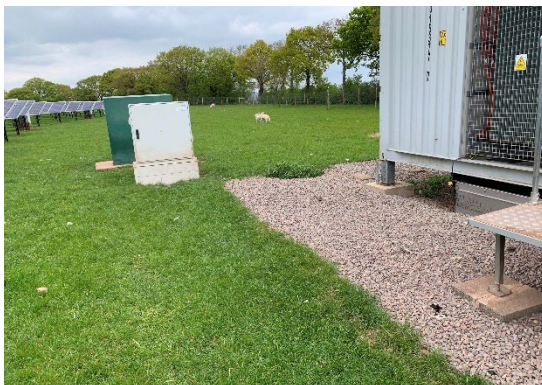
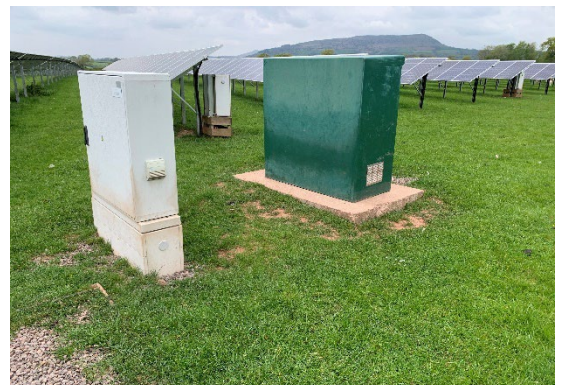
Connection Boxes

16.7.27 There may also be small connector boxes, such as those shown below.

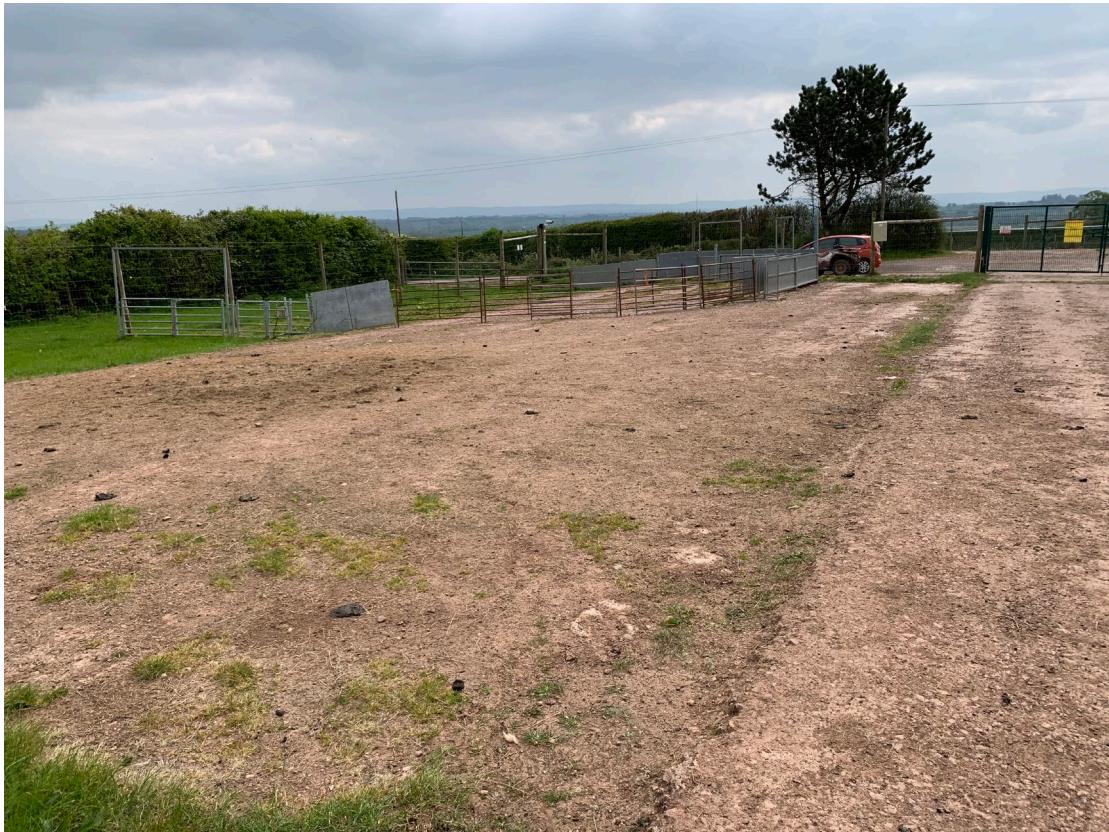
Track and Yard Area

16.7.28 The tracks are created by removing the topsoil and then adding stone to the surface. The tracks run along hederows except for the sections shown to access the transformers. These areas can be restored by removing the stone, decompacting the subsoil with agricultural machinery, and replacing the topsoil. The photo below also shows a yard area created for handling the sheep.

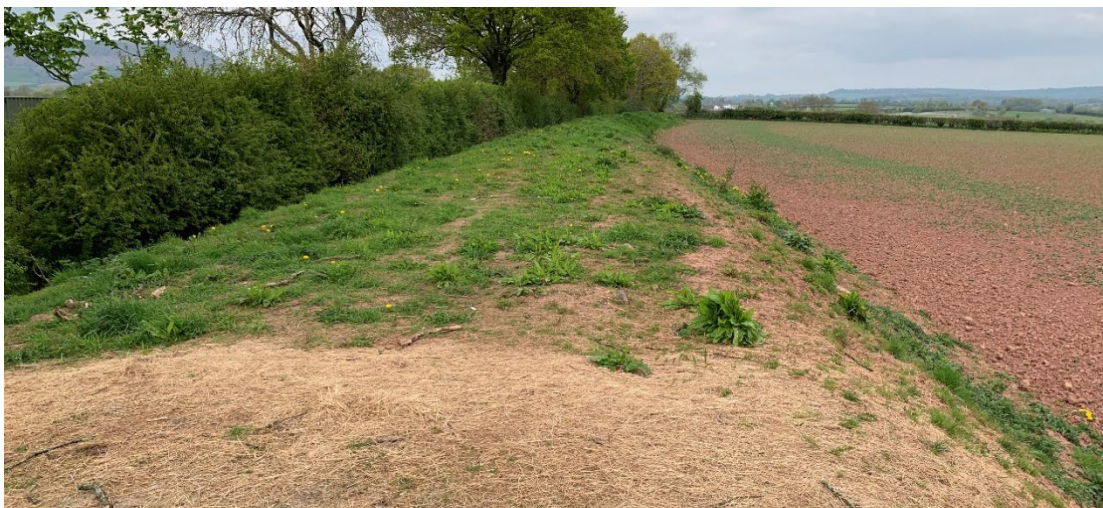
Storage Bund

16.7.29 The soil will be stored in bunds for reuse at the decommissioning stage, as shown below, or in lower bunds such as the example of a temporary storage bund.

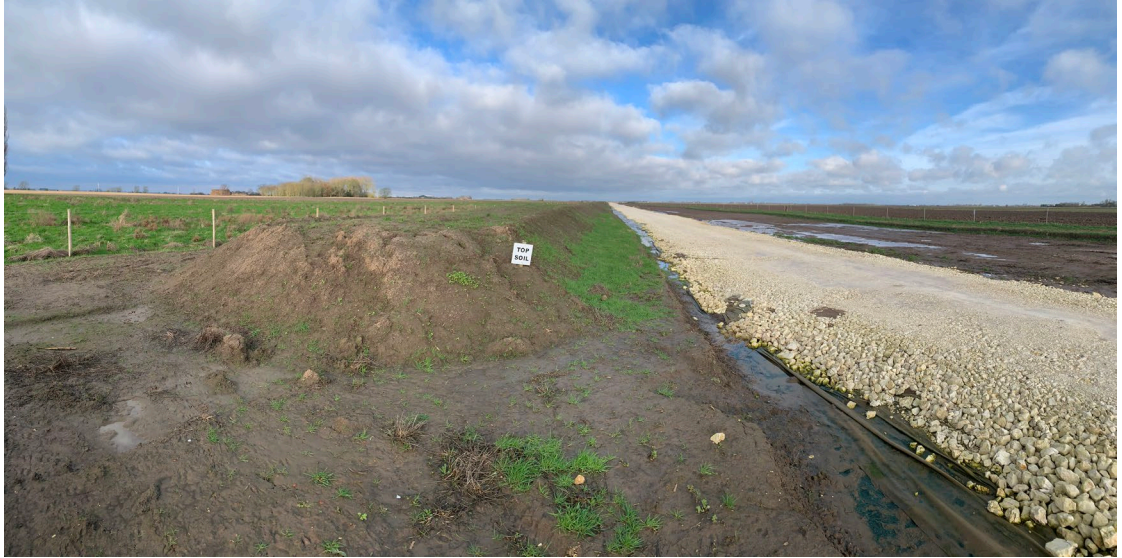
16.7.30 The construction compound will typically use mats to dissipate weight during use, and will be returned to agriculture after the works are completed.
