# Heckington Fen Solar Park

**Appendix 18.1: UXO Risk Assessment**

## Detailed Unexploded Ordnance (UXO) Risk Assessment

<b>Project Name</b>	Heckington Fen
<b>Client</b>	Ecotricity (Heck Fen Solar) Ltd
<b>Site Address</b>	Heckington Fen, Lincolnshire
<b>Report Reference</b>	DA16024-01
<b>Date</b>	09/09/22
<b>Originator</b>	ER

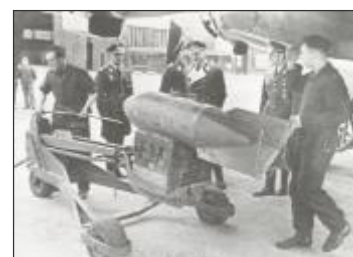
## SC 250kg

Bomb Weight	245-256kg (540-564lb)
Explosive Weight	125-130kg (276-287lb)
Fuze Type	Electrical impact/mechanical time delay fuze.
Bomb Dimensions	1640 x 512mm (64.57 x 20.16in)
Body Diameter	368mm (14.5in)
Use	Against railway installations, embankments, flyovers, underpasses, large buildings and below-ground installations.
Remarks	It could be carried by almost all German bomber aircraft, and was used to notable effect by the Junkers Ju-87 Stuka (Sturzkampfflugzeug or dive-bomber).

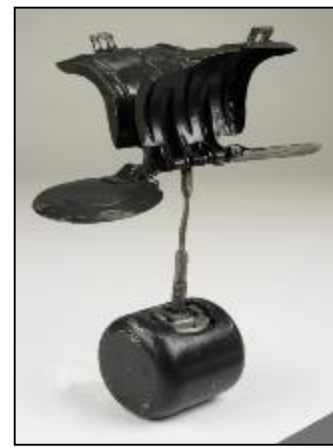
## Parachute Mine (Luftmine B / LMB)

Bomb Weight	987.017kg (2176lb)
Explosive Weight	125-130kg (276-287lb)
Fuze Type	Impact/ Time delay / hydrostatic pressure fuze
Bomb Dimensions	1640 x 512mm (64.57 x 20.16in)
Body Diameter	368mm (14.5in)
Use	Against civilian, military and industrial targets. Designed to detonate above ground level to maximise damage to a wider area.
Remarks	Parachute Mines were normally carried by HE 115 (Naval operations), HE 111 and JU 88 aircraft types. Deployed a parachute when dropped in order to control its descent.

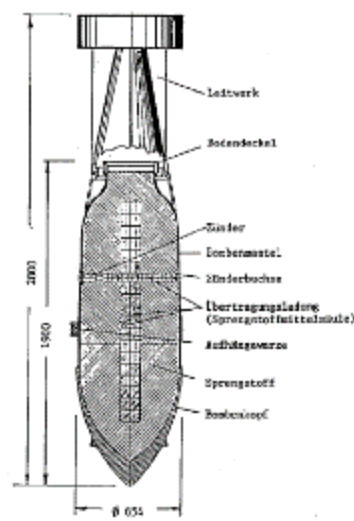
## SC 1000kg

Bomb Weight	996-1061kg (1,058-1,146lb)
Explosive Weight	530-620kg (551-573lb)
Fuze Type	Electrical impact/mechanical time delay fuze.
Filling	Mixture of 40% amatol and 60% TNT, but when used as an anti-shipping bomb it was filled with Trialen 105, a mixture of 15% RDX, 70% TNT and 15% aluminium powder.
Bomb Dimensions	2800 x 654mm (77 x 25.2in)
Body Diameter	654mm (18.5in)
Use	SC type bombs are General Purpose Bombs used primarily for general demolition work. Constructed of parallel walls with comparatively heavy noses. They are usually of three piece welded construction

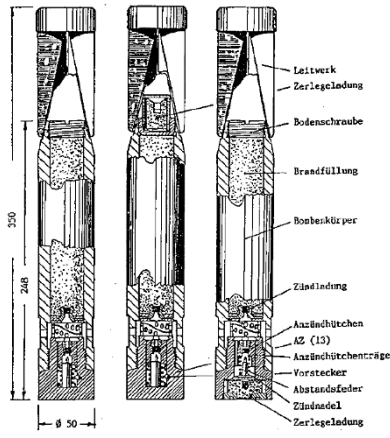
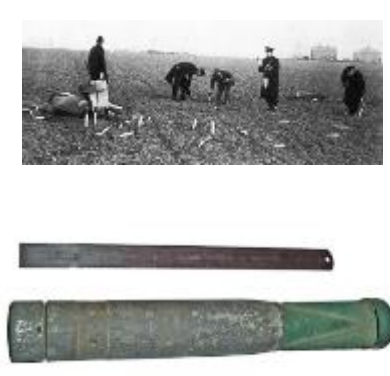
1kg Incendiary Bomb	
Bomb Weight	1.0 and 1.3kg (2.2 and 2.87lb)
Explosive Weight	680gm (1.3lb) Thermit
Fuze Type	Impact fuze
Bomb Dimensions	350 x 50mm (13.8 x 1.97in)
Body Diameter	50mm (1.97in)
Use	As incendiary – dropped in clusters against towns and industrial complexes
Remarks	Magnesium alloy case. Sometimes fitted with high explosive charge. The body is a cylindrical alloy casting threaded internally at the nose to receive the fuze holder and fuze.

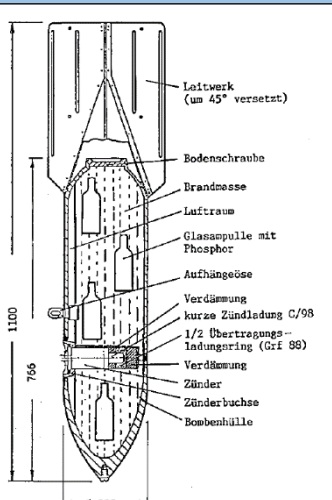
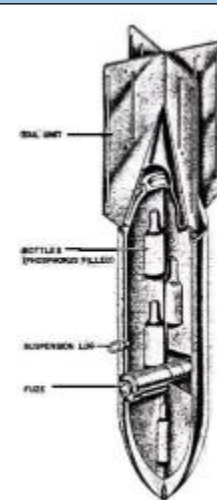
C50 A Incendiary Bomb	
Bomb Weight	c41kg (90.4lb)
Explosive Weight	0.03kg (0.066lb)
Incendiary Filling	12kg (25.5lb) liquid filling with phosphor igniters in glass phials. Benzine 85%; Phosphorus 4%; Pure Rubber 10%
Fuze Type	Electrical impact fuze
Bomb Dimensions	1,100 x 280mm (43.2 x 8in)
Use	Against all targets where an incendiary effect is to be expected
Remarks	Early fill was a phosphorous/carbon disulphide incendiary mixture

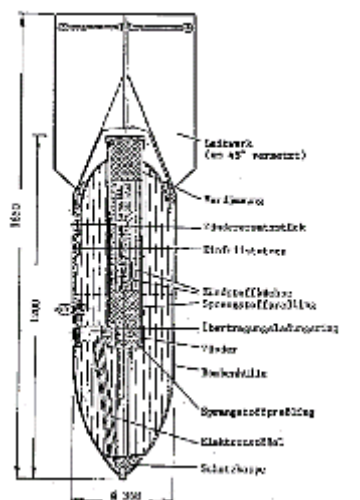
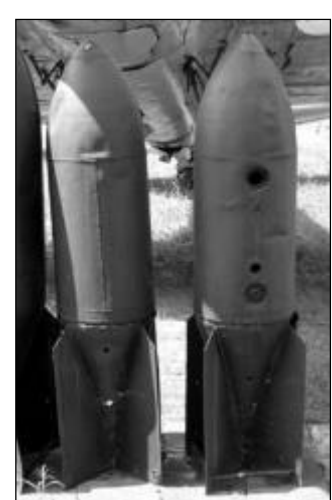
Flam C-250 Oil Bomb	
Bomb Weight	125kg (276lb)
Explosive Weight	1kg (2.2lb)
Fuze Type	Super-fast electrical impact fuze
Filling	Mixture of 30% petrol and 70% crude oil
Bomb Dimensions	1,650 x 512.2mm (65 x 20.2in)
Body Diameter	368mm (14.5in)
Use	Often used for surprise attacks on living targets, against troop barracks and industrial installations. Thin casing – not designed for ground penetration

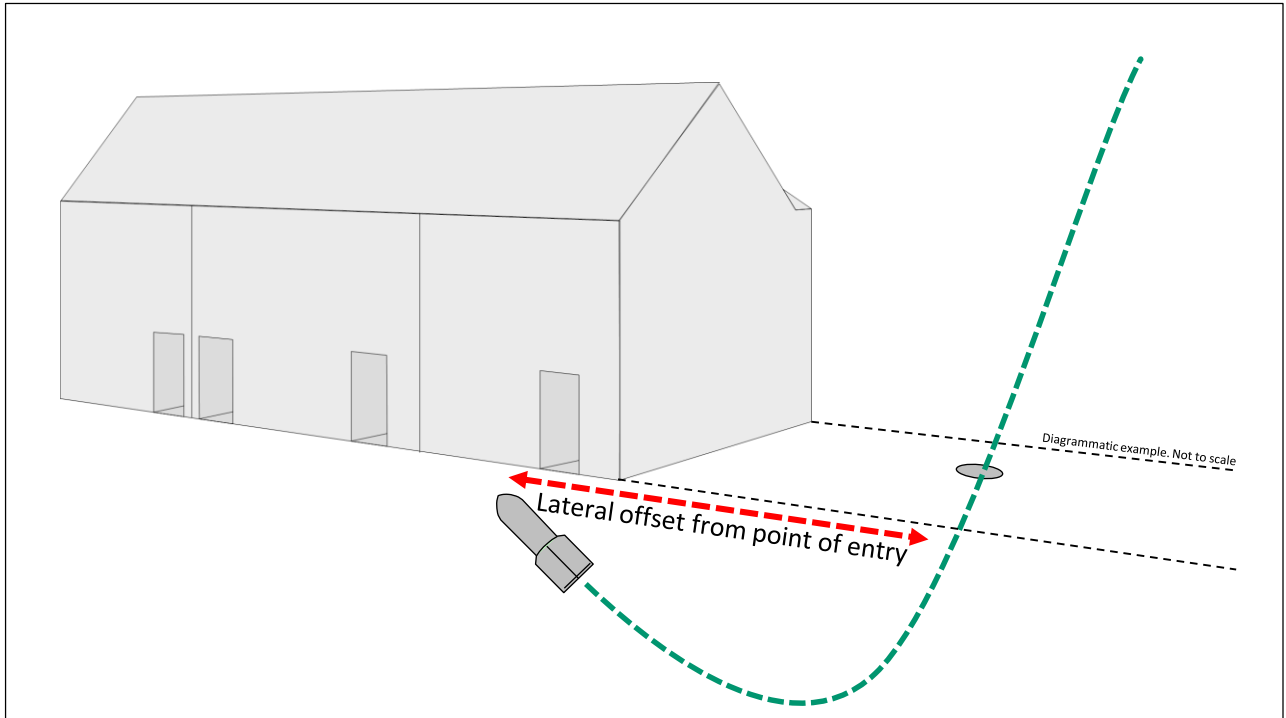
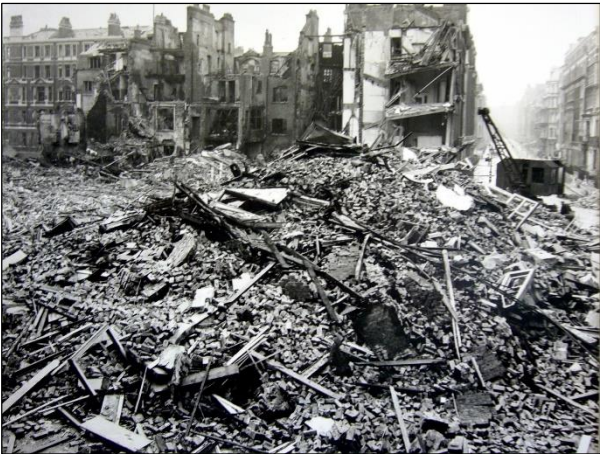
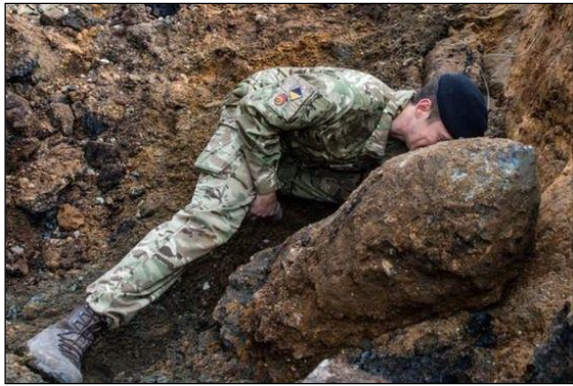
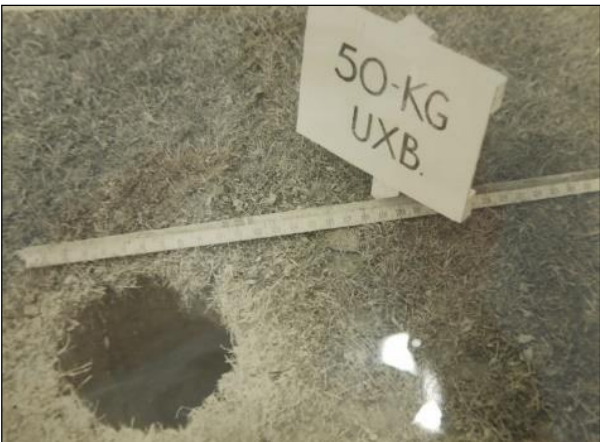
**Top:** J-curve Effect - Due to angle of entry, unexploded bombs would often end their trajectory at a lateral offset from point of entry, often ending up beneath adjacent extant structures/sites. The photograph above shows 250kg bomb found in Bermondsey pointing upwards, demonstrating 'J-curve'

One of the most common scenarios for UXO going unnoticed was when a UXB fell into a 'bomb site' (such as the area shown **Top Left**), the entry hole of the bomb obscured by any debris and rubble present. Note that the entry hole of a 50kg UXB could be as little as 20cm in diameter (**Left**).

J-curve is the term used to describe the characteristic curve commonly followed by an air delivered bomb dropped from height after it penetrates the ground. Typically, as the bomb is slowed by its passage through underlying soils, its trajectory curves towards the surface. Many UXBs are found with their nose cone pointing upwards as a result of this effect. More importantly, however, is the resulting horizontal offset from the point of entry. This is typically a distance of about one third of the bomb's penetration depth, but can be higher in certain conditions (see **Appendix iv**).

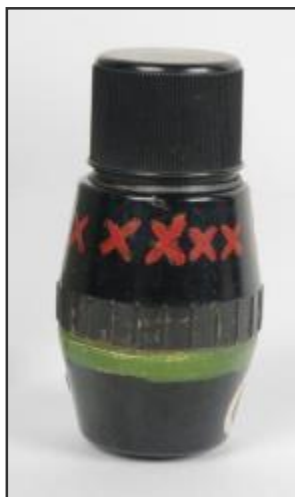
## No. 69 Grenade

Weight	383g (0.81lb)
Explosive Weight	93g (3.25 oz) of either Amatol, Baratol or Lyddite
Fuze Type	'All-ways' Fuze. Comprised of a safety cap, a weighted streamer attached to a steel ball bearing and a safety bolt designed to detonate from any point of impact.
Dimensions	114 x 60mm (4.5 x 2.4 in)
Use	A blast grenade for use as an offensive weapon.
Remarks	Introduced December 1940 and made from the plastic Bakelite as opposed to conventional metals. Detection is difficult due to this low metal content.

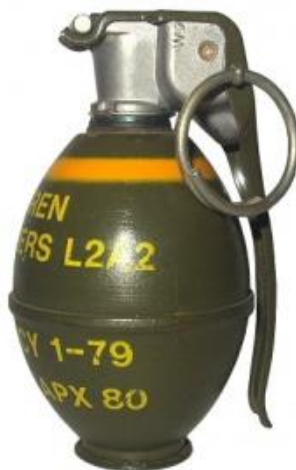
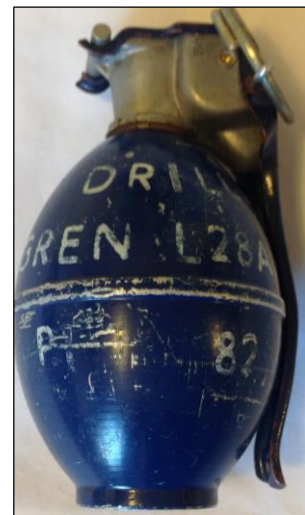
## L2 Grenade

Weight	454g (16 oz)
Explosive Weight	164g. (16 oz)
Fuze Type	Time Friction Fuze
Dimensions	Approx. 99 x 57 mm (3.9 x 2.2 in)
Use	A widely used anti-personnel grenade, a version of the American M26. Variants still see use in the present day.
Remarks	The L2 series also came as a Practice (L3) grenade and a Drill (L4) Grenade. The Drill variant, with a non-functional fuze and no filing, is visible on the far right.

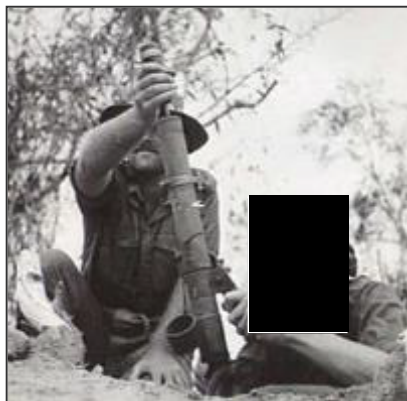
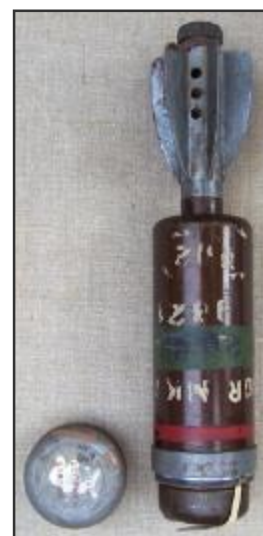
## Typical 2 Inch High Explosive Mortar

Weight	1.02kg (2.25lb)
Maximum Range	460m (500yards)
Filling	200g RDX/TNT
Dimensions	51 x 290mm (2in x 11.4 in )
Fuze Type	An impact fuze which detonates the fuze booster charge and in turn the high explosive charge.
Use	A small, portable mortar introduced into the British army in 1938. It had greater range and firepower over hand and rifle grenades, and was used to attack targets behind cover with high explosive rounds.
Remarks	Detonation causes the mortars bomb body to shatter producing optimum fragmentation and blast effect at the target.

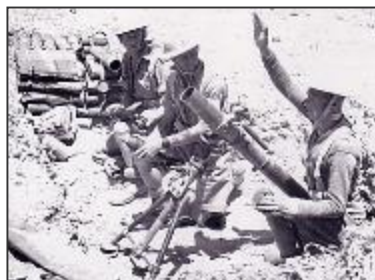
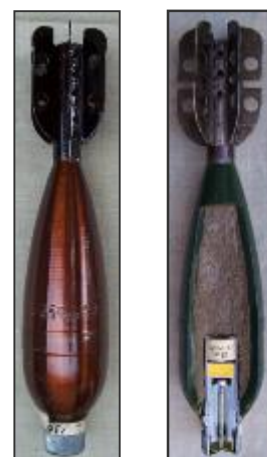
## Typical 3 inch Smoke Mortar

Weight	4.5kg (9lb 14oz)
Maximum Range	2515m ( 2,750 yards)
Filling	White phosphorus & smoke fill (also came in Explosive & Illuminating models)
Bomb Dimensions	490 x 76mm ( 19.3in x 3in)
Fuze Type	An impact fuze which initiates a bursting charge. This ruptures the mortar bomb 's body and disperses the phosphorus filler
Use	As a screening devices for unit movement or to impair enemy field of vision.
Remarks	This mortars long cylindrical body and tail sometimes causes it to be misrecognised as a German incendiary bomb.

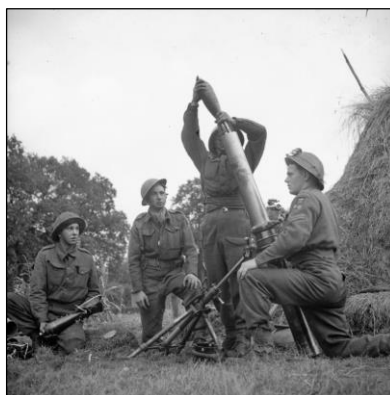
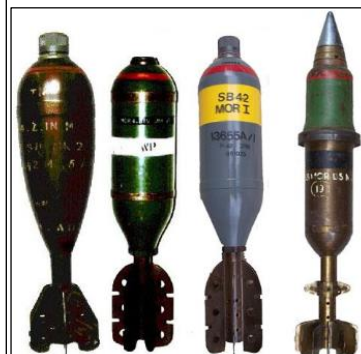
## ML 4.2 inch Mortar

Weight	9kg (19lb 13oz)
Maximum Range	3,750m (4,100 yards)
Filling	High explosive, smoke (white phosphorous or Titanium Tetrachloride) or chemical
Bomb Dimensions	500 x 105 mm (19 in x 4 in)
Fuze Type	Sensitive fuze with HE bursting charge.
Use	A widely used heavy motor which first saw use in 1942 and saw usage throughout the post-war period.
Remarks	Different markings denoted different fillings. See image to the right.

L to R: HE, Smoke, Chemical, Smoke BE.

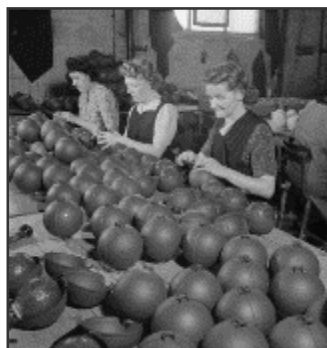
## No. 74 Grenade (Sticky Bomb)

Weight	Approx. 1.1kg ( 2lb 4oz)
Filling	Approx. 600g Nobel's No.283 (Nitroglycerine)
Design	A glass ball on the end of a Bakelite (plastic) handle. The inside of the ball would contain the explosive filling and the outside a very sticky adhesive coating.
Use	An anti-tank grenade primarily issued to the home guard. It required the user to come in very close proximity with the target and smash the glass explosive container against it.
Remarks	One of a number of weapons developed for use as an <i>ad hoc</i> solution to the lack of sufficient anti-tank guns in the aftermath of the Dunkirk evacuation amid fear of German invasion.

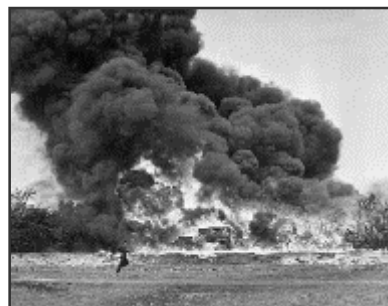
## Flame Fougasse Bomb

Weight	Various
Filling	Initially a mixture of 40% petrol and 60% gas. Ammonal provided the propellant charge.
Design	Usually constructed from a 40-gallon drum dug into a roadside and camouflaged.
Use	As an improvised anti-tank bomb. When triggered the Fougasse could project a beam of burning sticky fuel in a fixed direction from up to 3m (10ft) wide and 27m (30yards) long.
Remarks	A highly unorthodox weapon designed by the Petroleum warfare department to address a critical lack of weapons in 1940. 50,000 are estimated to have been distributed around the UK.

Figure 26. Flame Fougasse (10 gallons) (Army).

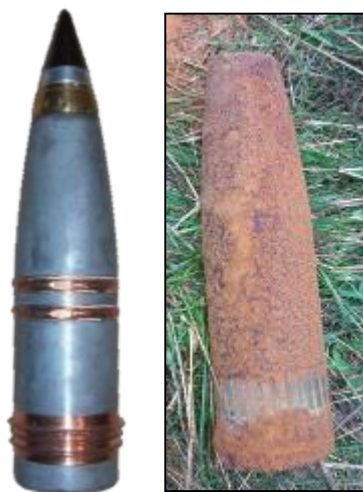
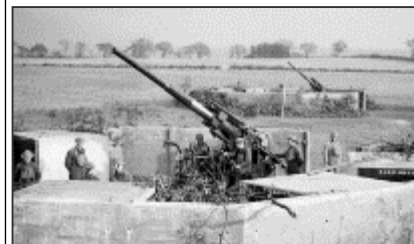
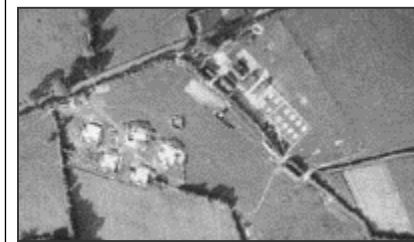
## QF 3.7 Inch WWII Anti-Aircraft Projectile

Projectile Weight	28lb (12.6 kg)
Explosive Weight	2.52lbs
Fuze Type	Mechanical Time Fuze
Dimensions	3.7in x 14.7in (94mm x 360mm)
Rate of Fire	10 to 20 rounds per minute
Use	High Explosive Anti-Aircraft projectile. 4.5in projectiles were also used in this role.
Ceiling	30,000ft to 59,000ft

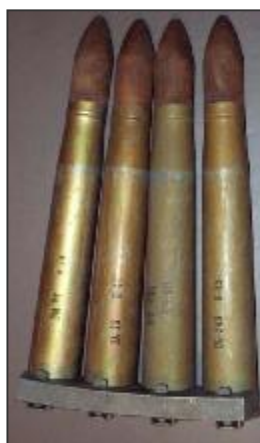
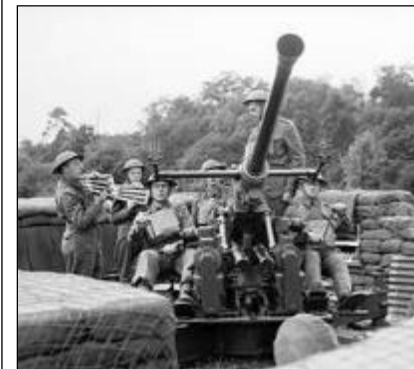
## 40mm Bofors Projectile

Projectile Weight	1.96lb (0.86kg)
Explosive Weight	300g (0.6lb)
Fuze Type	Proximity and Mechanical Time Fuze
Rate of Fire	120 rounds per minute
Projectile Dimensions	40mm x 310mm (1.6in x 12.2in)
Ceiling	23,000ft (7000m)

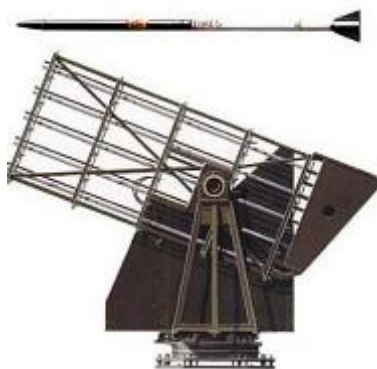
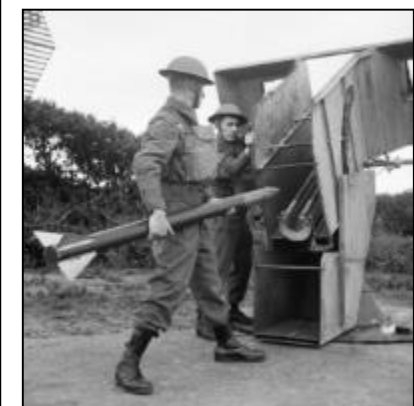
## Unrotated Projectile (UP) – Z Battery

Projectile Weight	84lb (24.5kg)
Warhead Weight	4.28lb (1.94kg)
Warhead	Aerial Mine with a No. 700 / 720 fuze
Filling	High Explosive
Dimensions	1930mm x 82.6mm (76 x 3.25in)
Use	As a short range rocket-firing anti-aircraft weapon developed for the Royal Navy. It was used extensively by British ships during the early days of World War II. The UP was also used in ground-based single and 128-round launchers known as Z Batteries.
