**Dogger Bank South Offshore
Wind Farms**

**Appendix 22-11 Phase 1 Trenching Report (Part 3
of 4)**

Document Reference: 7.22.22.11

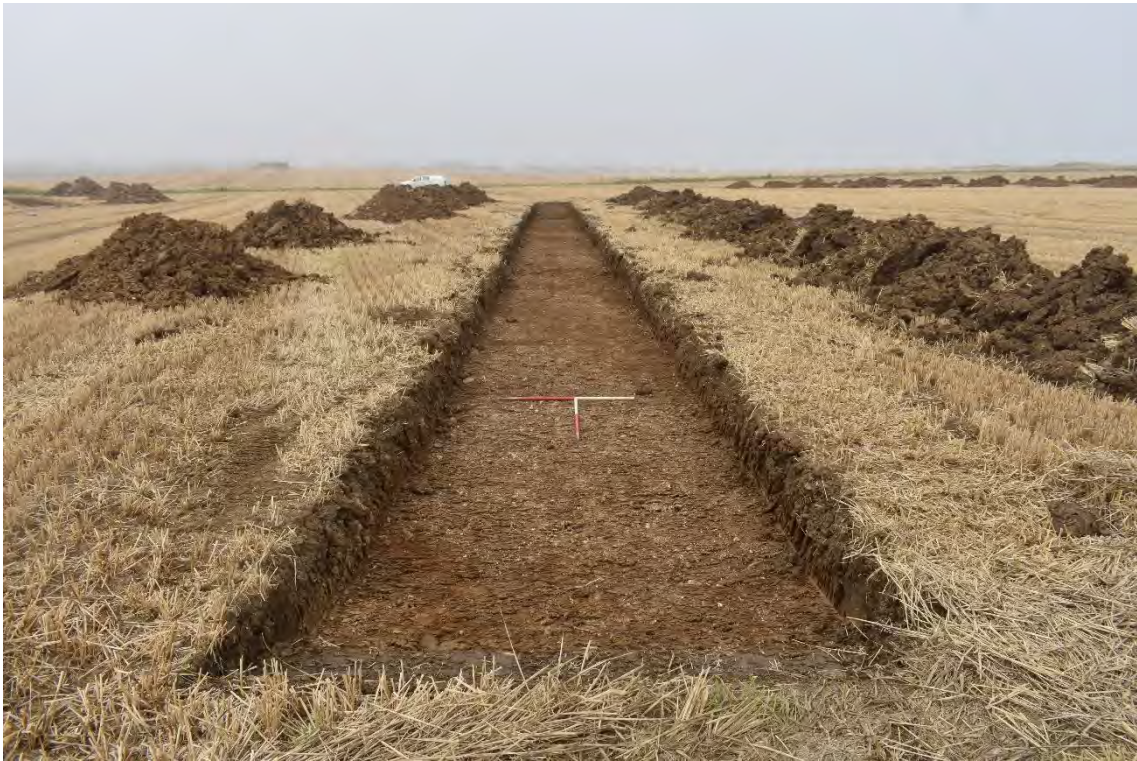
Plate 1.1: Trench 21. Trench shot showing a typical example of boulder clay natural. Looking northeast.

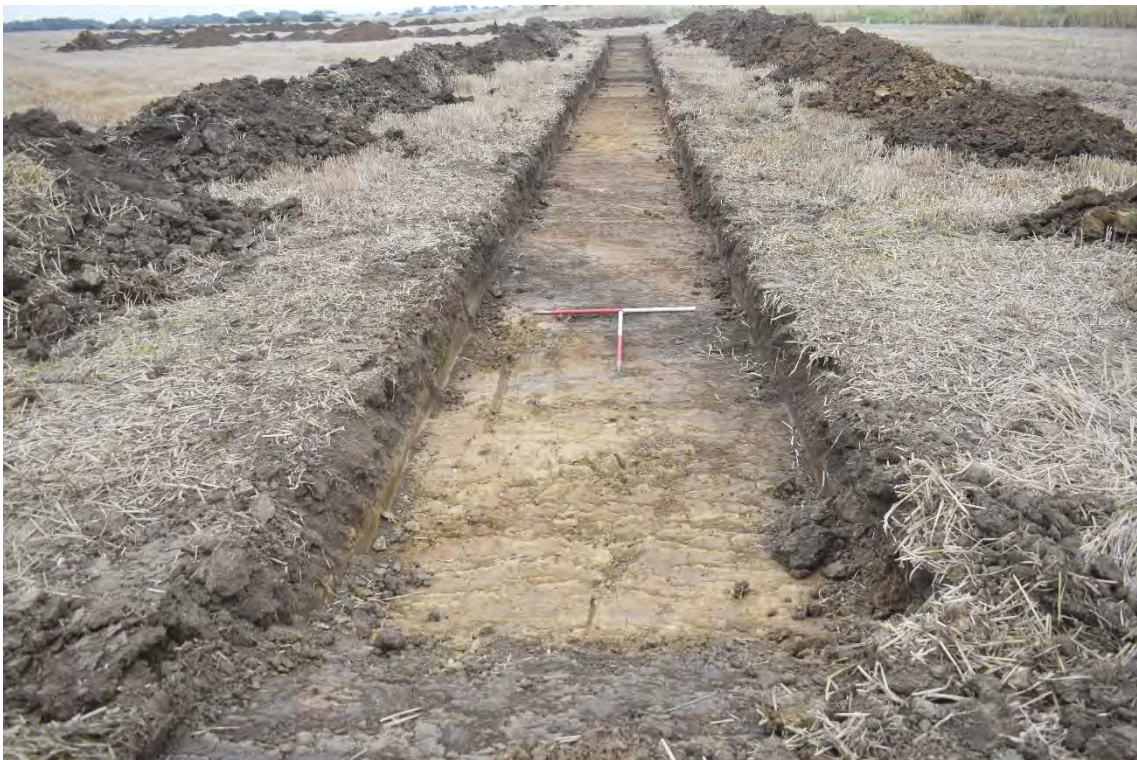
Plate 1.2: Trench 40. Trench shot showing a typical example of natural with dense natural silty clay layers or patches overlying the boulder clay. Ditch [4004] is visible in the foreground. Looking northeast.

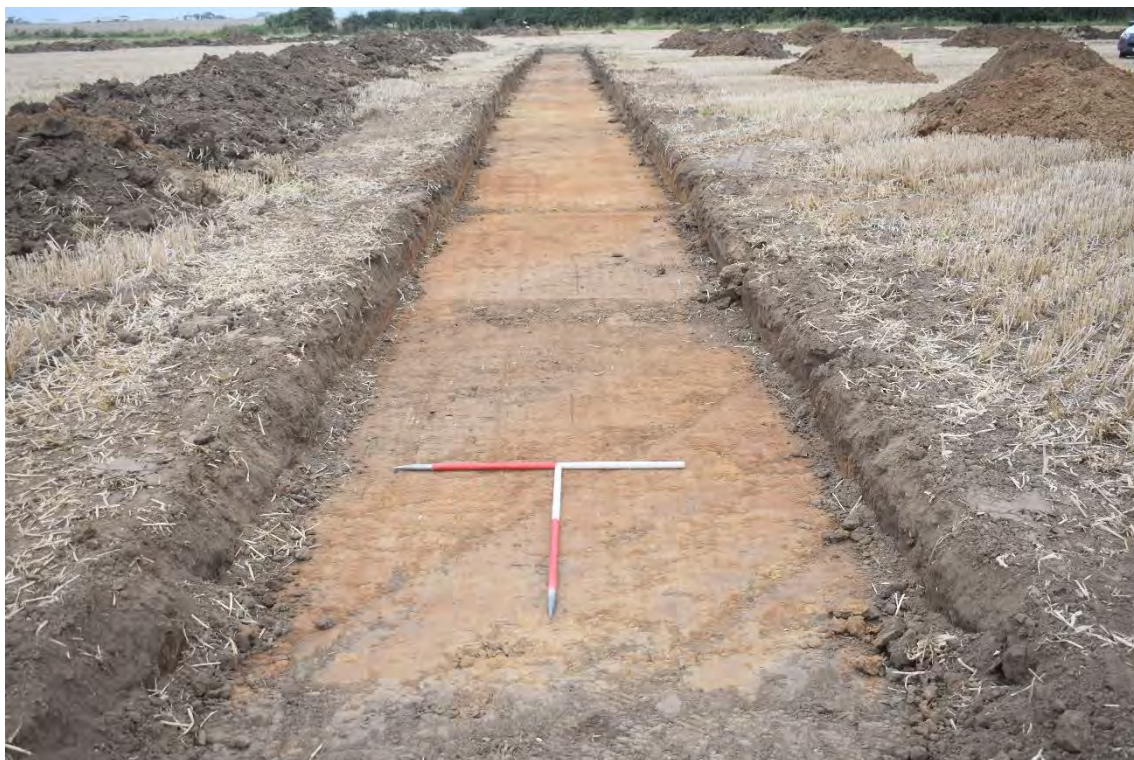
Plate 1.3: Trench 31. Trench shot showing a typical example of soft sandy natural. Looking southeast.

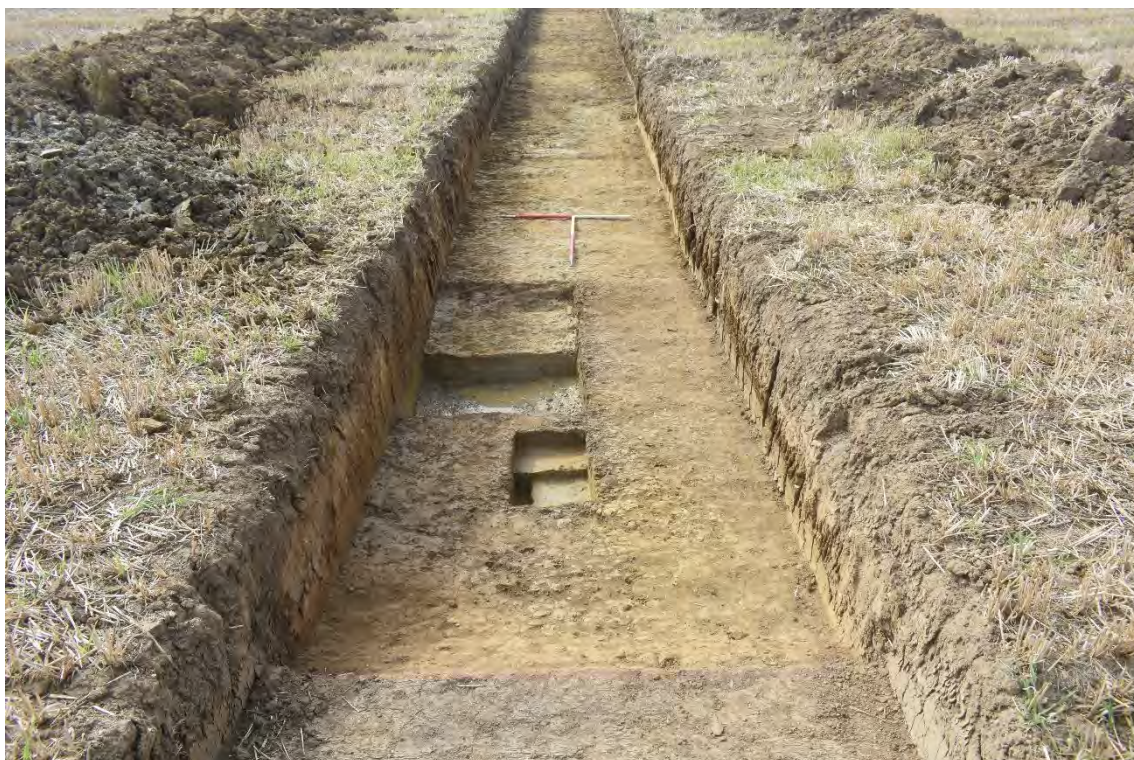
Plate 1.4: Trench 11. Plan view of investigations into pond-like sequence (1109)-(1107), looking west.

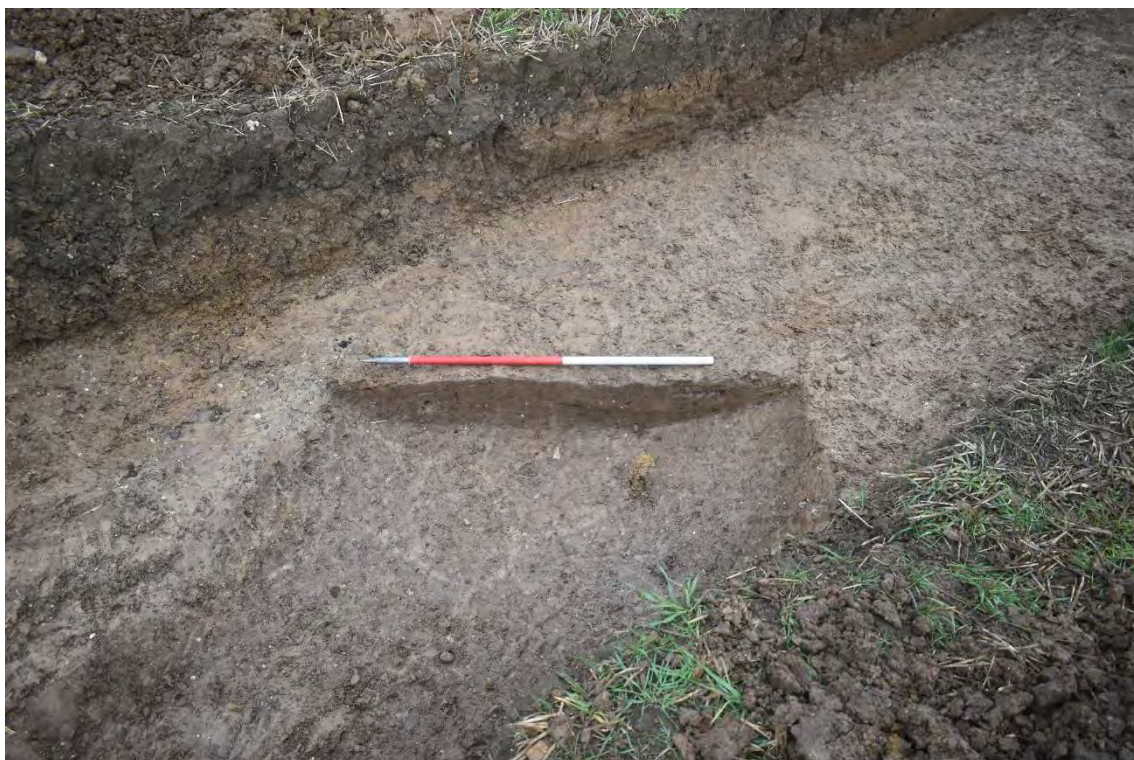
Plate 1.6: Trench 27. Probable geological channel [2704], looking east.

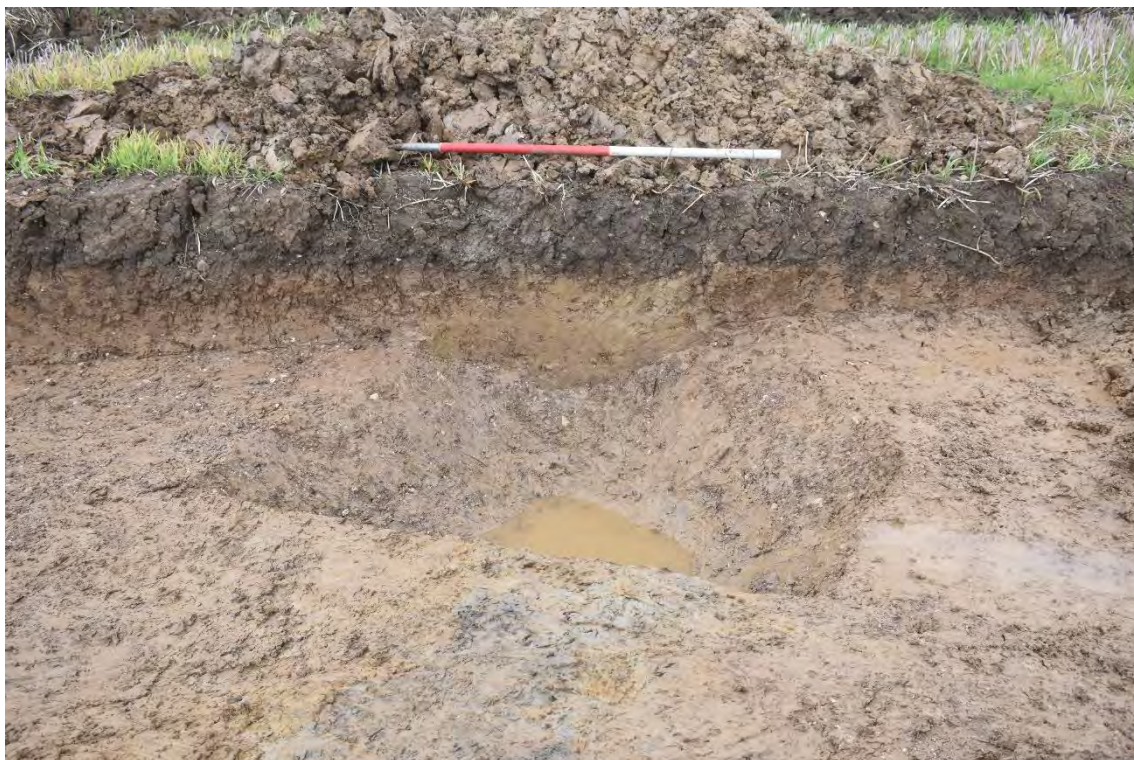
Plate 1.7: Trench 23. Probable tree throw [2309], looking north-northwest.

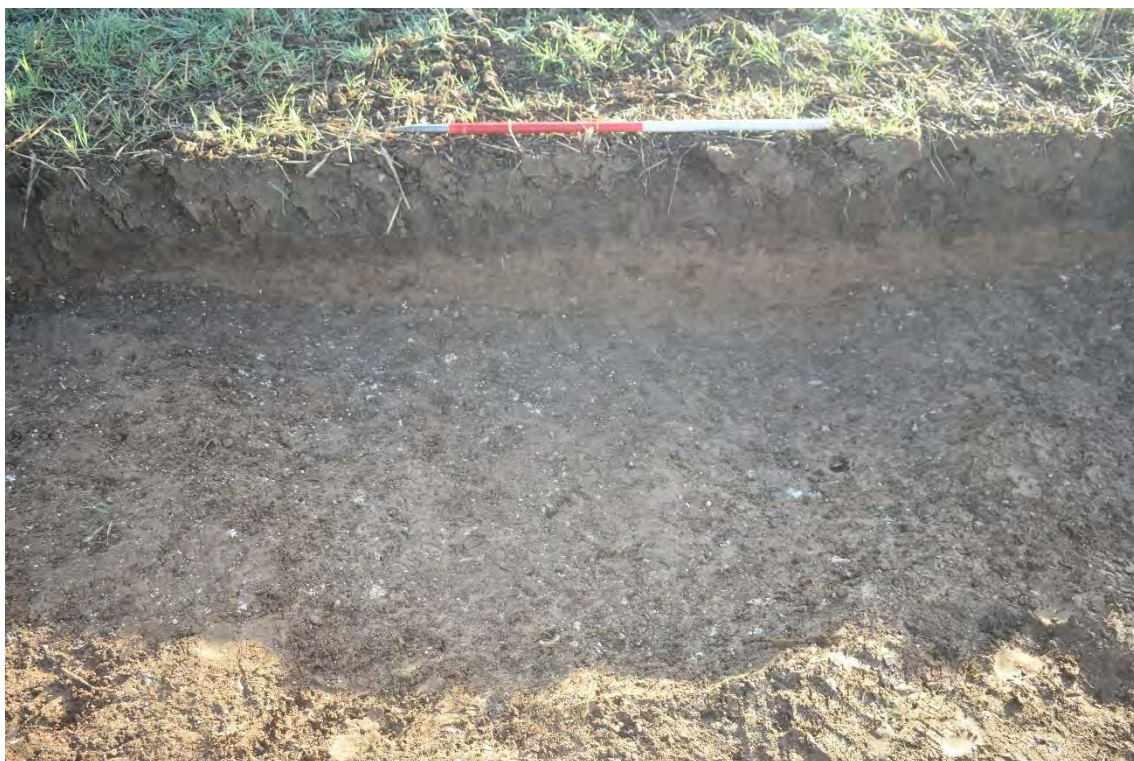
Plate 1.8: Trench 56. Fully excavated natural hollow [5603], looking east.

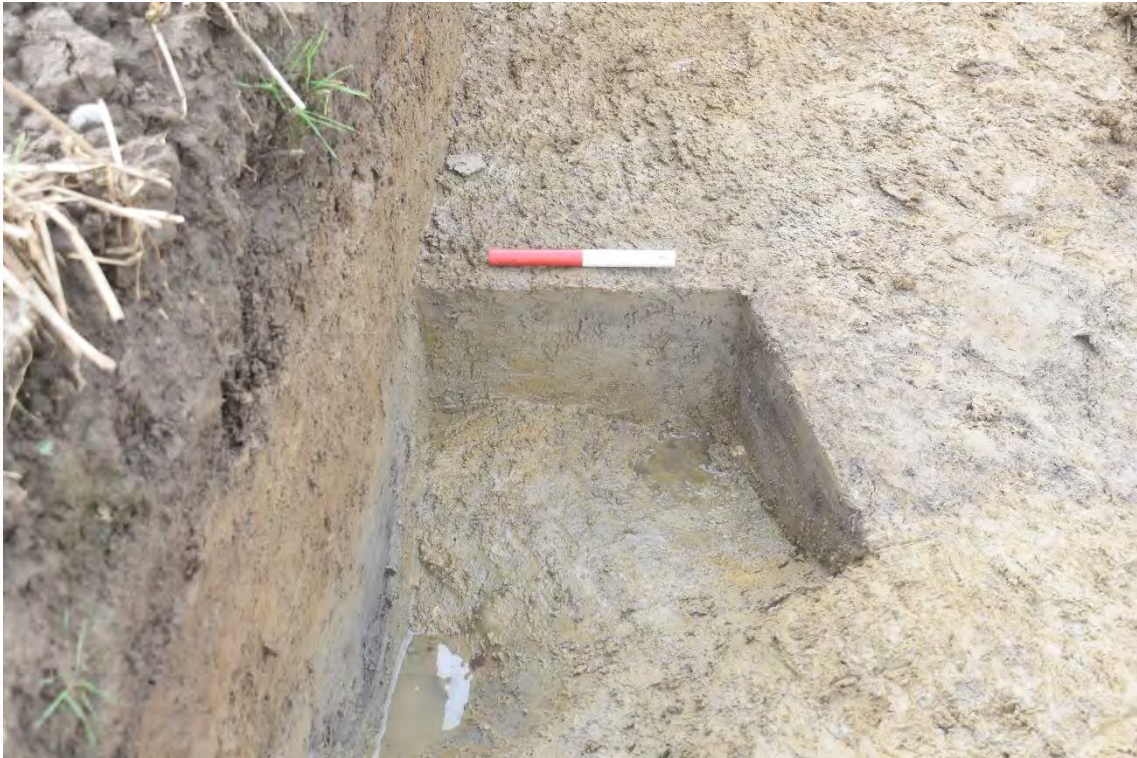
Plate 1.9: Trench 1. Sterile blue-grey and gleyed sandy fills in natural feature [105] within natural sandy clay (113). Looking southwest.

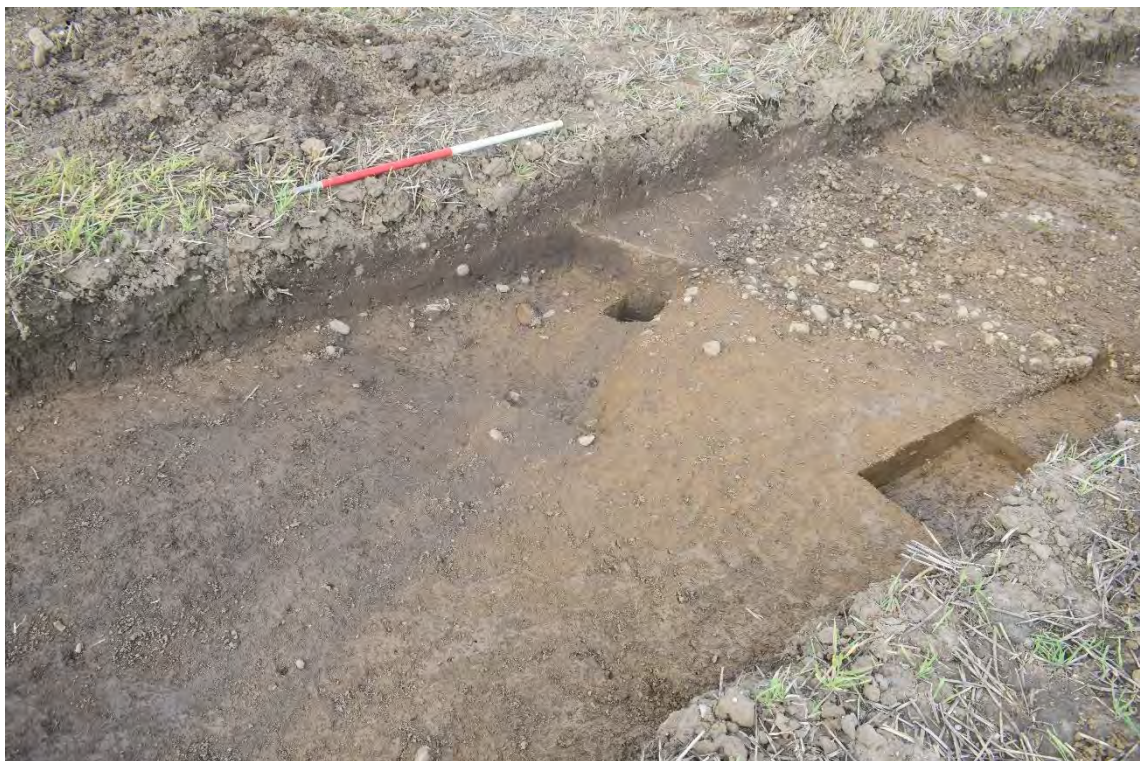
Plate 1.10: Trench 1. Ditch [119] cutting natural gravel (118), with the ground level dropping away to the northeast (right). Looking northwest.

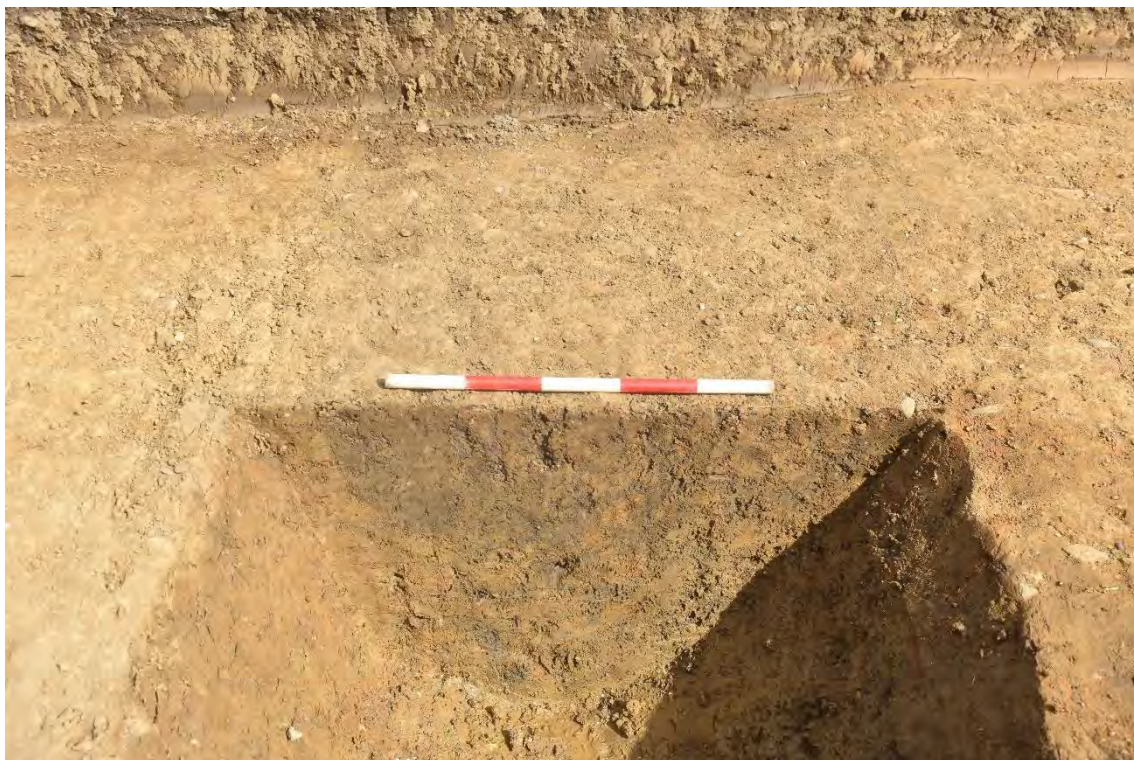
Plate 1.12: Trench 2. Ditch [203] with recut [206]; looking west.

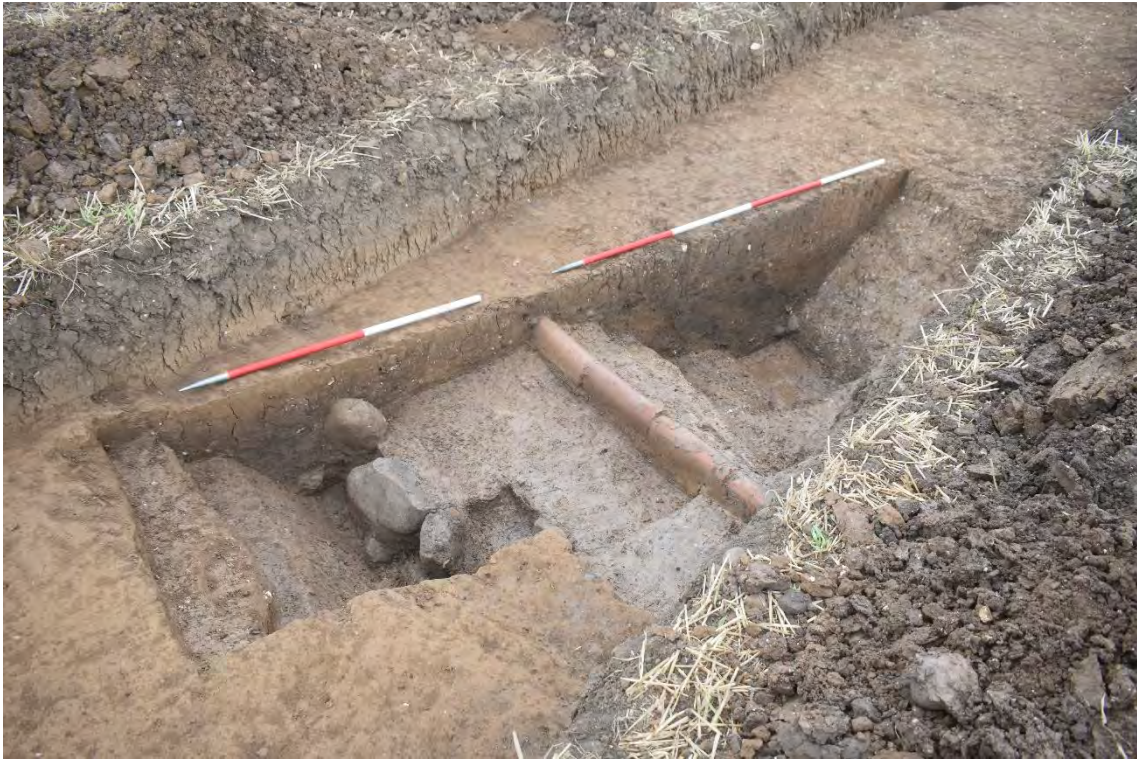
Plate 1.15: Trench 3. Oblique view of ditch [354] (mid-excitation) containing stone deposit (359), and parallel ditch sequence [355], [379], [381]. Looking northeast.

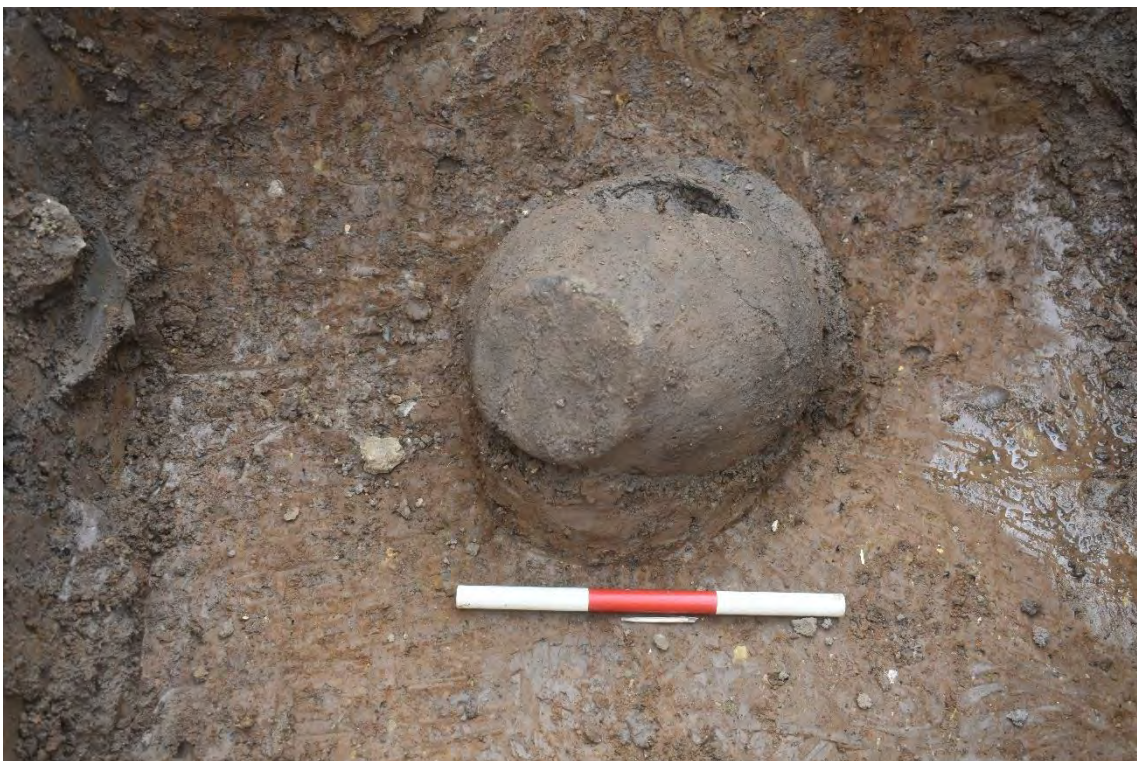
Plate 1.16: Trench 3. Plan view of near-complete pot RF DBS2/3, close to the base of the ditch recut [305] with unexcavated fills of the original ditch [330] visible below.

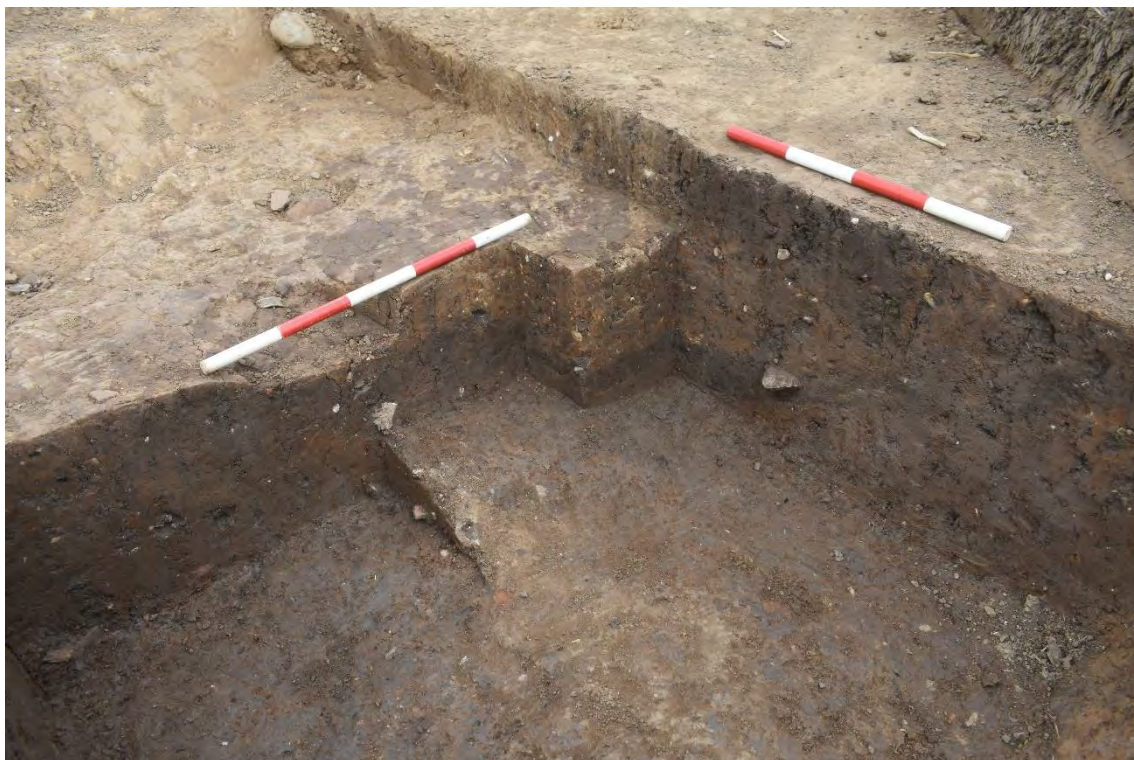
Plate 1.17: Trench 3. Feature [309], with distinctive yellow clay-rich lower fill (310), cutting into the backfilled ditch recuts [305], [307]. Looking east.

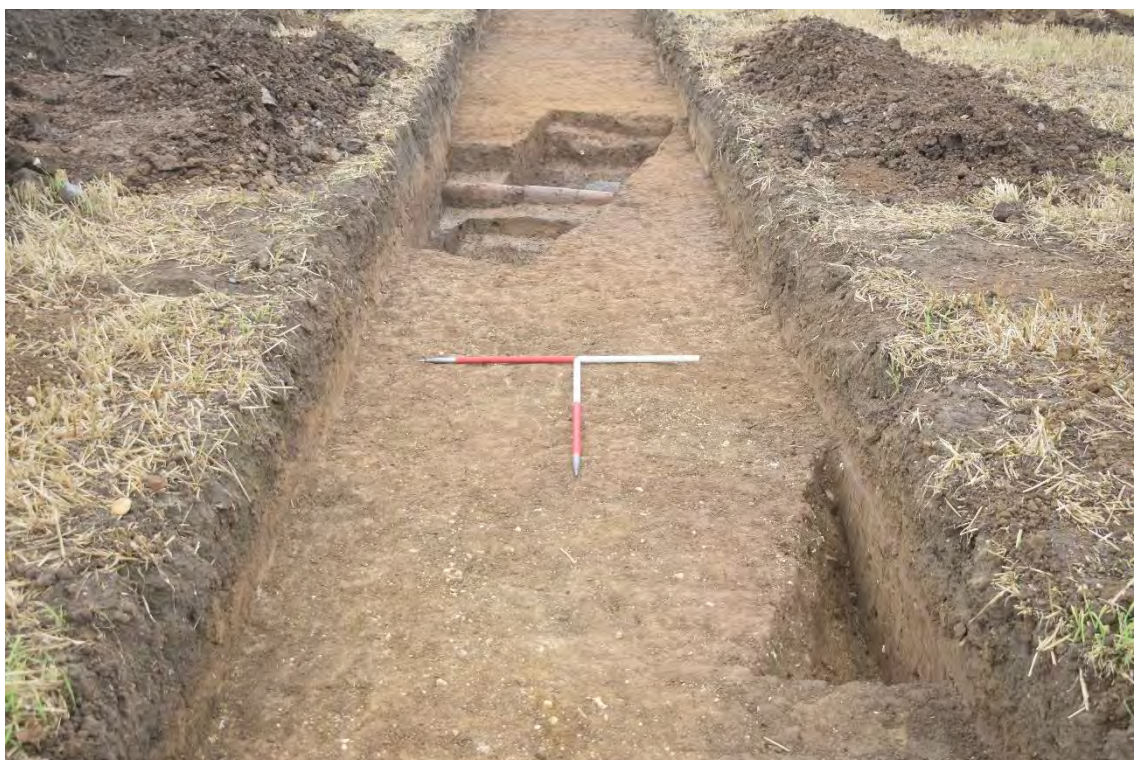
Plate 1.18: Trench 3. View from the eastern end of the trench with ditch [343] in foreground and perpendicular ditches [354], [355] in background. Looking west.

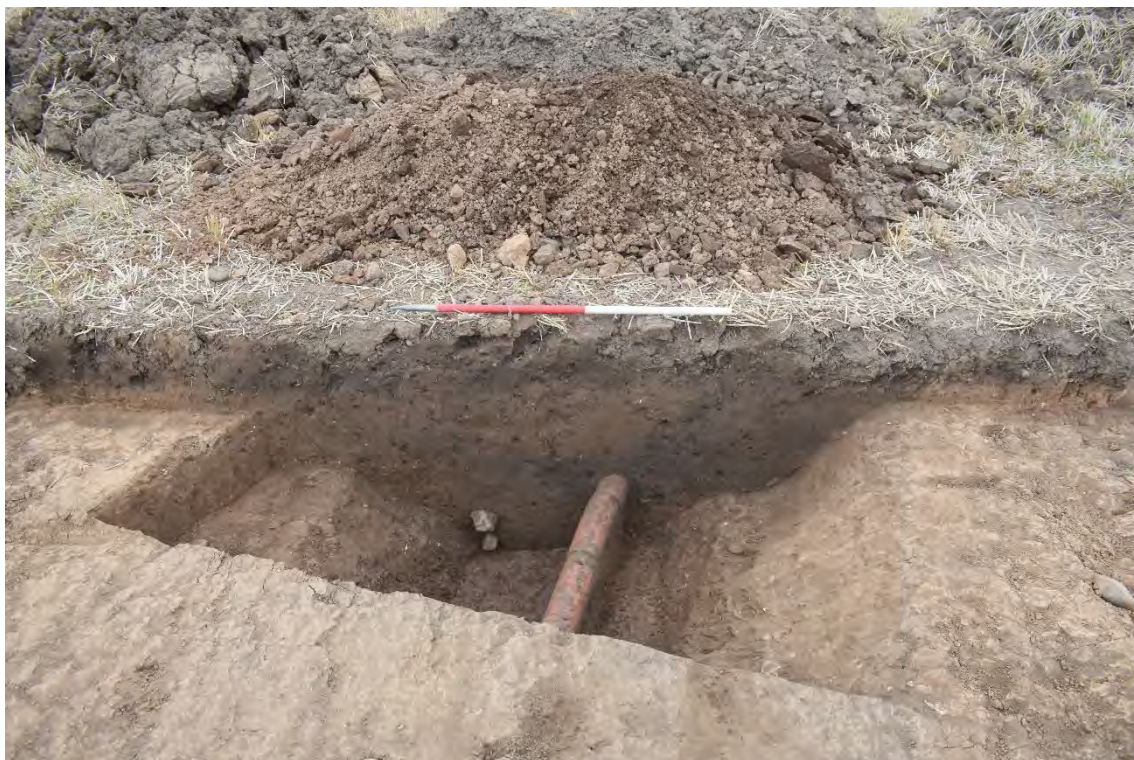
Plate 1.19: Trench 3. North-facing section of ditch [313], probable post-medieval recut [386] and drainage ditch [319], with broad and shallow cut [321] across the top. Looking south.

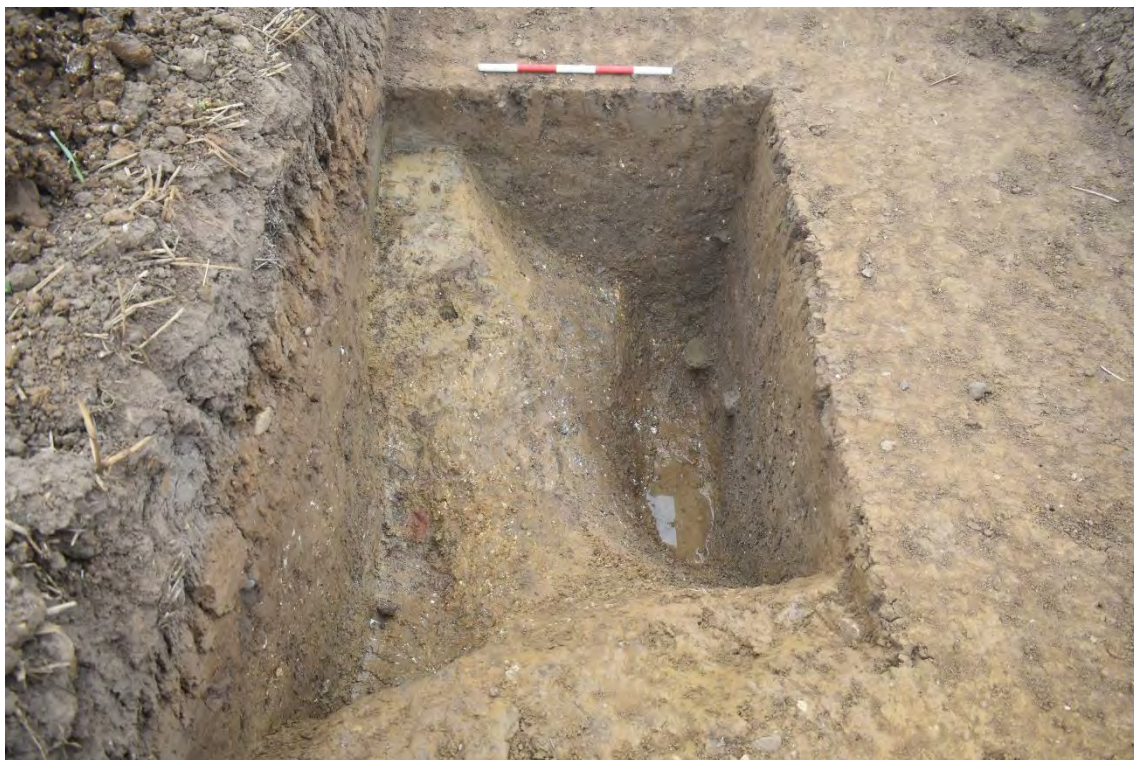
Plate 1.20: Trench 4. Plan view of pits [433], [431] and [429]. Looking southwest.

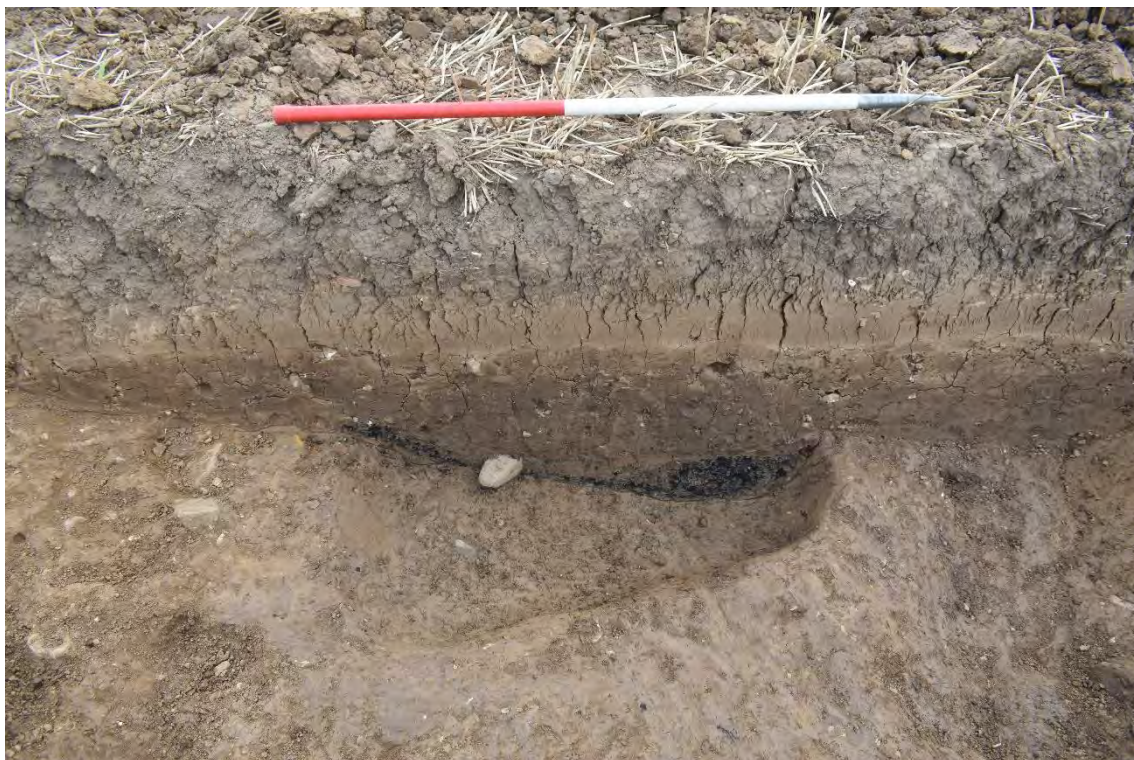
Plate 1.21: Trench 4. Pit [410] fully excavated, with lining (409) in section. The pit is cut into the fills of the southern trackway ditch [407] and its recut [420]. Looking southeast.

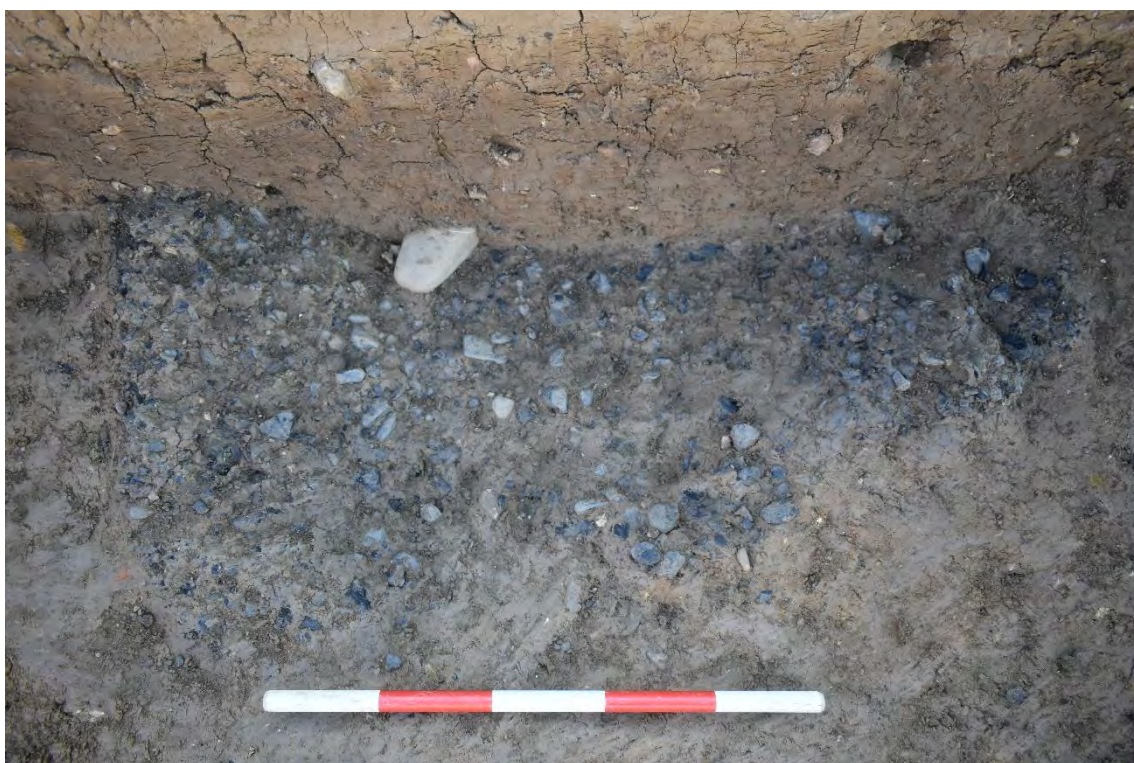
Plate 1.22: Trench 4. Detail view of coal/shale and pebble lining (409) in pit [410]. Looking southeast.

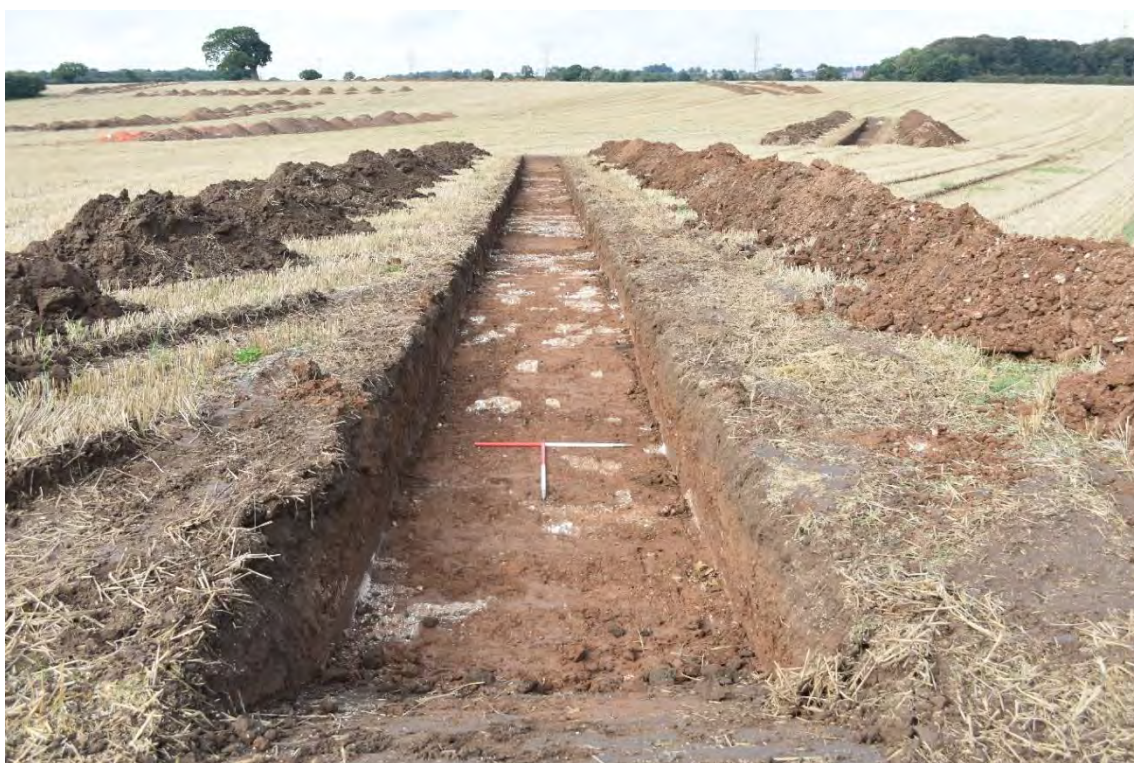
Plate 2.4: Trench 83. Trench shot showing an example of clay and chalk natural. Looking northwest.
