Dogger Bank South Offshore Wind Farms

Environmental Statement

**Appendix 22-5 Onshore Infrastructure Settings
Assessment (Revision 2) (Tracked)**

Application Reference: 7.22.22.5

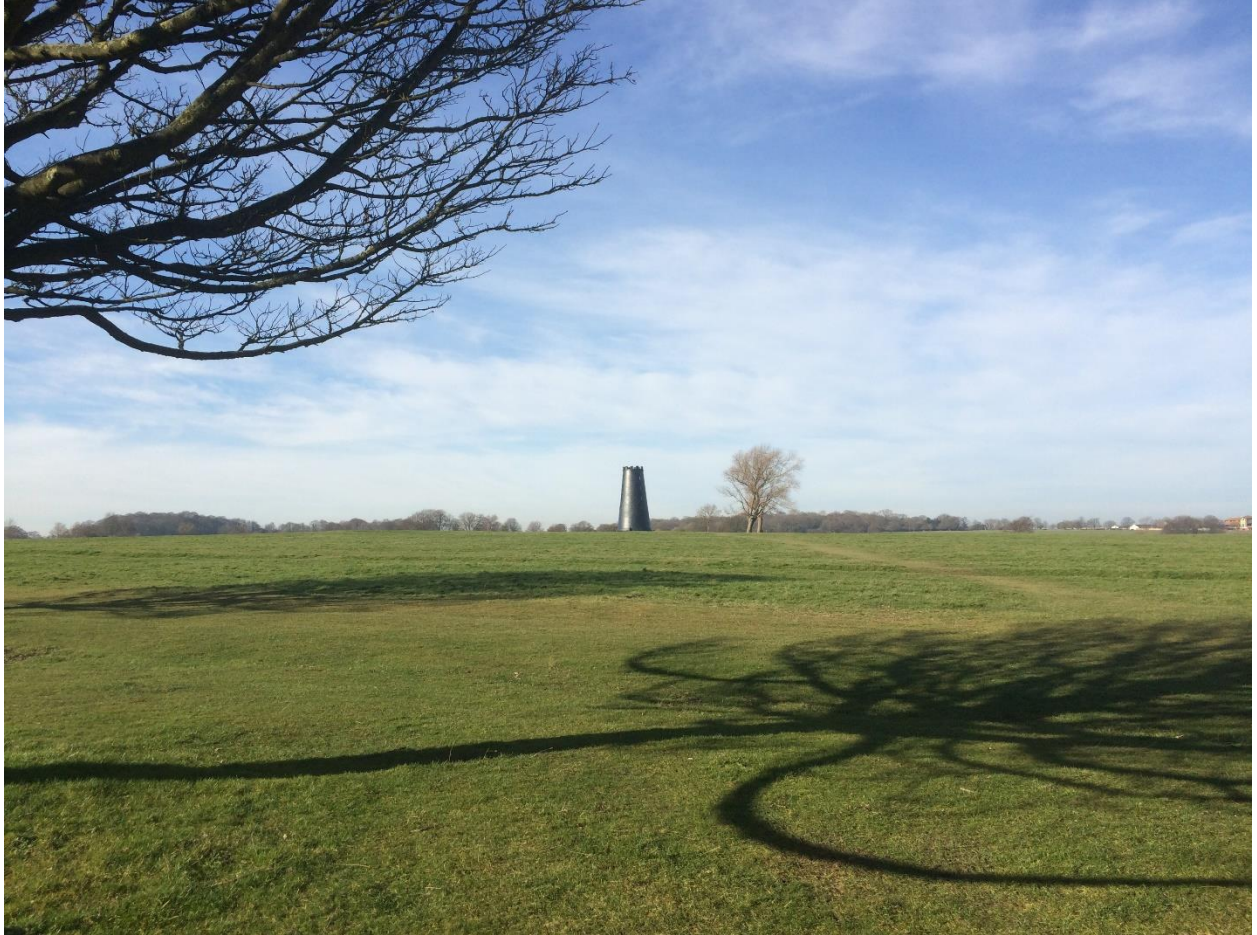
Plate 22-5-1 General view looking northwest towards the group of prehistoric barrows with Black Mill (1310087) at centre of image

~~43.45.~~ These assets are considered alongside the other Scheduled barrows which fall outside the ZTV as they are considered an important group of prehistoric funerary earthworks surviving together on Westwood Common and share the same or very similar settings (**Plate 22-5-1**).

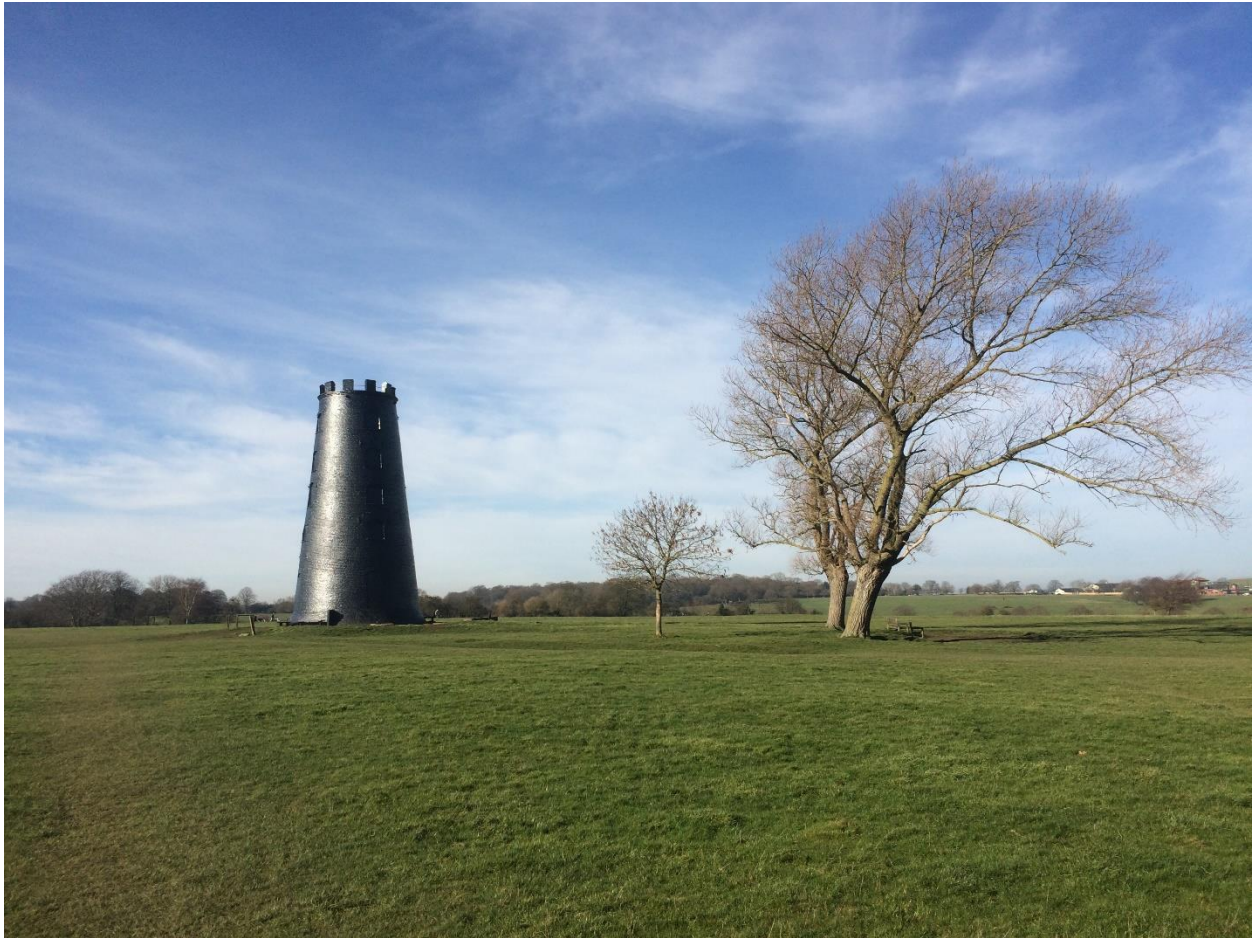
Plate 25-5-2 Black Mill (1310087), viewed from the east

~~55.57.~~ The mill originally formed part of a group of six mills on Westwood Common; five corn mills and one whiting mill. Black Mill and the windmill at the golf club (1346337), located approximately 400m to the south, are the only two surviving windmills on the common.

~~56.58.~~ Black Mill was damaged by fire in 1868 and all the timber parts and working gear were dismantled, with the mill later used as a dwelling until 1934.

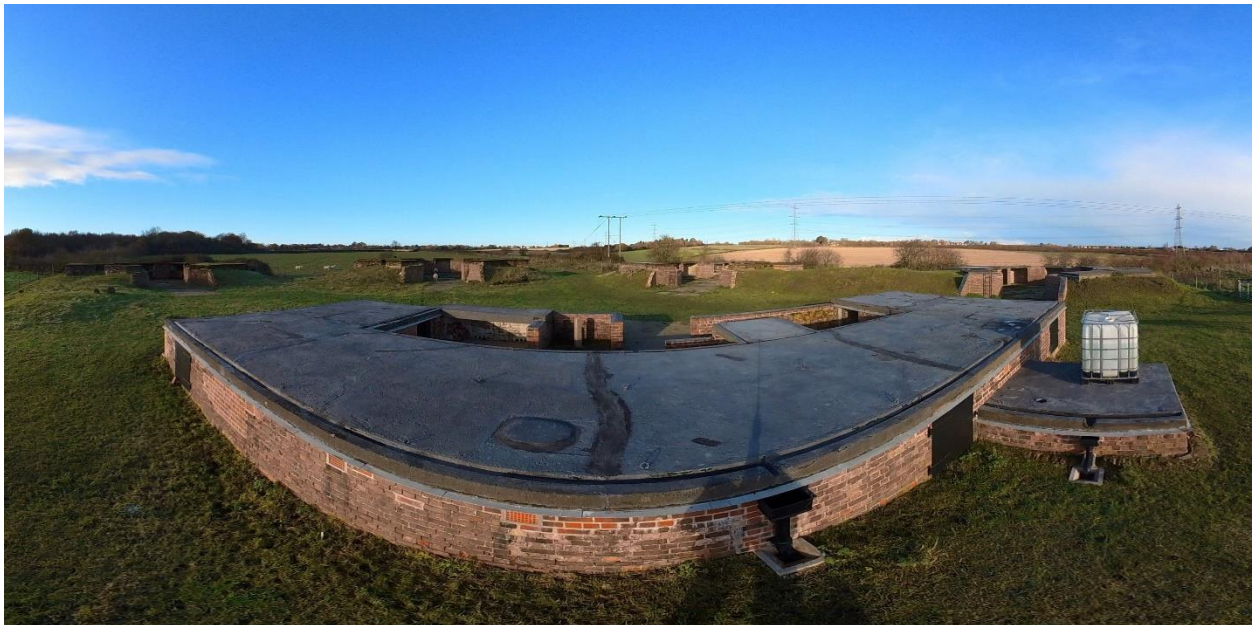
Plate 22-5-3 Heavy Anti-aircraft gunsite (1019186) with the command post in the foreground, viewed from southeast (taken with a 360° camera).

- ~~67.69.~~ The gun emplacements and command post are all constructed of brick with flat concrete roof sections and concrete floors. The battery is of a standardised pattern, designed with the gun emplacements in a chevron, with the apex in the direction of fire to maximise the concentration of fire, and command post and radar mounted in the arc behind the guns. They broadly follow standard designs. The four gun emplacements are arranged in an arc around the north west side of the command post which also faces north west (**Plate 22-5-3**).

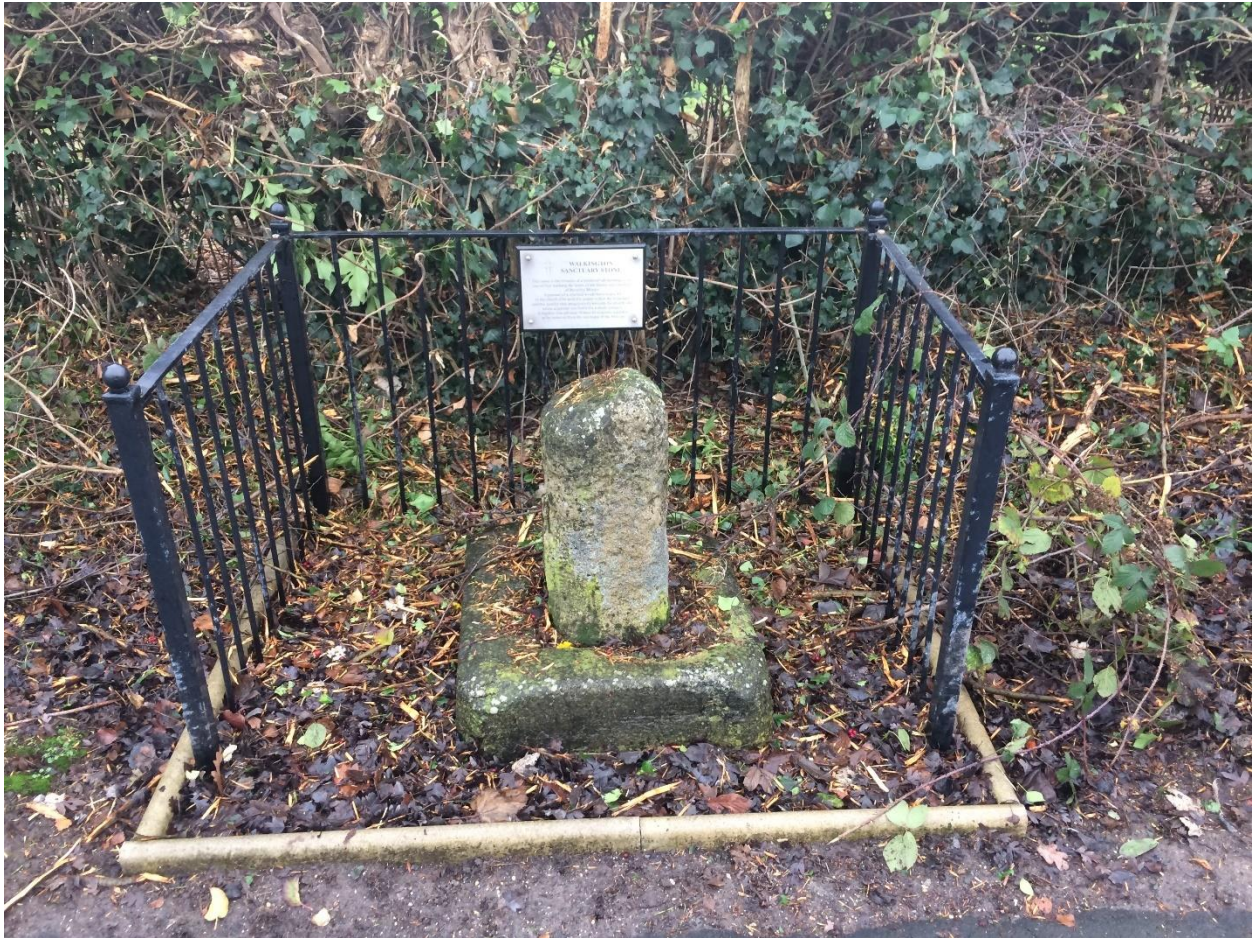
Plate 22-5-4 Walkington Cross (1012591), viewed from the north on East End Road

~~92.99.~~ Its roadside location forms its immediate setting. The village of Walkington to the west and Beverley to the east form the asset's wider setting and contribute to the ability to appreciate the asset's function and importance.

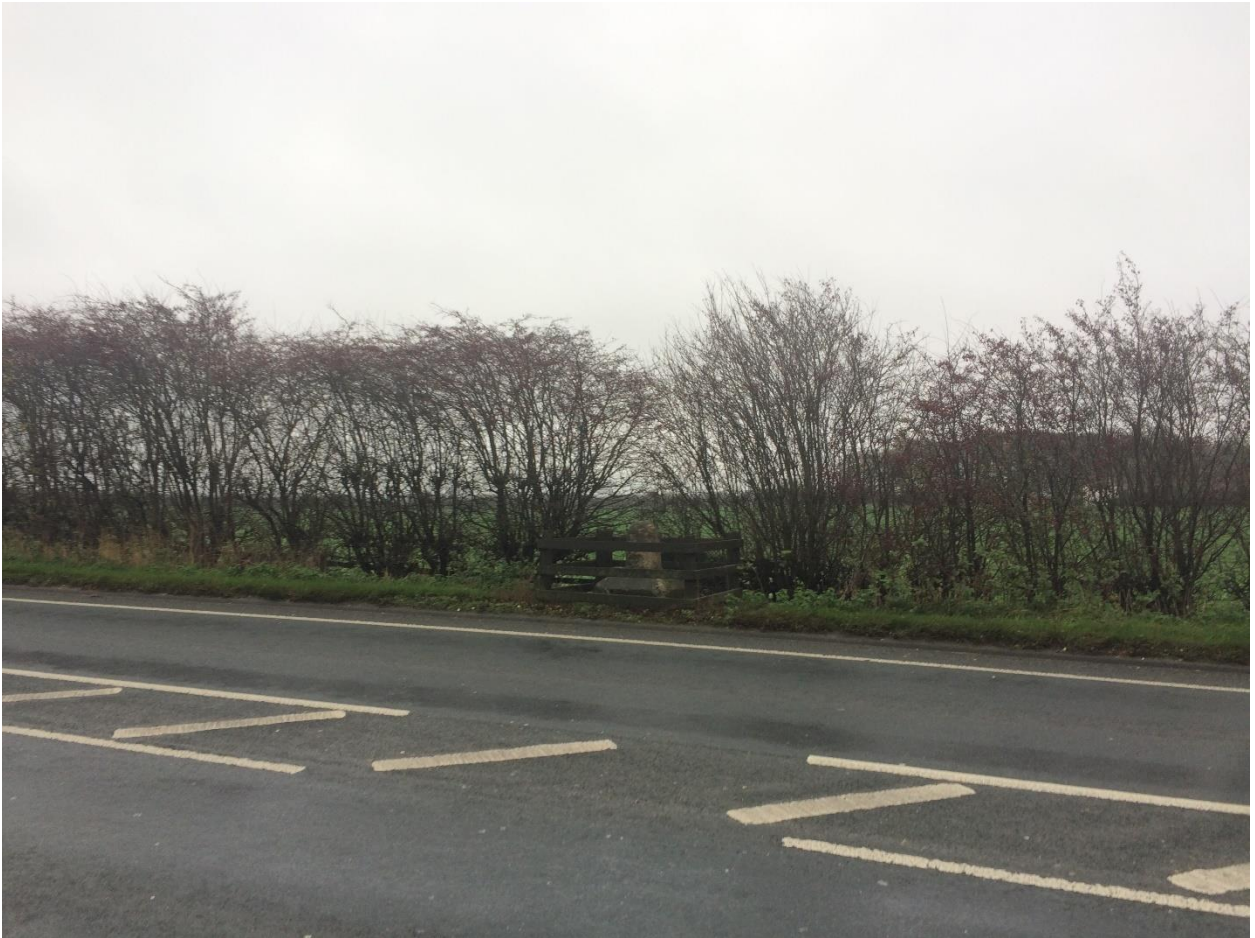
Plate 22-5-5 Bentley Cross (1012590), viewed from the west

~~100.107.~~ Its roadside location forms its immediate setting with the villages of Bentley to the south and Beverley to the north forming the asset's wider setting and contribute to the ability to appreciate asset's function and importance.

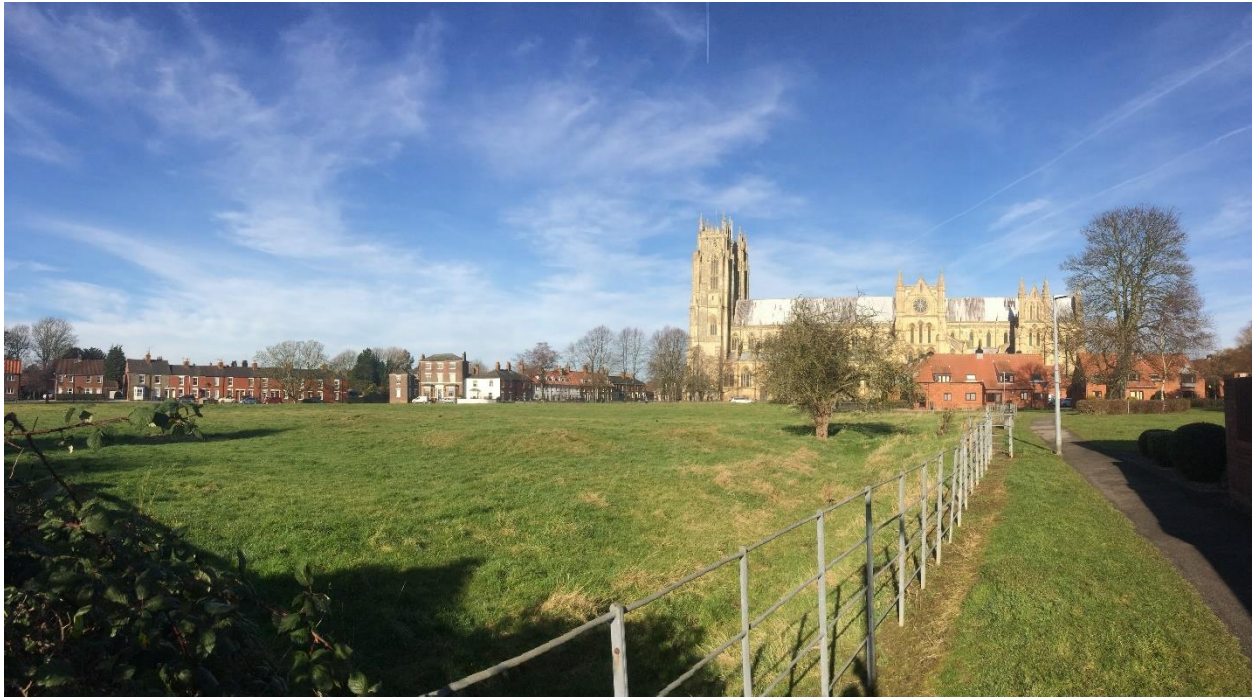
Plate 22-5-6 Beverley Minster (1084028) with Hall Garth Scheduled moated site (1008122) in the foreground

- ~~118.125.~~ The Minster is the focal point of Beverley's historical interest and significance, with the town's oldest roads converging on it, often still cobbled in form. This, along with the historic street names, intervisibility with St Mary's Church to the west, Hall Garth moated site, directly adjacent to the Minster, and the large number of contemporary buildings along the nearby streets to the north all contribute to a relatively intact historic setting, which is a contributor to the Minster's heritage significance (**Plate 22-5-6**).

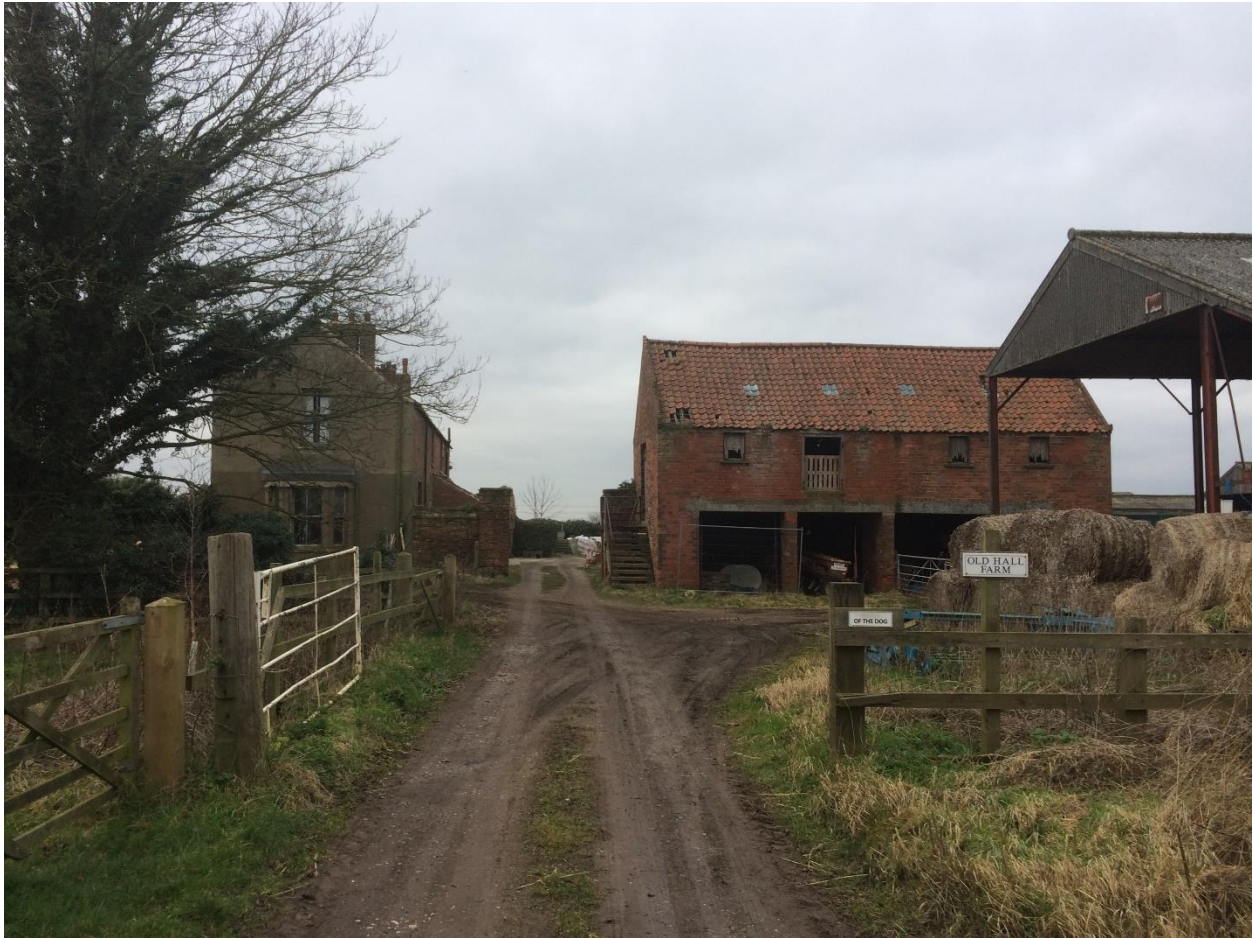
Plate 22-5-7 Old Hall (1103420) to left of image with the barn (1103419) to the centre-right

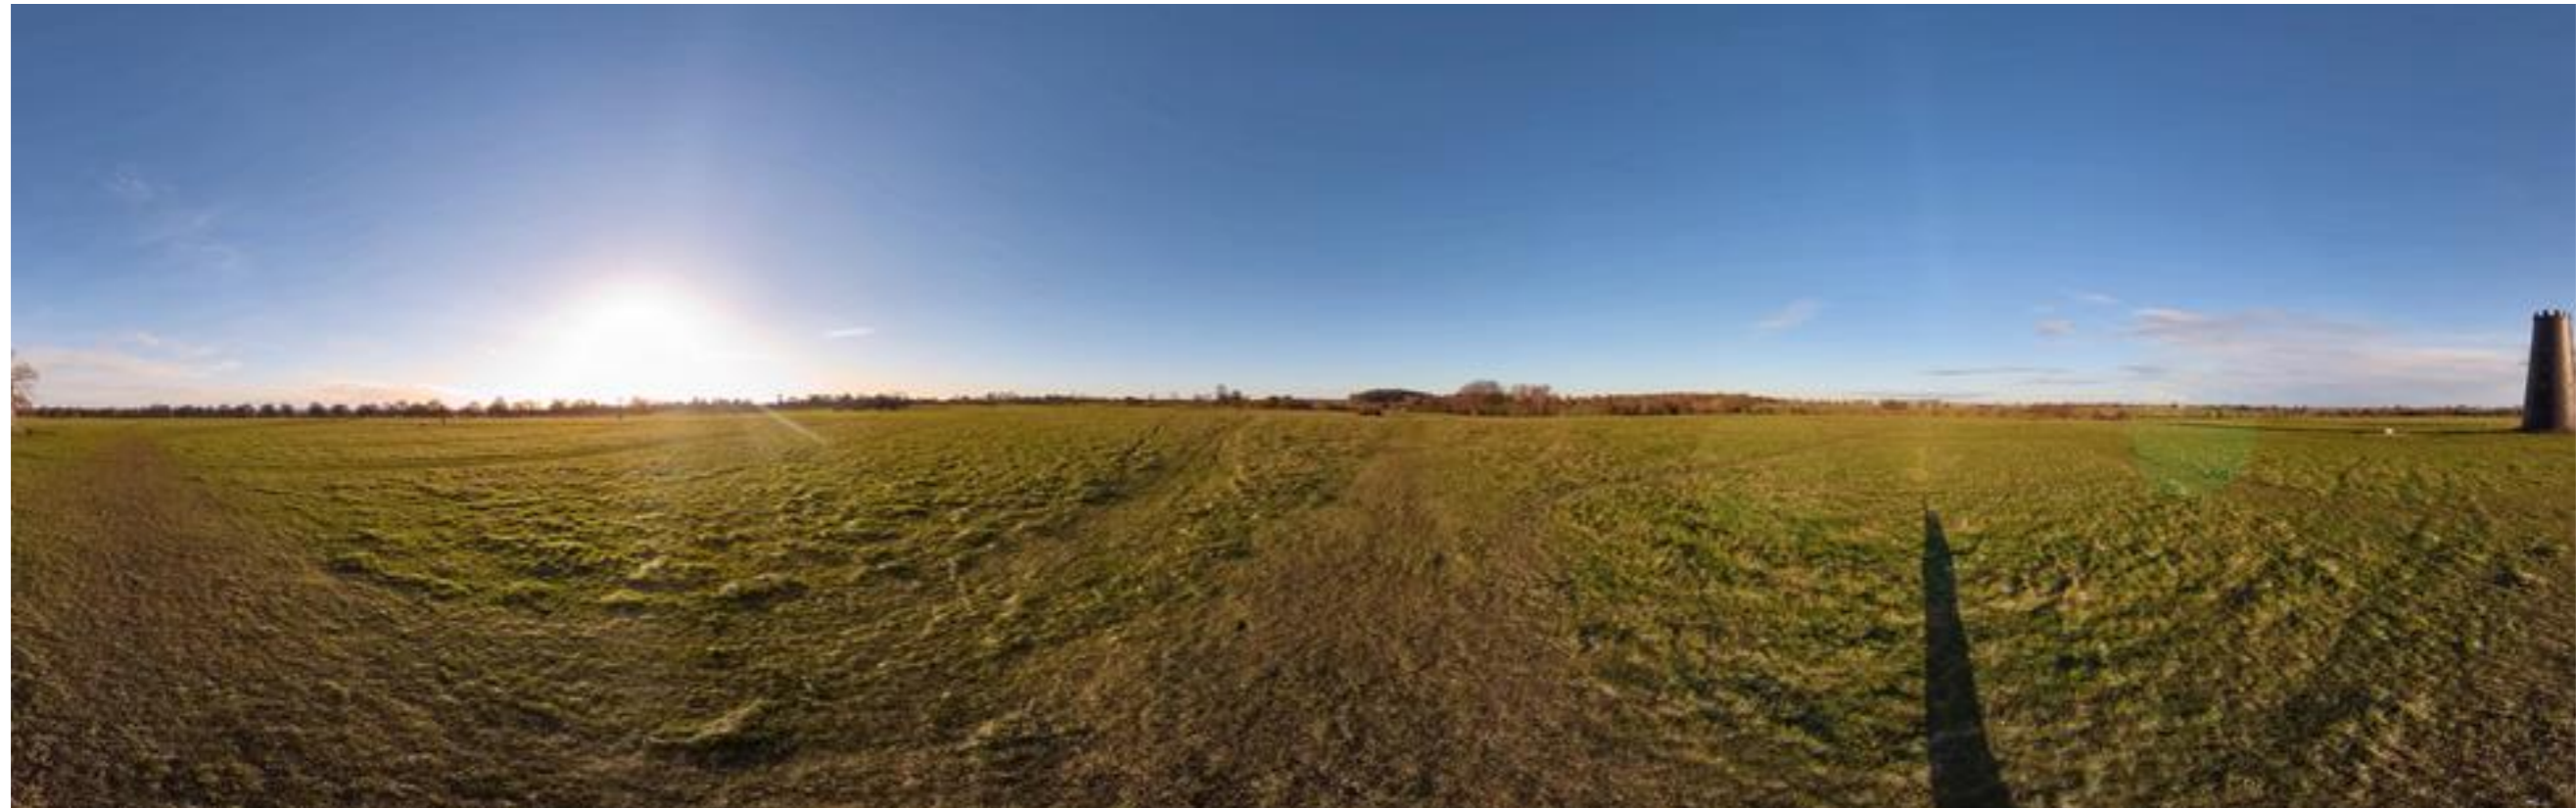
Plate 22-5-8 360° view from Westwood Common with Black Mill (1310087) to the right of the image and Beverley Minster (1084028) to the left of the image.

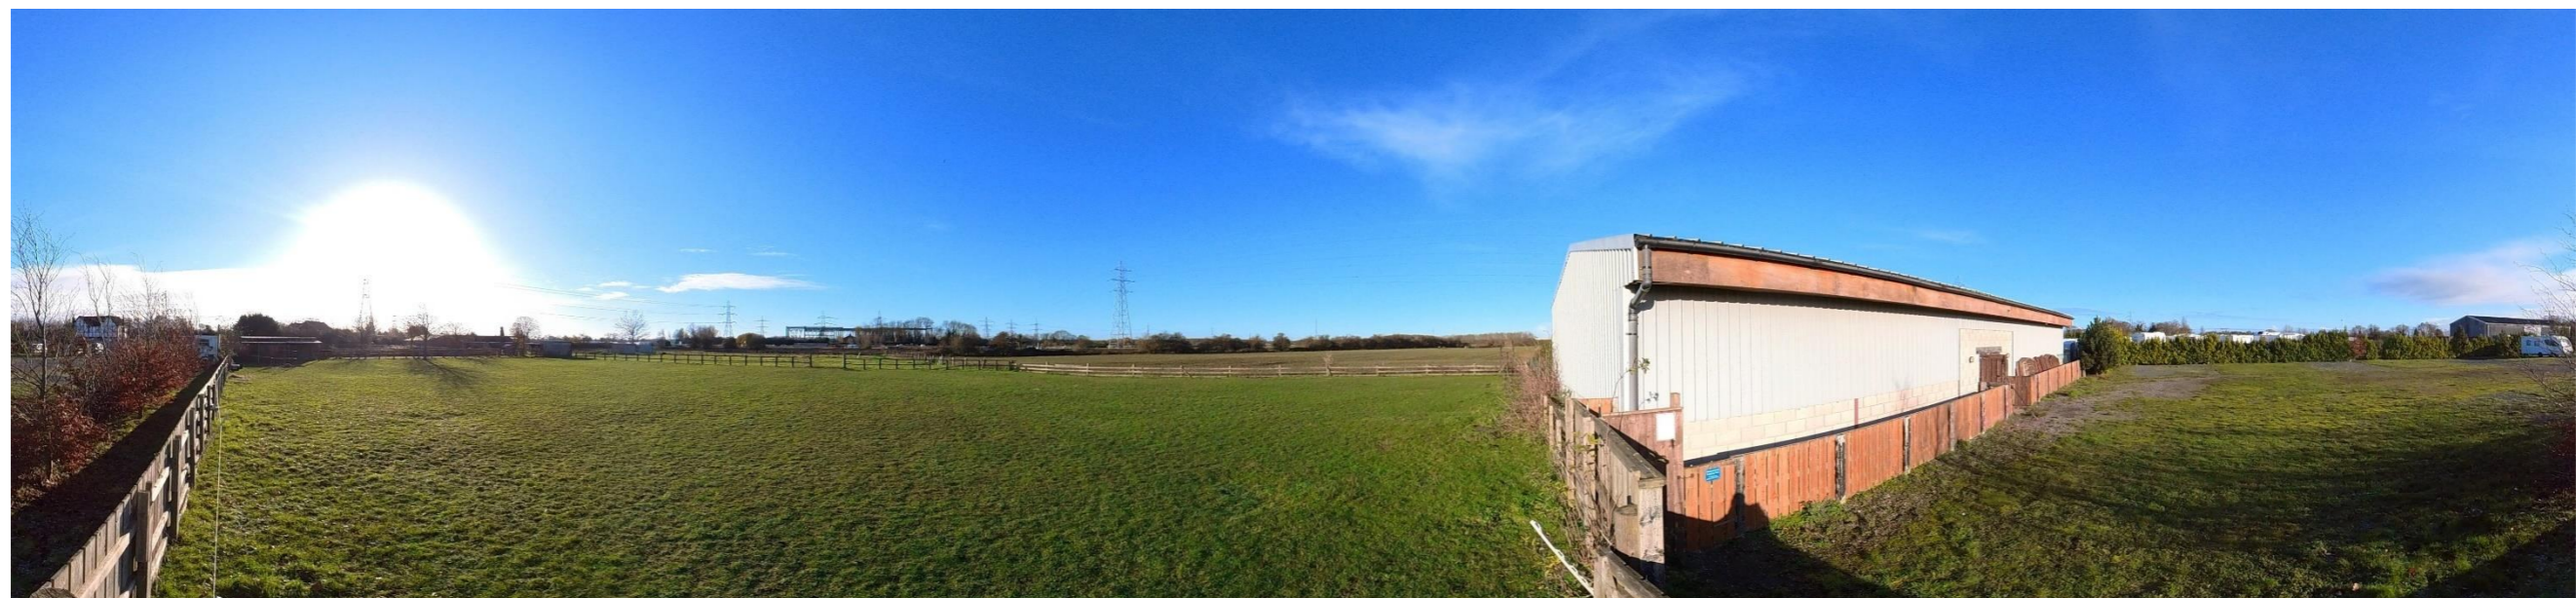
Plate 22-5-9 360° view from field located south of the Scheduled Bowl Barrow (1007731). Approximate location the Substation Zone is beyond the trees located towards the centre of the image.

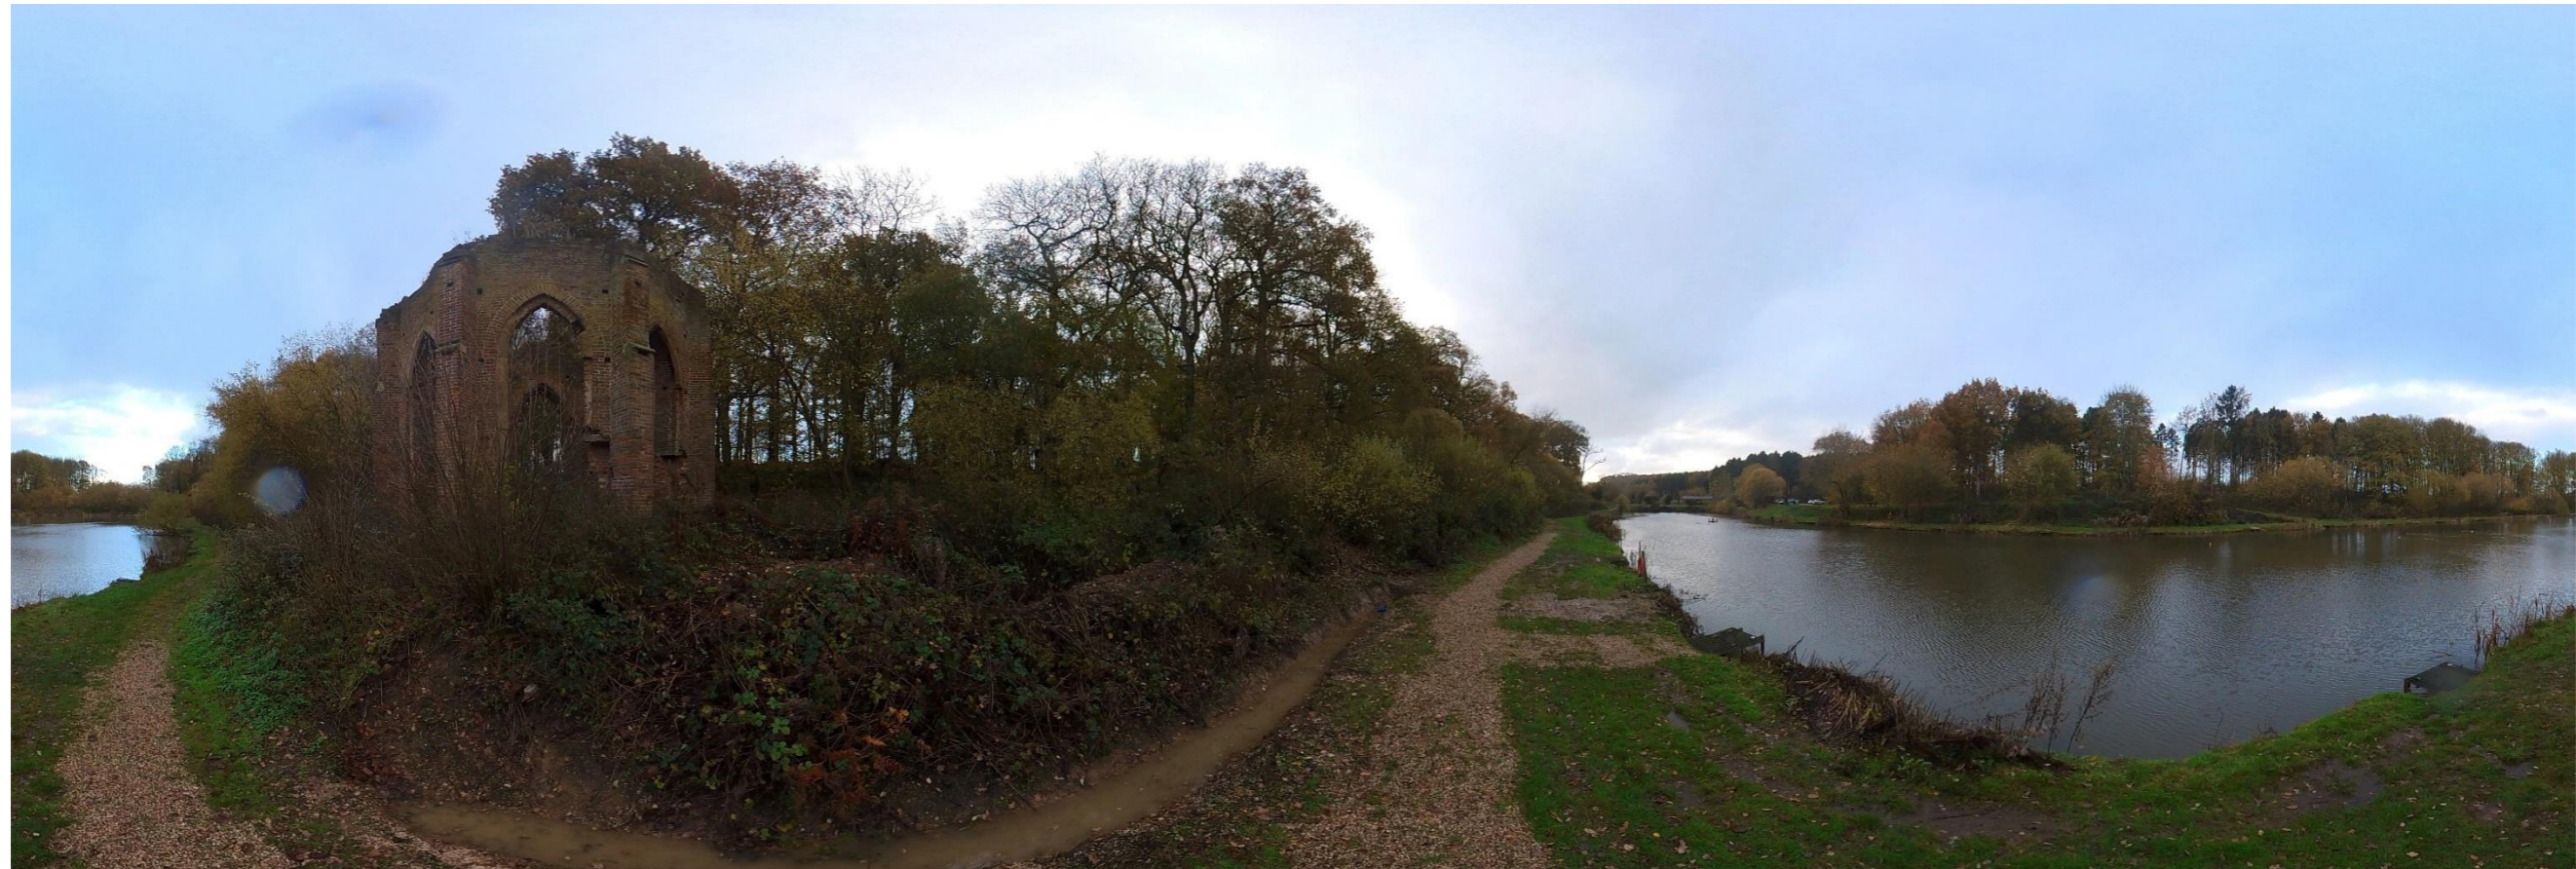
Plate 22-5-10 360° view from within Risby Hall Registered Park and Garden (1001419) with the Grade II Listed Folly in Fishpond Wood (11611815) to the left of the image.

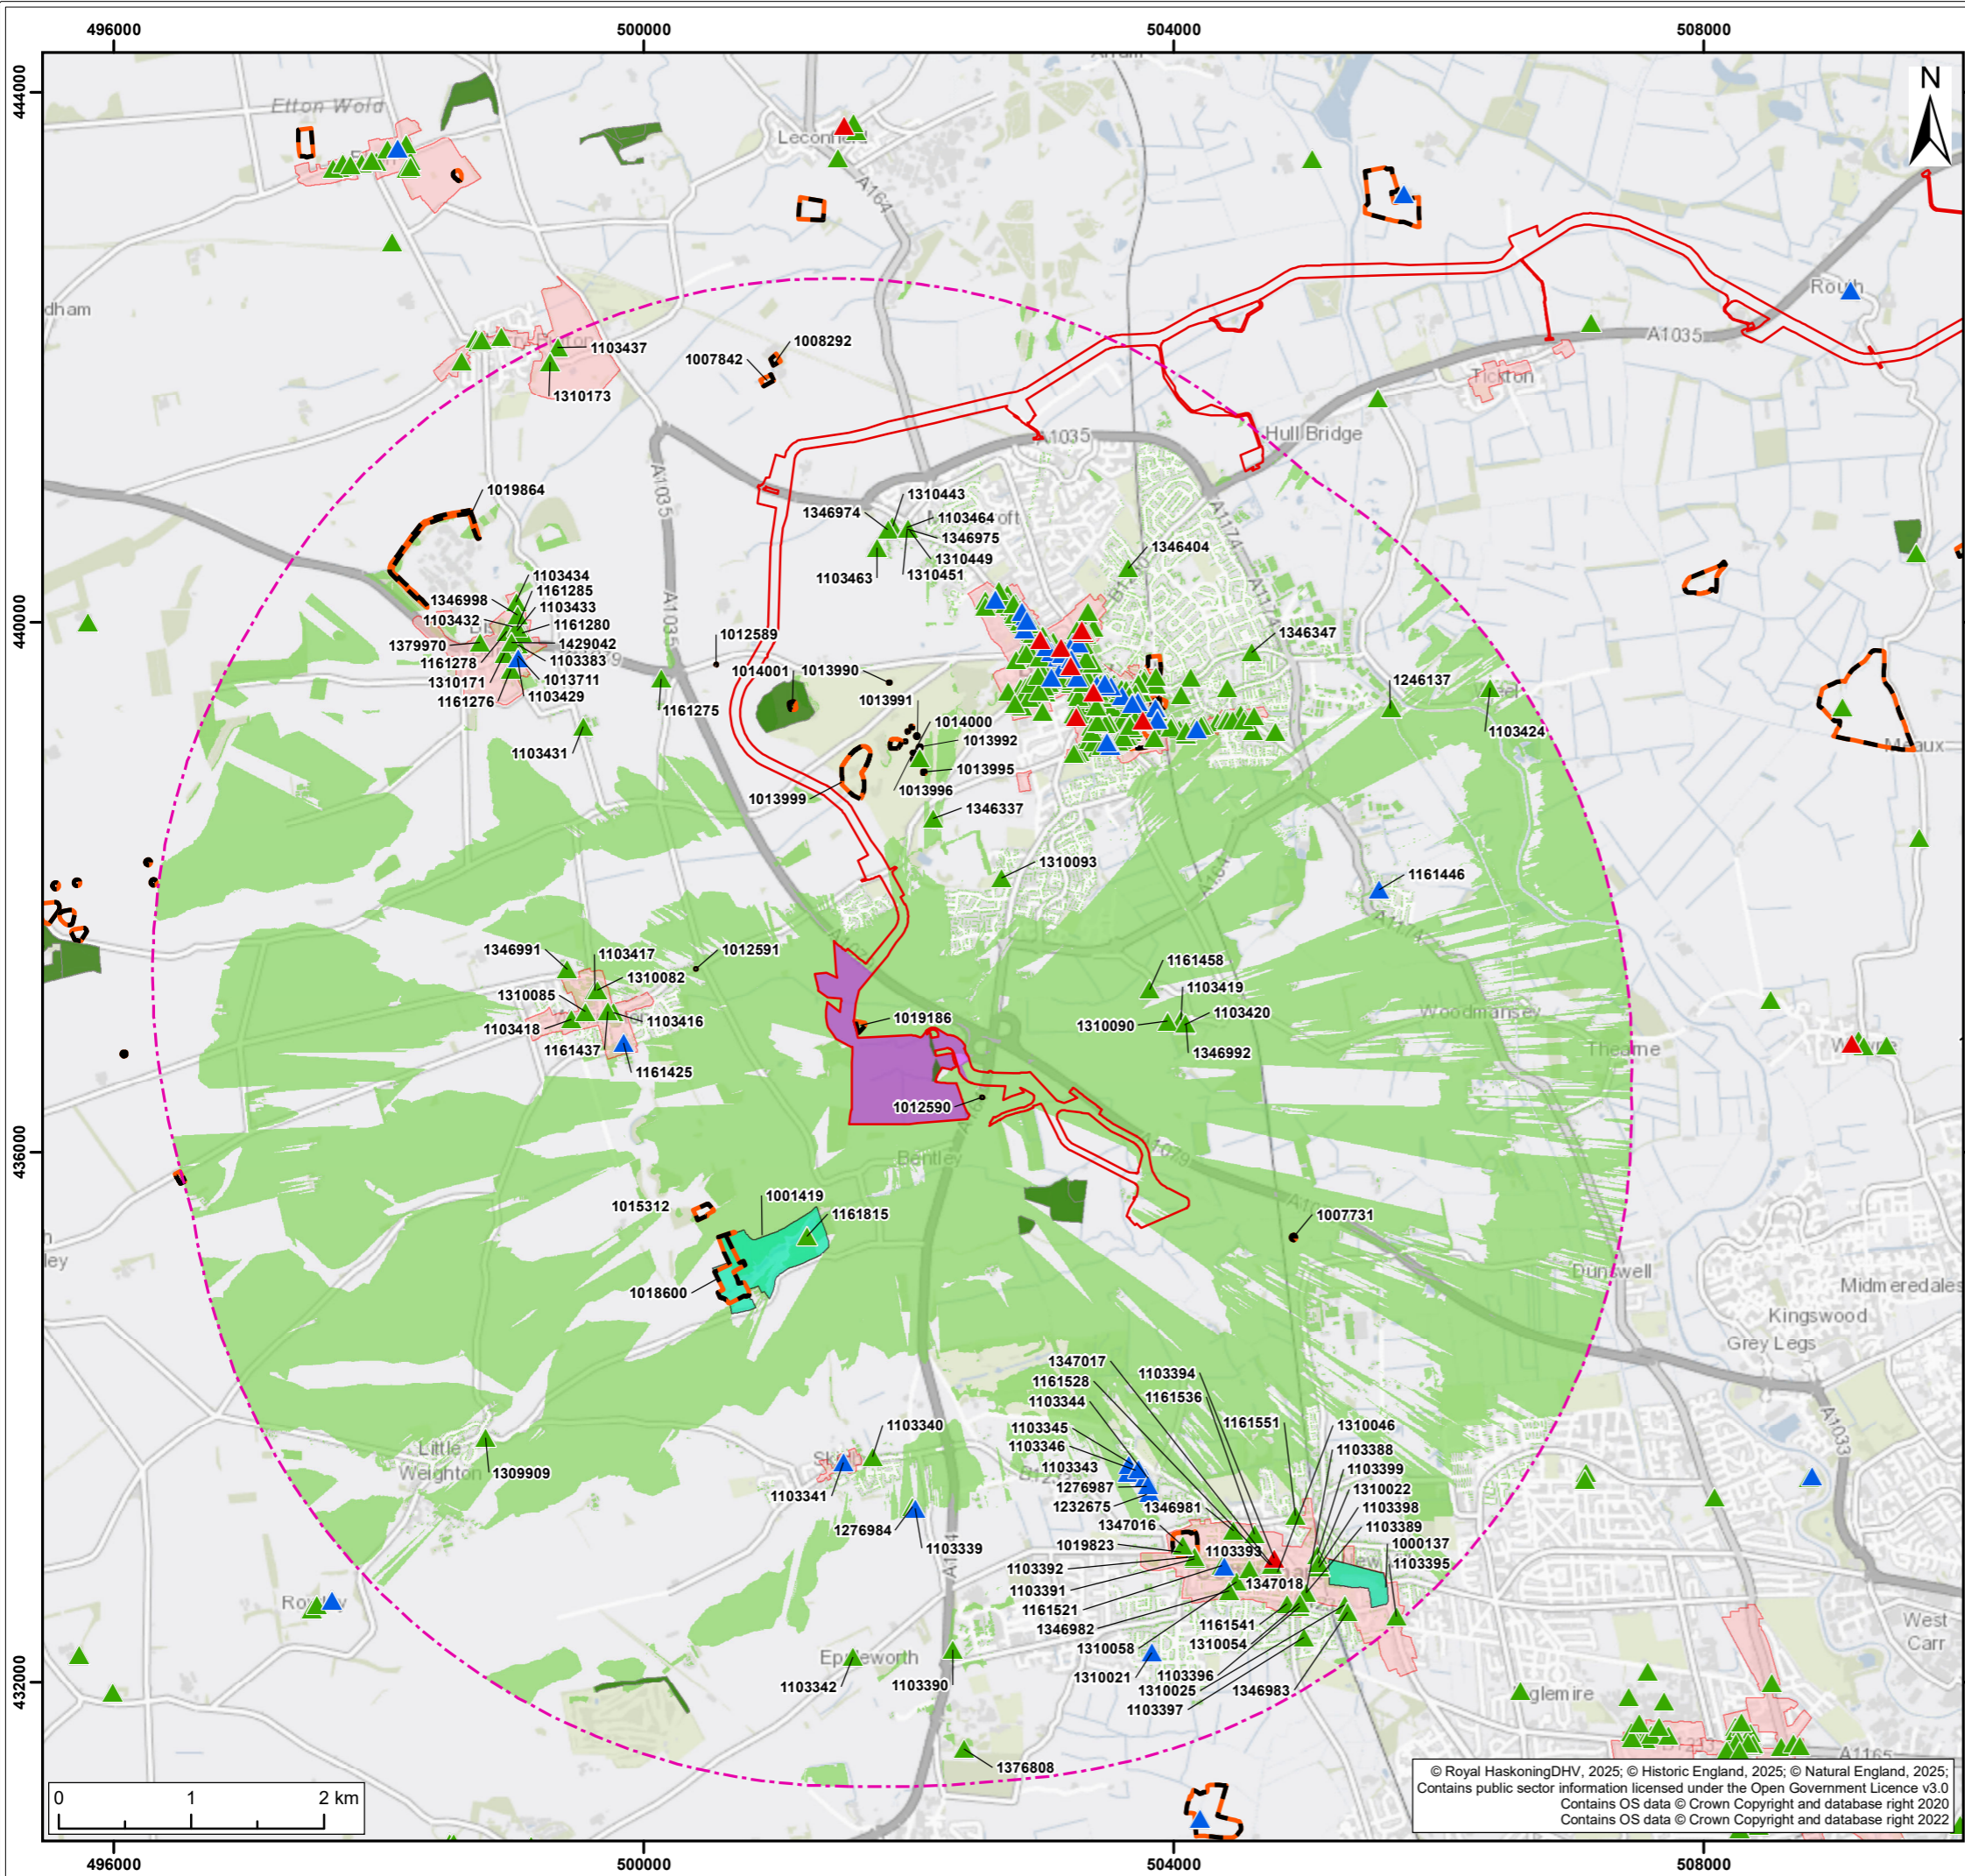
Figure: 22-5-2 Drawing No: PC2340-RHD-ON-ZZ-DR-Z-0657

- Onshore Development Area
- Designated Heritage Asset Study Area
- Substation Zone
- Scheduled Monuments
- Registered Parks and Gardens
- Conservation Areas
- Ancient Woodland
- Substation theoretically visible

~~20.22.~~ The screening assessment used a ZTV to identify heritage assets within a 5km study area where visibility of the Onshore Substation Zone may or may not be possible and experienced (**Figure 22-5-2**).

~~21.23.~~ The ZTV was calculated to a height of 24m for the indicative Onshore Converter Station operational footprint), from a viewing height of 2m above ground level. The terrain model is based on Ordnance Survey OS Terrain 5 digital terrain model (DTM) data (5m grid, obtained from Ordnance Survey in November 2022), edited to create an indicative Digital Surface Model (DSM), incorporating:

~~22.24.~~ Earth curvature and atmospheric refraction have been taken into account. The ZTV was calculated using ArcMap 10.8.1 software.

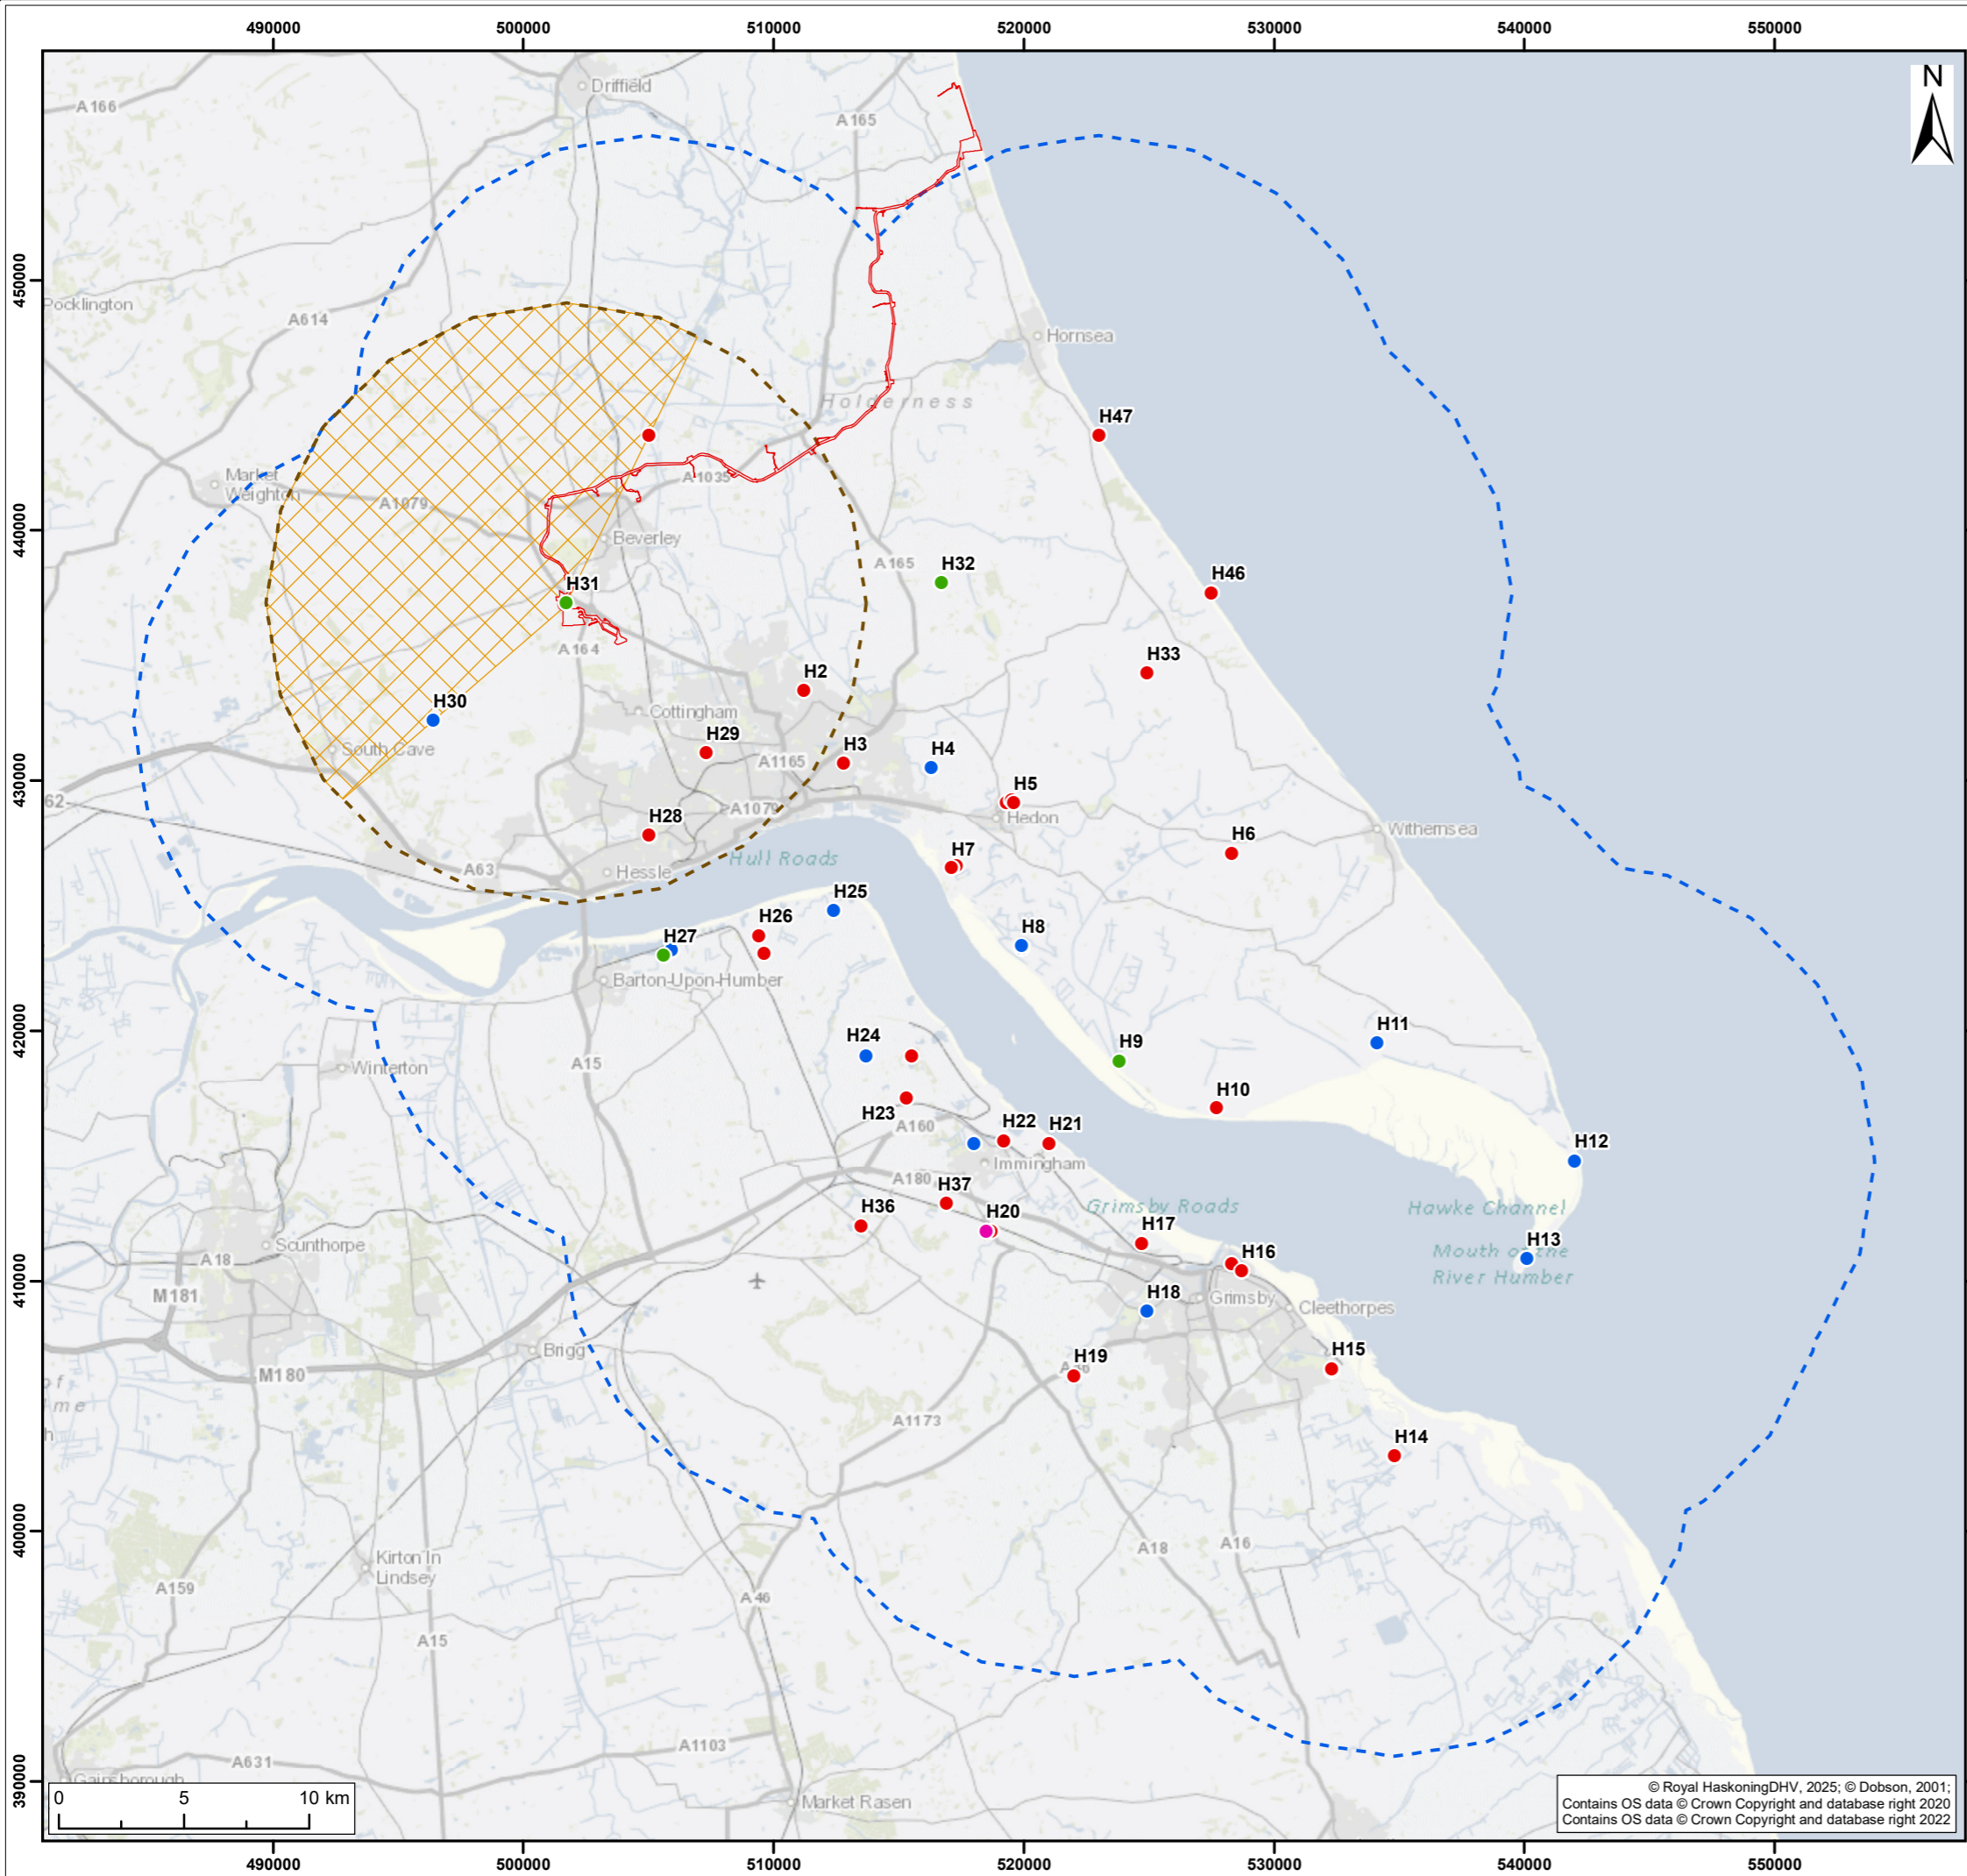
- Onshore Development Area
- Butt Farm HAA Field of Fire
- 12km Buffer of Butt Farm HAA
- Humber WWII defensive 'box'
