Dogger Bank South Offshore Wind Farms

Environmental Statement

**Appendix 22-5 Onshore Infrastructure Settings
Assessment (Revision 2) (Clean)**

June 2025

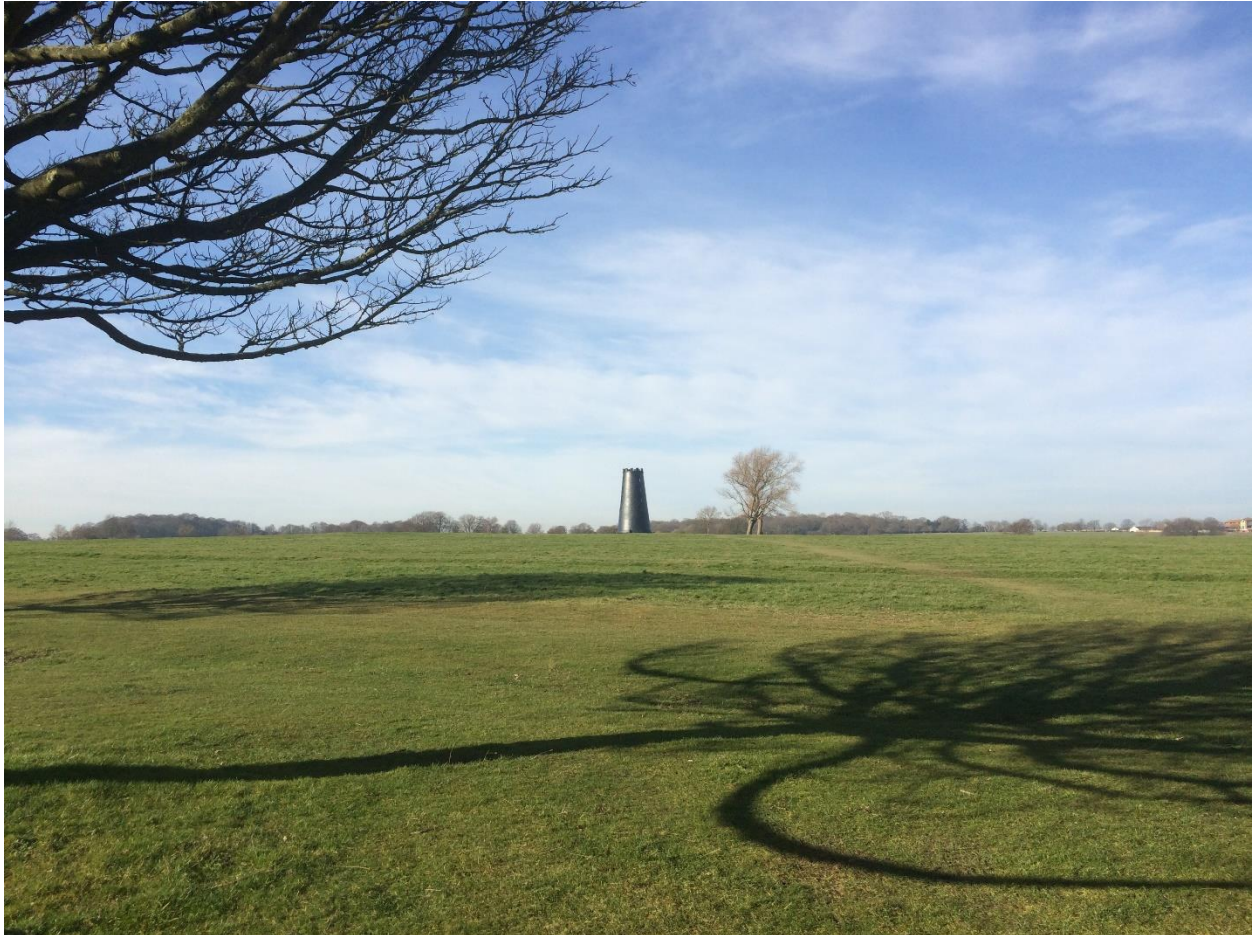
Plate 22-5-1 General view looking northwest towards the group of prehistoric barrows with Black Mill (1310087) at centre of image

45. These assets are considered alongside the other Scheduled barrows which fall outside the ZTV as they are considered an important group of prehistoric funerary earthworks surviving together on Westwood Common and share the same or very similar settings (**Plate 22-5-1**).

46. The barrows are located at approximately 40m AOD with the closest barrow (1013995) 1.9km north of the Onshore Substation Zone.

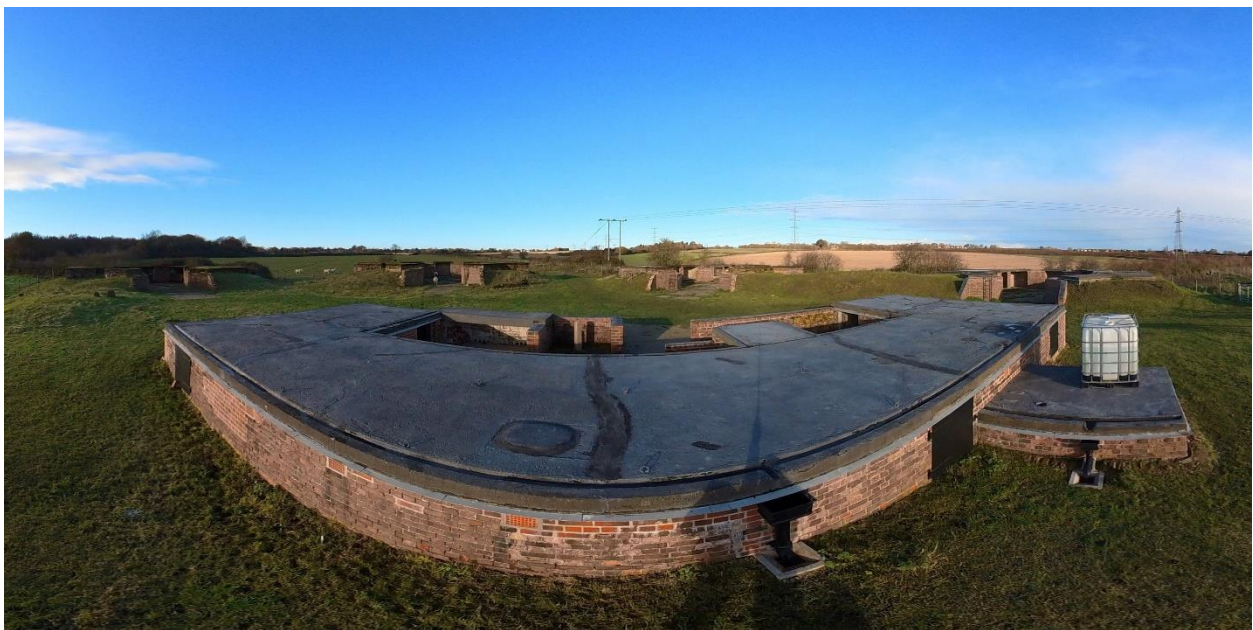
Plate 22-5-3 Heavy Anti-aircraft gunsite (1019186) with the command post in the foreground, viewed from southeast (taken with a 360° camera).

69. The gun emplacements and command post are all constructed of brick with flat concrete roof sections and concrete floors. The battery is of a standardised pattern, designed with the gun emplacements in a chevron, with the apex in the direction of fire to maximise the concentration of fire, and command post and radar mounted in the arc behind the guns. (**Plate 22-5-3**).
