# OUTLINE LANDSCAPE, BIODIVERSITY, ACCESS AND RECREATION DELIVERY STRATEGY: 7.9

## Cory Decarbonisation Project

PINS Reference: EN010128

Revision ED

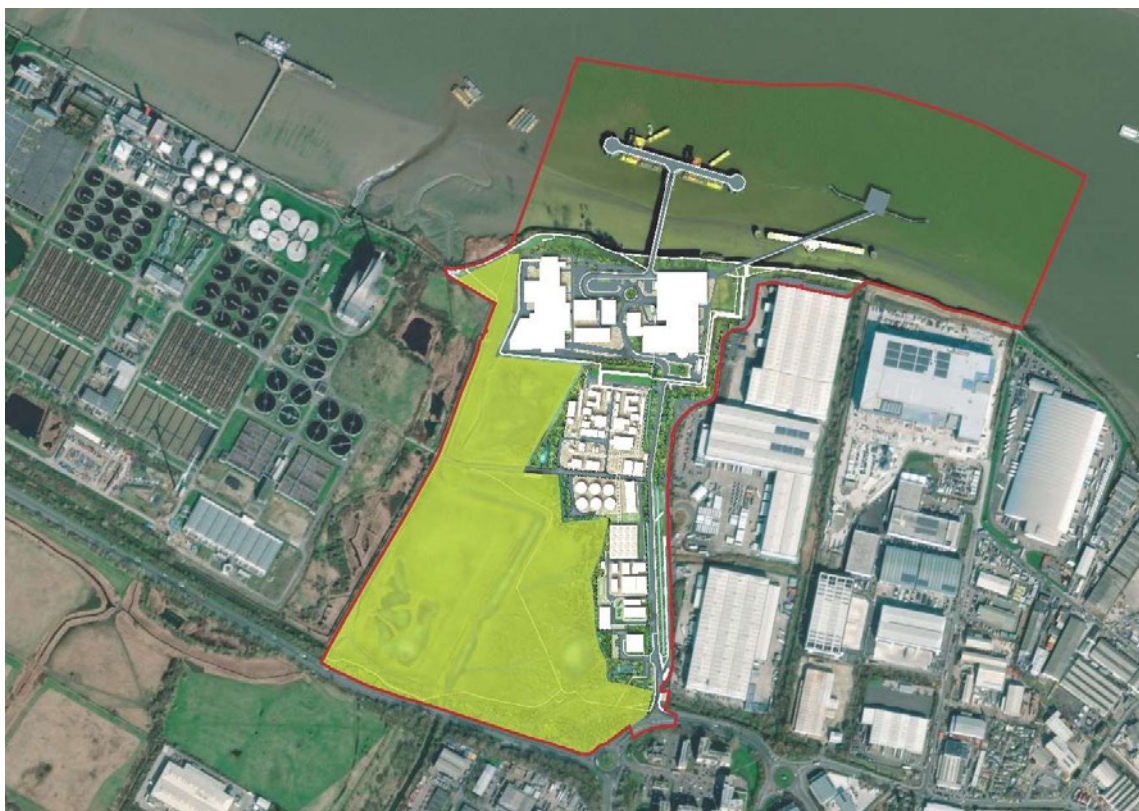
**Figure 3 - Mitigation and Enhancement Area**

- 5.2.2. The area is identified to allow for comprehensive masterplanning of a coordinated green infrastructure strategy and to support the proposed enlargement of the Crossness LNR to include Norman Road Field. This proposal is outlined in section [109](#).

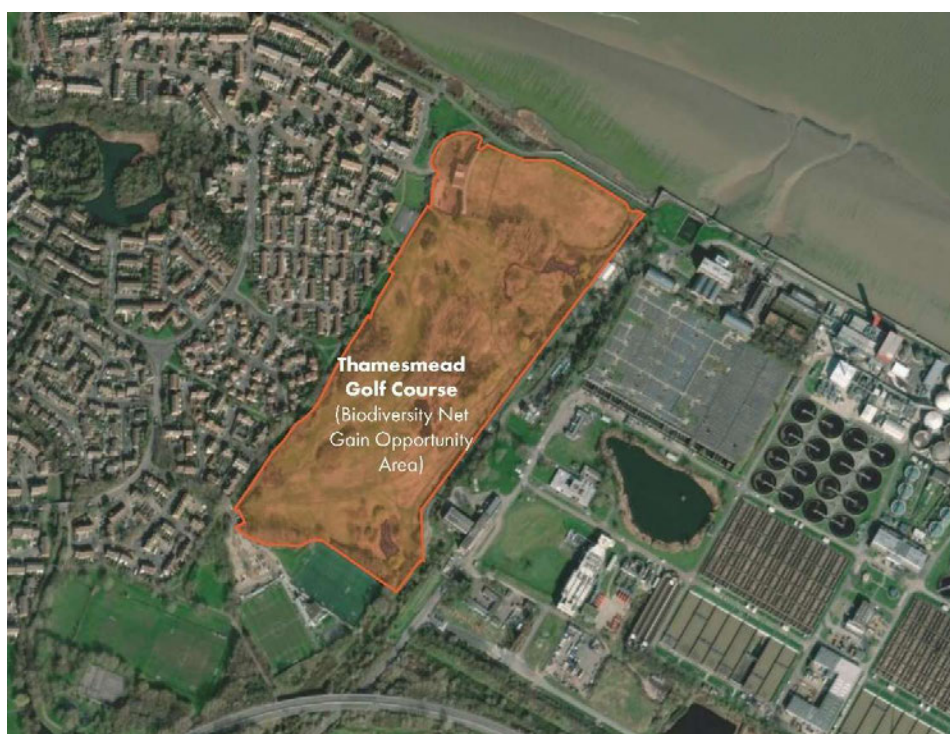
**Figure 4 - Offsite BNG Opportunity Area**

- 5.3.1. The BNG Opportunity Area is a possible area for offsite BNG provision located at the former Thamesmead Golf Course on the Thamesmead Estate, illustrated in **Figure 4**. The land is owned by the Peabody Trust and comprises a disused golf course that formed part of the Thamesmead development masterplan and has been identified in Peabody's 'Living in the Landscape' framework document as an area with potential for enhancement. The golf course has been subject to an ecological survey to understand the presence of existing habitats and their current condition.

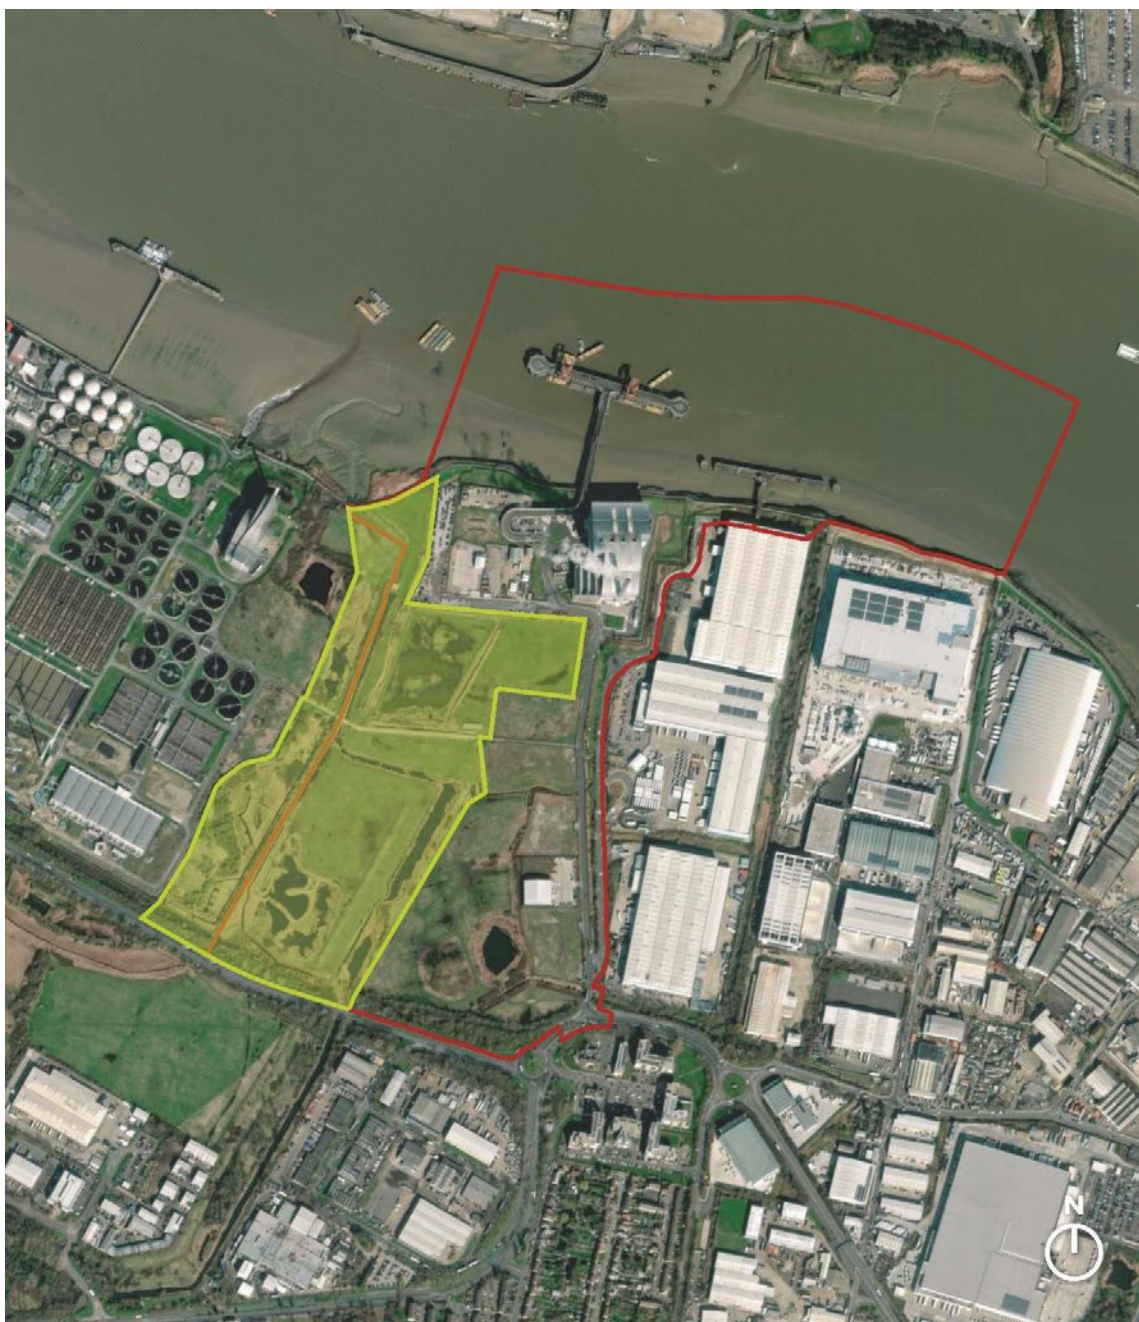
- 5.4.4. **Figure 5** illustrates the extents of the Crossness LNR.

- Site boundary
- Existing Nature Reserve

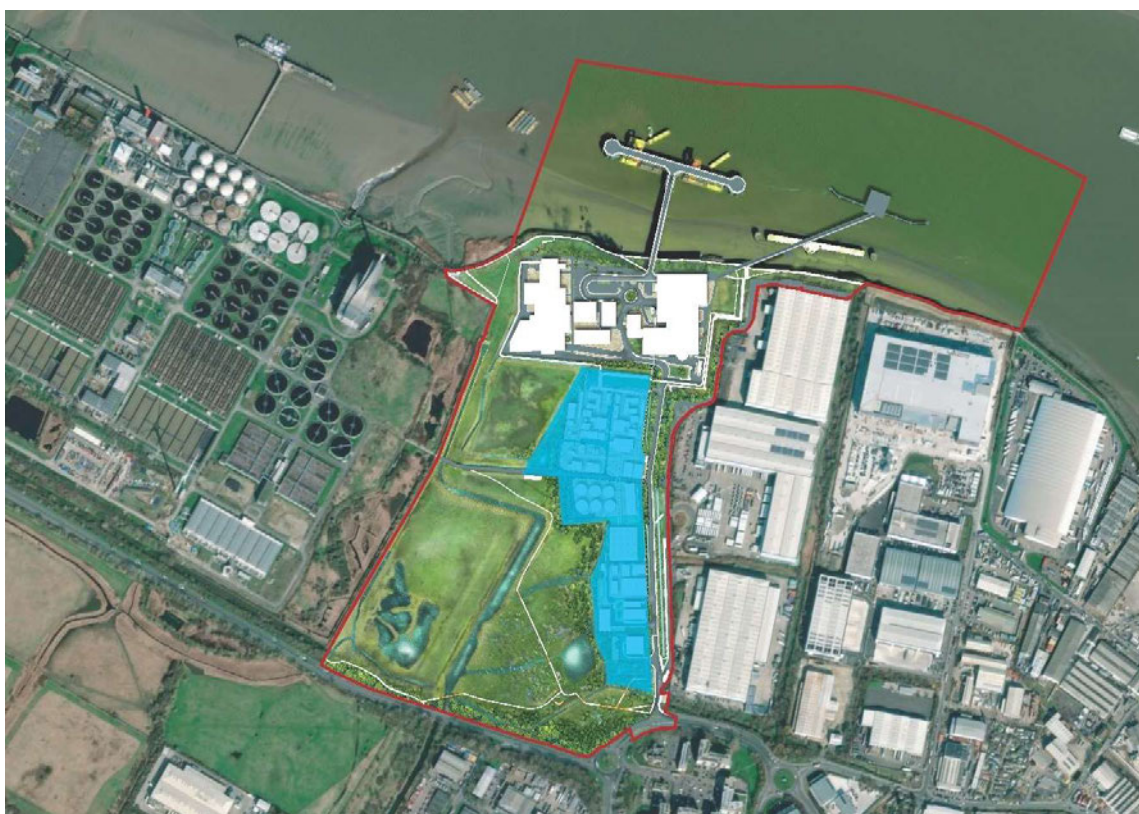
**Figure 6 Carbon Capture Facility (CCF) Area**

- 5.5.1. The CCF Area is illustrated in **Figure 6** and comprises a secure operational area adjoining the Mitigation and Enhancement Area to the west and Norman Road to the east. Norman Road comprises an adopted road that extends to the roadside kerb to the west (including a narrow grassed verge, portions of the existing ditch/main river feature) and a pavement to the west.

- 5.5.2. The CCF Area includes planting and habitat proposals to the east and western boundaries inside and outside the secure fence line. To the east, the existing ditch (water course) network is retained adjoining the Norman Road corridor along with new planted areas. To the west, the existing ditch profile is to be improved to support habitat development and soil rewetting along with new planting. To the southern end of the CCF Area, opportunities for habitat creation and planting are identified in combination with water management infrastructure and associated with the proposed LNR visitor car park.

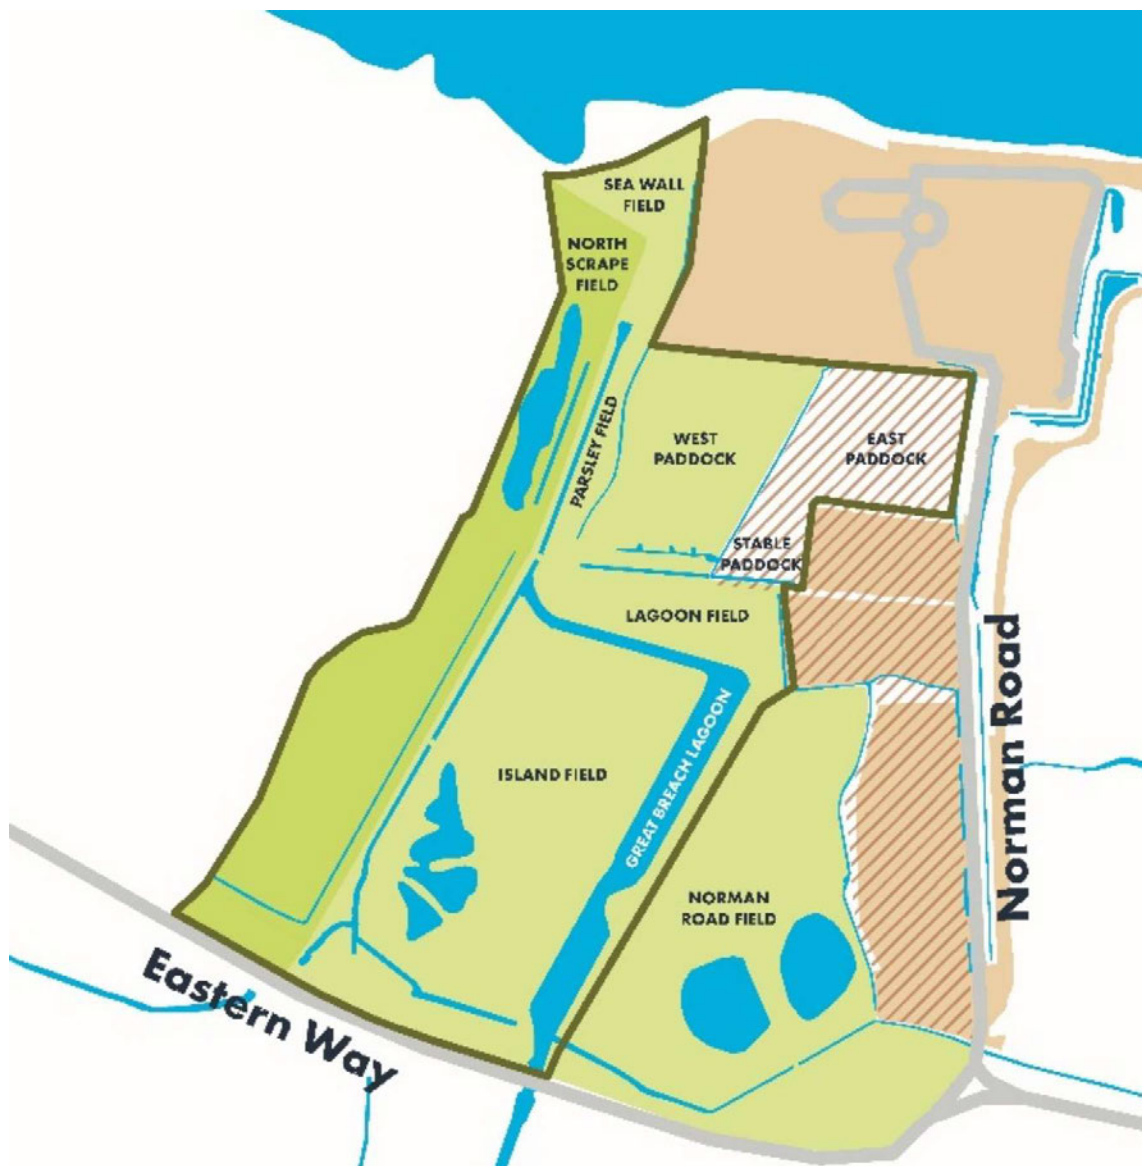
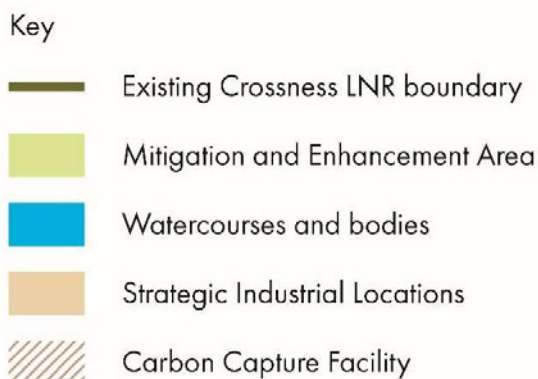
**Figure 7 – Onsite works Area and Field reference plan**

- 6.2.4. The extents of the CCF Area and onsite mitigation works overlay in part, the existing Crossness Local Nature Reserve (CLNR).

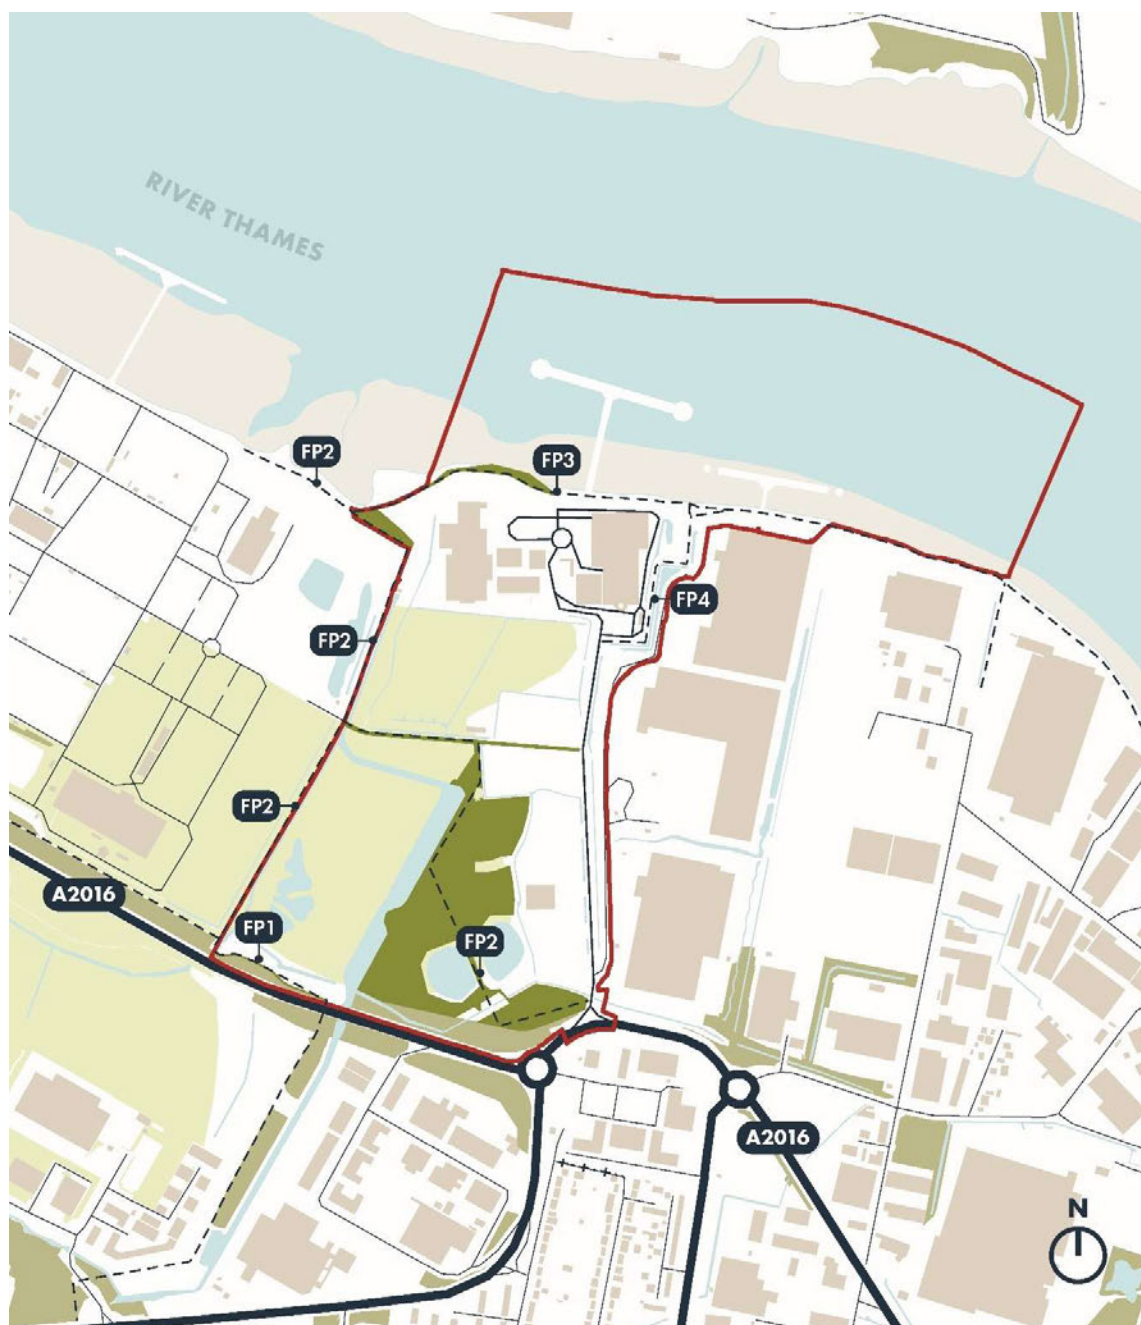
**Figure 8 - Existing PRow and Accessible Open Land**

- 6.4.1. A description of the construction and operational phase works associated with PRow is outlined below. The existing PRow subject to diversion (temporary or permanent) are illustrated in **Figure 8** and additional proposed PRow are illustrated in **Figure 9**.

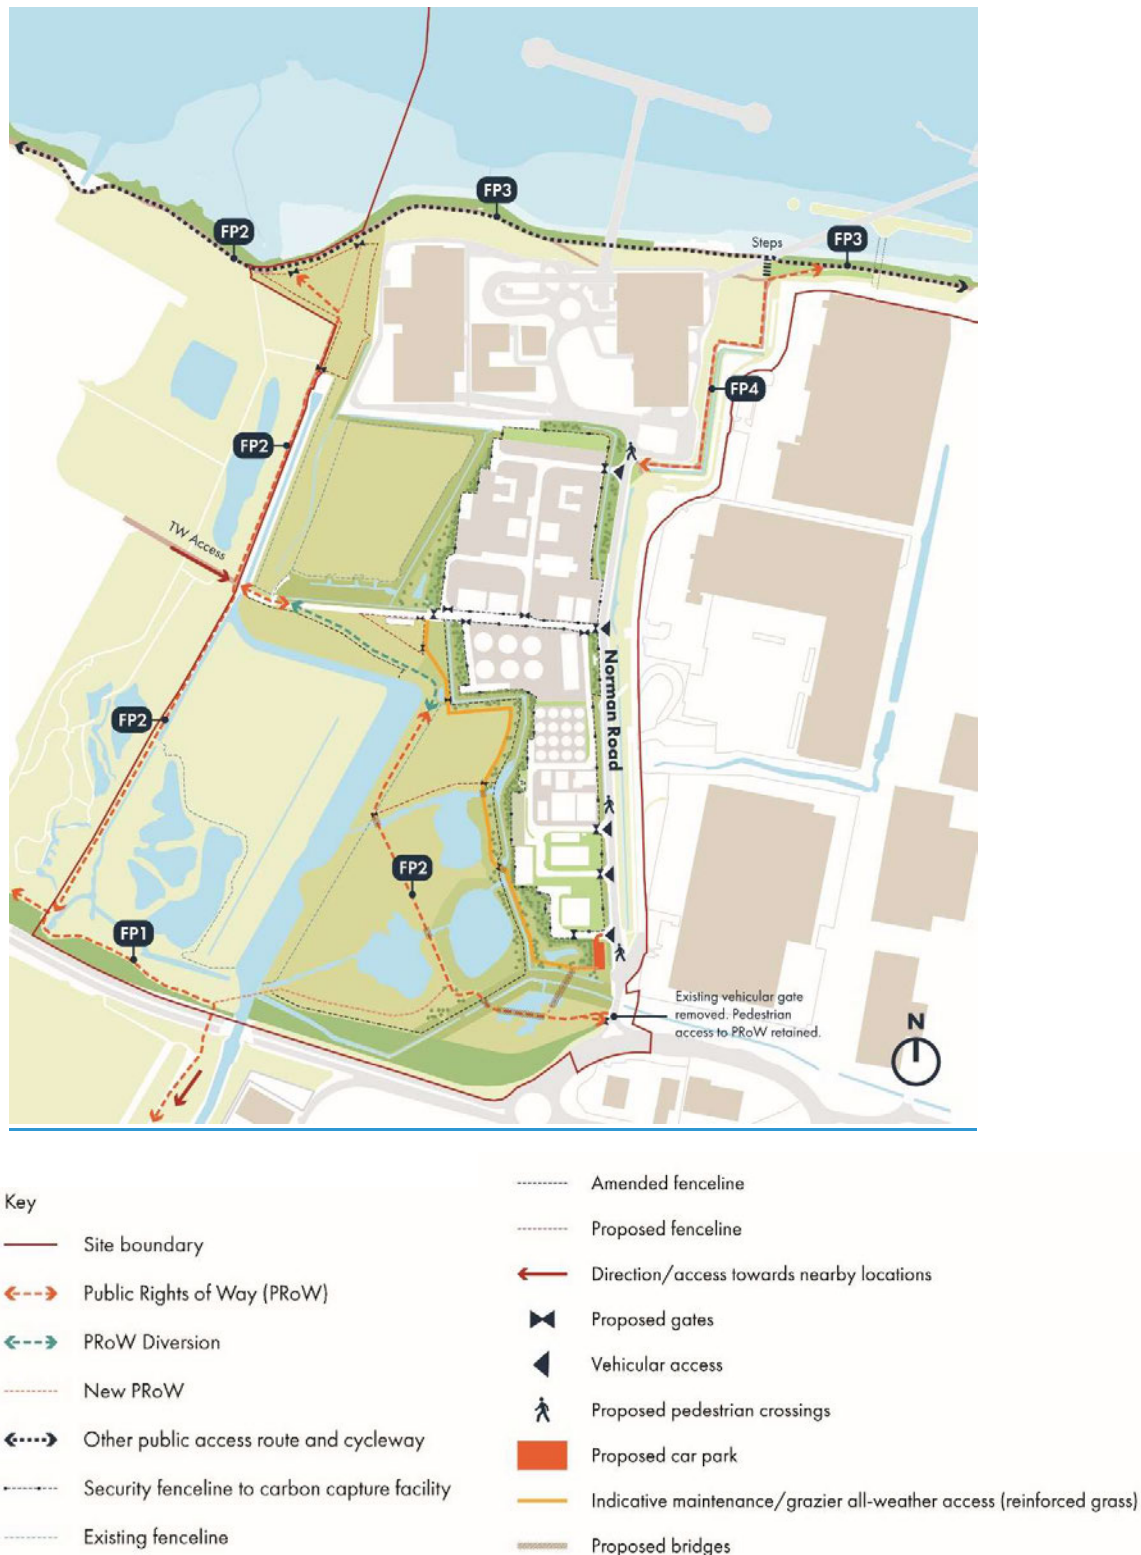
**Figure 9 – Operational phase PRow diversions and PRow creations**

- 6.4.14. Additional PRow routes are proposed illustrated on Figure 9 and detailed in section 9. Additionally, enhancements will be developed and provided including for example, interpretation boards and localised works to the boundaries to the immediate context of the England Coast Path (FP3/NCN1). These will be detailed as part of the full LaBARDS. The DCO also provides for the Applicant to be able to authorise motorised use of FP1 – FP4 during both the construction and operational phases – this is for the Applicant’s requirements, but also to allow for improved access arrangements for graziers and the Friends of Crossness LNR, if [required](#).

- 10.2.3. Opportunities have been identified for enhancement to existing ProW within the Order Limits for onsite works or via contributions to LBB via Deed of Obligation for offsite works. The proposed permanent alterations to PRoW are illustrated in **Figure 9** and comprise:

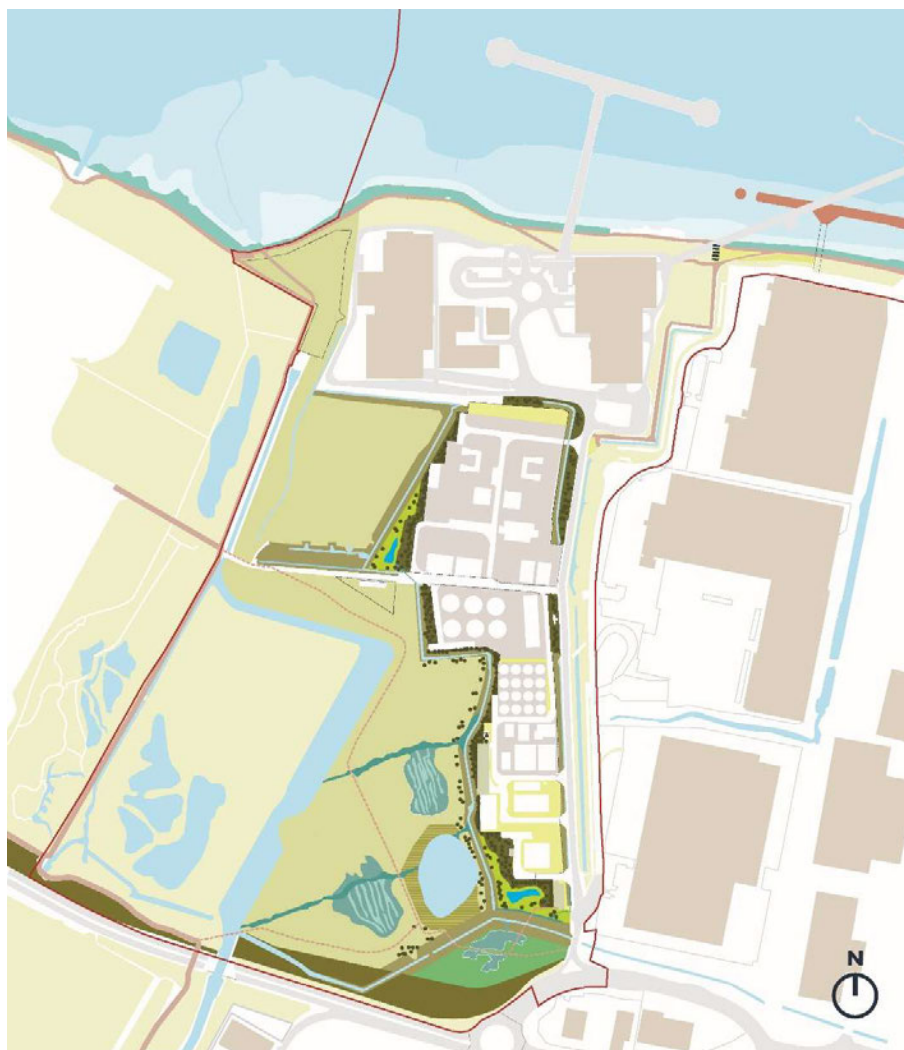
**Figure 14 – Existing Habitats, New Habitats and Landscape Proposals**

8.3.3. During the construction of the Proposed Scheme works to mitigate effects comprising the enhancement of existing habitats or the establishment of new habitats will commence and be subject to ongoing management to deliver the proposed mitigation defined in this Outline LaBARDS. **Figure 14** illustrates the existing habitats and those to be established which are detailed in section [109](#) and 12 of this document.

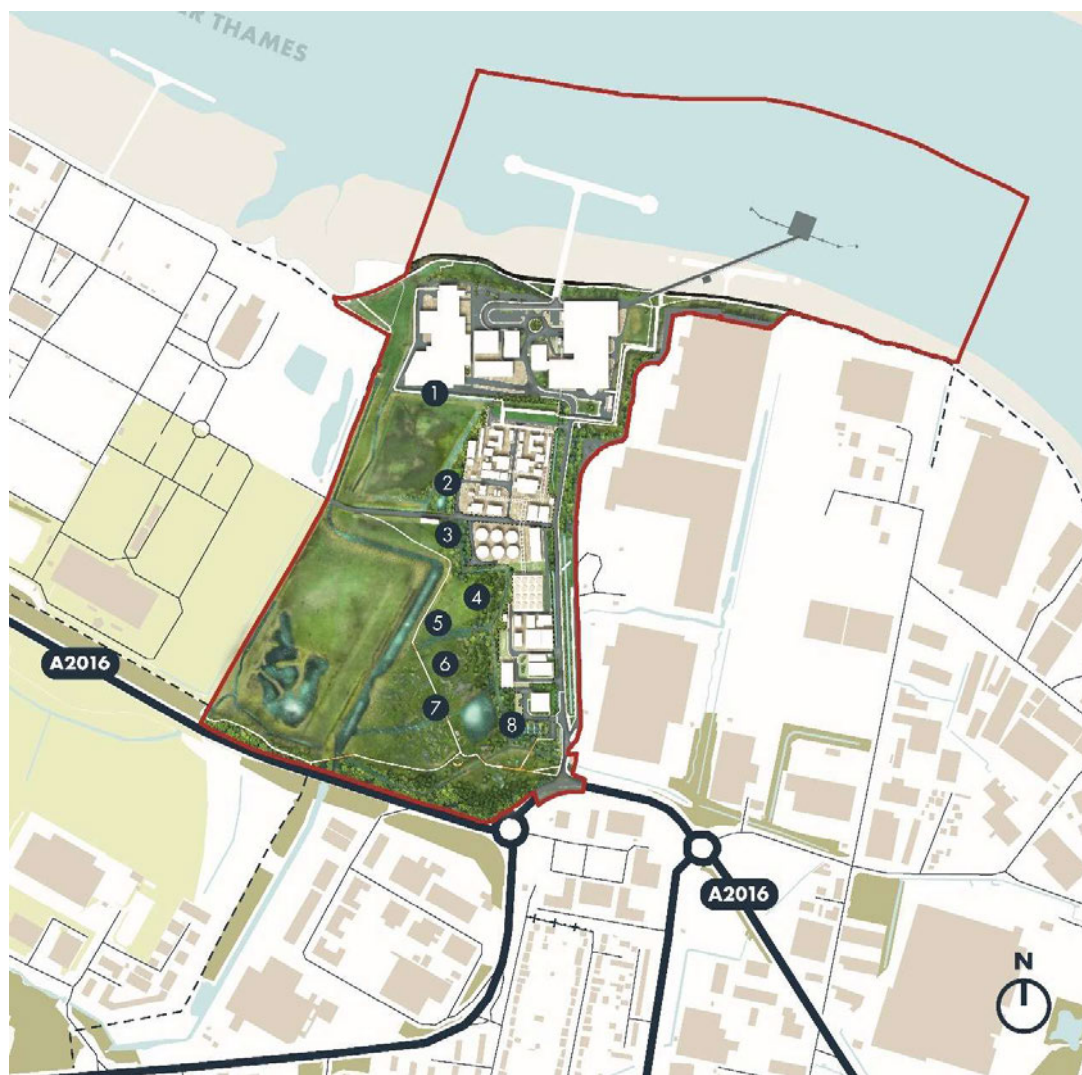
**Figure 15 – Environmental Proposals**

- 10.1.8. The Environmental Proposals are illustrated in **Figure 15** and reflect how the Applicant has sought to respond to planning policy constraints identified during

design development, the results of the EIA process and the desire to integrate the CCF into its setting.

- 6.2.1. The onsite works are illustrated on **Figure 15** in section 9. Plan area and field references are used to support the description of the proposals in section [109](#). The Environmental Proposals and Access and Recreation Proposals and BNG Strategies are scheduled in section [134](#) (Outline of Required Works to deliver the Proposals and Strategy) and the field references are illustrated on **Figure 7**.

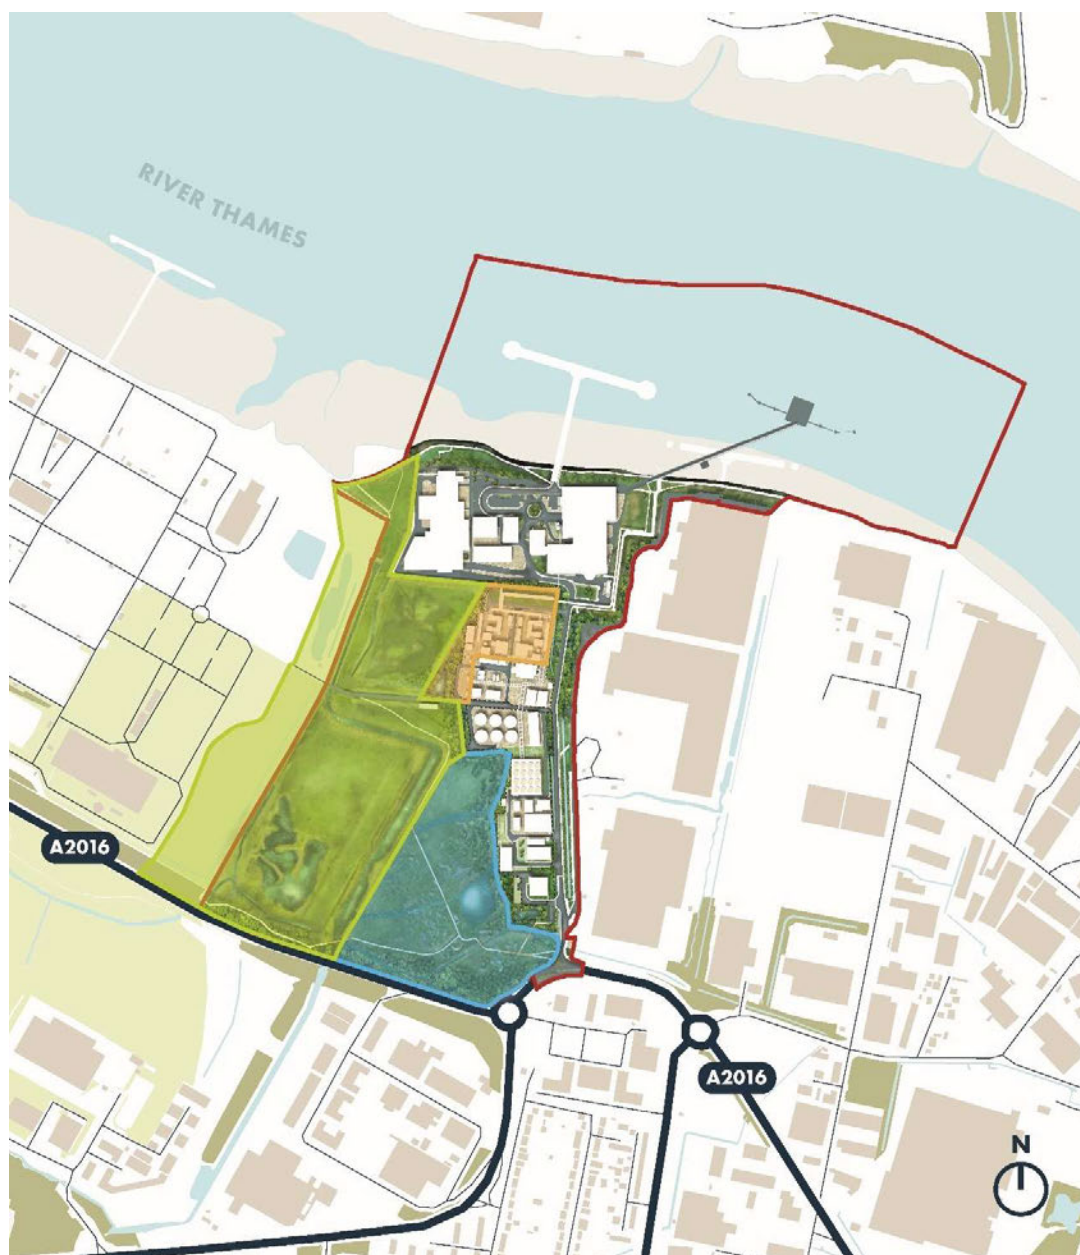
**Figure 16 – Existing and Proposed expanded Crossness LNR**

- Site boundary
- Existing Nature Reserve used for CCF
- Existing Nature Reserve retained
- Extended and managed Nature Reserve

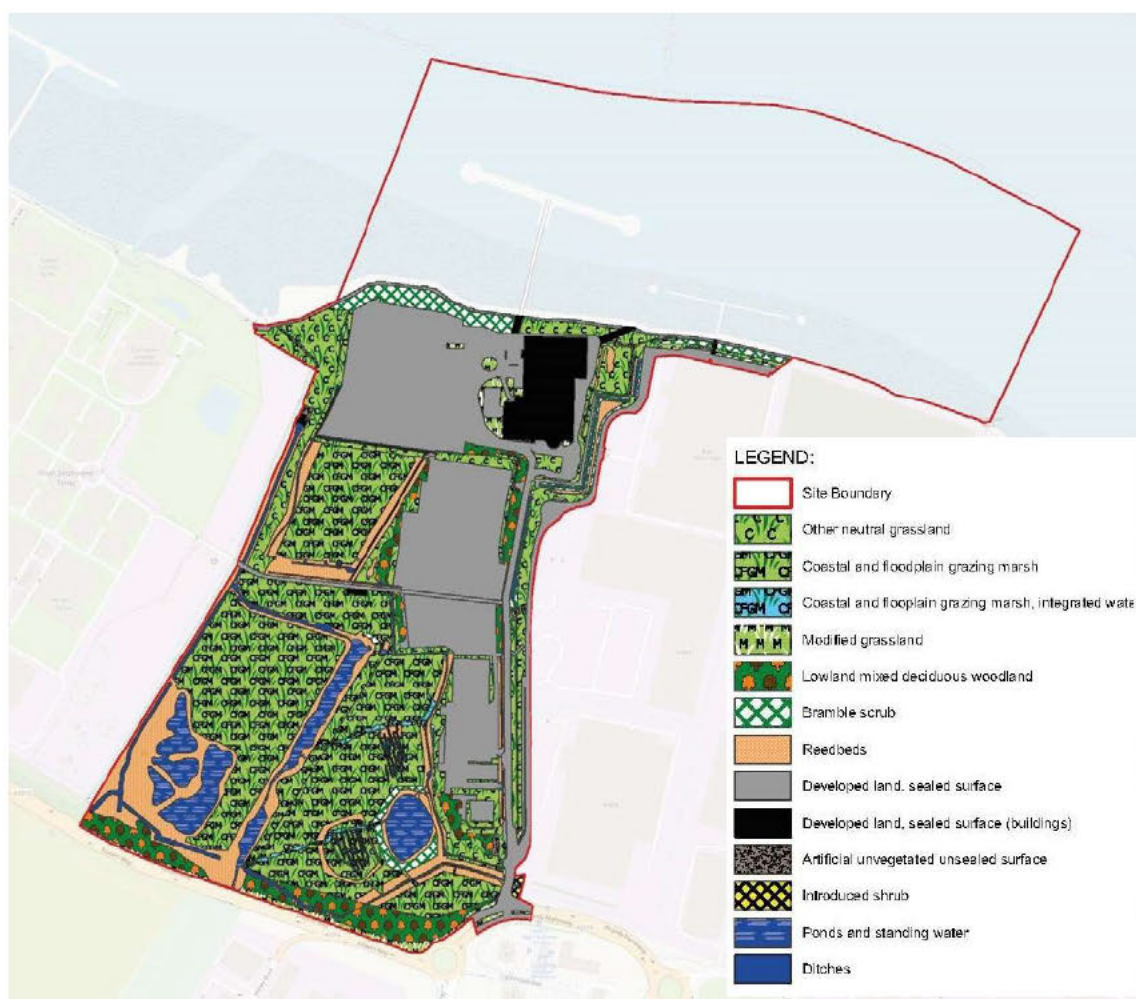
**Figure 17 – Post Development Biodiversity Strategy**

10.1.17. The priorities of the Environmental Proposals include:

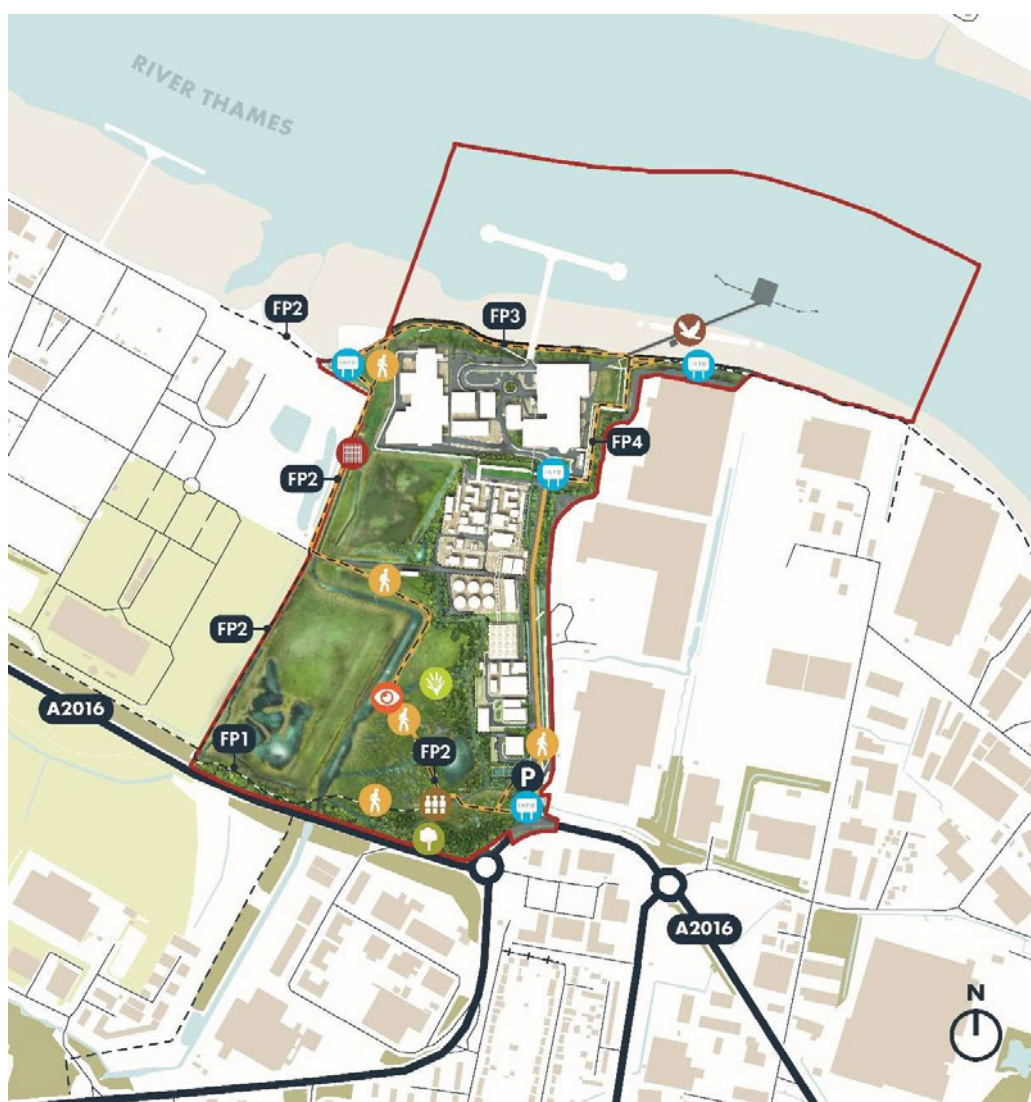
**Figure 18 – Access and Recreation Proposal**

- 10.2.1. The Access and Recreation Proposals are illustrated in **Figure 18** and supported by the Access and Movement Strategy illustrated in the **DAD (Document Reference 5.6)**.
- 10.2.2. The Access and Recreation Proposals provide enhanced PRow routes and connectivity within the Site and works offsite. The proposals encourage improved opportunity for active travel access, improved amenity and recreation experience and safety of routes.

Site boundary	 	Improved and new pedestrian connections
 	Hide/wildlife viewing area	 	Biodiversity enhancements
 	Rationalisation of fencing	 	Woodland management improvements
 	Bird nesting habitat feature	 	Improved signage strategy
 	Outdoor education area	 	Visitor parking opportunity

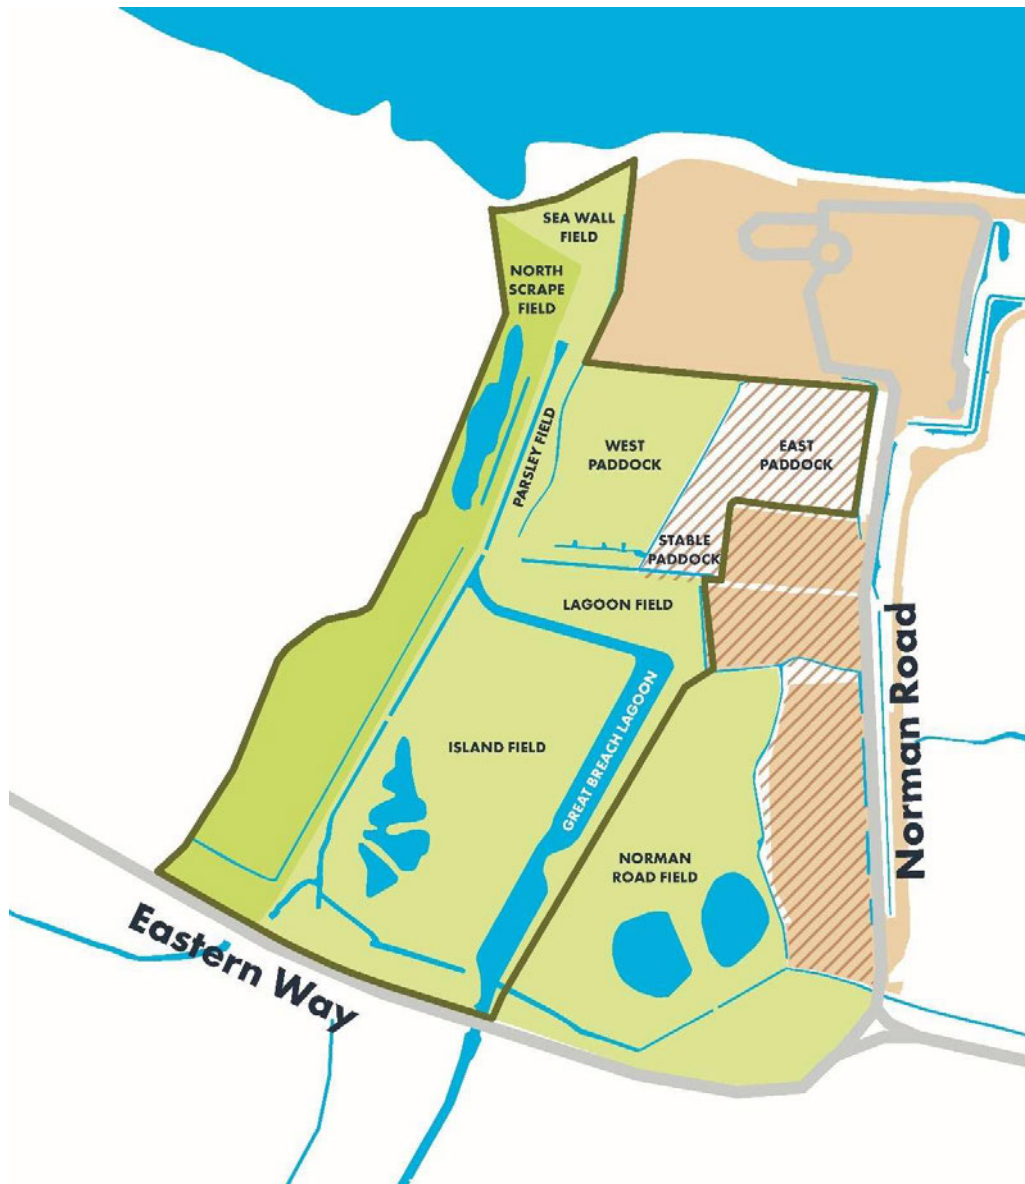
**Figure 7 – Onsite area and field reference plan (repeat)**

- 13.1.1. **Table 1** sets out the schedule of management proposals for landscape and habitat works (proposed and existing) across the Site comprising the CCF Area and the expanded Crossness LNR. For ease of reference the field name and area reference plan **Figure 7** is repeated to support the interpretation of the schedule.
