Cottam Solar Project

Environmental Statement Appendix 13.5: Heritage Statement (Part 1 of 4)

Prepared by: Lanpro Services
January 2023

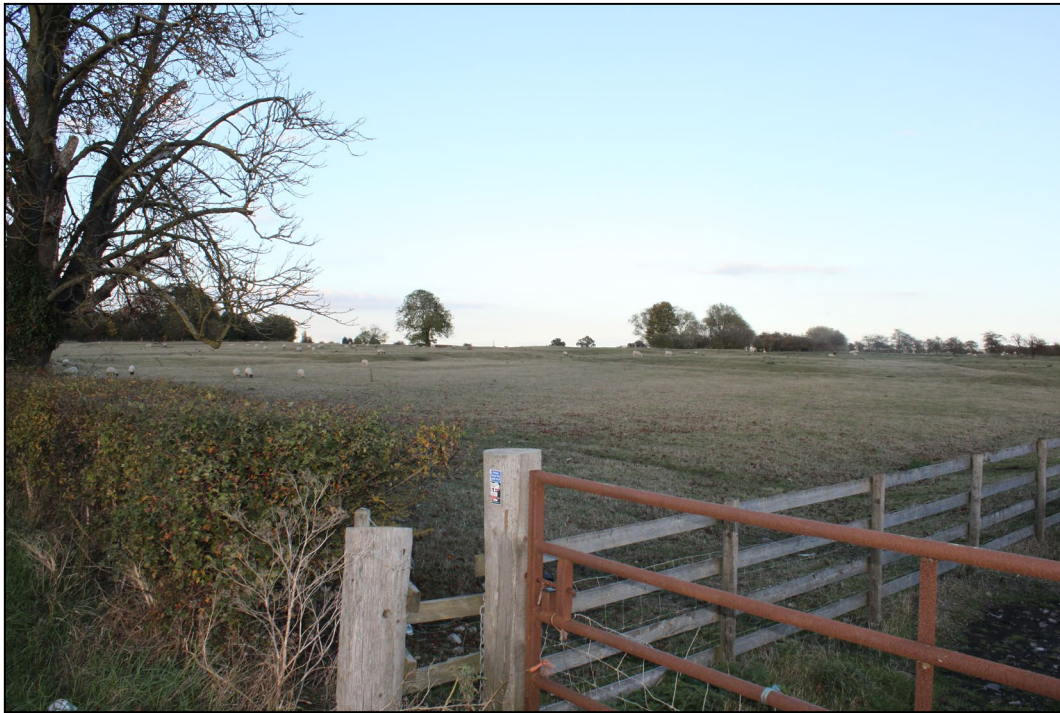
Photograph 1: View north-west towards Cottam 1 across the Deserted village of North Ingleby (NHLE 1003570) from Sturton Road).

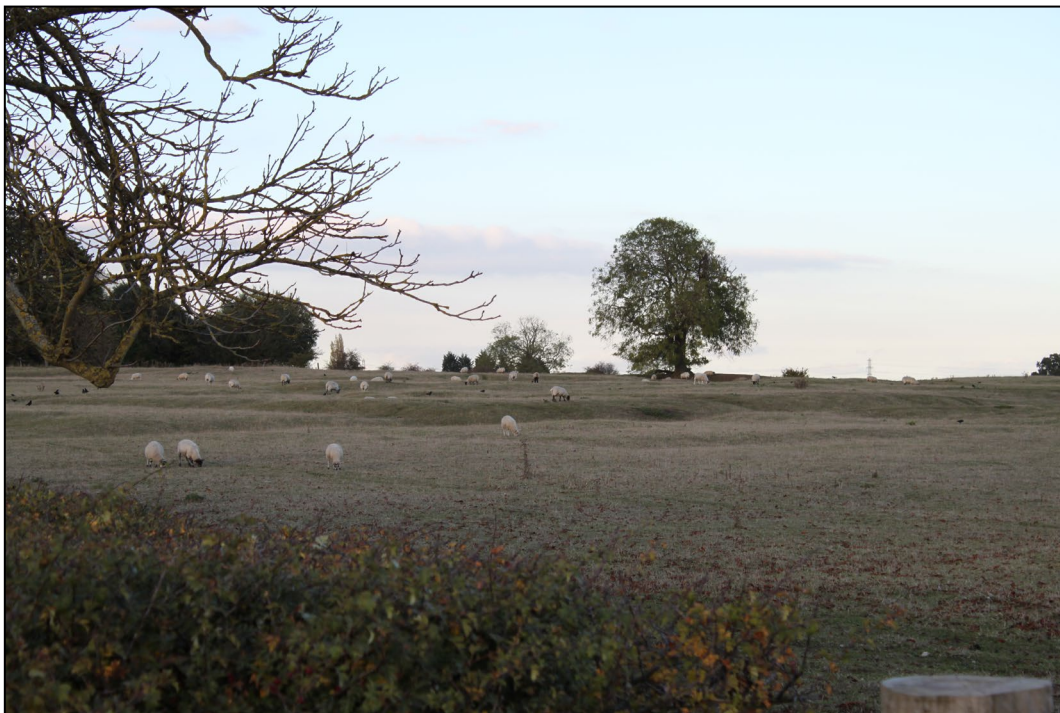
Photograph 2: Zoomed view as above.

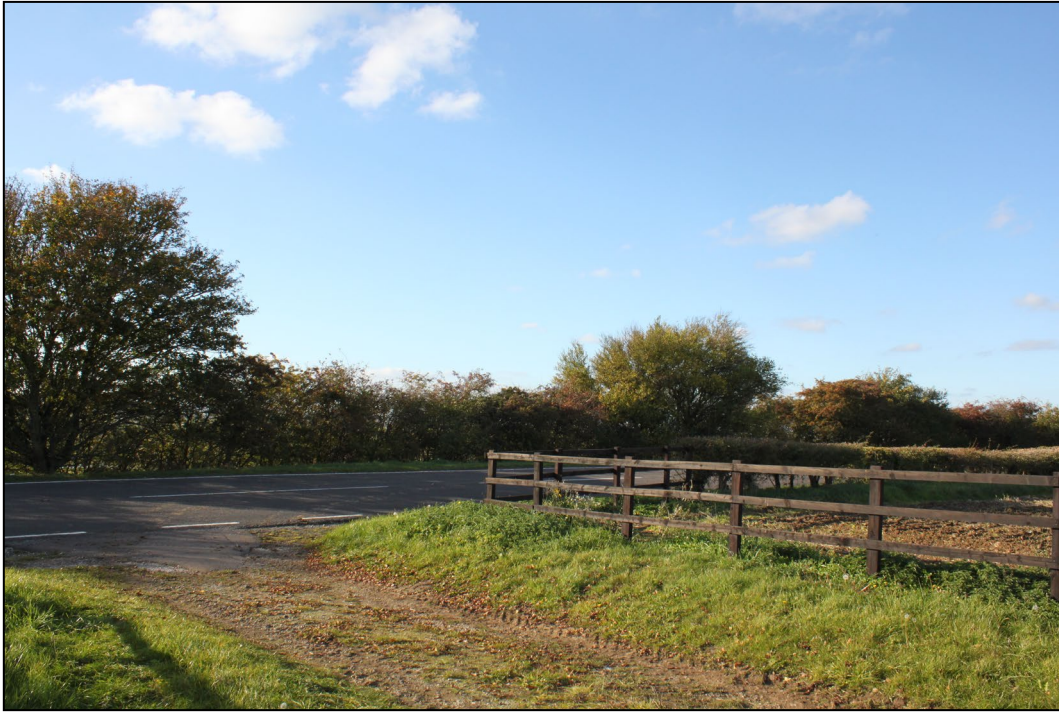
Photograph 3: View north-west towards Cottam 1 from the north-western corner of Roman villa W of Scampton Cliff Farm (NHLE 1005041).

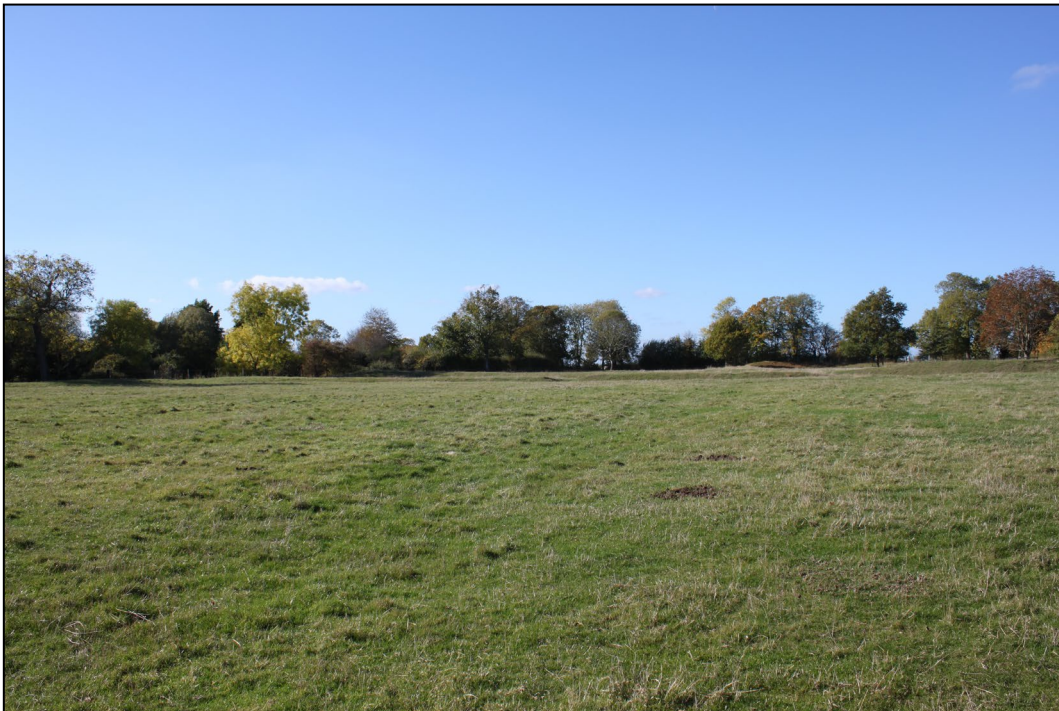
Photograph 4: View west-south-west towards Cottam 2 from the PRow that crosses the Site of medieval preceptory and settlement remains, Temple Garth, Willoughton (NHLE1007689).

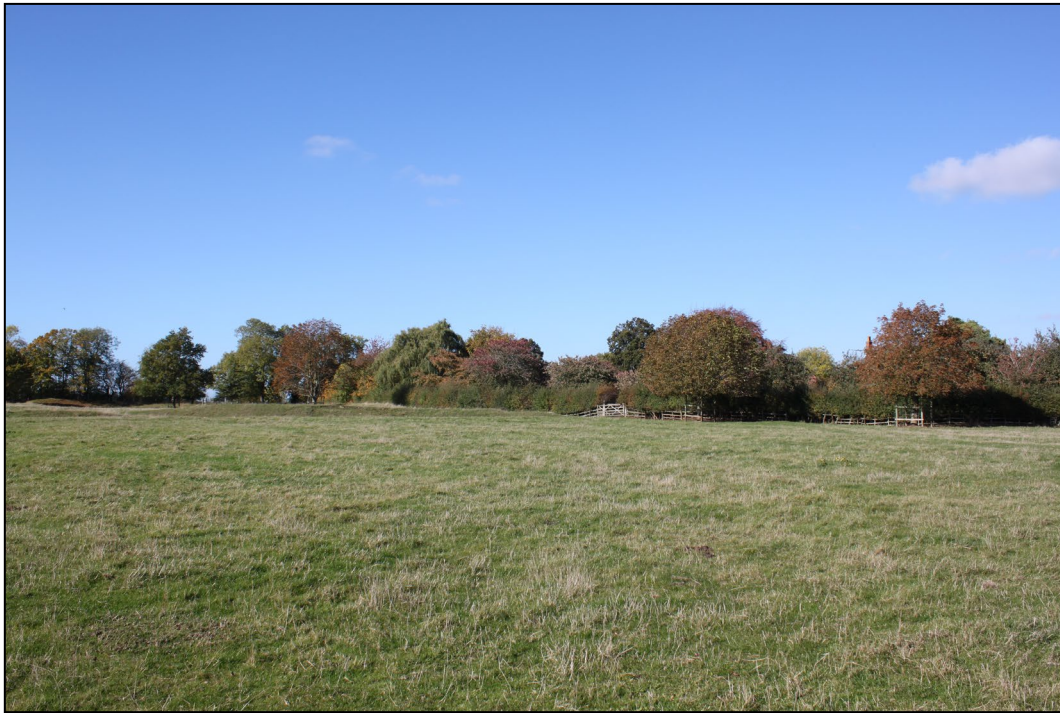
Photograph 5: View north-west towards Cottam 3 from the PRow that crosses the Site of medieval preceptory and settlement remains, Temple Garth, Willoughton (NHLE1007689).

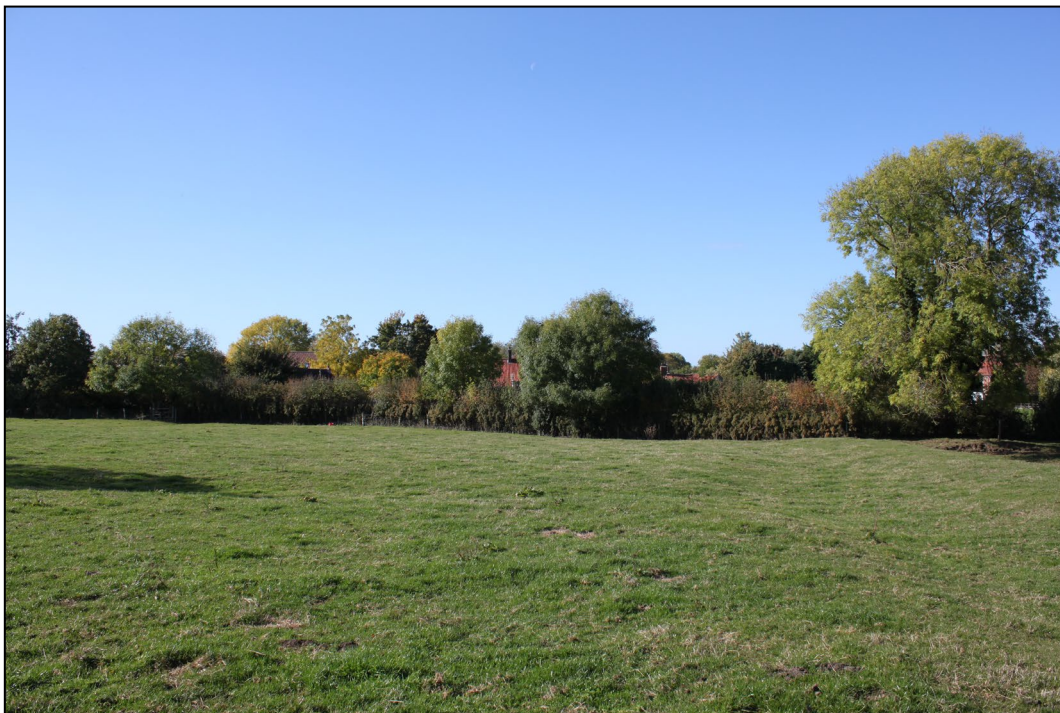
Photograph 6: View west-south-west towards Cottam 2 from the PRow within Monks Garth moated site, Willoughton (NHLE 1011456).

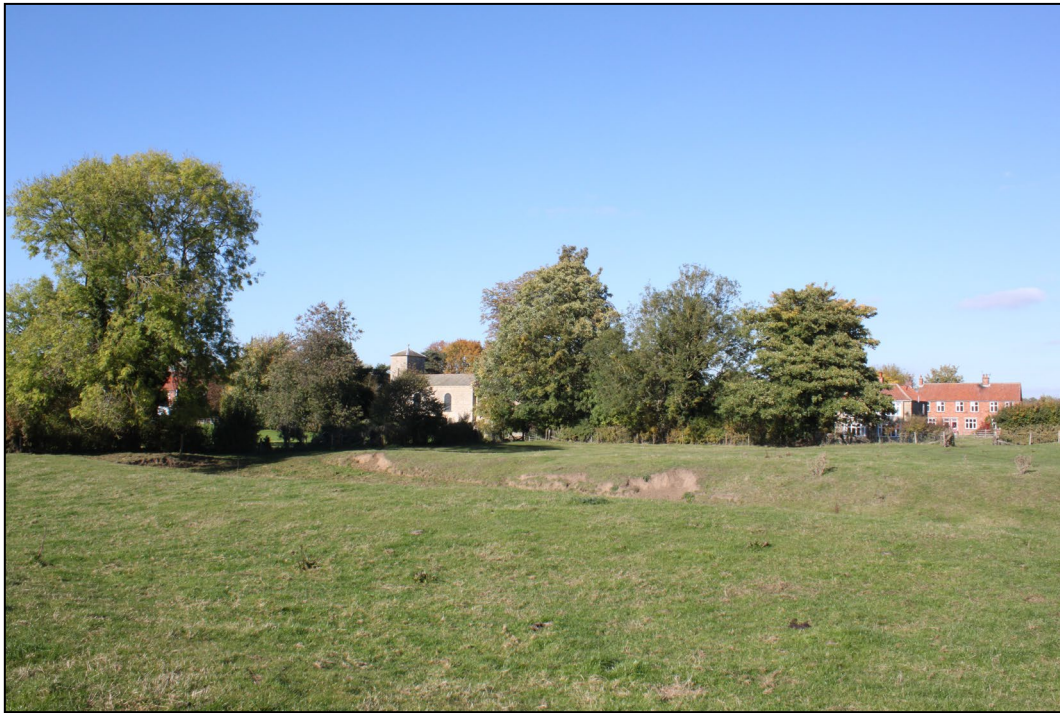
Photograph 7: View north-west towards Cottam 3 from the PRoW within Monks Garth moated site, Willoughton (NHLE1011456).

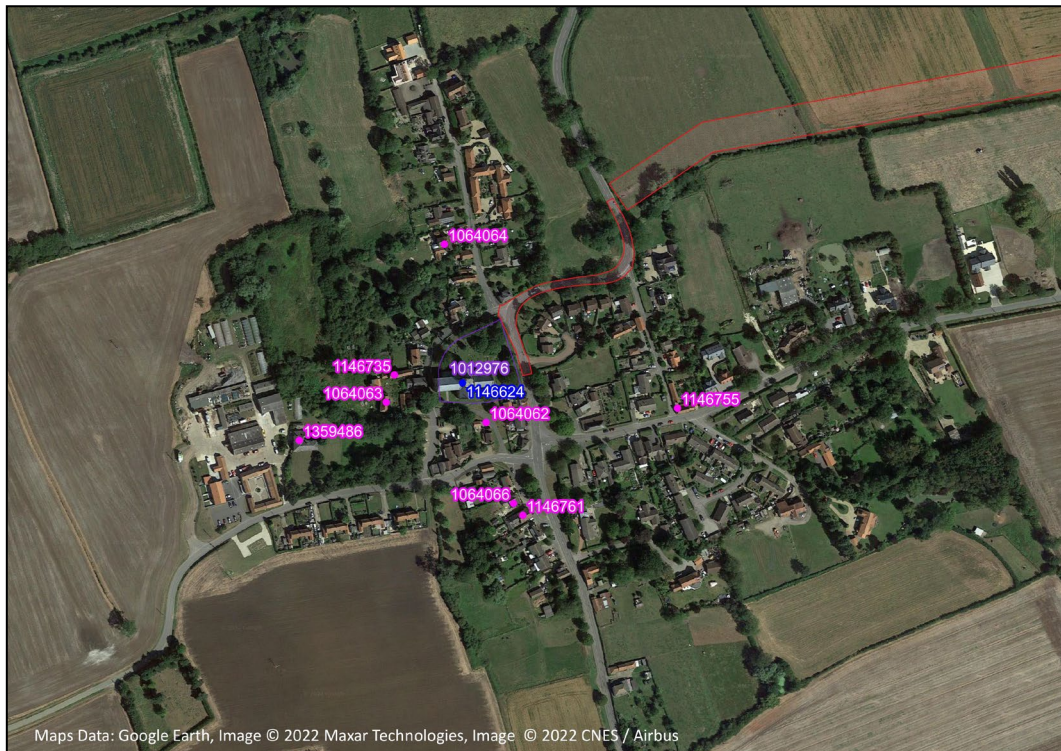
Photograph 8: Aerial image of the village of Stow and the designated heritage assets within it.

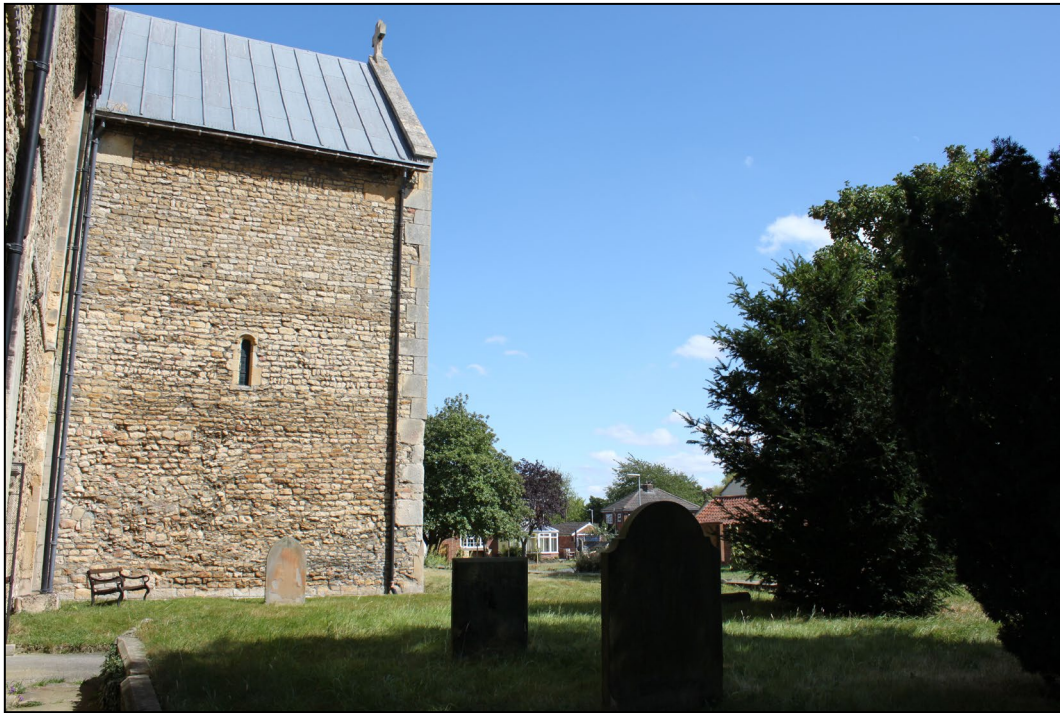
Photograph 9: General view of the screening afforded by the built environment to the east of the Site of a college and Benedictine Abbey, St Mary's Church, Stow (NHLE 1012976).

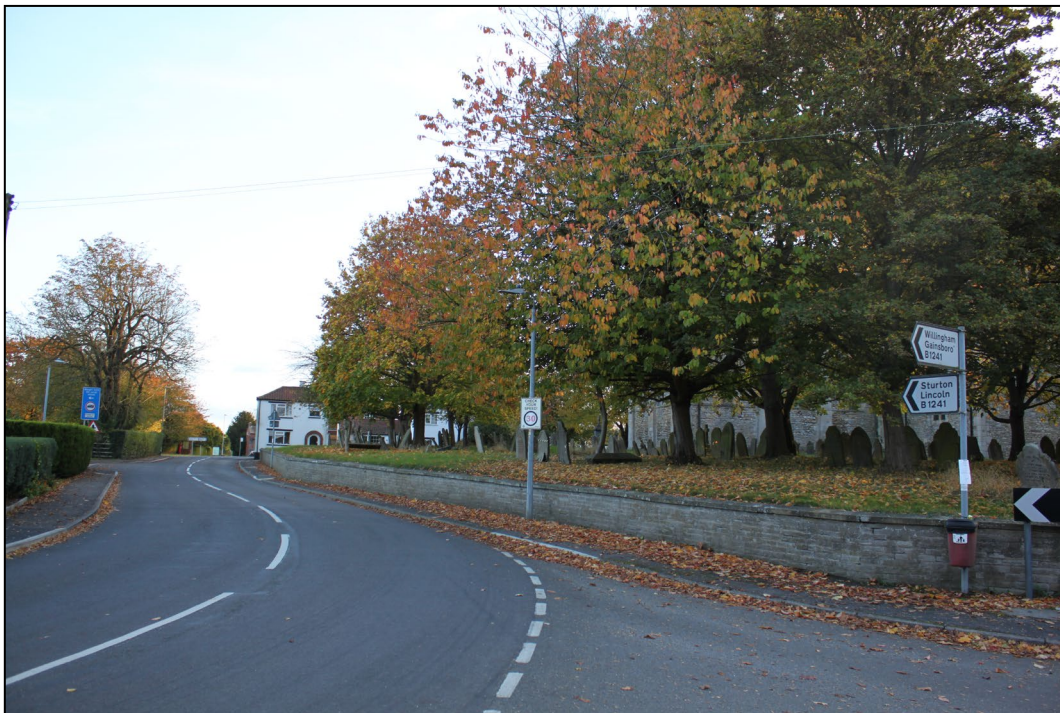
Photograph 10: View south along that part of the DCO application boundary adjacent to Site of a college and Benedictine Abbey, St Mary's Church, Stow, where abnormal loads access will be required during construction.

- 3.1.24 It should also be noted that part of the B4121 Sturton Road immediately to the east of the scheduled churchyard (Photograph 10) is included within the Order Limits, as this is an area where the delivery of a small number of abnormal loads (involving the transportation of large inverters) would require HGVs to mount the pavement. This would result in a small number of temporary and ephemeral impacts to the setting of the Scheduled Monument, and as such, these are considered to be impacts which would overall result in *No change* to the significance of the monument. Mitigation for the potential direct physical impacts caused by the proximity of abnormal loads to the Scheduled Monument is set out in the ES chapter (Section 13.8).

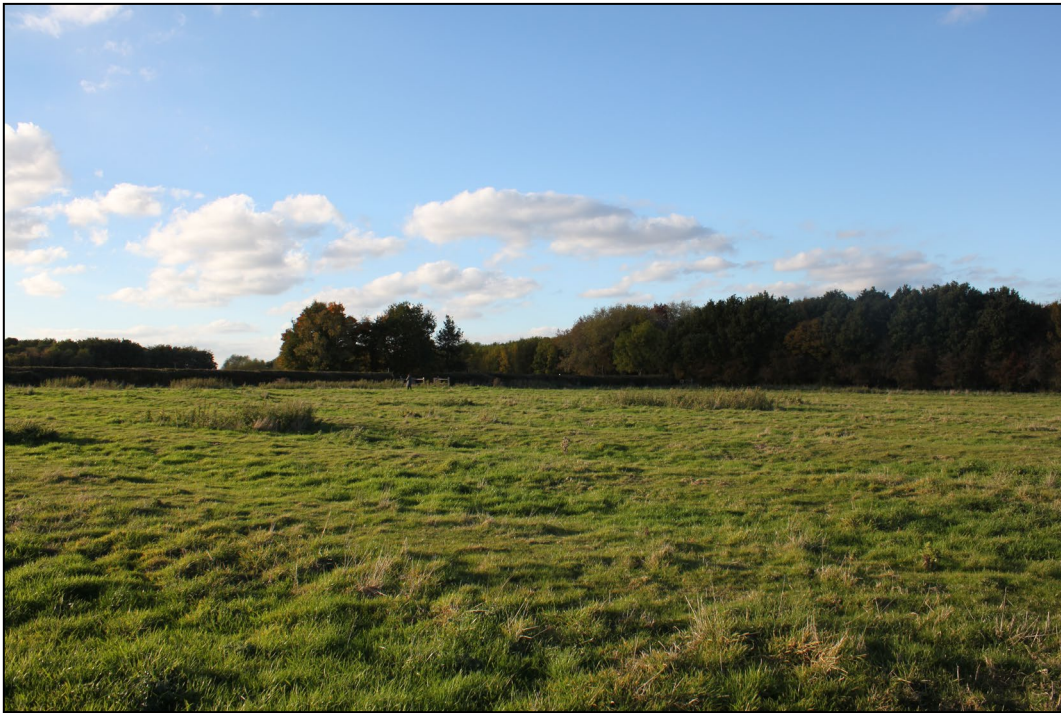
Photograph 11: View north-west from the PRow that crosses Broxholme medieval settlement and cultivation remains (NHLE 1016797).

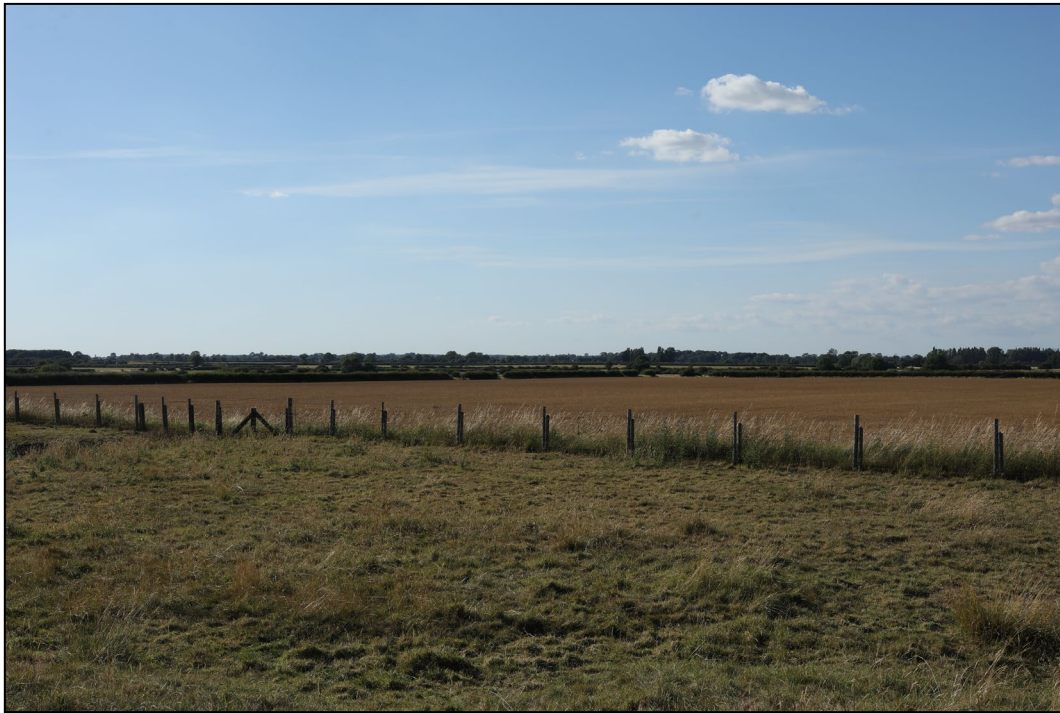
Photograph 13: View north-west from within Thorpe medieval settlement (NHLE 1016978) across the western side of field parcel D14 of Cottam 1d (immediately beyond the fence line).

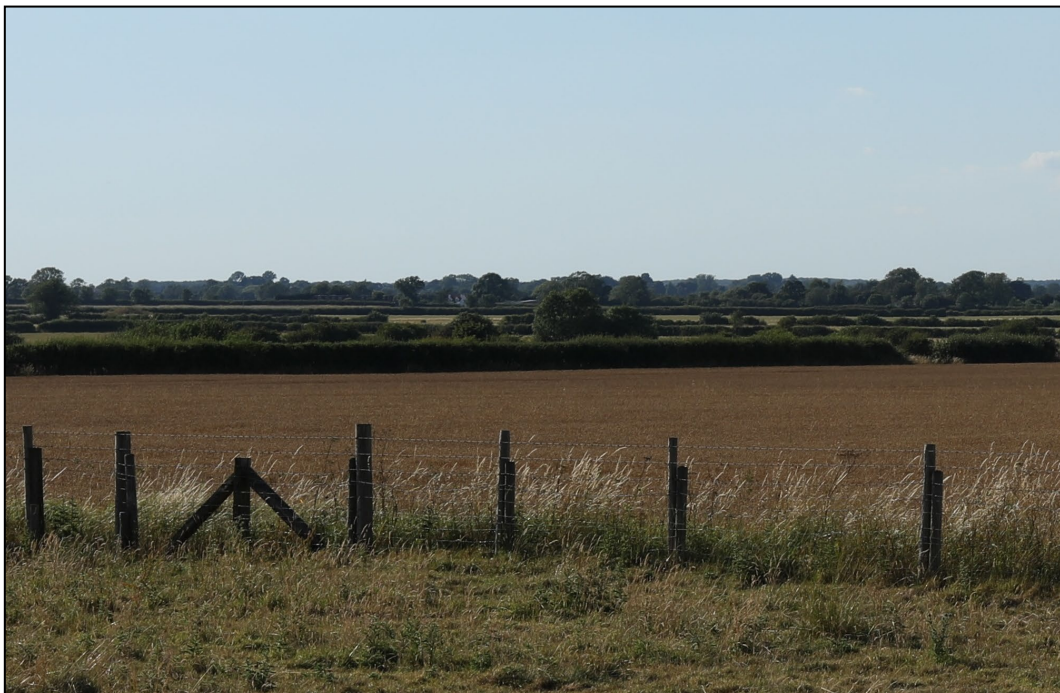
Photograph 14: Zoomed view as above, illustrating the layering of parcels within Cottam 1d to the north-west of D14 (summer).

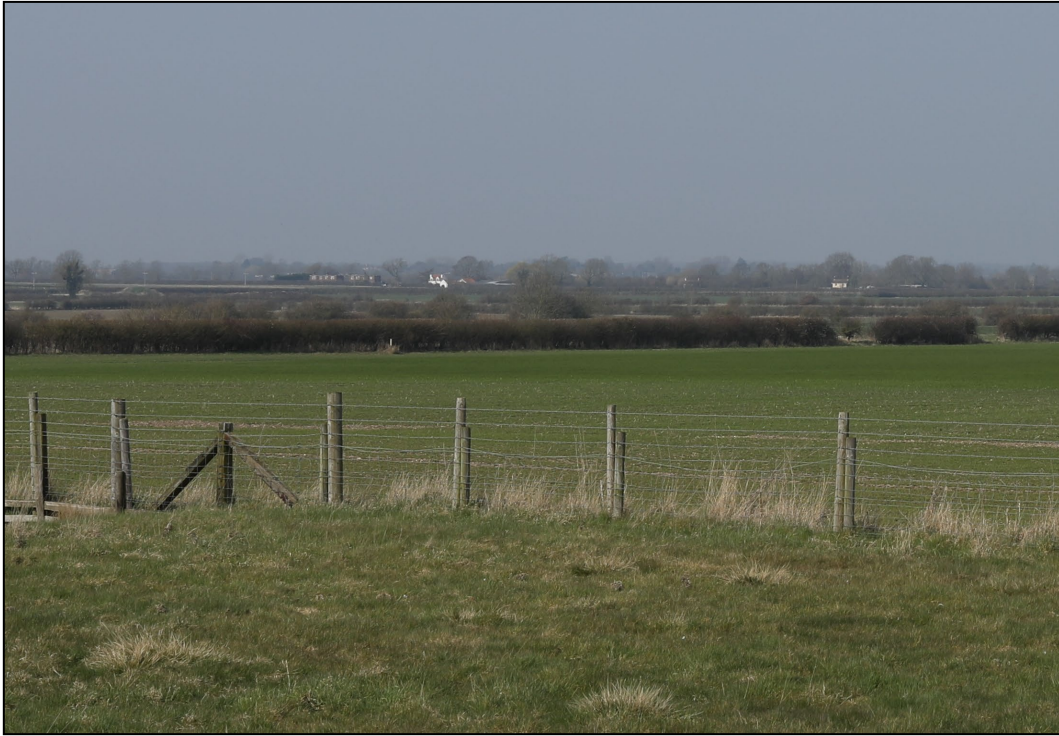
Photograph 15: As above, in winter when the leaves are off the trees. Buildings along Ingham Road beyond parcels D2 and D3 of Cottam 1d are visible in the distance.

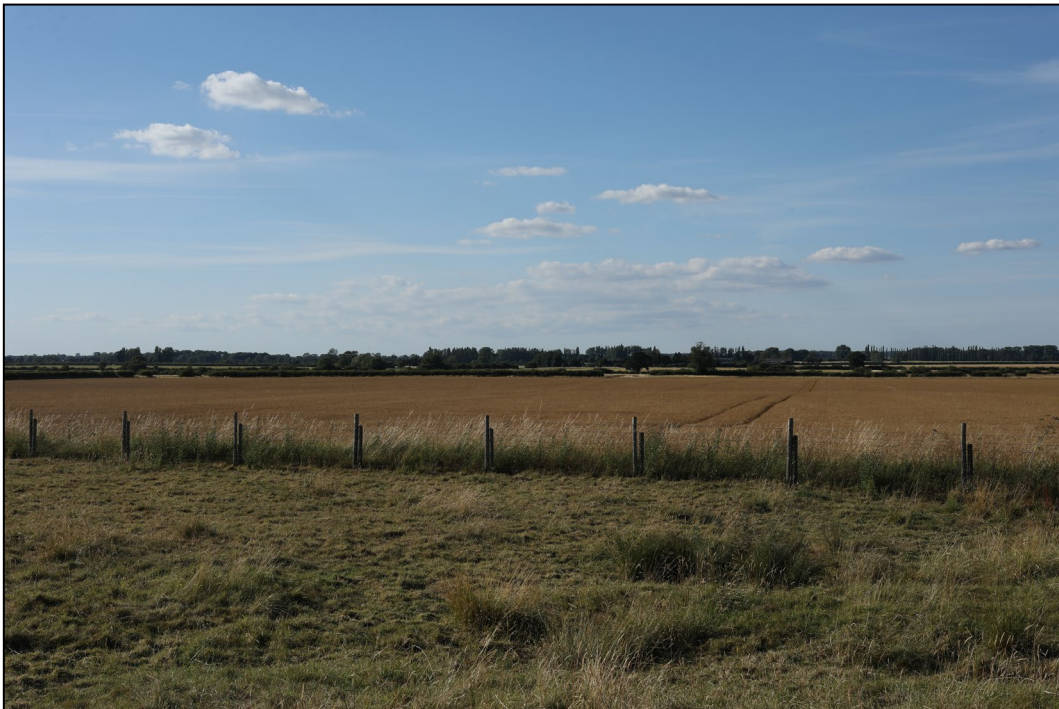
Photograph 16: View NNW from within Thorpe medieval settlement (NHLE 1016978) across the western and central parts of field D14 of Cottam 1d (immediately beyond the fence line).

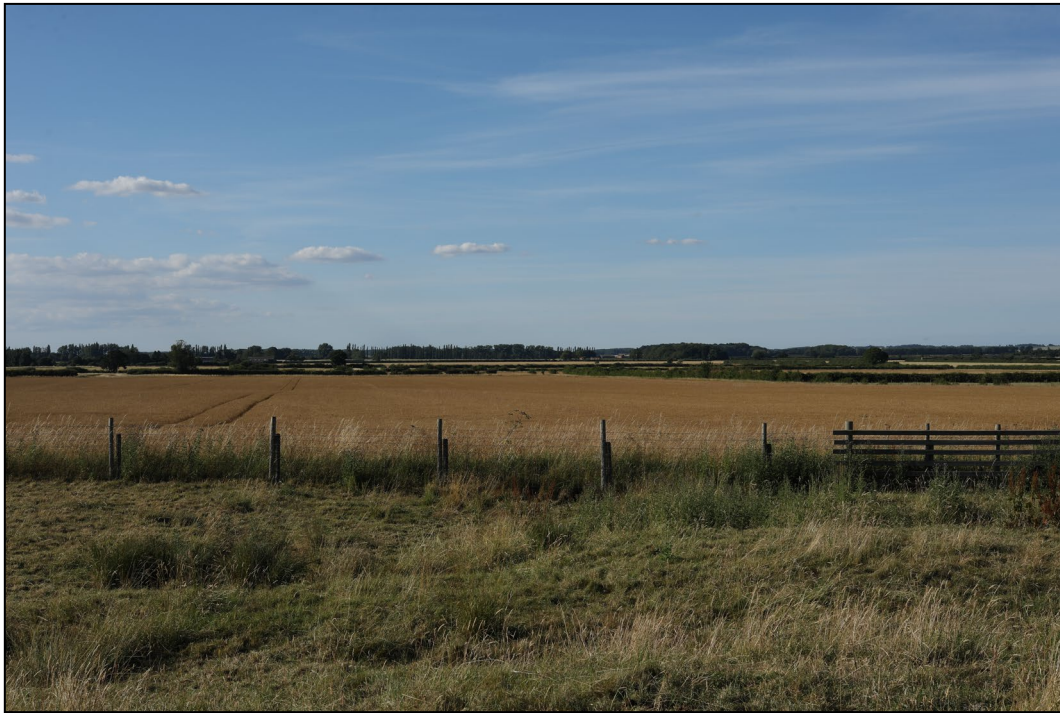
Photograph 17: View north from within Thorpe medieval settlement (NHLE 1016978) across the central and eastern parts of field D14 of Cottam 1d (immediately beyond the fence line).

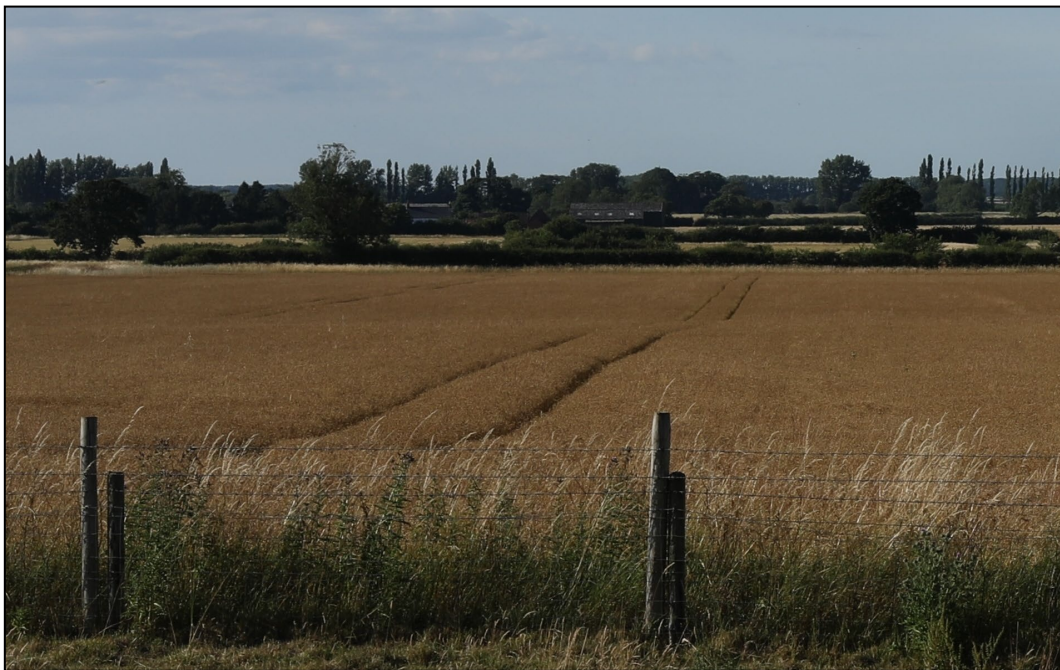
Photograph 18: Zoomed view as above (west side) showing parcel D13 layered in the middle distance and buildings associated with Lower Furze Hill farm beyond.

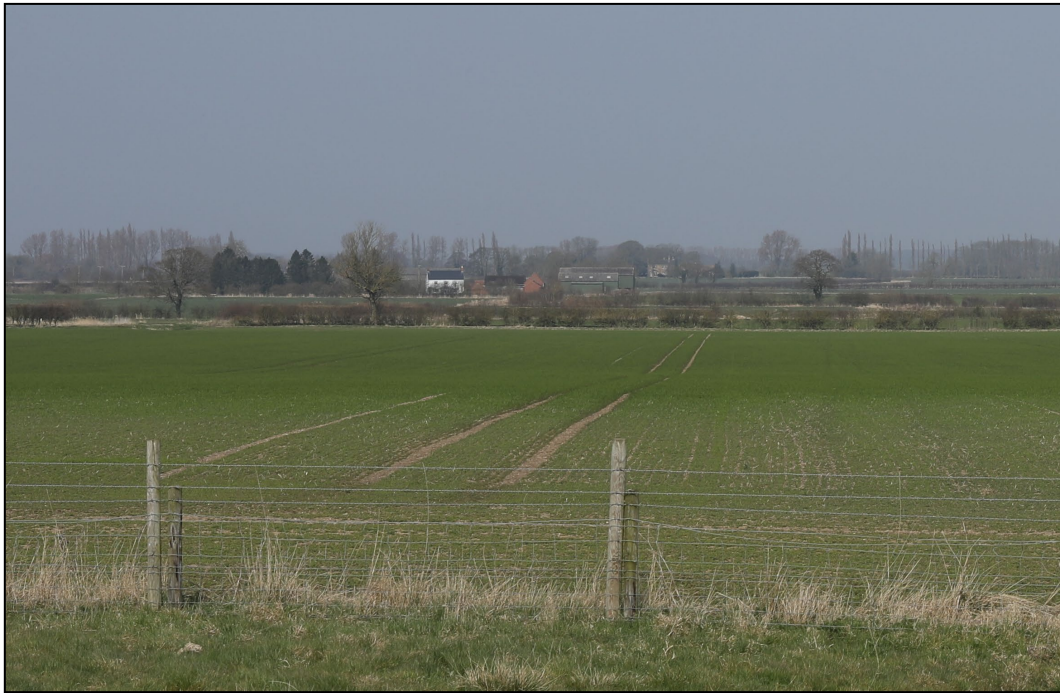
Photograph 19: As above, in winter when the leaves are off the trees. Coates Hall is visible in the distance to the right of Lower Furze Hill Farm.

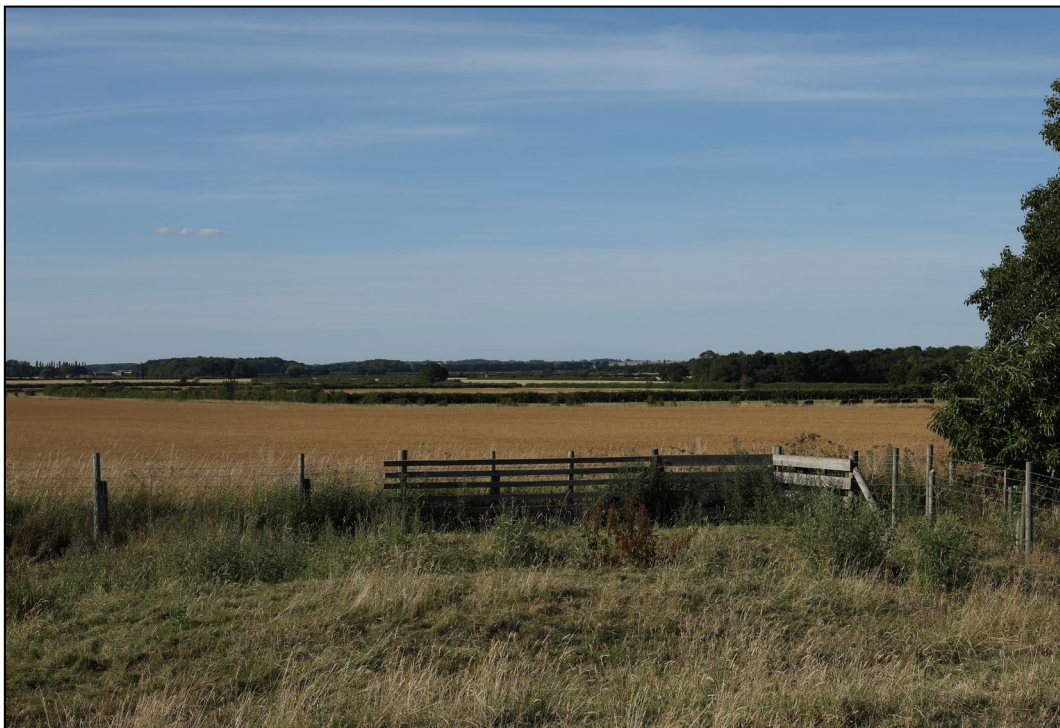
Photograph 20: Zoomed view of Photograph 17 (east side) showing hedgerow partially surviving along eastern boundary of field D14, and layered views across field D15 beyond. Grange Farm at Coates is visible in the distance on the left.

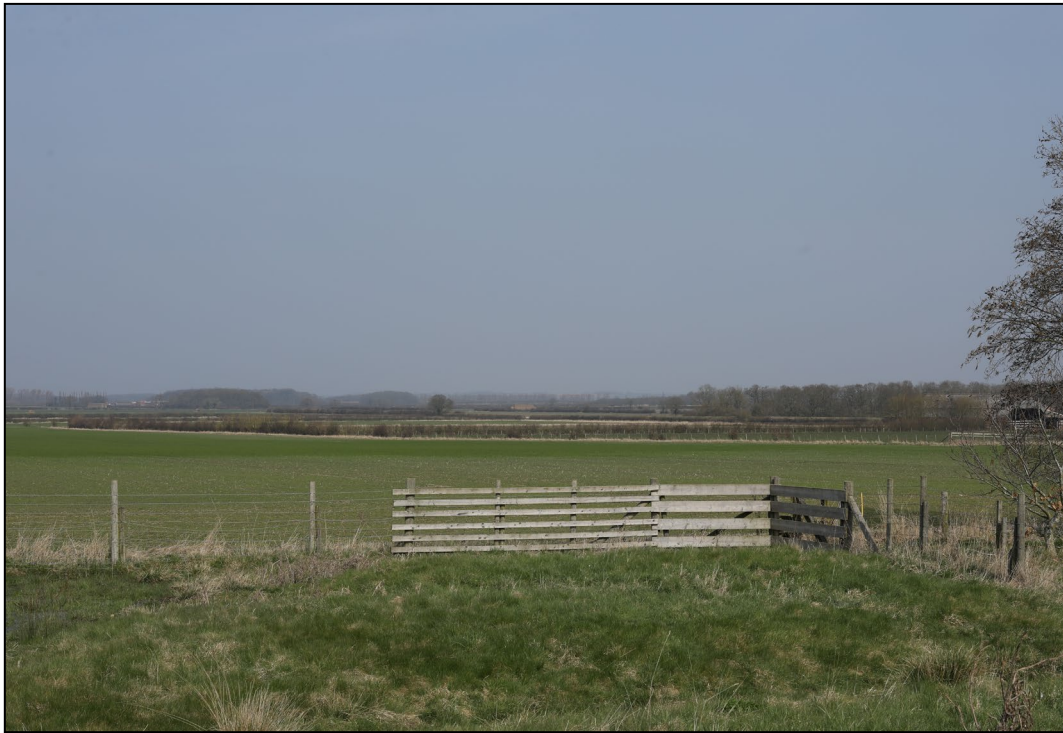
Photograph 21: As above, in winter when the leaves are off the trees revealing views of farm buildings at The Grange (right).

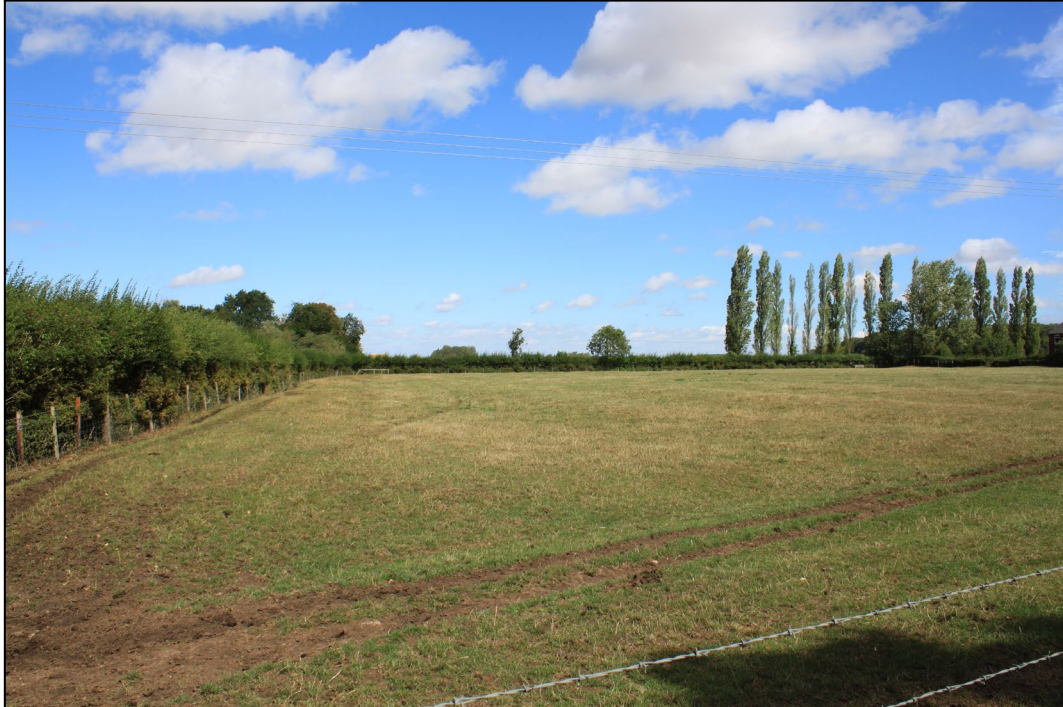
Photograph 22: View north across the eastern field of Coates medieval settlement in the direction of Cottam 1c, and it is evident that this would be unlikely to be visible from this part of the scheduled area.

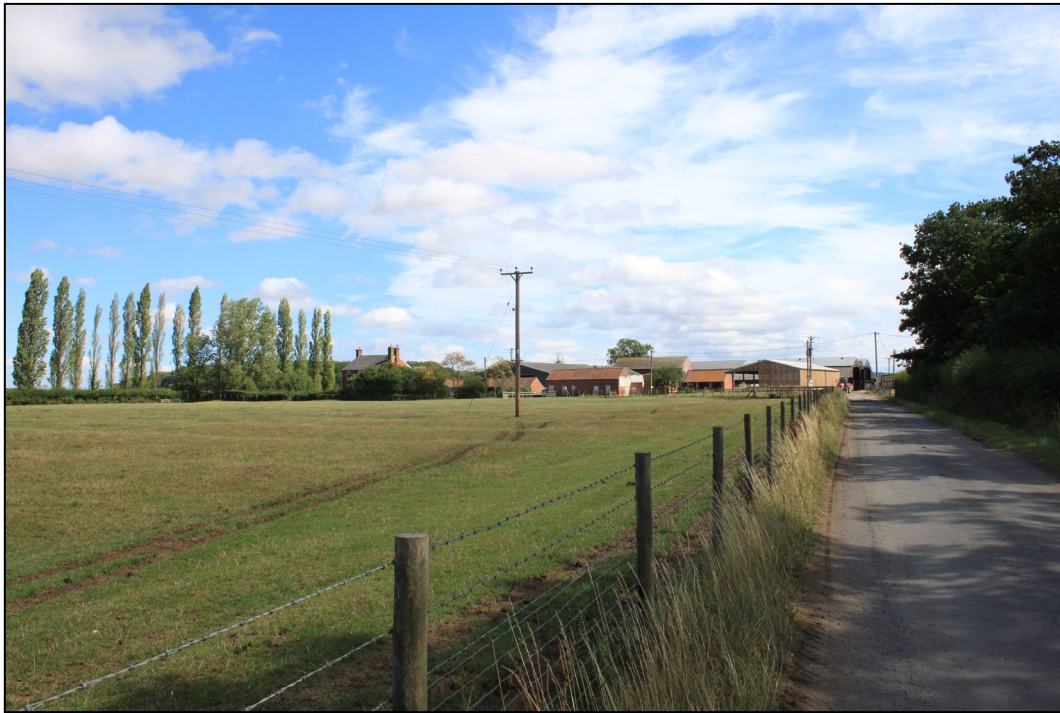
Photograph 23: View north-west across the eastern field of Coates medieval settlement (NHLE 1016979) in the direction of Cottam 1c which is unlikely to be visible from any of this area.

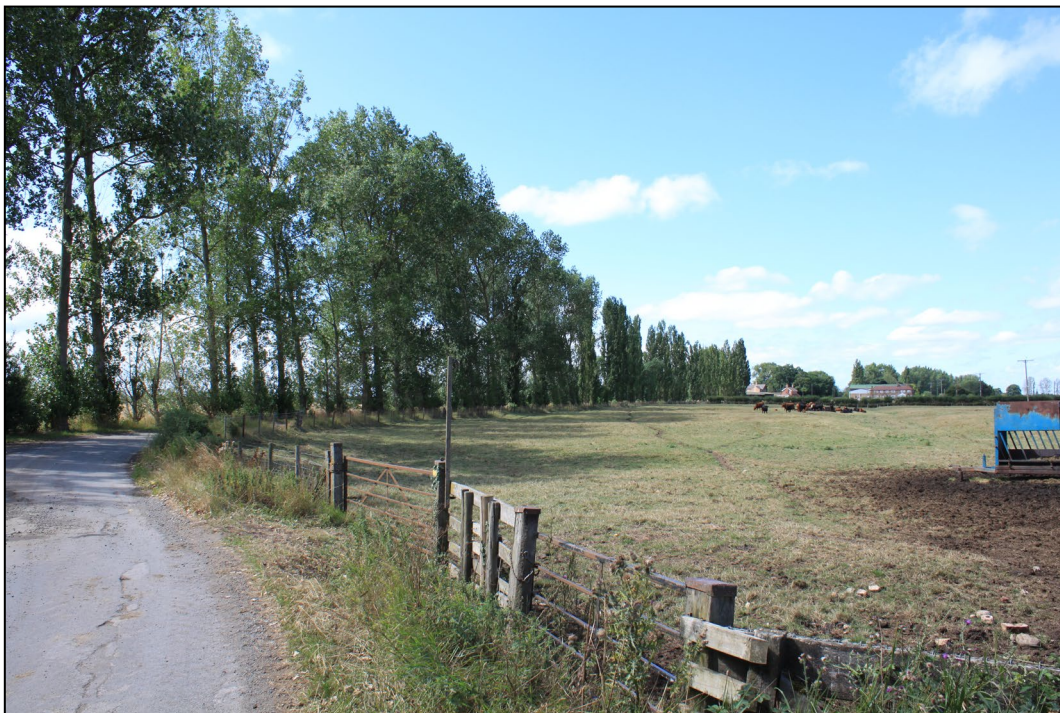
Photograph 24: View south-west along the southern edge of Coates medieval settlement (NHLE 1016979) looking towards Cottam 1e, showing the level of screening afforded by the belt of trees along the southern edge of the road.

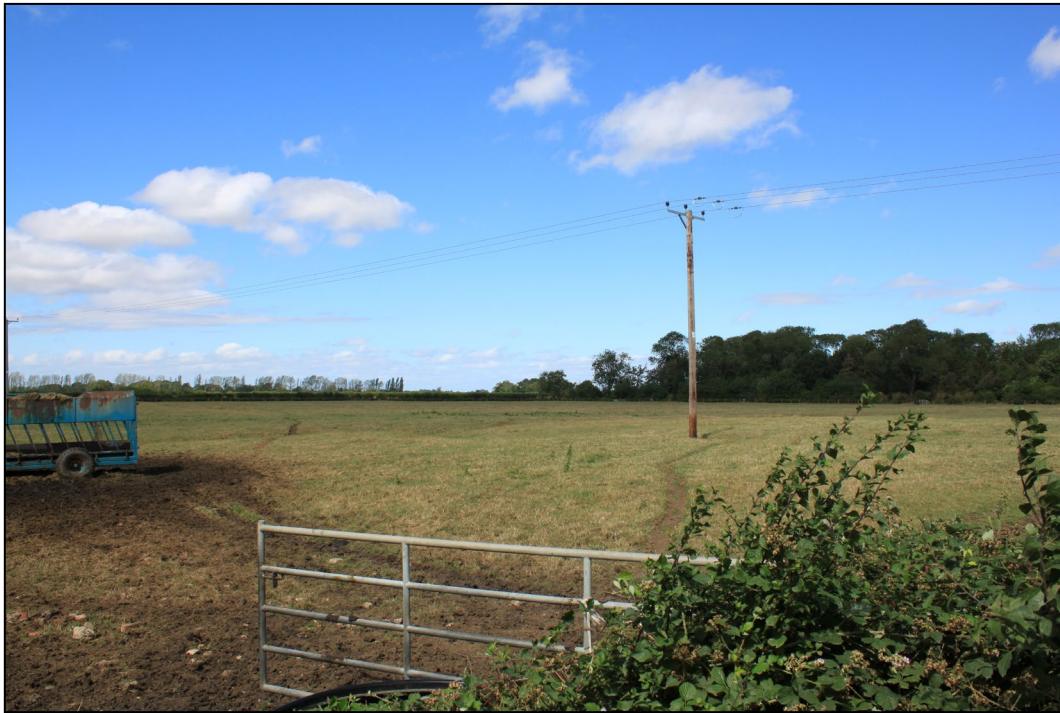
Photograph 25: View north-west across the western field of Coates medieval settlement (NHLE 1016979) looking in the direction of Cottam 1g.

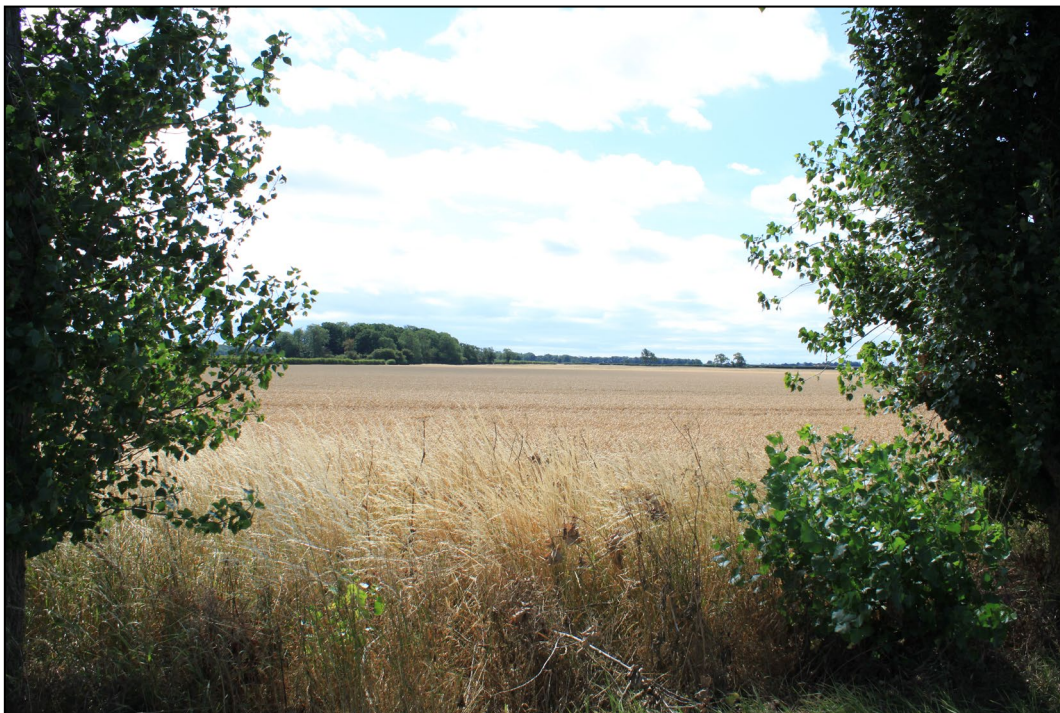
Photograph 26: Glimpsed view through the trees along the southern edge of Coates eastern field of Coates medieval settlement (NHLE 1016979) in the direction of Cottam 1d, which, if visible, would be seen in the context of the layering of trees and hedgerows along the horizon.

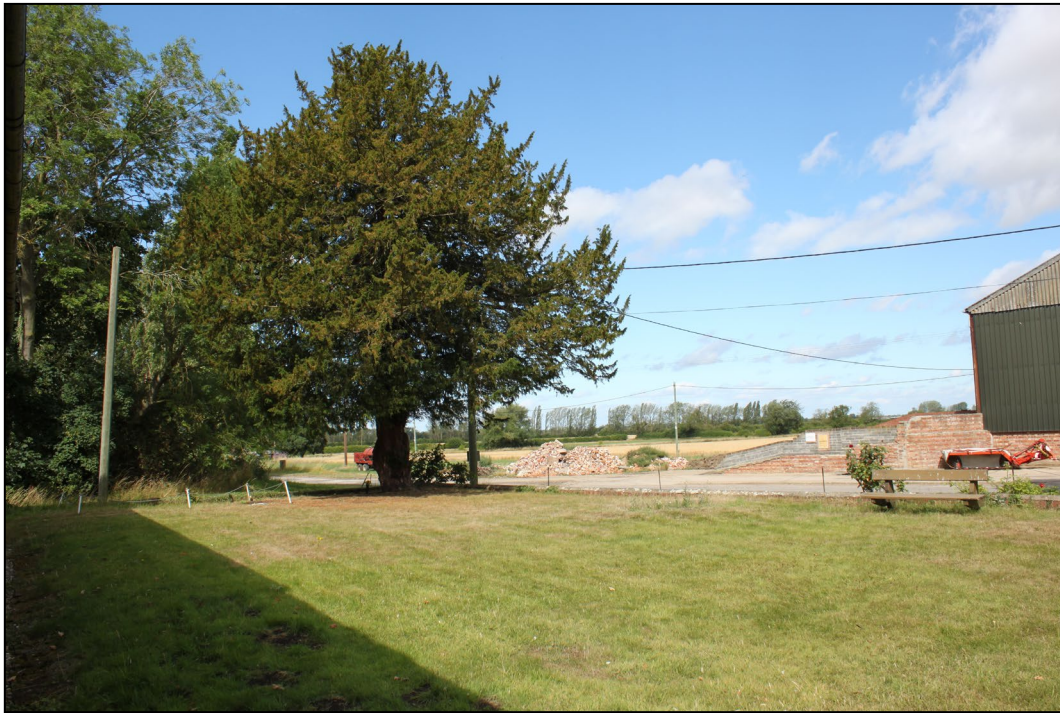
Photograph 29: View north-west towards Cottam 1g from the churchyard adjacent to the Coates moated site (NHLE 1016979).

more distant trees and hedgerows (Photograph 29), and if glimpses of any of the taller elements of the electrical substation proposed in this area would be possible these would be seen through these trees which would make them difficult to discern.

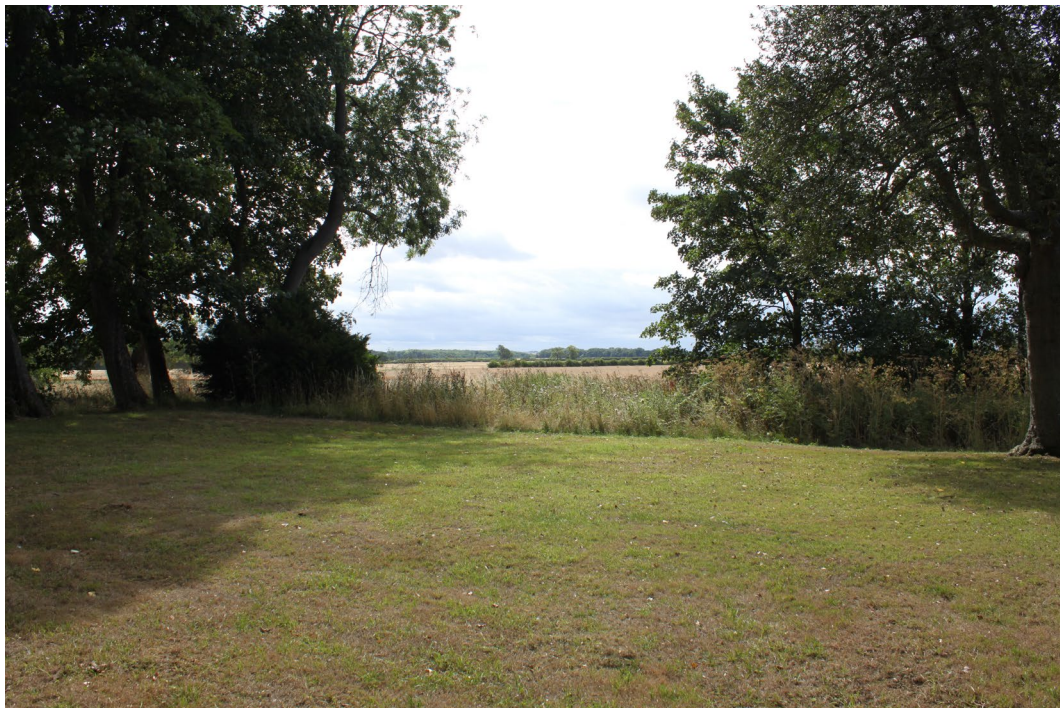
Photograph 30: View south-west through the gap in the trees lining the southern edge of Coates moated site (NHLE 1016979), looking towards Cottam 1d, which if visible would be glimpsed within the layering of trees and hedgerows along the horizon.

- 3.1.61 This Grade I listed church is located c.0.69km to the north-east of Cottam 1 at its nearest point (Cottam 1E) and greater than 5km distant from the Cottam 2 and 3 Sites. As discussed above in relation to the adjacent Scheduled Monument (see discussion of NHLE 1016979 above), a dense block of woodland occupies much of the moated site and, consequently, the immediate setting of the church is very much characterised by a sense of enclosure (Photographs 28, 69-70) most notably on its southern side (Photograph 69). Nevertheless, it is possible to obtain a view of part of the landscape which would be occupied by the Cottam 1D solar array from the south side of the churchyard, within the scheduled moated site, as described above (Photographs 30 and 31).

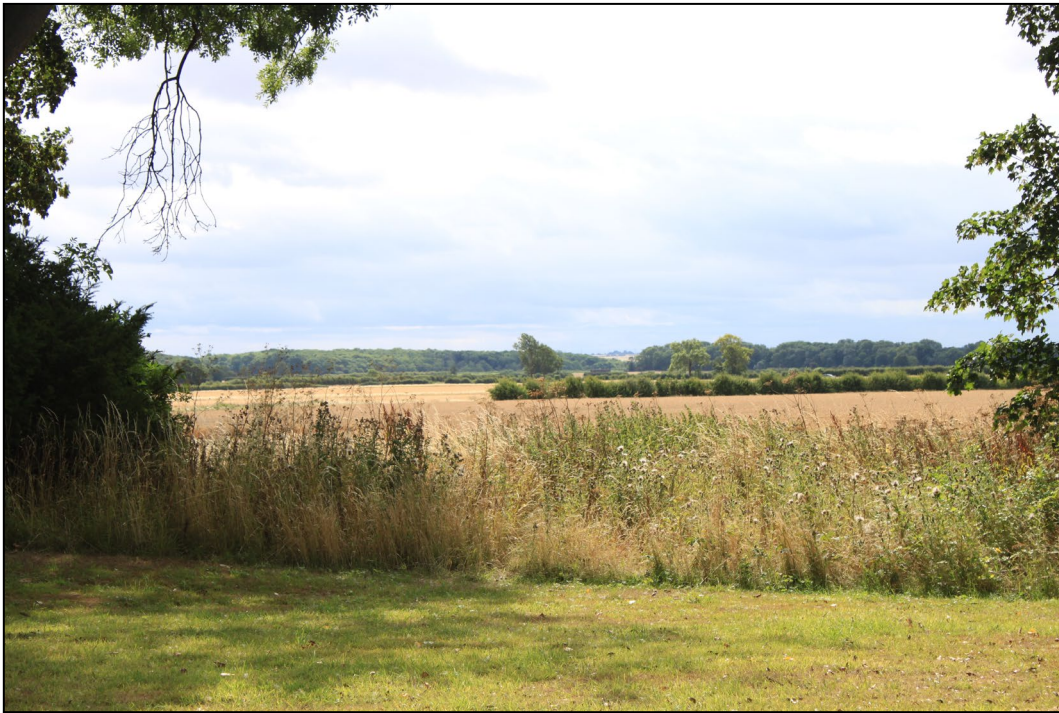
Photograph 31: Zoomed view as above.
