Cottam Solar Project

Environmental Statement Appendix 13.5: Heritage Statement (Part 1 of 4)

Prepared by: Lanpro Services
January 2023

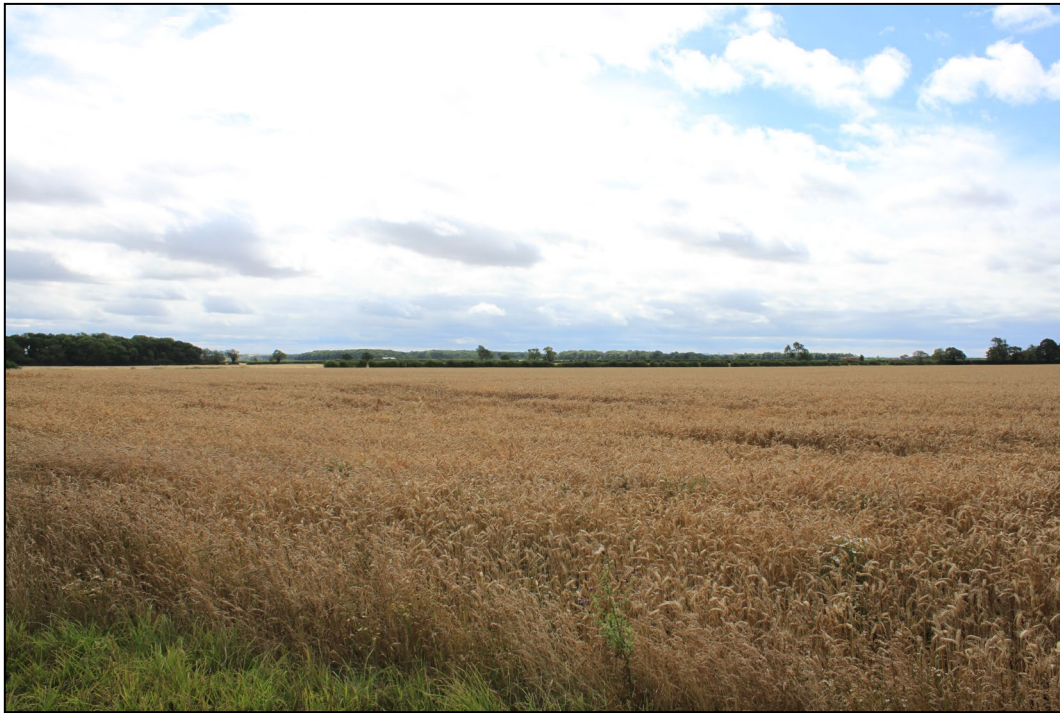
Photograph 33: View south (right) to south-east (left) from the southern edge of Coates moated site (NHLE 1016979), looking towards the central and eastern part of Cottam 1d, which, if visible, would be seen within the context of the layering of trees and hedgerows along the horizon.

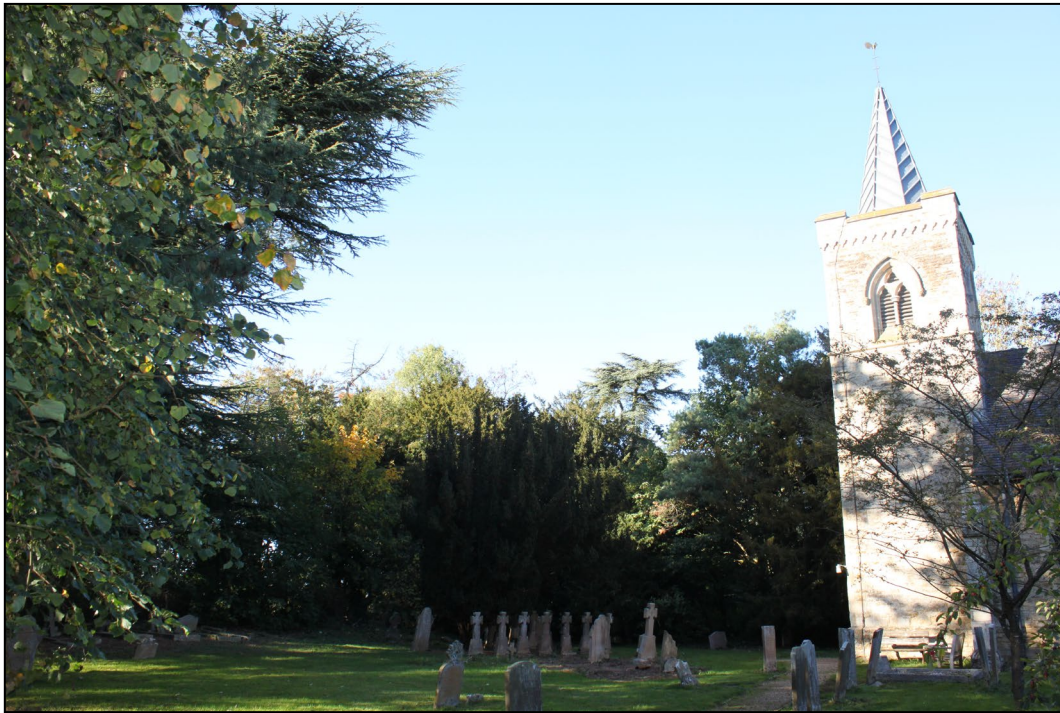
Photograph 35: View north towards Church of St. Cuthbert, Brattleby (NHLE 1063378) illustrating the level of screening provided by the vegetation to the west for views from the church and Cross in St Cuthbert's churchyard Scheduled Monument (NHLE 1018288).

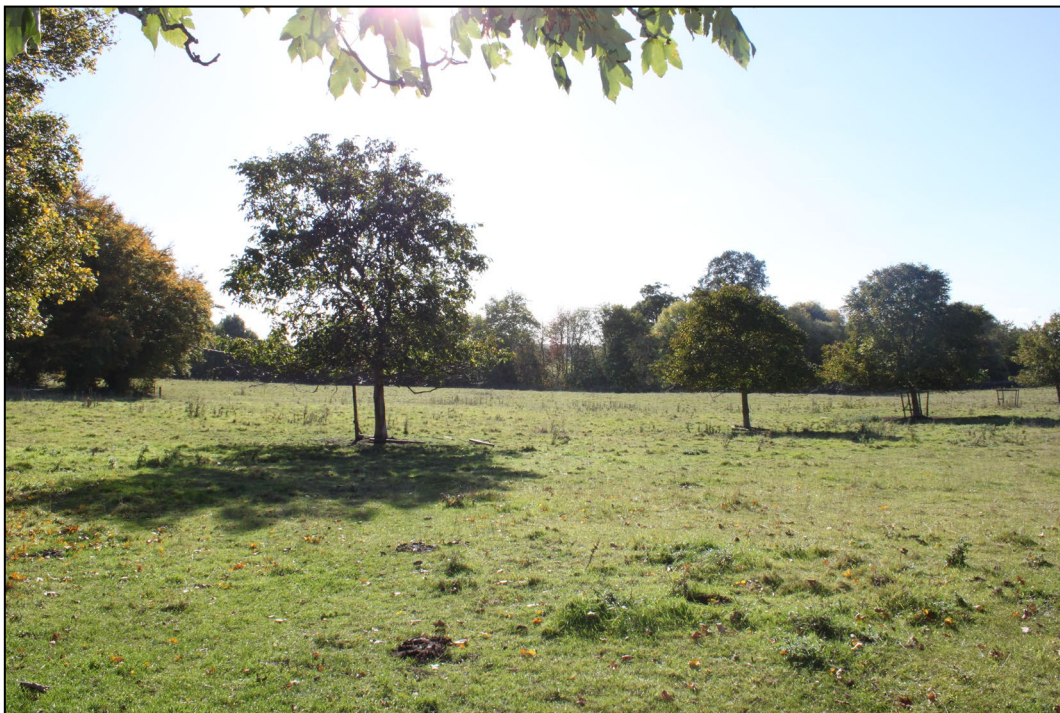
Photograph 38: View south-west towards Cottam 1 from the eastern edge of Harpswell Hall Scheduled Monument (NHLE 1019068), illustrating the level of screening afforded by the vegetated field boundary.

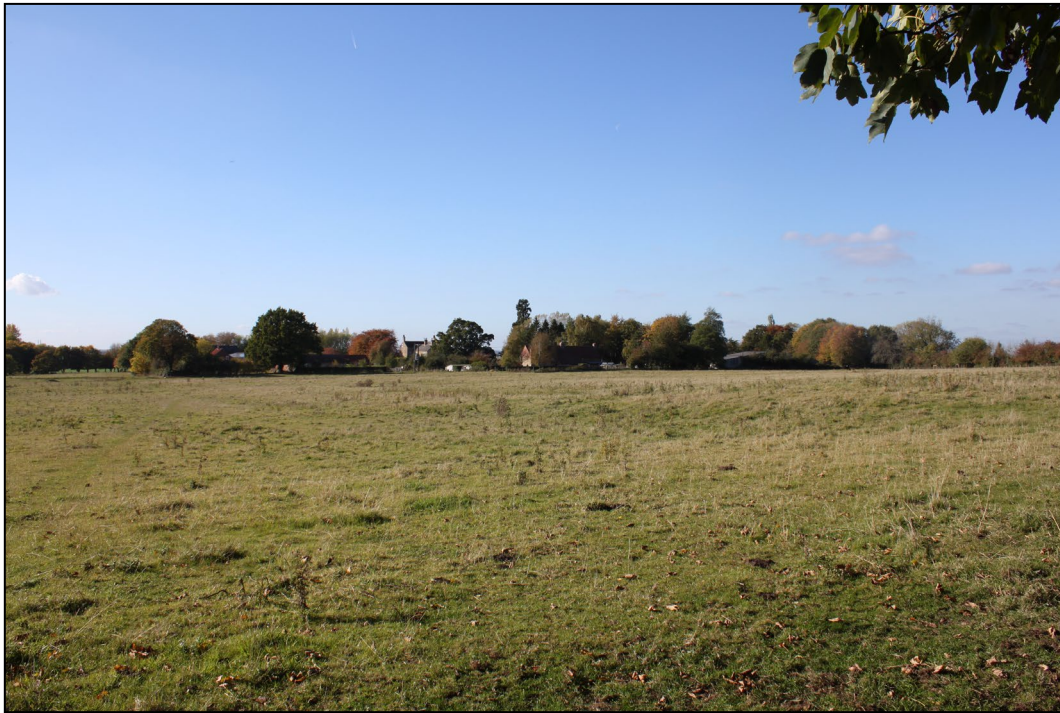
Photograph 39: View north-west towards Cottam 2 from the eastern edge of Harpswell Hall Scheduled Monument (NHLE 1019068) illustrating the level of screening afforded by the vegetated field boundary.

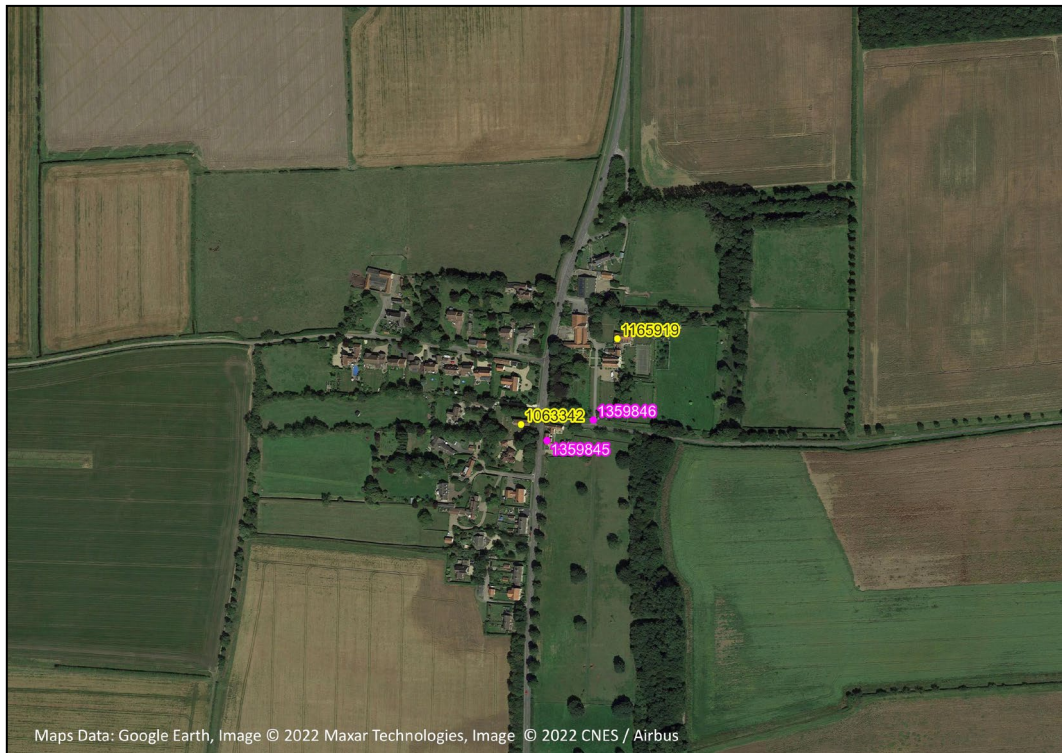
Photograph 41: Aerial view of Cammeringham showing the location of the Listed Buildings and illustrating the screening of views westwards provided by the surrounding built environment.

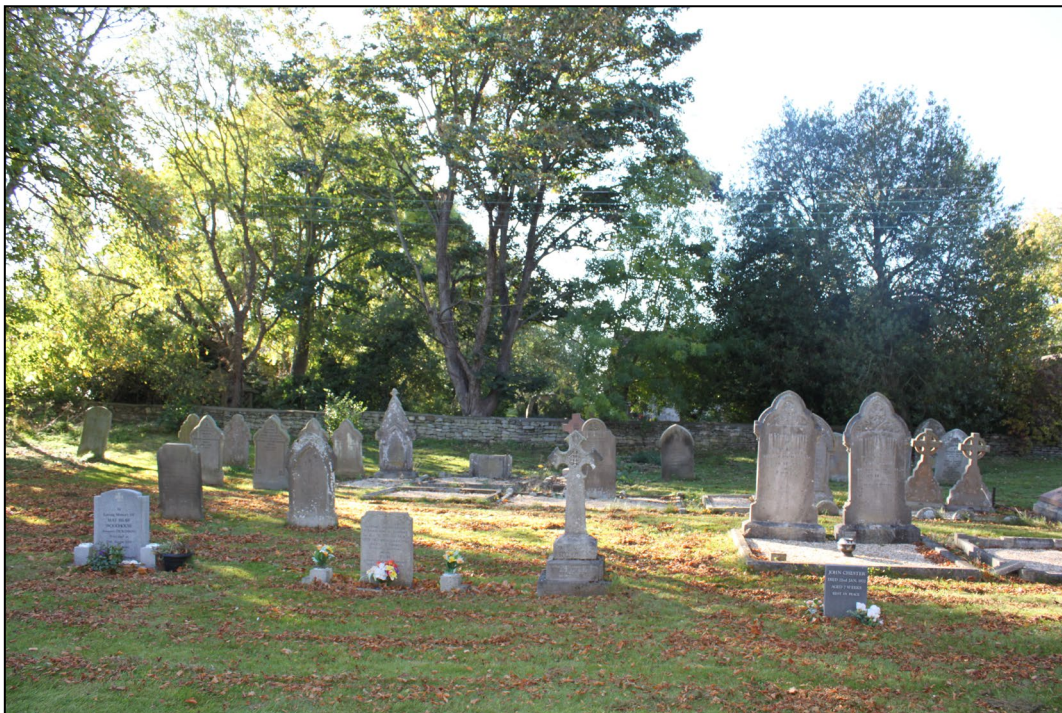
Photograph 42: View west from the Church of St Michael and All Angels, Cammeringham (NHLE 1063342) illustrating the extent of screening immediately beyond the church yard.

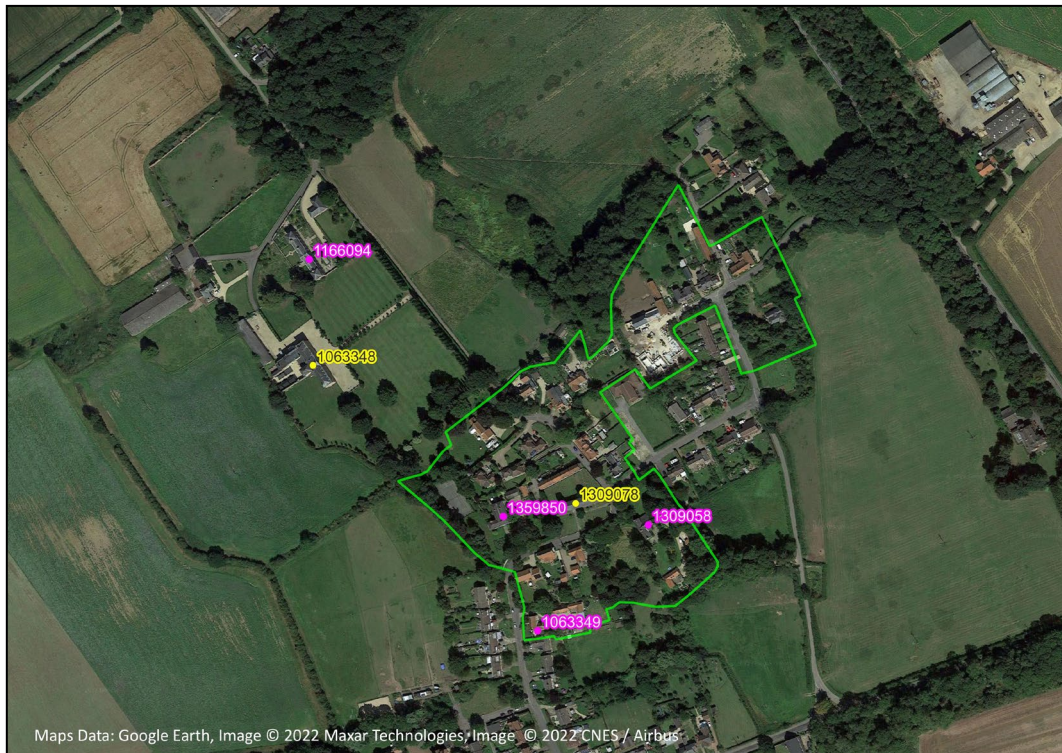
Photograph 43: Aerial view of Glentworth Hall (NHLE 1063348) and its stable block (NHLE 1166094), and Glentworth Conservation Area and its Listed Buildings to the south-east.

- 3.1.77 This Grade II* listed church is located c.1.79km to the north-east of Cottam 1B and greater than 5km distant from the other Sites. The church occupies a central location within the Conservation Area at Glentworth (Photograph 43) and, as such, is surrounded on all sides by the dwellings that make up the village settlement and the

- 3.1.117 It is evident from the aerial view of the settlement (Photograph 43) that all three of the Grade II Listed Buildings are in locations that have extensive screening immediately to the west, either due the presence of mature trees, the surrounding built environment of the village, or a mixture of the two. It is concluded, therefore, that no intervisibility with the proposed development at Cottam 1 to the south-west or Cottam 2 to the north-west would be possible from any of these buildings or the wider Conservation Area. Consequently, the Glentworth Conservation Area and the heritage assets within it have been scoped out of further consideration following Step 1 of the Historic England setting guidance (2017) as their significance would remain unaffected by the proposed development.

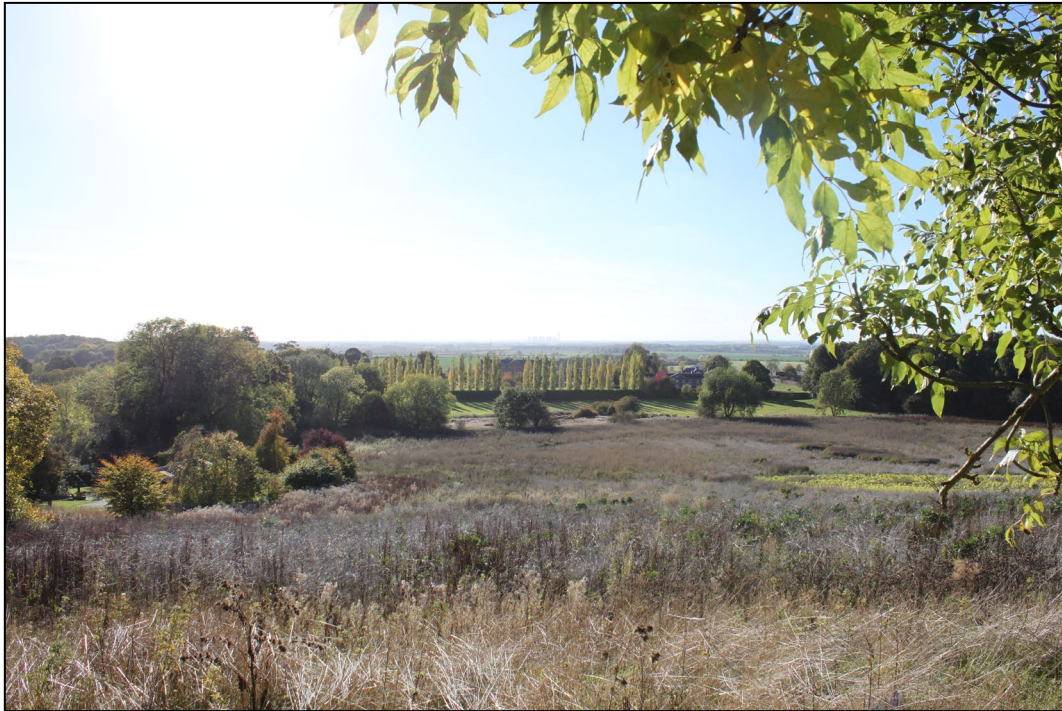
Photograph 46: View south-west towards Glentworth Hall (NHLE 1063348) from Middle Street on the Lincoln Cliff.

formerly running along the top of the Lincoln Cliff would have served to hide Middle Street from view from the hall, but also have prevented views towards the hall from the public highway. This plantation has since been largely removed, and just a single line of trees remains, and hence it is now possible to view the hall and the former stable block from the Lincoln Cliff, which includes wide views across the Trent valley beyond, although as the row of poplar trees planted as part of the recent landscaping works mature then this serves to screen the hall (Photographs 46 and 47).

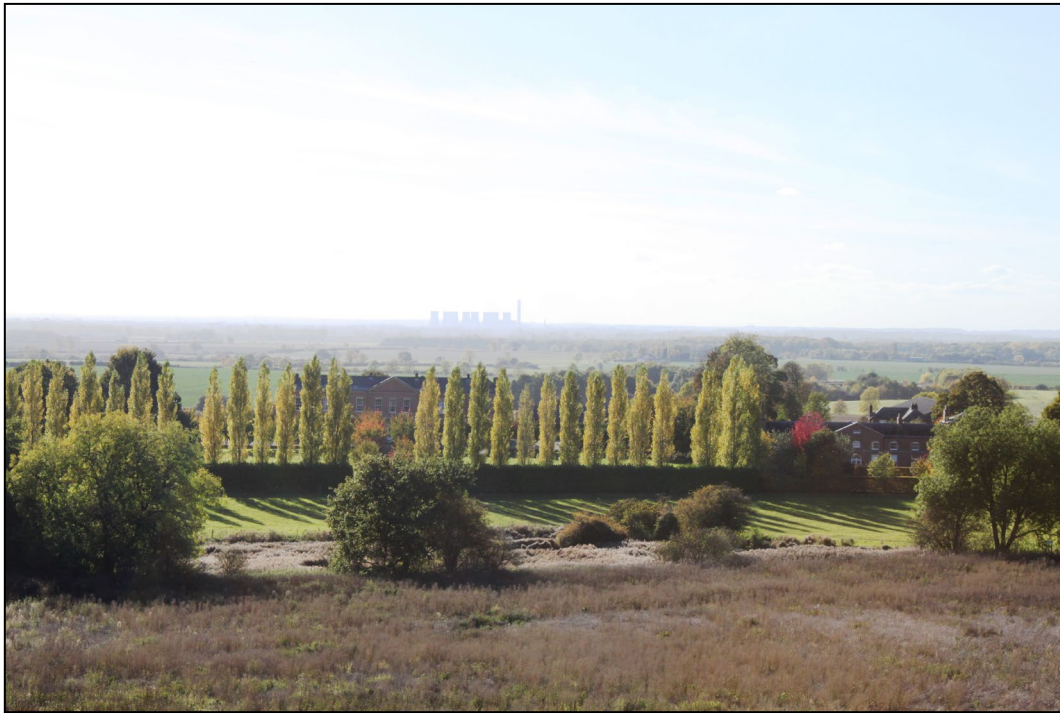
Photograph 47: Zoomed view as above, the Stable Block at Glentworth Hall (NHLE 116094) is visible on the right. Cottam 1 would be visible in the distance to the left of the Hall and Cottam Power Station which is silhouetted on the horizon.

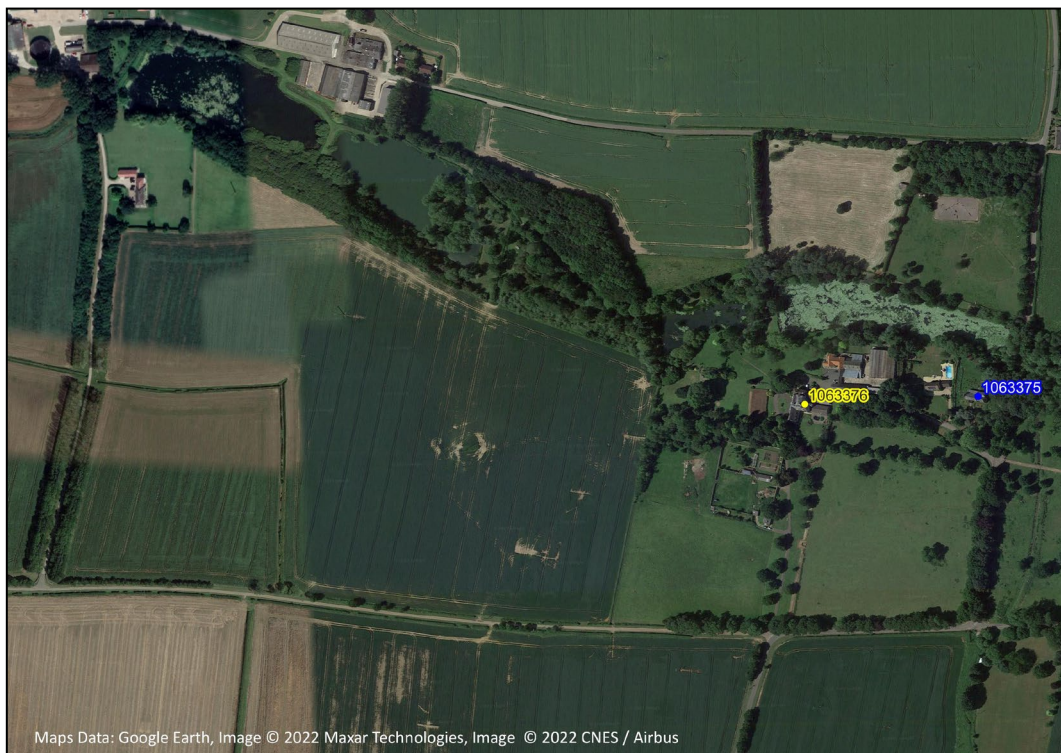
Photograph 48: Aerial view of Blyborough illustrating the extend of tree cover surrounding the two Listed Buildings and the shelter belts along the road to the west which provide further screening of views westwards towards the Sites.

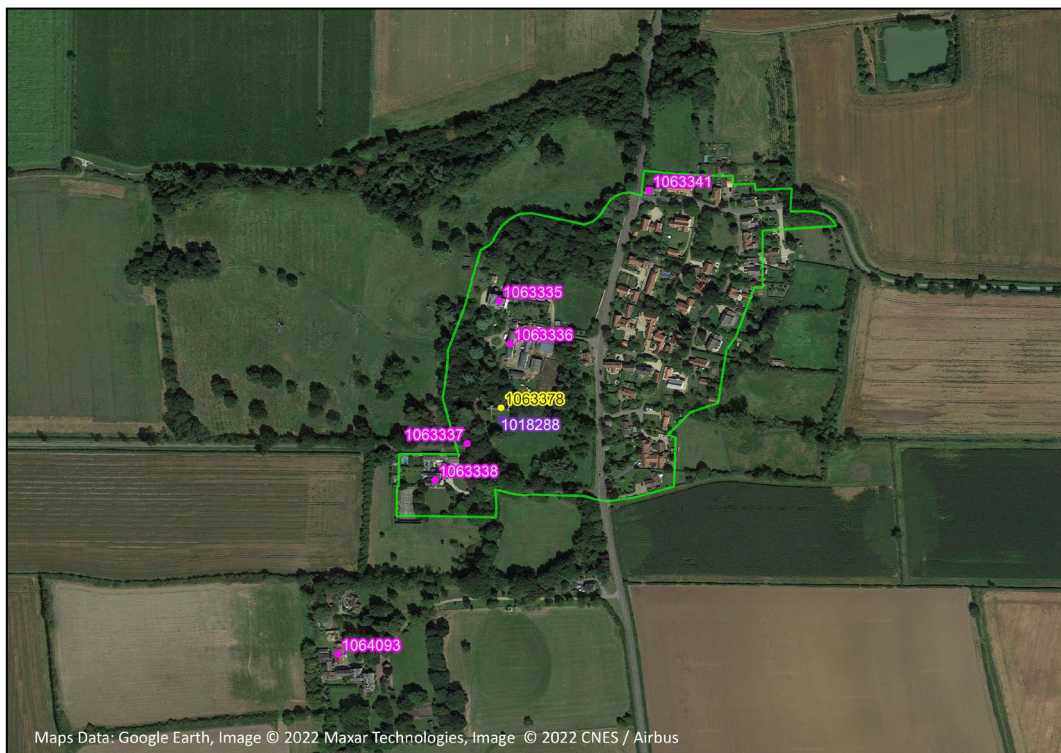
Photograph 50: Aerial view of Brattleby Conservation Area (to the north) and Aisthorpe (to the south) illustrating the extent of tree cover screening views to the west from the Listed Buildings.

- 3.1.89 There is a single Grade II Listed Building within the 2km study area within Aisthorpe, comprising the *Stables at Aisthorpe Hall* (NHLE 1064093), which is located 1.98km to the south-east of Cottam 1D. It is evident from aerial imagery (Photograph 50) that this 18th century stable block is situated in an enclosed setting, with the main hall buildings occupying the area to the south and west, further outbuildings to the north, and mature trees lining much of the curtilage boundary immediately to the west. Notwithstanding this, there is a gap in the line of trees to the north-west of the stable block and open fields beyond, which raises the possibility that glimpsed views of Cottam 1D could be possible in the view towards the Listed Building.

3.1.97 It is evident from the aerial view of the village (Photograph 50) that the western half of the Conservation Area contains a considerable amount of woodland, and the large field occupying the area immediately to its west and north-west also has a considerable wooded element around its edges. The Conservation Area Appraisal confirms that *Brattleby Hall* ‘... can only be appreciated from the Hall grounds, as it is generally hidden from view by its associated buildings, wall and tree filled grounds’²¹.

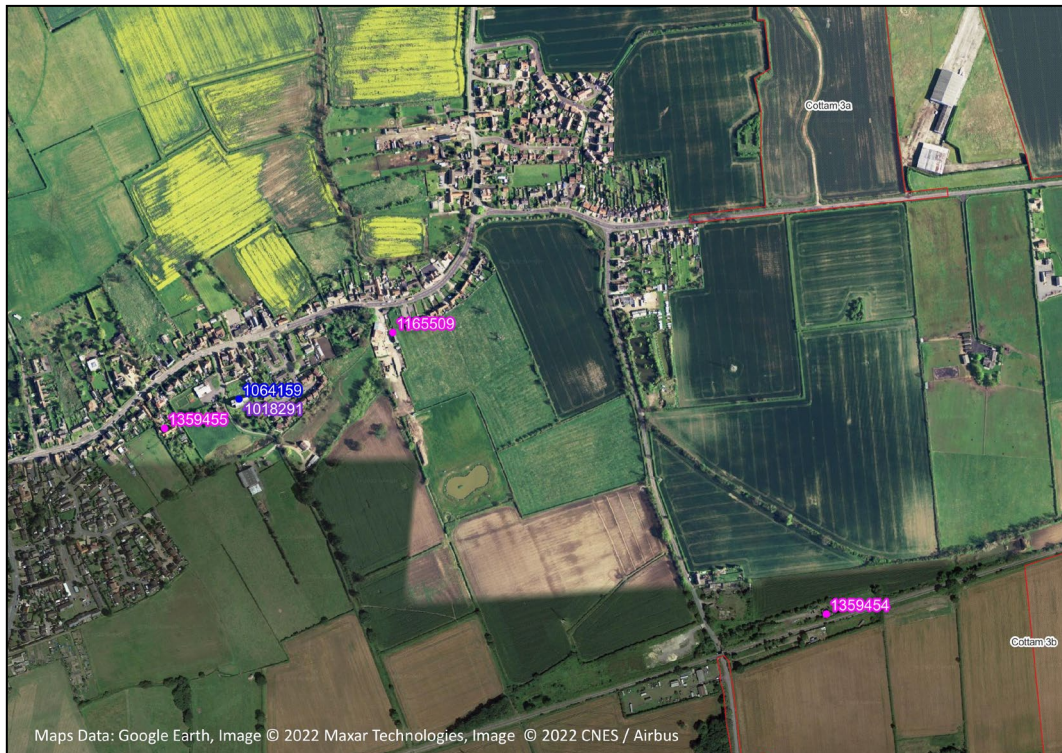
Photograph 55: Aerial view of Blyton illustrating the screening effect that the built environment in eastern part of the settlement will provide in views eastwards towards Cottam 3a from the Church of St. Martin (NHLE 1064159).

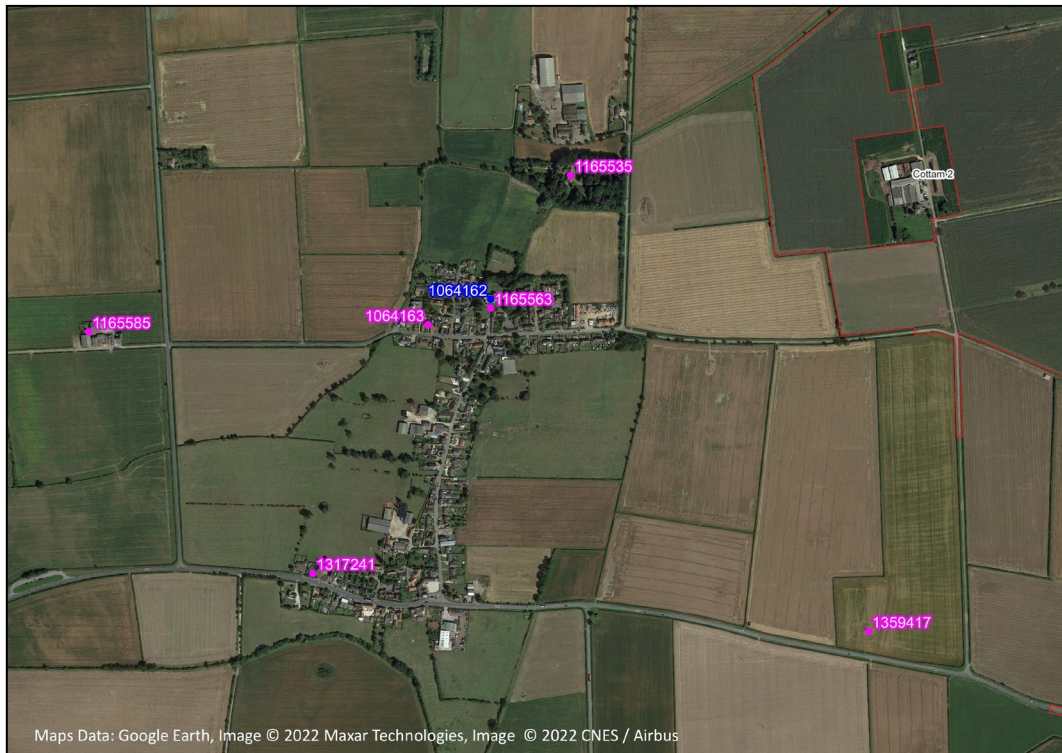
Photograph 57: Aerial view of illustrating how the surrounding built environment and trees provide screening for most of the Listed Buildings, though note the more open views from Corringham, Windmill to the east.

- 3.1.102 It is evident from the aerial view of the settlement (Photograph 57) that *Mill at Mill House Farm*, *Lychgate at Church of St Lawrence* and *1, High Street* are all located within or towards the western edge of the village where the surrounding built environment would screen any views eastwards towards the proposed development at Cottam 2. Consequently, these heritage assets have been scoped out of further consideration following Step 1 of the Historic England setting guidance (2017) as their significance would remain unaffected by the proposed development.

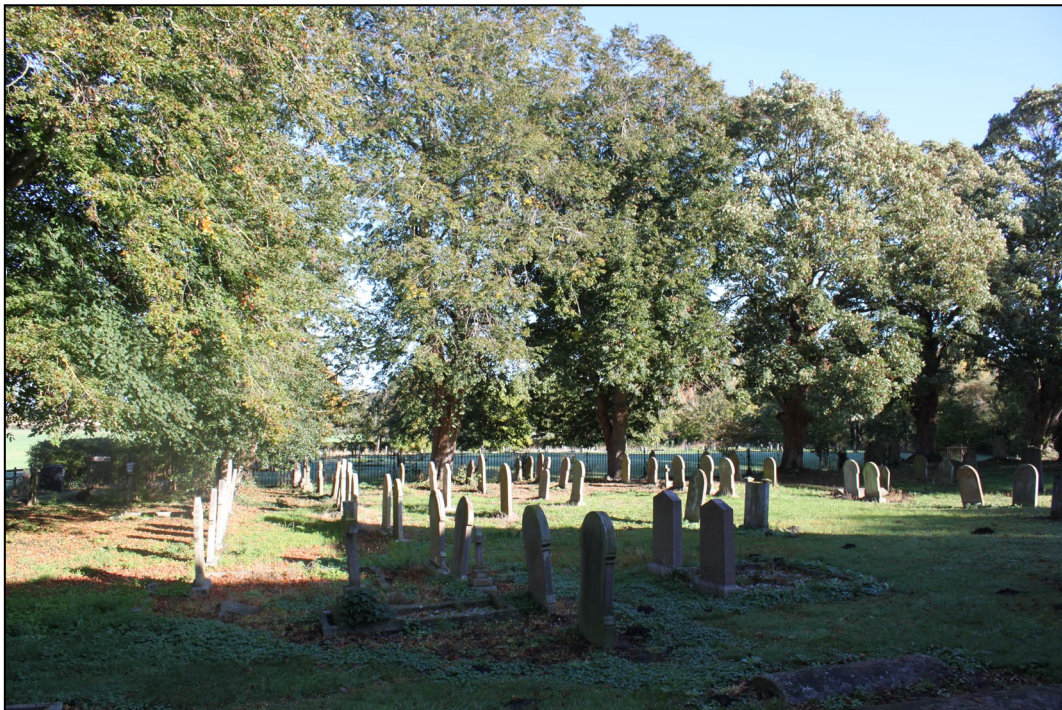
Photograph 58: View east towards Cottam 2 from the Church of St Lawrence, Corringham (NHLE 1064162).

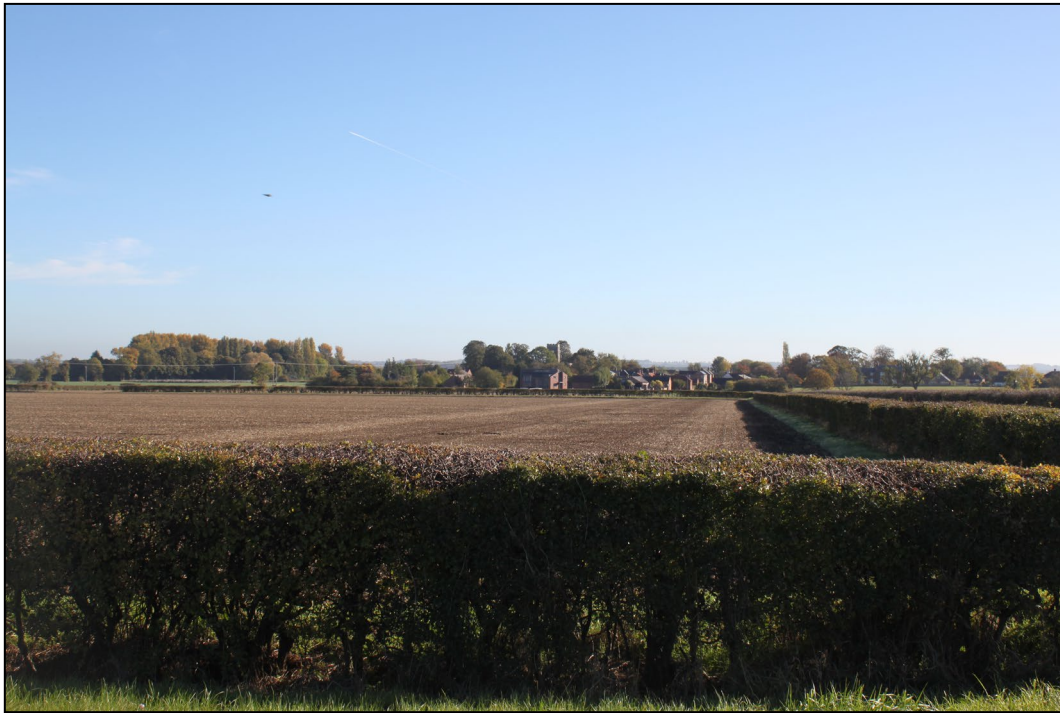
Photograph 59: View east towards the village of Corringham (Church of St. Lawrence visible at the centre of the photograph) illustrating the amount of tree cover which screens views of the landscape beyond from view.

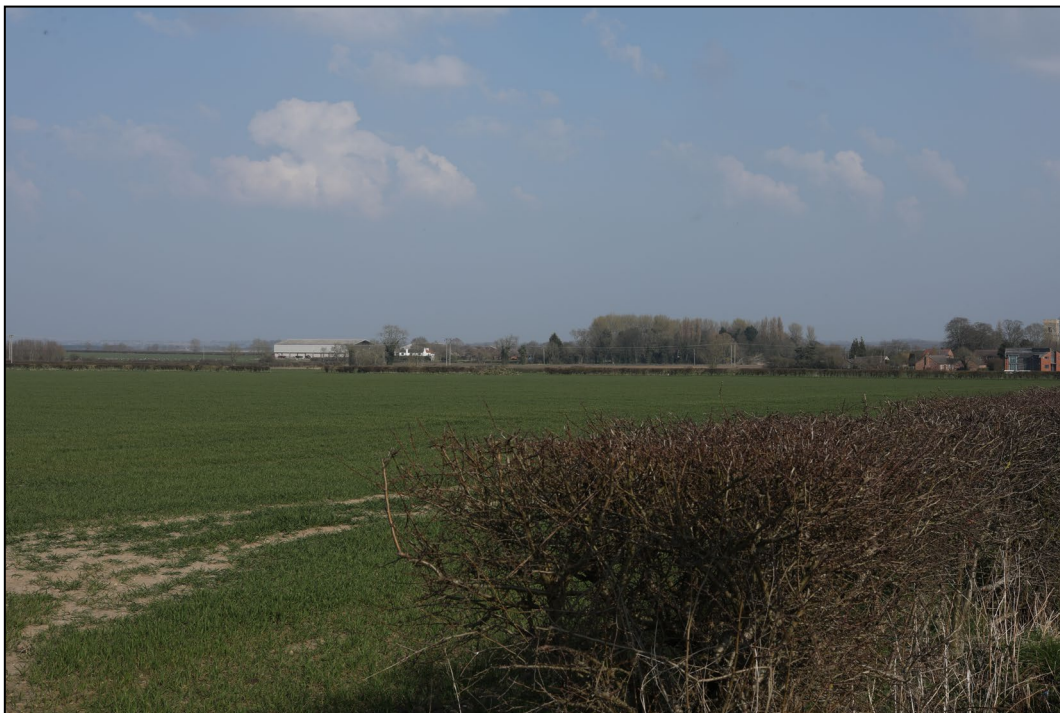
Photograph 60: Similar view to as above in the winter when the leaves are off the trees, illustrating the screening effect of the built environment and vegetation from the barn at Hall Farm (left) down to the Church of St. Lawrence (right). Cottam 2 would be located wholly behind this block of screening.

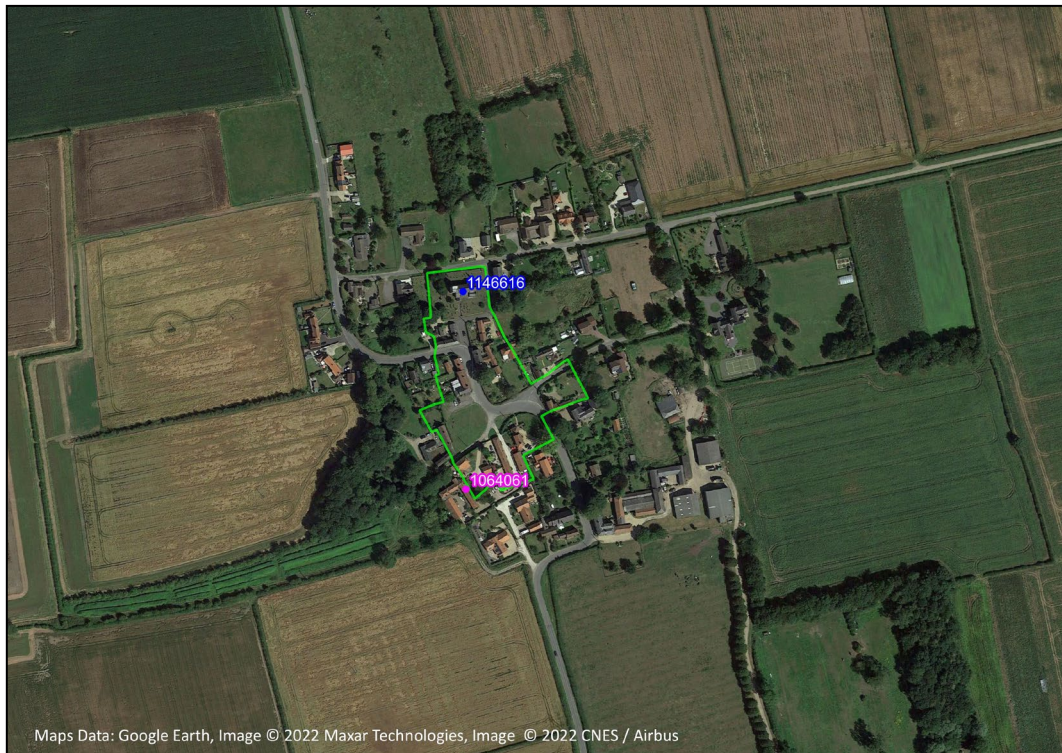
Photograph 61: Aerial view of Springthorpe illustrating the extent of the screening afforded by the surrounding built environment and vegetation in views north towards Cottam 2 and south-east towards Cottam 1 from the Listed buildings.

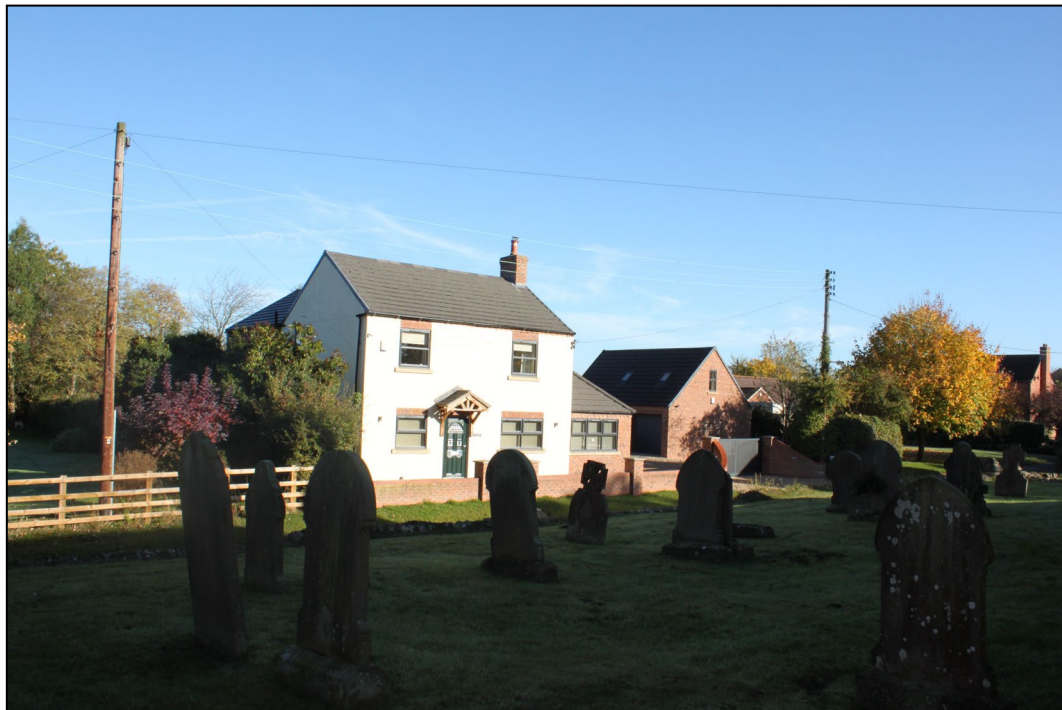
Photograph 62: View north-east from the Church of St Lawrence and St George, Springthorpe (NHLE 1146616) illustrating the screening of views towards Cottam 2 by the surrounding built environment.

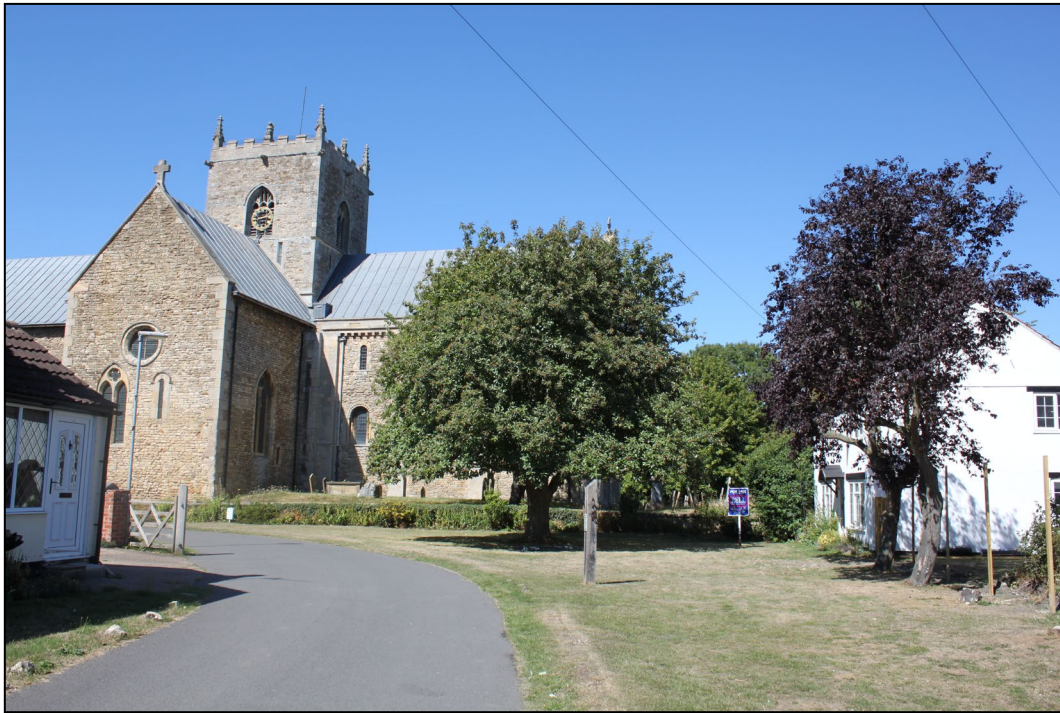
Photograph 63: General view illustrating the screening afforded by the built environment and vegetation to the east of St Mary's Church, Stow (NHLE 1146624), looking north. Note the Grade II listed Whipping Post (NHLE 1064062) on the grass verge in the foreground.

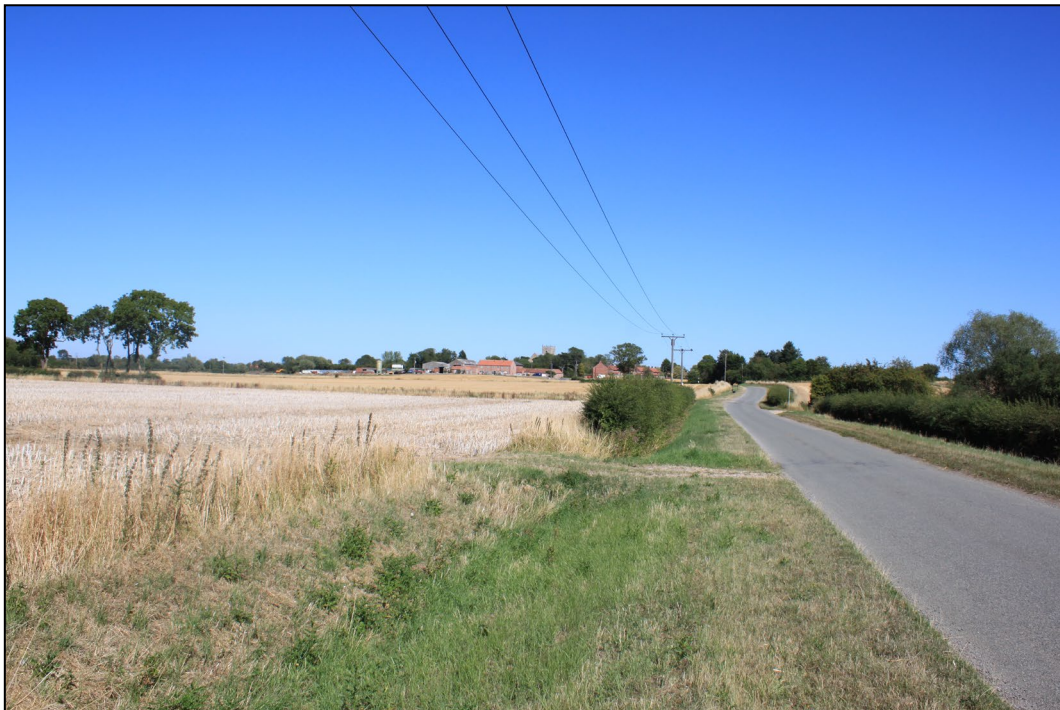
Photograph 64: View westwards towards the village of Stow illustrating the lack of visibility of the landscape beyond where the proposed development of Cottam 1 would be located.

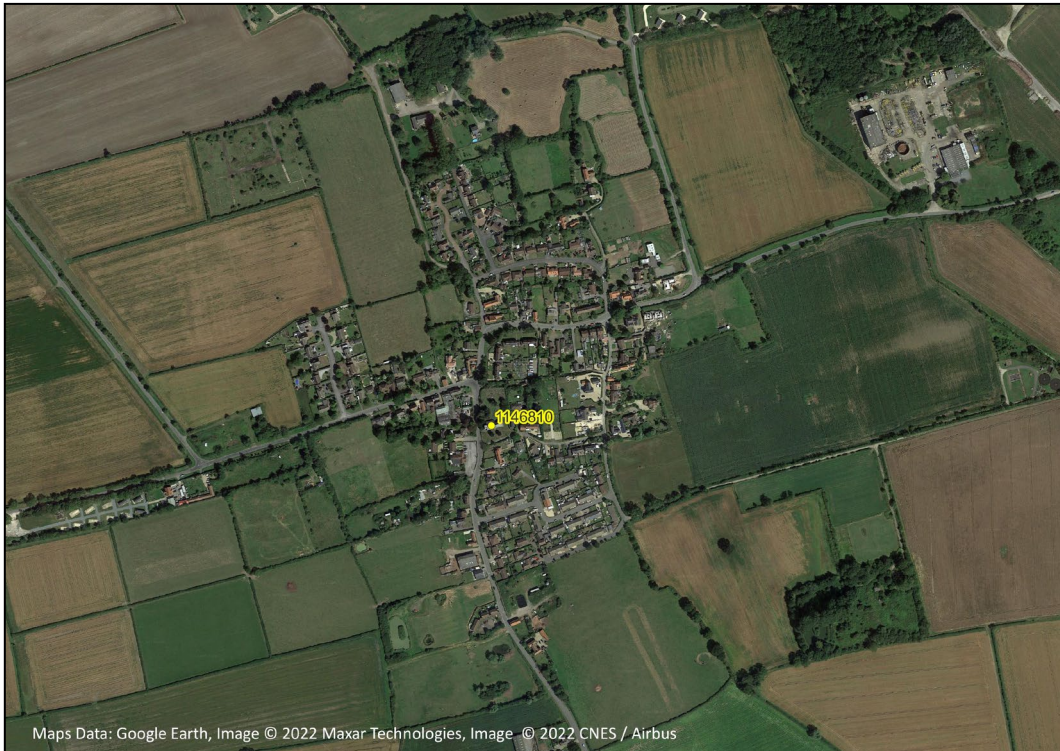
Photograph 71: Aerial view of Upton illustrating the extent of the surrounding built environment screening views to the south-east towards Cottam 1 and north towards Cottam 2 from the Church of All Saints (NHLE 1146810).

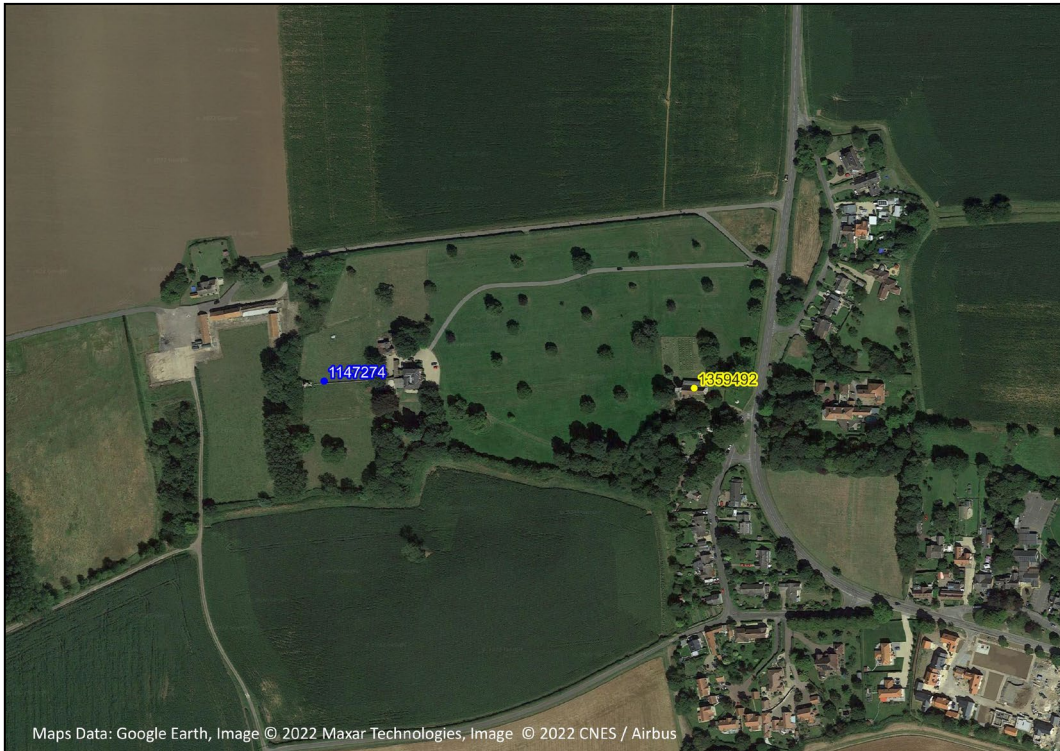
Photograph 75: Aerial view of Scampton illustrating the extent of the screening afforded by the vegetation and built environment in views to the north-west towards Cottam 1 from the Grade I Listed Gateway at Scampton House Farm (NHLE 1147274).

- 3.1.86 This Grade II* listed church is located c.2.92km to the south-east of Cottam 1D and greater than 5km distant from the other Sites. The church is located at the north-western tip of the village, surrounded to the north and west by open parkland associated with the former Scampton Hall (Photograph 75). A site visit was undertaken to ascertain whether any views across the parkland towards the Cottam 1 Site might be possible, and this confirmed that no views beyond the hedge line along the northern edge of the adjacent parkland are possible (Photograph 100). Consequently, this heritage asset has been scoped out of further consideration following Step 1 of the Historic England setting guidance (2017) as its significance would remain unaffected by the proposed development.

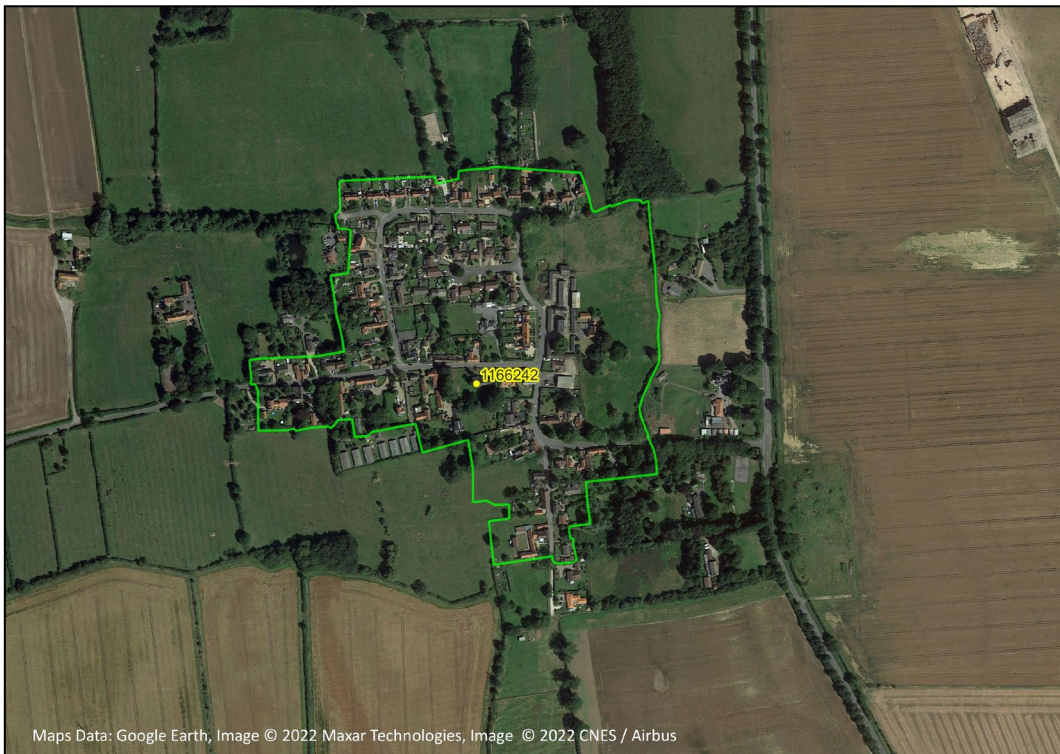
Photograph 80: Aerial view of Hemswell Conservation Area (outlined in green) illustrating the level of screening provided by the surrounding built environment and vegetation.

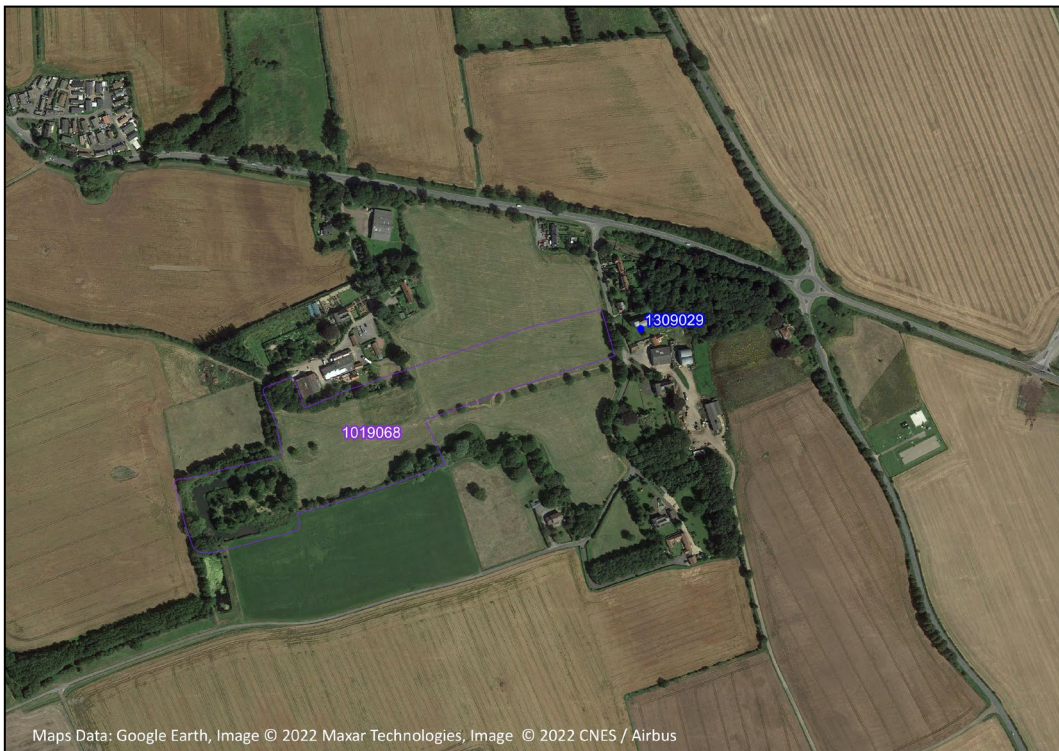
Photograph 82: Aerial view of Harpswell illustrating the frequent blocks of woodland and trees in close proximity to the Church of St. Chad (NHLE 1309029).

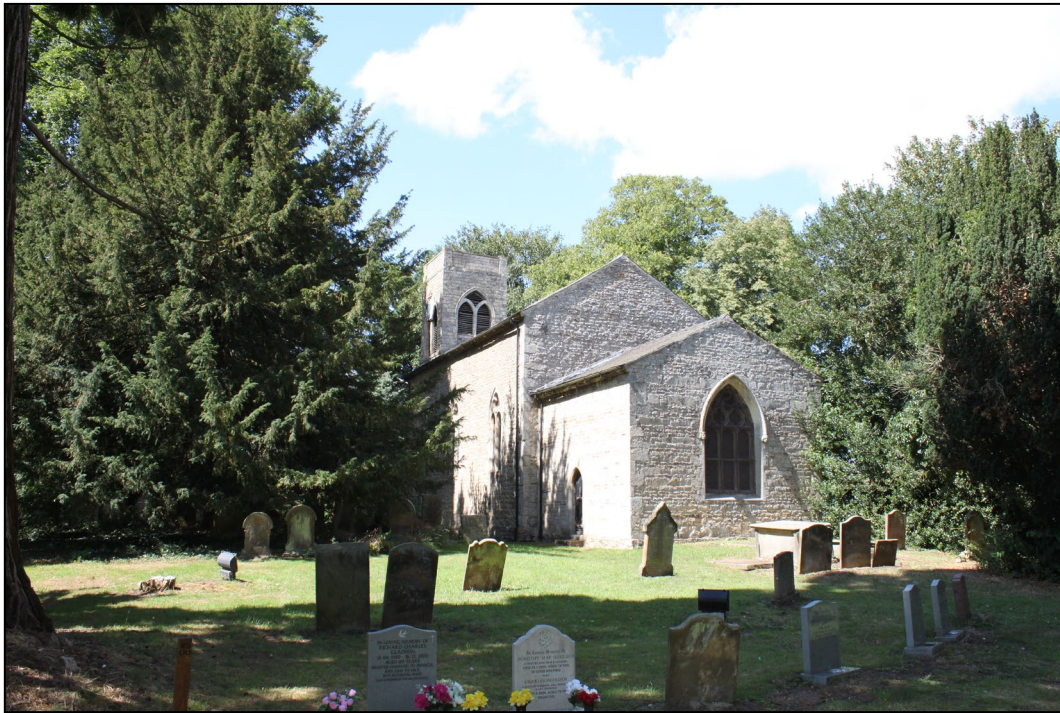
Photograph 87: View west along the southern side of the Church of St. Andrew, Fillingham, towards the location of the Grade II Listed monument within the churchyard (NHLE 1309113).*

- 3.1.88 This Grade II* listed church is located c.1.29km to the south-east of Cottam 1B and greater than 5km distant from the Cottam 1 and 2 Sites. The church is located on the northern edge of the village within a church yard that is heavily vegetated and enclosed (Photograph 87). There is a slight gap in the vegetation on the northern boundary of the churchyard where views beyond are possible, but this only allows a view across the field to the north and not of the landscape beyond to the north-west towards the Cottam 1B Site (Photographs 87, 104-105). Consequently, this heritage asset has been scoped out of further consideration following Step 1 of the Historic England setting guidance (2017) as its significance would remain unaffected
