Cottam Solar Project

Environmental Statement Appendix 13.5: Heritage Statement (Part 1 of 4)

Prepared by: Lanpro Services
January 2023

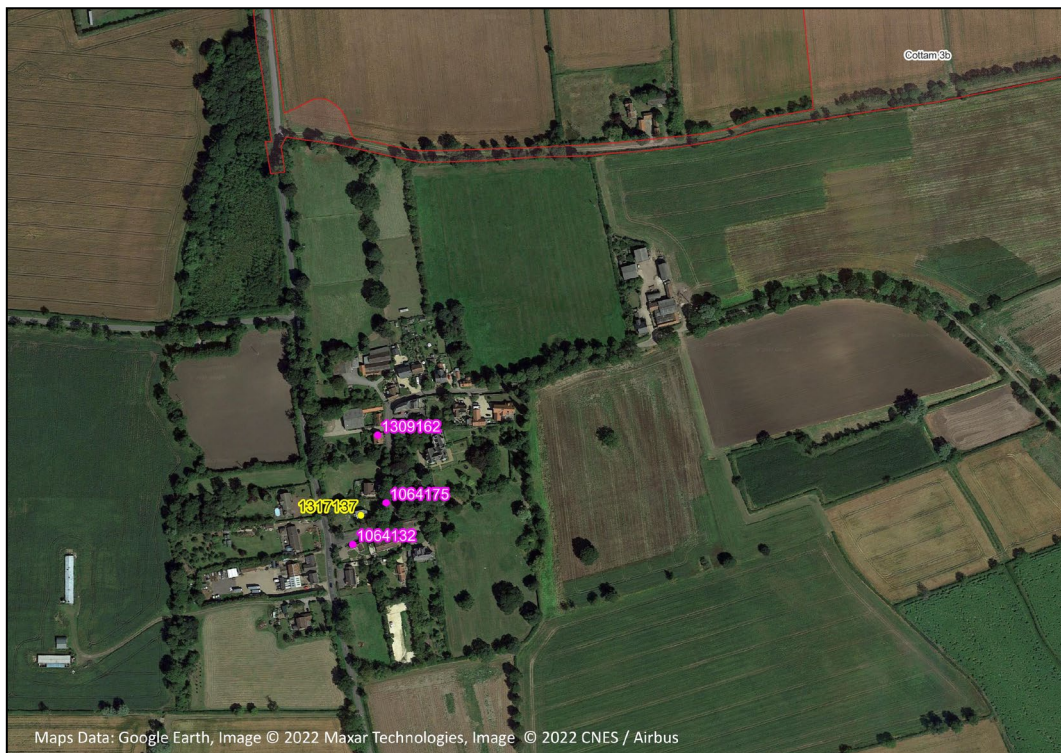
Photograph 88: Aerial view of Pilham illustrating the extent of the tree cover along the boundaries within the village, and the location of the Church of All Saints (NHLE 1317137) towards the centre of the settlement where north-westerly views towards Cottam 3b will not be possible in this flat landscape.

3.1.131 It is evident from the aerial view of the village (Photograph 88) that the settlement comprises numerous small plots divided by tree-lined boundaries. These frequent trees provide the village with a sense of intimacy, and no views out into the surrounding landscape would be possible from these Listed Buildings that are located within it. Consequently, these heritage assets have been scoped out of further consideration following Step 1 of the Historic England setting guidance (2017) as their significance would remain unaffected by the proposed development.

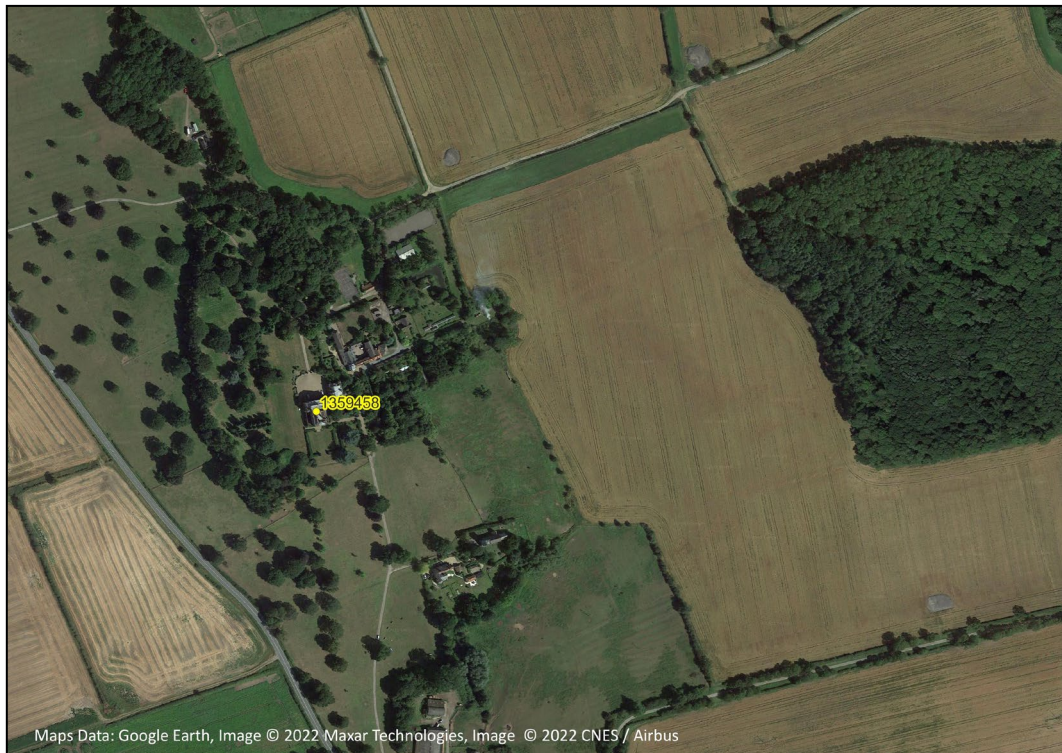
Photograph 93: Aerial view of Gate Burton Hall (NHLE 1359458) illustrating the extent of the surrounding woodland screening views eastwards towards Cottam 1.

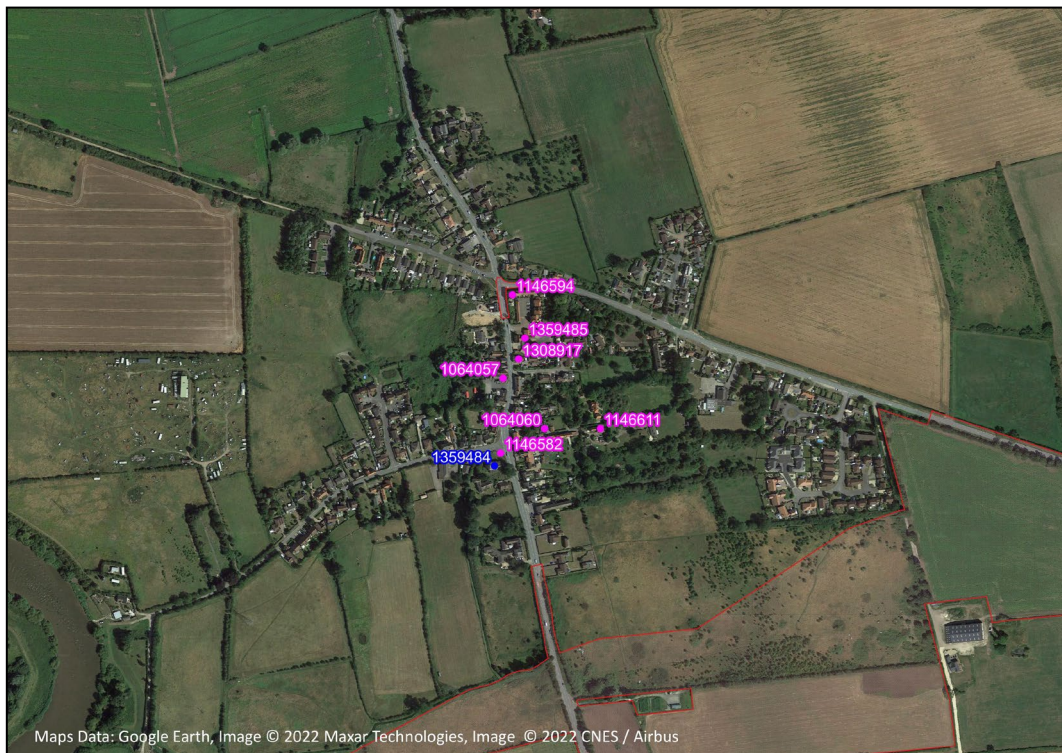
Photograph 94: Aerial view of Marton illustrating the extent of the built environment and wooded back plots to the east of the Church of St. Margaret of Antioch (NHLE 1359484) which screen the views towards the Cottam 1 Site parcels.

- 3.1.83 This Grade I listed church is located c.4.42km to the west of Cottam 1F and greater than 5km distant from the other Sites. It is located adjacent to the crossroads at the centre of the village of Marton and, as the built environment extends c.500m to the east of this location, and moreover contains back plots with heavily wooded boundaries, this view eastwards towards Cottam 1 is well screened and no views of the proposed development would be possible (Photograph 94).

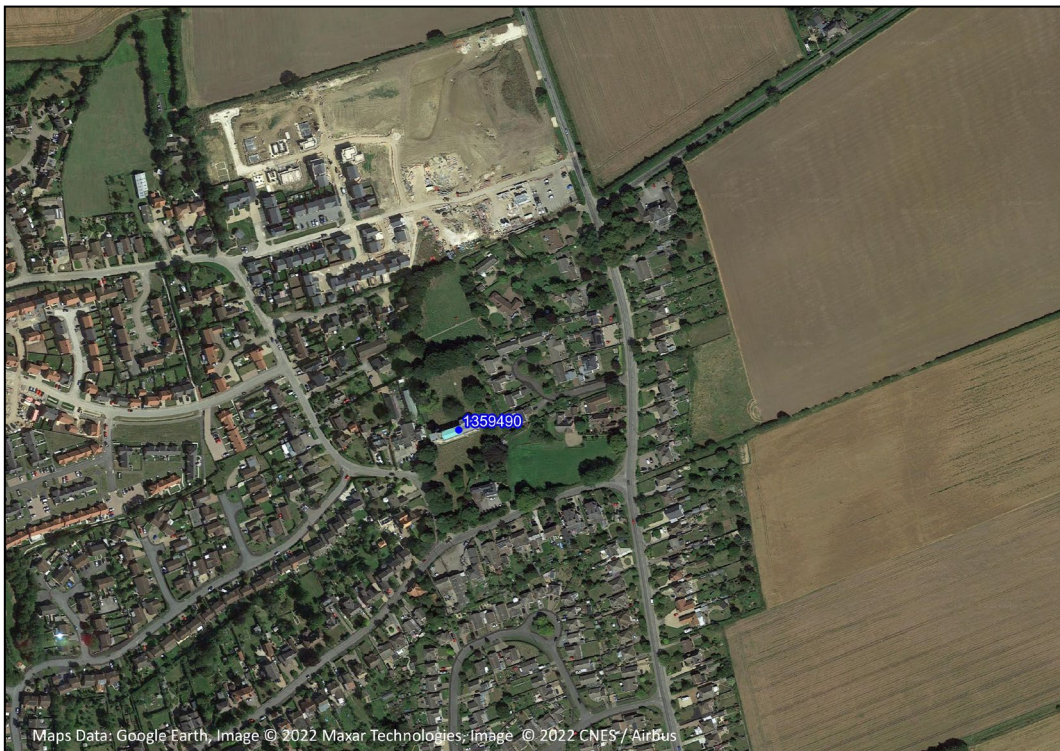
Photograph 98: Aerial view of Saxilby illustrating the location of the Church of St. Botolph in relation to the surrounding built environment and the new development of Ingham View under construction to the north.

new housing estate named 'Ingleby View' has recently been constructed in the field immediately to the north of the graveyard extension. In addition, built development interspersed with frequent trees extends for c.280m to the north-east of the churchyard (Photograph 98). Consequently, the views to the north and north-east from the church towards the Cottam 1 Site are totally screened and therefore, this heritage asset has been scoped out of further consideration following Step 1 of the Historic England setting guidance (2017) as its significance would remain unaffected by the proposed development.

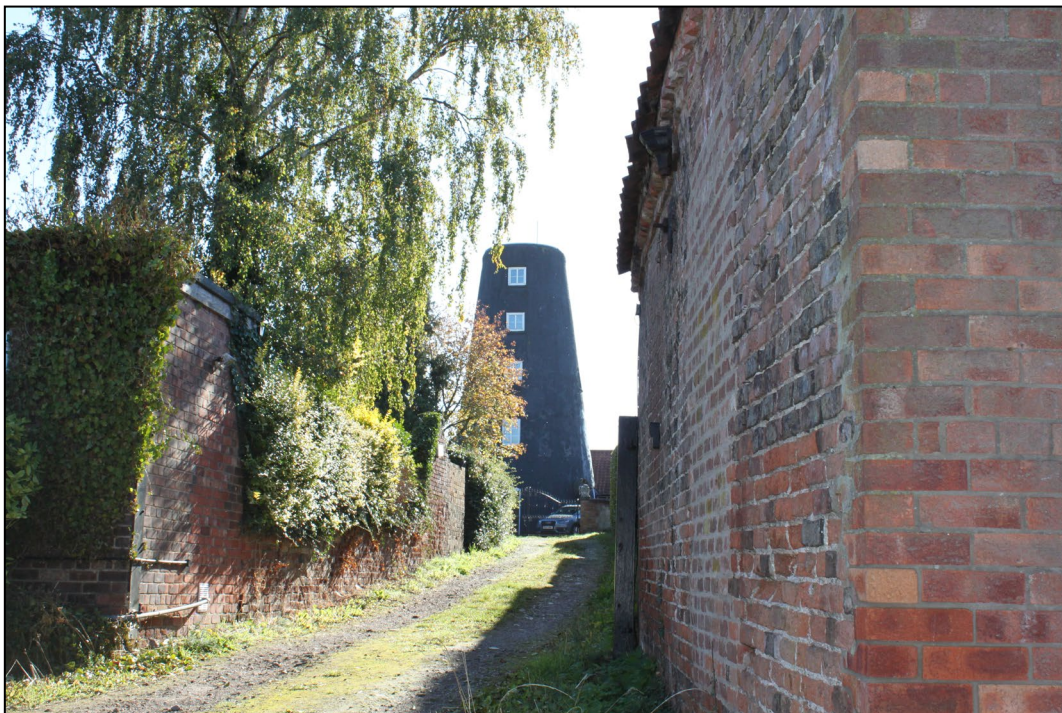
Photograph 106: View SSW from Blyton High Street towards The Old Windmill (NHLE 1359455).

- 3.1.92 *The Old Windmill* (NHLE 1359455) is located in a back plot behind the curtilage of the properties along the south side of the High Street, and as such is largely hidden from view, apart from a glimpse that is possible from the High Street looking south-east along the main driveway to the building where it is framed between the buildings on the High Street (Photograph 106). It is also possible to view the building from the network of public footpaths that criss-cross the back plot within which it is located, but from none of these viewpoints would the windmill be viewed within the same visual envelope as the development at Cottam 3a to the north-west or Cottam 3b to the south-east (Photographs 107-108). Consequently, this heritage asset has been scoped out of further consideration following Step 1 of the Historic England setting guidance (2017) as its significance would remain unaffected by the proposed development.

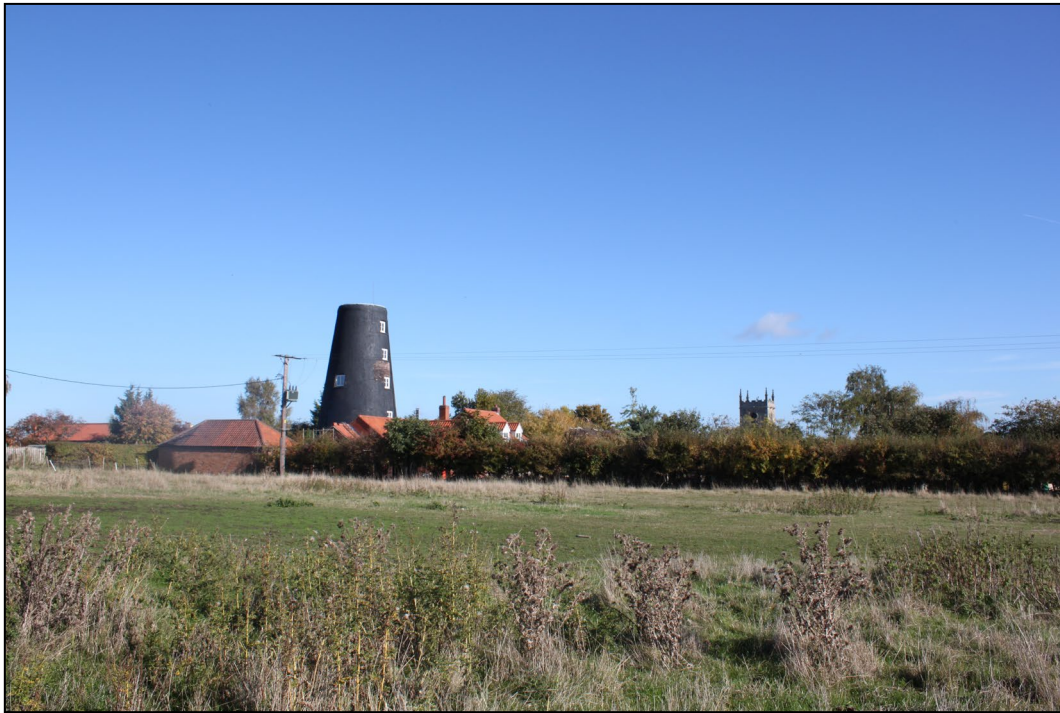
Photograph 107: View north-west from the PRoW network at Blyton towards The Old Windmill, (NHLE 1359455) and Church of St Martin (NHLE 1064159) illustrating that no views towards Cottam 3a would be possible due to the screening provided by the intervening vegetation and built environment.

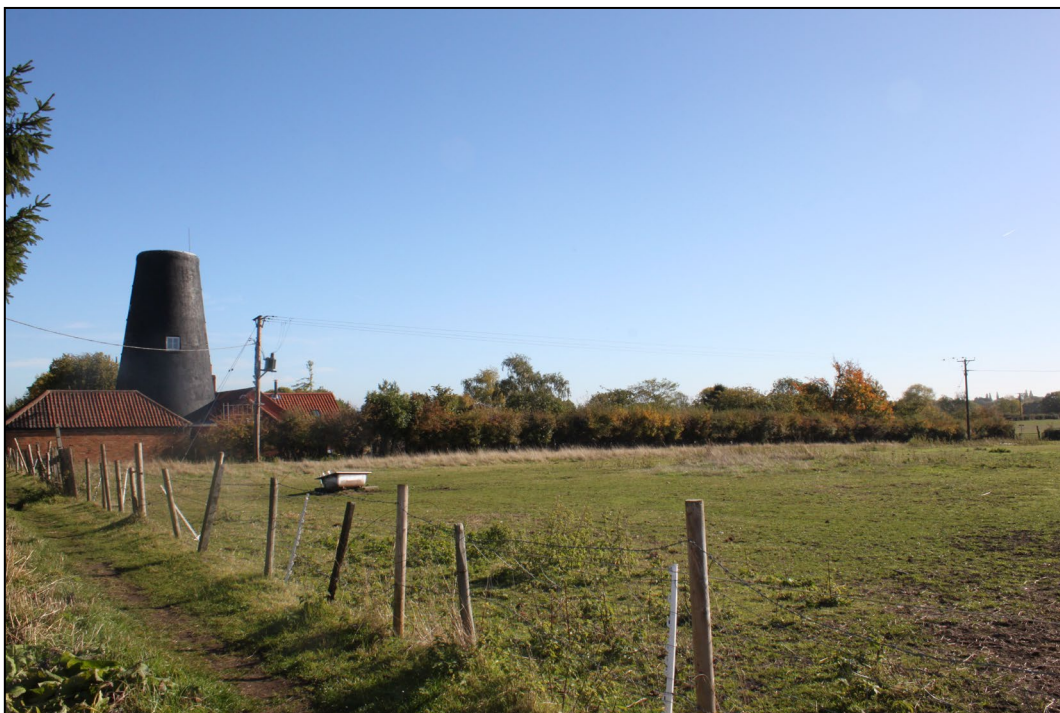
Photograph 108: View south-west from PRoW network at Blyton towards The Old Windmill (NHLE 1359455), illustrating that no views towards Cottam 3b would be possible due to the screening provided by the intervening vegetation.

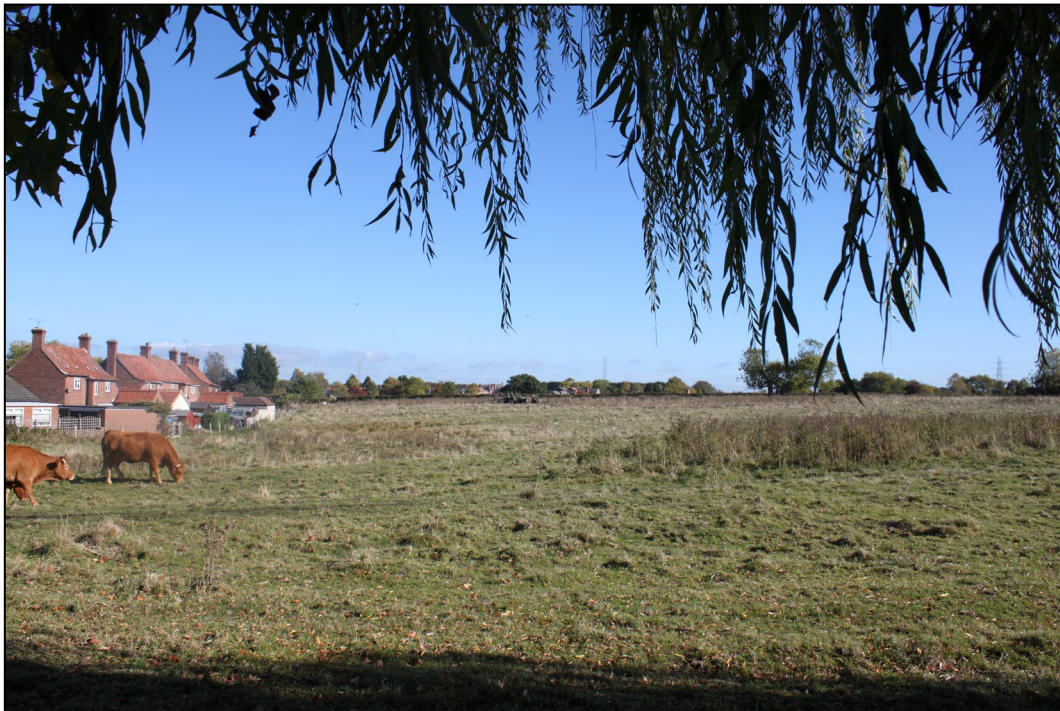
Photograph 110: View north-west towards Cottam 3a through the fence just to the south-east of Matt Hall (NHLE 1165509) illustrating the screening afforded by the vegetation on the horizon.

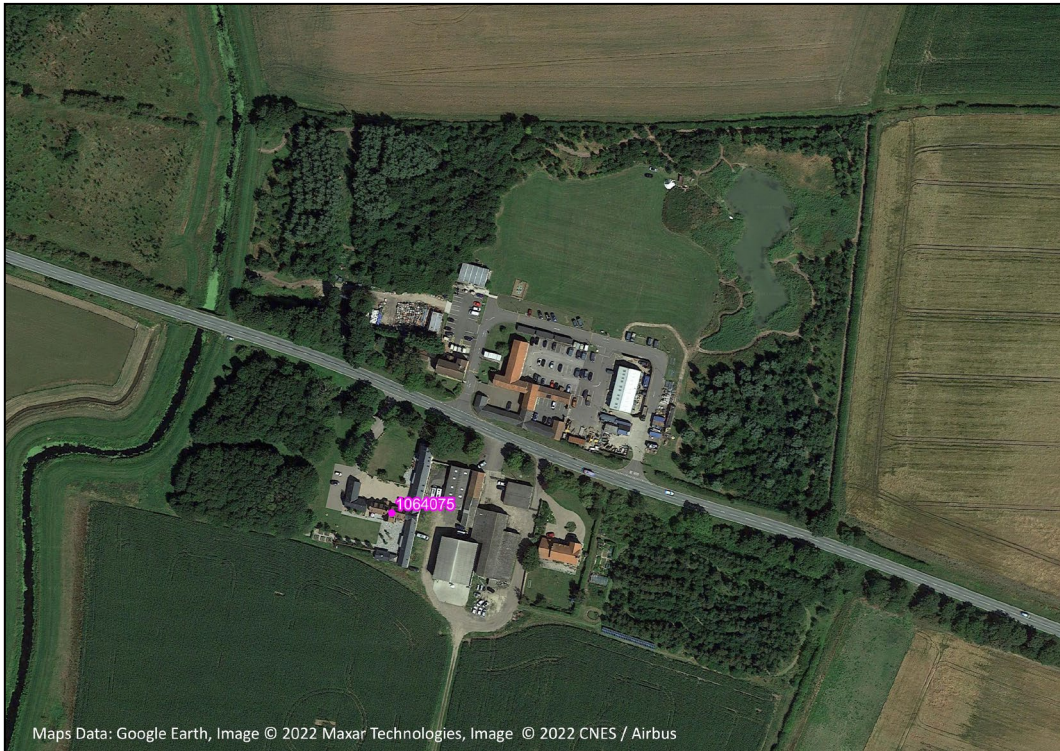
Photograph 115: Aerial view of Till Bridge Farm Cottages (NHLE 1064075), illustrating the considerable screening surrounding the Listed Building, preventing any views northwards towards Cottam 1d

3.1.133 It is evident from the aerial view of this location (Photograph 115) that the building is set back from Till Bridge Lane behind trees, and moreover there are numerous business premises and blocks of woodland occupying the area to the north of the

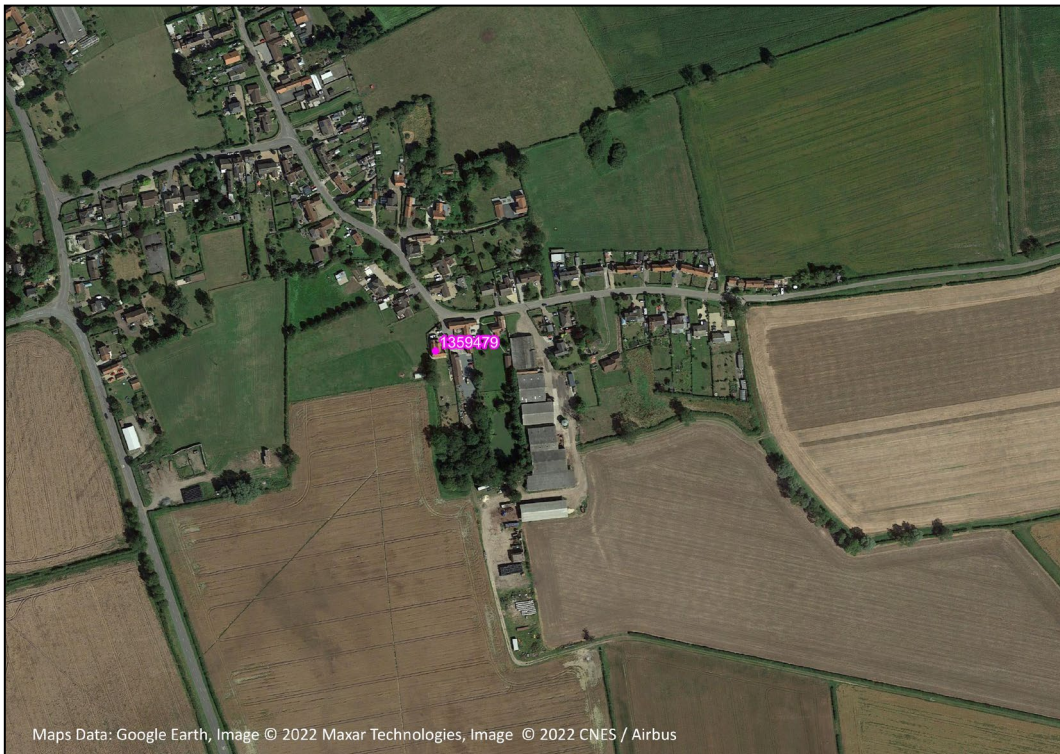
Photograph 116: Aerial view of Kexby illustrating the screening afforded by the trees and built environment in views from 2, Glenworth Road (NHLE 1359479) to the south-east and east towards Cottam 1g and 1c respectively.

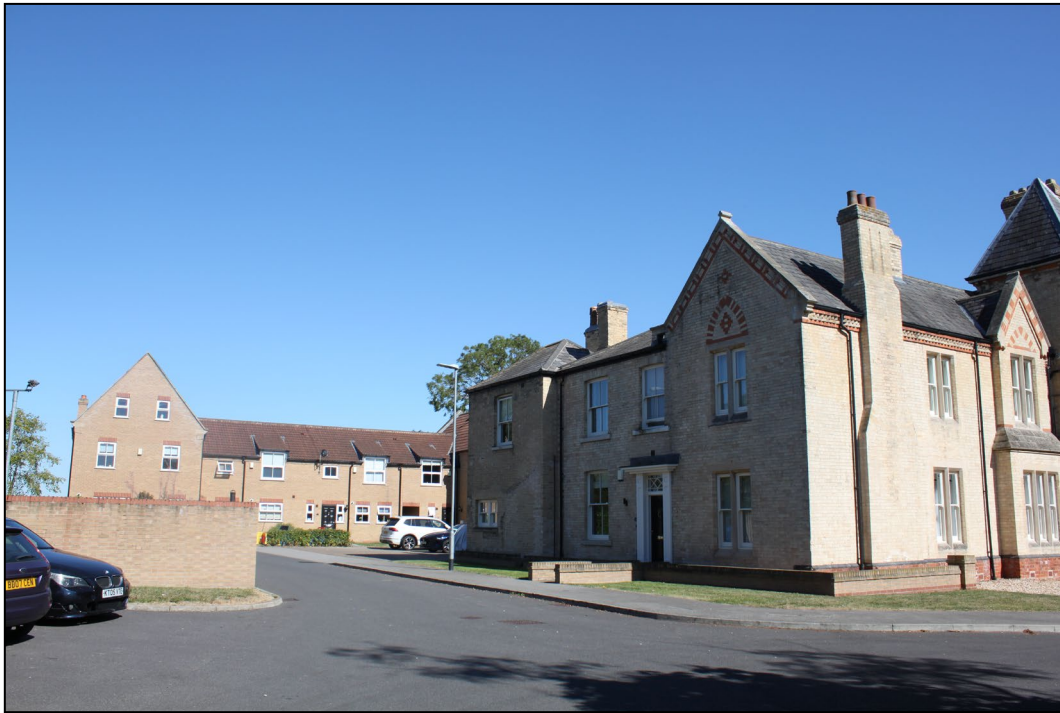
Photograph 123: View eastwards towards the Old Rectory Home for The Elderly (NHLE 1359488), Sturton by Stow, illustrating the screening effect of the modern accommodation block to the east of the Listed Building.

- *Barn at Bransby House for Retired Horses* (NHLE 1359487)
 - *Old Rectory Home for The Elderly* (NHLE 1359488)
- 3.1.138 Similarly to Stow, the village of Sturton by Stow occupies a generally flat topographic setting, and therefore there is no visibility out into the surrounding landscape from those buildings within the central area of the village including *Lych Gate and Wall of Church of St Hugh of Avalon* (NHLE 1064068), *Church of St Hugh of Avalon* (NHLE 1146772), and *Old Hall* (NHLE 1146778) as these are screened by the surrounding built environment (Photographs 120-122). Further to the north, the *Old Rectory Home for The Elderly* (NHLE 1359488) is located on the eastern edge of the settlement, but views eastwards towards Cottam 1 are screened by a 20th century accommodation block associated with the care home (Photograph 123), and views north and north-east are screened by the modern housing that surrounds the Old Rectory.

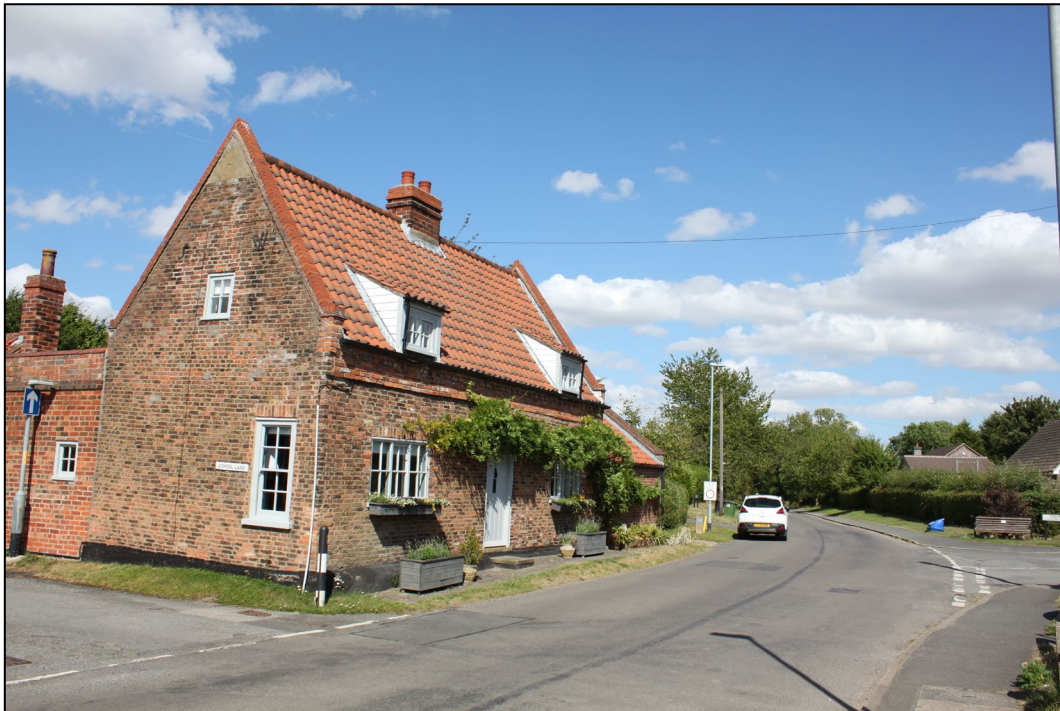
Photograph 124: View east towards 9 Ingham Road, Stow (NHLE 1146755) illustrating the lack of intervisibility with the surrounding landscape towards the eastern end of the village.

- 3.1.139 The Listed Building at *9, Ingham Road, Stow* (NHLE 1146755) is located towards the eastern edge of the settlement, but no views eastwards towards Cottam 1 are possible due to the further settlement with frequent trees extending eastwards from here (Photograph 124).

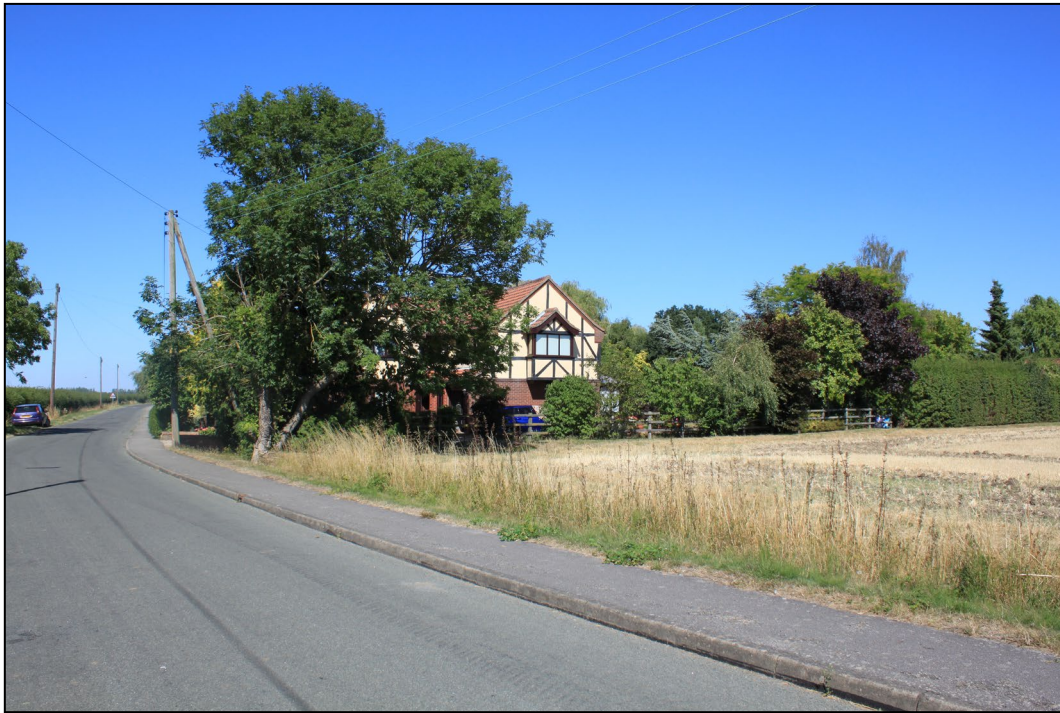
Photograph 125: View north-east towards Brickyard Cottages (NHLE 1146766) illustrating the screening afforded by the vegetation to the rear of the Listed Buildings.

- 3.1.140 *Brickyard Cottages* (NHLE 1146766) comprises an outlying cluster of buildings c.1km to the east of the core of the village. These two cottages are located at the western end of a c.300m long toft and to the south of an adjacent toft and further plots beyond, extending c.180m to the north. All of these curtilages are separated by densely vegetated boundaries and consequently no views of the proposed development would be possible from these Listed Buildings (Photograph 125).

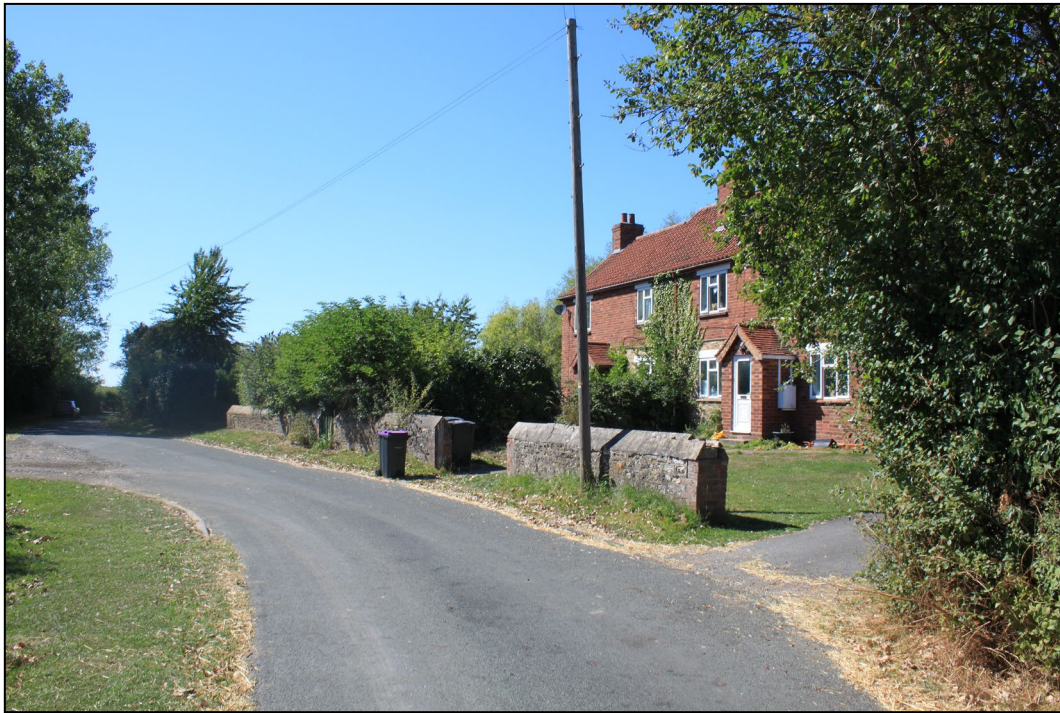
Photograph 127: View west along Village Street illustrating the screening afforded by the built environment and hedgerows to the north of Thorpe in the Fallows Farmhouse (NHLE 1308921).

- 3.1.144 There is one Grade II Listed Building within Thorpe in the Fallows, which comprises *Thorpe in the Fallows Farmhouse* (NHLE 1308921). This early 19th century farmhouse is set back from the south side of Village Street by c.40m, to the south side of a cluster of farm buildings which shield it from view from the road (Photograph 126). Mature trees flank the farm buildings to the west and east along Village Street, and further screening is provided by the presence of the house opposite and its surrounding vegetation (Photograph 127). Consequently, views to the north-west, north and north-east from this building towards Cottam 1D are well screened, and the key view of the building looking westwards towards its main east-facing frontage would also not include any elements of the proposed scheme.

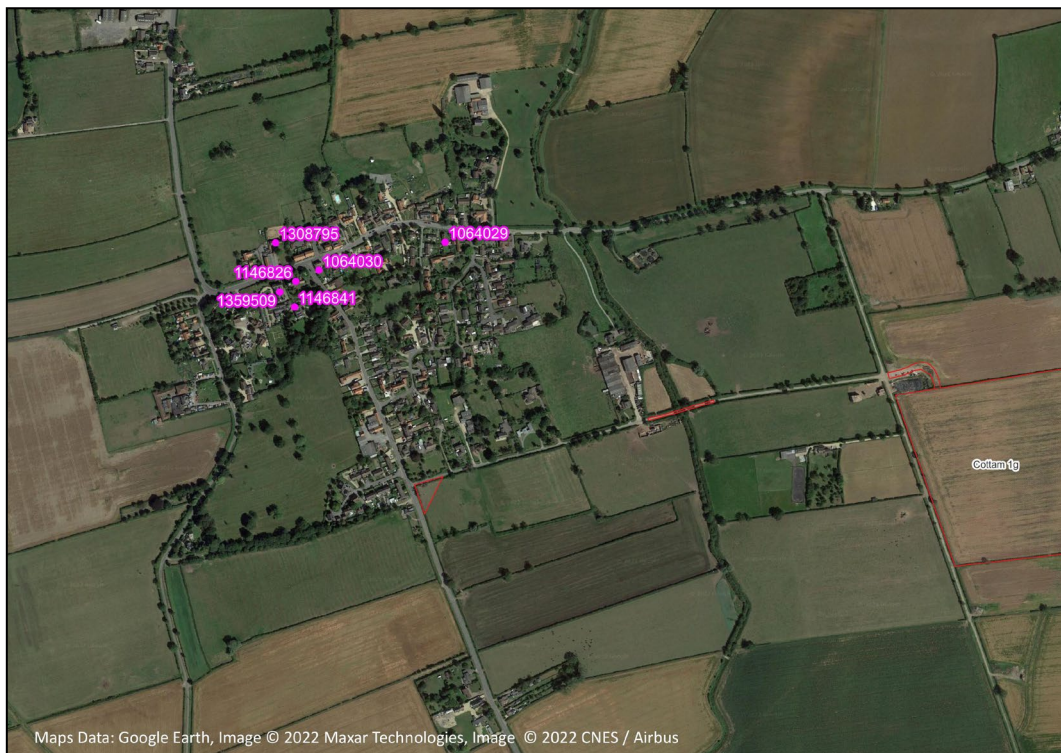
Photograph 128: Aerial view of Willingham by Stow illustrating the locations of the Listed Buildings in relation to Cottam 1g.

3.1.147 The village is situated on a slight north-south oriented ridge with the ground sloping away gently to the east. Most of the buildings are located in a cluster in the centre of the village adjacent to the junction of Stow Road and High Street (Photograph 128). Views out to the surrounding landscape from the vicinity of these buildings are largely screened by the surrounding built environment (Photographs 129-130). However, a view out to the landscape beyond the village is possible when travelling eastwards for a short distance along High Street from adjacent to the *Church of St. Helen*, looking past *1 and 3 Stow Road* (NHLE 1064030). This view is framed by the buildings and trees further east on High Street and extends across the agricultural fields immediately north of Cottam 1C as far as a small unnamed woodland situated between Primrose Farm and Magin Moor Farm c.2km distant (Photographs 131). These trees appear to merge with the more distant and larger Fillingham Low Wood, c.4km distant, and also Nursery Plantation, some 3km beyond that. One of the dwellings on Middle Street in the vicinity of Glentworth Cliff Farm is just visible on the horizon at a distance of c.8km from Willingham by Stow, on the top of the Lincoln Cliff (Photograph 132). Cottam 1A and 1B are both located along this line of sight, but within the intervening space between Fillingham Low Wood and Nursery Wood, and consequently it seems likely that they would be screened from view, although the possibility that elements might be glimpsed within these woodland layers cannot be discounted. Notwithstanding this, it is considered that any such visibility, at this distance, would have a barely perceptible visual impact upon this view of *1 Stow Road*.

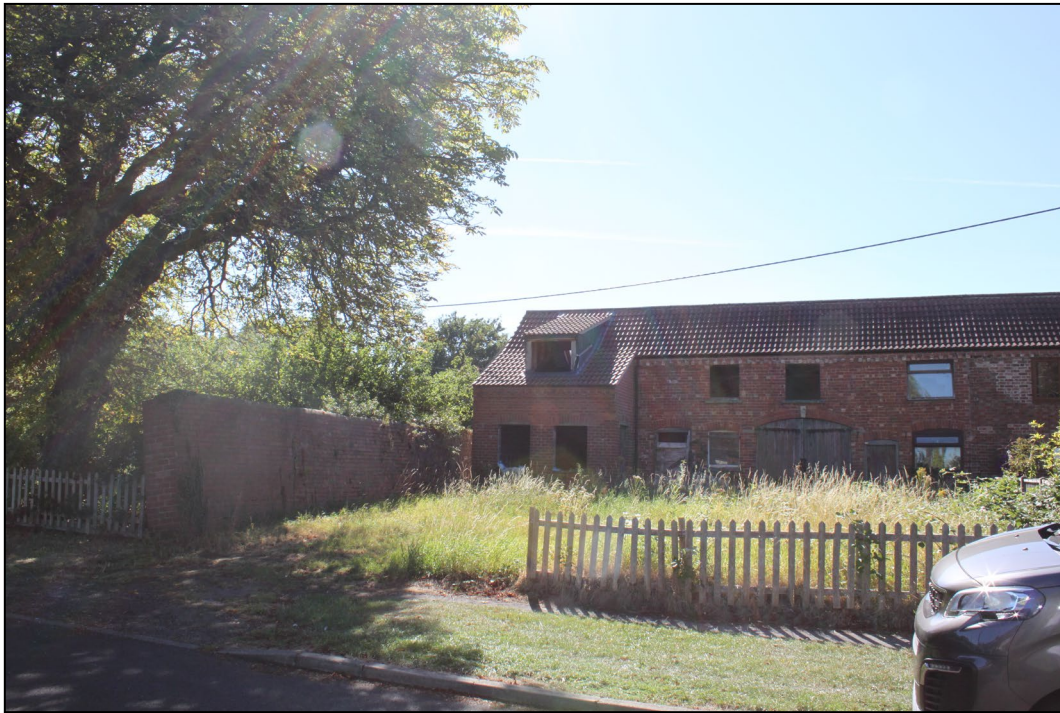
Photograph 133: View north towards 20, Fillingham Road (NHLE 1064029), illustrating the screening afforded by the vegetation to the west.

3.1.148 *20, Fillingham Road* (NHLE 1064029) is located at a lower elevation further to the east of the cluster of Listed Buildings discussed above, where views out into the surrounding landscape are screened by the surrounding built environment and vegetation (Photograph 133).

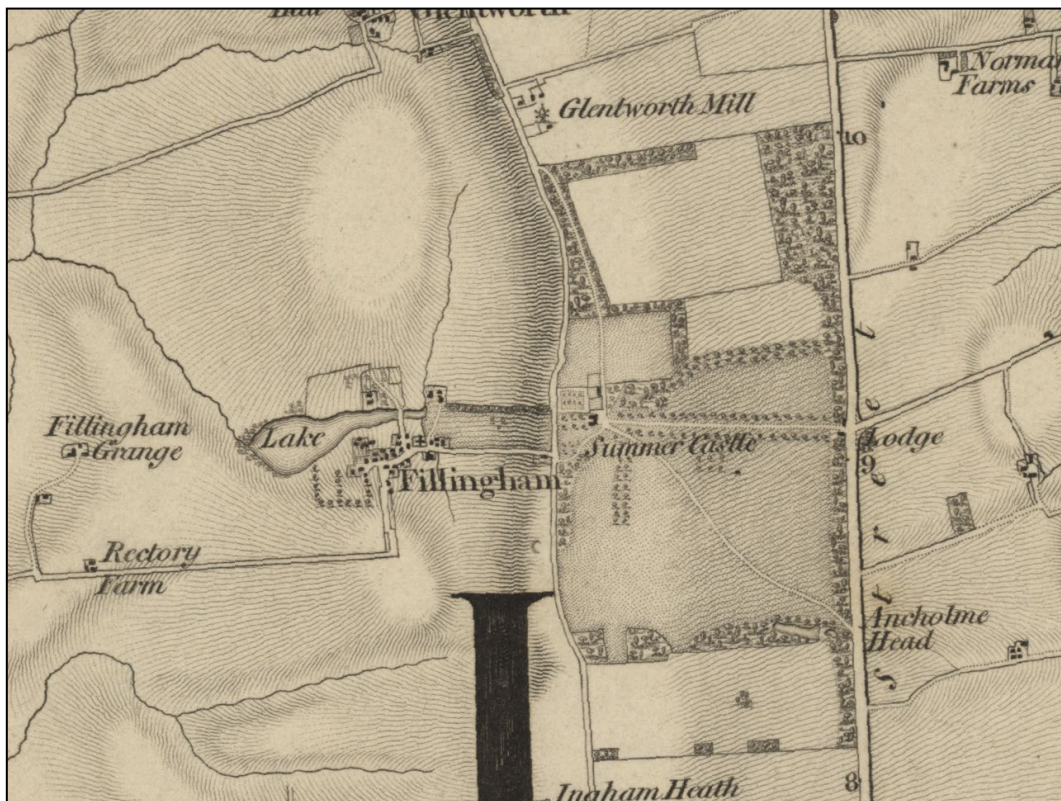
Photograph 134: Extract from the Ordnance Survey Old Series map of 1824 illustrating the extent of parkland surrounding Summer Castle at Fillingham at that time.

- 3.2.20 The essential setting of Grade I Listed *Fillingham Castle* (NHLE 1166045) largely comprises the parkland that surrounds it, and as this has been designated as a significant historic asset in its own right, comprising the *Fillingham Castle* Grade II registered Park and Garden (NHLE 1000977), it was considered appropriate to discuss the settings of these in tandem.
- 3.2.21 Fillingham Castle was constructed as a neo-Gothic country mansion for Sir Cecil Wray between c.1760 and 1770, thought to have been designed by the noted architect John Carr of York. The house was known 'Summer Castle', which is thought to have been so named after Wray's wife, Esther Summers. Armstrong's 1779 map

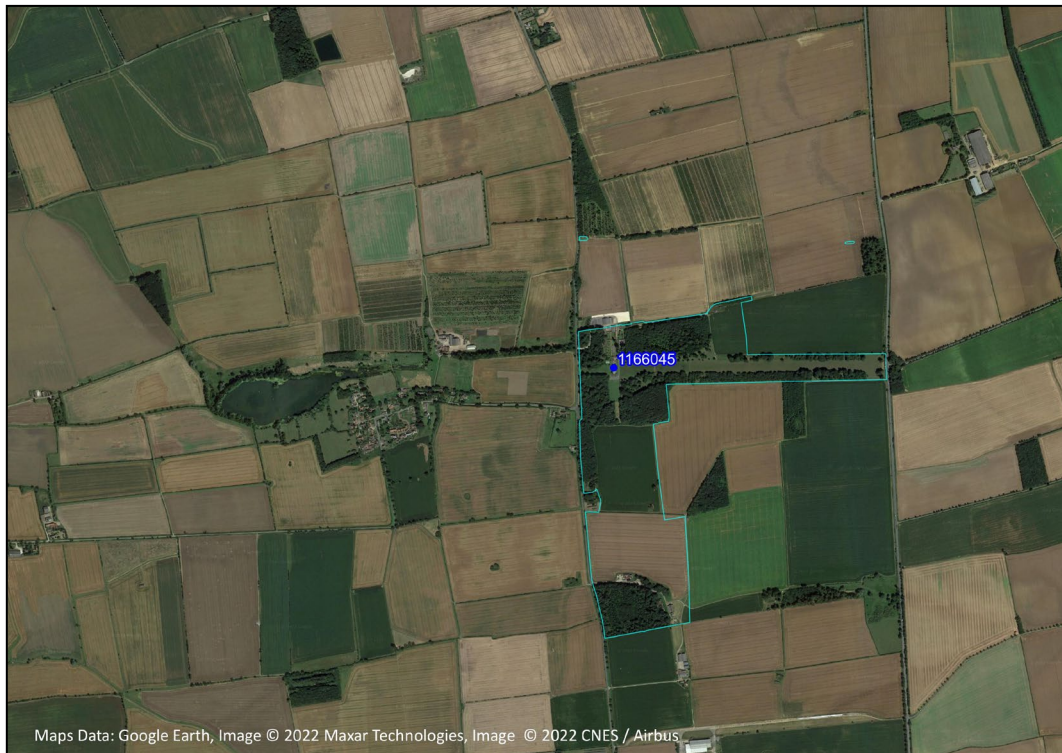
Photograph 135: Aerial view of Fillingham Castle illustrating how much of the parkland has now returned to arable. The main west-east axis from Fillingham Lake to the Lodge at the western end of the avenue where it meets Ermine Street is still clearly legible. Registered Park and Garden outlined in magenta.

- 3.2.22 The parkland at Fillingham Castle, as depicted on Armstrong's 1779 map of Lincolnshire, originally occupied a rectangular area measuring c.1.4km west to east and c.2. north to south, bounded to the east by Ermine Street and to the west by Middle Street, and open farmland to the north and south. The next available map is the Ordnance Survey Old Series map of 1824 (Photograph 134), and this illustrates that the parkland had been reduced in size by more than a third, the most northerly fields apparently being returned to agriculture, although the woodland surrounding them still survived.

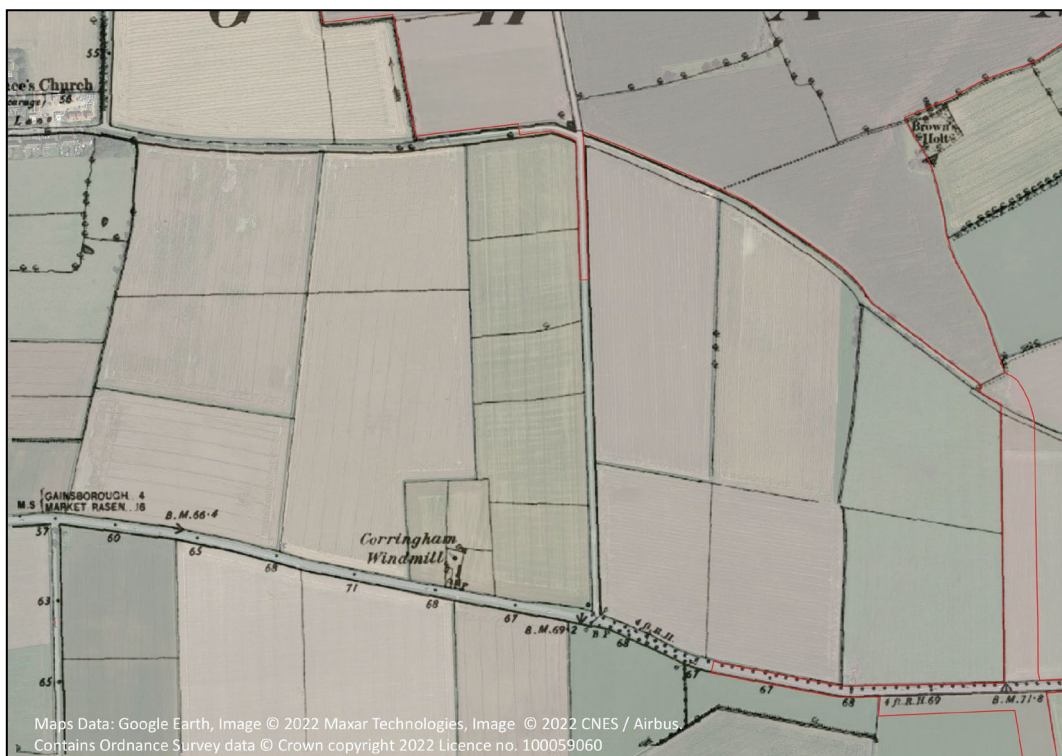
Photograph 138: Extract from the 1888 OS 1st edition map illustrating how Upper Pool Furlong became fossilised in the pot-enclosure field system. More recent boundary loss has resulted in the windmill now occupying an agglomerated 'reverse-L' shaped field bounded to the north, east and south by the roads depicted on this image. The boundary of the Cottam 2 Site and the cable route running south of this is outlined in red.

- 3.2.36 The windmill was still in use in at the time of the OS 1st edition map of 1886 where it is depicted within the same small rectangular enclosure labelled 'Corringham Windmill (Corn)' which also contained two buildings to the south and a smaller rectangular area with trees in likely to be a garden (Photograph 138). The wider enclosed parcel of the former Upper Pool Furlong had been further subdivided into three smaller parcels by this time. However, the windmill had fallen out of use by 1905 when it is labelled as 'Corringham Windmill (Disused)' on the OS 2nd edition map. The building to the south of the windmill and its surrounding enclosure was still extant at the time of the 1948 OS map, but the building had been demolished by 1951. By 1982 its surrounding curtilage had been removed and the building stood alone within the bounds of the former Upper Pool Furlong, but subsequently this has lost its eastern field boundary and has been amalgamated with the elongated agglomerated field to the east. In 1993 the building was converted to hold owl boxes with the provision of a new felt and timber roof, and the bricking up of most of its openings⁶⁵.
