EAST PARK ENERGY

EN010141

Environmental Impact Assessment Scoping Report

October 2023

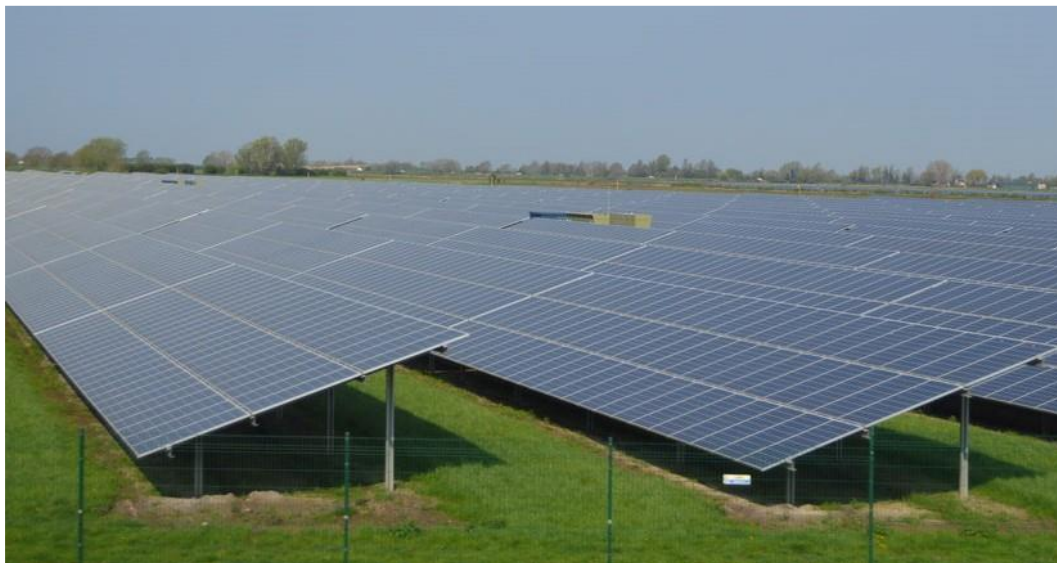
Image 3.1 – Example Solar PV Panel Arrangement

- 3.3.8 The solar PV support frame structures would consist of steel uprights and aluminium or steel cross bars. The steel uprights would comprise hollow steel posts with a u-shaped cross section which are ram-driven into the ground using specialist small-scale piling machines to a depth of typically up to 2.4m, depending on ground conditions. The rest of the support frame would then be fitted to the posts to create angled support tables ready for the solar panel installation.

- 3.3.9 The solar PV panels would be mounted on the pre-constructed support frame table. The solar PV panels convert solar irradiance (sunlight) into direct current (DC) electricity, and are capable of operating on sunny or cloudy days. The individual solar PV panels typically comprise dark blue, dark grey or black photovoltaic cells. PV technologies are an evolving technology and it is not possible to specify the precise panel type, as this will depend on the competitive procurement process and the best technology available at the time of construction. Where flexibility is sought each relevant topic of the ES will assess the worst-case scenario.
- 3.3.10 The solar PV panels would be connected in strings and cabling would be secured to the rear of the solar panel and would be protected by suitable trunking.

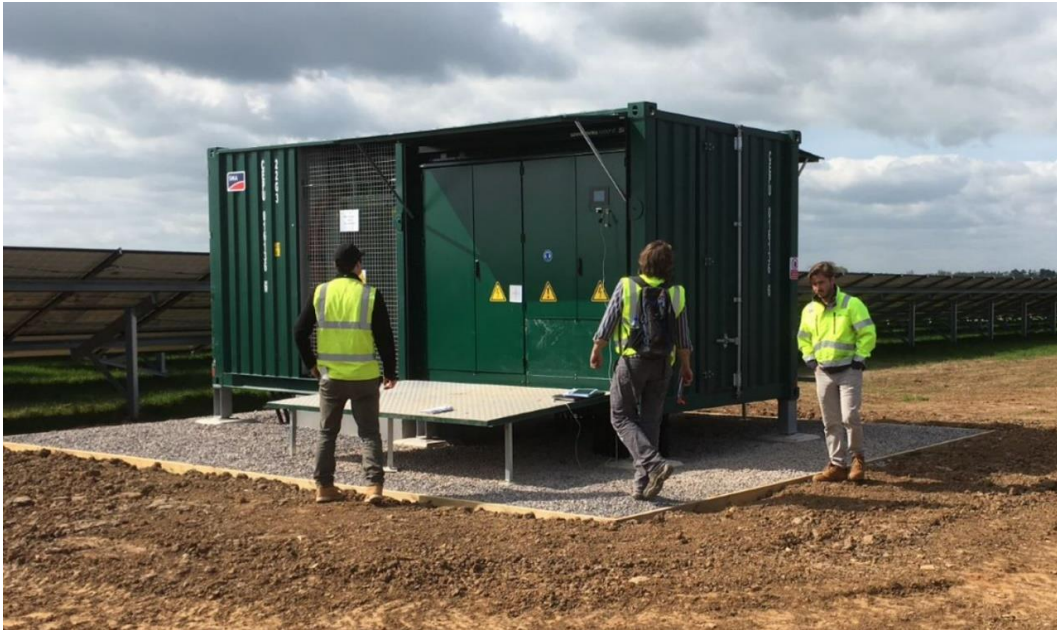
Image 3.2 – Example Centralised Inverter / Transformer Station

- 3.3.11 Inverters convert the DC electricity produced by the solar PV panels into alternating current (AC) that can be exported to the National Grid. The inverters can be located at regular intervals throughout the Scheme and are typically containerised with associated control and switchgear equipment, referred to as 'centralised inverters'. Centralised inverter structures are typically up to 3.5m in height. Alternatively, inverters can be mounted

underneath the rear of the panels, referred to as ‘string inverters’. The option selected will be determined by a number of technical and environmental factors and will be dependent on the final technology supplier. Where flexibility is sought each relevant topic of the ES will assess the worst-case scenario.

3.3.12 Transformers are used to increase the voltage of the electricity produced before it reaches the East Park substation. The transformers are typically co-located with the Inverters at regular intervals throughout the Scheme. They are normally housed in containers that also include control equipment. Image 3.2 above provides an image of a combined centralised inverter / transformer station. Independent transformer stations are similar in appearance.

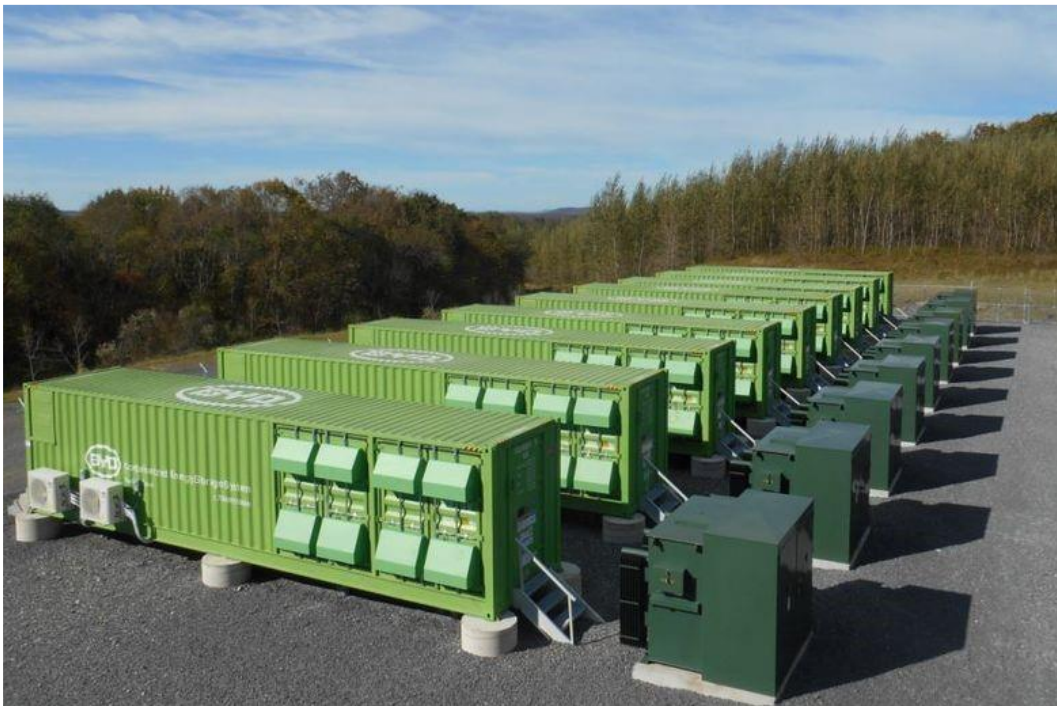
Image 3.4 – Example BESS Facility

3.3.22 The BESS would comprise battery containers along with associated inverters and transformers and is expected to be co-located with the East Park Substation. The battery containers contain battery modules, air conditioning units, a fire suppression system, and battery monitoring, management, and protection system. The BESS would be linked via cabling to the other electrical infrastructure equipment within the East Park Substation.

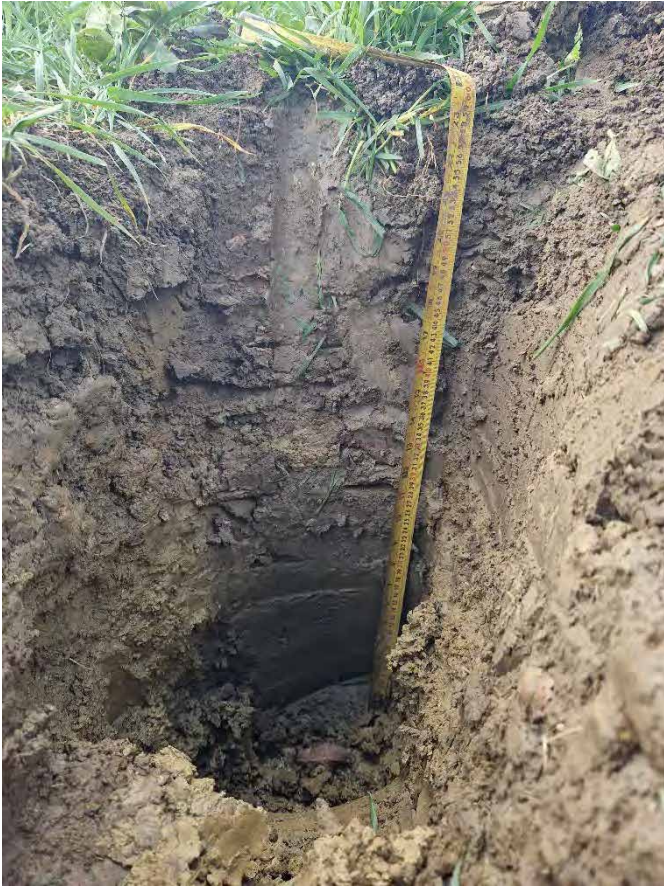
Pit 3 overview

Comment: the upper subsoil has good structure and the drainage impedance occurs deeper than 60cm depth, so Wetness Class is II. ALC Grade is 2 (Wetness and droughtiness).

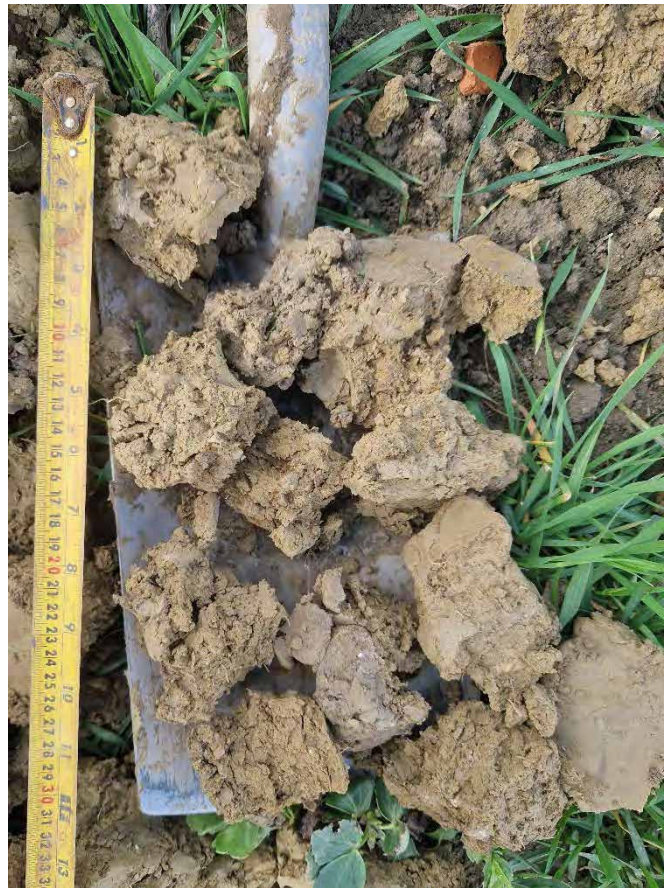
Unmottled clay upper subsoil

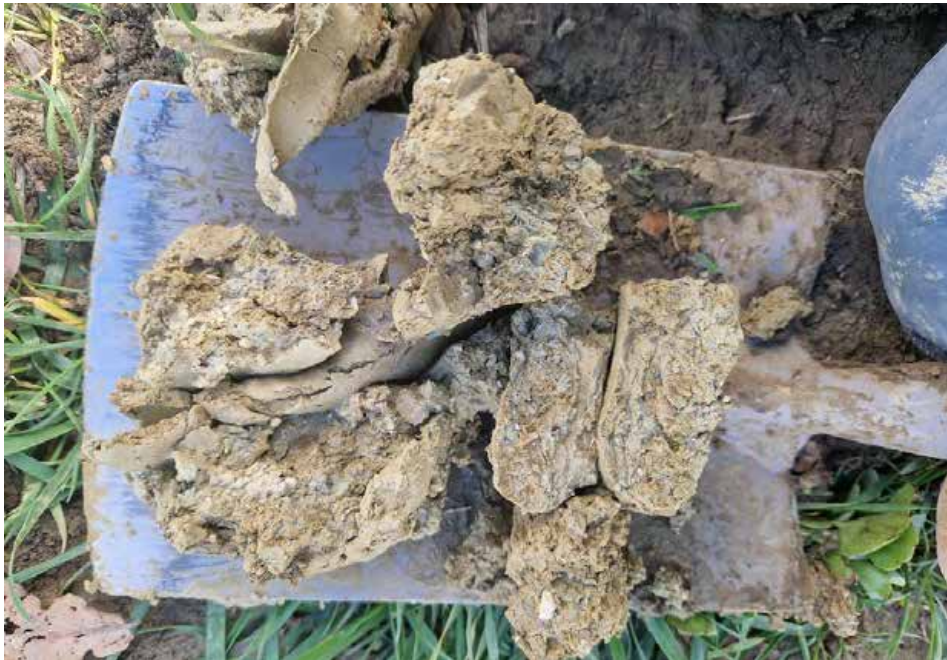
Slowly permeable clay lower subsoil

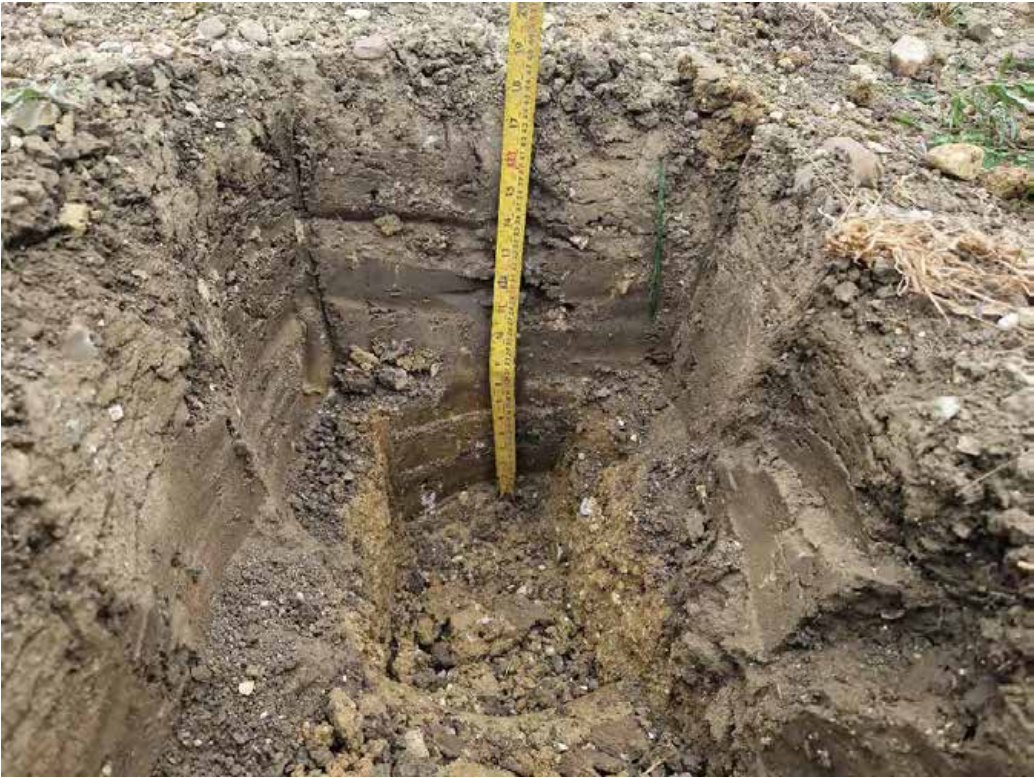
Pit 8 overview

Dense grey clay lower subsoil

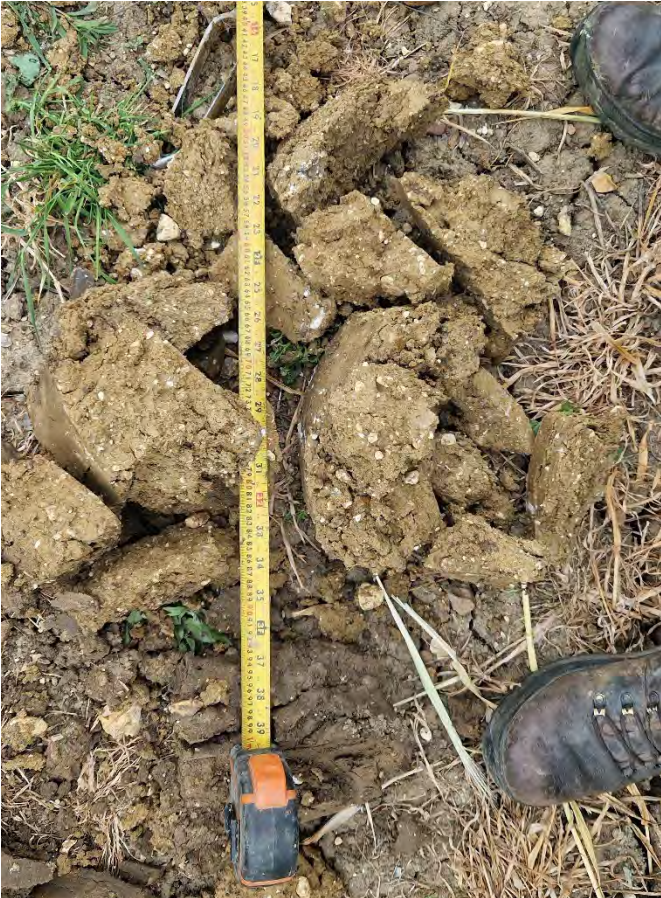
Unmottled, upper subsoil clay with calcareous stone
