East Park Energy

Environmental Statement

Appendix 8-3: Watercourse Crossing Assessment

September 2025

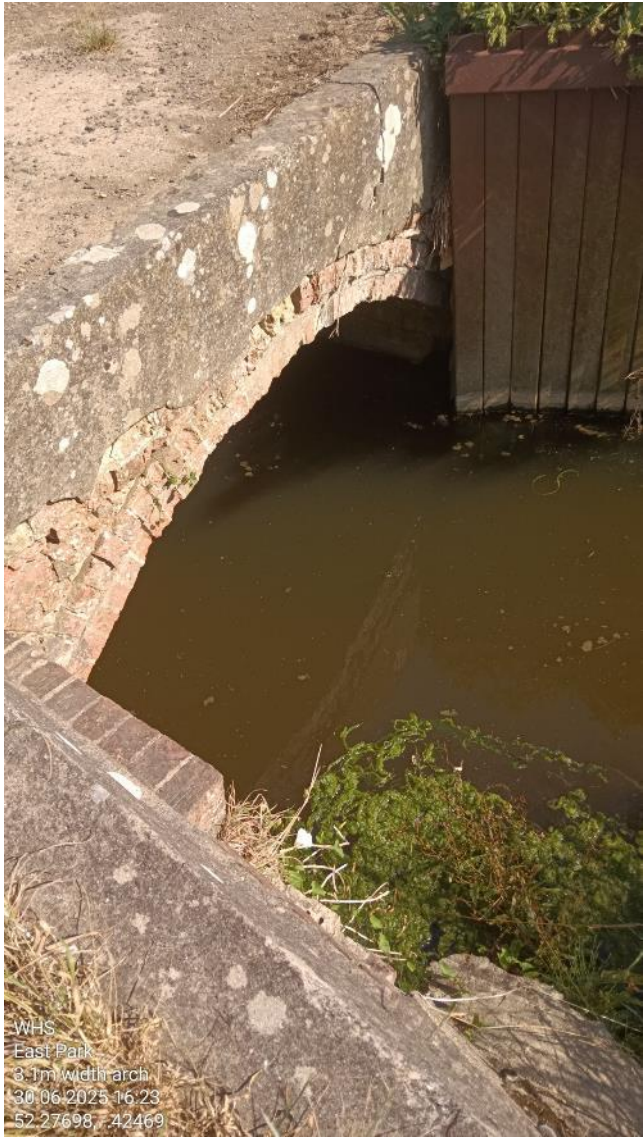
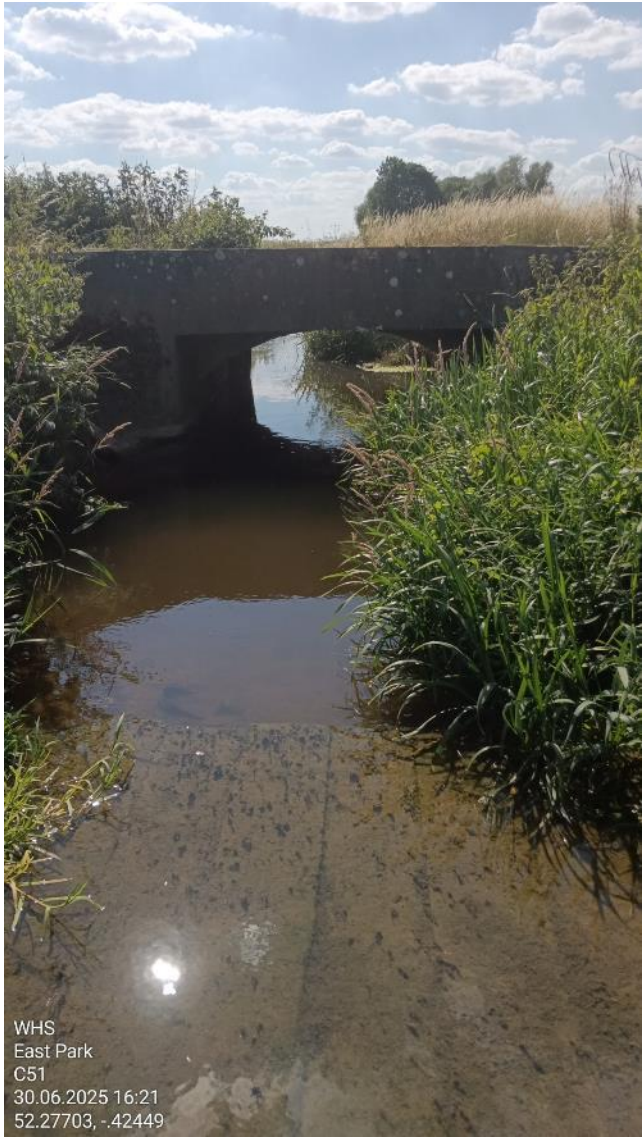
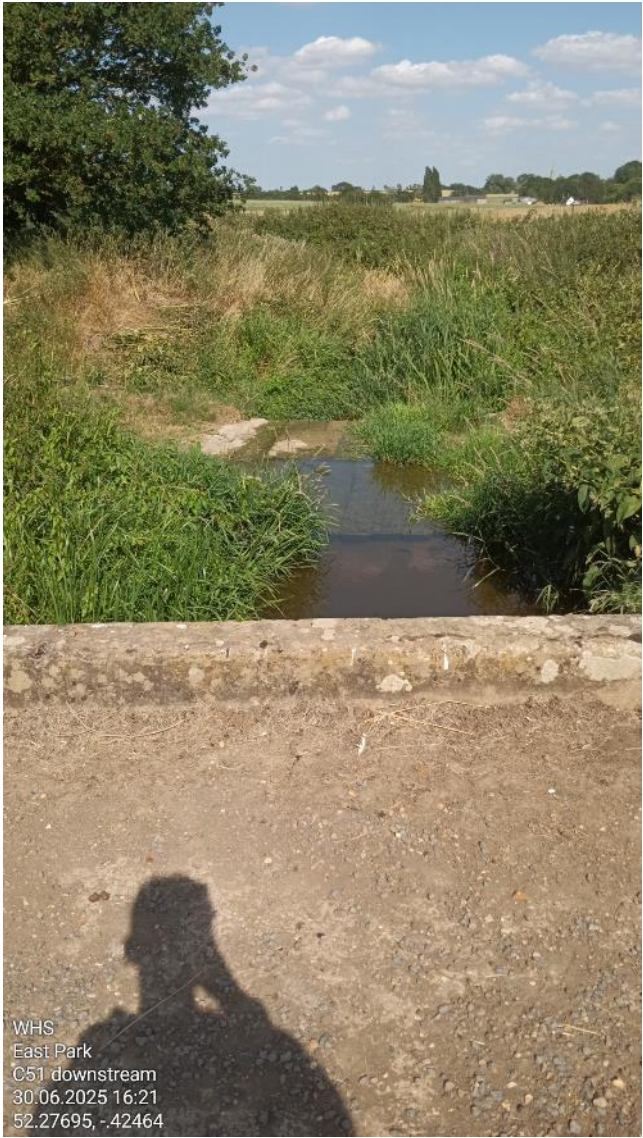
Crossing C01

Crossing	Valley Shape	Wetted Width (m)	Bankfull Width (m)	Channel Max Depth (m)	Bank Profile and Stability	Channel Planform and upstream catchment	Pool Riffle Development	Comments
C01	Flat fields on either side	1.5 upstream from bridge	1.8 upstream from bridge	1.2 (to top of bank/deck)	V-shape wingwalls providing stability out 2m from crossing, up and downstream. Channel otherwise stabilised by vegetation (grasses)	Single channel, shallow. Gently meandering channel downstream through vegetation. Soft soil bed. Upstream largely rural catchment (arable farmland and forest) area of ~26km².	n/a.	Existing bridge 4.2m deck width. 3.1m width arch upstream, box shape outlet downstream. Appears to be natural bed underneath crossing. Ford crossing located 10m downstream of bridge.

Upstream arch opening					Downstream of crossing facing Outlet (rectangular shape)		Downstream view from bridge deck

<p>WHS East Park C51 30.06.2025 16:21 52.27701, -4.42466</p>		  <p>WHS East Park 3.1 m box outlet 30.06.2025 16:24 52.27695, -4.42463</p>
Existing Crossing (view from north)		Downstream Outlet (rectangular)
Proposed Crossing Type:	Existing crossing to be maintained

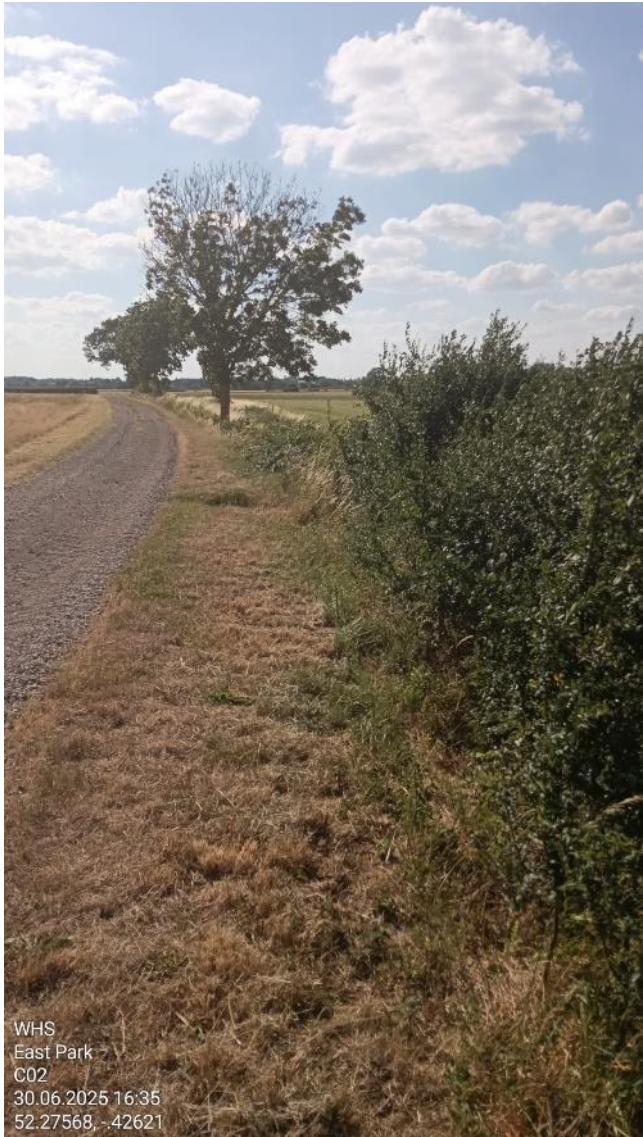
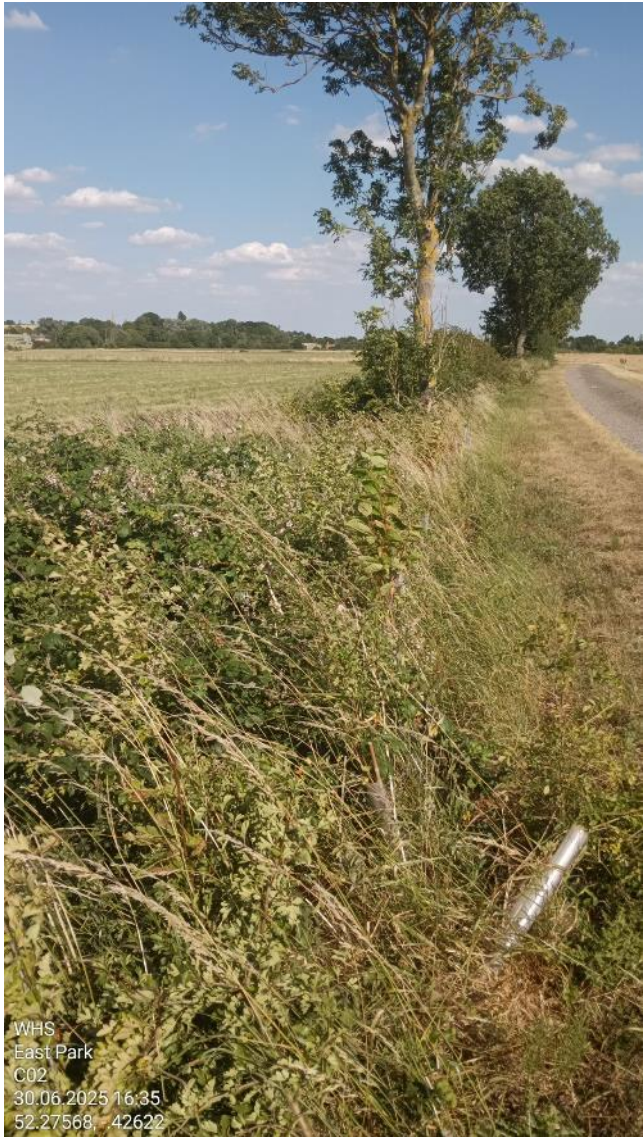
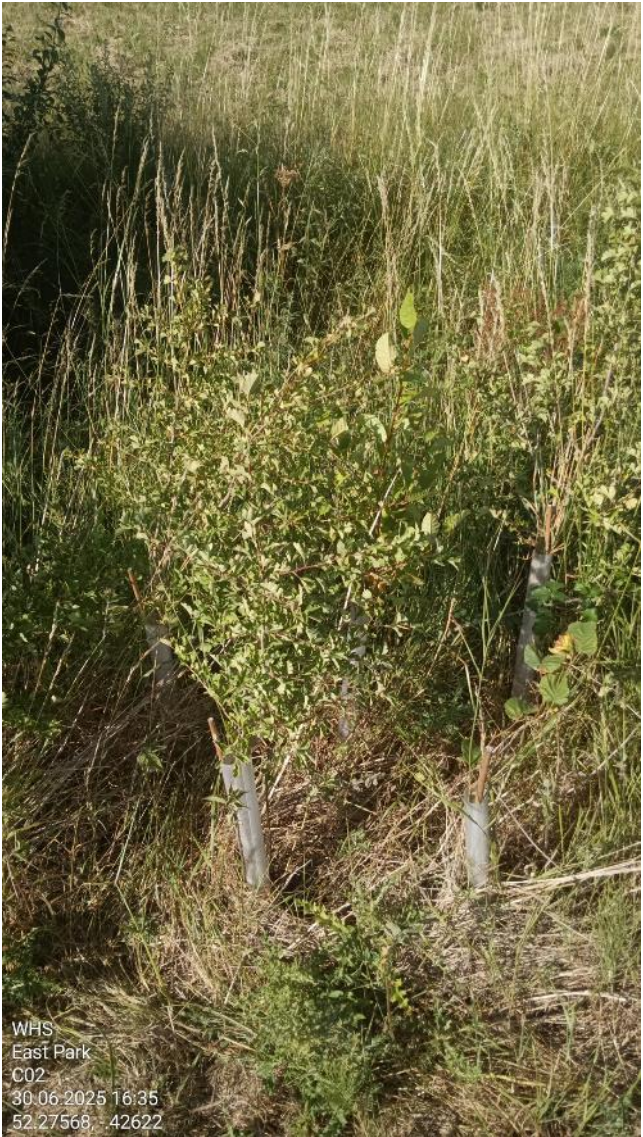
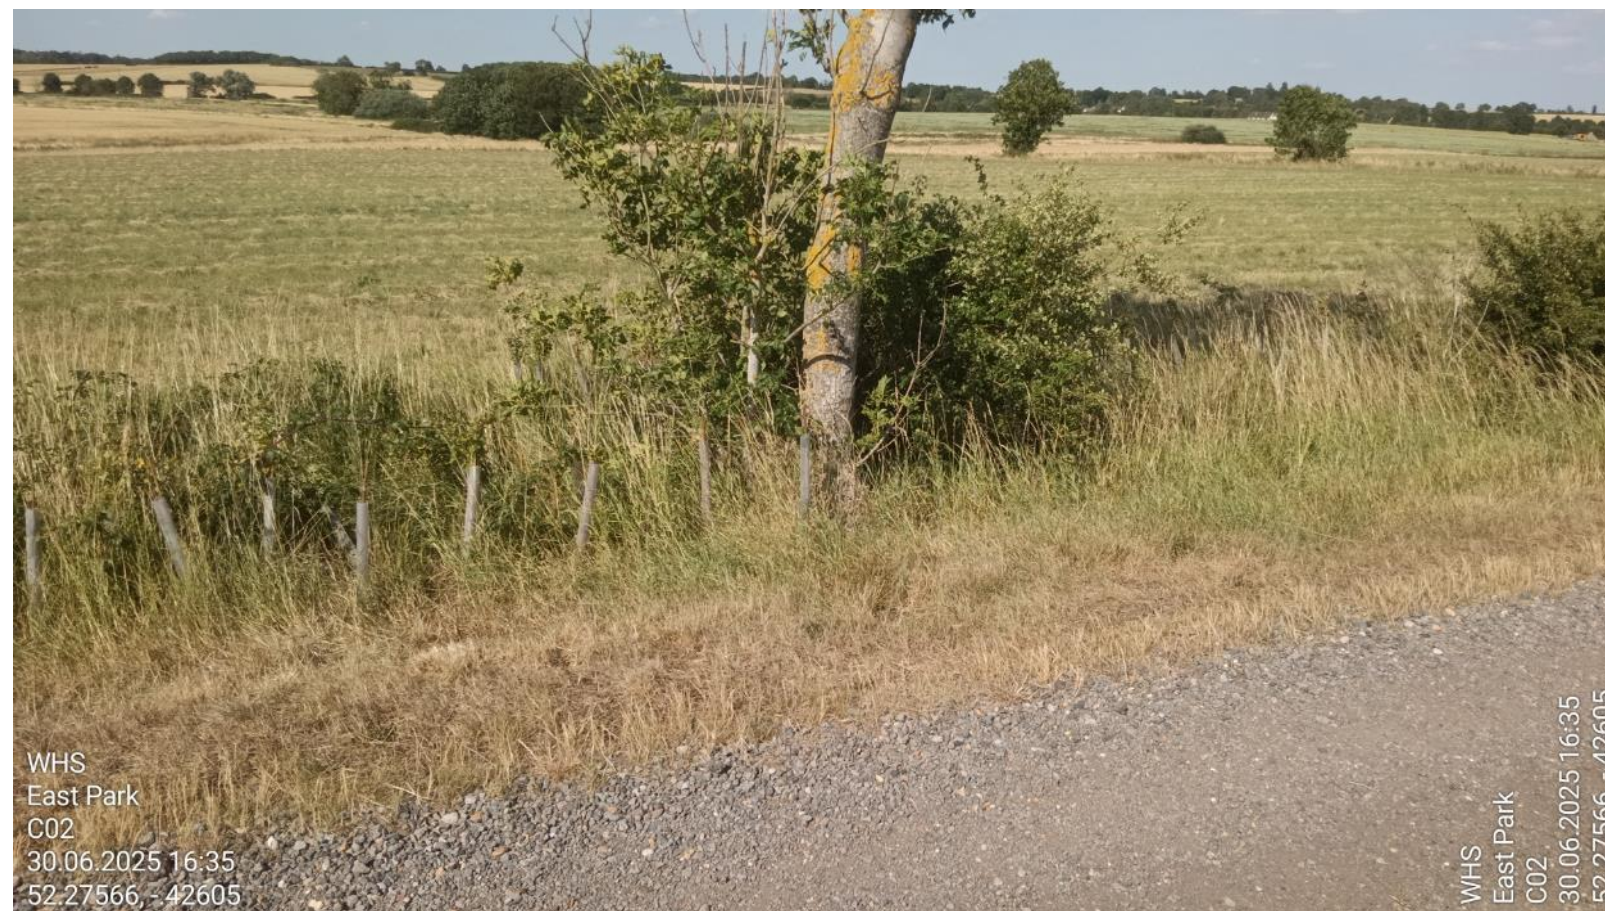
Crossing C02

Crossing	Valley Shape	Wetted Width (m)	Bankfull Width (m)	Channel Max Depth (m)	Bank Profile and Stability	Channel Planform and upstream catchment	Pool Riffle Development	Comments
C02	Expansive fields, gently sloping northwards (field drain)	n/a - dry at time of survey	1.8	1.2	Stable banks, heavy vegetation growth obscuring both banks in photos	Single channel, field drain, reinforced by vegetation. Soft soil bed. Very small contributing catchment, likely 200m downstream of flow split in drain.	n/a.

<div> <div>WHS</div> <div>East Park</div> <div>C02</div> <div>30.06.2025 16:35</div> <div>52.27568, -42622</div> </div>		
View upstream of Proposed Crossing			View downstream of Proposed Crossing			Channel at proposed crossing location

View Across Proposed Crossing Site

Proposed Crossing Type:	Proposed open span crossing, maintaining natural channel bed and banks
-------------------------	--

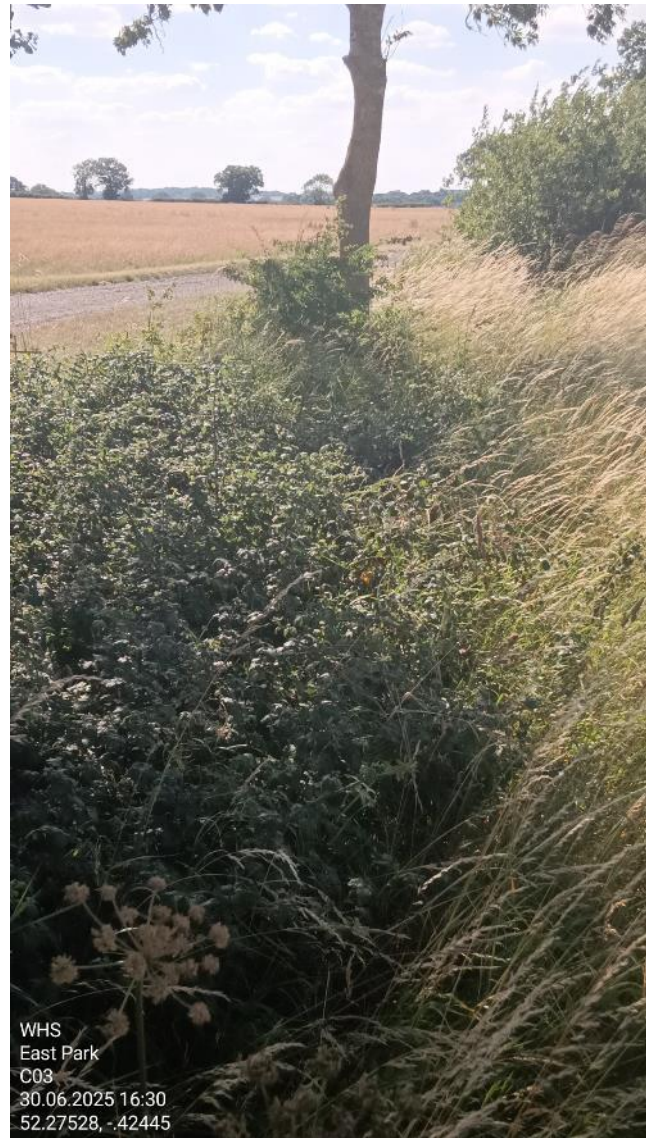
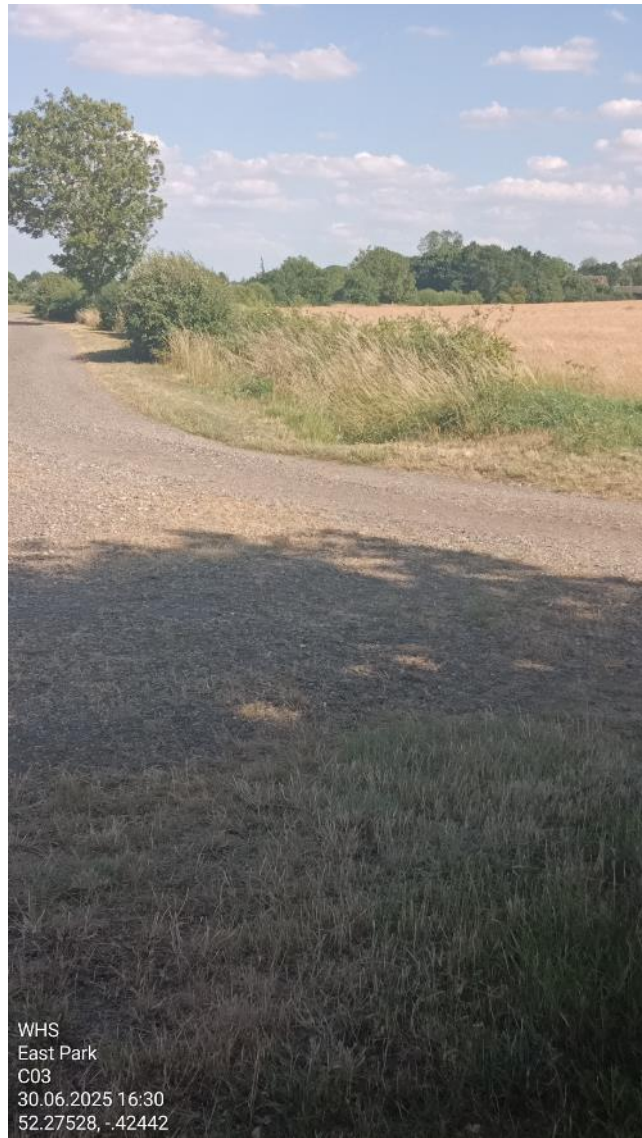
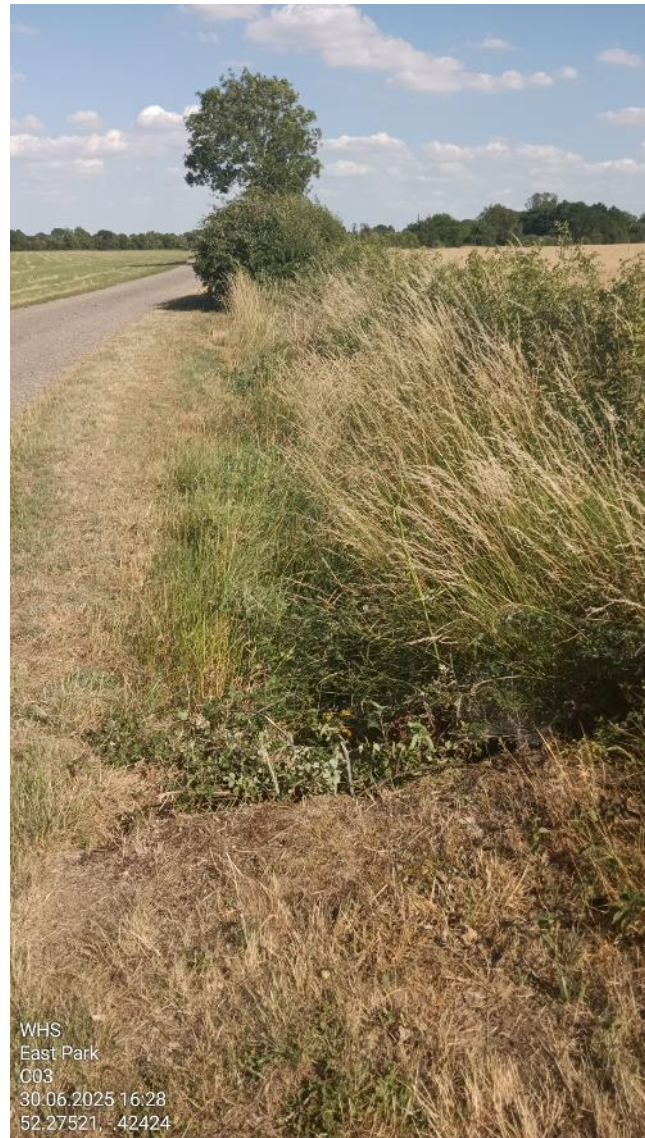
Crossing C03

Crossing	Valley Shape	Wetted Width (m)	Bankfull Width (m)	Channel Max Depth (m)	Bank Profile and Stability	Channel Planform and upstream catchment	Pool Riffle Development	Comments
C03	Expansive fields, gently sloping (field drain)	n/a - dry at time of survey	1.5	1.0	Steep earth bank stabilised by mixture of long grass and shorter maintained grass	Straight gently sloping channel. Small contributing catchment, crossing appears to be 300m from upstream extent (head) of drain.	n/a.	Existing circular culvert under track, 0.3m diameter

Upstream of Crossing			Existing Crossing location			Downstream of Crossing		
Proposed Crossing Type:	Existing crossing to be maintained.

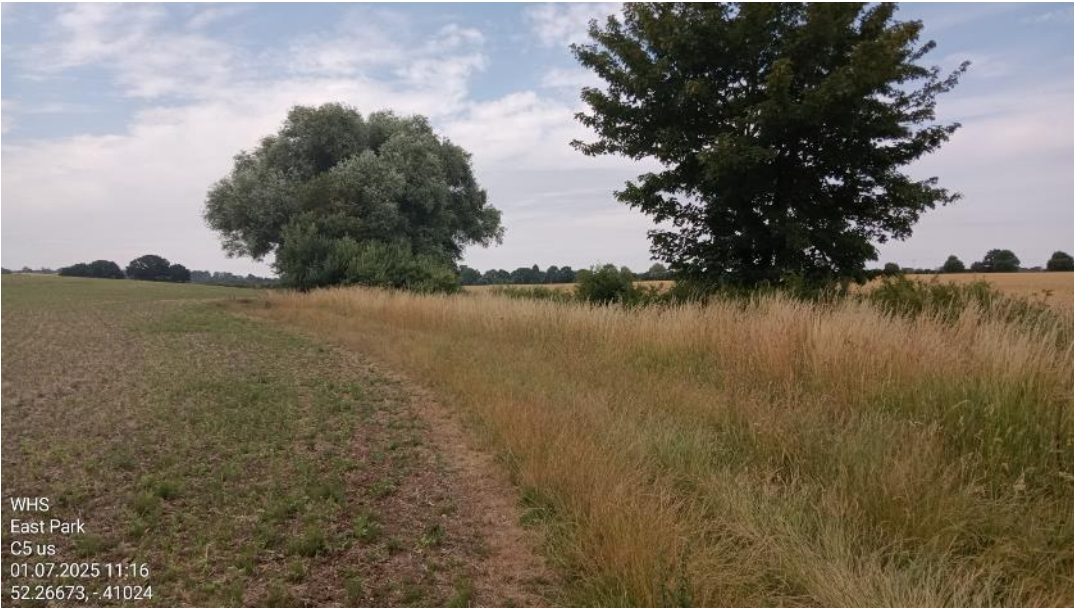
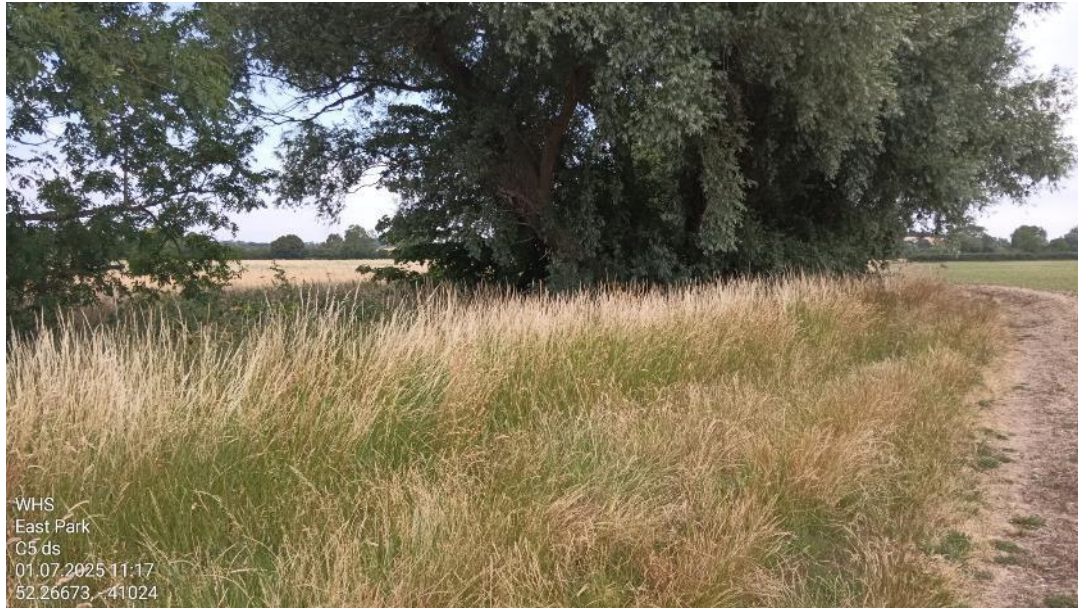
Crossing C05a / C05b

Crossing	Valley Shape	Wetted Width (m)	Bankfull Width (m)	Channel Max Depth (m)	Bank Profile and Stability	Channel Planform and upstream catchment	Pool Riffle Development	Comments
C5b	Expansive fields, relatively flat (field drain)	n/a - mostly dry during visit, occasional ponding observed	4.5	2.5	Earth bank stabilised by mixture of long grass and shorter maintained grass	Gently meandering. Contributing catchment area of 11.9km² is very rural, majority arable farmland.	n/a.	-

Upstream view					Downstream view

<div>WHS East Park C5 01.07.2025 11:14 52.26682, -4.1030</div>		  <div>WHS East Park C5 01.07.2025 11:13 52.26682, -4.1030</div>		  <div>WHS East Park C5 01.07.2025 11:14 52.26682, -4.1030</div>	
Stream bed		Upstream Bed		Downstream Bed	
Proposed Crossing Type:	Temporary construction access. Proposed Bailey Bridge crossing, maintaining natural channel bed and banks

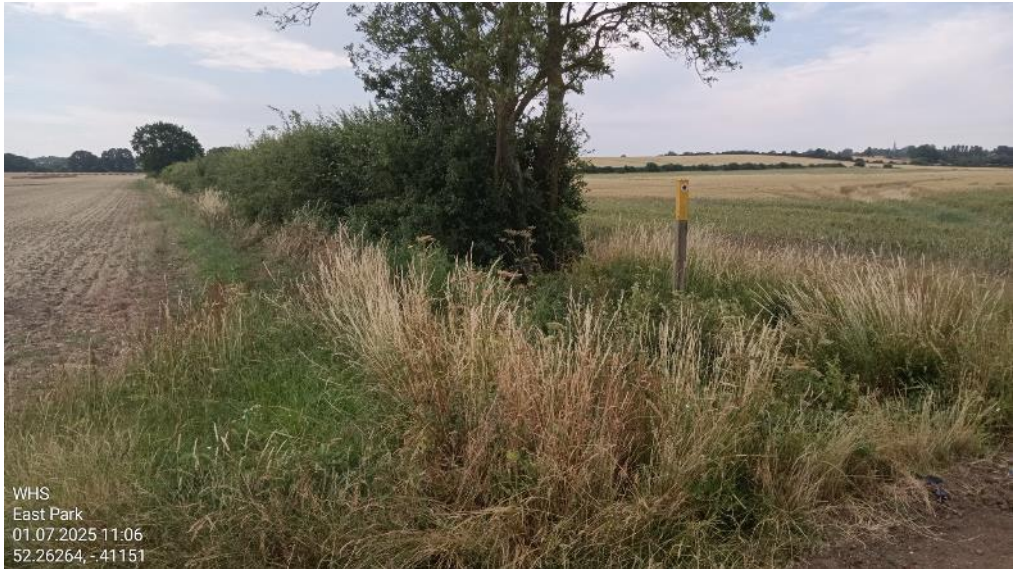
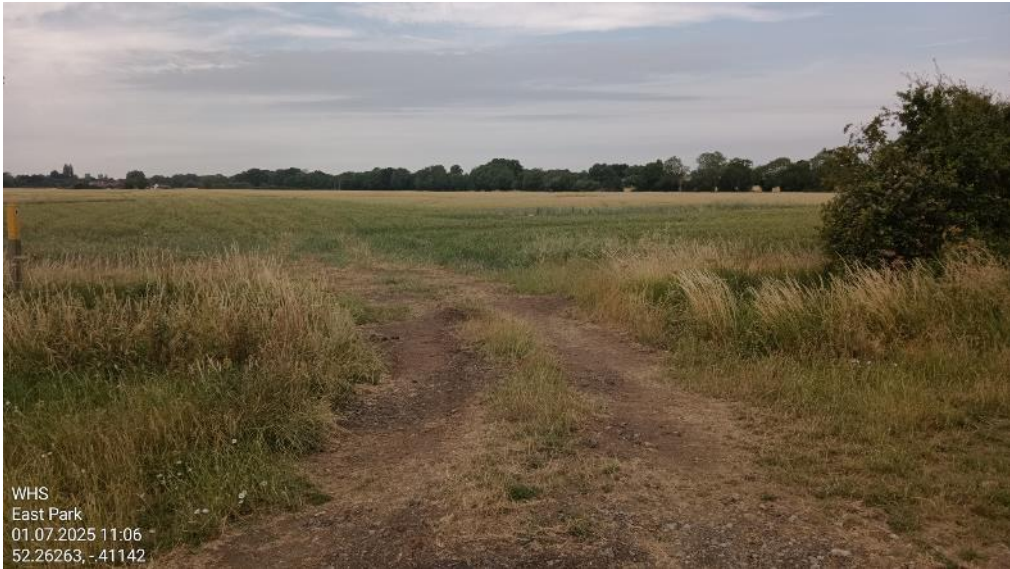
Crossing C06

Crossing	Valley Shape	Wetted Width (m)	Bankfull Width (m)	Channel Max Depth (m)	Bank Profile and Stability	Channel Planform and upstream catchment	Pool Riffle Development	Comments
C06	Expansive fields, relatively flat	n/a - dry at time of visit	1.6m	1.1m	Stable banks, vegetation obscuring most of channel	Single channel - field drain, located on 45° bend of field ditch, otherwise straight with a very gentle gradient. Small contributing catchment, majority arable farmland. Complex network of upstream drains.	n/a.	Existing box (brick) culvert 0.4m wide, 0.5m height. Existing deck width 4.6m.

<div> <div>WHS</div> <div>East Park</div> <div>01.07.2025 11:06</div> <div>52.26263, -41142</div> </div>			
Upstream view					Existing crossing

<p>WHS East Park C06 01.07.2025 11:00 52.26252 - 41159</p>		  <p>WHS East Park C6 01.07.2025 11:05 52.26261 - 41154</p>		  <p>WHS East Park C6 01.07.2025 11:05 52.26261 - 41154</p>
Stream bed		Upstream channel		Downstream channel
Proposed Crossing Type:	Existing Crossing will be maintained

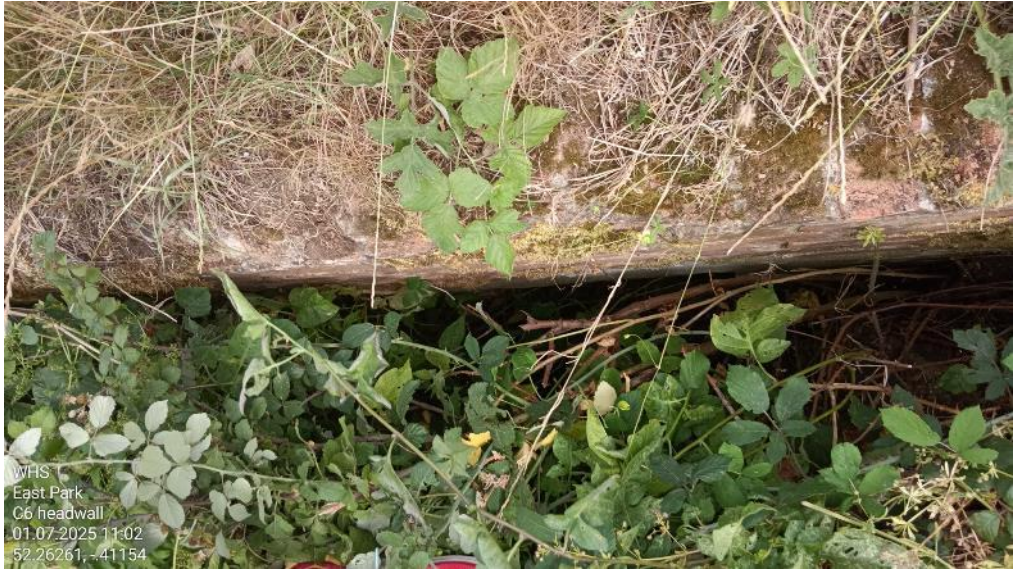
Headwall

<div> <div>WHS</div> <div>East Park</div> <div>C6 headwall</div> <div>01.07.2025 11:02</div> <div>52.26261, -41154</div> </div>

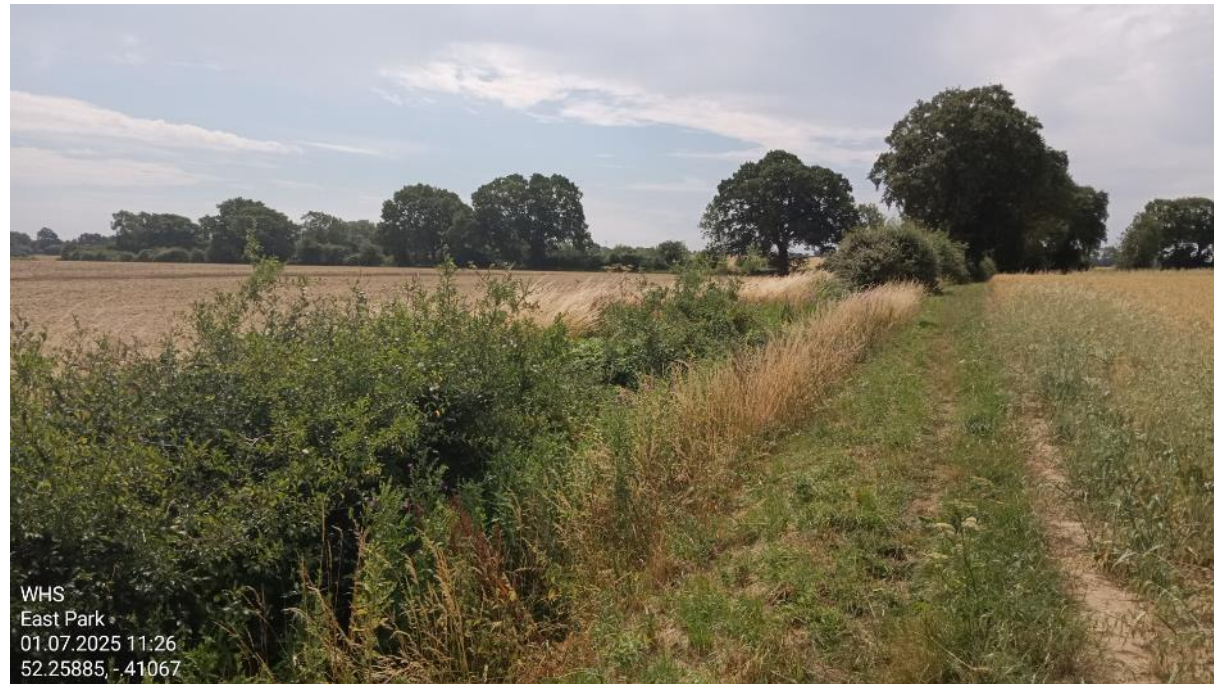
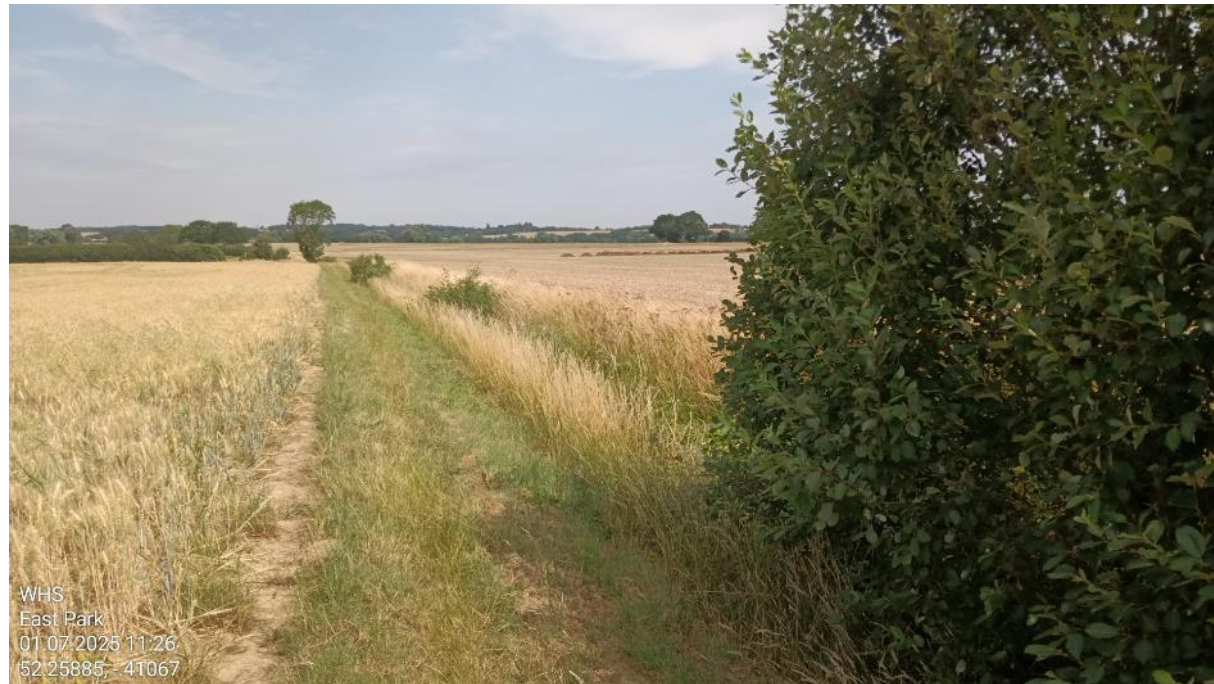
Crossing C08

Crossing	Valley Shape	Wetted Width (m)	Bankfull Width (m)	Channel Max Depth (m)	Bank Profile and Stability	Channel Planform	Pool Riffle Development	Comments
C08	Expansive fields, relatively flat	n/a - dry at time of visit	2.0	1.6	Earth banks with significant vegetation growth, including large shrubs	Single channel on gently sweeping bend. Field drain. Soft soil bed with occasional trees within channel. Shallow gradient. Complex upstream network of drains, small contributing catchment, likely less than 3km², largely rural.	n/a	-

<div>WHS East Park 01.07.2025 11:26 52.25885, -41067</div>			
Upstream					Downstream			
Proposed Crossing Type:		Proposed open span crossing for access track, maintaining the natural channel bed and banks

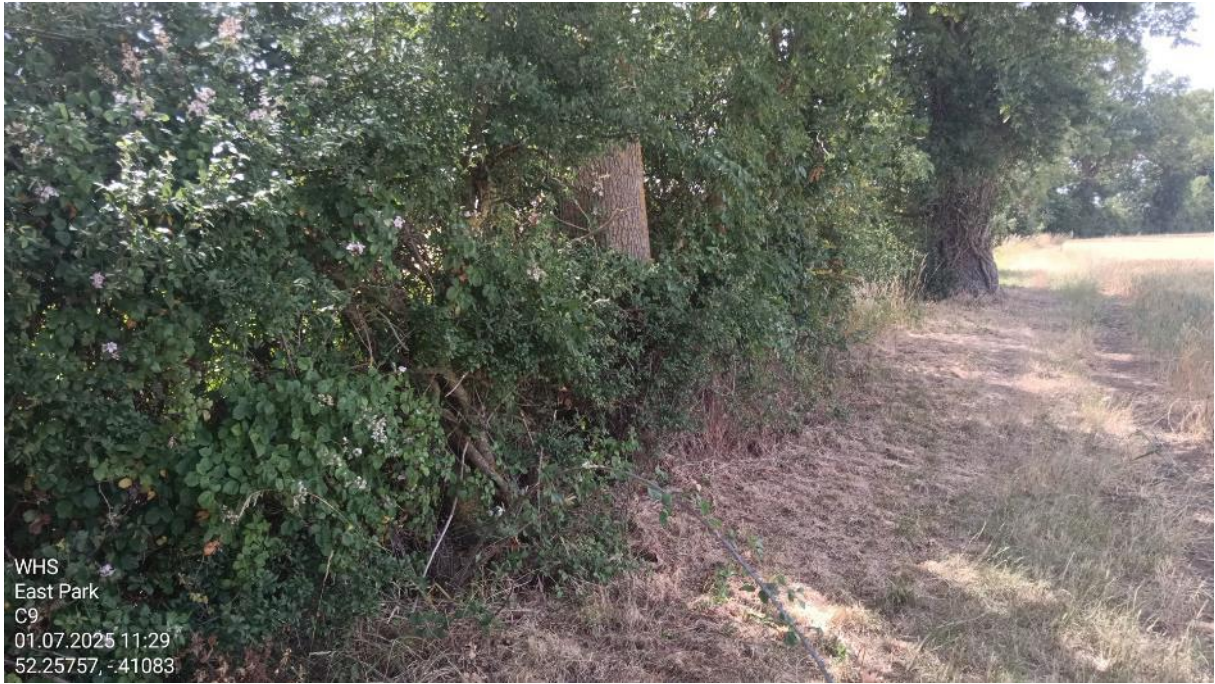
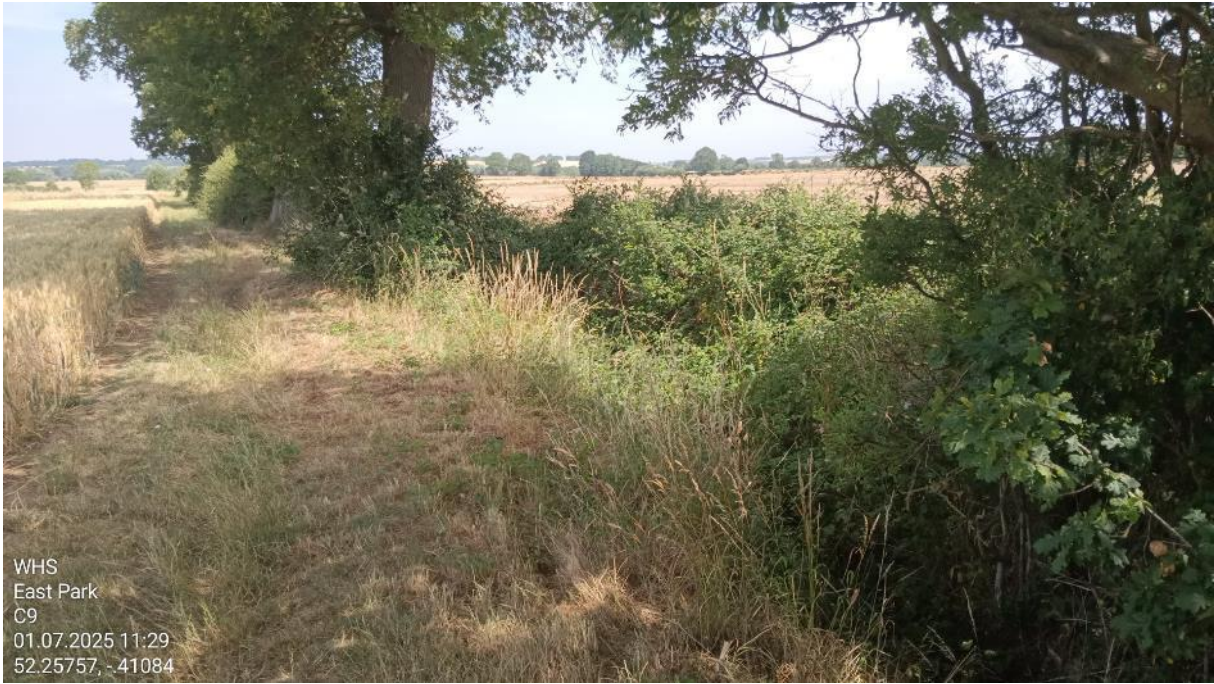
Crossing C09

Crossing	Valley Shape	Wetted Width (m)	Bankfull Width (m)	Channel Max Depth (m)	Bank Profile and Stability	Channel Planform and upstream catchment	Pool Riffle Development	Comments
C09	Expansive fields, relatively flat	n/a – dry at time of visit	2.2	0.8	Stable banks, significant growth of large shrubs and trees within channel and on banks near crossing site.	Drain connecting two larger networks, flow direction uncertain, though likely westwards. Relatively straight reach. Likely very small contributing catchment (less than 1km ²).	n/a.	-

<div> <div>WHS</div> <div>East Park</div> <div>C9</div> <div>01.07.2025 11:29</div> <div>52.25757, -41084</div> </div>			
Upstream view					Downstream view

Channel Bed at Crossing (earth bed visible)		Upstream Channel view	Downstream Channel view
Proposed Crossing Type:	Proposed open span crossing for access, maintaining natural channel bed and banks

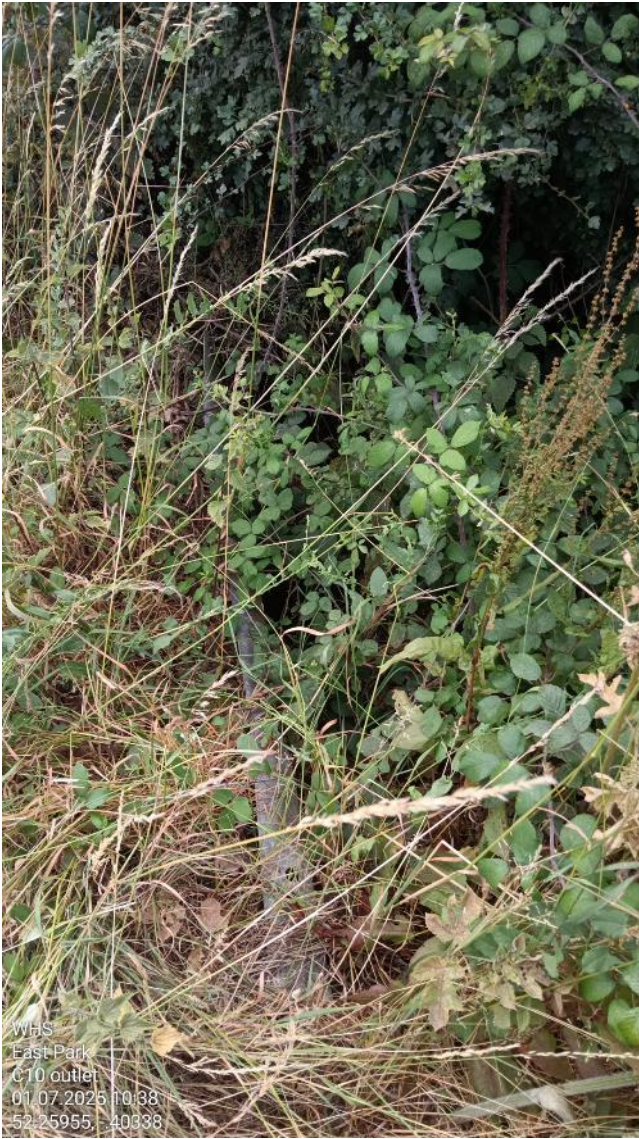
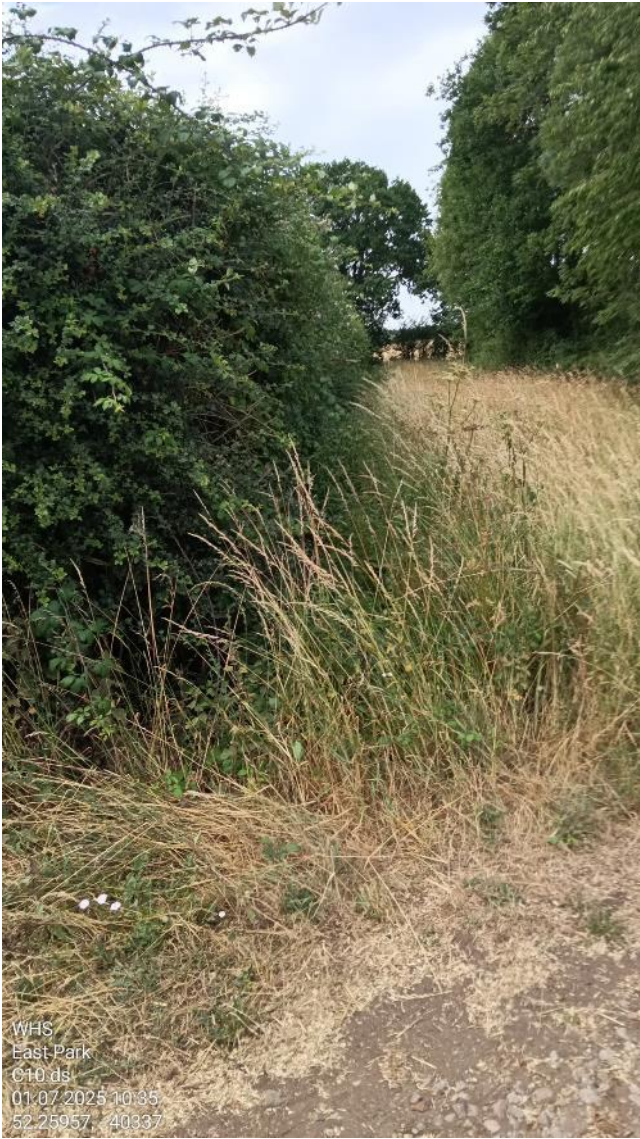
Crossing C10

Crossing	Valley Shape	Wetted Width (m)	Bankfull Width (m)	Channel Max Depth (m)	Bank Profile and Stability	Channel Planform and upstream catchment	Pool Riffle Development	Comments
C10	Expansive fields, relatively flat	n/a – dry at time of visit	2.0	0.8	Shallow, stable banks	Single channel field drain, culvert located on bend, banks reinforced by vegetation. Gentle gradient. Very small contributing catchment (less than 1km²), entirely rural.	n/a.	1.5m top opening width for existing culvert, though heavy vegetation growth and soil accumulation has constricted opening. 6m deck width.
  <div> <div>WHS</div> <div>East Park</div> <div>C10 inlet</div> <div>01.07.2025 10:36</div> <div>52.25960, -40331</div> </div>

Inlet			Outlet			Downstream view

<div>Existing Crossing location (view from downstream to upstream)</div> <div>Looking upstream (channel on left of track)</div>	
<div>Proposed Crossing Type:</div>	<div>Access track to utilise existing crossing.</div>

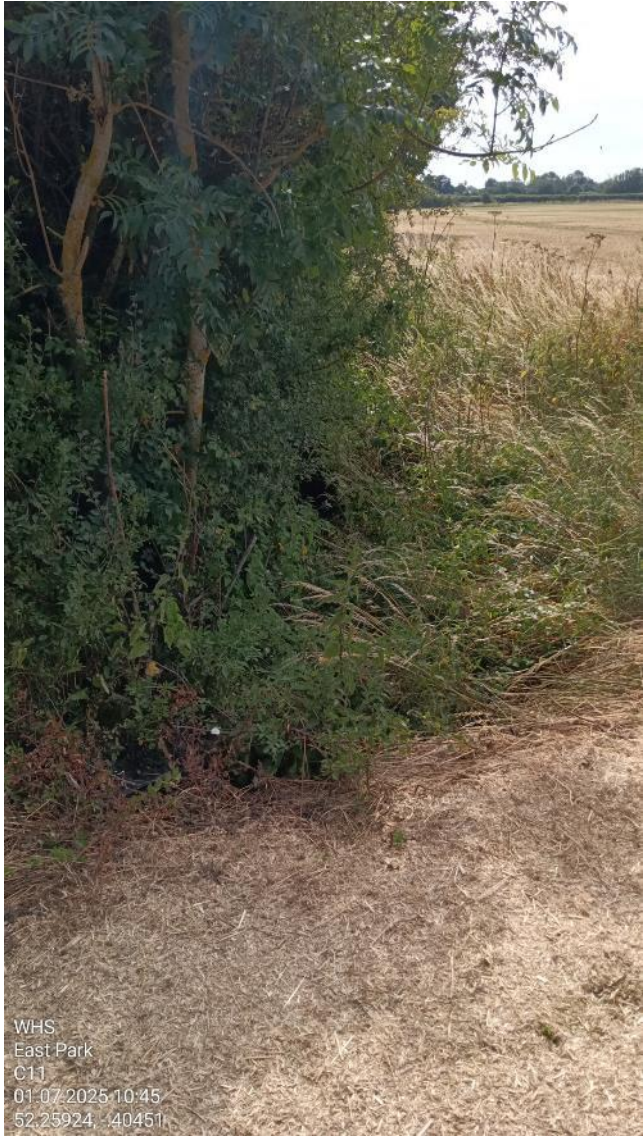
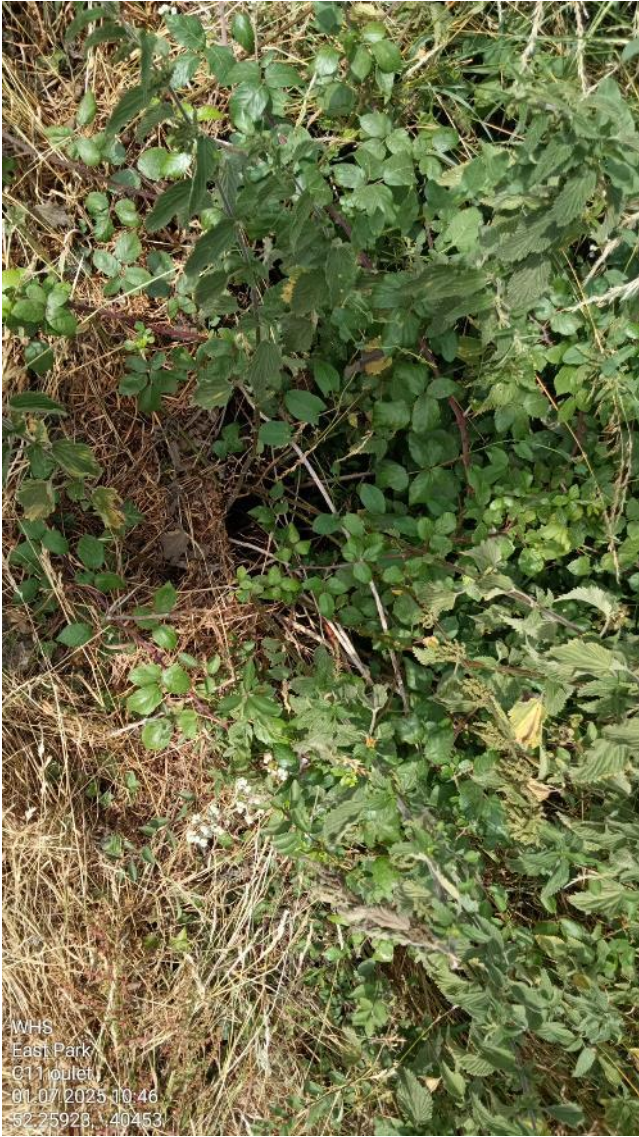
Crossing C11

Crossing	Valley Shape	Wetted Width (m)	Bankfull Width (m)	Channel Max Depth (m)	Bank Profile and Stability	Channel Planform and upstream catchment	Pool Riffle Development	Comments
C11	Expansive fields, relatively flat. 7m upstream of confluence.	n/a – dry at time of visit	1.9	0.9	Relatively shallow banks, coarse stone bed	Single channel field drain, immediately upstream of confluence with larger stream. Complex upstream network of drains, however catchment likely less than 1km² and almost entirely rural (arable farmland).	n/a.	Existing crossing deck width of 4.8m. Heavy vegetation meant unable to accurately determine existing culvert dimensions, roughly measured 1.5m width (rectangular), uncertain if natural bed under crossing.

Inlet/Upstream			Outlet			Downstream

Existing crossing looking north		Existing crossing looking south	
Proposed Crossing Type:	Access track to utilise existing crossing

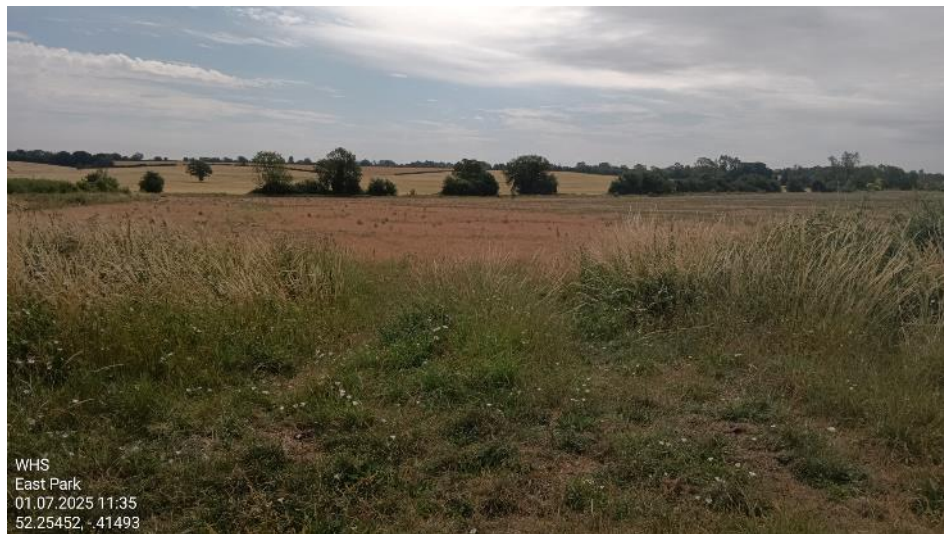
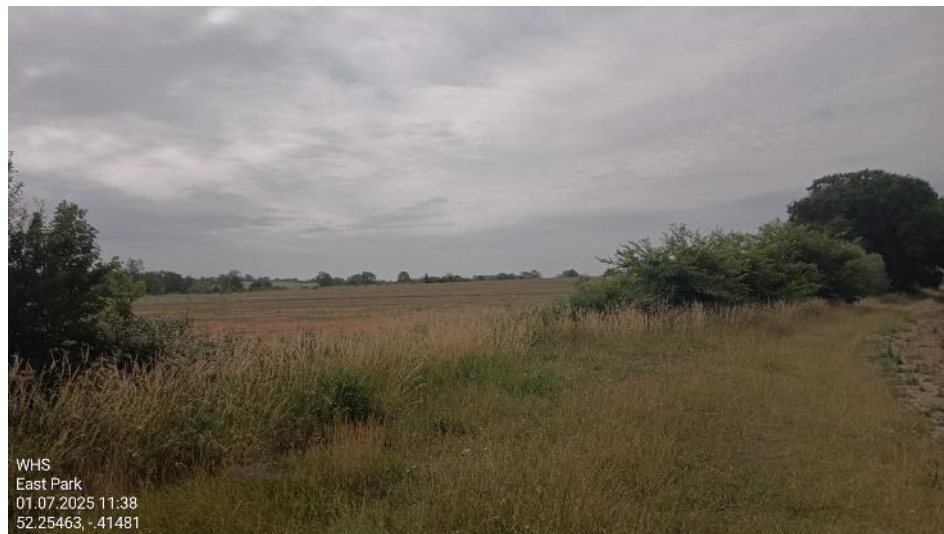
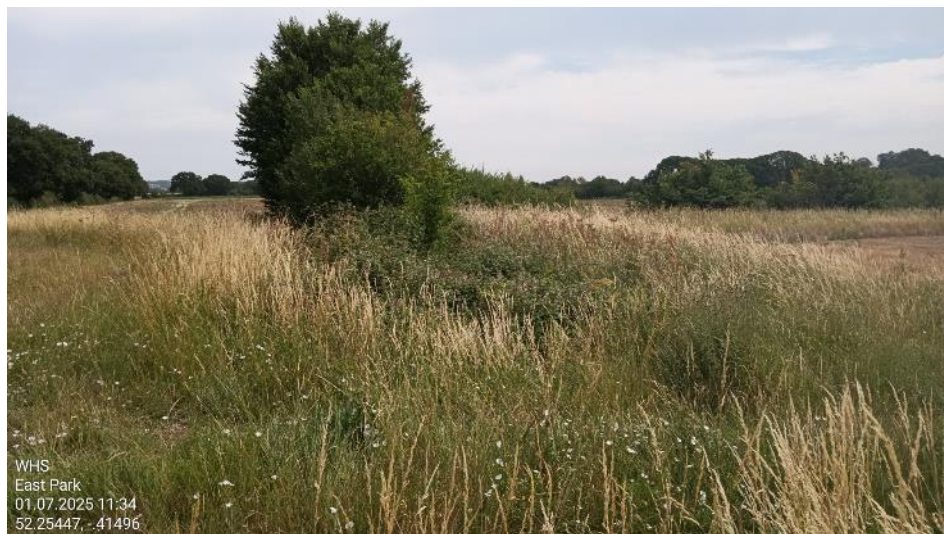
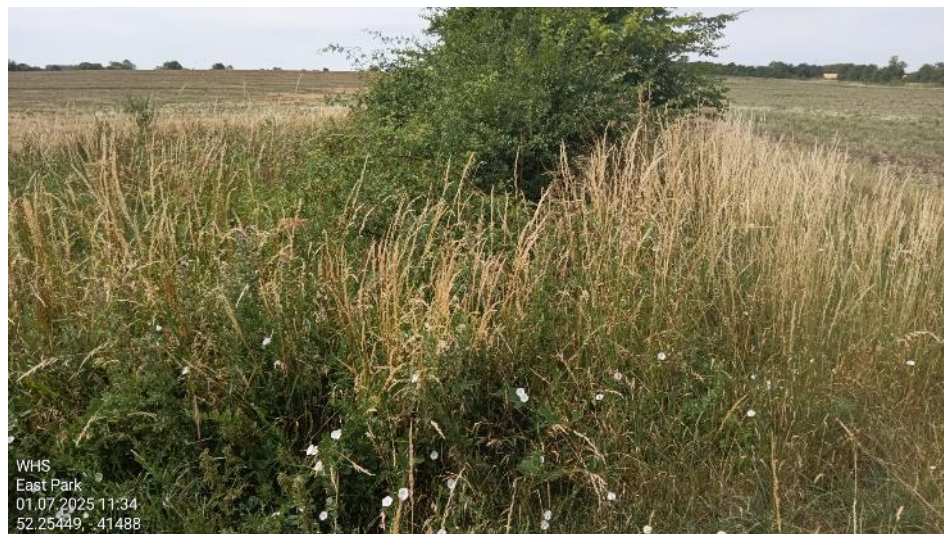
Crossing C12

Crossing	Valley Shape	Wetted Width (m)	Bankfull Width (m)	Channel Max Depth (m)	Bank Profile and Stability	Channel Planform and upstream catchment	Pool Riffle Development	Comments
C12	Expansive fields, relatively flat	n/a – dry at time of visit	Too overgrown to measure - likely less than 2m	n/a	Shallow banks reinforced by significant vegetation growth,	Single channel field drain, 24m upstream of right angle bend – otherwise straight. Complex upstream network of drains, small contributing catchment, likely less than 2.5km², largely rural (arable farmland).	n/a.	Existing deck width of ~4m. Overgrowth too dense to accurately measure channel or culvert.

<div>WHS East Park 01.07.2025 11:38 52.25463, -41481</div>			
Existing Crossing					Upstream

Downstream					Drain Channel			
Proposed Crossing Type:		Existing crossing to be maintained (assumed existing culvert)
